Ty Pair, Mynachlog Fawr, Strata Florida, Pontrhydfendigaid, Ceredigion.

Archaeological Excavation & Watching Brief

HRSWales
Report No: 222

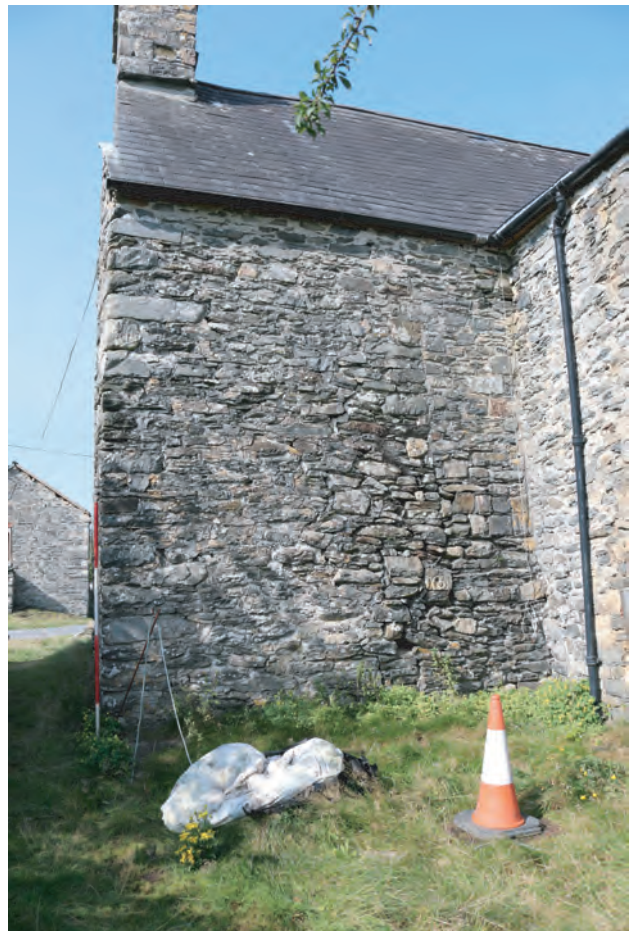
Plate 10(c). Far southern end of east wall of Mynachlog Fawr showing numerous features including apparent line of former tall window.

- 6.9 At the far south end of the east facing external elevation is an apparent blocked in tall window that has been interpreted as a possible former medieval lancet window. This is evident from an apparent joint line and a possible cill (see Photo 10(c)) However, the fact that this section of wall appears to have been rebuilt and repaired on a number of occasions in the past, with re-use of abbey stones, as well as a number of other smaller anomalous features within the fabric around the blocked window, add to the confusion in interpreting this feature. However, what is certain is the fact that the width and continuation of this wall within the interior of the house does suggest that this wall may well have a late medieval foundation.

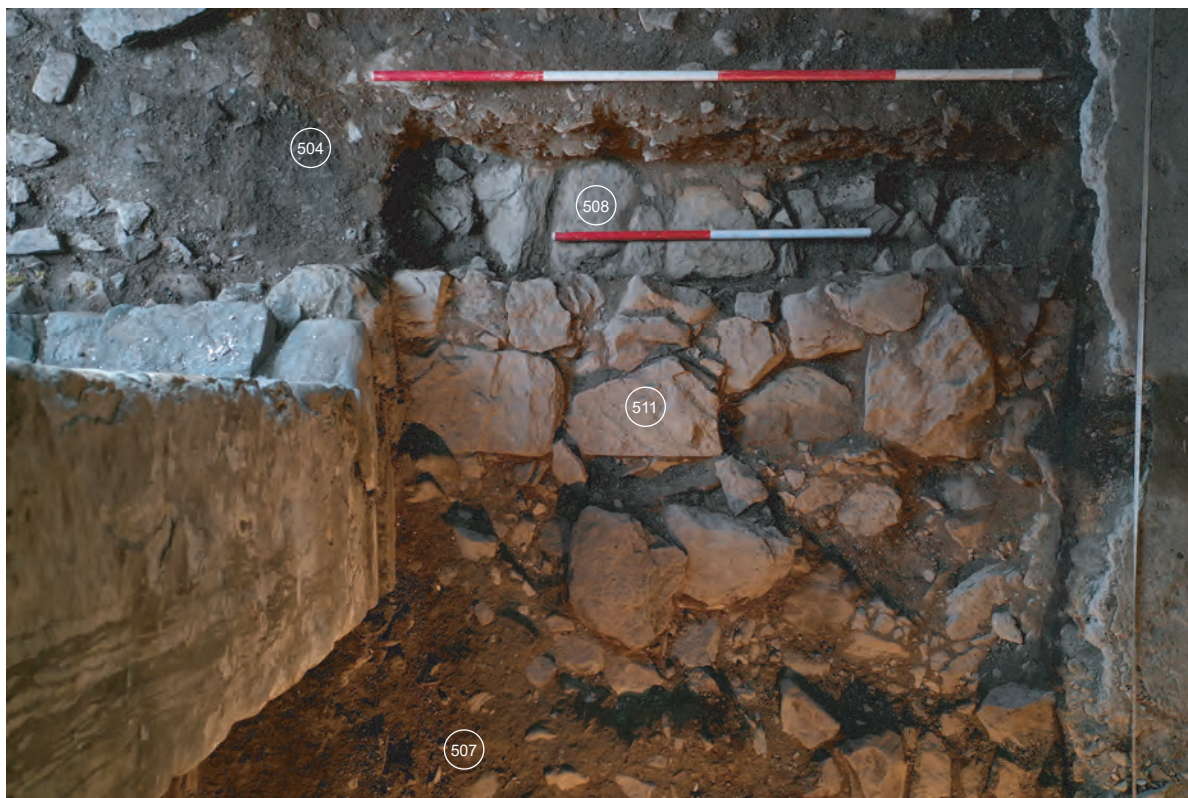
Plate 86. Trench 5 - Aerial drone photo of section of Refectory west wall (508) exposed following insertion of investigation trench. Note parallel wall (511) running alongside Refectory wall.

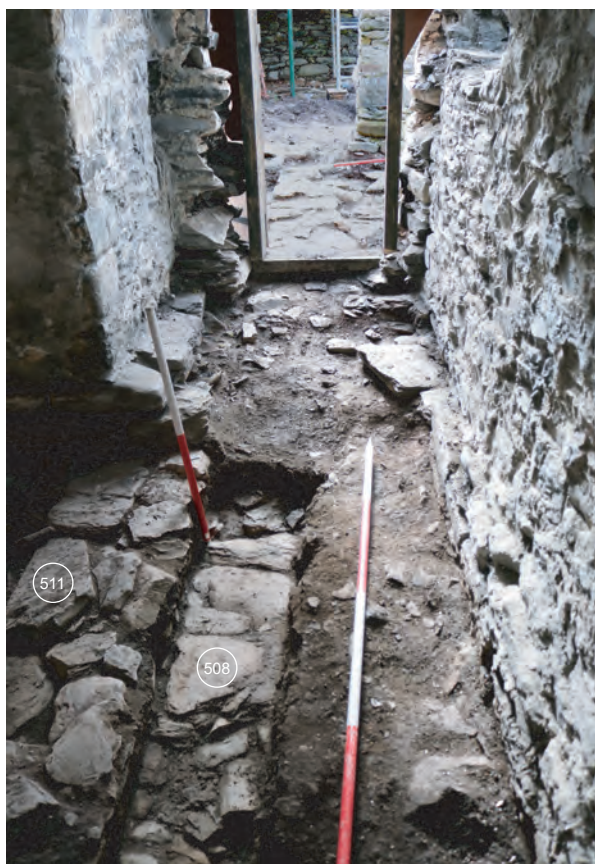
Plate 87. Trench 5 - View of section of Refectory west wall (508) and parallel wall (511) running alongside. Looking south with continuation of Refectory wall in background..

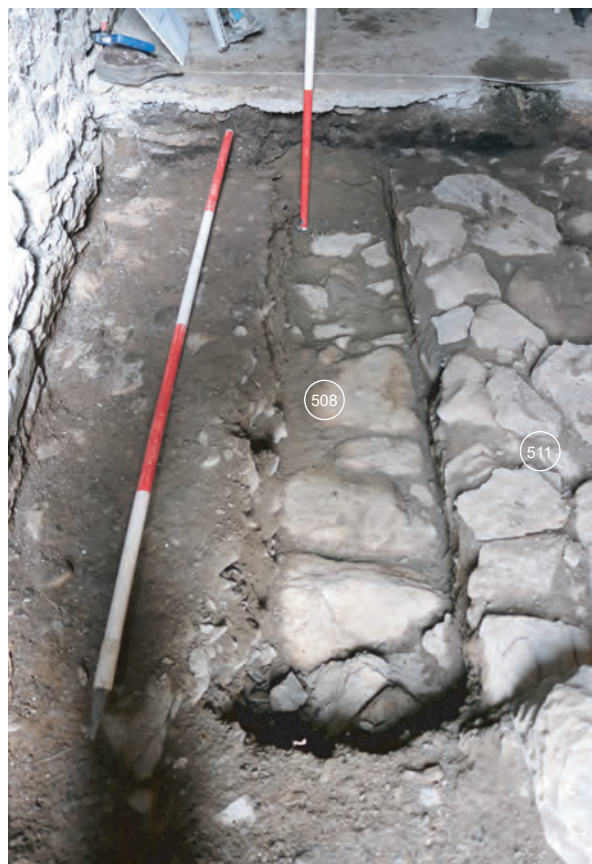
Plate 88. Trench 5 - View of section of Refectory west wall (508) and parallel wall (511) running alongside. Looking north.

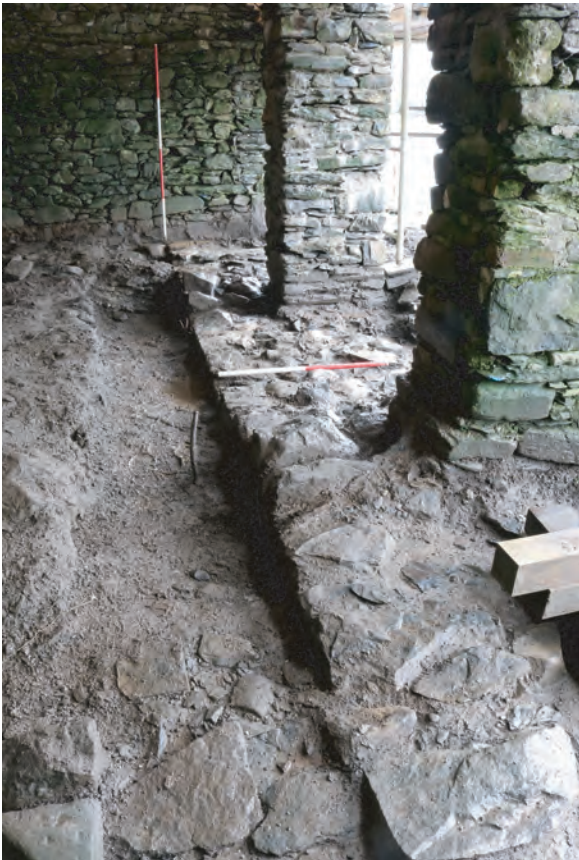
Plate 108. Cart Shed - Continuation of Refectory west wall now fully exposed within Cart Shed following removal of slabs and floor reduction work. Looking southwest.

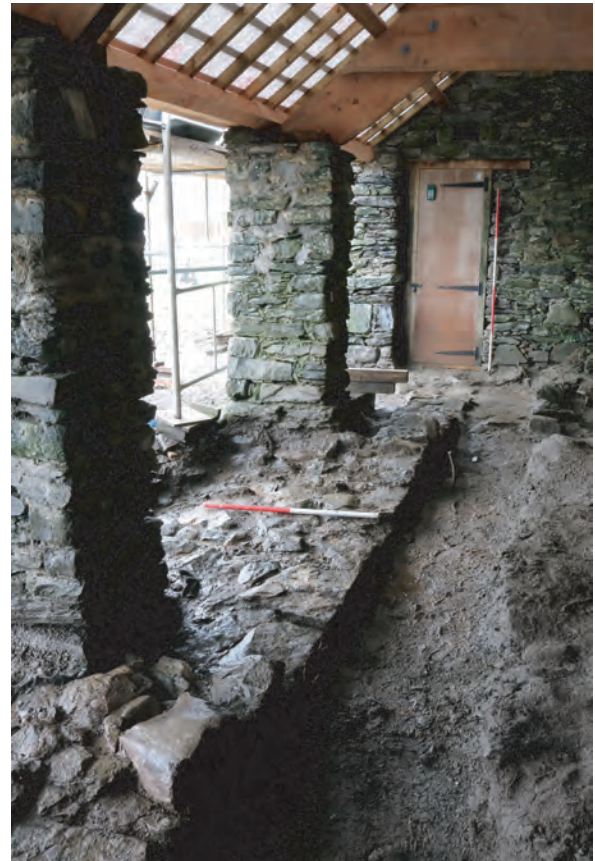
Plate 109. Cart Shed - Continuation of Refectory west wall now fully exposed within Cart Shed following removal of slabs and floor reduction work. Looking northwest.

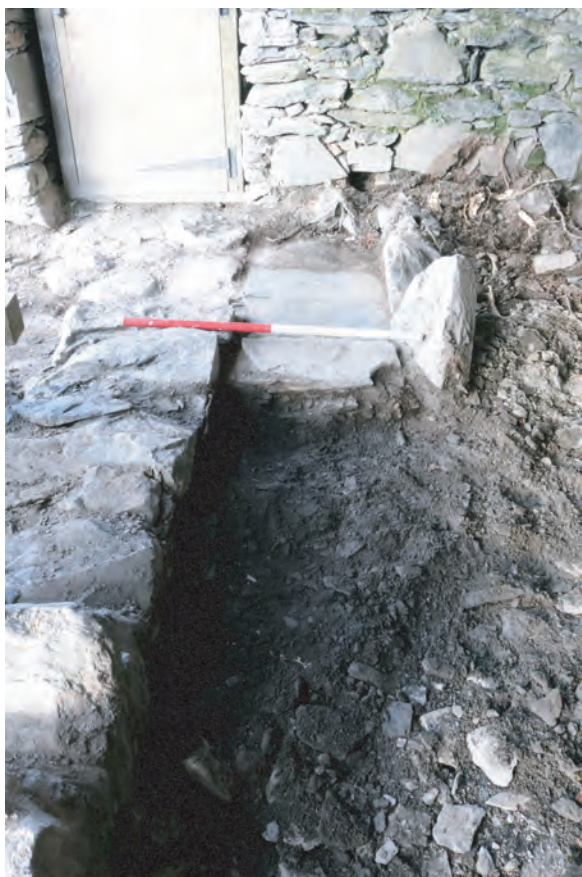
Plate 115. Cart Shed - Investigative slot inserted into drain feature (208) at north end of Cart Shed in order to investigate possible continuation of feature (511) edxposed within Trench 5 in Bakehouse. Looking north.

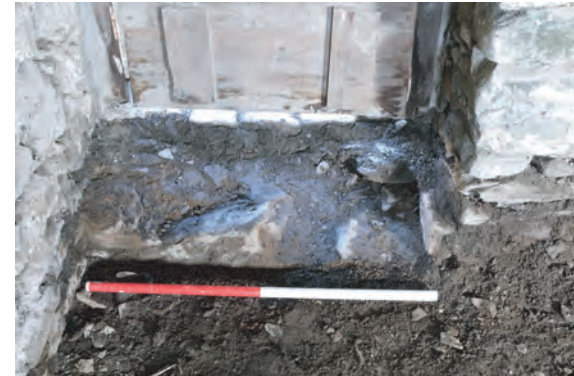
Plate 128. Oven/Bake House - Base of opening in east wall showing continuation of wall foundation, implying doorway is a later insertion.
