**Quay Street
Cardigan, Ceredigion**

Archaeological Evaluation

**Landsker Archaeology Ltd.
Project 810, 5 August 2009**

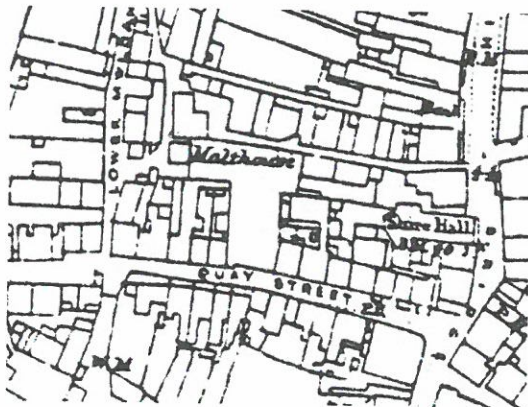
Figure 4 Ordnance Survey 1890 25inch

The final map of the series is the Ordnance Survey map of 1890. The entire site is clear of structures with the malthouse being entirely on the west side of the present west boundary wall of the site. This was not certain prior to the excavation and it was thought possible that the malthouse might have lain inside the limits of the site.

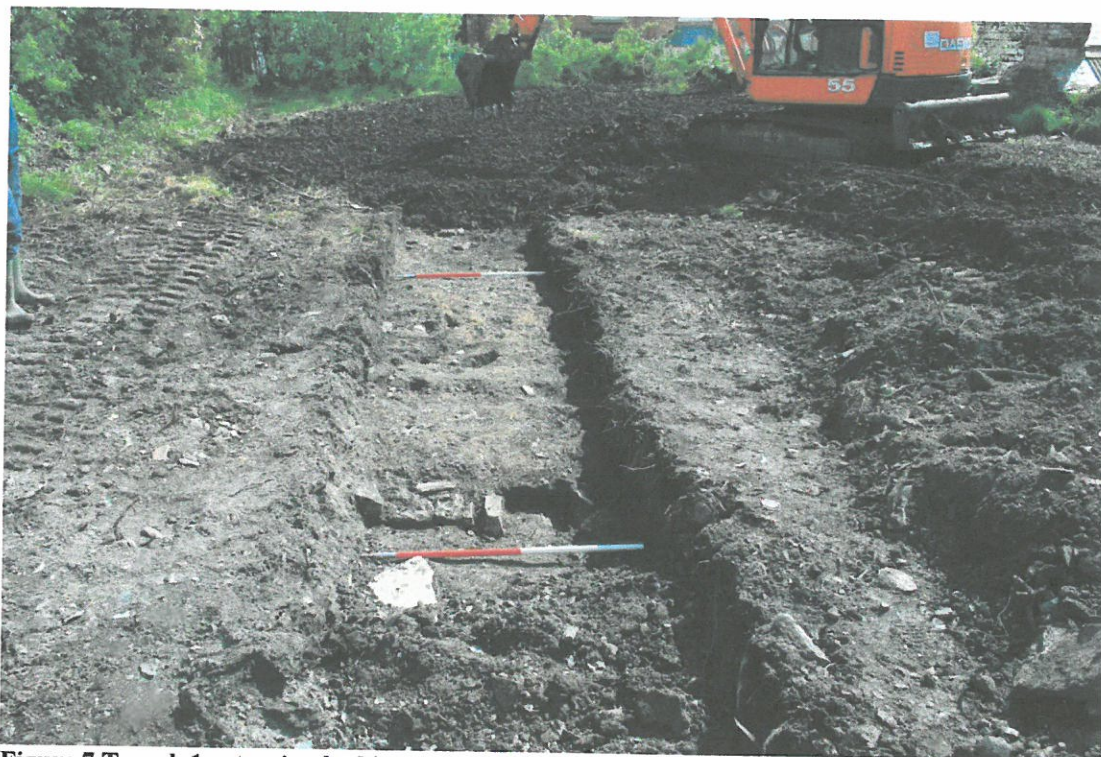
Figure 7 Trench 1 extension looking south at wall base 106

cement. The stone wall base (106) found in the extension of trench 1 could well relate to this period.

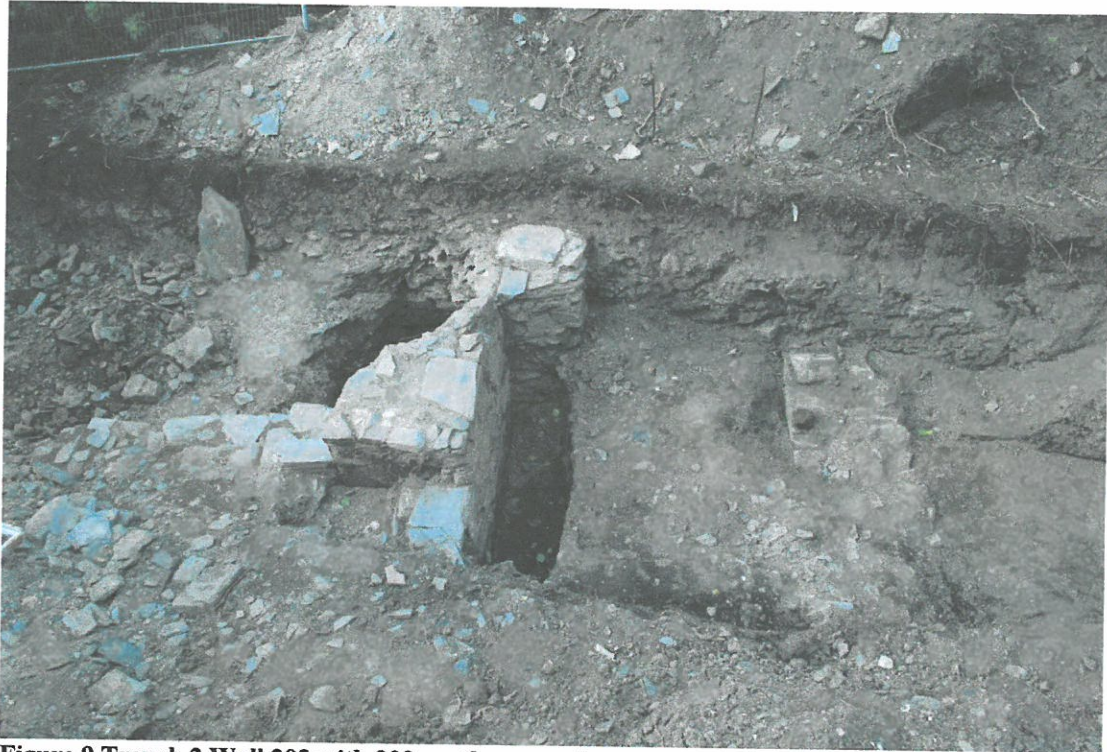
The main features of this trench were a series of stone walls to the west of the site, forming parts of structure shown on maps of 1833. These buildings appeared to have been demolished around the 1850's when the present structure of walls enclosing the site was formed. The building consists of a wall running north to south (202) with a window opening (204) to the south and some form of opening to the north, possibly an oven, which incorporated bricks. This structure was not fully exposed and was largely collapsed (203). Within the interior of the building was a dividing wall (205) built later than the wall and lying between (204) and (203).

Figure 9 Trench 2 Wall 202 with 209 partly exposed

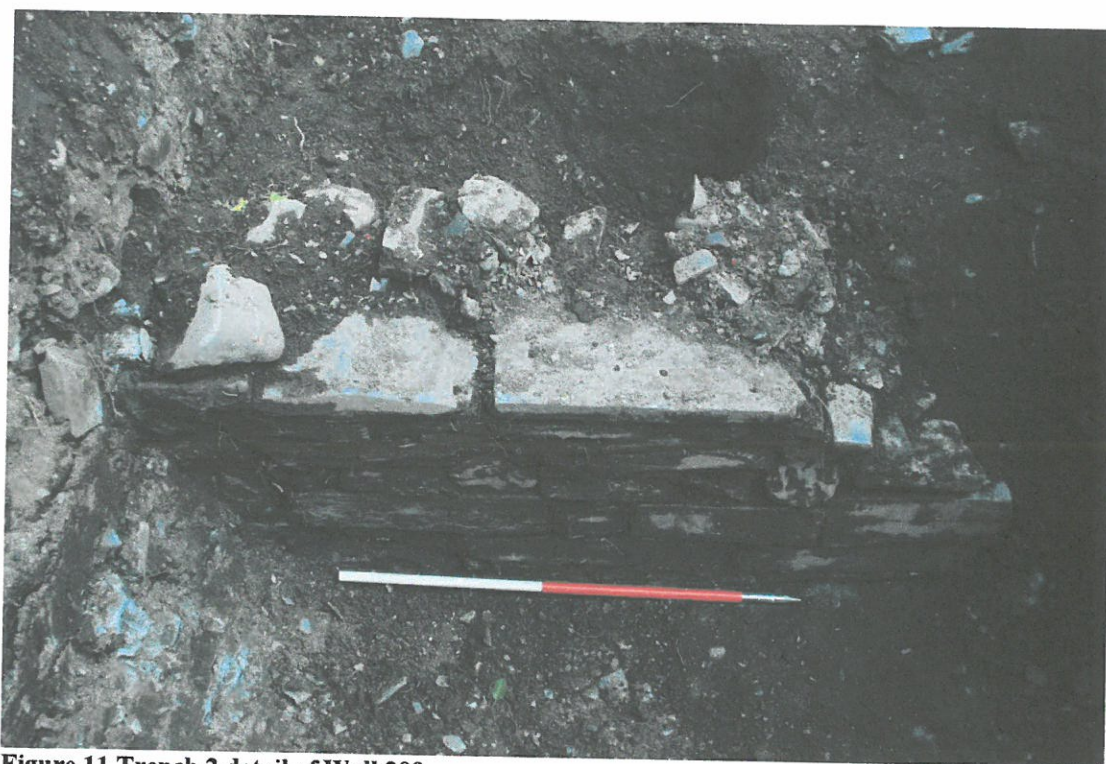
To the east of the structure was a wall (209) built of slate slabs and appearing to contain rounded stones, similar in form to the 'banded' construction style of many walls in Cardigan and the district. This wall appeared to be a retaining wall for the soil that built up from the uphill, east side of the site (207) and (208).

Figure 11 Trench 2 detail of Wall 209

The wall to the side of Market Lane will be removed. This should be recorded before it is removed as it contains evidence of the local 'banded' building style.

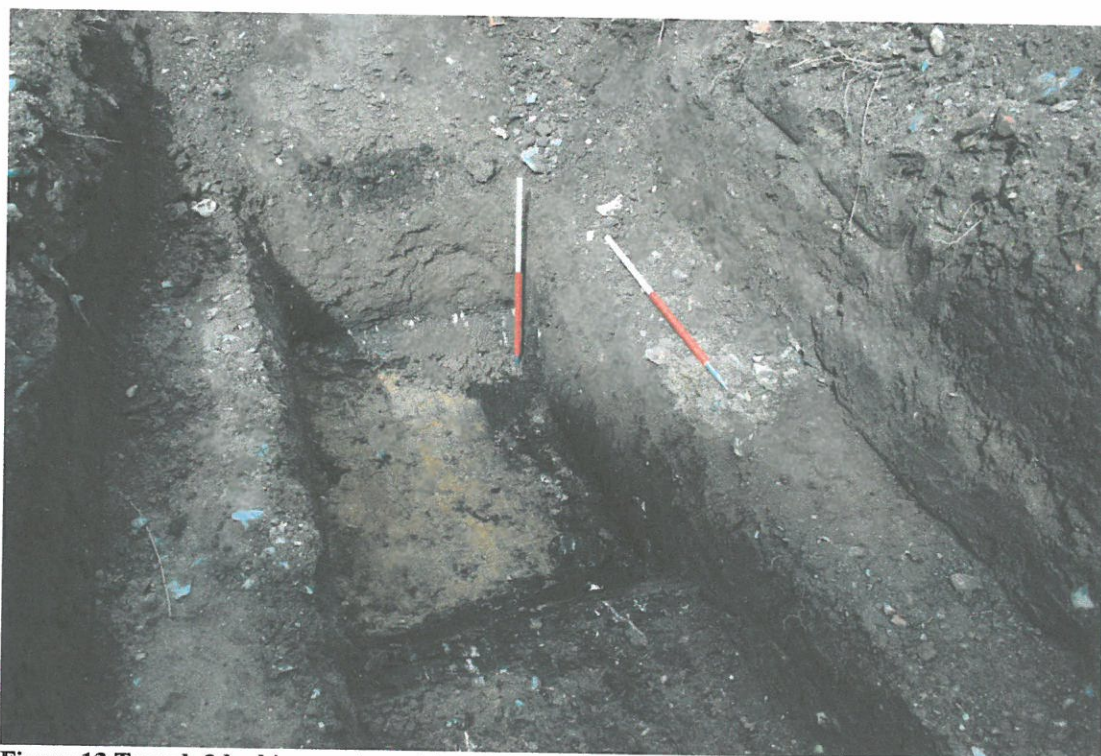
The base of the hollow was filled with a silty clay loam (311) containing rounded pebbles and also a high proportion (up to 10%) of limestone fragments and flecks. The layer appeared to be running down hill from east to west, filling the gully from the uphill side, as shown by the orientation of stones. The limestone fragments were found throughout the extent of the trench, and appeared to be concentrated to the uphill side as though the point of origin was not very distant. The hollow appeared to be filled by deposits with a high humic content as though the environment had been damp and undisturbed (314) with evidence of gradual filling along with episodes of more dramatic levelling suggested by a dump of mortar and stone (307) which formed a band across the west of the trench. The upper horizons of the trench were clean brown humic loam (309), (310), (313) and (302).

Figure 13 Trench 3 looking west machine cut deposits at base of hollow
