## **1.0 Introduction**

- 1.0.3 A Historic Buildings Pilot Project has been set up to develop a broad understanding of farmsteads in their historic and landscape context, and has been made possible by a grant from Cadw. It is recognised that farmsteads are an important component of the historic environment, and contribute to local and regional distinctiveness. However, compared with other rural building types, such as houses and places of worship, farm buildings are comparatively poorly understood. The pilot study is a characterisation of the surviving stock of farm buildings, which draws out themes and patterns in the built heritage, and considers variables such as geographical, social and chronological factors.

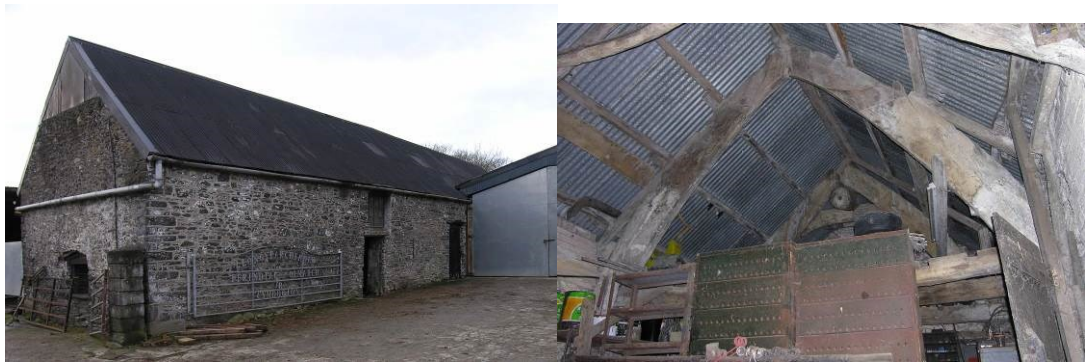
Fig 2. Exterior and roof truss of Gelligarneddau barn (Llangybi).

- 2.0.5 Only a minority of farmsteads in south-west Wales have buildings erected before 1800. At Gelligarneddau (Llangybi) is a large barn with a seventeenth-century roof that must have served a holding much larger than the present farm (fig 2). It stands in a farmstead loosely organised around a yard. A smaller barn at Pencefn (Tregaron) on the edge of Tregaron bog is dated 1689. It stands behind the late nineteenth-century farmhouse in an illogical position relative to the nineteenth-century farm buildings forming the main yard. The barn may be earlier, but it had been left isolated from the main farm group in nineteenth-century improvement. Another early barn, at Derlwyn Fawr (Llangeitho), has been incorporated into the later farmyard (fig 3). At least two farms, Trefynor Isaf and Tai'n Coed (both Nantcwnlle), have farm buildings of the late seventeenth or early eighteenth century arranged around a yard.

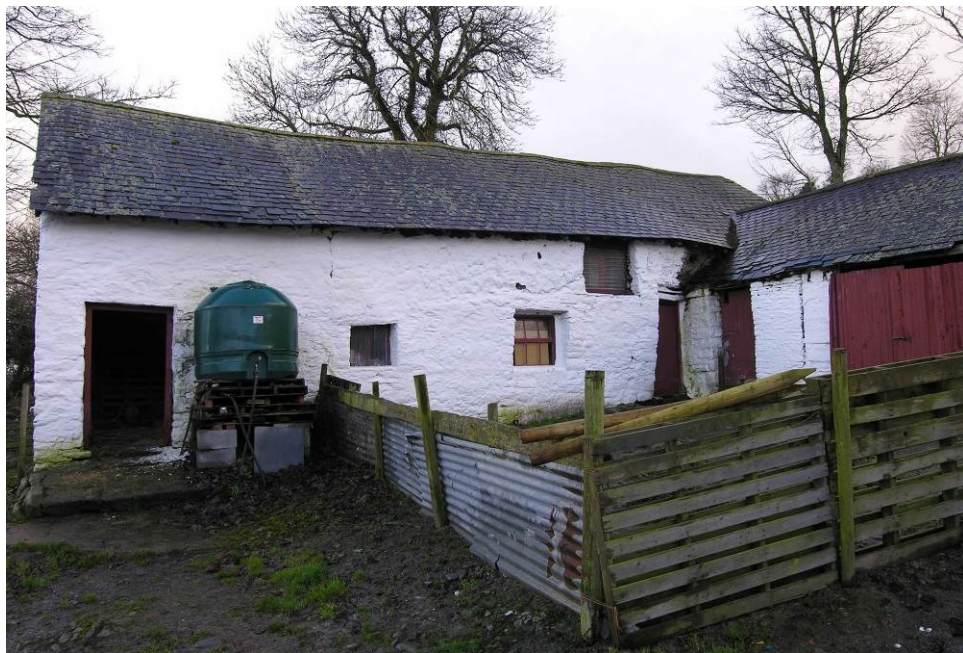
Fig 3. Early barn, later extended on the left side, at Derlwyn Fawr (Llangeitho).

- 4.4.1 Barns were used to store the year's crop and for threshing. The earliest farm buildings revealed in the survey are barns – Gelligarneddau (Llangybi), Pencefn (Tregaron), Tai'n Coed (Nantcwnlle) and Derlwyn Fawr (Llangeitho) (figs 2, 3). In these cases opposing doors are evidence that they were used for threshing.

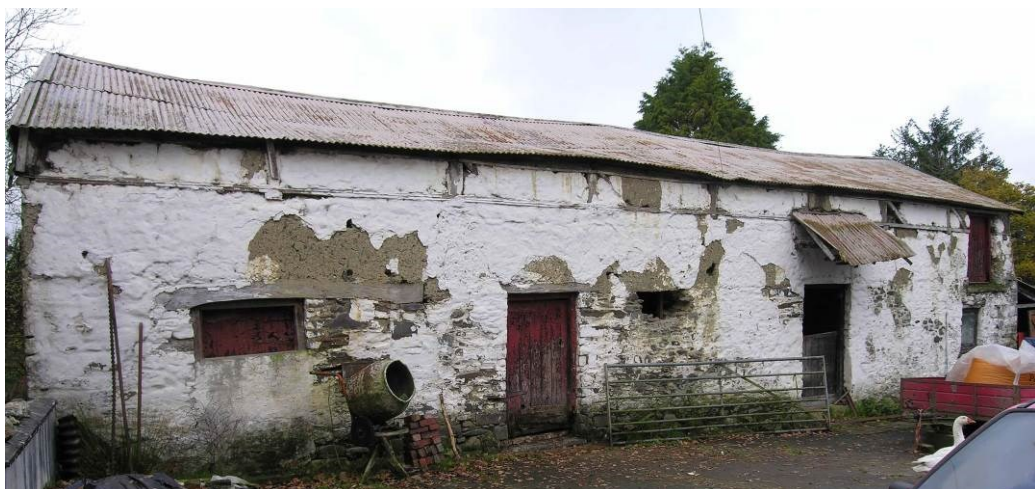
Fig 4. Eighteenth-century barn, stable and cart house at Trefynor Isaf (Nantcwnlle).

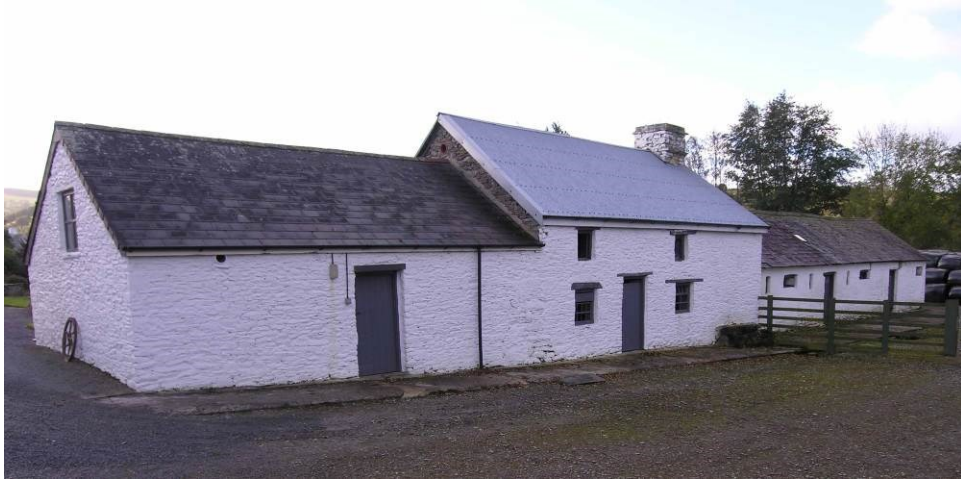
Fig 5. Felinfach (Pencarreg), with house in the centre, cow house to the right and later stable on the left.

- 3.0.3 The most common early farm plan is to have a cow house in-line with the farmhouse. In surviving examples like Trefynor Isaf (Nantcwnlle) and Felinfach (Pencarreg) the extant house and cow house are not necessarily of the same date, having undergone staggered rebuilding (fig 5). Earliest examples are built on the downslope with the cow house at the downhill end, although this type is uncommon in the survey area. Examples include Trefynor Isaf (Nantcwnlle), Allt Ddu (Llanddewi Brefi), Hafod-y-gofaint Isaf (Ystrad Meurig) and the much modernised farmsteads at Blaen Plwyf (Llangybi) and Bryn Goleu (Llanfihangel Ystrad). This downhill linear form continued to be built until the early nineteenth century, for example at Bronfynwent (Lledrod). In most examples where the house and cow house are in line, they are built across the slope, or else on level sites. Pen-y-Gaer (Nantcwnlle) preserves the concept very well, even though the house was extended slightly and the present cow house is a later addition, probably replacing the original (see fig 18). Well-preserved later examples include the early-nineteenth century Felinfach (Pencarreg) on a flat site in the Teifi valley and the hill farm at Maes-y-beudy (Ysbyty Ystwyth) (figs 5, 54). This type was prevalent in the nineteenth century on small farmsteads, but was associated with a lower social status than it had been in the seventeenth century. It was used for smallholdings, including small upland farmsteads at Banc Llanafon and Pen y Coed (both Trawsgoed) that have been thoroughly modernised. On Mynydd Bach it is especially prevalent in an area of small nineteenth-century upland farmsteads, such as Fen Onwyn (Lledrod) (fig 7).

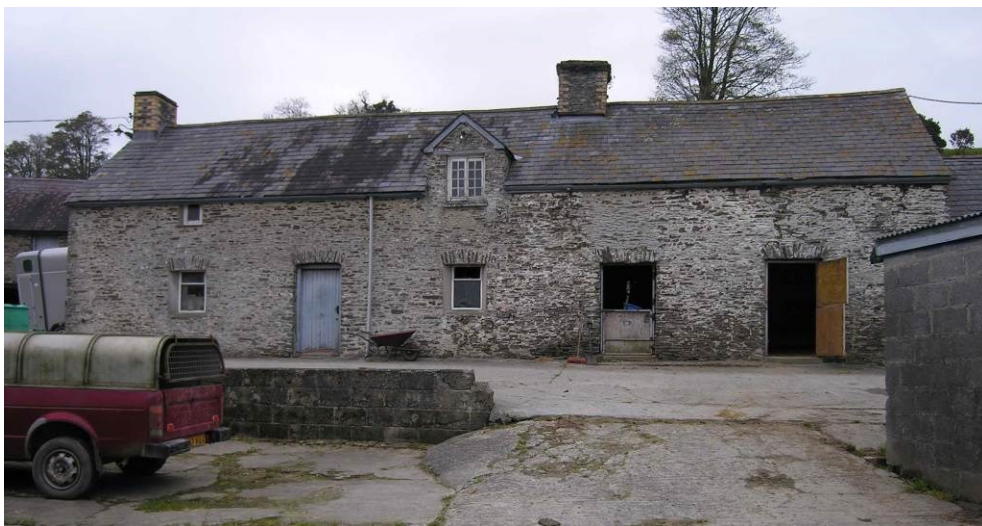
Fig 6. Old house and cow house at Tanygraig (Llangybi).

- 3.0.4 Other farmsteads have early house and cow house in-line across the slope, notably at Tanygraig (Llangybi) and Coed Parc (Llangybi), where later buildings changed the character of the farm into a courtyard plan (fig 6). At Tanygraig the building of a new house detached from the farm buildings kept pace with changing fashion in the siting of houses, discussed in more detail below.

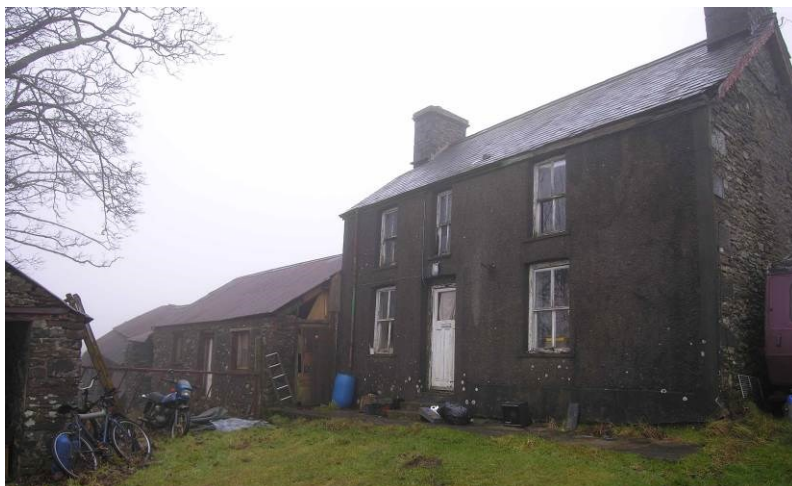
Fig 7. Fen Onwyn (Lledrod), with house and cow house of the later nineteenth century.

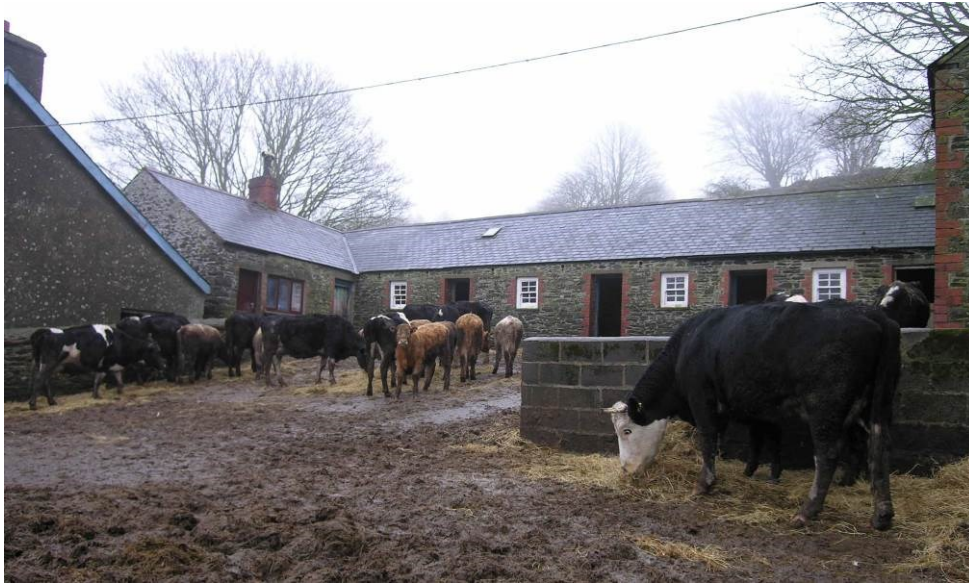
Fig 8. Lluest Newydd (Llangwryfon) was built in the 1920s but retains a traditional farmyard plan.

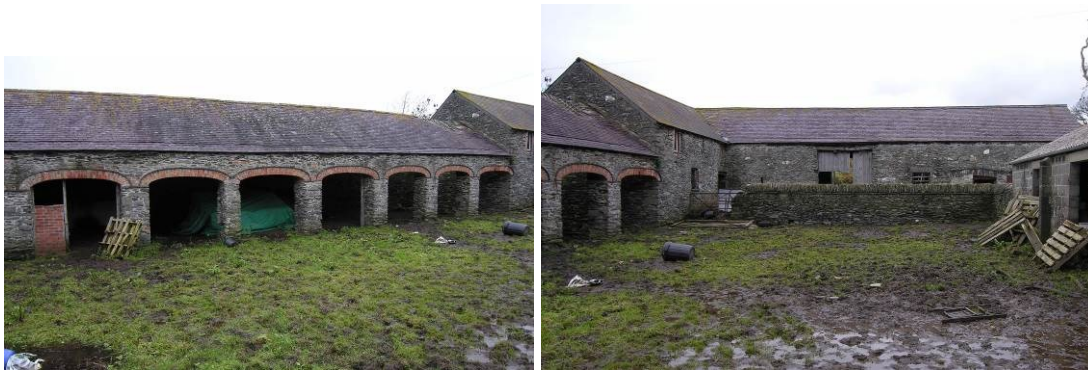
Fig 9. Shelter shed, fold yard and barn at Cwmnewydion Isaf (Trawsgoed).

- 3.1.3 Cwmnewyddion Isaf (Trawsgoed) was acquired by the Trawsgoed estate in 1786 (Morgan 1997, 196). It has barn, granary and stable forming an impressive L-shaped block of at least two phases, and possibly of the late eighteenth century (fig 9). In the nineteenth century a long shelter shed was added in line with the stable, which together with a cow house at right angles created a large yard closed by a wall on two sides. This is one of the minority of farms where a fold yard was created, and its presence can be seen both as an expression of higher status and as a statement of good, modern farming practice.

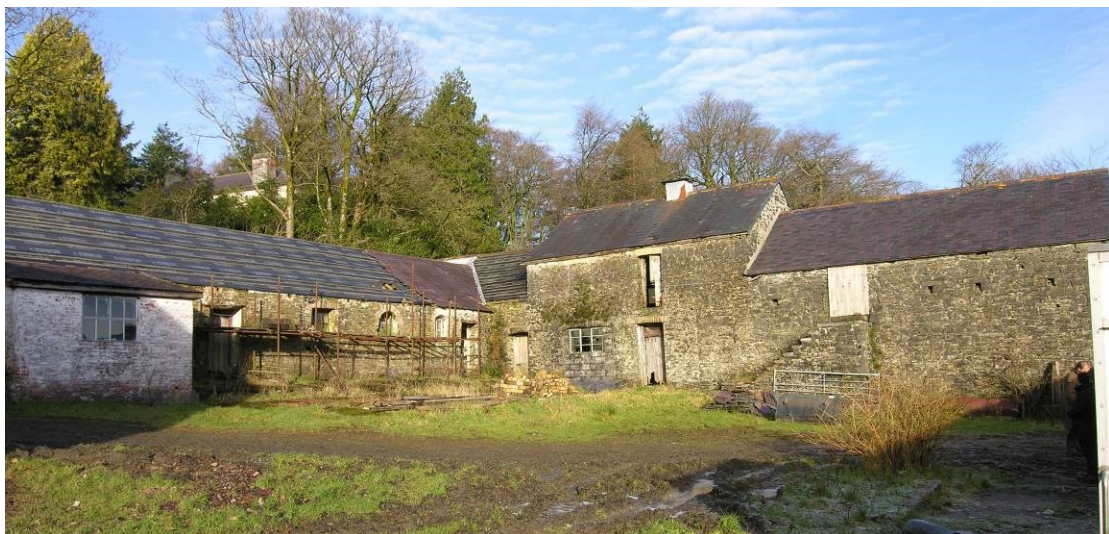
Fig 10. Cwrt Mawr (Llangeitho), showing cow shed, cart shed and stables.

- 3.1.4 Cwrt Mawr (Llangeitho) was described by Samuel Lewis in 1833 as an ancient mansion reduced to a farm. The present house was rebuilt in the 1840s and stands well above the farm buildings. These are arranged in an impressive courtyard plan, which is clearly the result of piecemeal development (fig 10). They include cow house and open-fronted shelter shed across the upper and lower ends of the yard, and a downslope stable and cart house, of which the cart house may have been partly adapted from an earlier C18 house, as it retains a fireplace with lath-and-plaster hood (Lloyd, Orbach and Scourfield 2006, 519). It is possible that this house was still inhabited in the nineteenth century. The latest element is a downslope barn, the roof of which is extended over a covered passage attached to the earlier cow house, that forms the main entrance to the yard.

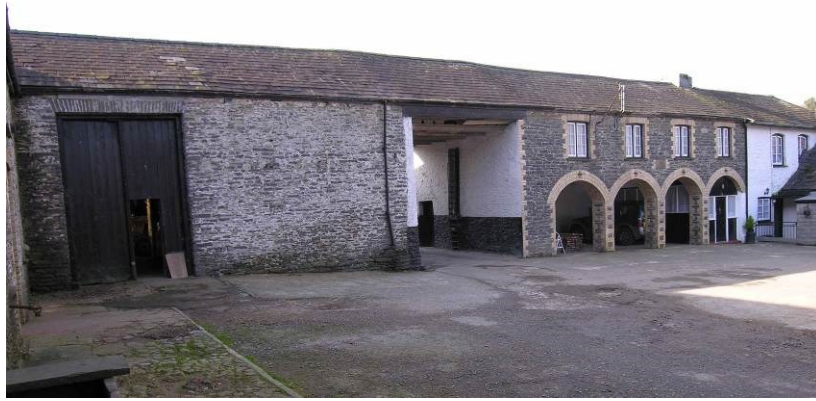
Fig 11. Falcondale Home Farm (Lampeter) showing cart house and passage of 1885 linking with earlier barn and house at either end.

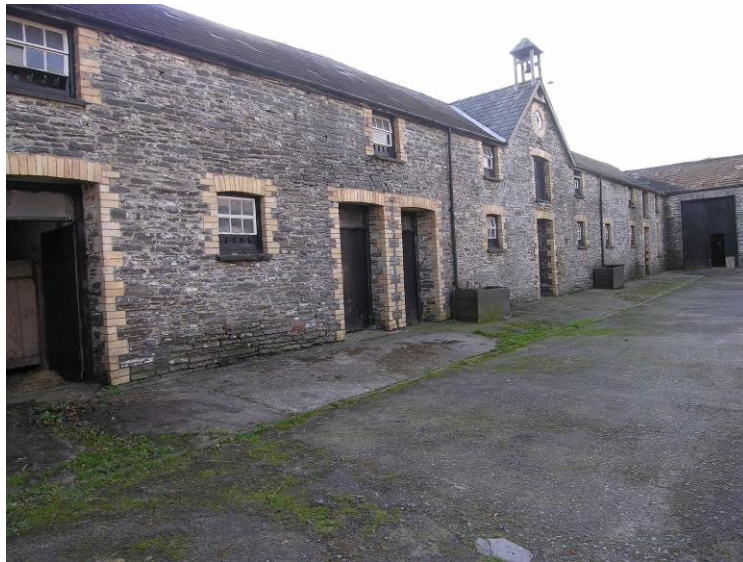
Fig12. Multi-purpose range at Falcondale Home Farm (Lampeter), of 1885. The yard is cobbled.

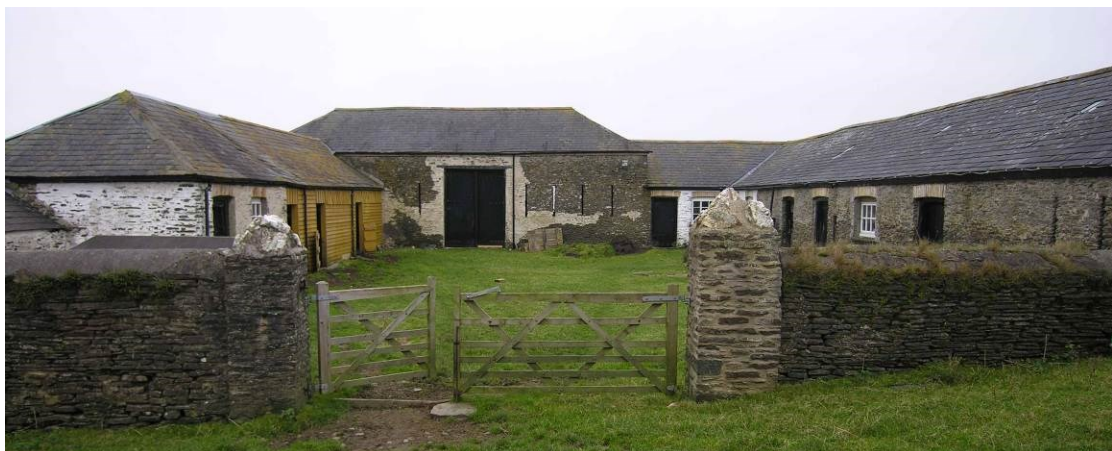
Fig 13. Berthlwyd (Llanfihangel Ystrad), a planned Falcondale estate farm, including walled fold yard and barn with hipped roof.

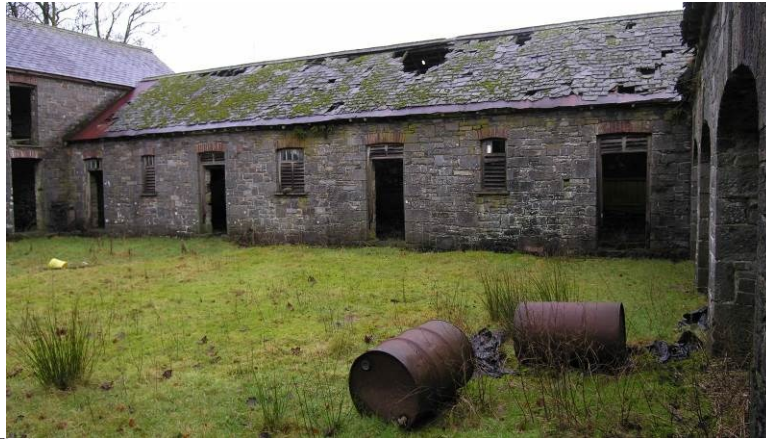
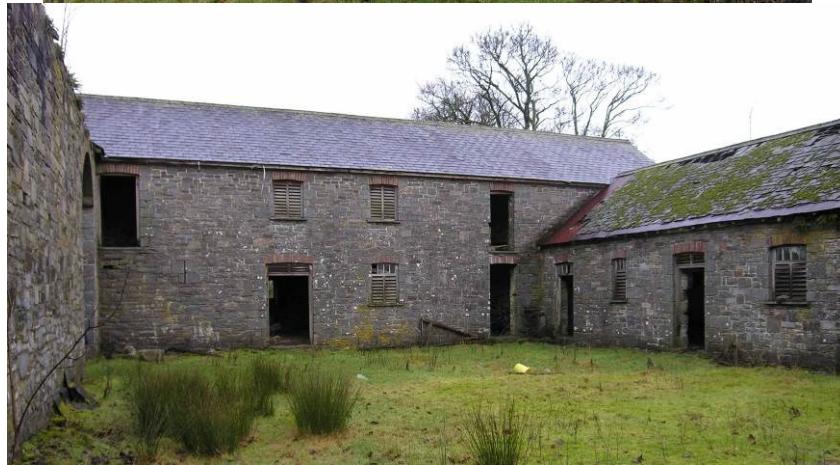
Fig 14. Berthdomled (Lledrod), showing cow house and barn of 1870.

- 3.1.7 Berthdomled (Lledrod) is a planned farm dated 1870, which has seen almost no subsequent alterations apart from deterioration of the structures. It is larger than Berthlwyd but otherwise has many similarities and was built to perform the same range of functions. The house is set in front of the farm, within a large walled garden with gate piers to the entrance. The buildings form a tight courtyard plan, comprising cow shed and shelter shed, pigsties and boiler house, barn, cart shed and stables (fig 14). The stables and cart shed face outwards, whereas the other buildings face the yard. There is an open entrance beside the pigsties, where cattle might have been brought in to the shelter sheds; but the main entrance is through an arched passageway (now roofless). The buildings are distinguished by the use of hammer-dressed snecked stonework, which is unusual in this area but not unknown. The barn roof trusses comprise king posts with raking struts, which is not a local type, and suggests that the design and construction of the farm was not executed by local builders.

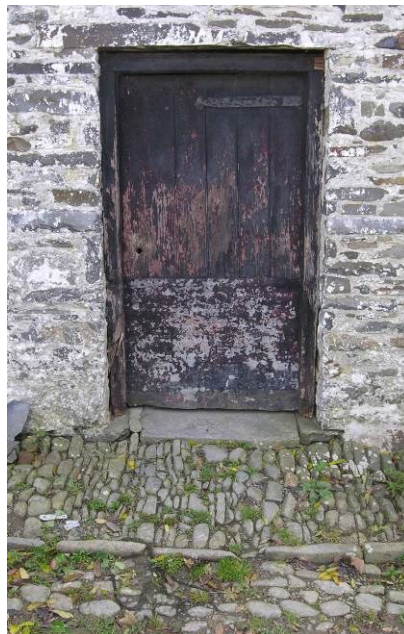
Fig 15. Cobbled surface, with kerb stones, outside a cow house.

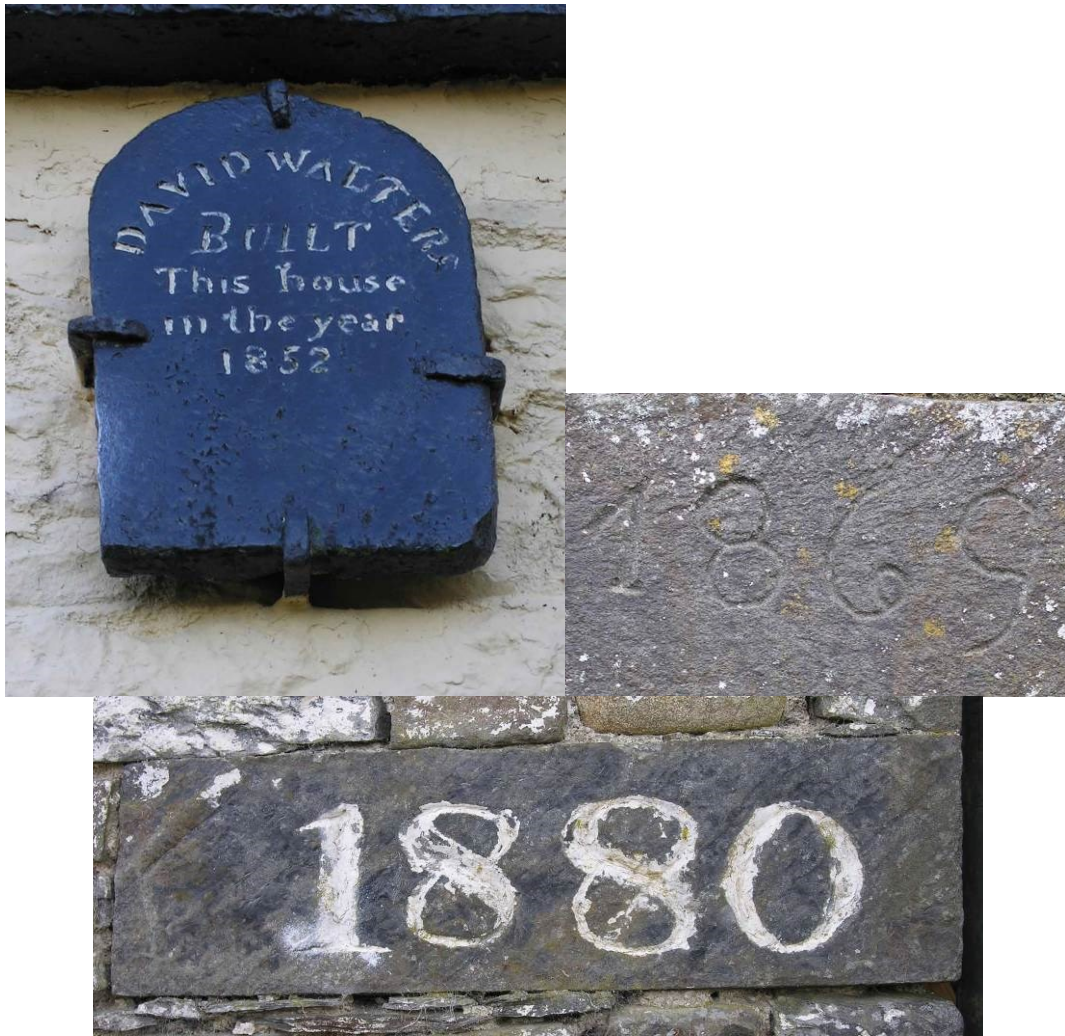
Fig 16. Date stones of 1852 at Pentre Brain (Llanddewi Brefi), 1869 at Wenallt (Llangeitho) and 1880 at Wern Fach (Llanddewi Brefi)

- 4.0.3 Date stones of various types are found on a number of buildings (fig 16). Stone tablets are found on few farm buildings, such as Trecefel of 1836 (Tregaron), but are more common on houses. Some of them record the owners of houses, such as William Price at Dolaugwyrddon Uchaf (Lampeter) of 1837. Maes Llyn (Tregaron), a Trawsgoed estate farm dated 1815, has a tablet recording the tenant, implying that he organised the building of the house himself. Others record the builders. Tablets appear on two buildings at Maes Bach (Pencarreg). One records D Davies of Dolauduon on a multi-purpose range (1880) and the other records E Davies of Faerdrefawr (1896) on the house. Most are set within the stonework but the round-head tablet at Pentre Brain (Llanddewi Brefi), of 1852, is fixed to the wall with iron staples.

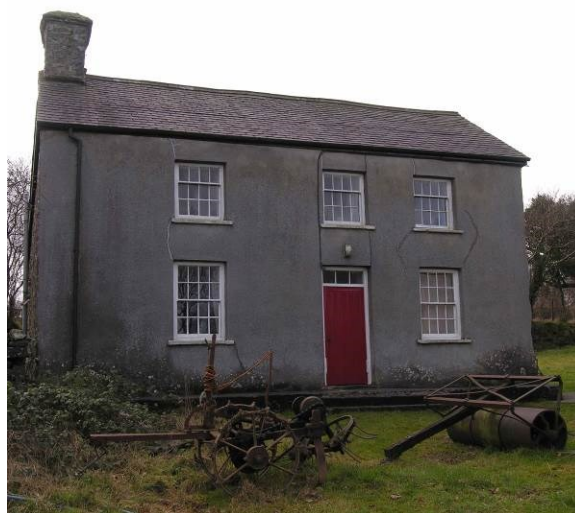
Fig 20. Georgian-style farmhouse at Berthlwyd (Ystrad Meurig).

- 4.1.4 Houses influenced by the urban Georgian style appear in the third quarter of the eighteenth century, at first in the homes of the minor gentry. Cilpyll (Llangeitho) is dated 1768. The principle of these houses is to provide a central entrance with rooms of equal size on either side of it. In practice the openings are offset from the centre because of the large fireplace in the kitchen. Where the openings are not evenly placed they reveal unequal internal planning, which is also a descendant of the sub-medieval house. The two-storey house, with two or three windows in the upper storey, is the predominant farmhouse type of the nineteenth century. Small examples are even found in the marginal areas where the vernacular tradition described above persisted in the nineteenth century (fig 20). Higher status three-storey houses are in the same style, such as Pen-y-bont, Trecefel (both Tregaron) and Hafod (Nantcwnlle). Dimensions of the buildings change over time, so the earlier examples are broader and lower, the later narrower and taller.

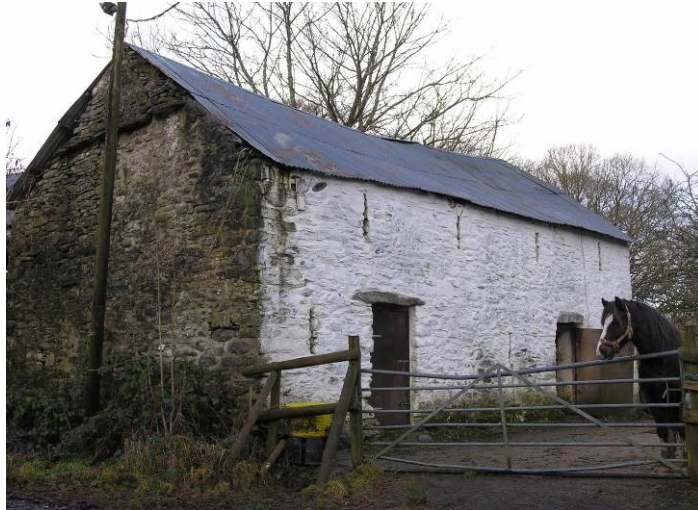
Fig 21. Cow house at Hendre (Lledrod) with vents in loft.

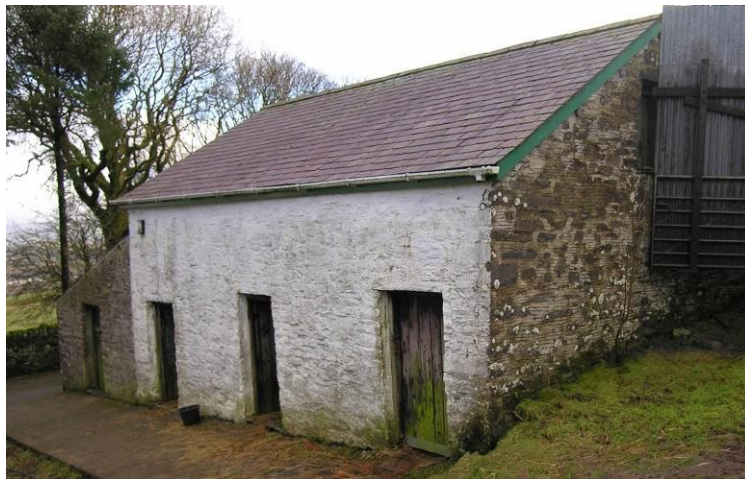
Fig 22. Nineteenth-century three-door cow house at Bronfynwent (Lledrod).

- 4.2.2 The internal arrangement of the cow shed is often reflected on the outside by the position of the doorways. Nineteenth-century cow houses with three or five doorways facing the yard are likely to have had one or two transverse feed passages, and muck passages. Well-preserved three-door cow houses are found across the survey area, as at Bronfynwent (Lledrod), Felinfach (Pencarreg), Pantscawen (Lampeter), and at Tynffynnon (Lampeter) of the early twentieth century (figs 5, 22). Cefn Coed (Llangeitho) shows how fragile such buildings can be when they are earth-walled (see fig 53). Five-door cow houses are common in the north of the survey area, with good examples at Cwmpenllydan (Trawsgoed), Penlan Gwnnws and Broncaradog (Ystrad

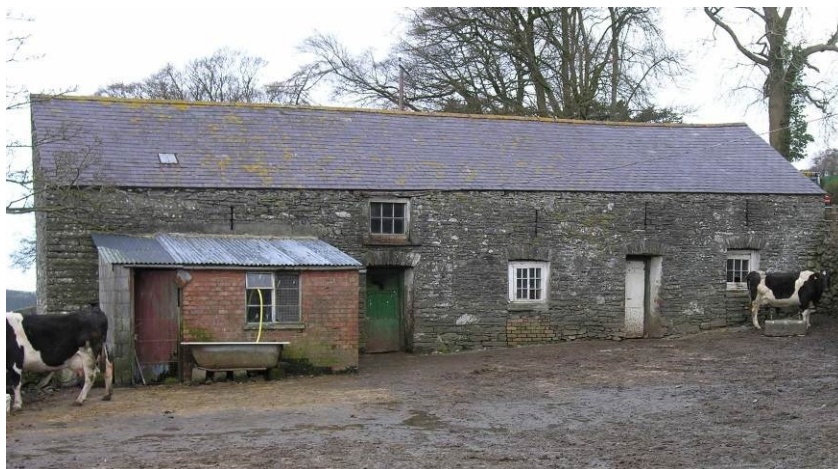
Fig 23. Five-door cow house at Broncaradog (Ystrad Meurig). Two doorways later became windows and a cool house was added in the mid twentieth century.

- 4.2.4 From the later nineteenth century, windows with ventilators began to appear in cow houses. In many three- and five-door cow houses some of the doorways were converted to windows (fig 23). A good example of this arrangement is at Glandulas Isaf (Llangybi), which has replacement windows, superseding an earlier form of unglazed openings that can still be seen at Felinfach (Pencarreg) (fig 5). Windows and ventilators took two main forms. Neuadd Fawr (Llanwnnen) has small-pane glazing above vents with horizontal-sliding covers. Cefn Llwyn and Berthdomled (both Lledrod) have small-pane glazing above louvered vents (fig 24). In the twentieth-century steel-framed hopper windows became the standard type.

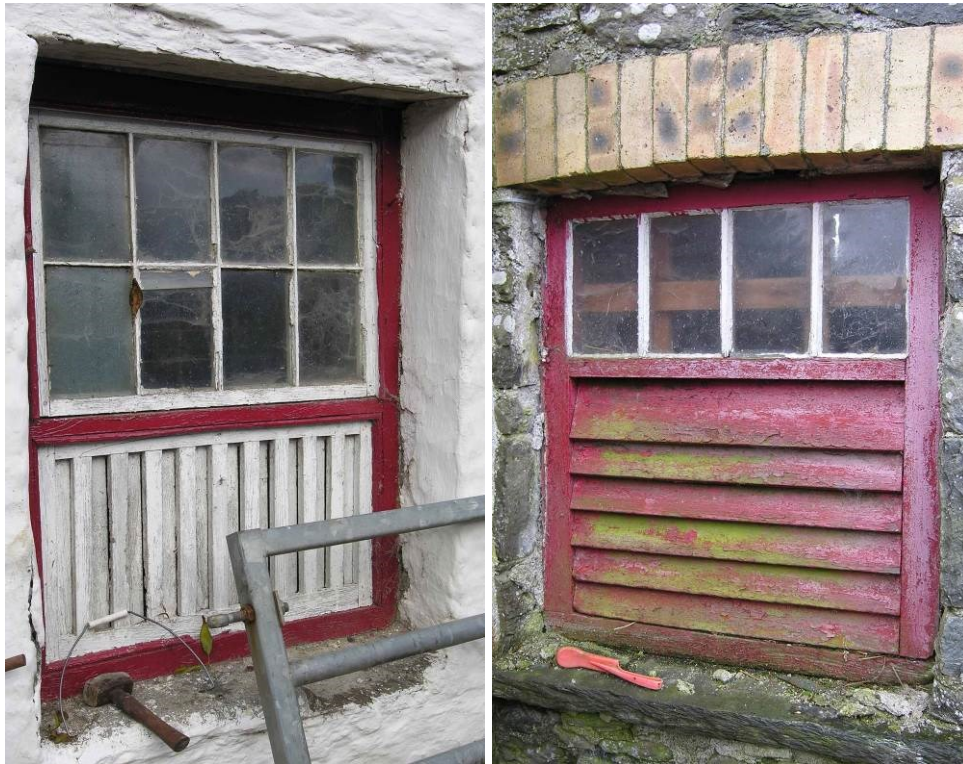
Fig 24. Sliding and louvered wooden vents in cow house windows.

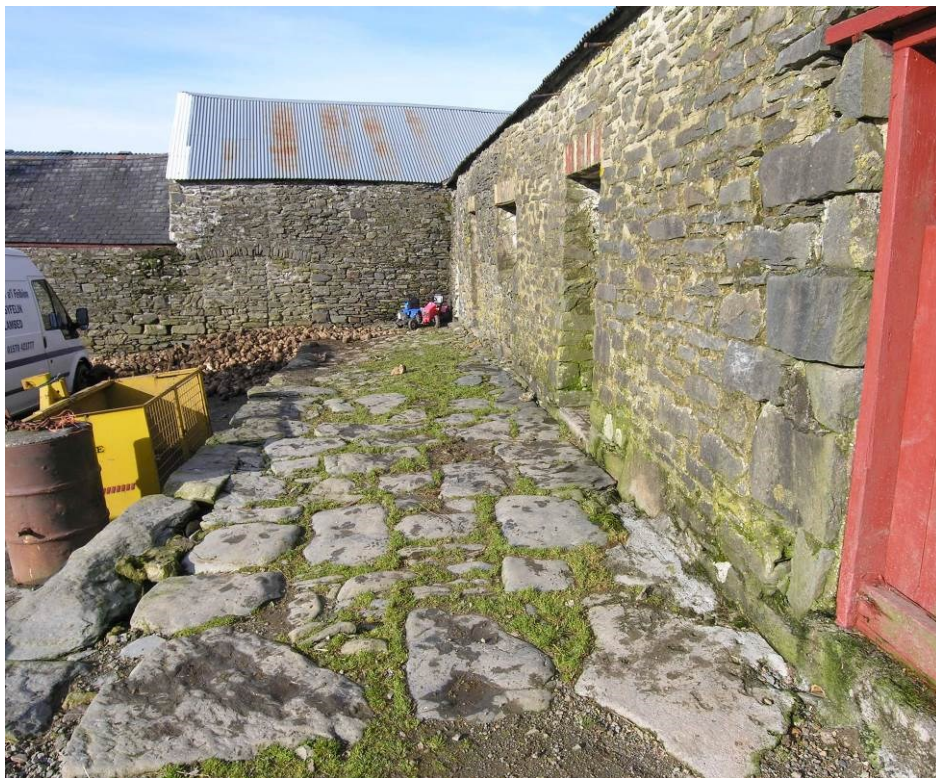
Fig 25. Raised walkway in front of cow house at Llwynmwyn (Ystrad Fflur).

- 4.2.5 Raised walkways are a distinctive feature associated with cow houses and are found across the survey area where the yard is a sloping site. At Llwyn Bwch (Lledrod) the associated cow house is dated 1809. Walkways are most often associated with cow houses built across the slope, such as Allt Goch (Lampeter), Tynlon, Ffos (both Ystrad Meurig), Pen-y-wern-hir (Ystrad Fflur), and have stone retaining walls. At Llwynmwyn (Ystrad Fflur) the walkway is partly paved with irregular slabs, and partly cobbled (fig 25).

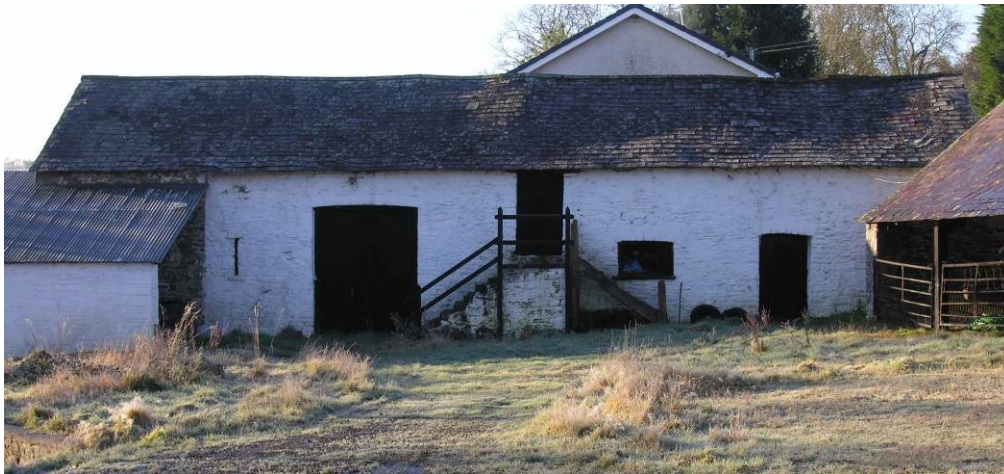
Fig 26. Eighteenth-century barn at Cilpyll (Llangeitho)

- 4.4.2 The familiar form of lofted barn was established by the eighteenth century. Cilpyll (Llangeitho) is probably contemporary with the house of 1768 (fig 26). In these lofted barns the doorways could be wide enough for a wagon to pass through the building, or they could have one wide opening for a wagon to back into the barn for unloading (figs 27, 28). In such cases there is a smaller winnowing door in the opposite wall, which facilitated a through draft for threshing. This second type is common throughout the area (fig 29). Smaller barns may have only winnowing doors to the front and the rear. The type of doorways found in a barn is generally a factor of size rather than date, and size of barn is generally in proportion to farm size and topography. The majority have wagon doors on one side and a winnowing door on the other. There is a contrast between the impressive barns on the larger farms such as Cwmnewydion Isaf (Trawsgoed) and Great Abbey Farm (Ystrad Fflur) which have wagon bays, and the small barns found on farms at higher altitude, for example those in Ystrad Meurig community at Tegfriw Fawr, Bryn Meherin and Llwyn y gog (dated 1853), and in Ystrad Fflur at Cwm Meurig Isaf and Pen-y-wern hir (figs 9, 29). Opposed doors were not universal. In two examples, at Cwrt Mawr (Llangeitho) and at Deri Garon (Tregaron) the wagon bay is in the gable end, with another door (only a small door at Cwrt Mawr) in the side wall.

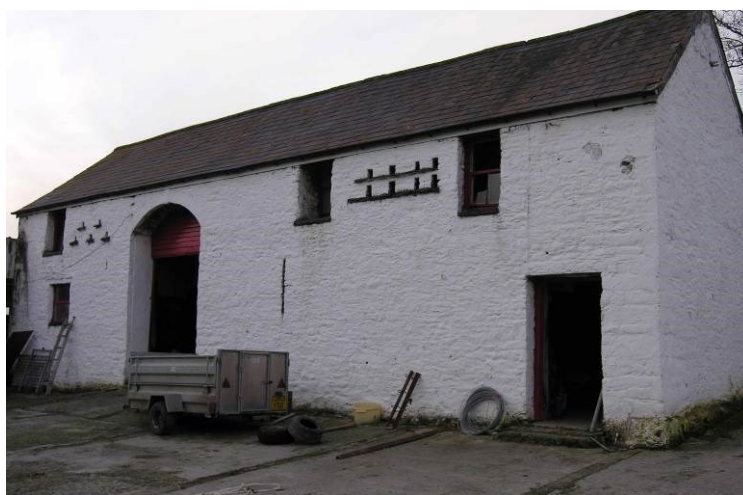
Fig 27. Barn, incorporating stable and pigeon loft, at Llwyn (Llanddewi Brefi).

- 4.6.1 Most farms appear to have used horses as draught animals by the end of the eighteenth century. They continued to be used until at least the mid twentieth century. Broncaradog (Ystrad Meurig) had ten working horses in 1947. Smaller farms such as Pendre (Ysbyty Ystwyth) could accommodate four horses. Stables are found at all farmsteads and some smallholdings, and in many cases nineteenth-century wooden stalls have been retained. Stables sometimes face outwards rather than into the yard, as at Berthdomled (Lledrod) and Cwrt Mawr (Llangeitho). However, of all the farm-building types, stables are most likely to be found as part of multi-purpose ranges (fig 27). To combine the barn with the stable allowed straw to be forked down from one to the other.

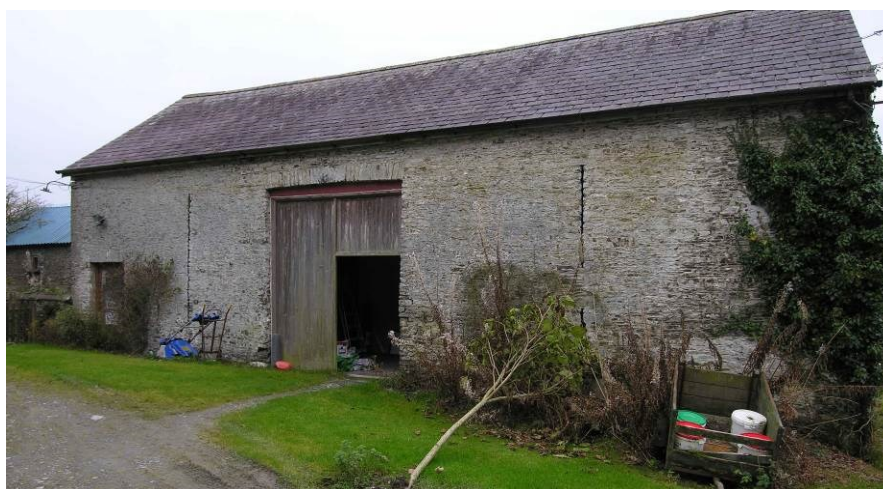
Fig 28. Nineteenth-century barn with wagon bay at Gelli-Gwenyn (Llangybi).

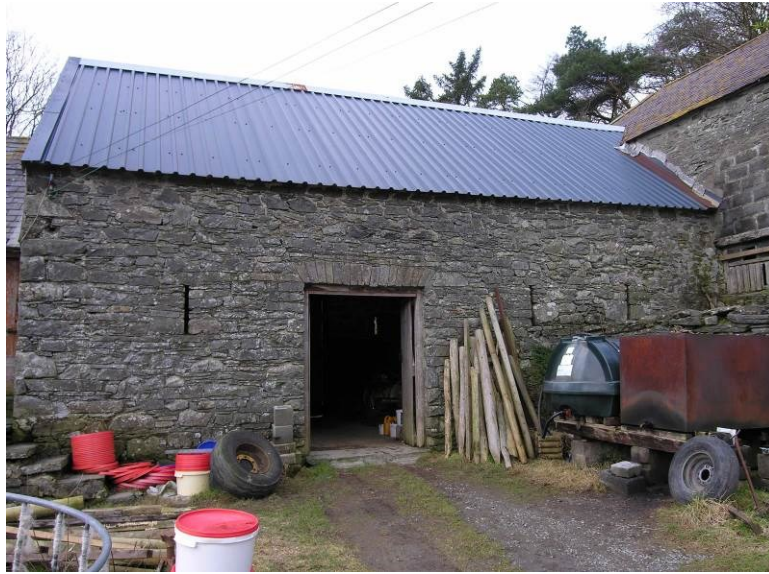
Fig 29. Small barn of 1836 at Tegfriw Fawr (Ystrad Meurig).

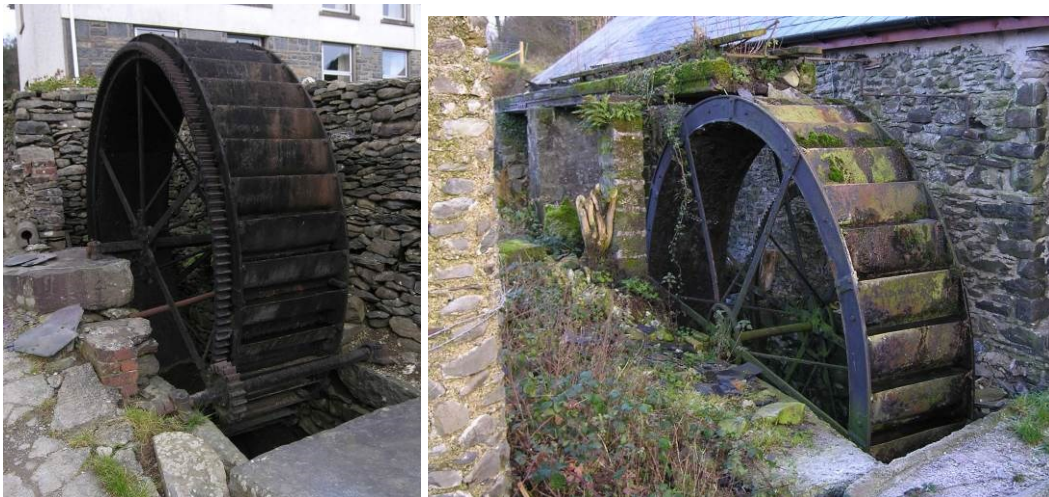
Fig 30. Barn waterwheels at Llanfair Fach (Llanfair Clydogau) and Llanio Fawr (Llanddewi Brefi).

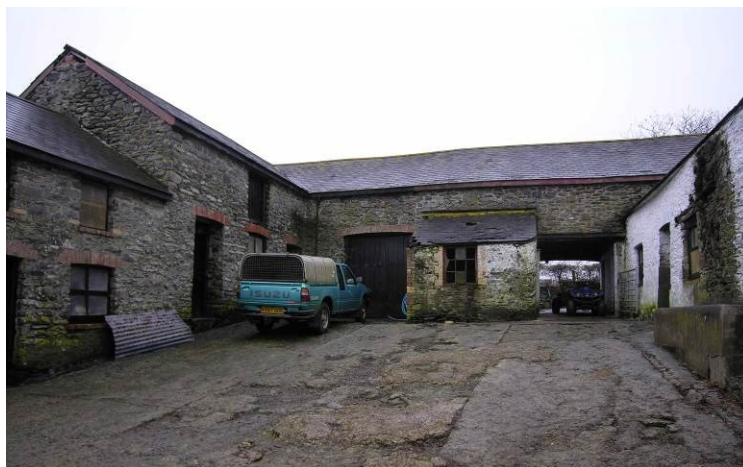
Fig 31. Barn of 1914 at Tyn-y-berth (Tregaron), with integral lean-to engine house.

- 4.5.3 At Great Abbey Farm (Ystrad Fflur) the internal combustion engine superseded the waterwheel to power threshing machinery. Offset from the barn wall is a lean-to feeding a former waterwheel. However, a later lean-to against the wagon bay housed an engine. In this instance it is also self-evident that the practice of driving a wagon through the barn had been discontinued. Other barns show evidence of former engines in stone lean-tos, such as Gorwydd (Llangybi). At Ty'n-y-berth (Tregaron) the lean-to engine house is an integral component of a barn built in 1914 (fig 31). The latest dated example found was at Cefn Meurig Mawr (Ystrad Fflur), of 1924. Other twentieth-century engine houses were of corrugated iron, as at Tanllan (Llangeitho) and Dolbeudiau (Ystrad Fflur).

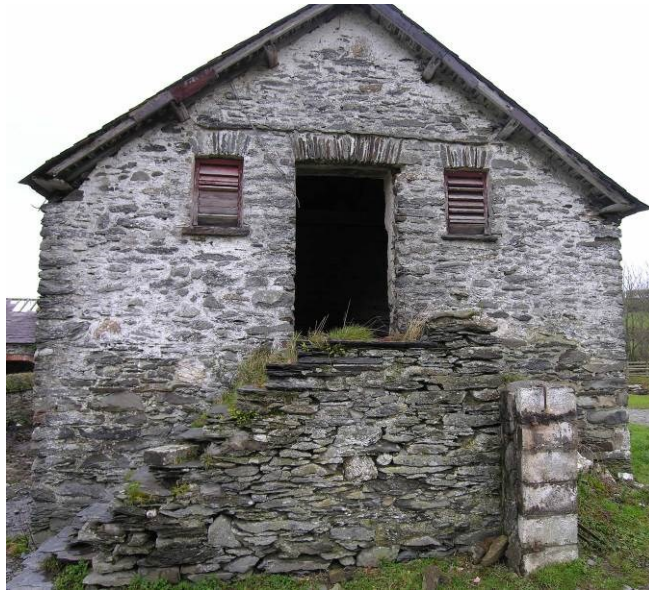
Fig 32. Granary entrance above cart shed at Cwmnewydion Isaf (Trawsgoed), retaining original louvered vents.

- 4.7.2 Cart sheds are usually lofted buildings, the loft space housing a grain store or granary. Absence of granaries on Ceredigion farmsteads was noted in the late eighteenth century. Some grain was kept in sacks in farmhouses but lack of suitable storage space often obliged farmers to sell their grain in winter when the price was lowest, and then buy food in spring when the price was highest (Davies 1815, i, 133). The appearance of granaries in the nineteenth century was a direct product of farmstead improvement, and a sign of increased rural prosperity. Farmsteads in Ceredigion and Carmarthenshire did not grow enough grain to warrant erection of separate granaries. Instead, the loft above the cart shed was used. It was reached by external steps in the gable end, was comparatively dry and free from vermin. Some granaries retain louvered vents, as at Cwmnewyddion Isaf (Trawsgoed) (fig 32).

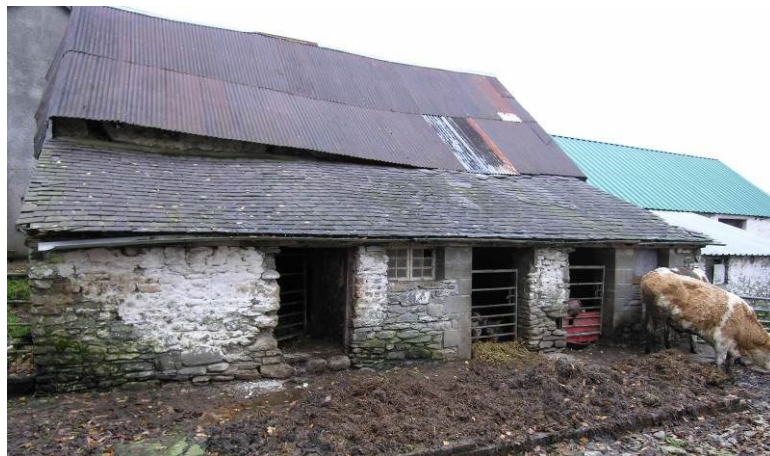
Fig 33. Pigsties at rear of Trefynor Isaf (Nantcwnlle). Pens have been removed.

- 4.8.2 There are some interesting variations in the position and layout of sties. At Great Abbey Farm they are built against the rear of the cow house; at Trefynor Isaf (Nantcwnlle) they are lean-tos against the rear of the house (fig 33). At Mynydd Brith (Lledrod) there are two sties but the pens are built against different walls rather than being placed side-by-side. In this case the pigsties also combine a small hen house (fig 34). Hen coops were commonly combined with pigsties. Usually, as at Denmark Farm (Llangybi) and Maes Isaf (Pencarreg), there is a small hole with ledge in the upper wall or gable of the sty.

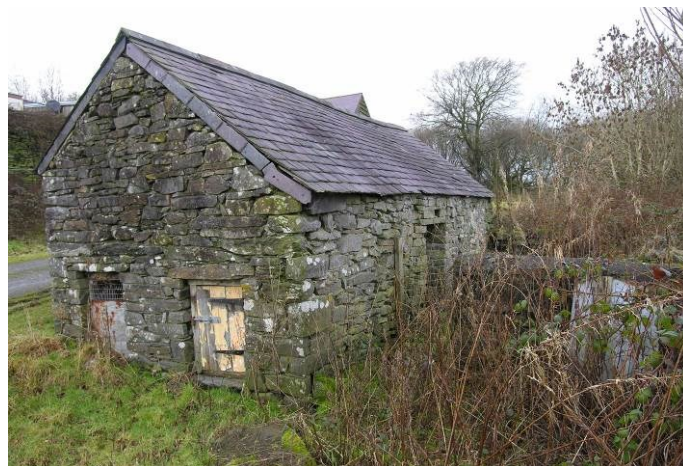
Fig 34. Pigsties and hen house at Mynydd Brith (Lledrod).

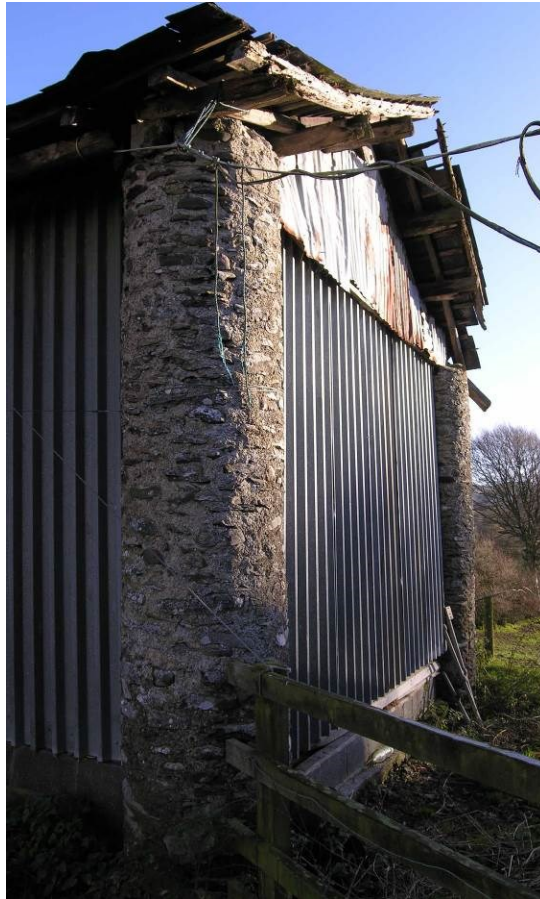
Fig 36. Hay shed at Olmarch Isaf (Llangybi).

7.3.2 Building materials are generally field stone with slate roofs. The tradition of limewashing has declined sharply. A special characteristic of this area is the survival of open-sided stone hay sheds on piers or orthostats, the best examples of which are at Llwyn, Cefn Llwyn (both Llanddewi Brefi) and Olmarch Isaf (Llangybi) (figs 36, 37).

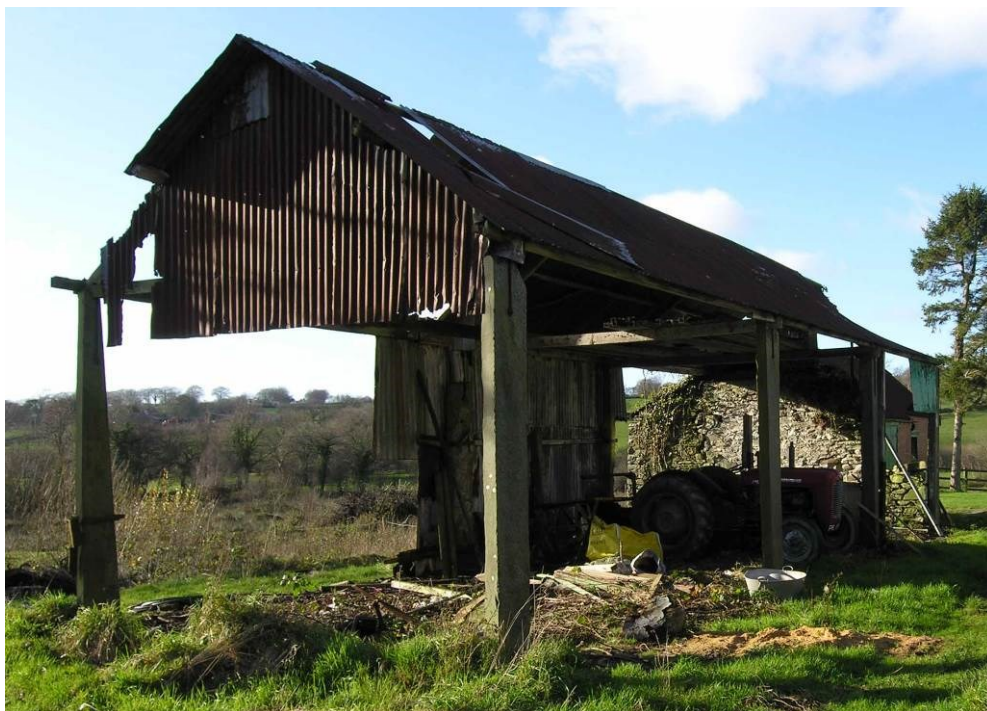
Fig 37. Stone hay shed at Cefn Llwyn (Llanddewi Brefi).

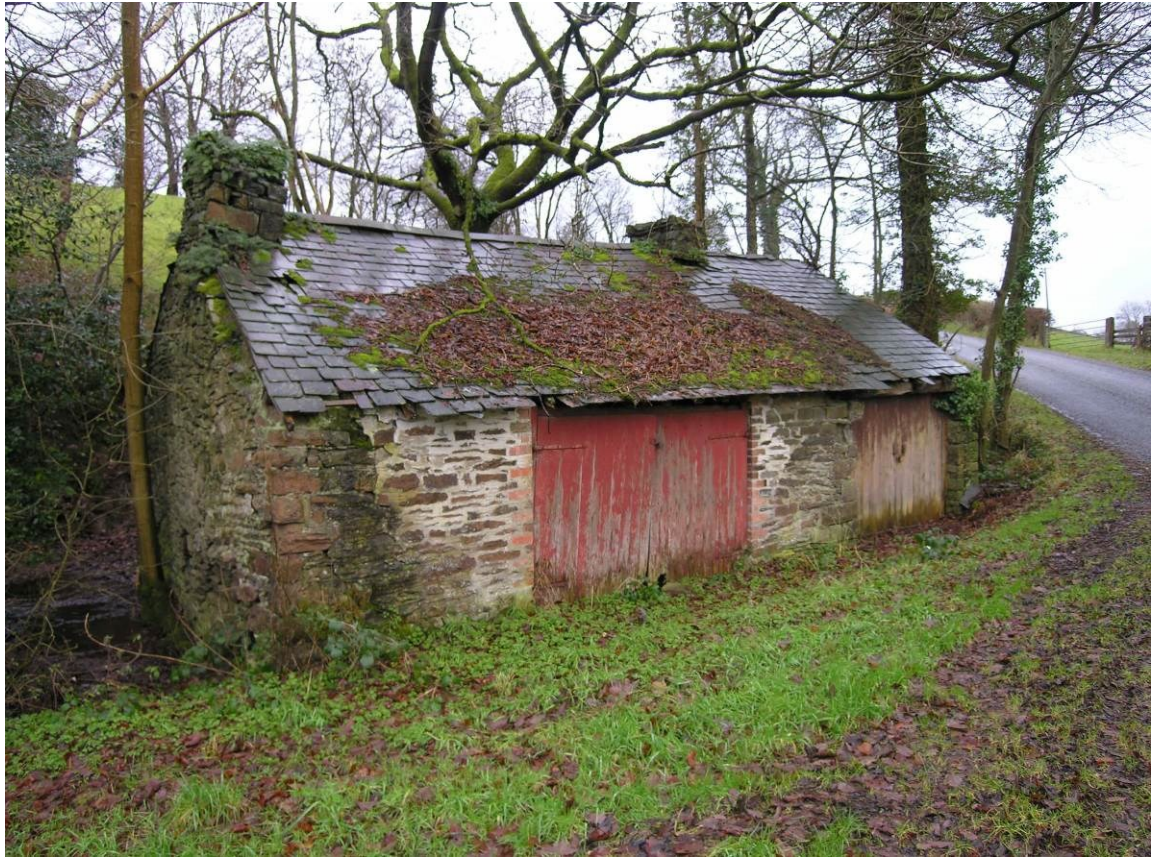
Fig 38. Nineteenth-century roadside smithy at Ffynnon Geitho (Llangeitho).

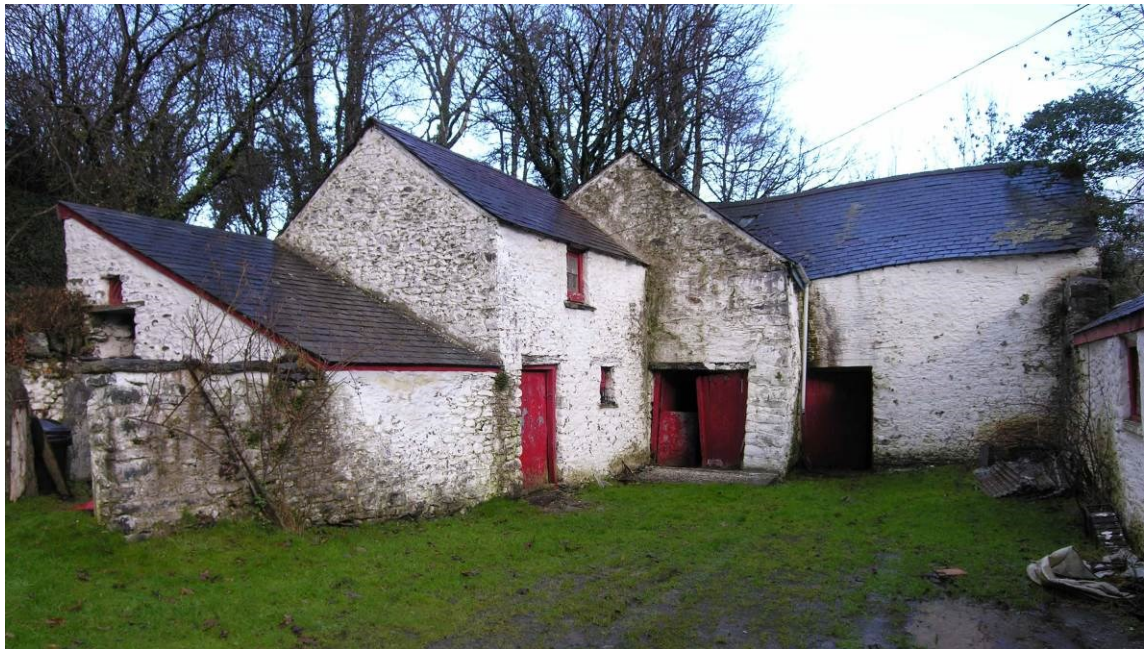
Fig 39. Corn mill at Felin Rhydypandy (Llangeitho)

- 5.1.2 Felin Coed retains a miller's house, but also remnants of pigsties and cow house. Felin Fach (Lledrod) was part of an 88-acre holding with farm buildings, and at Felin Rhydypany (Llangeitho) are pigsties (fig 39). Corn mills can therefore be seen as part of a group of buildings, where mill work was supplemented by farming. At Felin Coed (Nantcwnlle) the corn-drying kiln and drying house have survived in part. Other corn-drying sheds are at Fullbrook Mill (Tregaron), Felin yr Aber and Felin Fach (Lledrod).

- 7.4.3 The special feature of this area is its building materials. One or more buildings either partly or substantially built of clom are to be found at many farmsteads, and from conversations with farmers it appears that many more such buildings were lost in the twentieth century. Related to the use of earth walling, and buildings of early date, is the use of coursed field stone and scarfed crucks. Most of the scarfed crucks identified during the survey were found in this area. There is much evidence of limewash on stone and earth-walled buildings, but the practice is in decline. By no means all buildings in the Aeron valley are of clom, however. Buildings of field stone are found throughout the area, especially on the higher ground on the north side of the valley. Farmsteads of superior status such as Cilpyll (c1768) and Cwrt Mawr (Llangeitho), are also of stone (figs 10, 26). Larger farm buildings of the nineteenth century, with the exception of the stone and clom barn at Penlan Fach (Llangeitho) of c1830 (see fig 45), are also built of stone. This area also includes important surviving corn mills, as at Felin Rhydypany (Llangeitho), Felin Fach and Felin Coed (both Nantcwnlle) (fig 39).
