## **1.0 Introduction**

- 1.0.3 A Historic Buildings Pilot Project has been set up to develop a broad understanding of farmsteads in their historic and landscape context, and has been made possible by a grant from Cadw. It is recognised that farmsteads are an important component of the historic environment, and contribute to local and regional distinctiveness. However, compared with other rural building types, such as houses and places of worship, farm buildings are comparatively poorly understood. The pilot study is a characterisation of the surviving stock of farm buildings, which draws out themes and patterns in the built heritage, and considers variables such as geographical, social and chronological factors.

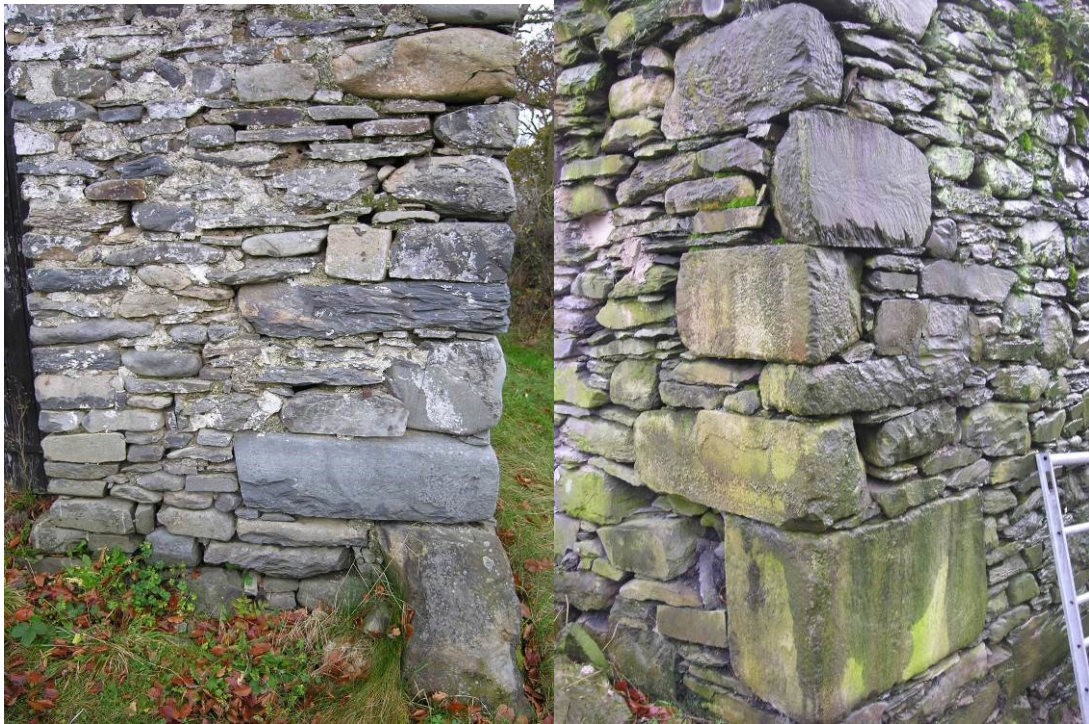
Fig 40. Field stone with large roughly squared quoins at Frith Wen (Nantcwnlle) and on a barn of 1853 at Llwyn-y-gog (Ystrad Meurig)

- 6.1.2 Field stone was used in lower-lying areas such as the Teifi and Aeron valleys, but not exclusively so. It is characterised by rounded boulders and large blocks broken up to yield stones of manageable sizes, although boulders are often used for footings. It also features stones of different geological formations, so it is not unusual to see quartz in a wall of sedimentary stones. Field stone is laid in courses of varying regularity, but is not laid as ‘random rubble’. The tradition of using found material continued to the latter half of the nineteenth century. Field-stone walls of the nineteenth century were combined with the use of bigger quoins, which were probably quarried and were roughly squared, and the use of dressed-stone voussoirs for doorways and windows (fig 40).

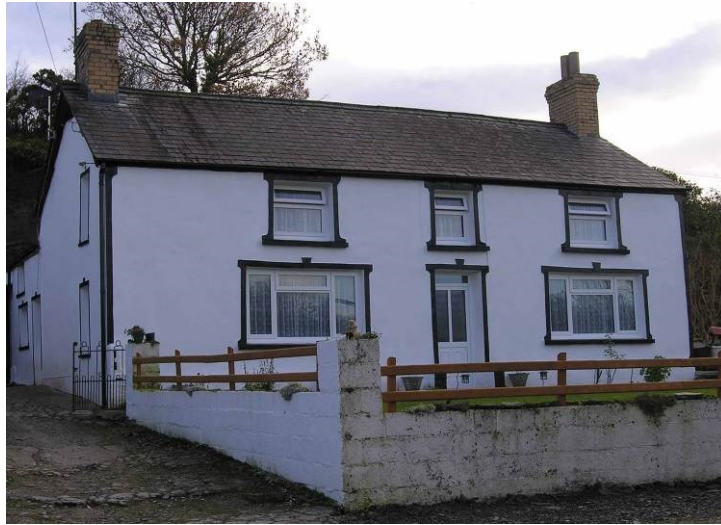
Fig 43. Nineteenth-century farmhouse at Pent-y-rhew (Nantcwnlle), partly clom built.

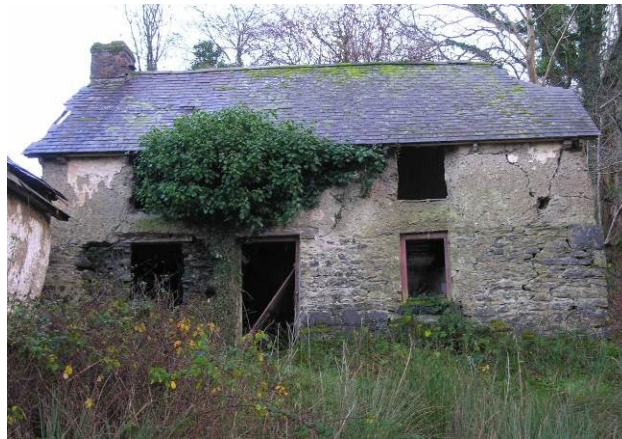
Fig 44. Nineteenth-century house at Lletty-du Uchaf (Llangeitho), the upper storey of which is clom.

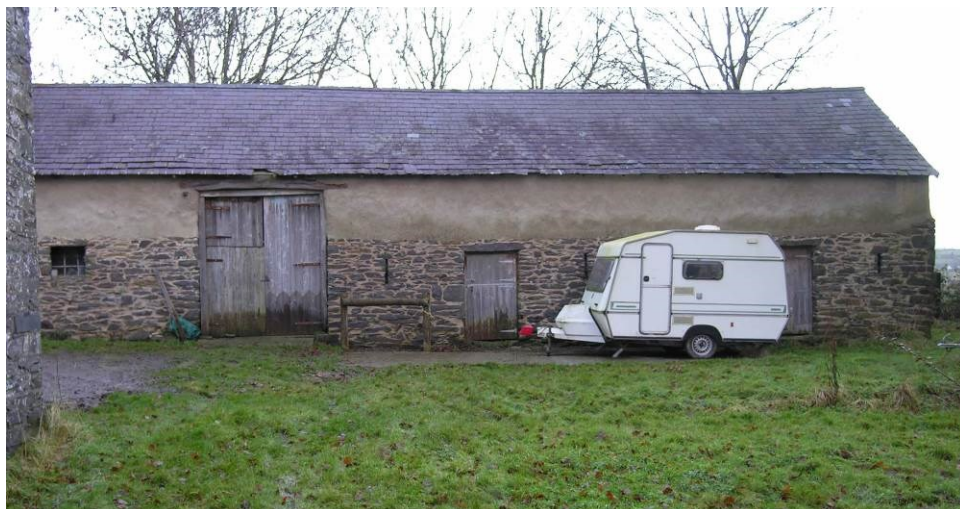
Fig 45. Barn at Penlan Fach (Llangeitho), of c1830.

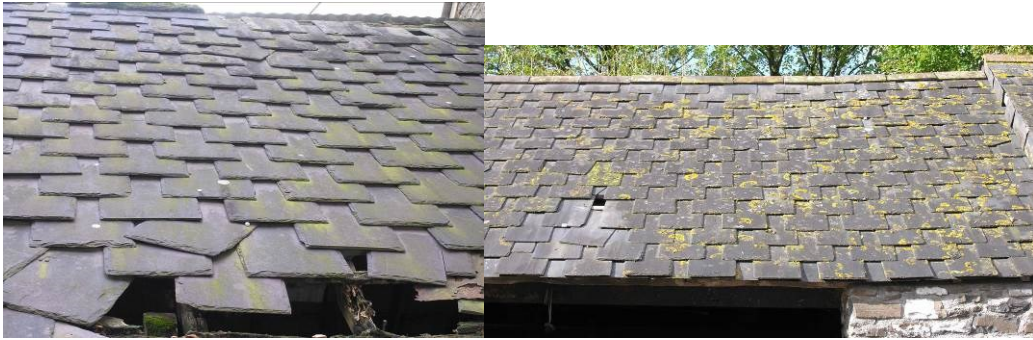
Fig 47. *To-brat* roofs.

- 6.7.2 An important variation on slate roofing is the *to-brat* roof (fig 46). In this style of roofing every third slate is left out, which gives the roof slope a distinctive visual pattern (fig 47). For obvious reasons it was also sometimes known as a *to-cybydd* or ‘miser’s roof’ but it had a practical function in allowing ventilation of a building. For that reason it is found on various animal houses, usually cow houses or, at Maes Isaf (Pencarreg) on a pigsty. *To-brat* roofs are concentrated at the south end of the survey area, in Llanfihangel Ystrad, Lampeter, Llanwnnen, Llangybi and Pencarreg communities. At Tynloff (Llangybi) the cow-shed roof was re-done in this style in the 1950s. Blaen plwyf Lodge (Llangybi) has a *to-brat* roof on a twentieth-century brick cow house.

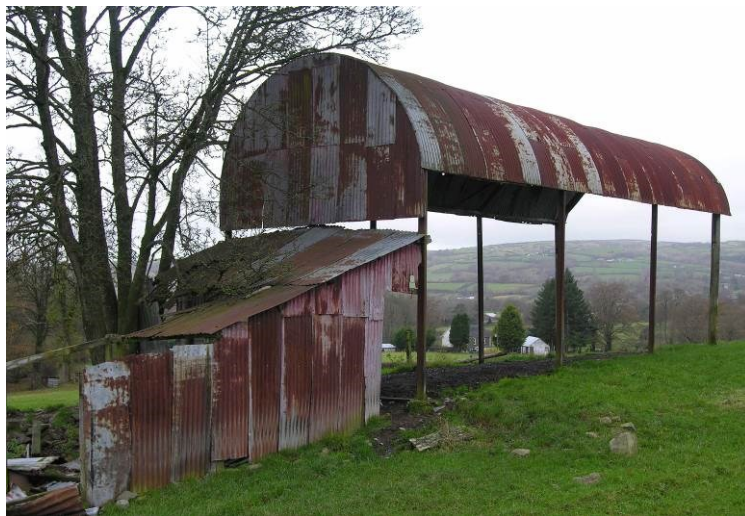
Fig 48. Corrugated-iron Dutch barn at former Hendre Las farm (Llanfihangel Ystrad).

- 6.6.1 Cast and wrought iron were not found as major building materials. Dutch barns on I-section girders, or made from discarded railway track, are of steel (fig 49). No examples were identified earlier than 1900.

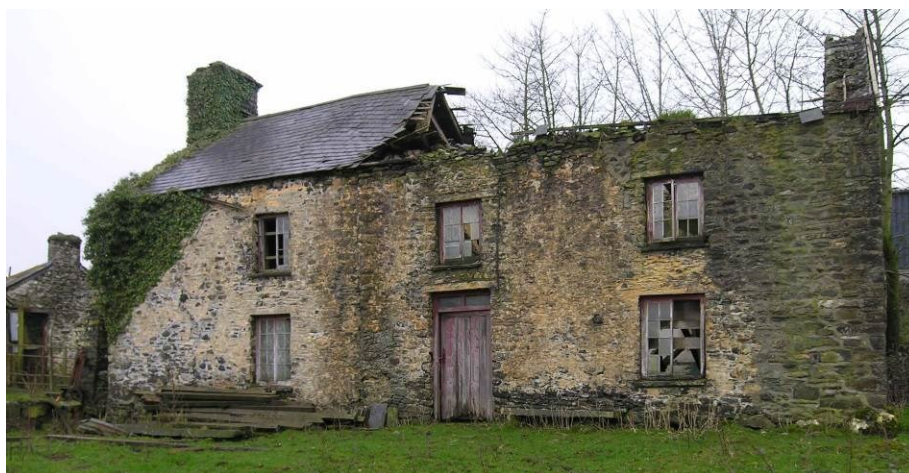
Fig 52. Ruined house at Deri Odwyn (Llangeitho)

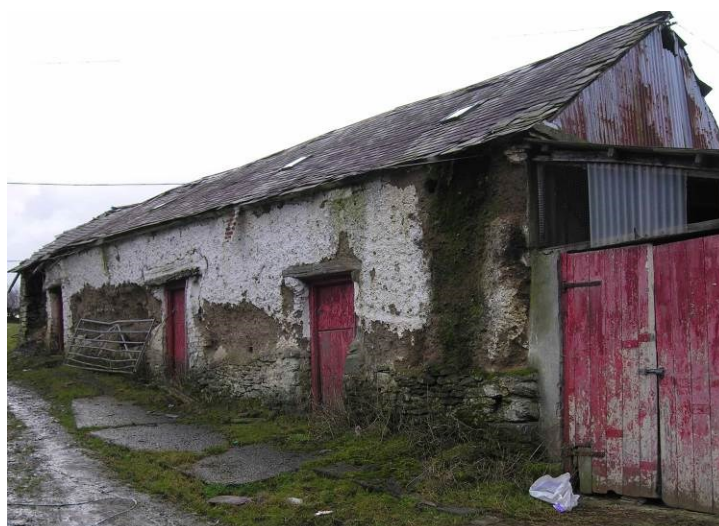
Fig 53. Earth-walled cow house at Cefn Coed (Llangeitho).

- 4.1.3 Single-storey houses, or houses with a *croglofft*, were also built in the nineteenth century for smallholdings or small farms. At Maes-y-beudy, Storehouse (both Ysbyty Ystwyth) and Rhos-goch (Dyffryn Arth) they have attached cow houses (see fig 54). These are all modest houses on marginal land. At Cefn Coed (Llangeitho) is a separate range at right angles (see fig 53).

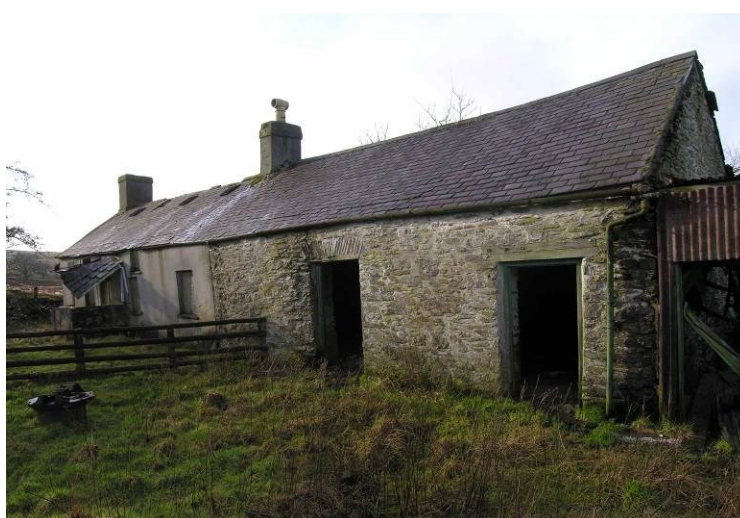
Fig 54. Uninhabited farmstead at Maes-y-beudy (Ysbyty Ystwyth).
