# **Pengwern Isaf, Cenarth, Carmarthenshire Watching Brief**

September 2013

Trysor Project No. 2012/321

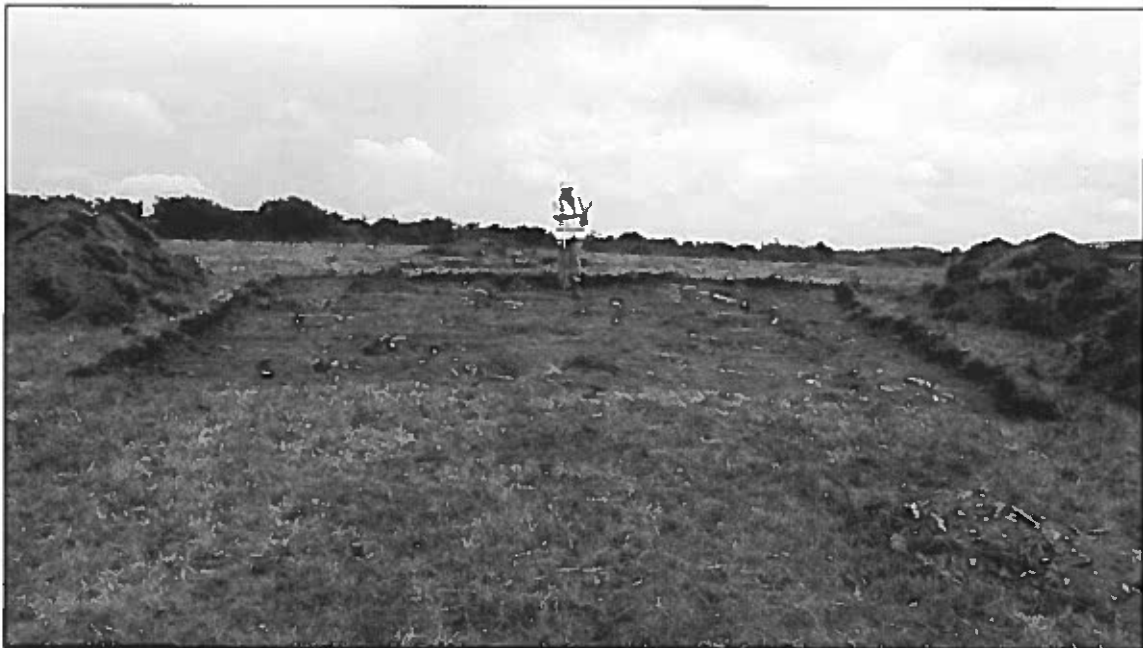
*Cover photograph: Foundation trench (Trench 1) for the southwestern turbine, looking east-southeast.*

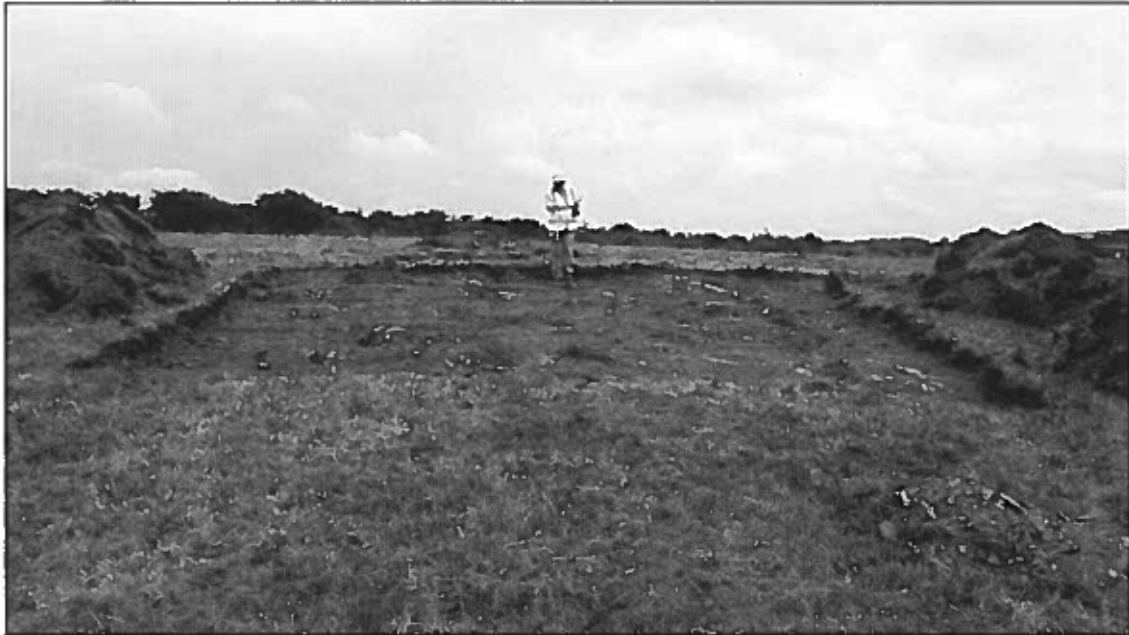
#### a) Trench 1 at SN2719540038

Context Number	Depth	Description	Interpretation
001	0.10m - 0.20m	10YR4/3, dry, friable with small stones	Topsoil
002	-	10YR4/4, dry, friable with small stones	Subsoil
003		Vertically bedded shale with an undulating surface, some quartz in the eroded surface of the shale, part of a natural quartz vein.	Natural rock

*Plate 1: PGI2013\_101, Stripping of Trench 1, looking east southeast.*

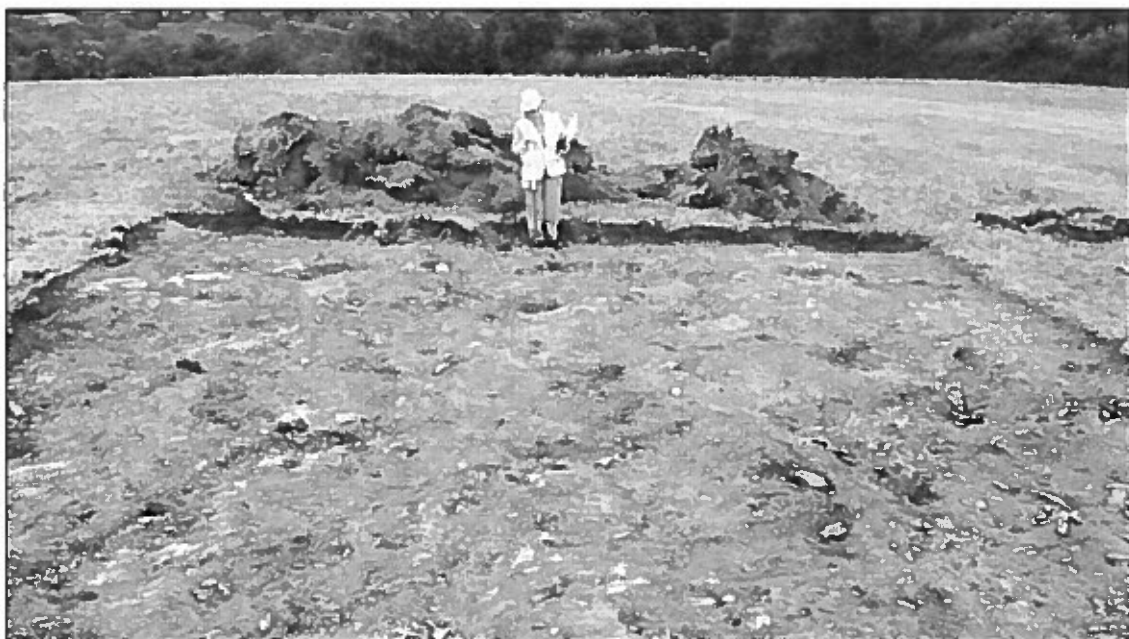
*Plate 2: PGI2013\_102, The stripped surface of Trench 1, looking south southwest.*

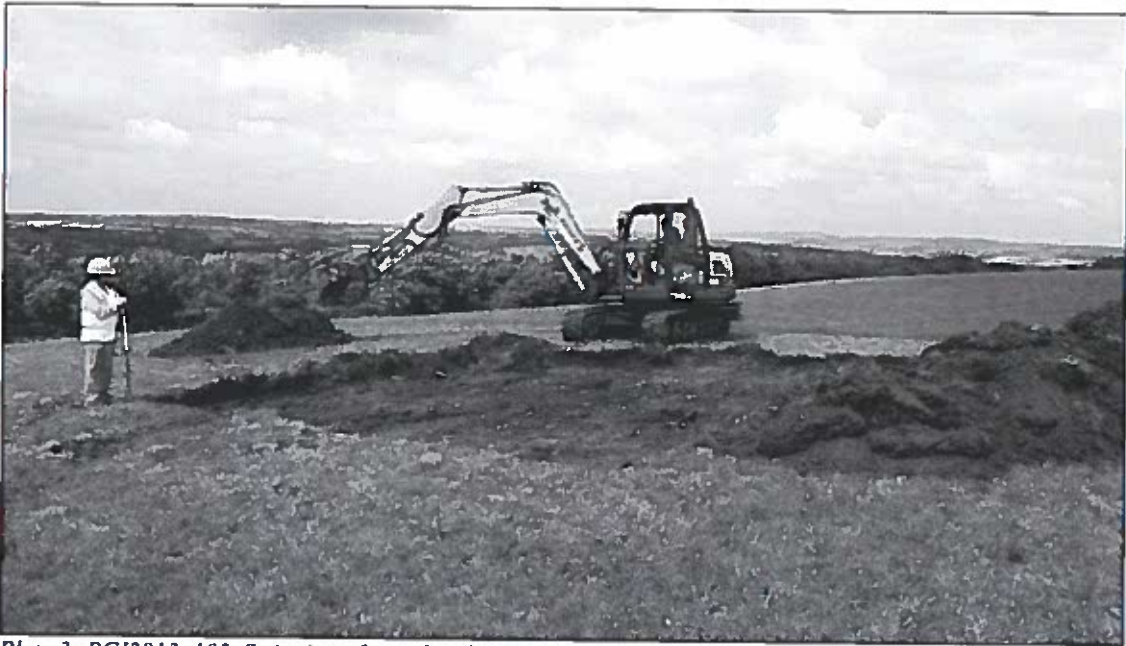
a) Trench 2 at SN2731740158

Context Number	Depth	Description	Interpretation
004	0.20m	10YR4/2, dry, friable with small stones	Topsoil
005		5YR4/6	Subsoil
006		10YR3/2, a 1 metre wide layer in natural hollow	Subsoil, probably coloured by iron panning
007	-	10R3/4, layer of iron panning	Natural iron panning
003	-	Vertically bedded shale with an undulating surface, some quartz in the eroded surface of the shale, part of a natural quartz vein.	Natural rock

*Plate 3: PGI2013\_103, Stripping of trench 2, looking northeast.*

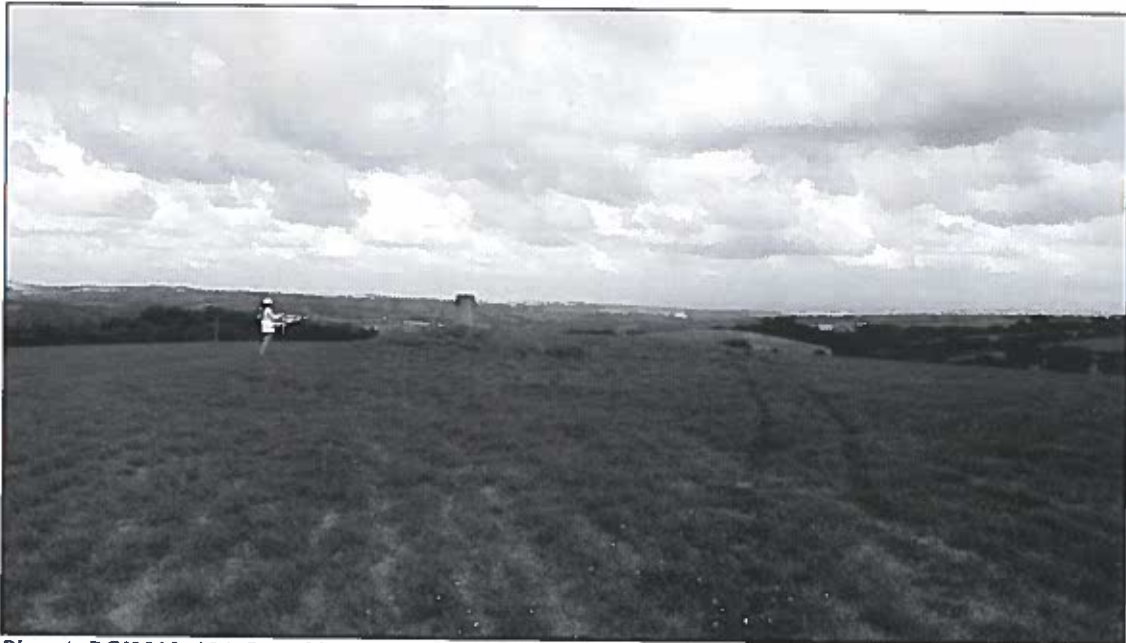
They concluded that the potential for archaeological remains of Palaeolithic, Mesolithic, Iron Age, Roman, Early Medieval, Medieval, and Post Medieval date was low. However a probable Bronze Age round barrow was identified during their field visit, 120 metres from the northernmost turbine. It was therefore thought possible that other Bronze Age features may be found nearby.

*Plate 4: PGI2013\_104, Round barrow, PRN 100717, with a concrete triangulation pillar on top of it. The barrow lies on the highest point of the rounded hill and 110 metres east of the closest turbine base, trench 1, looking northeast.*
