4, 5, 6 Castle Terrace and 7 & 8 Northgate Street, Pembroke Historic Environment Desk-based Assessment

Trysor Project No. 2012/268

For: Kinver Kreation

October 2012

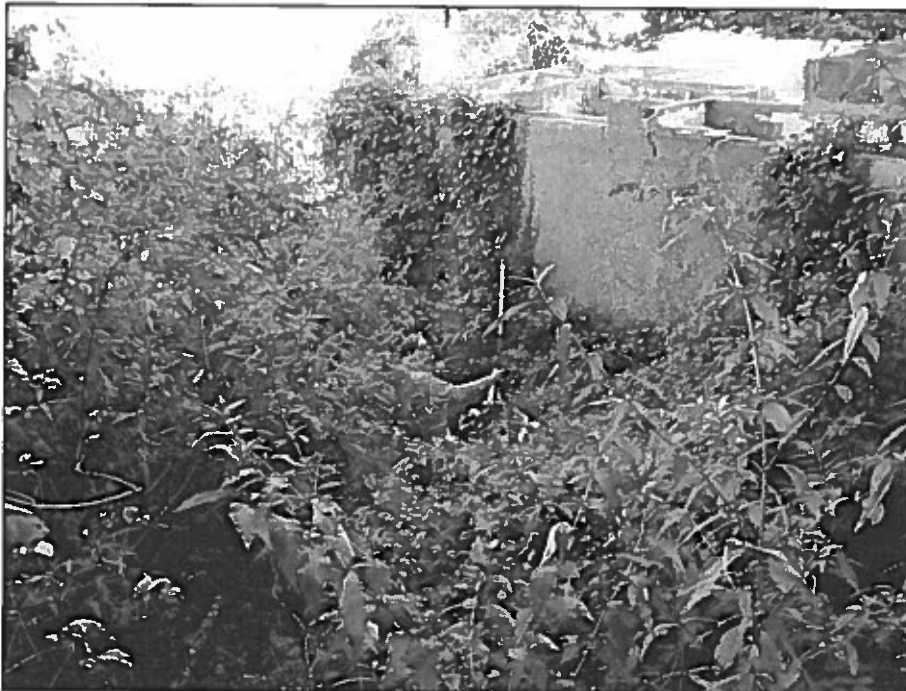
Plate 1: The overgrown garden to the rear of 5, Castle Terrace

7.2.3 Mitigation. The proposal is merely to clear the vegetation which has overwhelmed the garden and erect a timber fence to divide the garden into northern and southern parcels. During this work, care must be taken not to damage or disturb the stone walls ID numbers 65 & 66 or the stone steps (ID number 67), which are historic features. If fence posts are inserted deeper than 50cm to erect the timber boundary fence, it is recommended that an archaeological watching brief is considered as there may be archaeologically significant deposits in this area. The timber fence must be constructed in a fashion that does not damage or threaten to damage the walls which define the eastern and western sides of the garden.

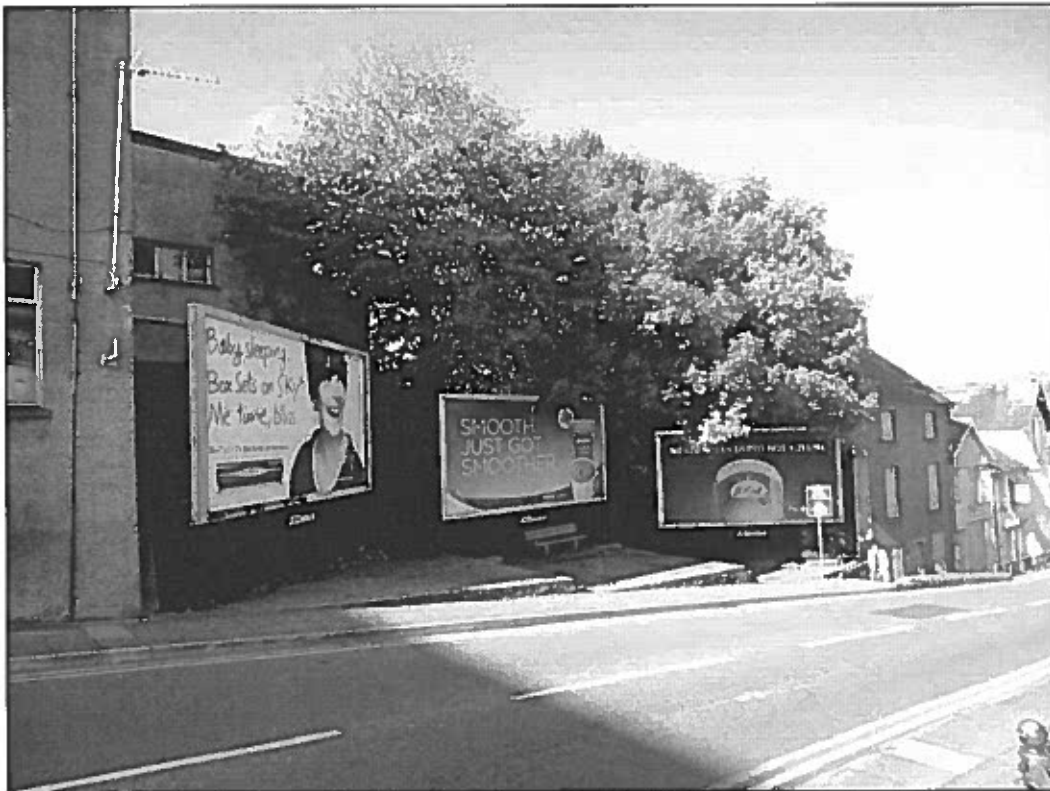
Plate 3: Northgate Street. No 7 is the salmon pink building to the right of the trees and No.8 is the light blue building downslope of it.

7.11.3 Mitigation. A photographic record, with an appropriate scale, should be made of each floor of this property before any work is undertaken. Appropriate materials should be used for any new external windows and doors and colours appropriate for the setting and period of the property should be used for any external decoration.
