Watching brief for Western Power  
June 2018

# PRIORY STREET, CARMARTHEN

## ARCHAEOLOGICAL WATCHING BRIEF IN THE CAR PARK, JUNE 2018

### REPORT BY NEIL LUDLOW FOR WESTERN POWER DISTRIBUTION

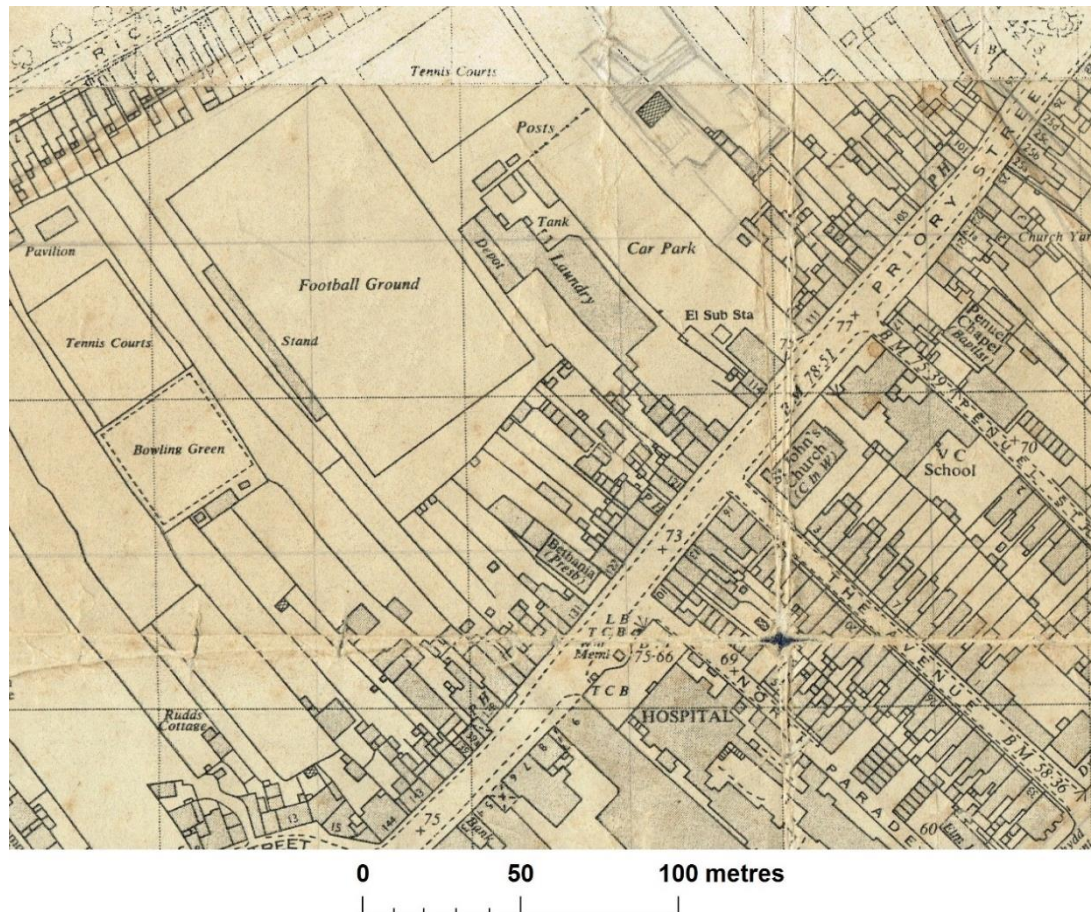
foundry straddled these two zones. By the late 1960s, a large building occupied much of the northwest half of the development plot (behind Nos. 116-118 Priory Street), partly overlying – or adapted from – the main block of the foundry (see Figs. 4, 5, 7 and 12); both lay southeast of the watching brief site. Labelled ‘Laundry’ on the 1969 Ordnance Survey map (Figs. 7 and 12), this later building was associated with a feature labelled ‘Tank’ to the northwest, and a building labelled ‘Depot’ further west. The remainder of the rear half of the plot was occupied by a car park. The electricity substation, and football pitch, had already been established.

*Fig. 7 – Detail from Ordnance Survey 1:2500 map, published in 1969. The development plot lies just right of centre. Cf. Figs. 4, 5 and 12.*

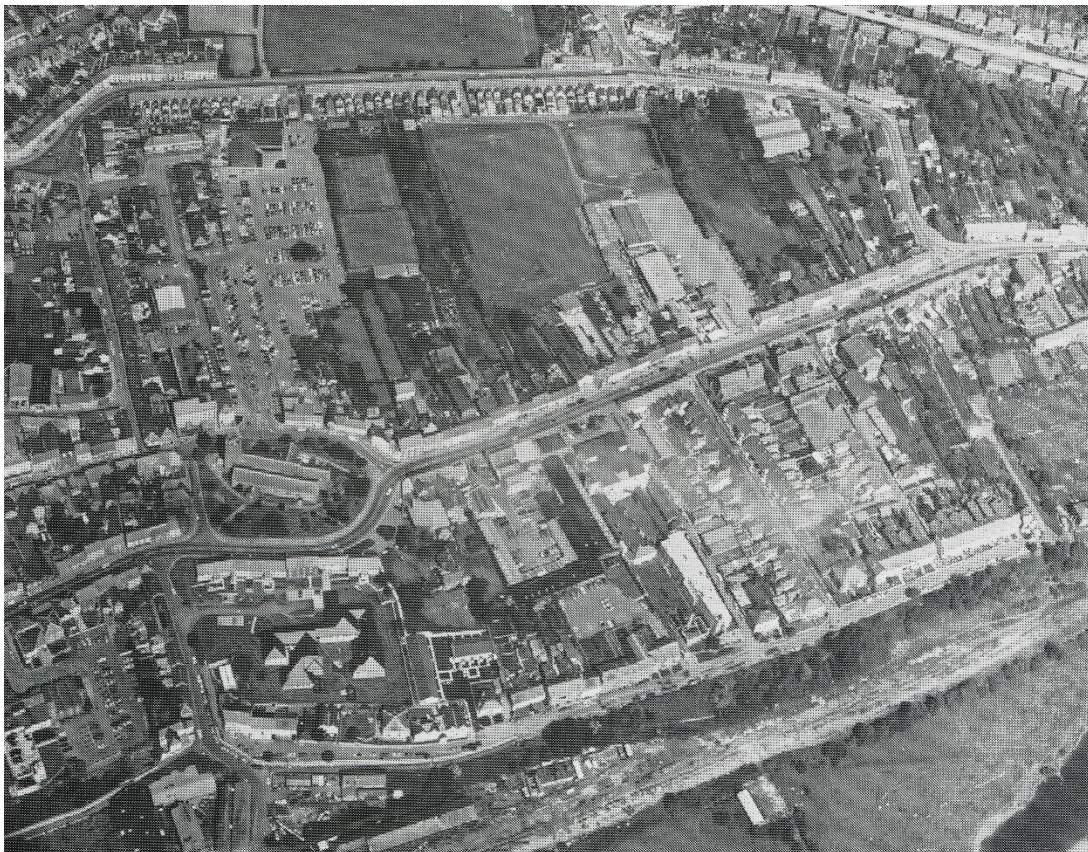
*Fig. 9 – Aerial photograph of the entire Roman town in 1985, from the southwest; the outline of the defences is preserved in the present street plan. The football pitch is top centre, with the development plot immediately to the right. Also visible are the garage building, former nightclub, depot and car park (from James 1992, Plate 3).*

The laundry building appears to have gone by 1979, when the present garage (recently demolished, see above) was shown on the site in an aerial photograph (Fig. 8); map evidence suggests that it occupied a slightly different footprint from the laundry. The depot was still standing while, immediately to the east of it, another large, prefabricated building had been erected. These buildings are also clearly shown in an aerial photograph from 1985 (Fig. 9), by which time the prefabricated building had become a nightclub, ‘Merlins’.

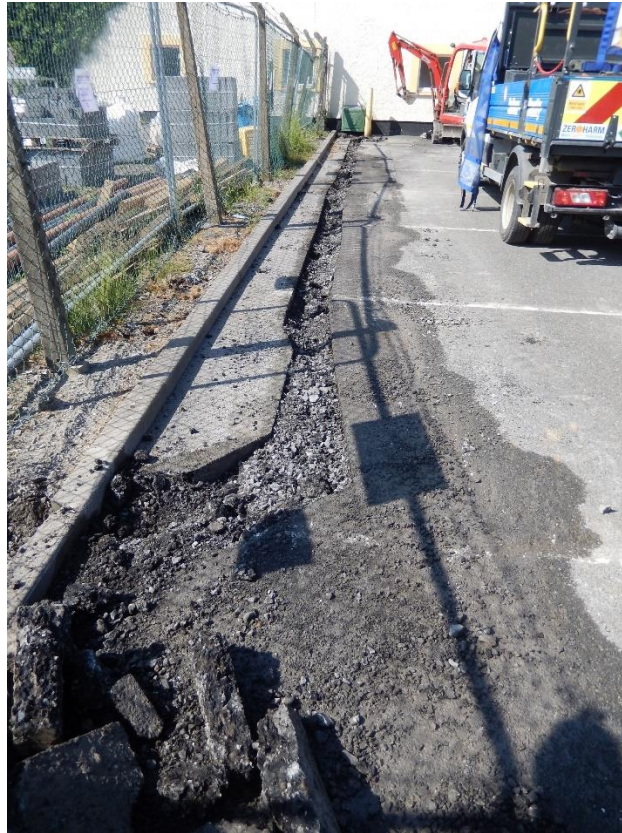
*Photo 1 – Cable trench (Trench A), looking southwest towards the football club pavilion at commencement of excavation*

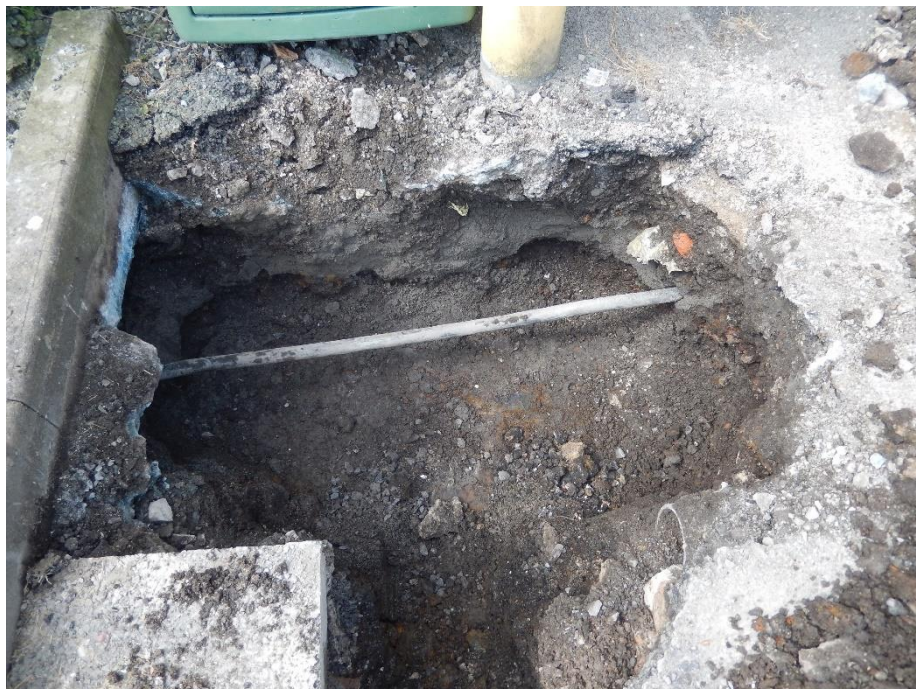
Only one deposit was observed throughout the trench, occurring directly beneath the tarmac and extending to the bottom. It was a very mixed, dark-brown silt-loam material, containing some brick fragments and lenses of clay, ash and chippings, some of which were quite extensive. Shards of frosted glass, of twentieth-century date, were also present, while dominating the inclusions was a high percentage of iron slag, some of which was in the form of large concretions up to 0.20m across. This slag can be seen, in the spoil, in the photographs at the end of this report (see appendix).

*Photo 2 – The southwest end of the cable trench (Trench A), looking southwest at completion of excavation*

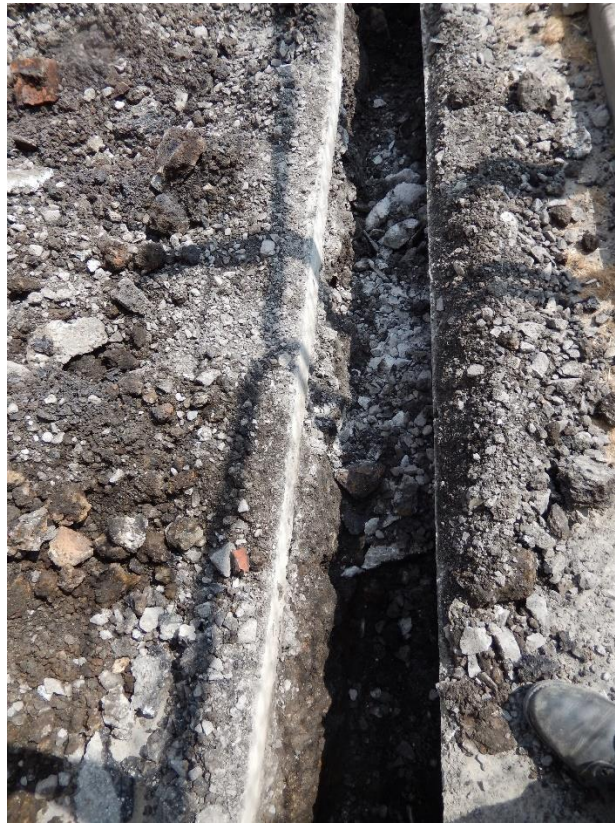
Two areas of concrete were present, both running beneath both sides of the trench section, and neither removed to its base (Fig. 11). To the southwest, a concrete surface appeared at a depth of 0.40m and ran for 1.50m through the trench. To the northeast, a narrower 'band' of concrete appeared 0.20m beneath the surface; it was 0.30m wide.

*Photo 3 – The western concrete feature, from southwest*

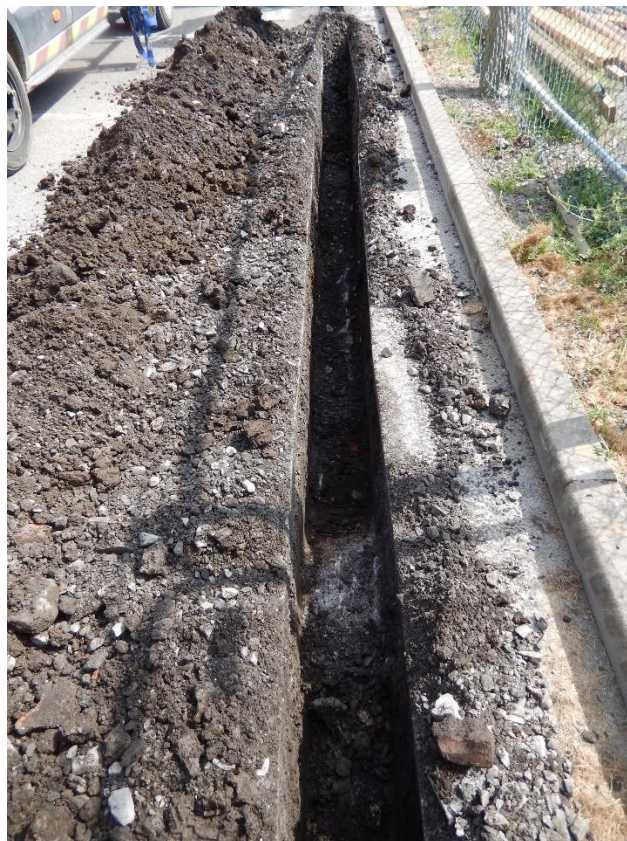
*Photo 4 – The eastern concrete feature, from southwest*

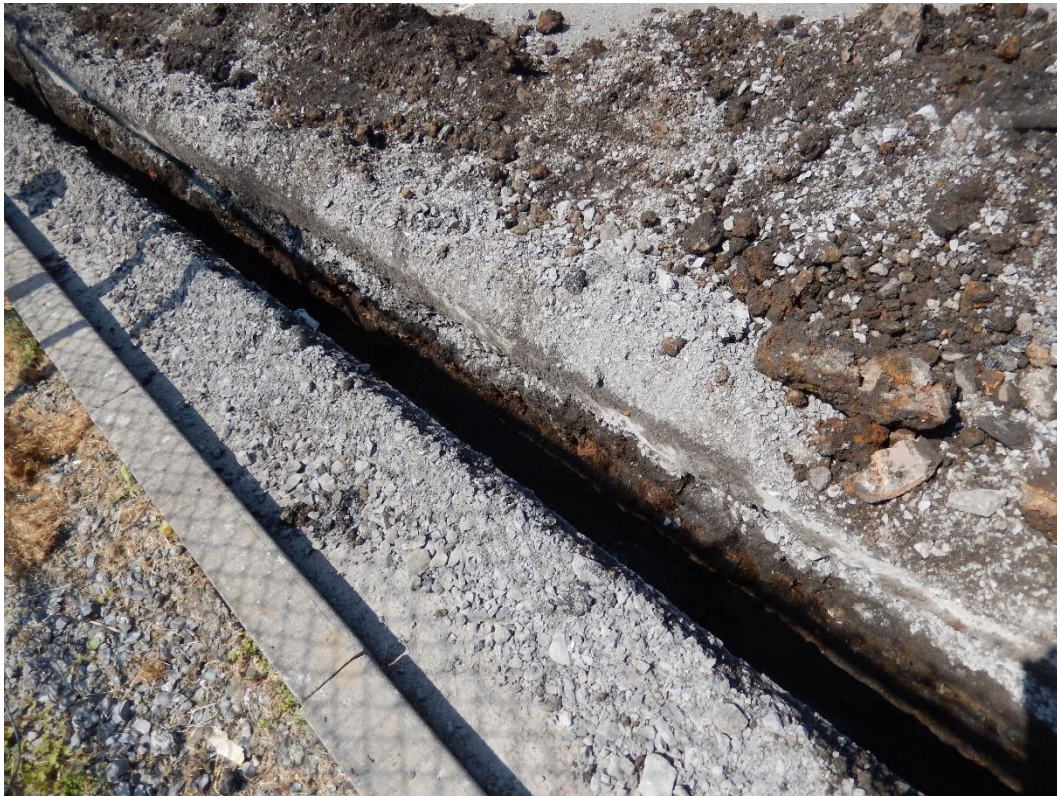
*Photo 6 – The northern edge of the cable trench (Trench A), looking north at completion of excavation*

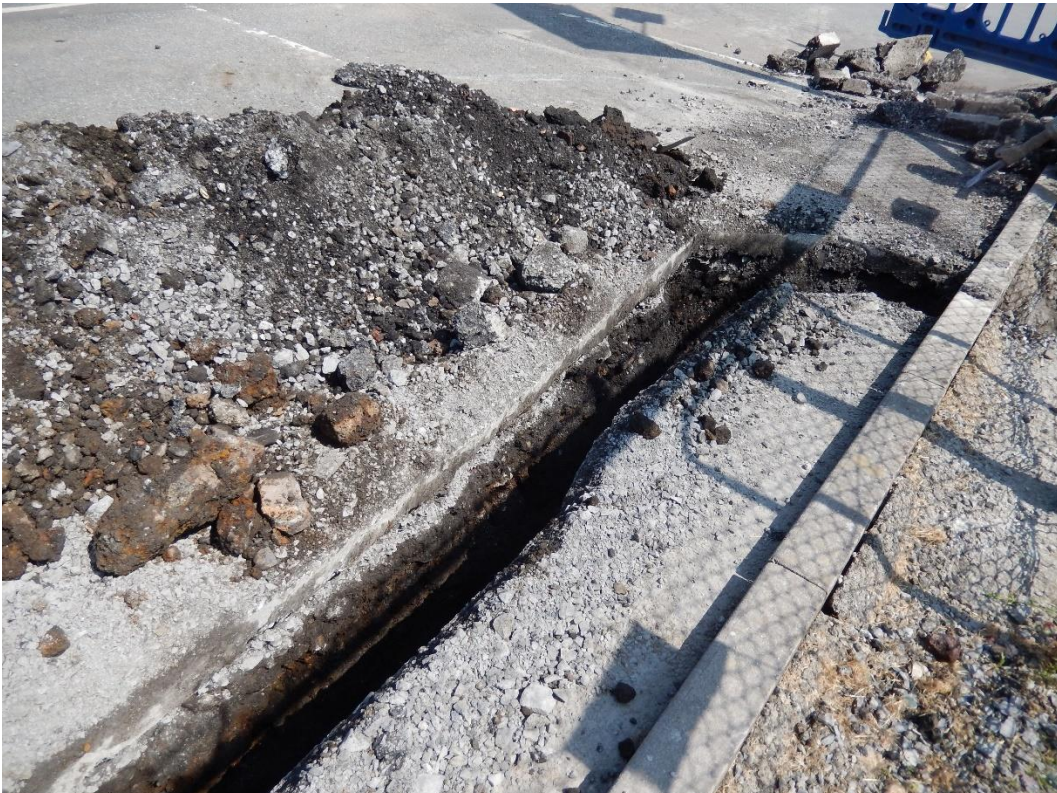
*Photo 6 – The northeast end of the cable trench (Trench A), looking north at completion of excavation*
