CARMARTHEN CASTLE

ARCHAEOLOGICAL WATCHING BRIEF OUTSIDE THE GATEHOUSE, MAY 2018

**REPORT BY NEIL LUDLOW
FOR WESTERN POWER DISTRIBUTION**

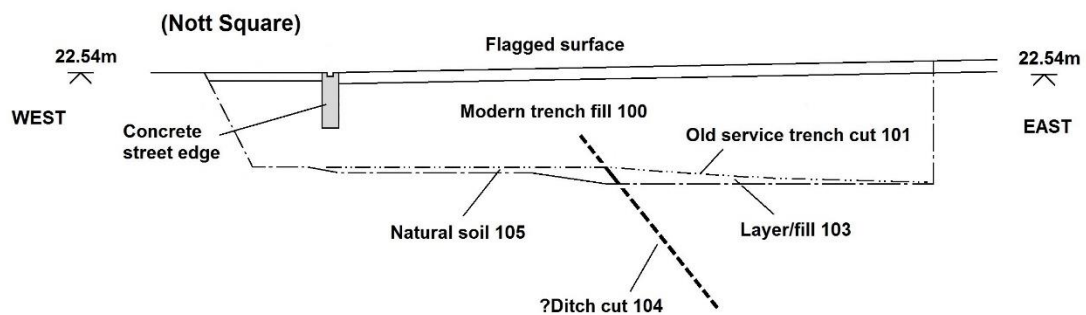
Section A - A

The latest features comprised the late twentieth-/twenty-first-century surfaces mentioned above, which averaged 0.10m in thickness. They were separated by concrete edging running north-south along the east side of Nott Square, laid in the mid-2000s; it descended to a depth of 0.45m, concealing the features and deposits in the upper half of the eastern section of the trench.

Context 103 (Trench A) – This was a deposit occupying the eastern half of Trench A, where it had been truncated by earlier service trenches 101. It was only seen in the very bottom of the trench, at a depth of 0.80m-0.85m. It was a black, loamy material, similar to context 102, but was only partly revealed and not be properly characterised. It may have been a fill of the possible ditch 104 (Fig. 4).

Context 104 (Trench A) – This was a possible cut feature (Fig. 4). It represents the edge between deposit 103 and the natural soil 105, at a depth of 0.80m, and may therefore be the western edge of the medieval defensive castle ditch revealed during the 2003 excavations (see Section 5.0 below).

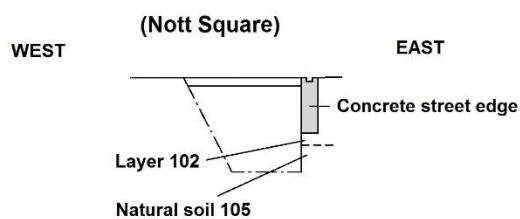
Trench B
Section B - B

Context 102 (Trench B) – This was a deposit that was only seen in the eastern section of Trench B, immediately beneath the foot of the concrete street edging at a depth of 0.45m-0.50m. It was a black, loamy material averaging 0.05m in thickness which, in the limited exposure, could not be properly characterised. It directly overlay the natural soil 105 (Fig. 4).

The surface of this natural soil, where exposed in Trench B (Nott Square), lay 0.50m beneath the present surface – that is, 0.25m higher than in Trench A where it had been truncated by previous service trenches (Fig. 4). The level of the natural soil in Trench B therefore represents the lowest point from which the medieval ditch can have been cut, and the lowest possible level of the surface of Nott Square itself during the medieval period. It is apparent therefore that some post-medieval truncation of horizons must have occurred here. Nott Square clearly sloped much more steeply downhill to the west during the medieval and early post-medieval periods: rapid survey in 1994 by the author and Gavin Evans (Carmarthen Museum), of No. 5 St Mary's Street, 30 metres west of the watching brief site, revealed an external doorway threshold, of probable sixteenth-century date, two metres beneath present road level.

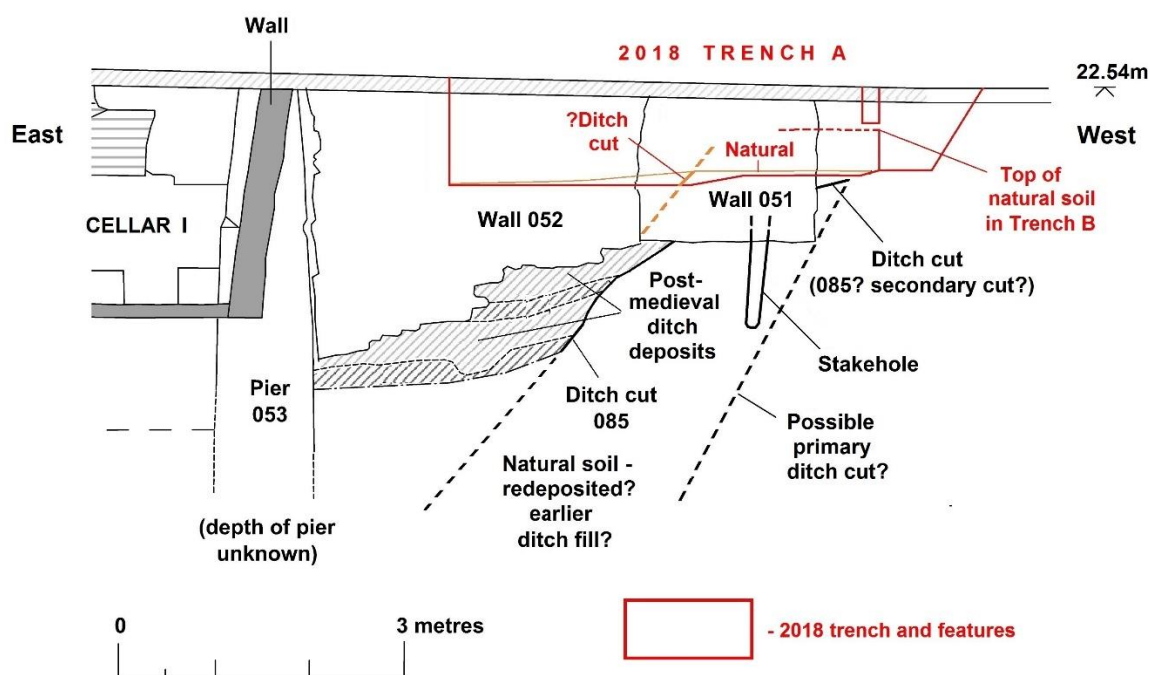
Fig. 5 – Section through the 2003 excavated area relative to the 2018 joint trench section

The results can be assessed alongside the results of the 2003 excavation. Recording in 2003 was chiefly confined to the excavated area immediately north of Trench A, from which it was separated by the post-medieval, east-west wall 052 (Fig. 3). The junction between the two areas was concealed behind the concrete street edging along the east side of Nott Square. Nevertheless, the archaeological sequence seems to tally between the two areas (Fig. 5).

In both, the earliest deposit encountered was the natural soil (2018 context 105). It was felt, in 2003, that this may have been redeposited subsoil, filling the western side of an earlier, wider and steeper defensive ditch (Schlee 2004, 24; see Fig. 5). However, the deposit observed in 2018 appeared to be entirely sterile, and typical of natural fluvio-glacial gravels. Owing to the constraints described above, no cut features – post-holes, stakeholes etc. as revealed in 2003 (Figs. 3 and 5) – could be observed within it.

The western, external edge of the defensive ditch had been thought, as a result of the 2003 excavations, to correspond more-or-less with the eastern edge of Nott Square and Bridge Street (Schlee 2004, 24). However, if 2018 context 104 does represent the ditch edge, then it lay further east – perhaps between 1.5m and 1.7m east of Nott Square. Nevertheless, comparison between the 2003 and 2018 sections, situated north and south of post-medieval cellar wall 052 respectively, shows that the suggested edge 104 more-or-less corresponds with the main body of the ditch cut 085 (Fig. 5). While the latter appears to become shallower towards the top, sloping towards Nott Square (see Fig. 5), this upper part may represent a secondary cut associated with post-medieval development – in particular, east-west wall 052 and the abutting diagonal wall 051 (Figs. 3, 5 and 6). No evidence for these walls was observed in the eastern section of Trench B, where their truncated remains partly lie behind the concrete edging of Nott Square, while the evidence suggests that they probably run out against the slope of the secondary(?) ditch cut, just to the east of Trench B (Figs. 3, 5 and 6).

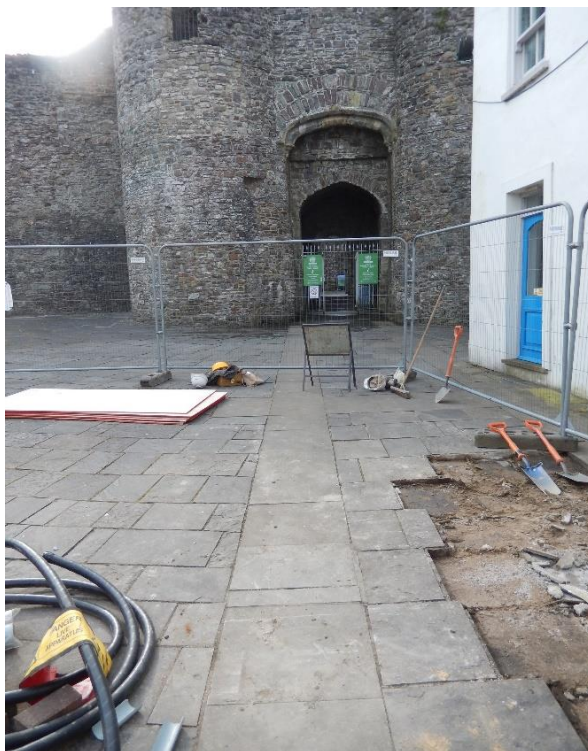
Photo 1 – Trench A, looking east towards the castle gatehouse at commencement of excavation

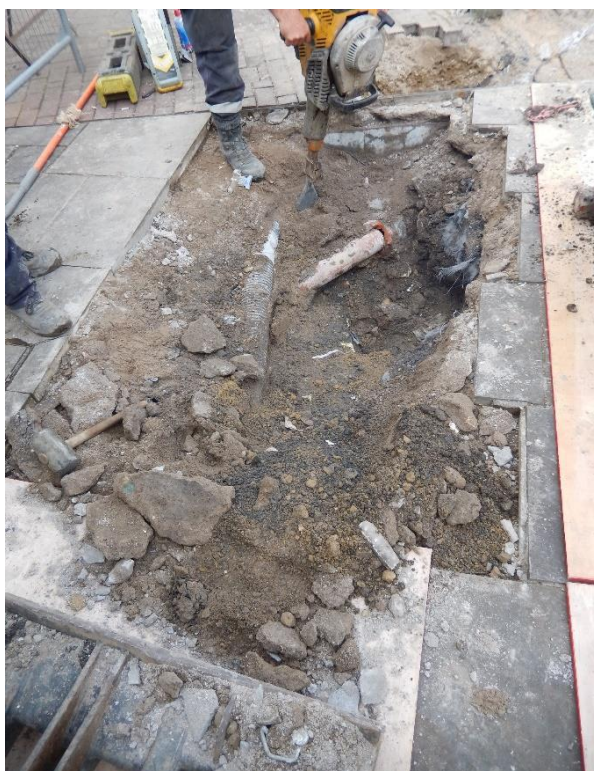
Photo 2 – Trench A, looking west during excavation

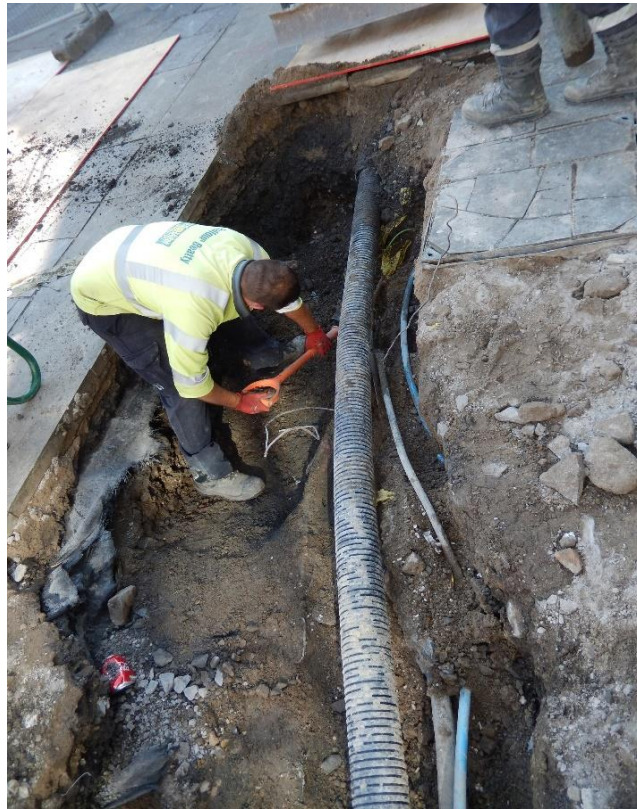
Photo 3 – Trench A, looking northeast during excavation

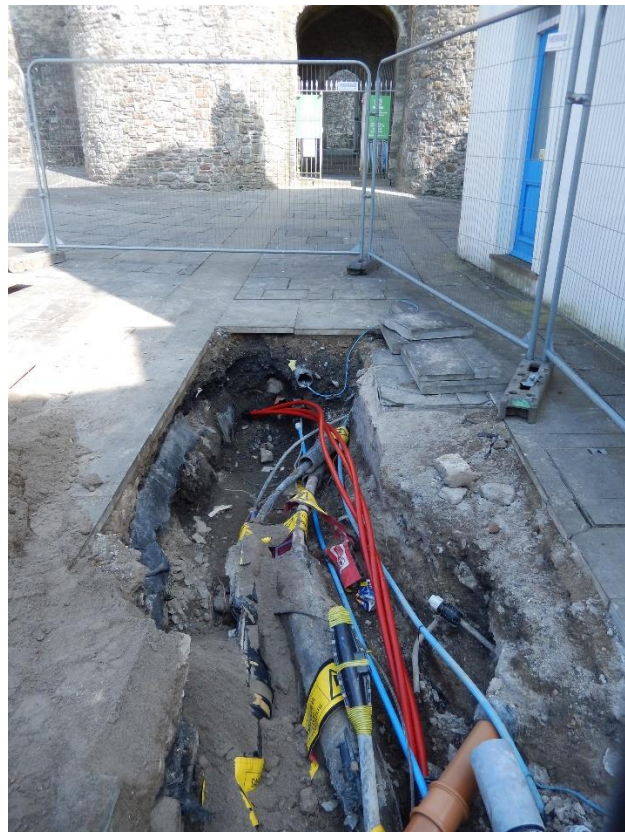
Photo 4 – Trench A, looking east at completion of excavation

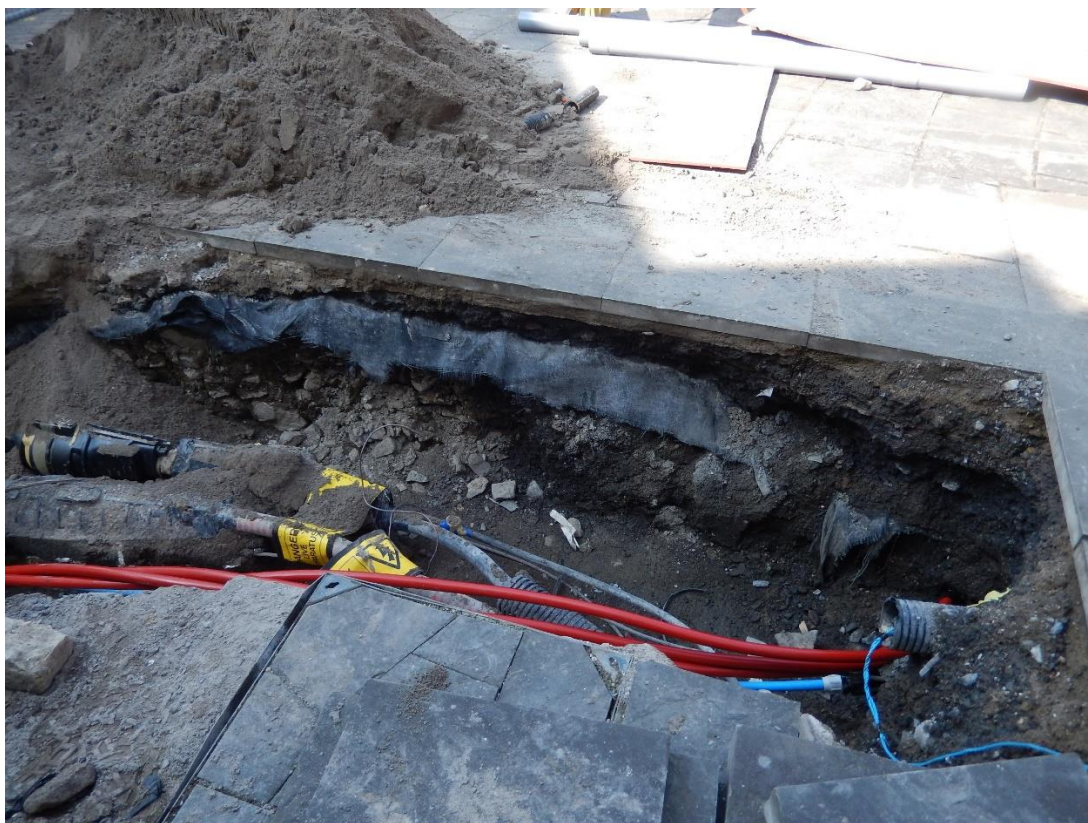
Photo 5 – Trench A, looking north at completion of excavation

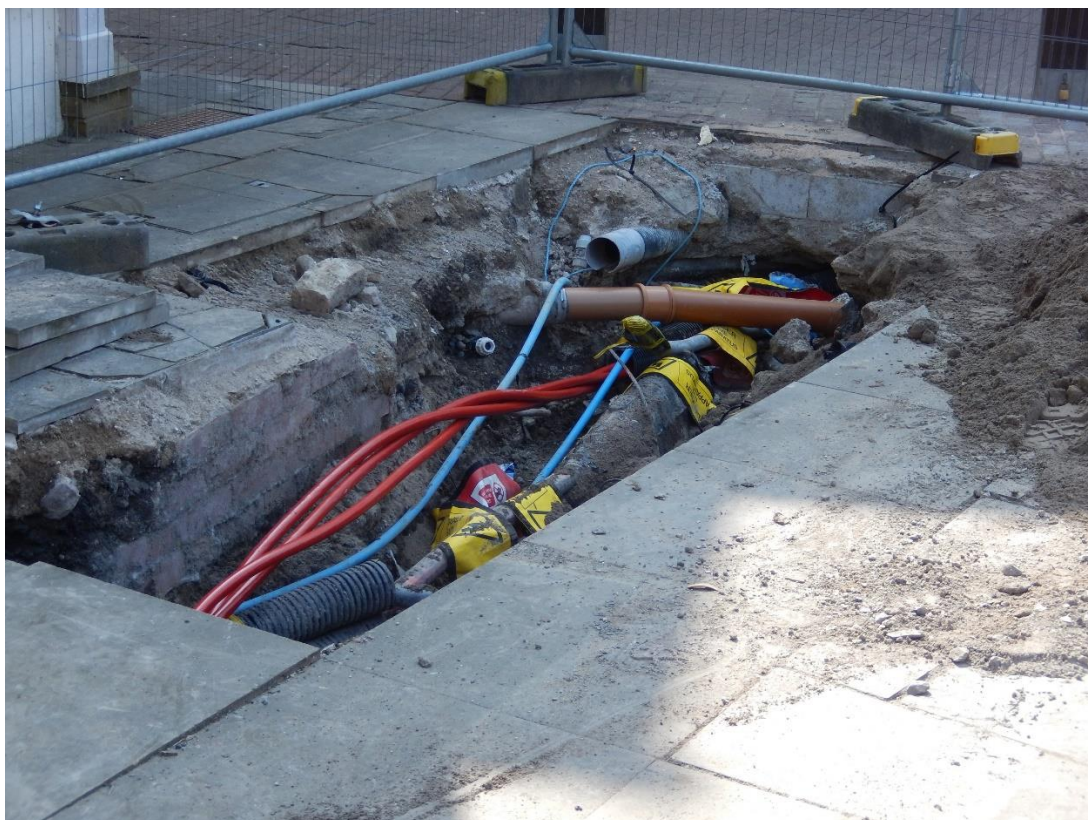
Photo 6 – Trench A, looking southwest at completion of excavation

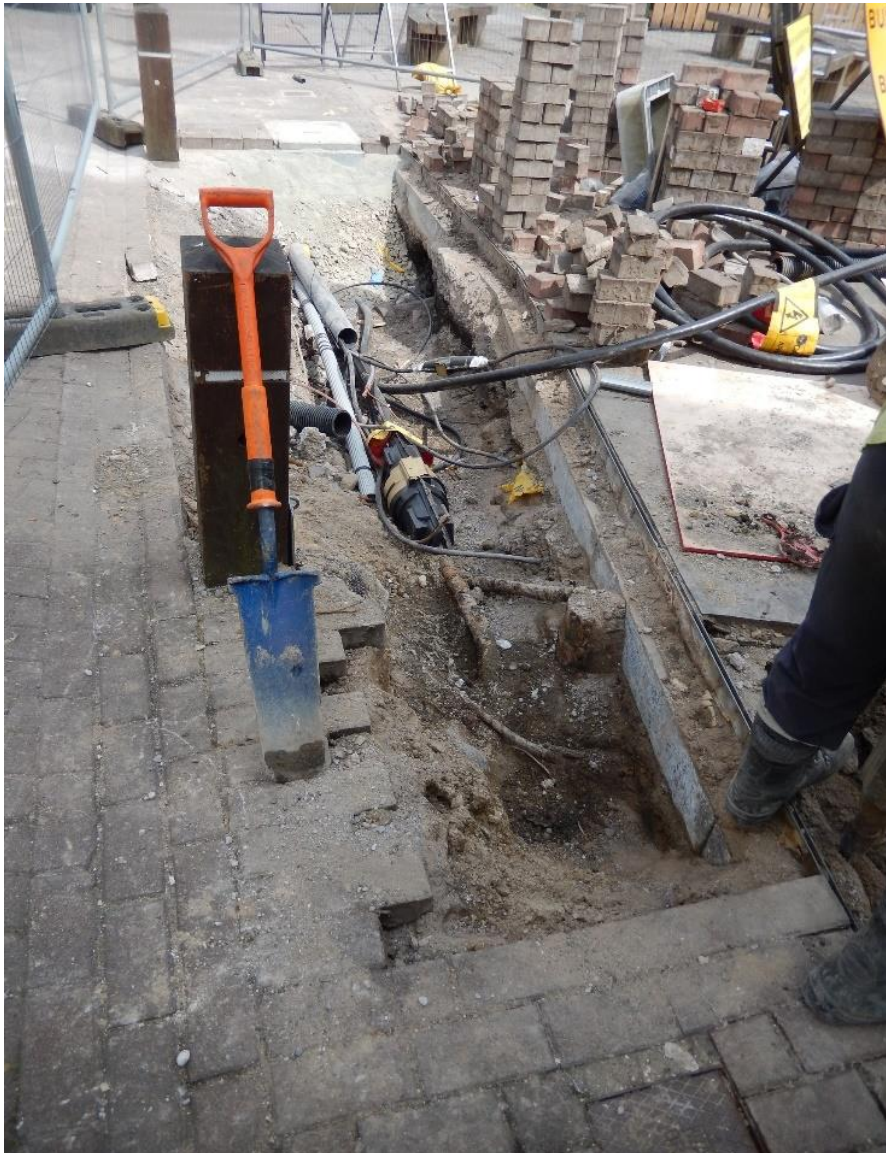
Photo 8 – Trench B, looking north during excavation
