**SUMMARY OF HISTORIC ENVIRONMENT
DESK-BASED ASSESSMENT AND
WALKOVER SURVEY FOR A
ONE PLANET DEVELOPMENT AT
COEDTALYLAN, CARMARTHENSHIRE
19/17176/PAYPRE**

Trysor Project No. 2018/630

RHIF YR ADRODDIAD - REPORT NUMBER: Trysor 2018/630

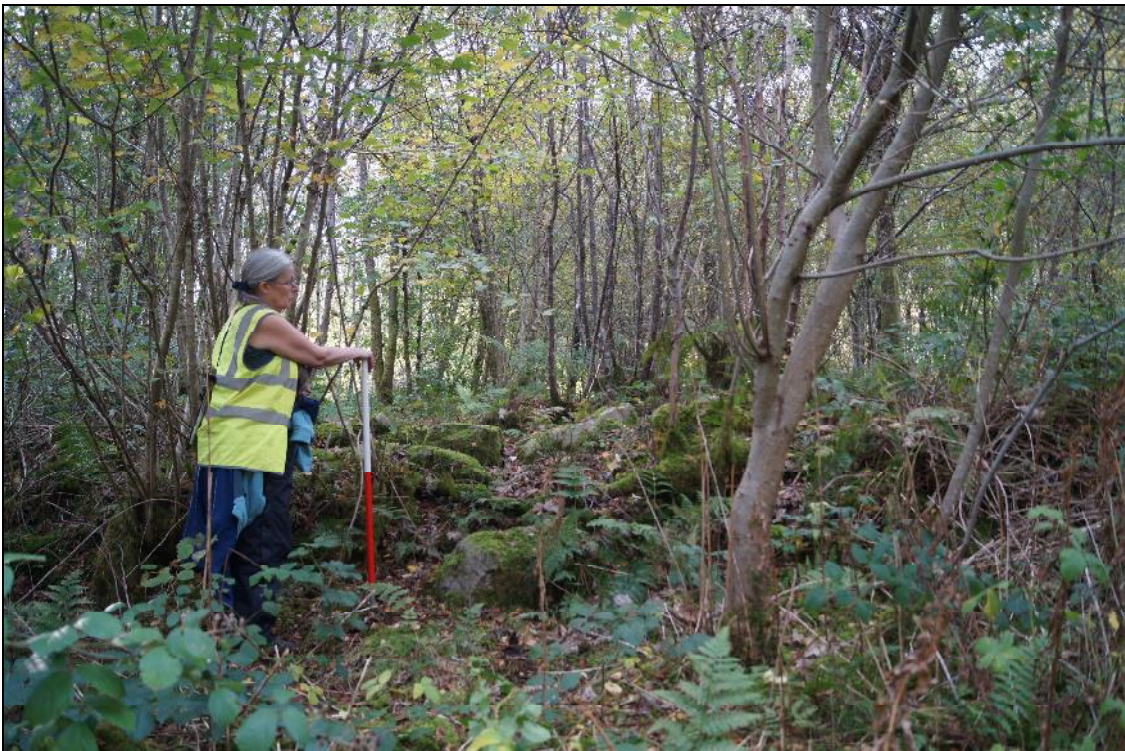
Cover photograph: Stone bank or lynchet, ID number 025, looking west.

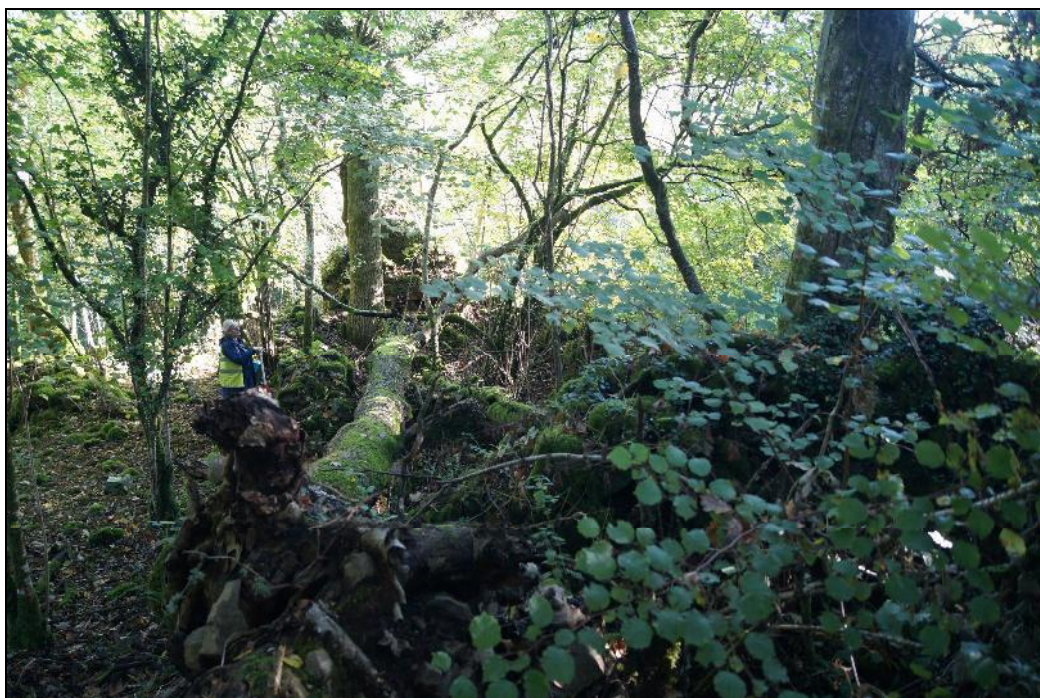
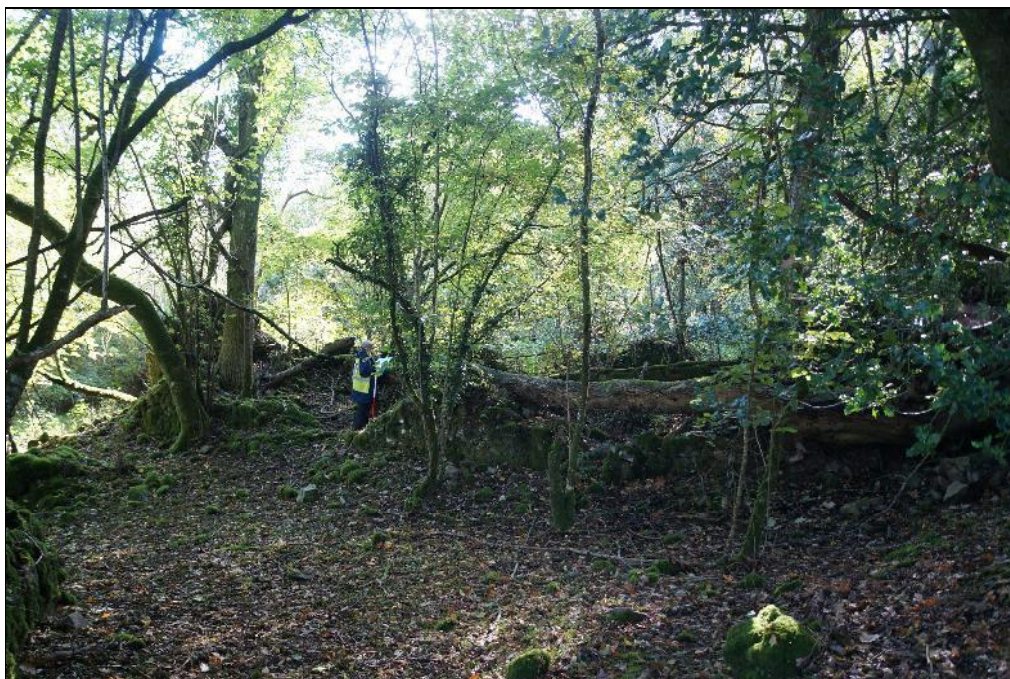
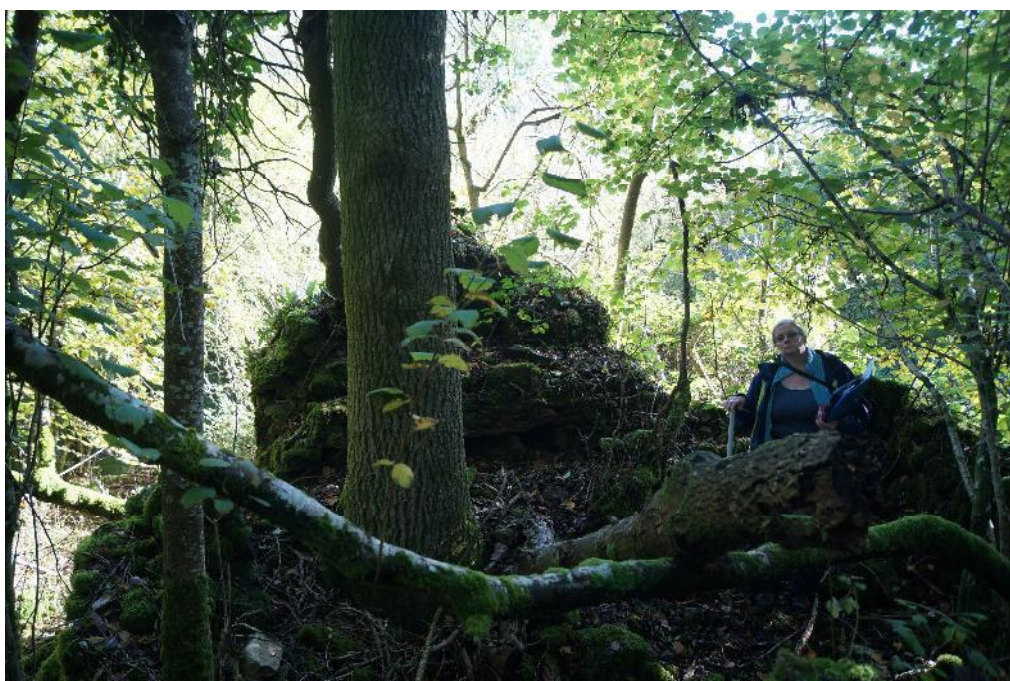
Plate 1: CTL2018_001 – the ruins of Pentrebach cottage (ID number 139) looking northeast.

Plate 2: CTL2018_002 – the ruins of Pentrebach cottage (ID number 139) looking northeast.

Plate 3: CTL2018_003 - the ruins of Pentrebach cottage (ID number 139) looking east.

Plate 4: CTL2018_004 - the ruins of Pentrebach cottage (ID number 139) looking northeast.

12.2.1 No management recommendations or mitigations have therefore been made for historic assets within this area, apart from ID number 139.

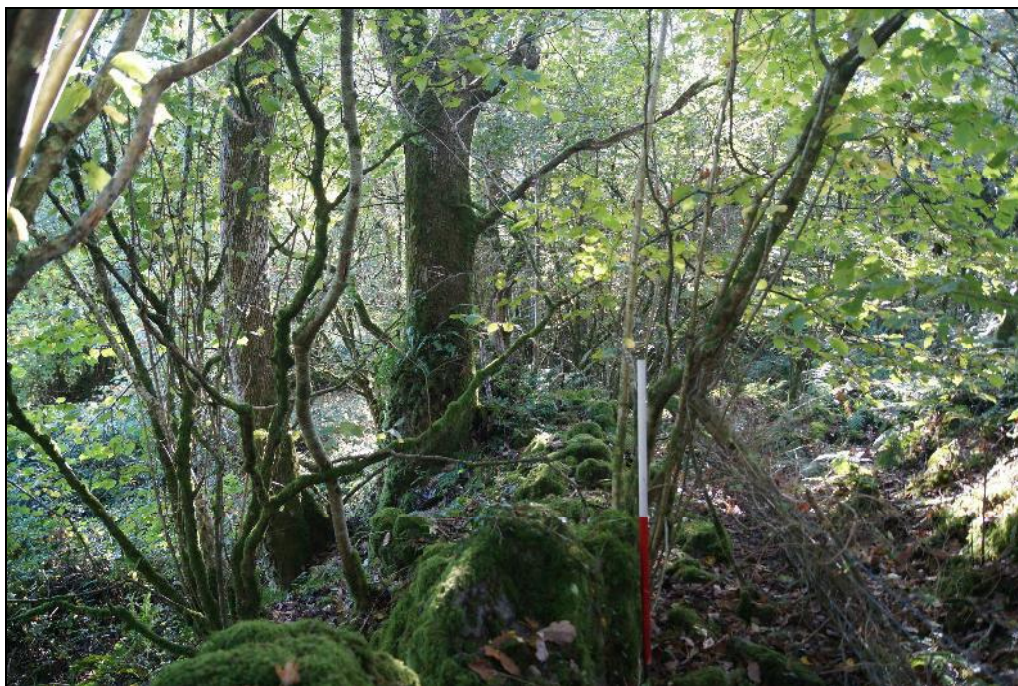
Plate 5: CTL2018_005 – a view along field boundary ID number 001, looking southeast. This section of the boundary is a drystone wall.

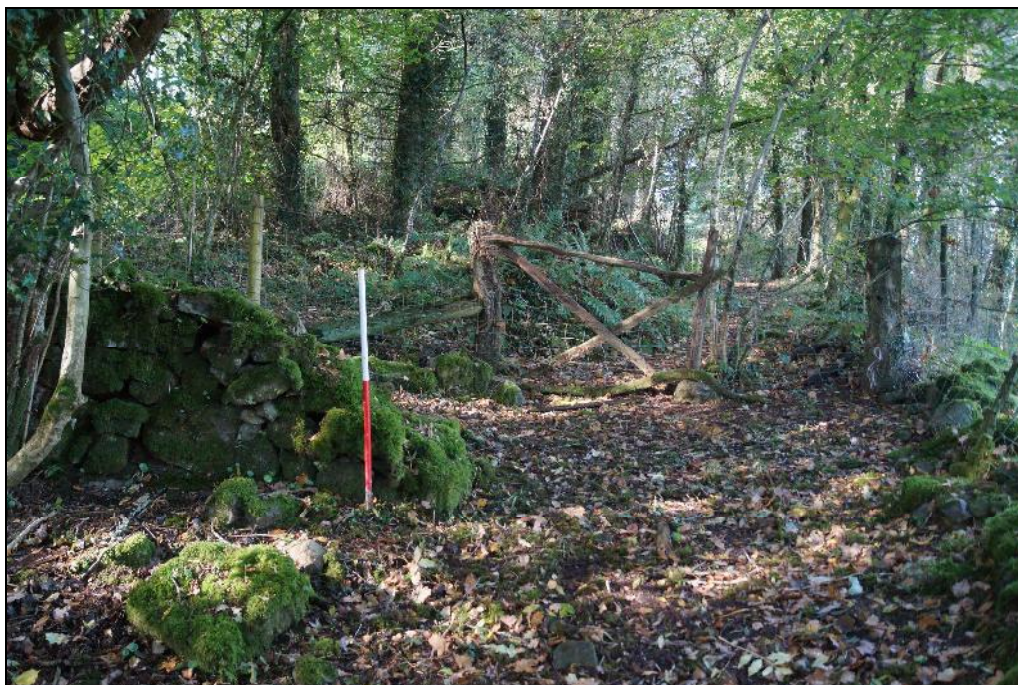
Plate 6: CTL2018_006 – Post and wire fence, looking west. The end of boundary ID number 001 is seen to the left. Trackway ID number 009 runs through the bottom centre of the photograph and up the slope.

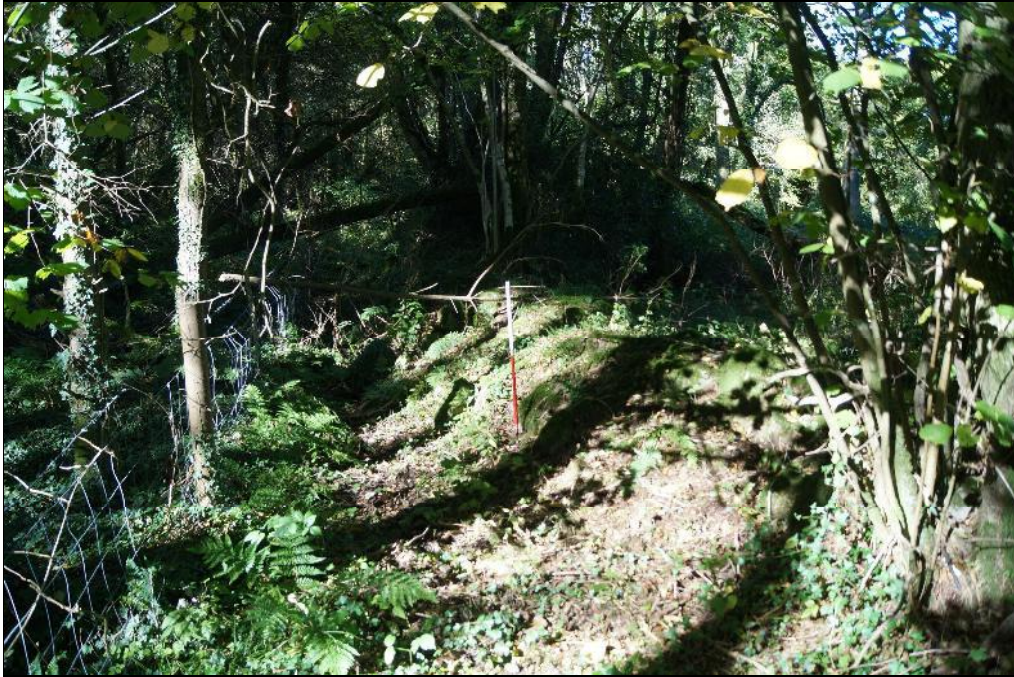
Plate 7: CTL2018_007 – a view of field boundary ID number 001, looking west-northwest. Towards its eastern end the boundary takes the form of a broad earthwork bank. Post and wire fence is visible to the left.

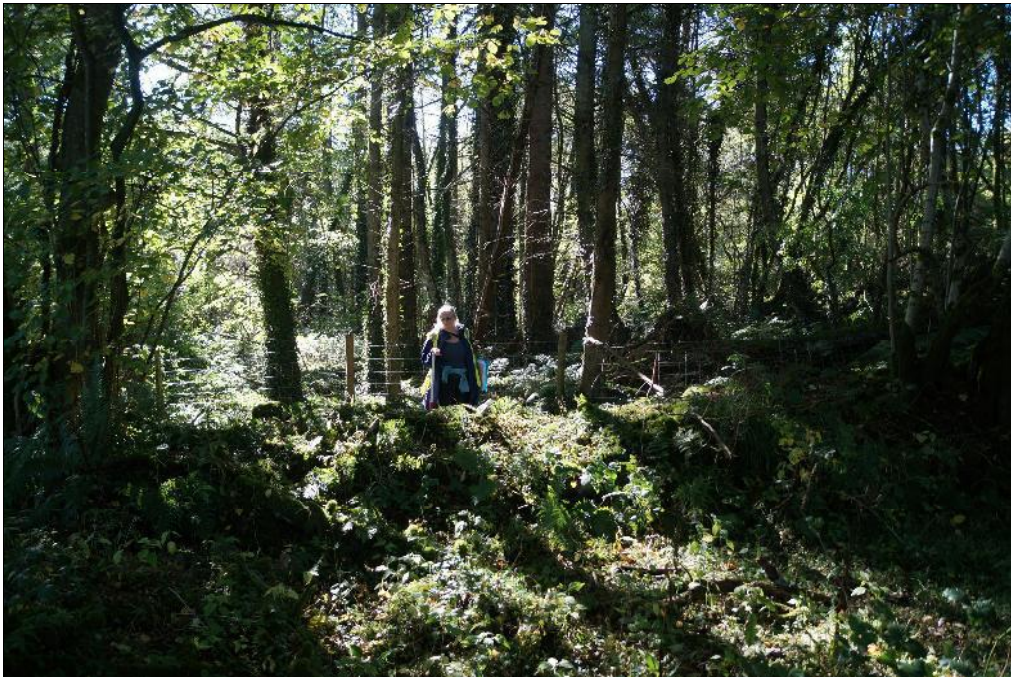
Plate 8: CTL2018_008 – a view of field boundary ID number 001, looking south-southwest. Towards its eastern end the boundary takes the form of a broad earthwork bank. Post and wire fence is visible behind the bank.

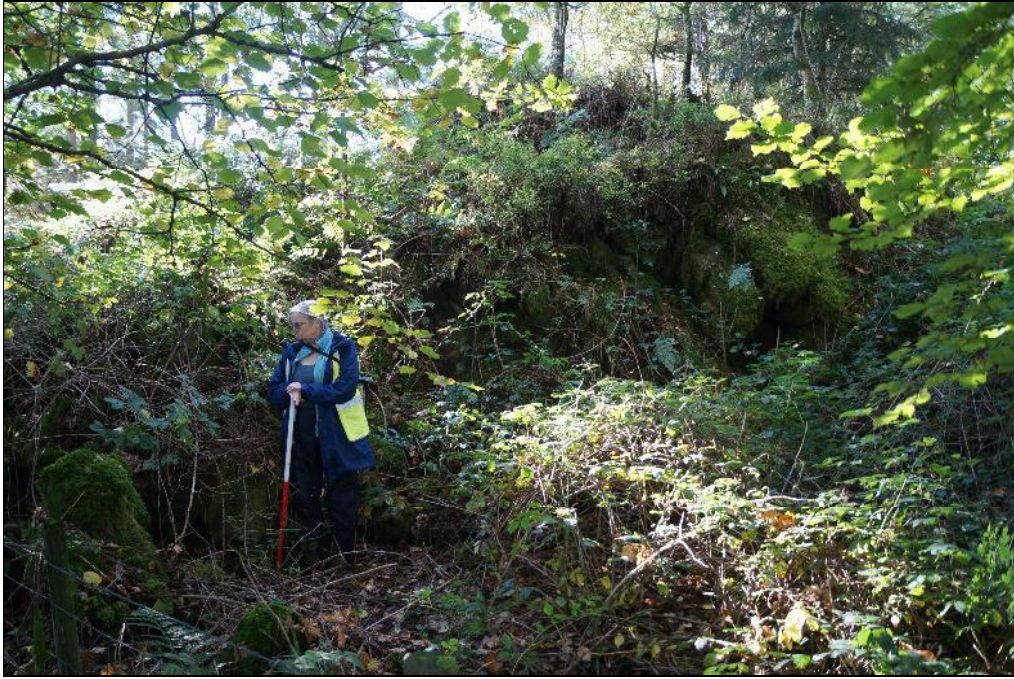
Plate 9: CTL2018_009 – a view of the area where boundary ID number 003 should end. No trace of a bank or wall exists. It is possible that the rocky outcrop here formed part of the boundary shown on the parish tithe map. Large slabs of stone to the left may be a crude boundary, extending the rocky outcrop to meet boundary ID number 001, which is to the left of this photograph. Looking south.

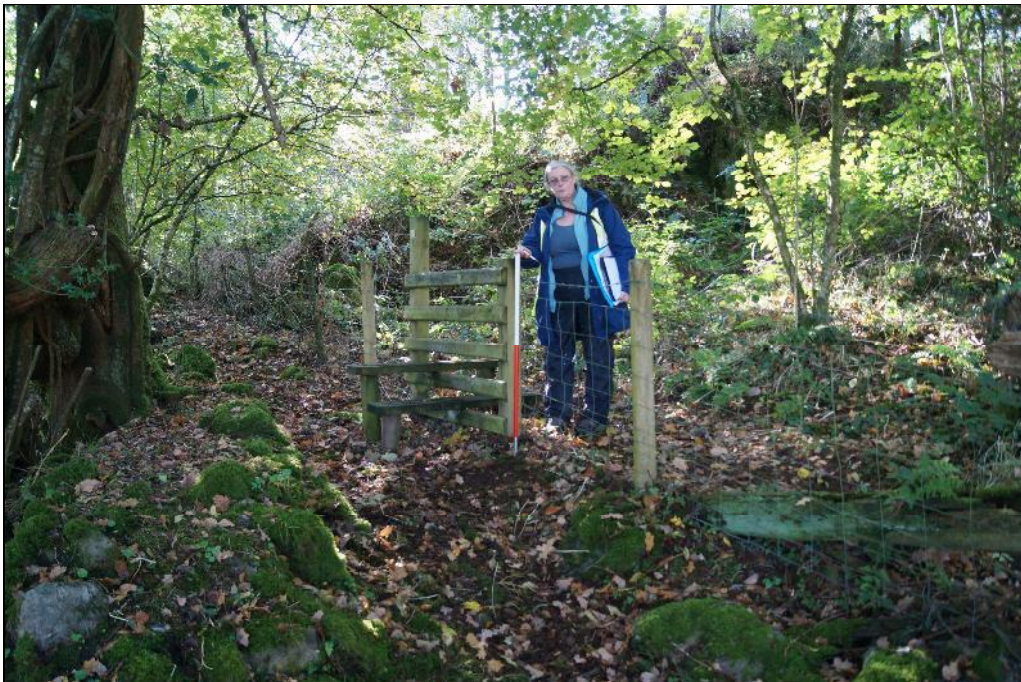
Plate 10: CTL2018_010 – a stile across the post and wire fence, looking south. Boundary ID number 001 is to the left. The rocky outcrop at the location of boundary ID number 003 is in the background.

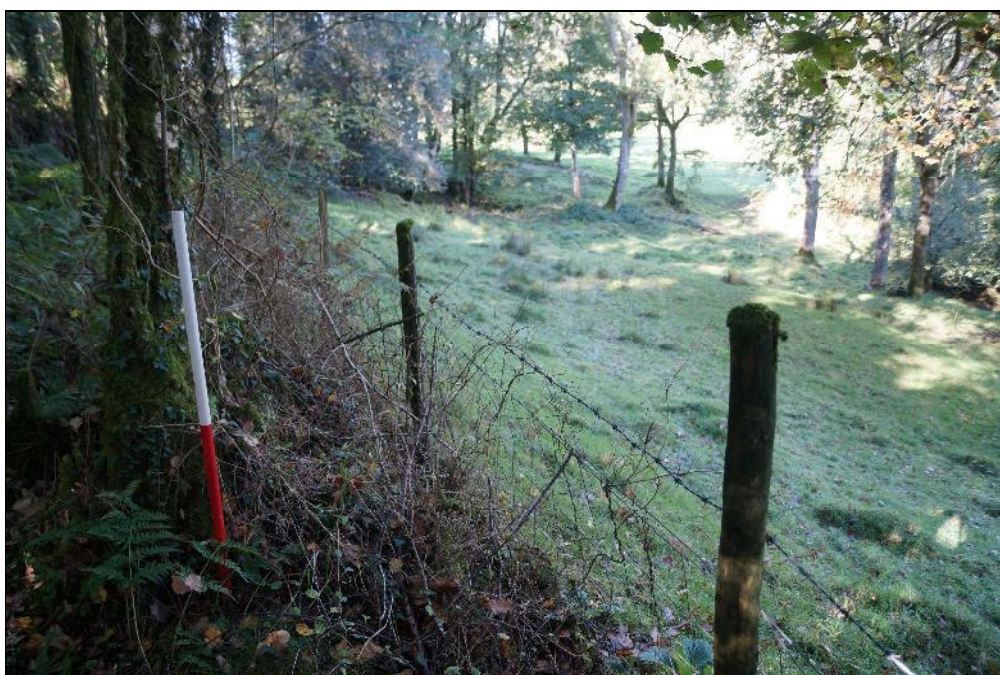
Plate 12: CTL2018_012 – a view of a post and wire fence, looking west-northwest.

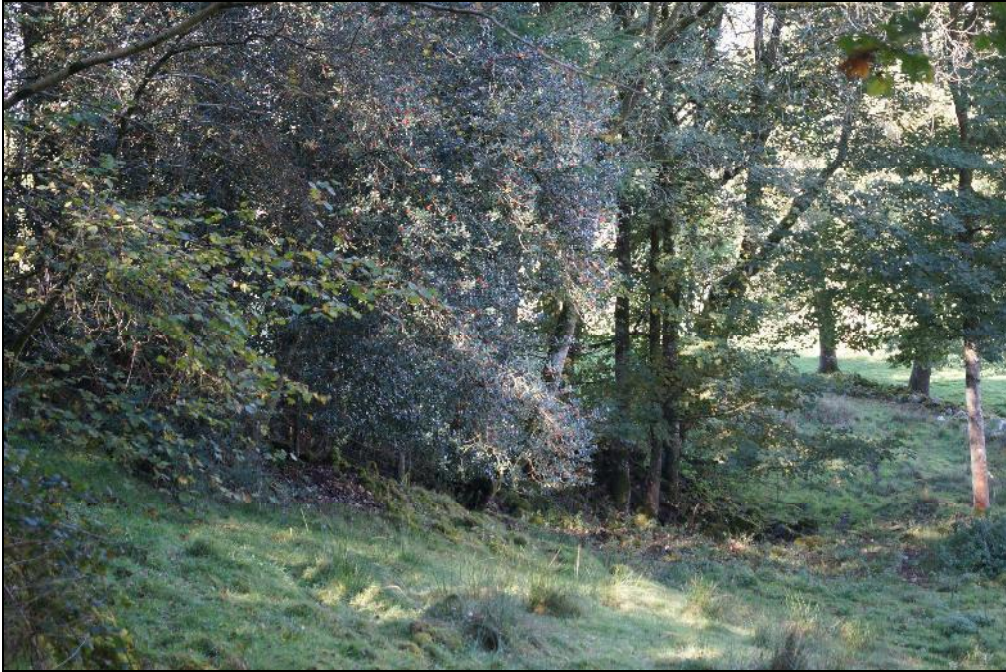
Plate 13: CTL2018_013 – a view of a part of boundary wall ID number 007, with the posts of the post and wire fence just discernable beneath the trees beyond. Looking west-northwest.

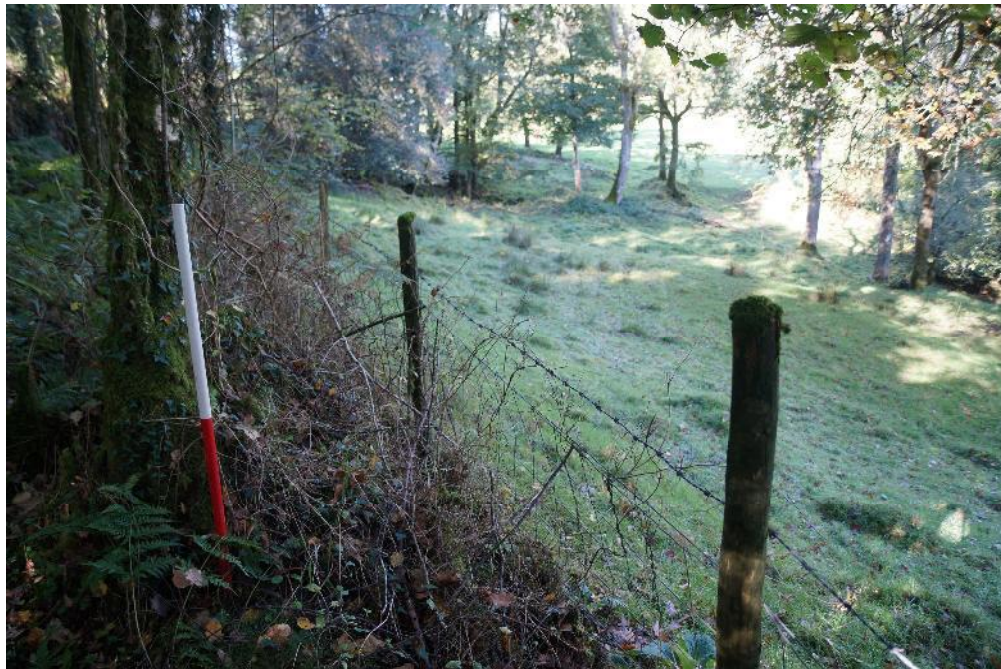
Plate 14: CTL2018_014 - a view across the post and wire fence, looking west. Boundary wall ID number 007 is hidden in the grass immediately outside this fence and has disappeared from the surface. Looking west-northwest.

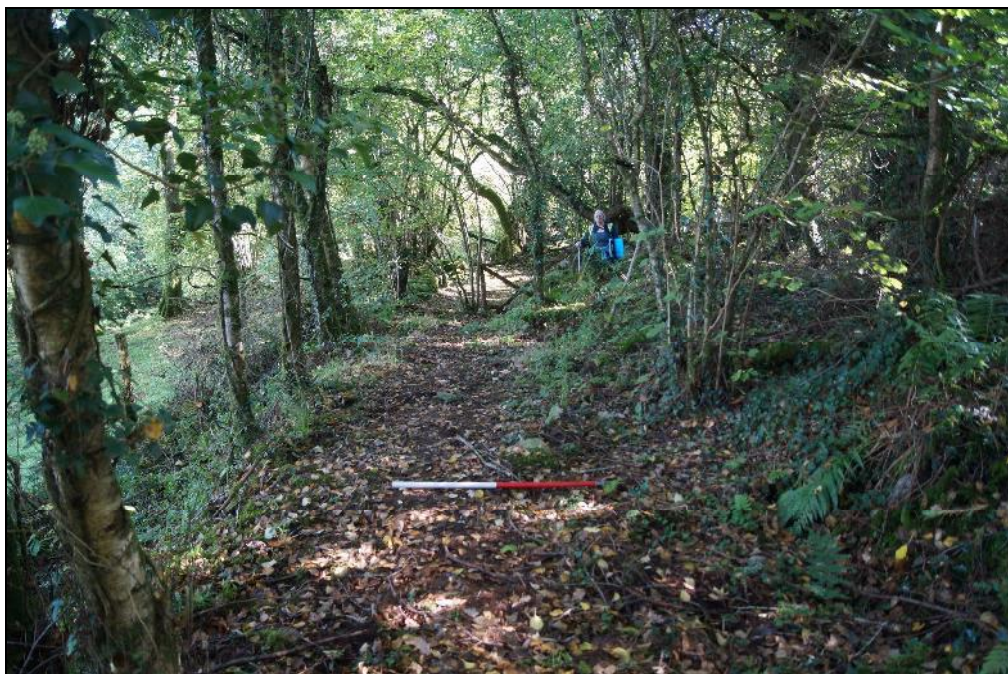
Plate 15: CTL2018_015 – a view of trackway ID number 009, looking east.

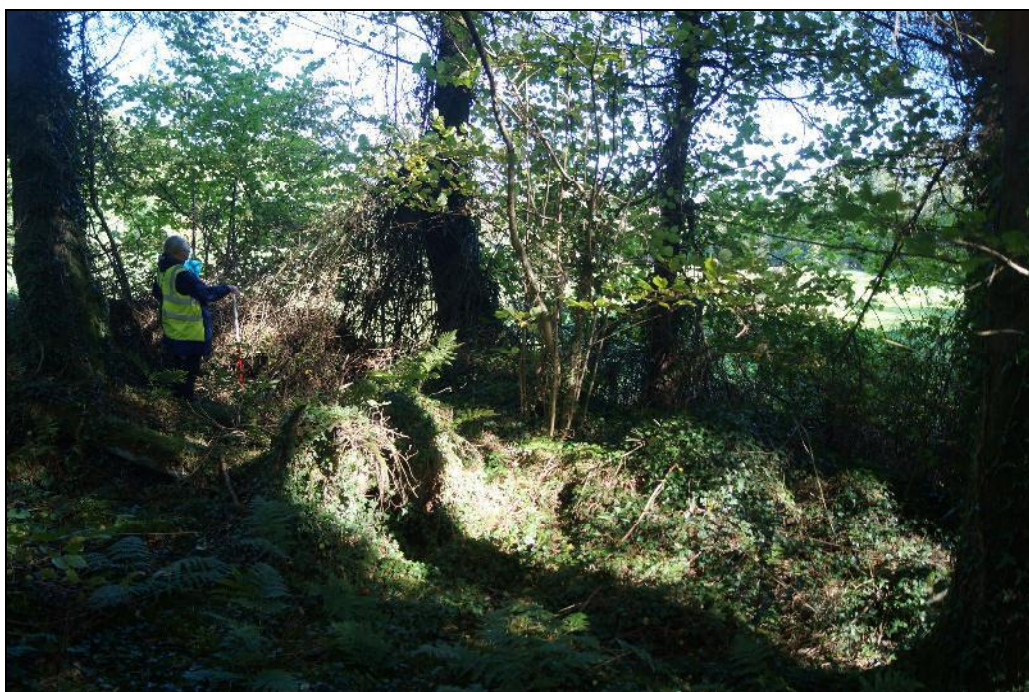
Plate 17: CTL2018_017 – a view of boundary bank fence ID number 013, looking northeast. Hidden in the vegetation beyond is the post and wire fence.

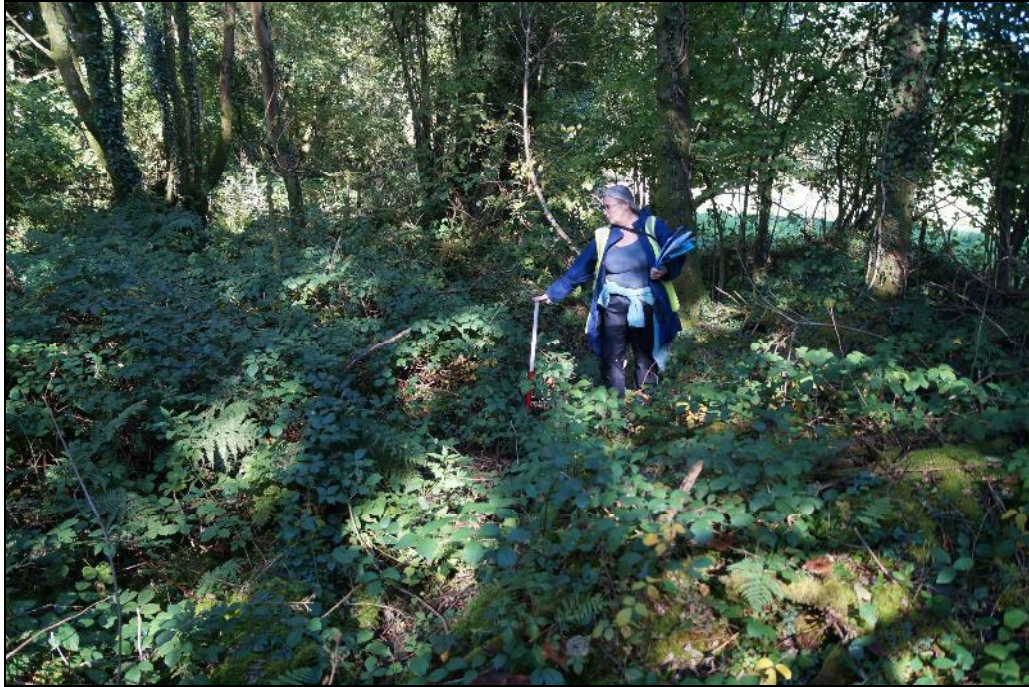
Plate 18: CTL2018_018 – a view of a now disused watercourse ID number 014 which is hidden in ground vegetation. It runs from the bottom left corner of the image towards the person in the centre and then turns to run towards the top left of the image. Looking northeast.

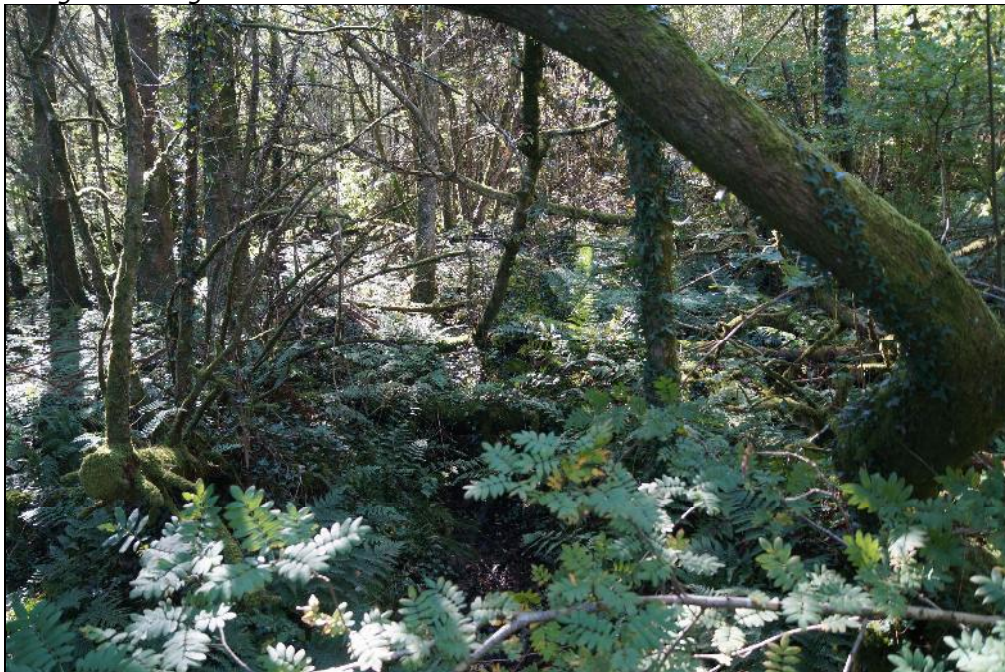
Plate 19: CTL2018_019 – a view of a now disused watercourse ID number 014 which is hidden in ground vegetation. It runs from the bottom centre of the image towards the centre and disappears into the woodland beyond. Looking southwest.

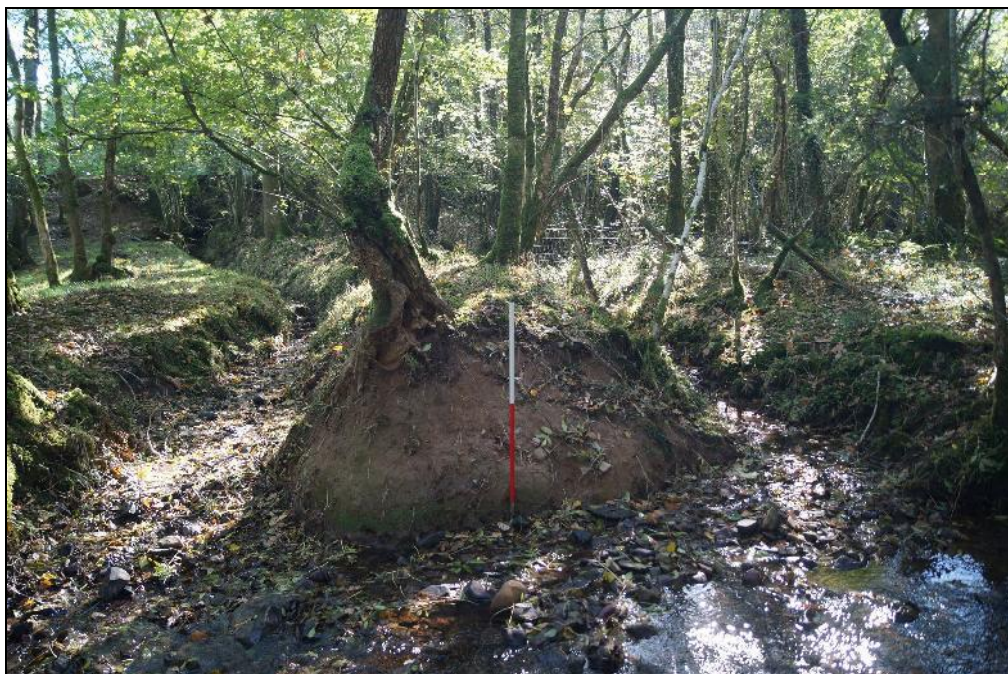
Plate 20: CTL2018_020 – a view of earthwork boundary bank ID number 015, looking south-southeast. There appears to be a drainage ditch either side of the bank.

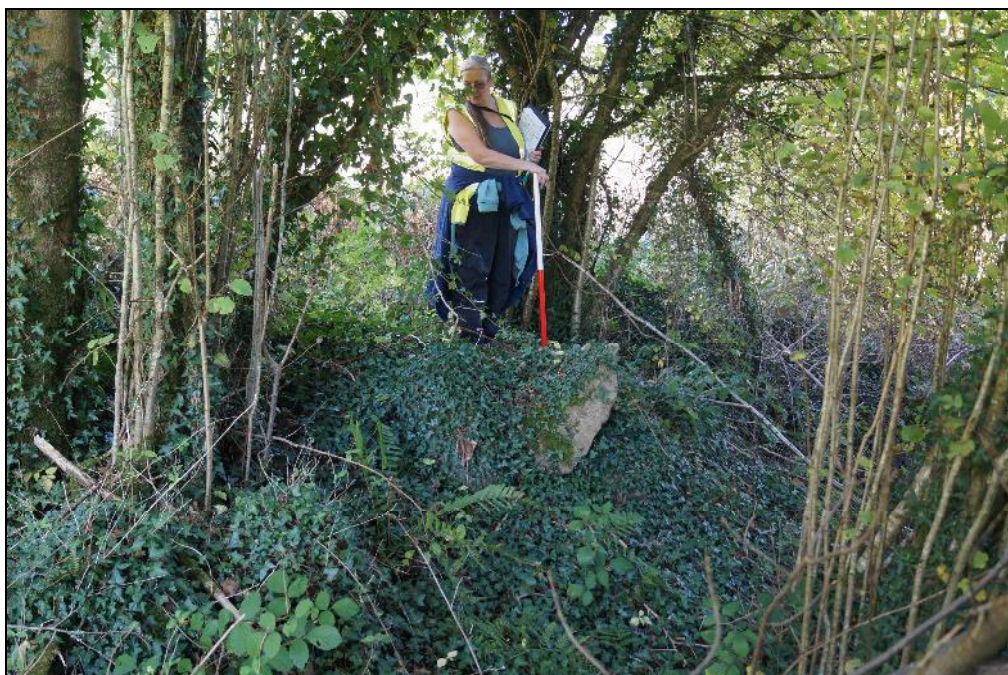
Plate 23: CTL2018_023 – a view of boundary ID number 018, looking north.

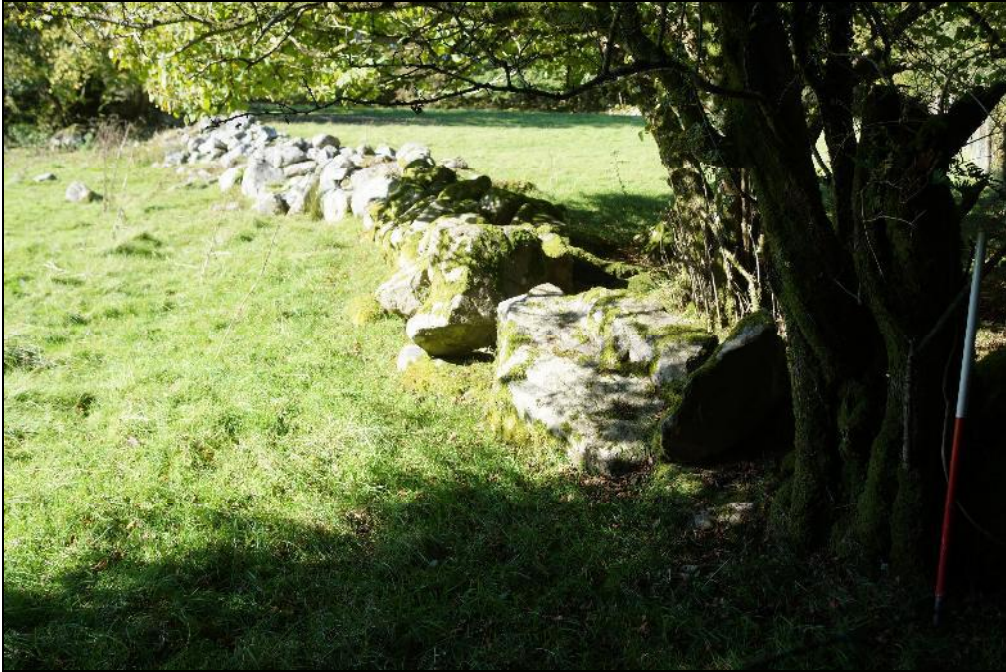
Plate 24: CTL2018_024 – a view of the continuation of field boundary ID number 018 as it runs northwest out of the wood into an adjacent field. This gives an idea of how substantial the boundary was, though it is now largely hidden by vegetation where it passes through the woodland. Looking northwest.

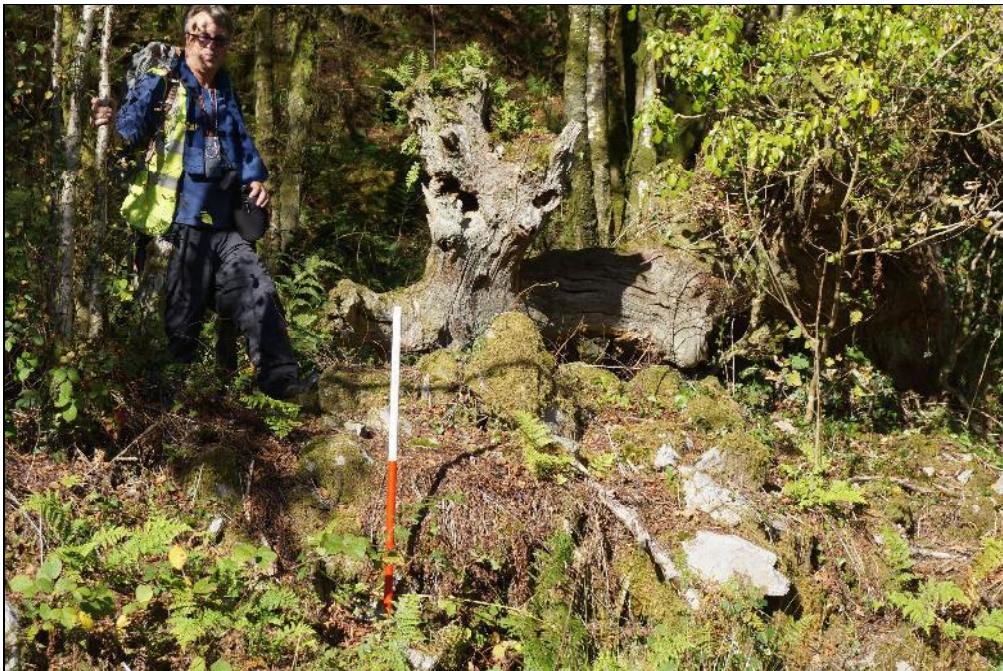
Plate 25: CTL2018_025 – a view looking north-northwest of field boundary ID number 018. This section is at the edge of the Development Area and care needs to be taken not to disturb it.

11.2.2 Table 3a shows that within the Development Area, only 1 historic assets is found, Boundary Bank ID number 18, which could be exposed to an indirect impact. This would only arise if the development within the area impinged on the boundary at the edge of the area, an impact which could be avoided completely with appropriate mitigation.

13.3.2 A more specific recommendation is that proposed new structures within the development area do not cause the disturbance of field boundary bank ID number 18.

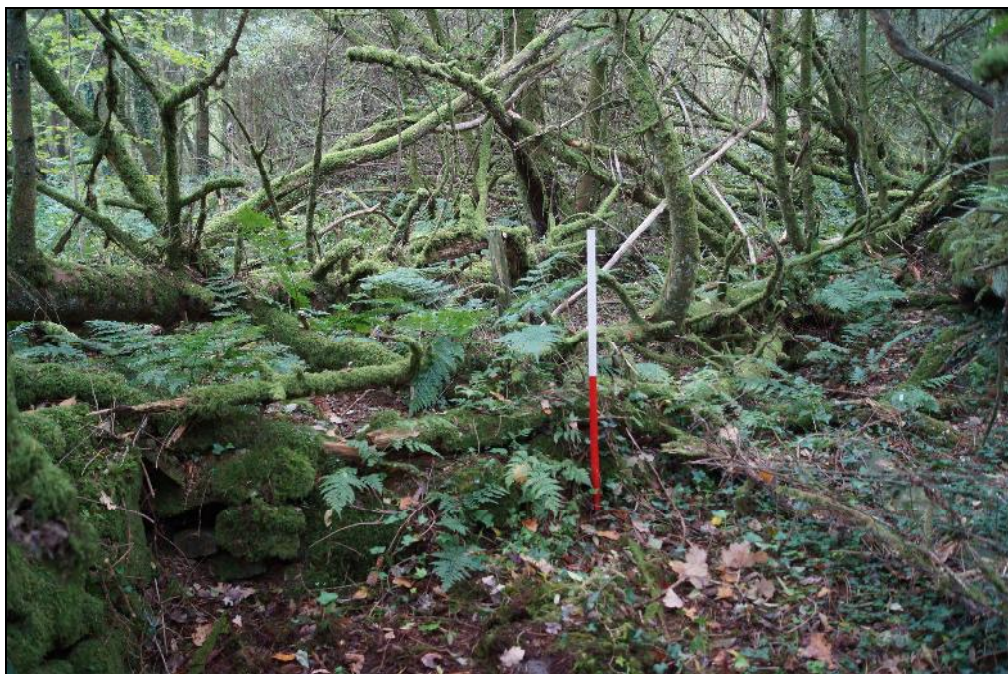
Plate 27: CTL2018_027 – a view of boundary wall ID number 022, into an area of unmanaged woodland. Looking southeast

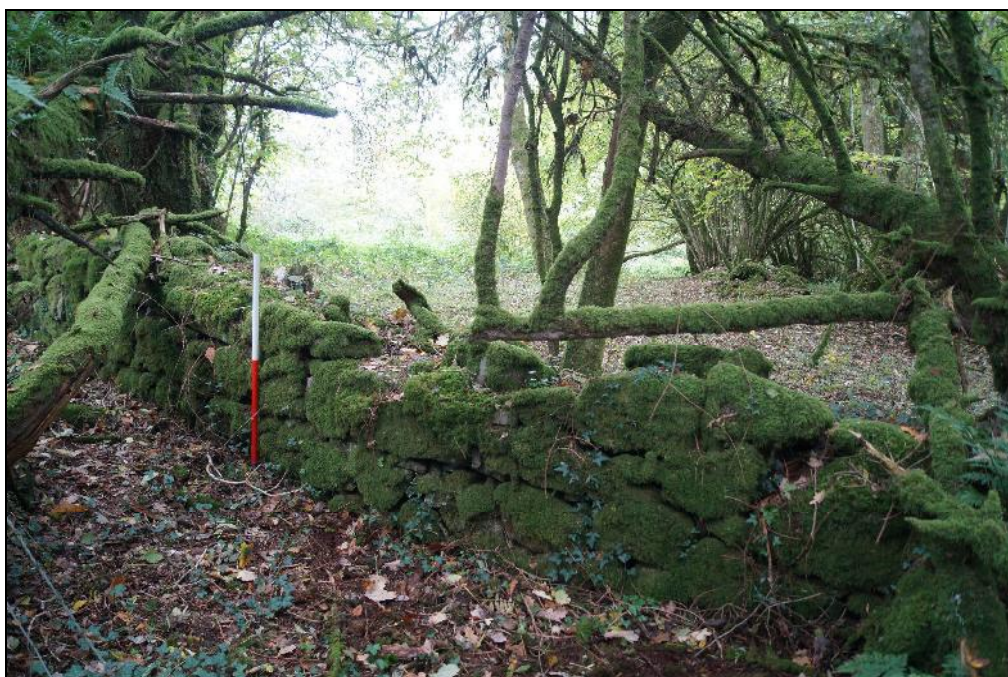
Plate 28: CTL2018_028 – a view of a well-preserved section of dry-stone walling on boundary ID number 001, looking northeast.

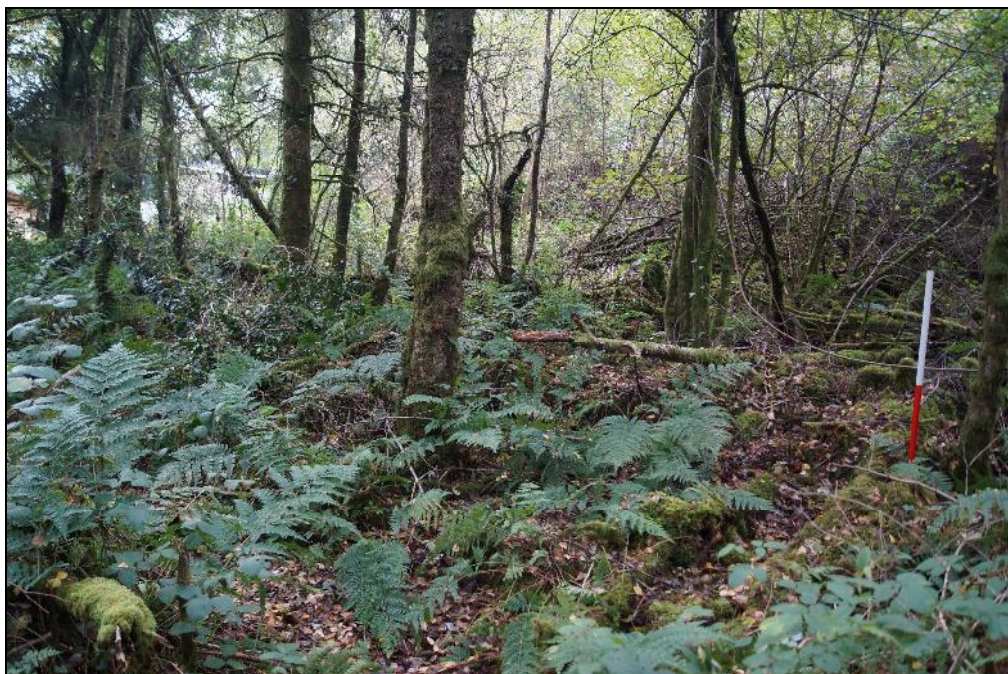
Plate 29: CTL2018_029 – a view of boundary ID number 018, looking west. Building ID number 050 is just visible through the trees at the upper left of the image.

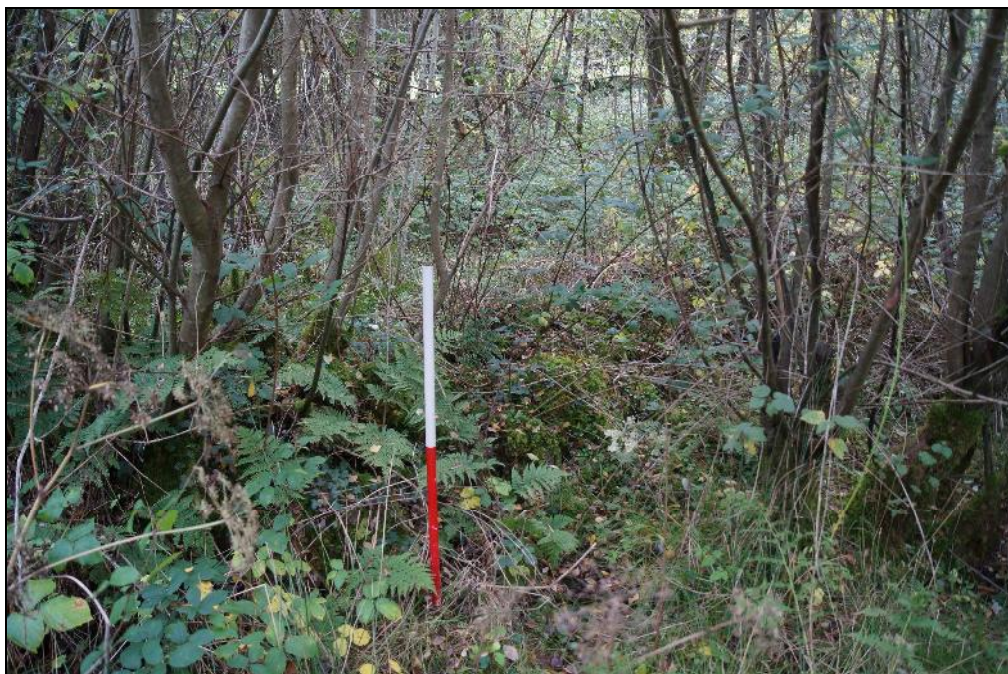
Plate 31: CTL2018_031 – a view of boundary ID number 25, looking west from the main access trackway ID number 21.

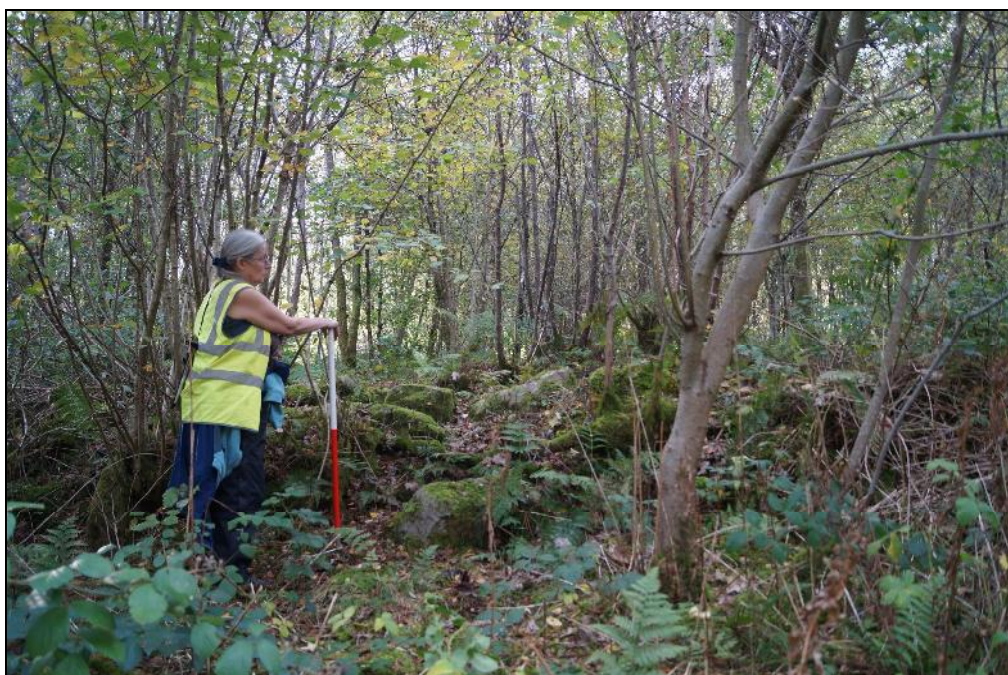
Plate 32: CTL2018_032 - a view of boundary ID number 25, looking northwest from the edge the main access trackway ID number 21.

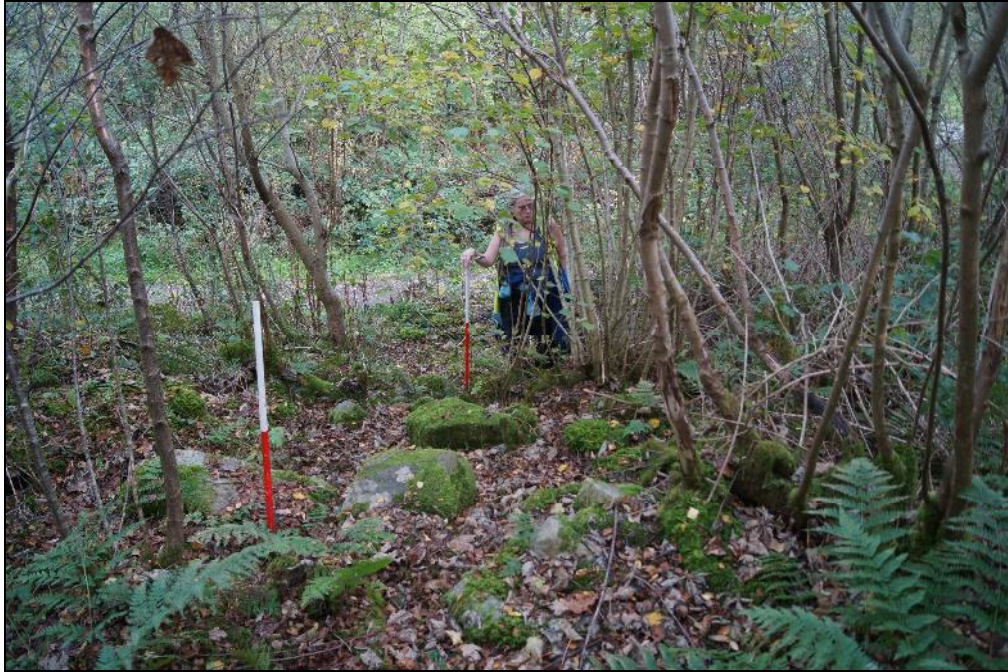
Plate 33: CTL2018_033 - a view of boundary ID number 25, looking southeast with the main access trackway ID number 21 in the background.

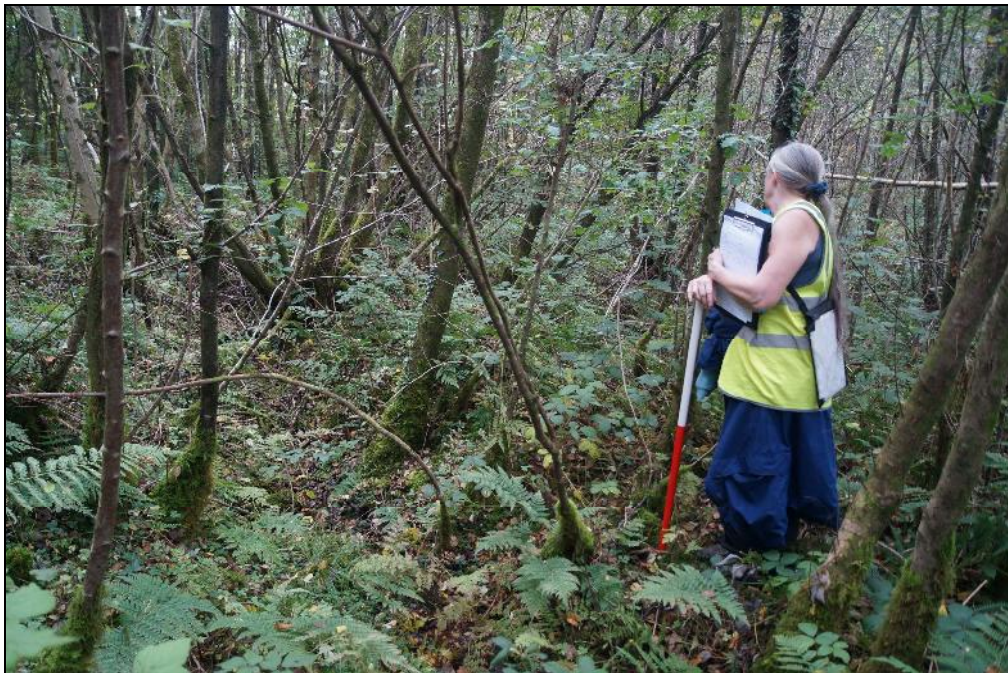
Plate 37: CTL2018_037 - a view of the very denuded boundary bank ID number 028, the ditch of which runs from bottom centre to top left of the image. The person is standing on the remains of the bank. Looking west.

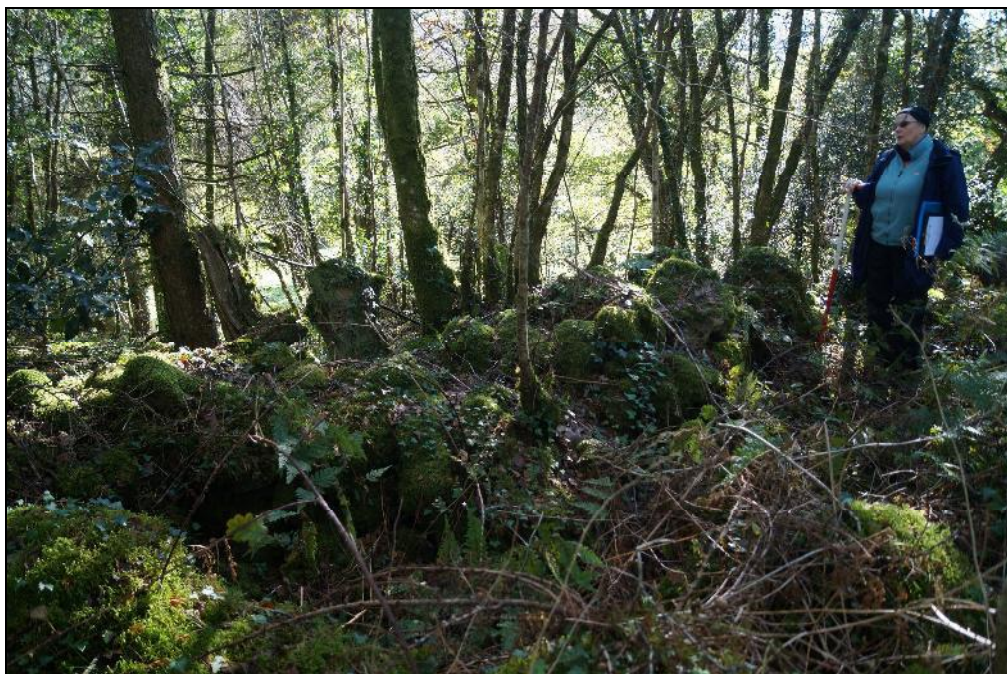
Plate 47: CTL2018_047 – a view of boundary wall ID number 036, looking south.

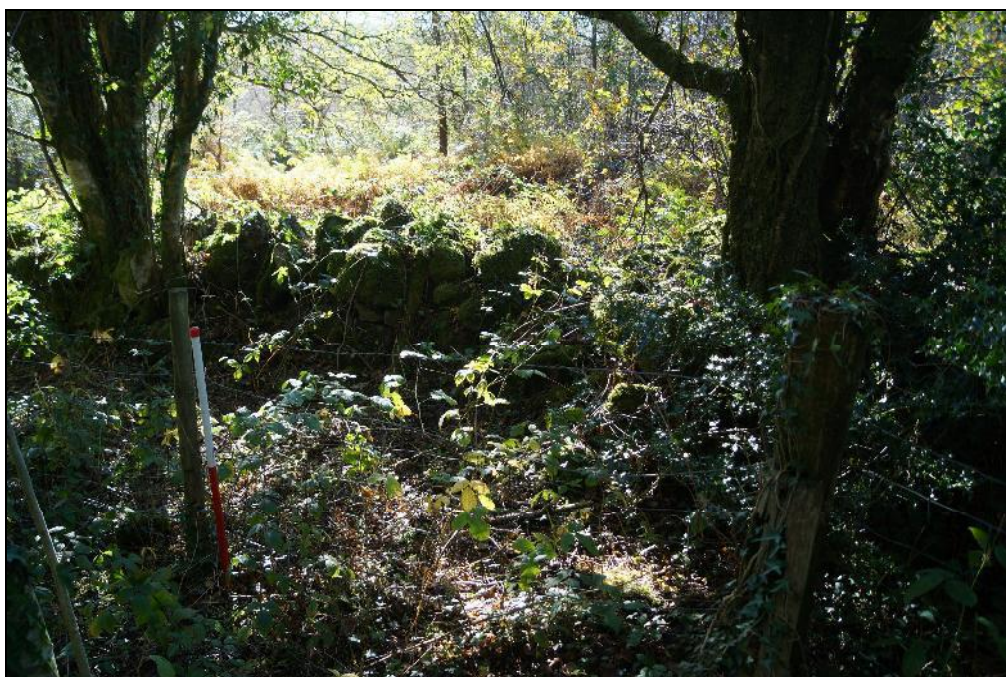
Plate 50: CTL2018_050 – a view of boundary wall ID number 040, at the southwestern end of Carreg y Gath ridge. Looking southwest. The post and wire fence stands in front of the wall.

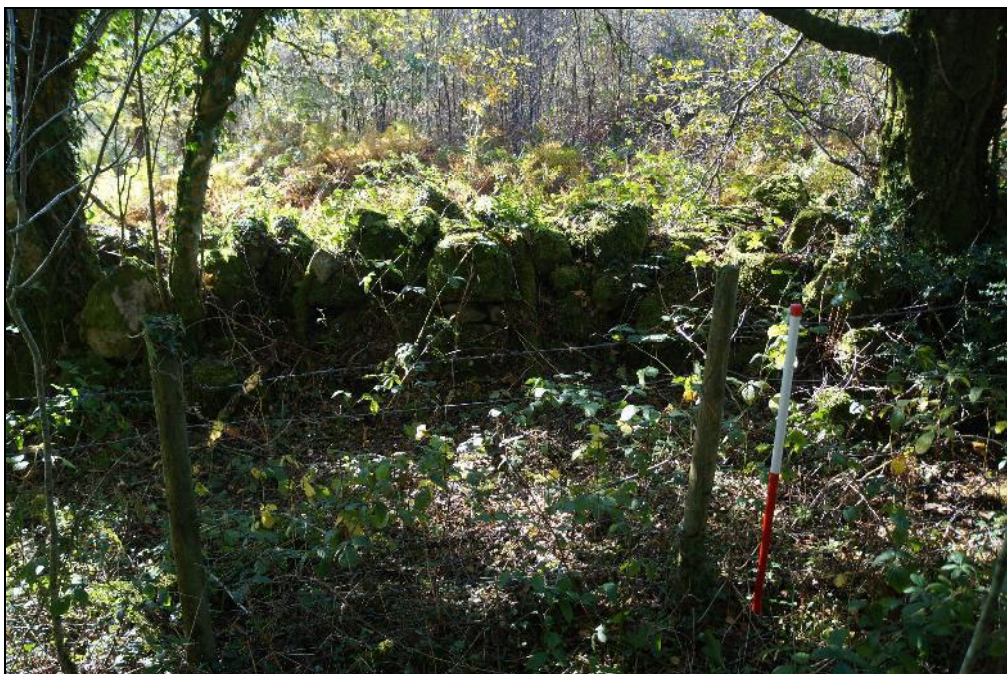
Plate 51: CTL2018_051 - a view of the post and wire fence at the southwestern end of Carreg y Gath ridge. Boundary wall ID number 040 stands behind the wall. Looking southwest.
