**SUMMARY OF HISTORIC ENVIRONMENT
DESK-BASED ASSESSMENT AND
WALKOVER SURVEY FOR A
ONE PLANET DEVELOPMENT AT
COEDTALYLAN, CARMARTHENSHIRE
19/17176/PAYPRE**

Trysor Project No. 2018/630

RHIF YR ADRODDIAD - REPORT NUMBER: Trysor 2018/630

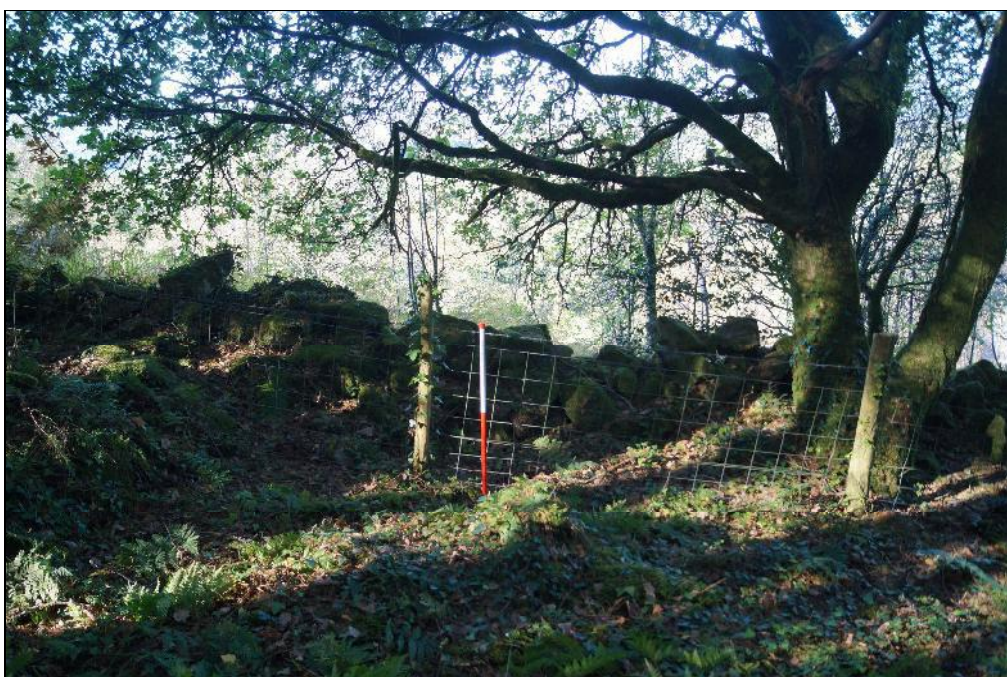
Plate 52: CTL2018_052 - a view of boundary wall ID number 040, at the southwestern end of Carreg y Gath ridge. Looking northwest. The post and wire fence stands in front of the wall.

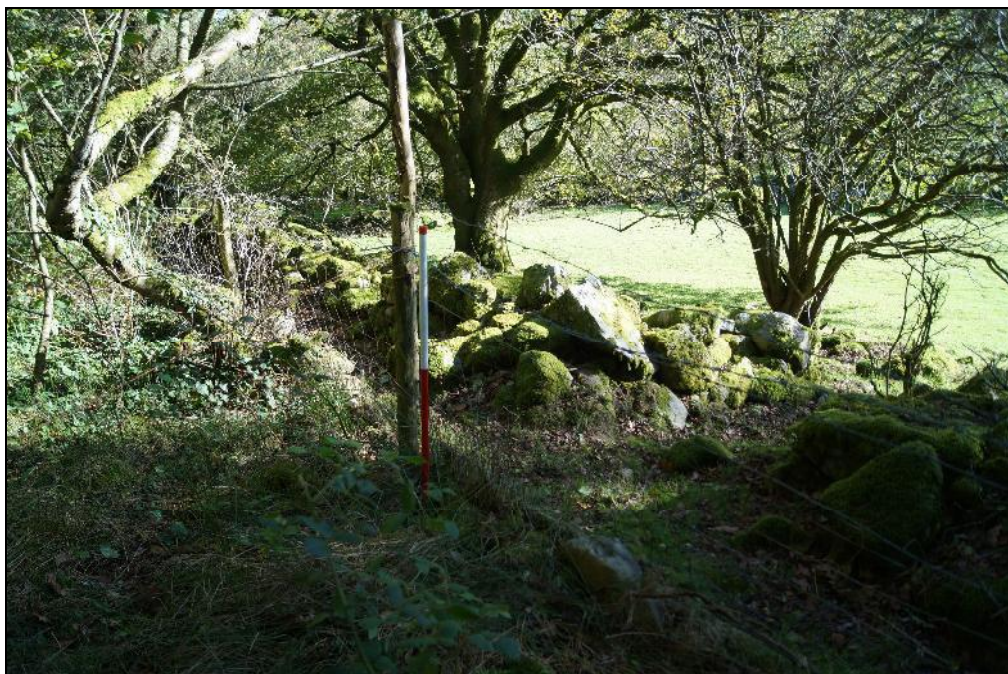
Plate 53: CTL2018_053 - a view of boundary wall ID number 034 at the southern side of Carreg y Gath ridge. The post and wire fence stands in front of the wall. Looking southeast.

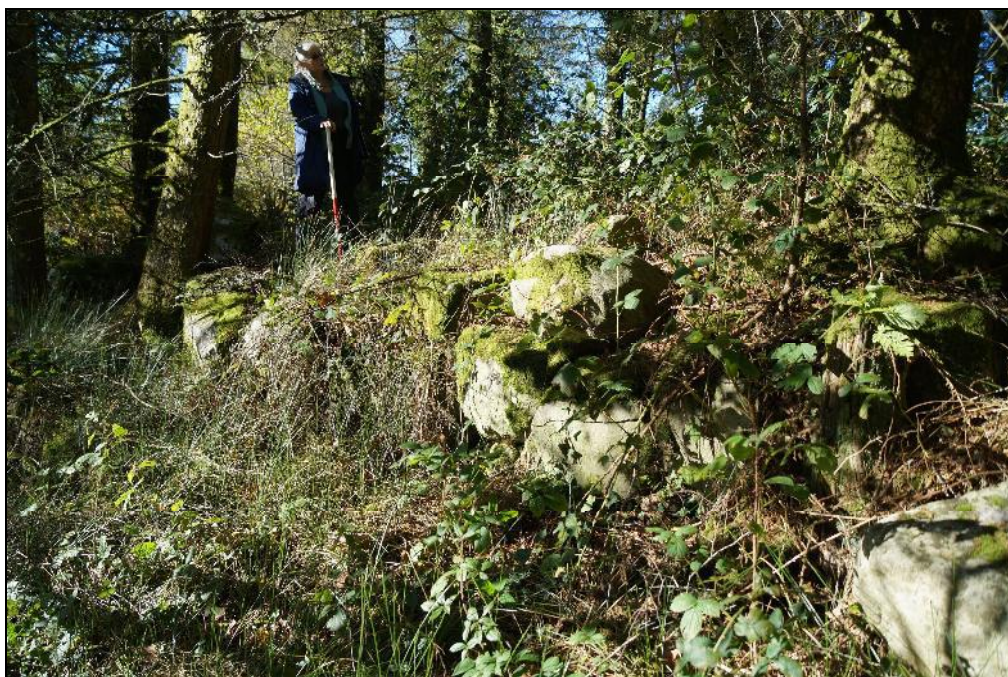
Plate 54: CTL2018_054 - a view of the wall ID number 042, looking northwest. This wall or revetment does not appear on any historic maps and its purpose is not known.

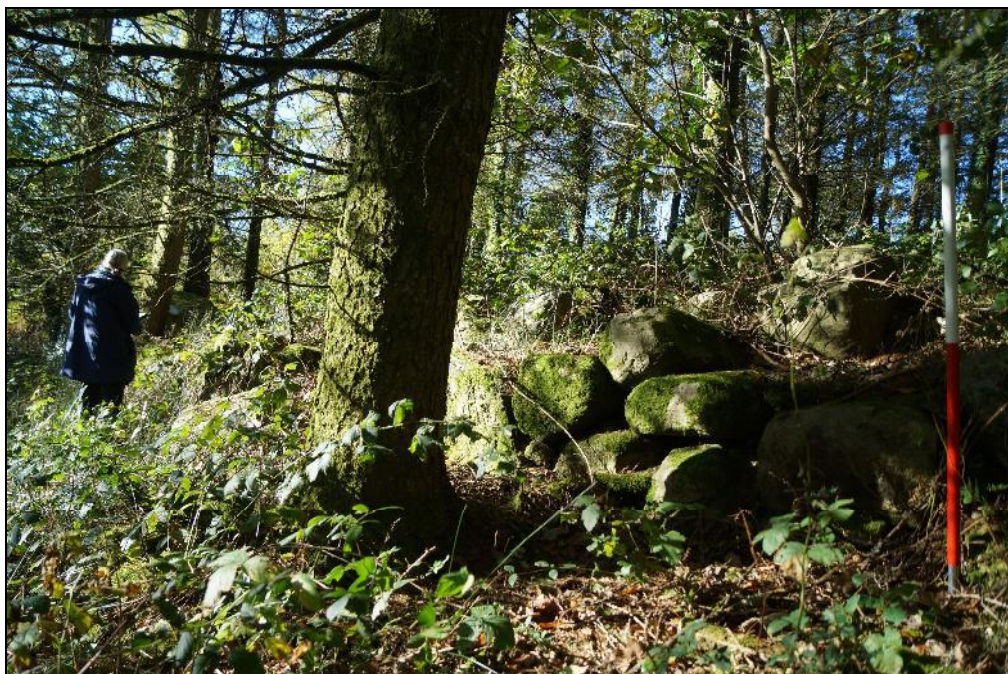
Plate 55: CTL2018_055 - a view of the wall ID number 042, looking west. The wall can be seen to the left of the person in the background, running away from the camera.

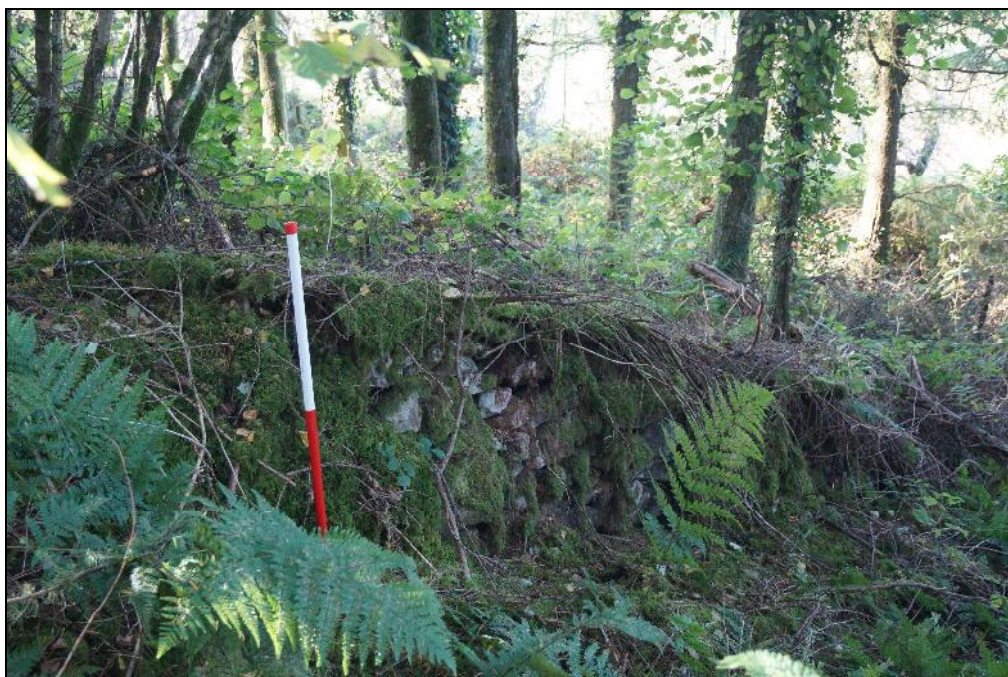
Plate 56: CTL2018_056 - a view of wall ID number 043 looking west.

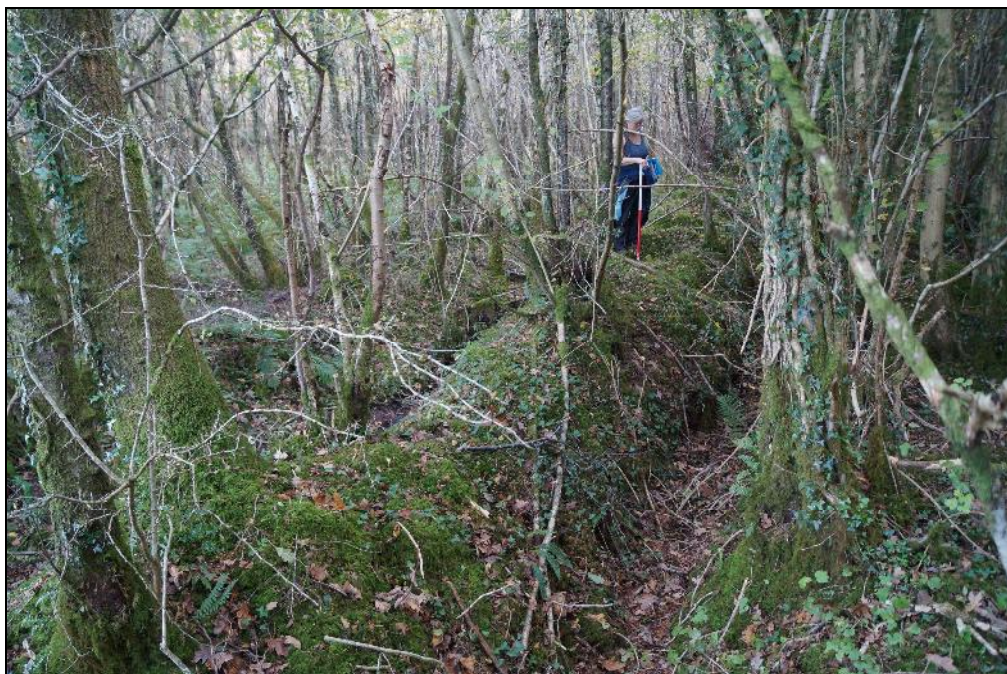
Plate 71: CTL2018_071 - a view of boundary bank ID number 015 at SN7028524600 looking southeast.

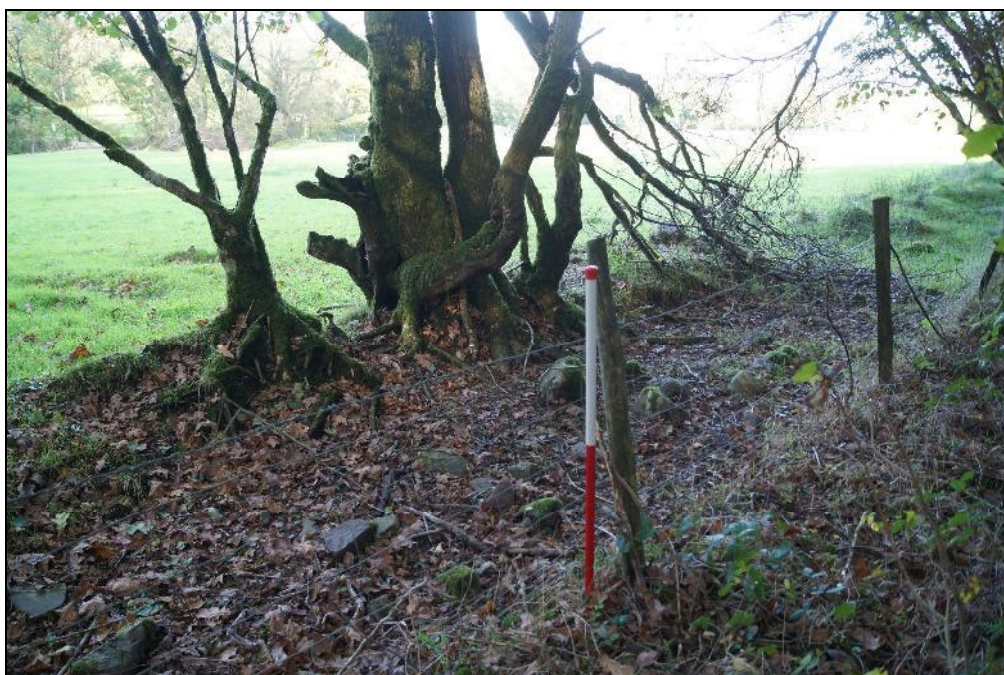
Plate 72: CTL2018_072 - a view of the post and wire fence, with the denuded field boundary bank ID number 060 behind, looking north.

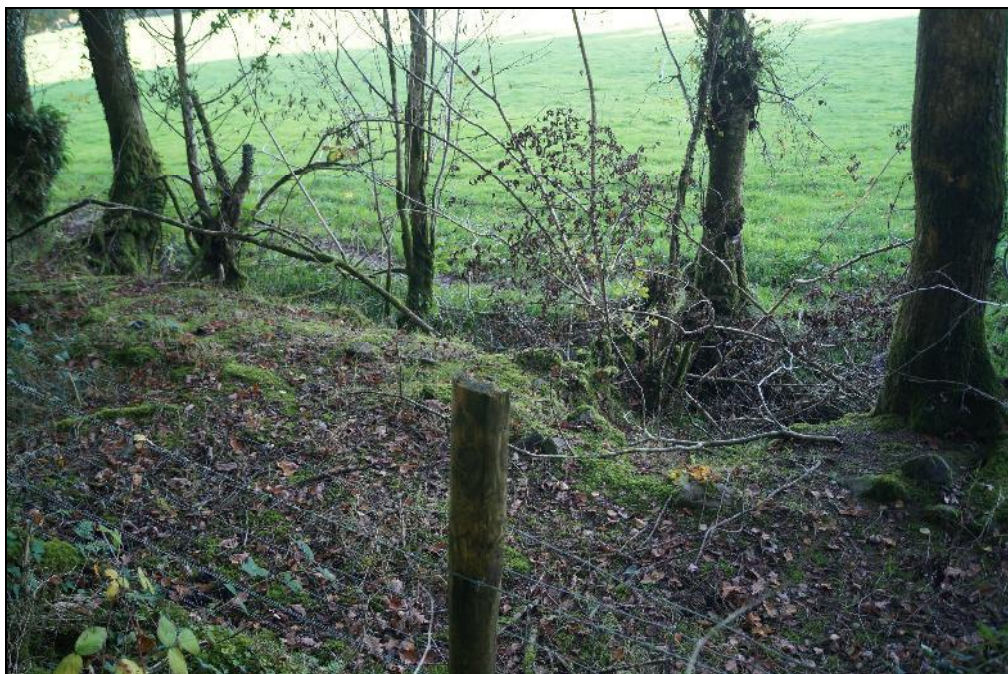
Plate 73: CTL2018_073 - a view the post and wire fence, looking north. There was no bank beyond the fence, the old boundary appeared to be a drainage ditch, carrying on the line of boundary bank ID number 062 (see plate 74).

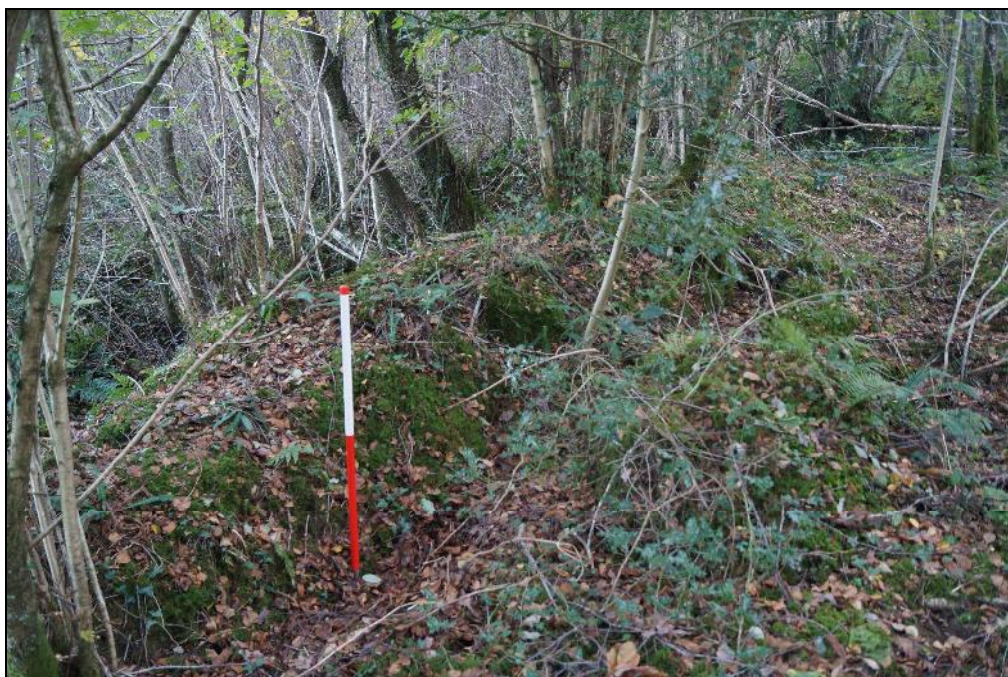
Plate 74: CTL2018_074 - a view of boundary bank ID number 062, looking southeast.

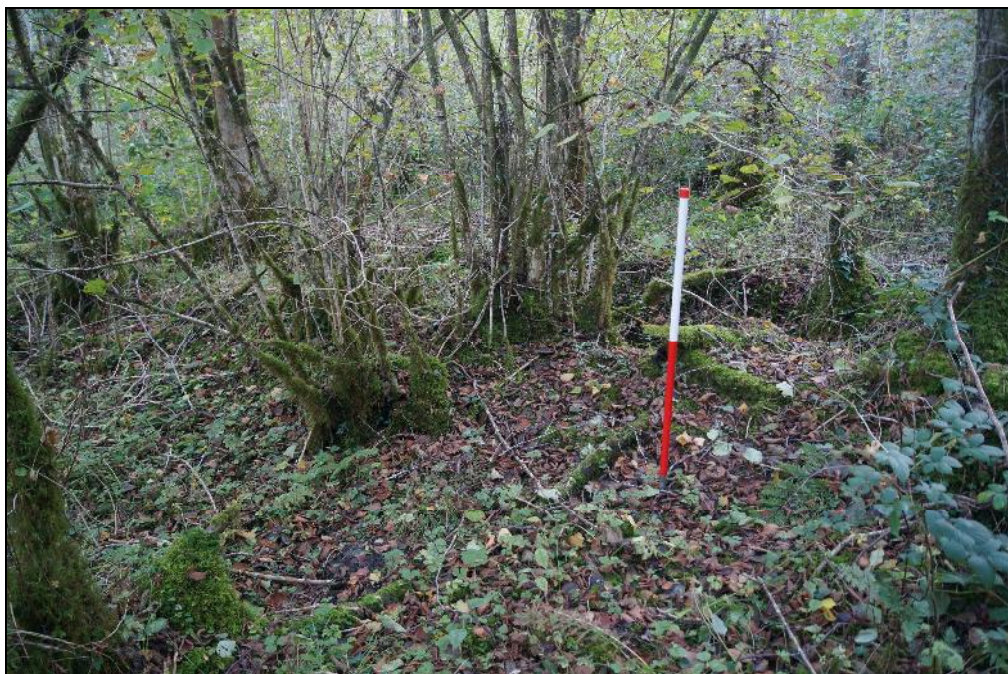
Plate 78: CTL2018_078 - a view of the possible remains of boundary bank ID number 064, looking southwest. It crosses right to left in the photograph behind the scale rod.

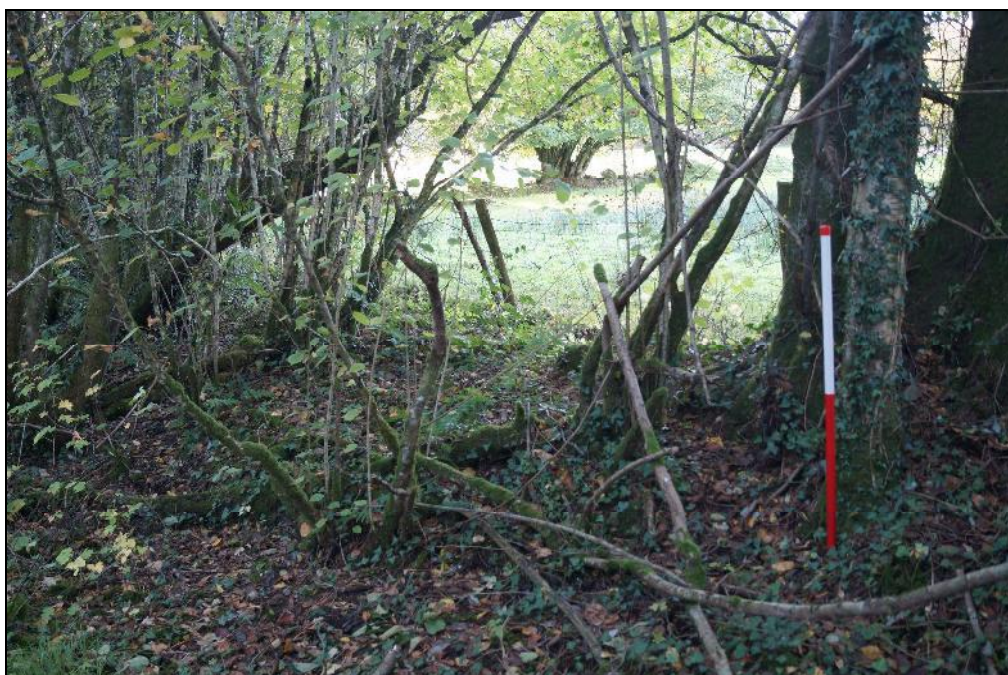
Plate 79: CTL2018_079 - a view of boundary bank ID number 065, with the post and wire fence behind, looking southwest.

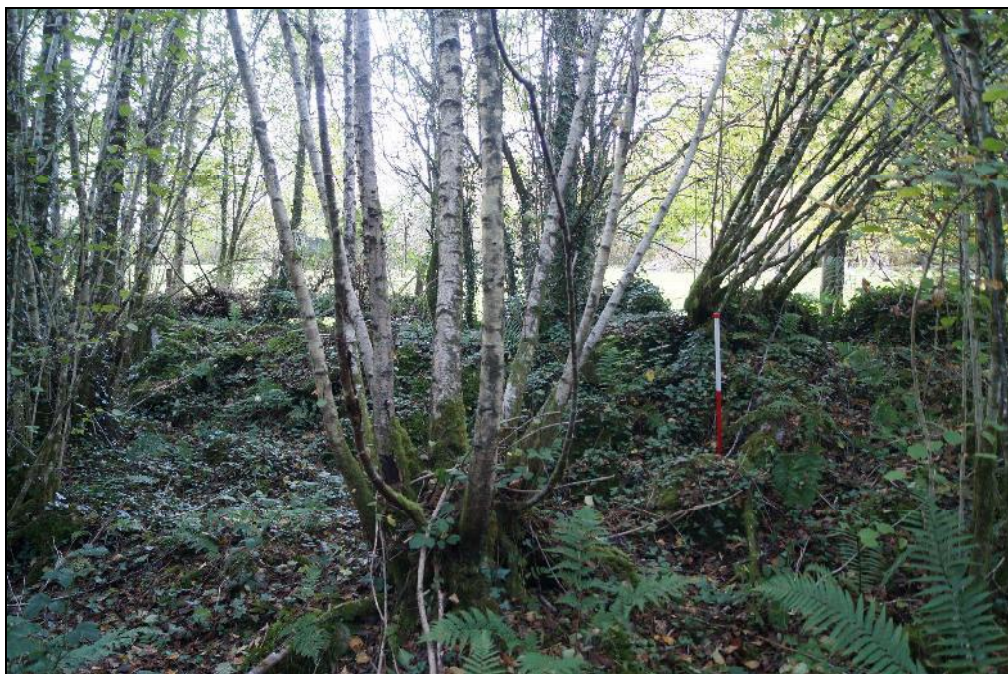
Plate 80: CTL2018_080 - a view of boundary bank ID number 065, which becomes a lynchet-like feature as it runs westwards. Looking north-northwest.

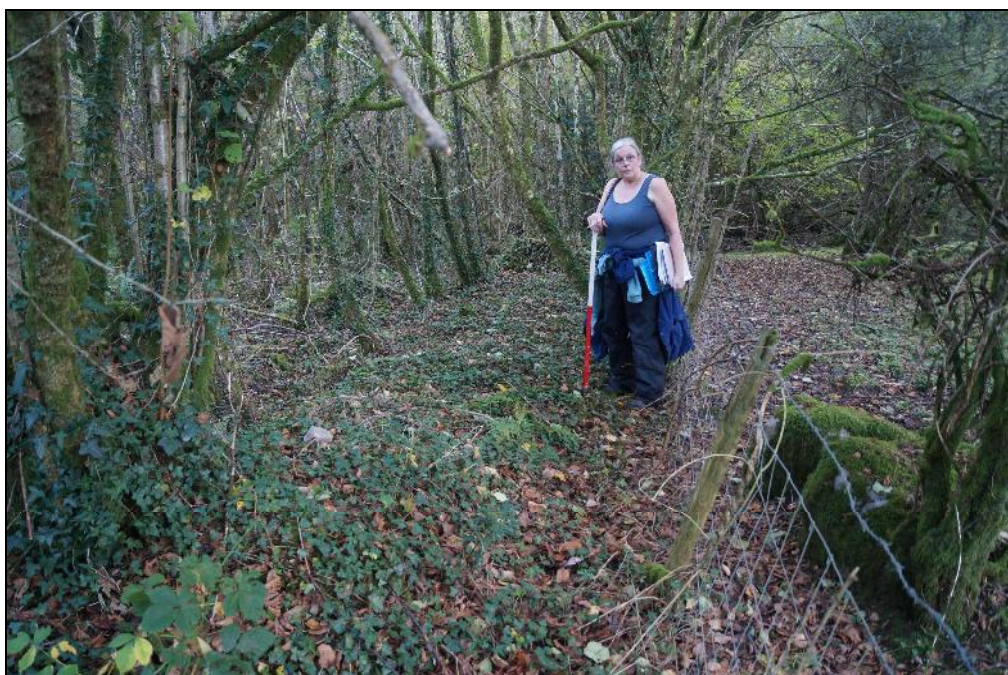
Plate 81: CTL2018_081 - a view of boundary bank ID number 066, with the boundary fence ID number 017 to the right, looking south.

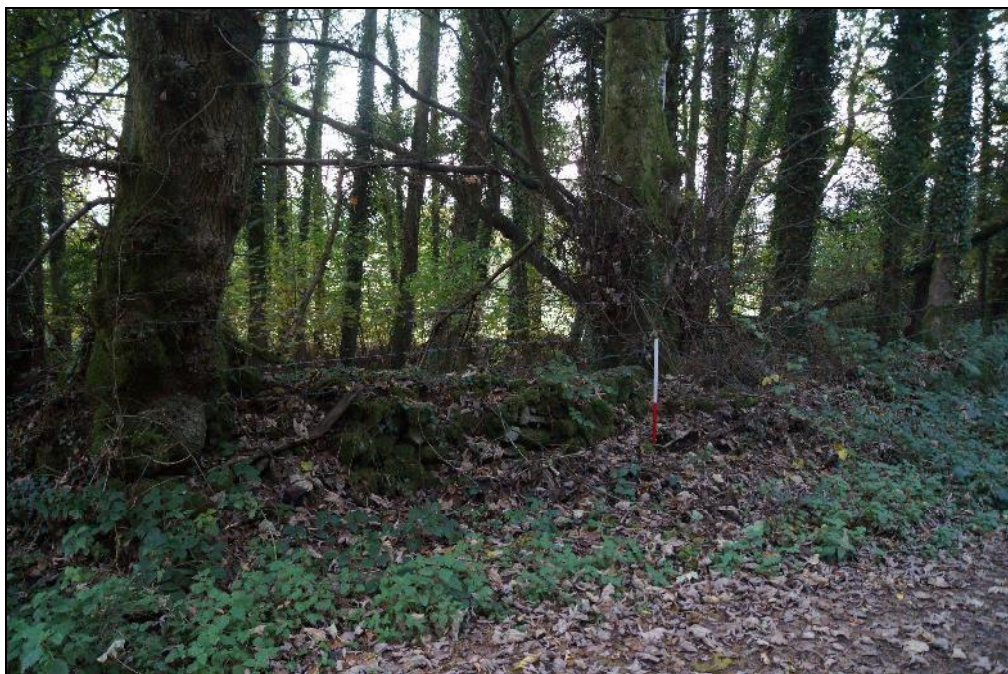
Plate 82: CTL2018_082 - a view of boundary wall ID number 067, looking northeast.
