**ARCHAEOLOGICAL WATCHING BRIEF
DURING GROUNDWORKS
FOR A NEW HOUSE ADJACENT TO THE
FORMER ROSE AND CROWN INN,
LLANDYFAELOG, SA17 5PR
PLANNING APPLICATION: W/37245
(Carmarthenshire)**

**Archaeological Watching Brief
During Groundworks
For a New House Adjacent to the Former
Rose and Crown Inn,
Llandyfaelog, SA17 5PR
Planning Application: W/37245
(Carmarthenshire)**

Trysor Project No. 2018/633
HER Event Record PRN: 114806

RHIF YR ADRODDIAD - REPORT NUMBER: Trysor 2018/633

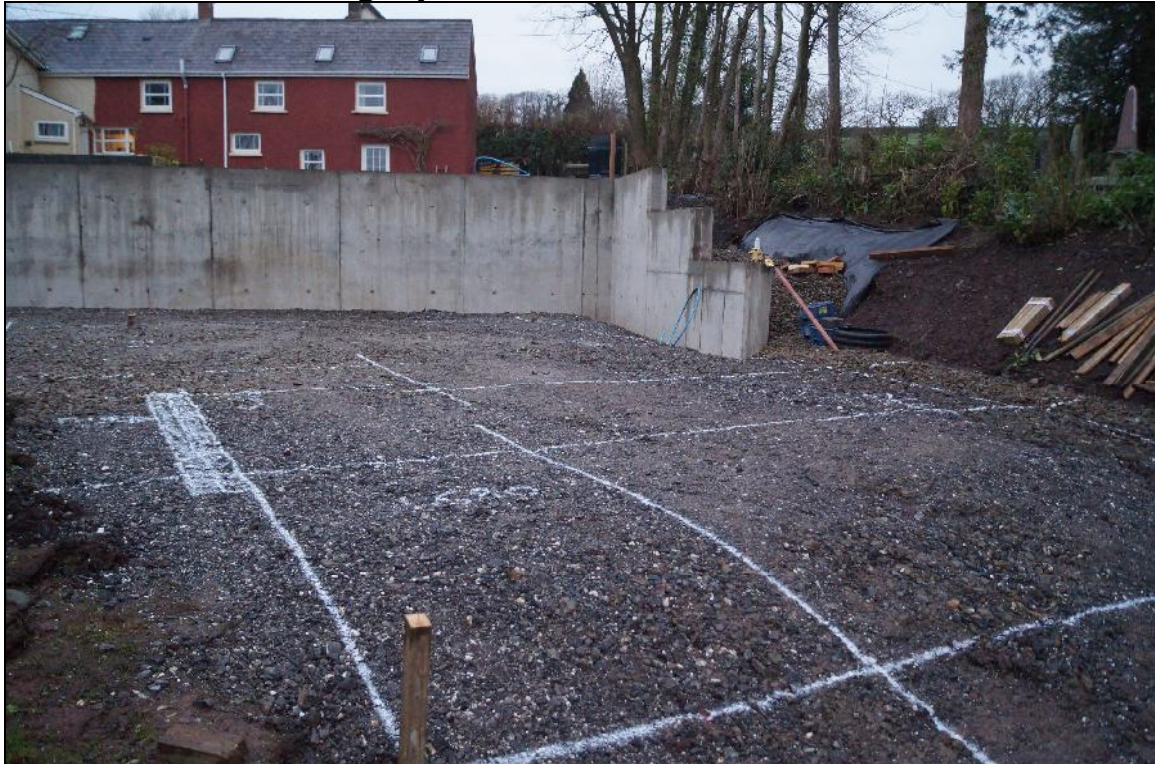
Plate 1: RCL2018_101, General view of the development area before foundation trenches excavated, looking west northwest. Previously the retaining wall, not part of the planning application, was built, and the area to its east reduced and covered in scalplings

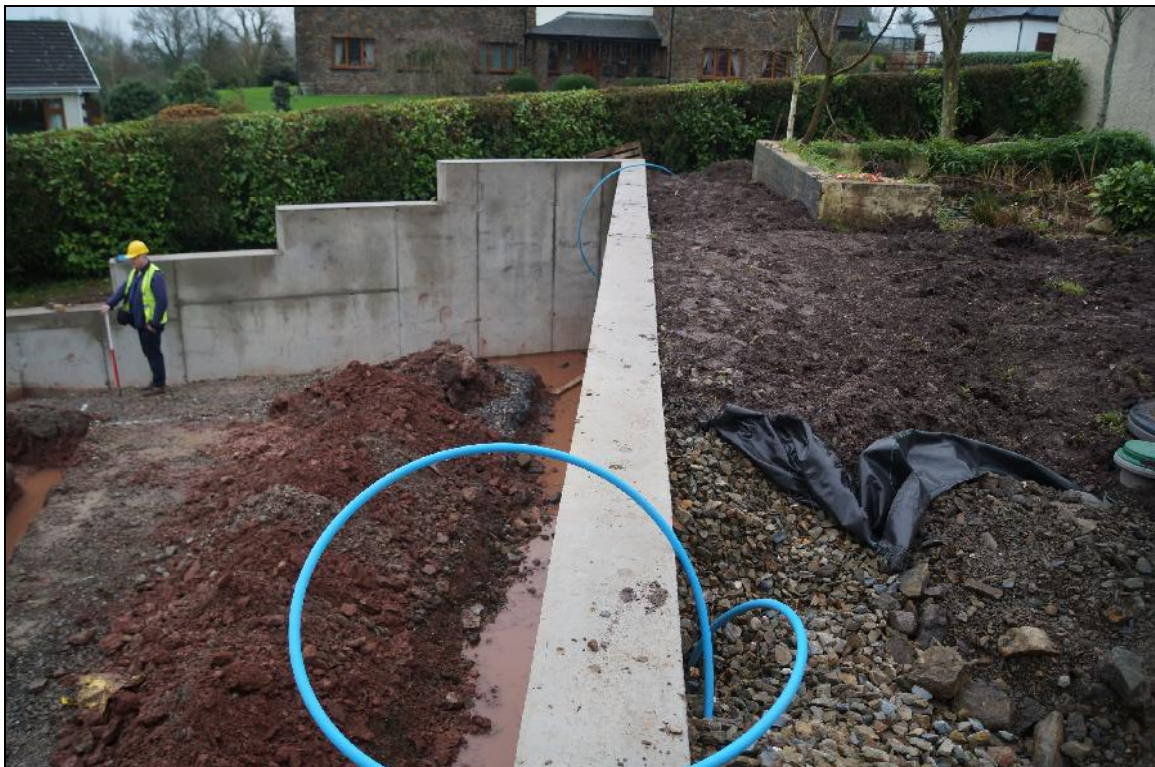
Plate 4: RCL2018_104, The retaining wall showing the difference in level between the west and east side of the wall, looking south.

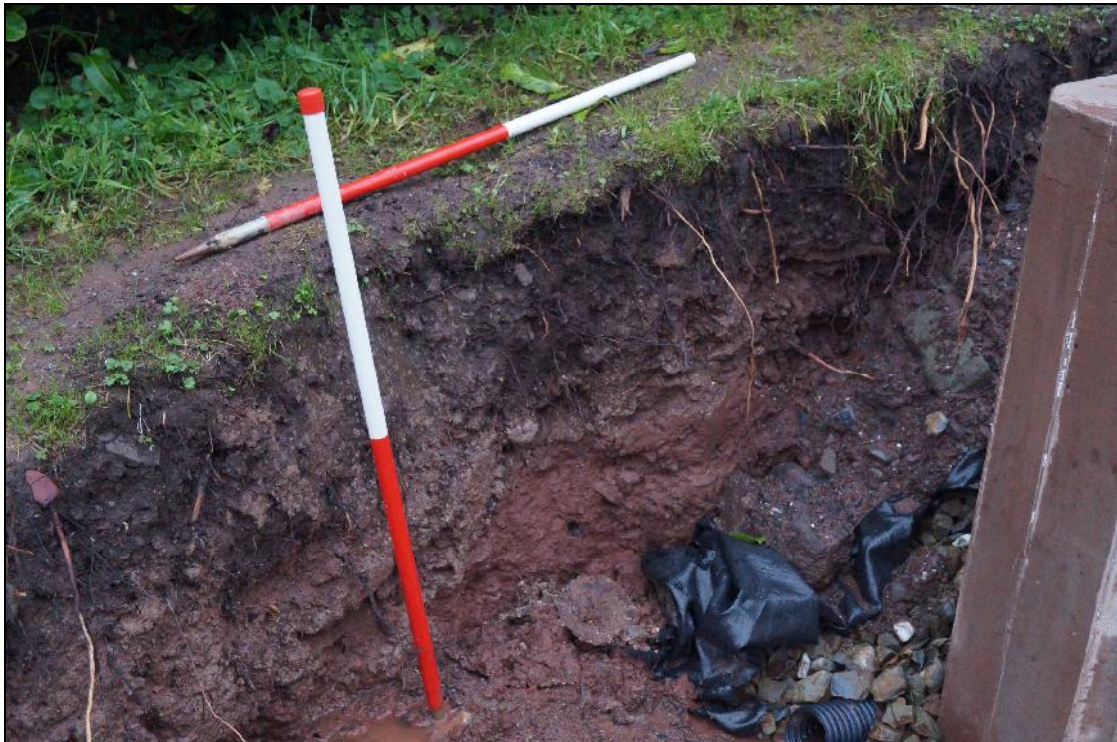
Plate 5: RCL2018_105, A section to the side of the southern arm of the retaining wall showing the garden soil (001) overlying the natural subsoil (002), looking south-southwest.

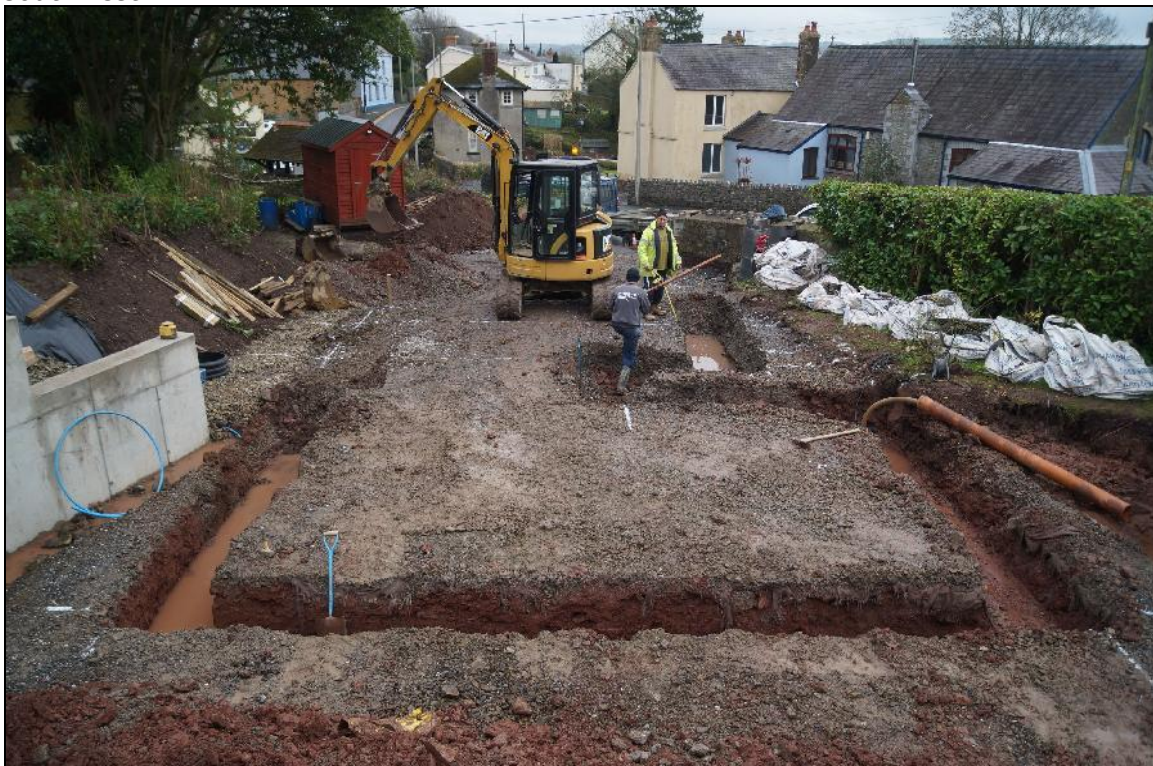
Plate 6: RCL2018_106, From the top of the retaining wall to the west looking east. Trenches visible show subsoil (002) under the layer of scalpings deposited to firm up the ground surface during the construction of the retaining wall.

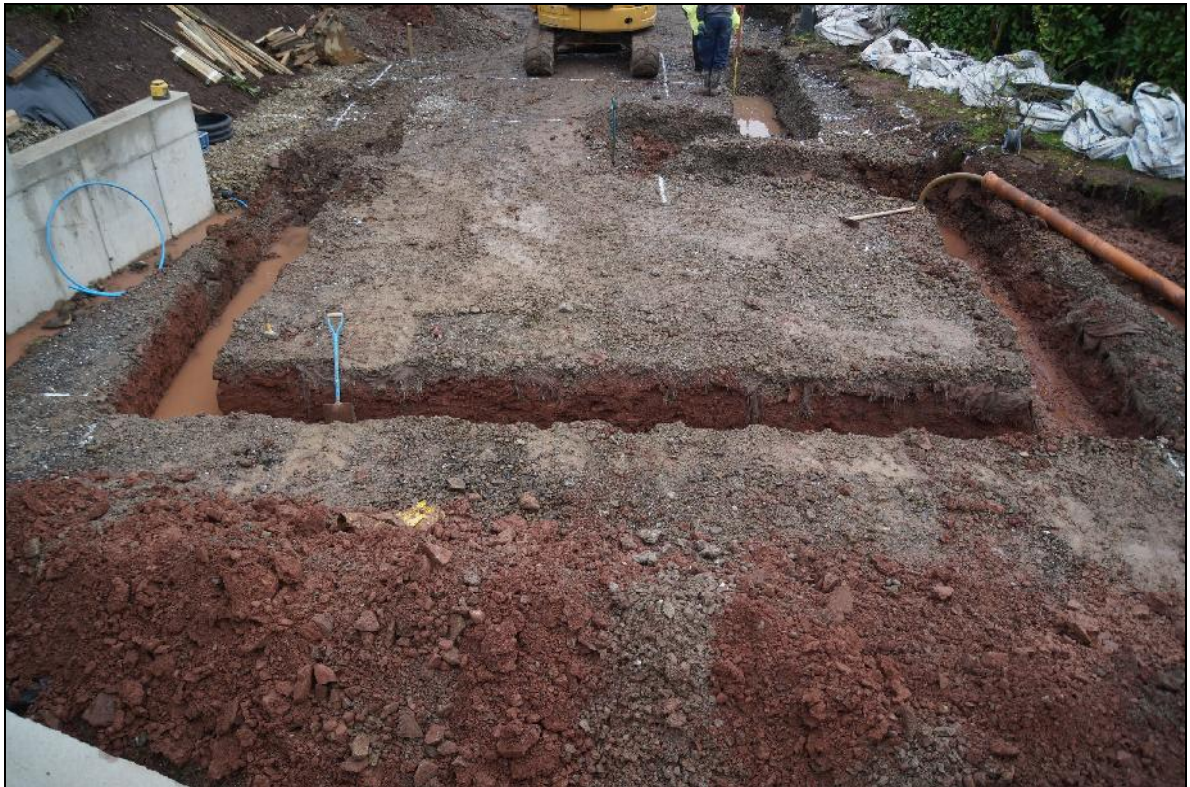
RCL2018_107	From the top of the retaining wall to the west. Trenches visible show subsoil (002) under the layer of scalpings deposited to firm up the ground surface during the construction of the retaining wall.	11/12/2018	Looking east

Plate 7: RCL2018_107, From the top of the retaining wall to the west, looking east. Trenches visible show subsoil (002) under the layer of scalpings deposited to firm up the ground surface during the construction of the retaining wall.

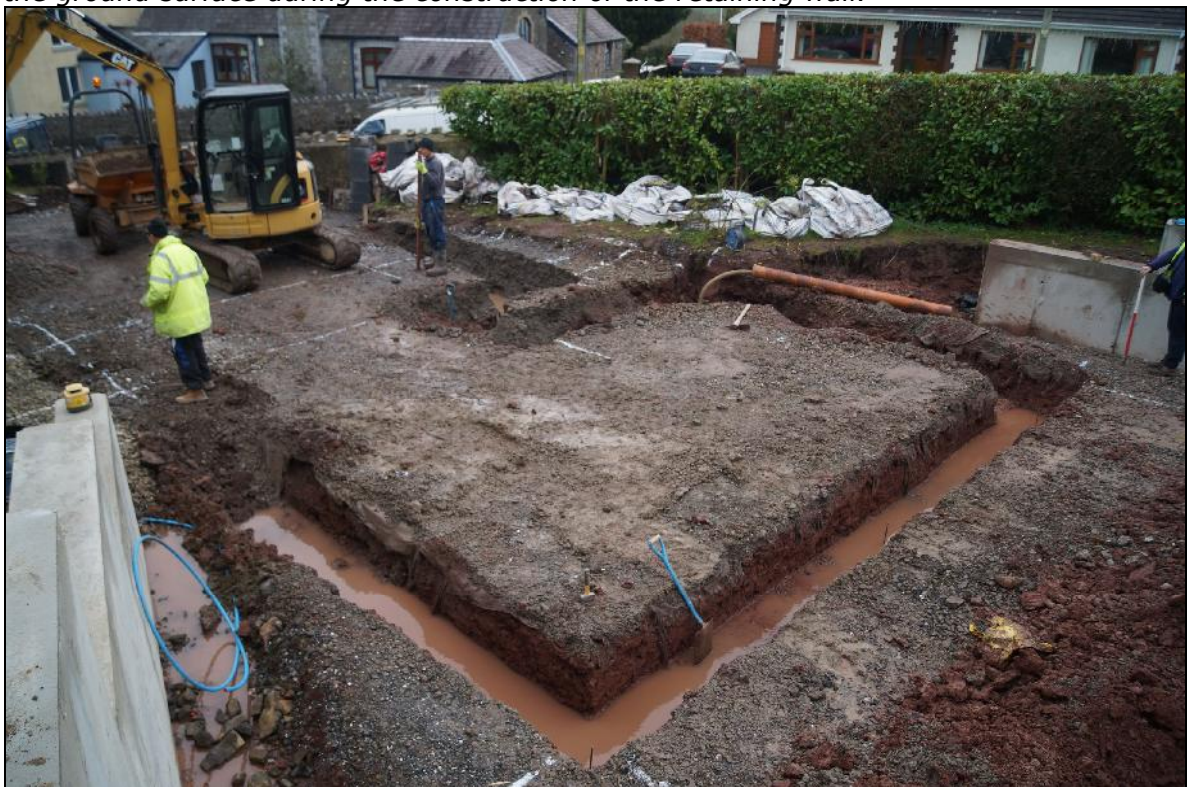
Plate 8: RCL2018_108, From the top of the retaining wall to the west looking south-southeast. Trenches visible show subsoil (002) under the layer of scalpings deposited to firm up the ground surface during the construction of the retaining wall.

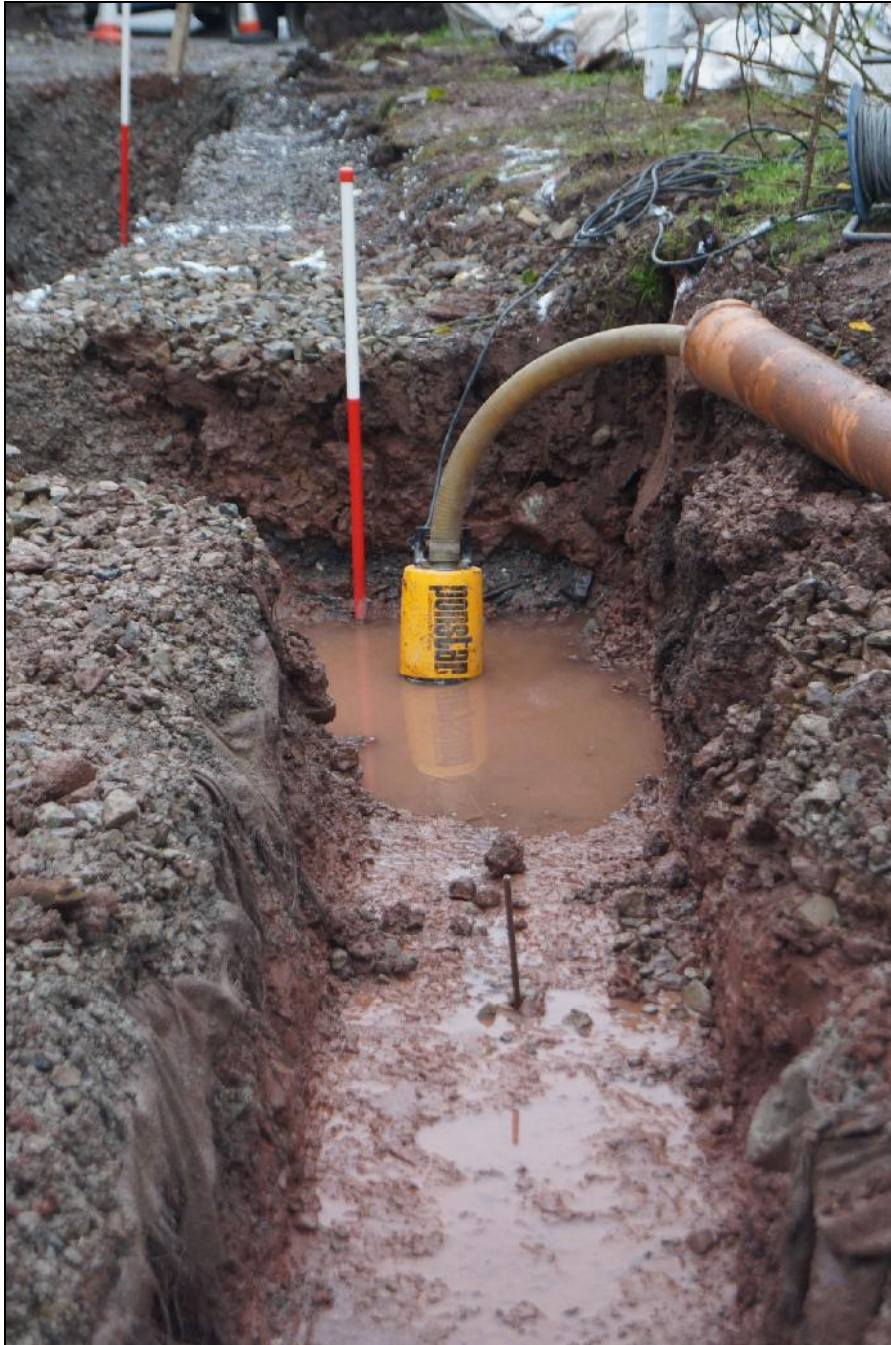
Plate 9: RCL2018_109, Looking east along the southern foundation trench showing subsoil (002) with scalplings above

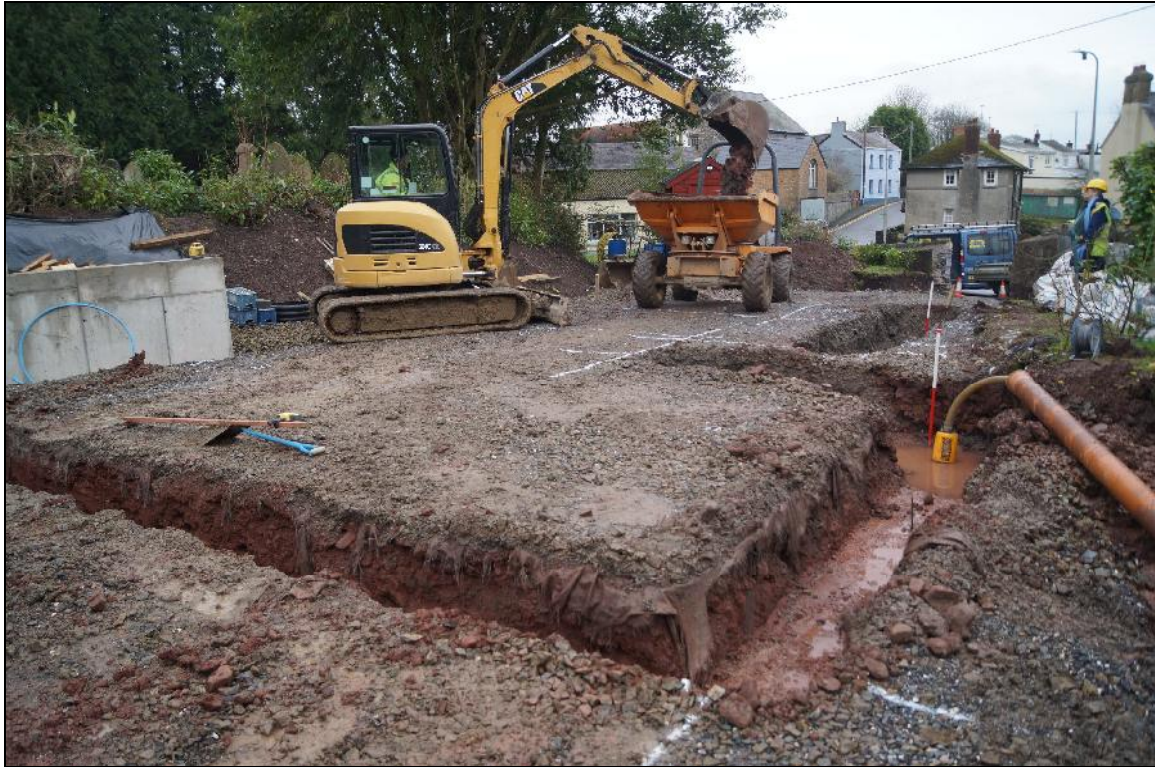
Plate10: RCL2018_110, House foundation trenches looking northeast, the furthest trenches were cut only though scalplings not subsoil.

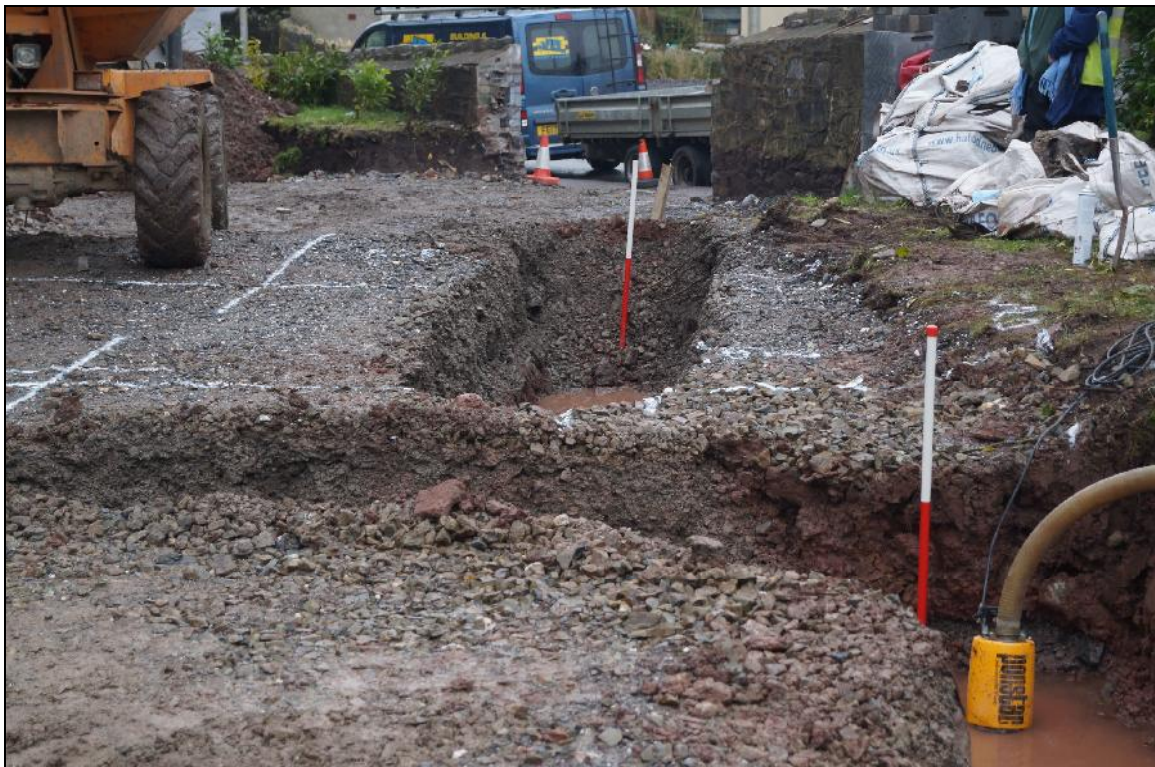
Plate 11: RCL2018_111, Southeastern foundation trench looking east. It can be seen that the eastern trenches cut only though scalplings.

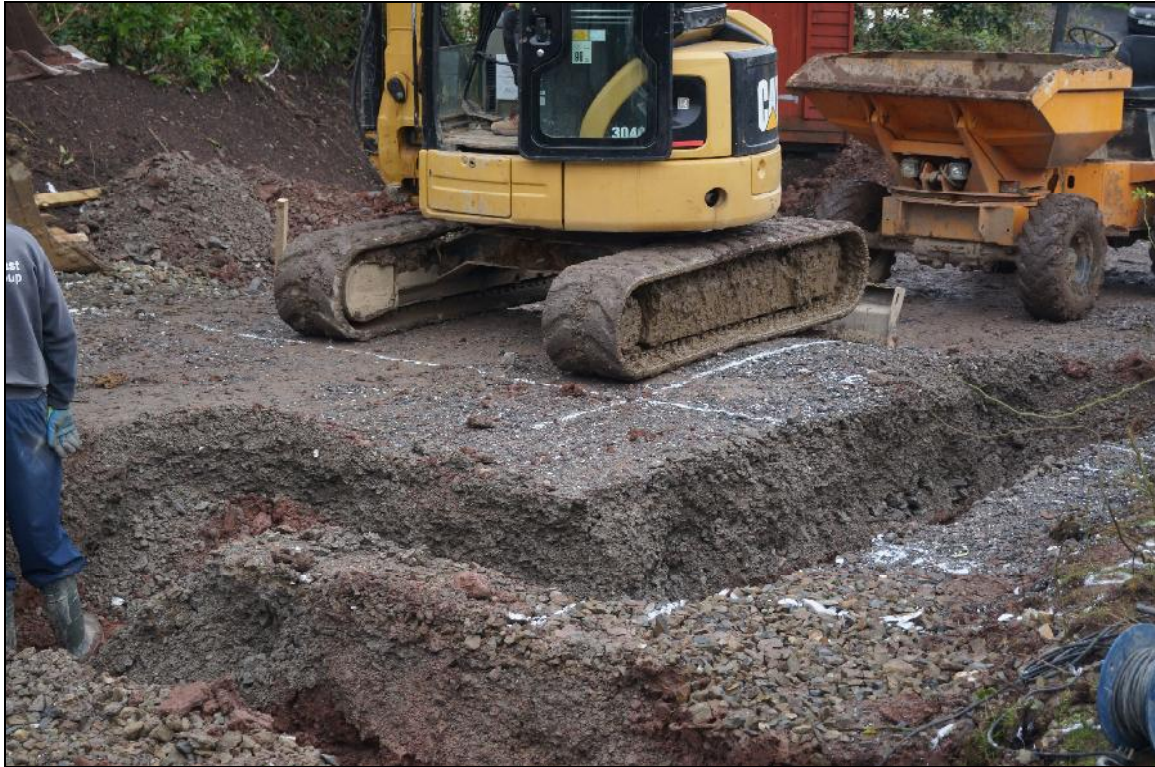
Plate 12: RCL2018_112, Eastern trenches, looking northeast, cut through scalplings

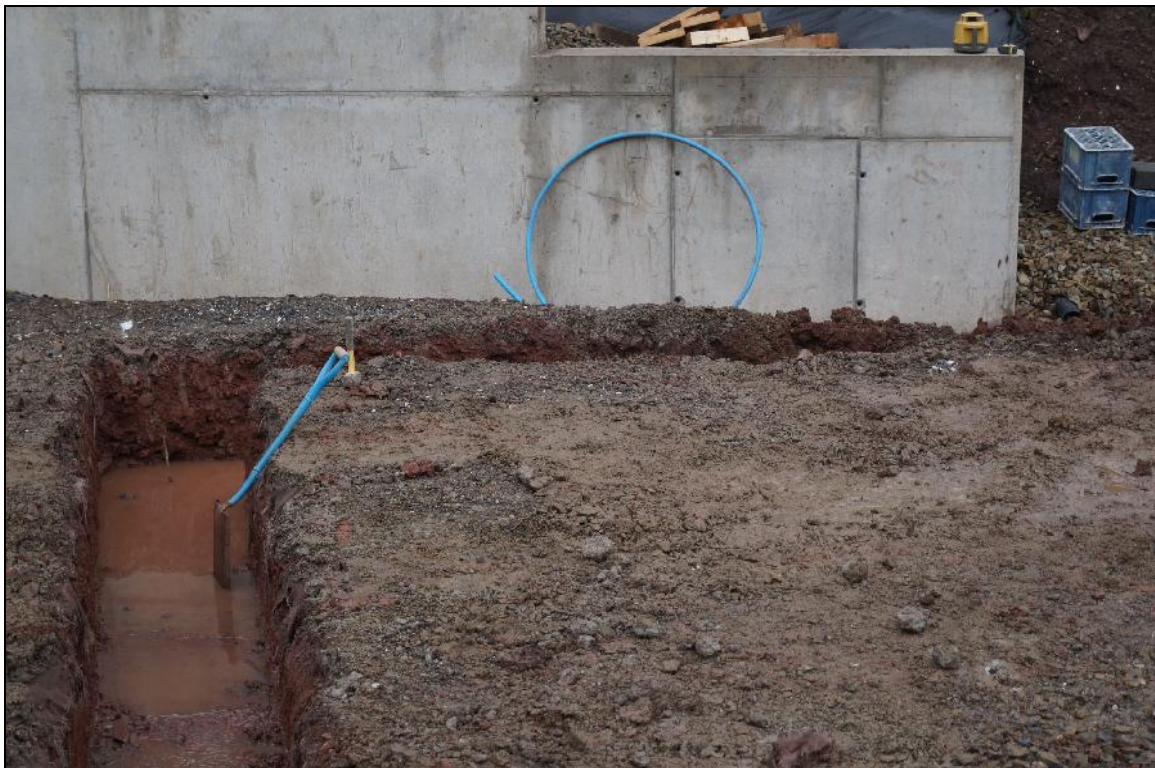
Plate 13: RCL2018_113, Western trench, looking north, showing (002) and scalplings

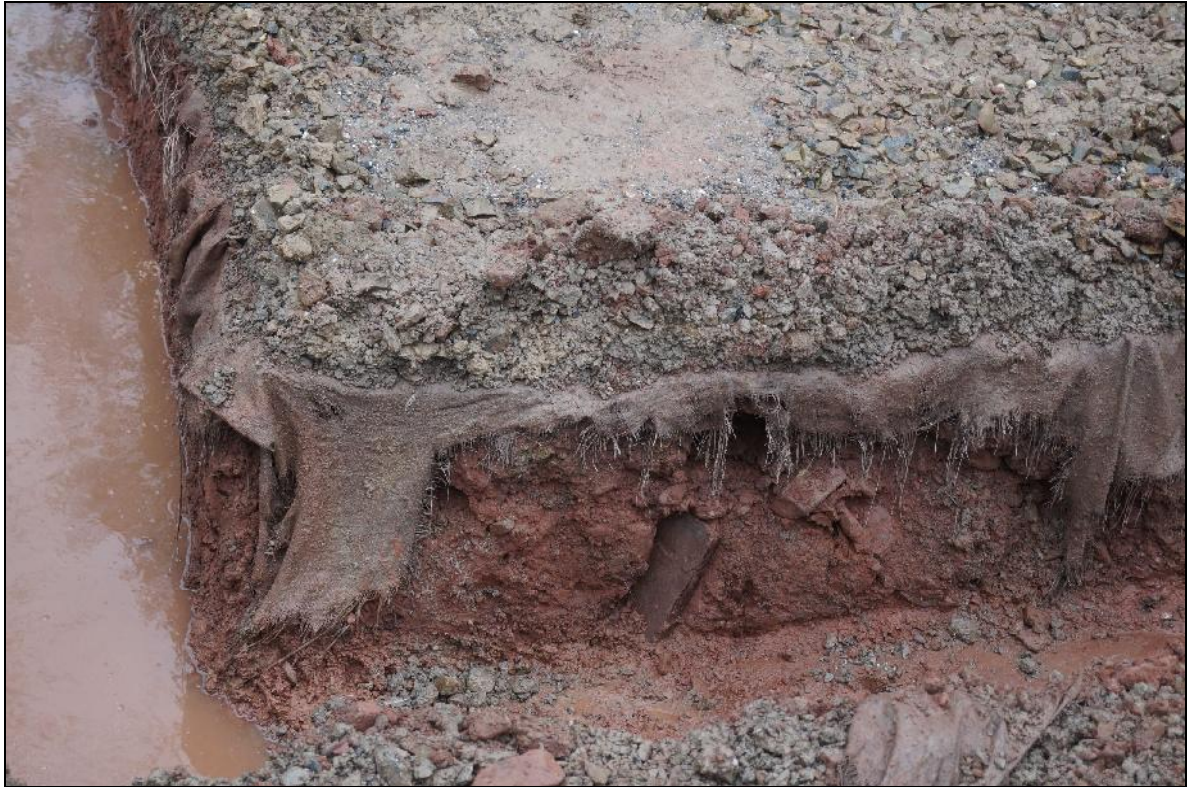
Plate 14: RCL2018_114, Detail of southwestern corner of trenches, looking northeast, showing (002) and scalpings.
