**Micro Hydro Scheme,  
Pant y Turnor, Llanddeusant  
Carmarthenshire  
18/16877/FUL (BBNPA)  
Historic Environment  
Desk-based Assessment**

February 2019

Trysor Project No. 2019/656  
DAT HER Event Record PRN: 114814

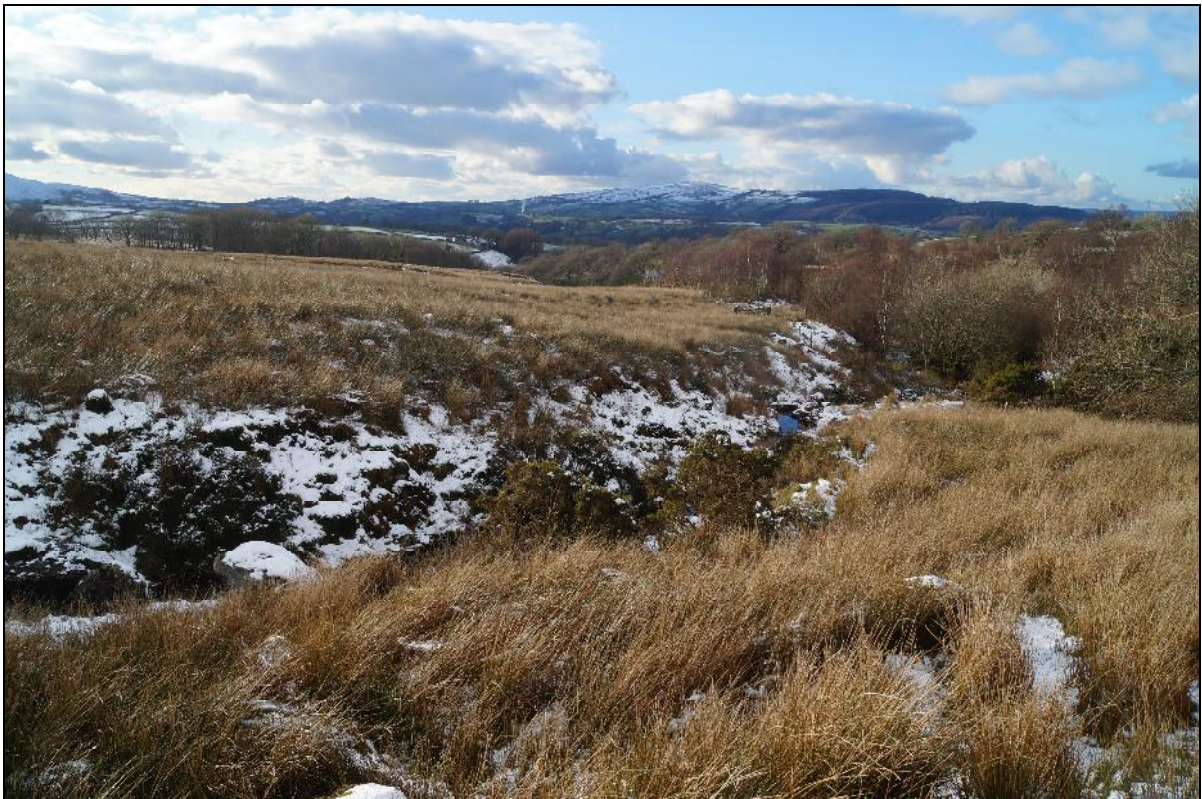
*Cover photograph: The Nant Ffynnon Wen at the boundary between the open mountain land and the enclosed land of Pant y Turnor, looking west. The pipe to the turbine would run on the east side of the stream.*

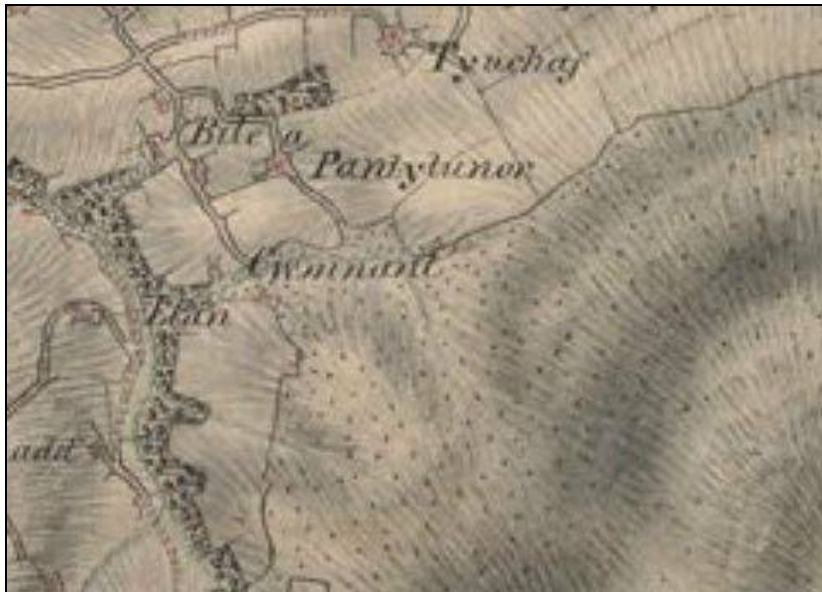
Figure 2; The 1811 Ordnance Survey Original Surveyors Drawing of the development area shown Pant y Turnor. There are no features shown on the adjacent common, but this should not be interpreted as meaning that features such as sheep folds were not present at the time. Note the location of the possible cottage ID number 10 above the "t" in Cwmnant.

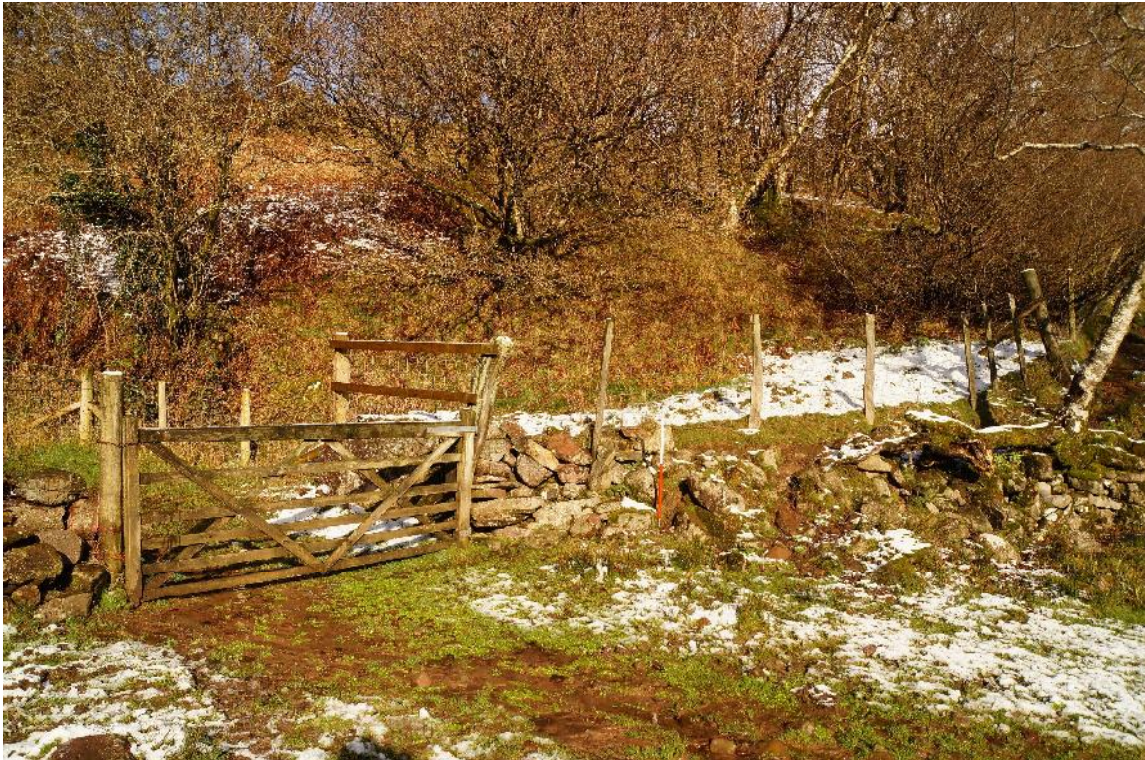
*Plate 1: PYT2019\_001 – a view of the ruinous wall ID number 13 at the gate which gives access to the common. The turbine house would be position on the slope above the wall left of centre here. Note the tumble-down section of the wall to the left of the ranging rod used for scale. Looking north.*

10.2.1 One historic asset, Wall ID number 13, would experience a Moderate, direct impact, though only on a small section where a water pipe would pass through its line and some repair would be necessary. Two undated boundary banks (ID numbers 16 & 17) will have a Low, direct impact as a water pipe will pass through them. The former barn at Pant y Turnor will experience a Very Low, direct impact due to the electricity cables being connected to the building. None of these features are of more than Local importance and none have statutory protection.

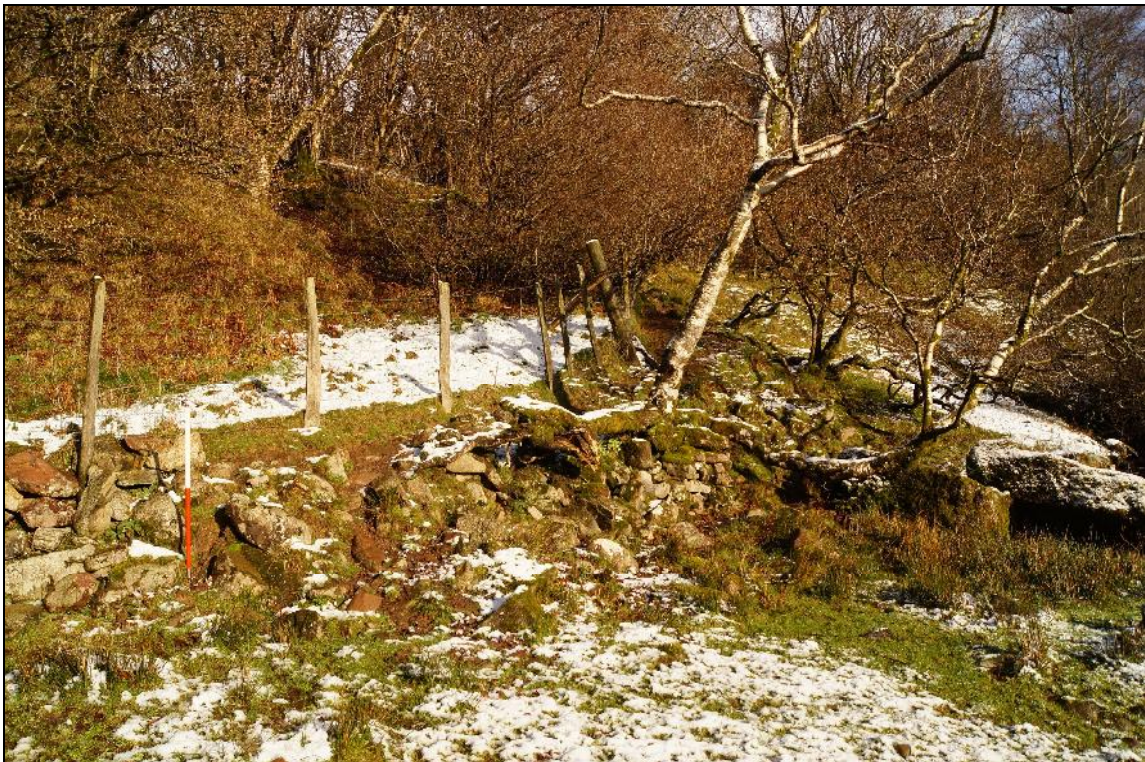
*Plate 2: PYT2019\_002 – wall ID number 13 viewed again. The tumble down section of walling seen to the left of the ranging rod would be a suitable point through which to pass the pipe returning water to the stream from the turbine house. The repair of this section of wall once the pipe has been laid would help prevent further erosion here. Looking northeast.*

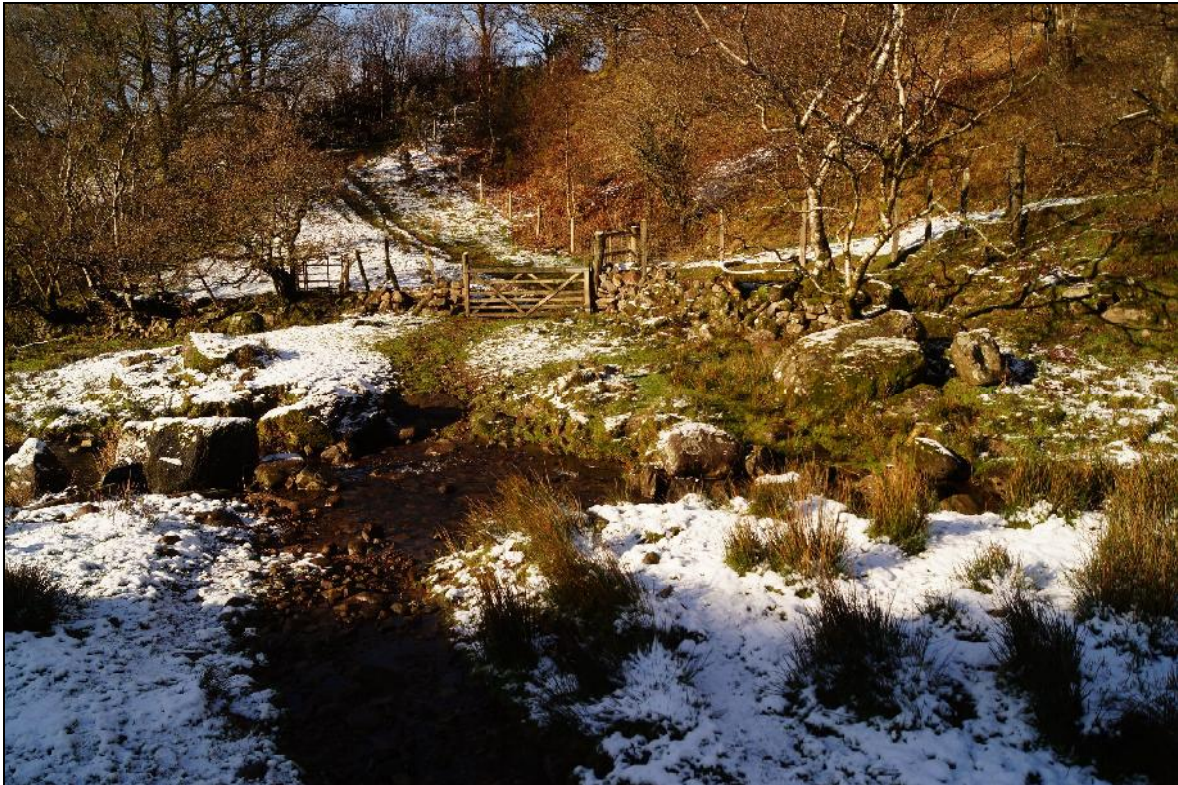
*Plate 3: PYT2019\_003 – a view across the ford on the Nant Ffynnonwen, toward the gate and wall ID number 13. Looking northwest.*

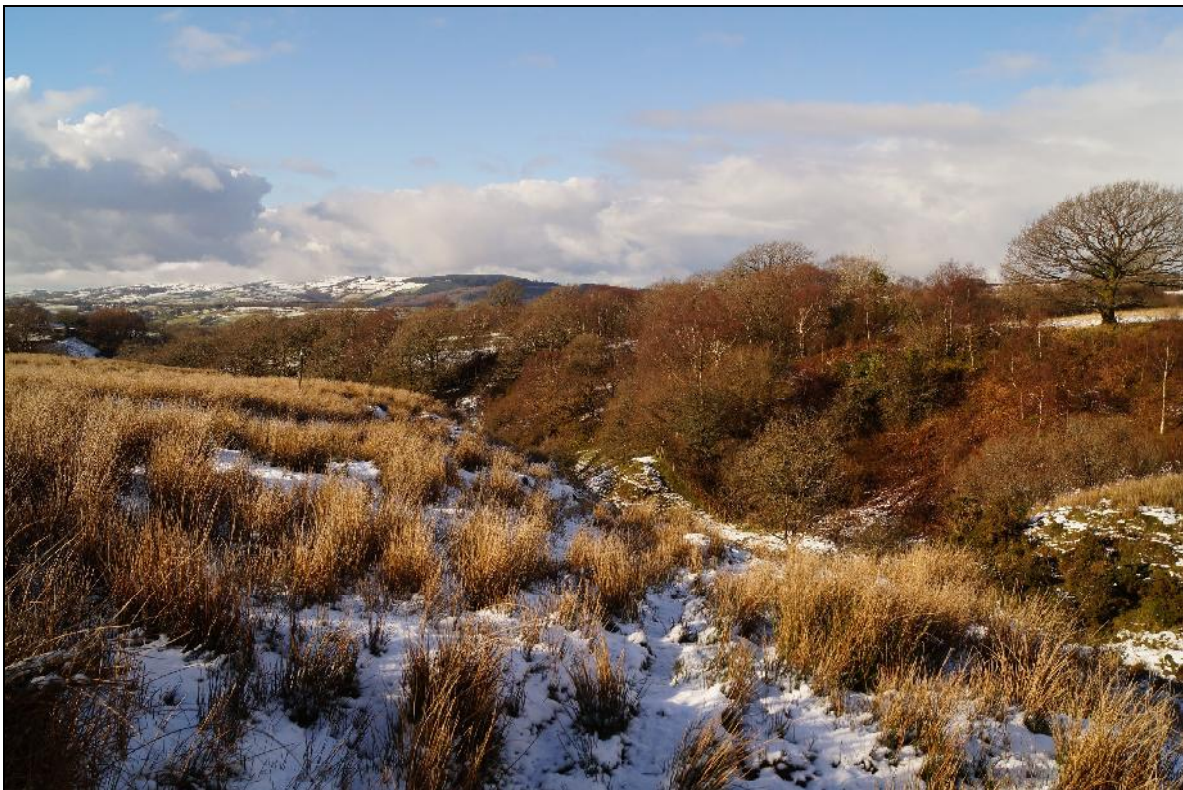
*Plate 4: PYT2019\_004 – a view of the Nant Ffynnonwen valley from the common to the southeast, looking towards the area where the turbine house would be located, on the opposite side of the valley. Looking west-northwest.*

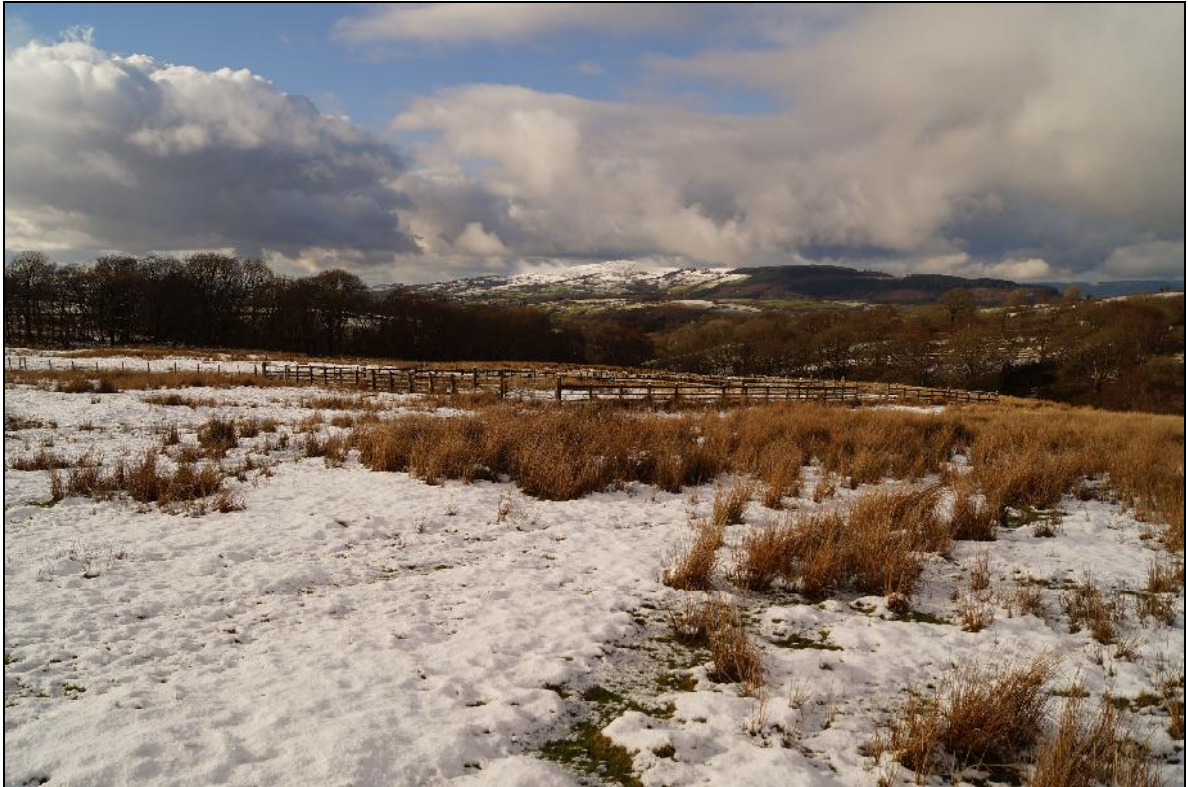
*Plate 5:PYT2019\_005 – a view of the modern timber and sheep-wire fold ID number 19 on the open common. Looking west-northwest.*

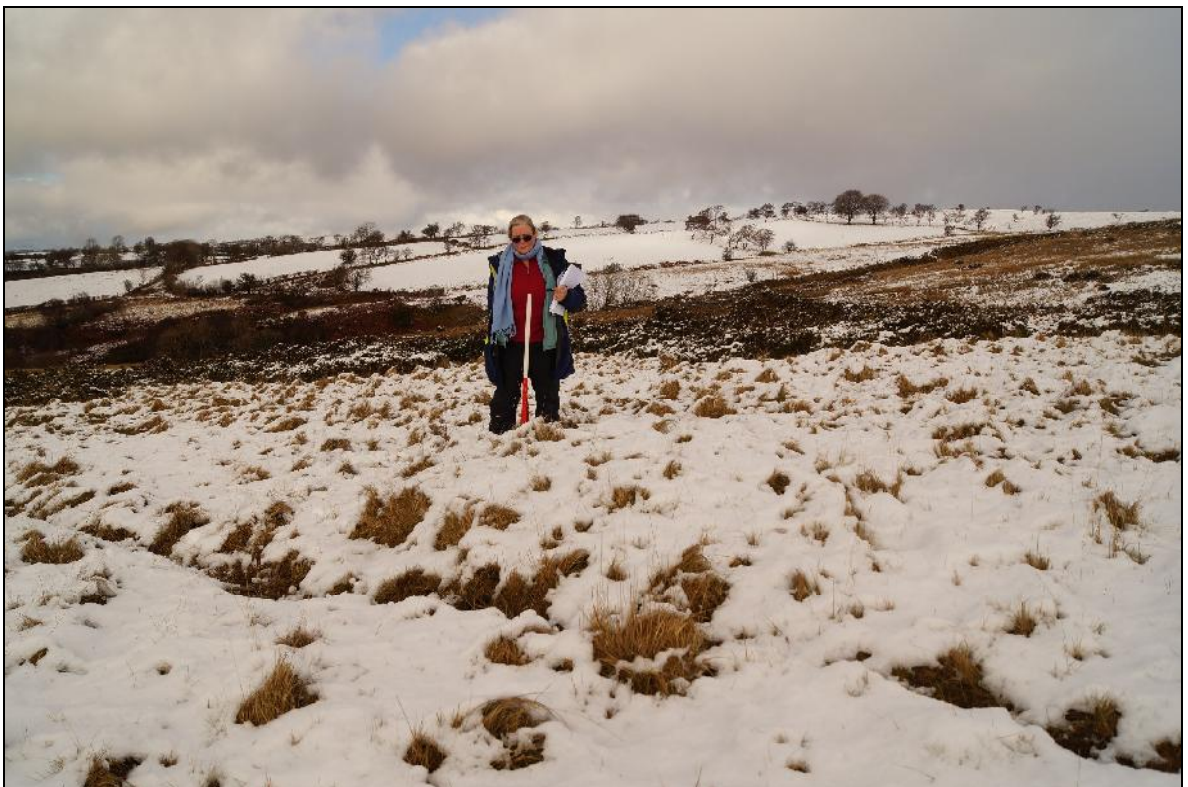
*Plate 6: PYT2019\_006 – a small earth mound ID number 18, difficult to photograph under snow cover, but hiding the feet of the figure in the image. Looking north-northwest.*

11.5.3 Five historic assets may be exposed to indirect, physical impacts from construction activity, particularly erosion by vehicular activity. These are the mound (ID number 18), the platform (ID number 15), boundary banks (ID numbers 16 & 17) and the sheep fold (ID number 14). These historic assets should be identified to contractors in advance of the development and marked to ensure they are visible and damage can be avoided.

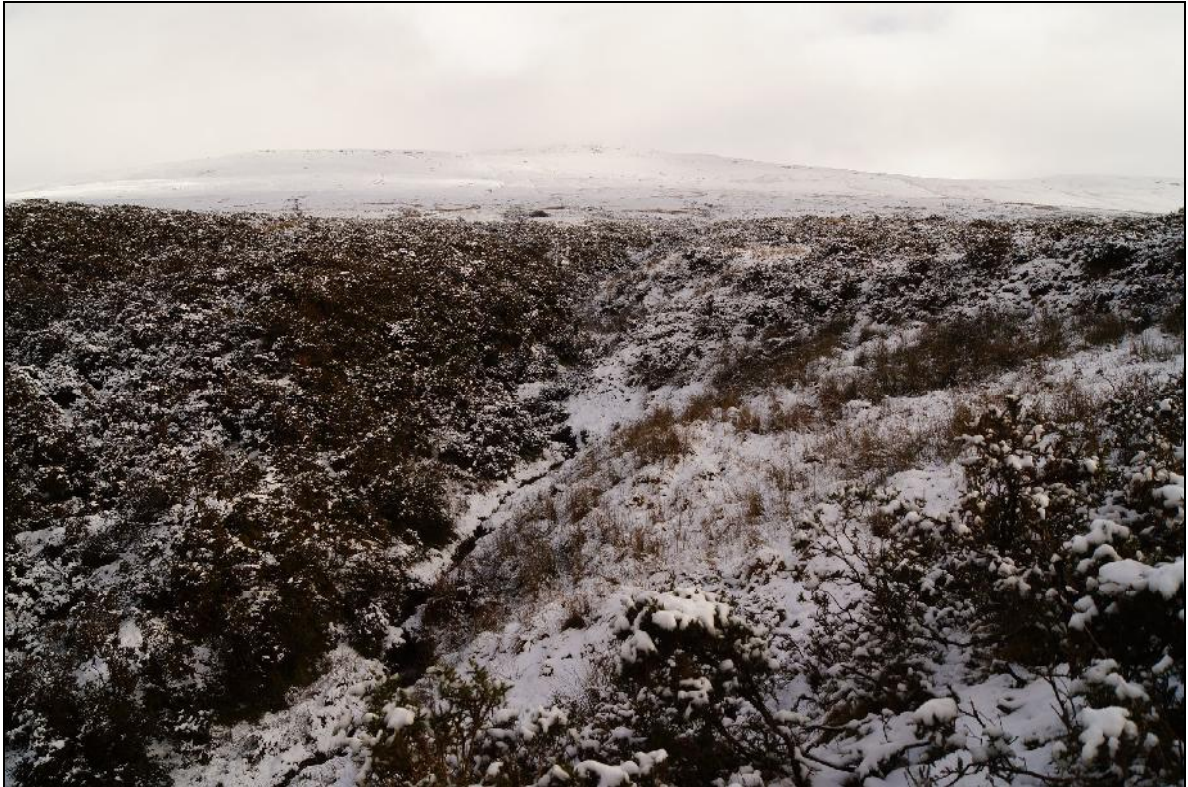
*Plate 7: PYT2019\_007 – a view of the upper reaches of the main Nant Ffynnonwen valley where the tank for the main pipeline will be located shows that the valley surface is heavily obscured by ground vegetation, including gorse along the steep sides. Looking southeast, up the slope.*

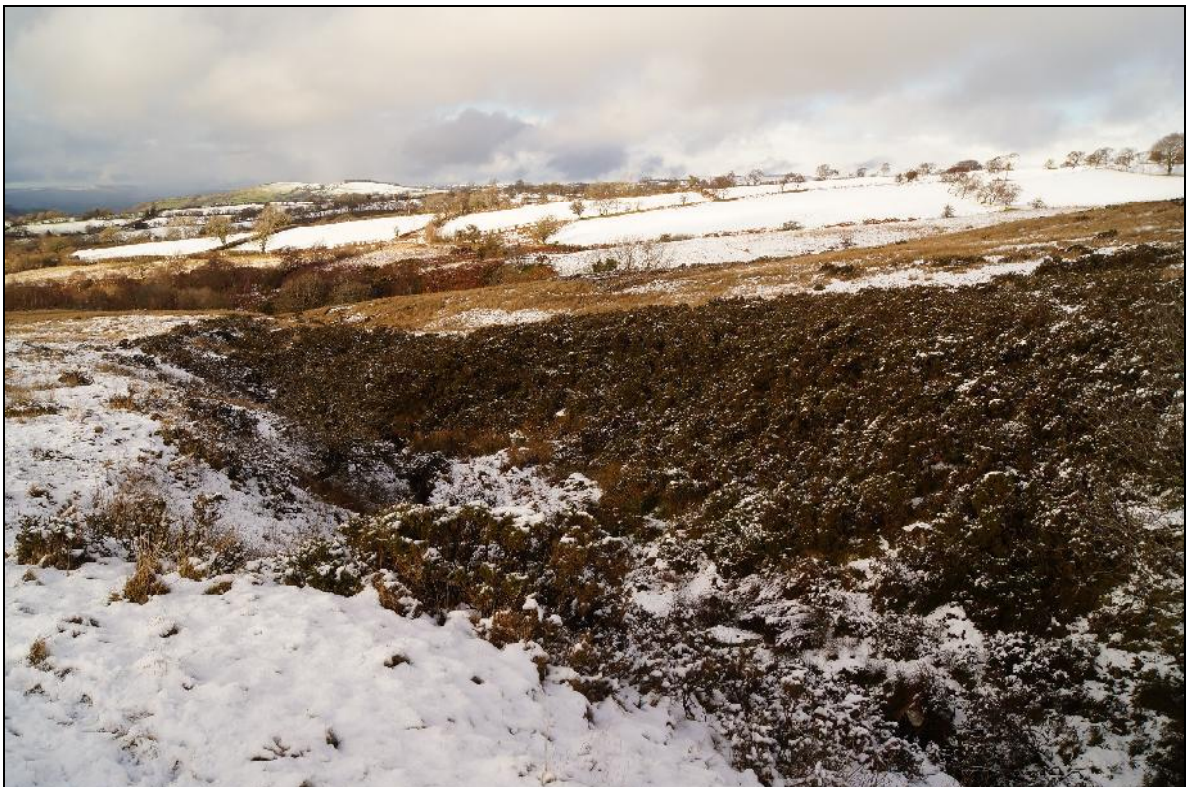
*Plate 8: PYT2019\_008 – a view down the upper reaches of the Nant Ffynnonwen again shows this mountain rill to be heavily vegetated, with large gorse bushes dominant along the northeastern side of the valley. Looking northwest.*

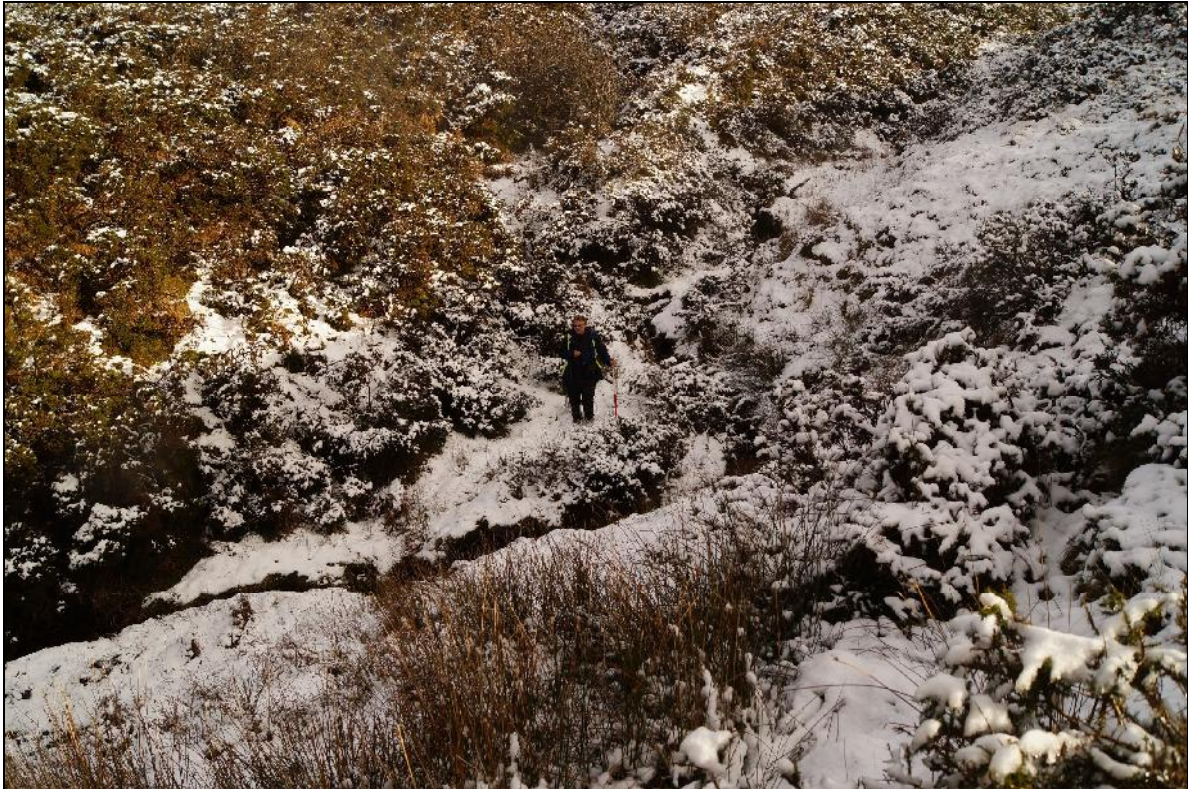
Plate 9: PYT2019\_009– a view into the upper part of the valley to the location of the dam where the main pipeline would begin. The valley floor is narrow and rough and the valley sides are steep. There are no archaeological features visible along the valley and it would not be suited to typical upland monument types such as long huts and burnt mounds due to its narrowness and steepness of the valley sides. Looking east-northeast.

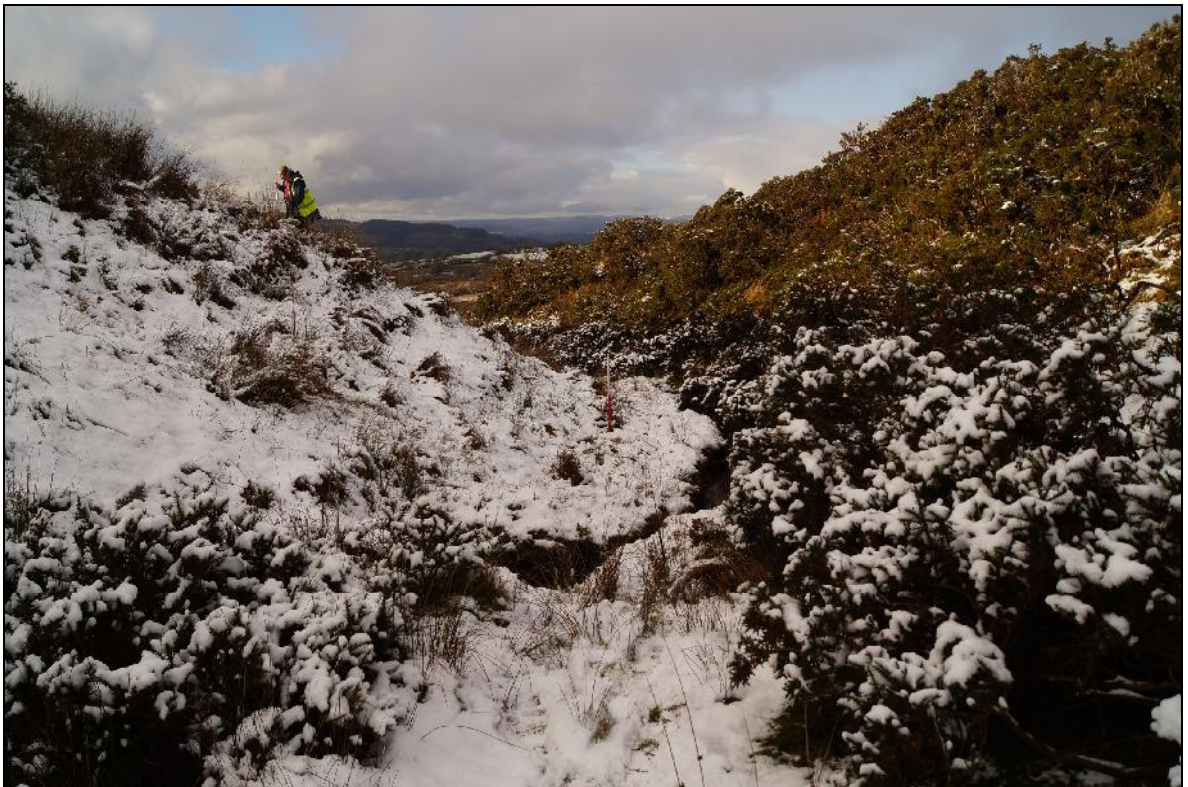
Plate 10: PYT2019\_010 – a return view from the location of the dam where the main pipeline would begin. Looking northwest.

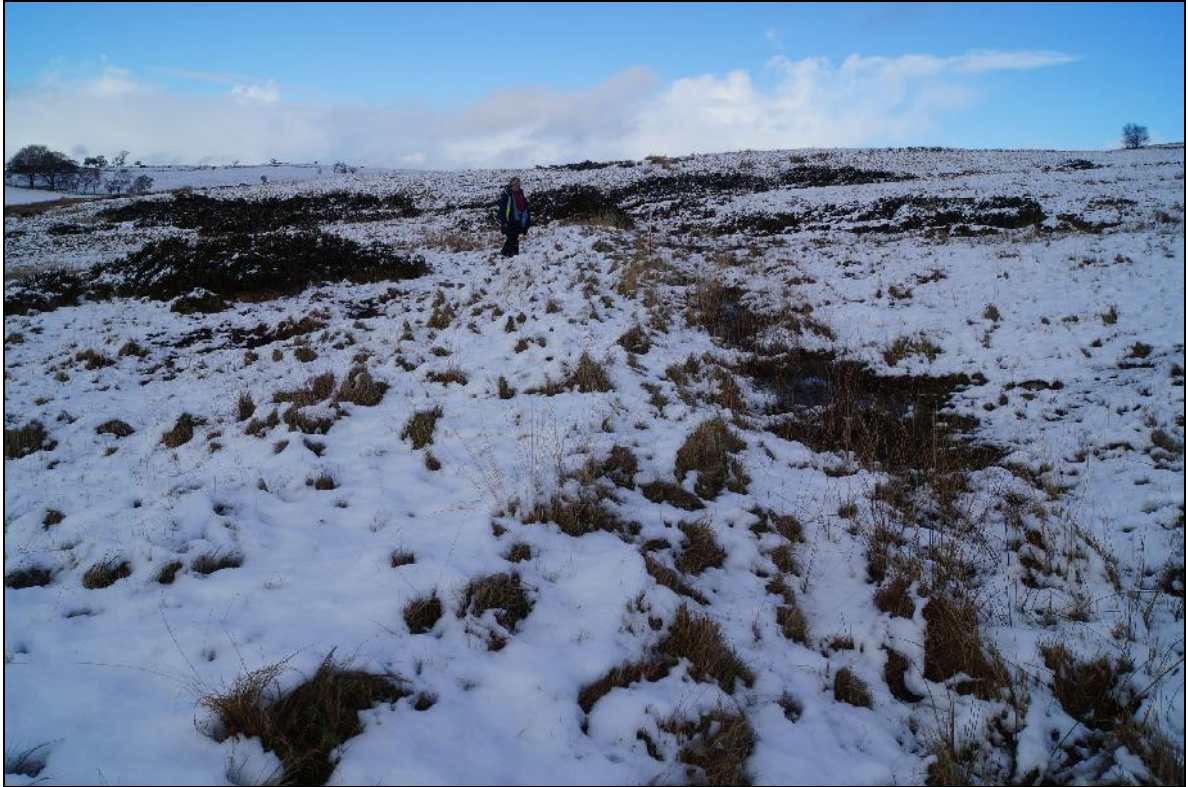
*Plate 11: PYT2019\_011 – a view of the denuded field boundary bank ID number 17, looking north-northeast.*

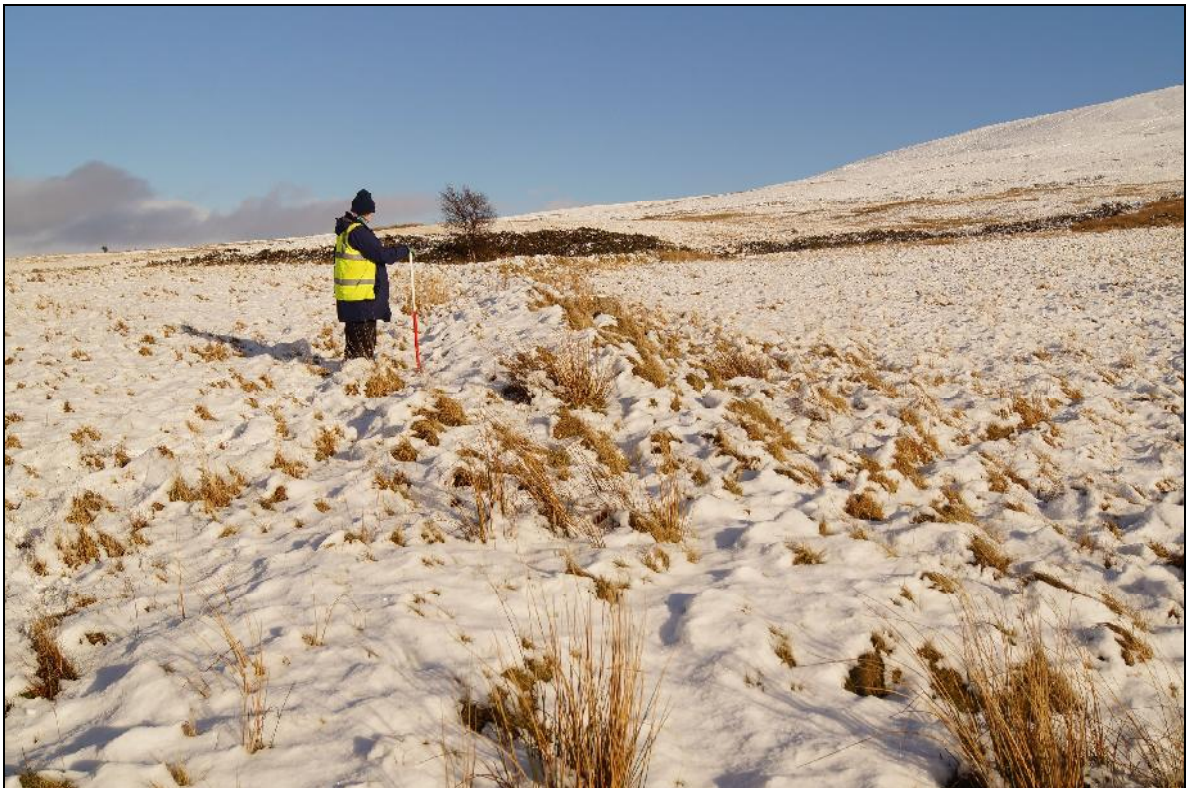
*Plate 12: PYT2019\_012 – a view of the denuded field boundary bank ID number 16. Both this bank and bank ID number 17 are part of a much more extensive enclosure of the mountain which extends up onto Brest y Rhos beyond the tree seen in the middle distance here. Looking east-northeast*

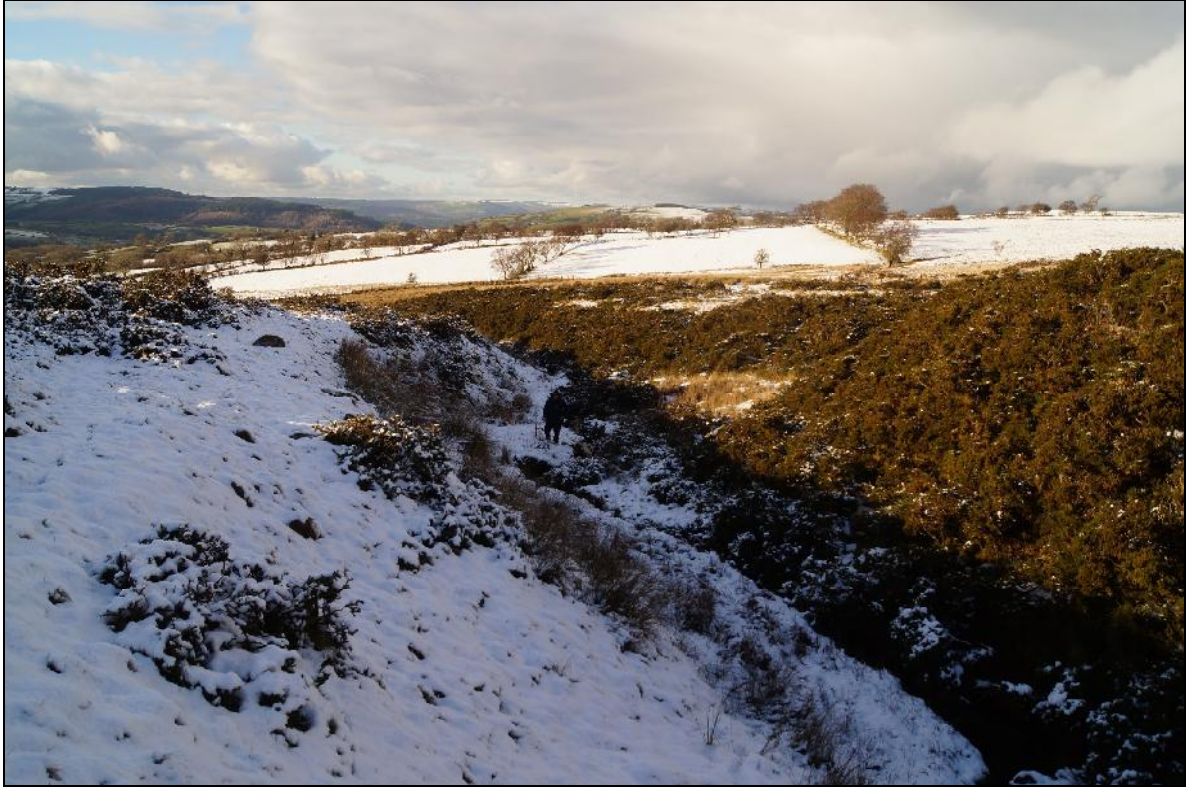
Plate 13: PYT2019\_013 – a view of the tributary rill of the Nant Ffynnonwen, to the north of the main valley, where a second tank and feeding pipe would be located. Again this rill has steep sides and a narrow floor and ground vegetation, especially gorse, obscures much of the surface. Looking northwest.

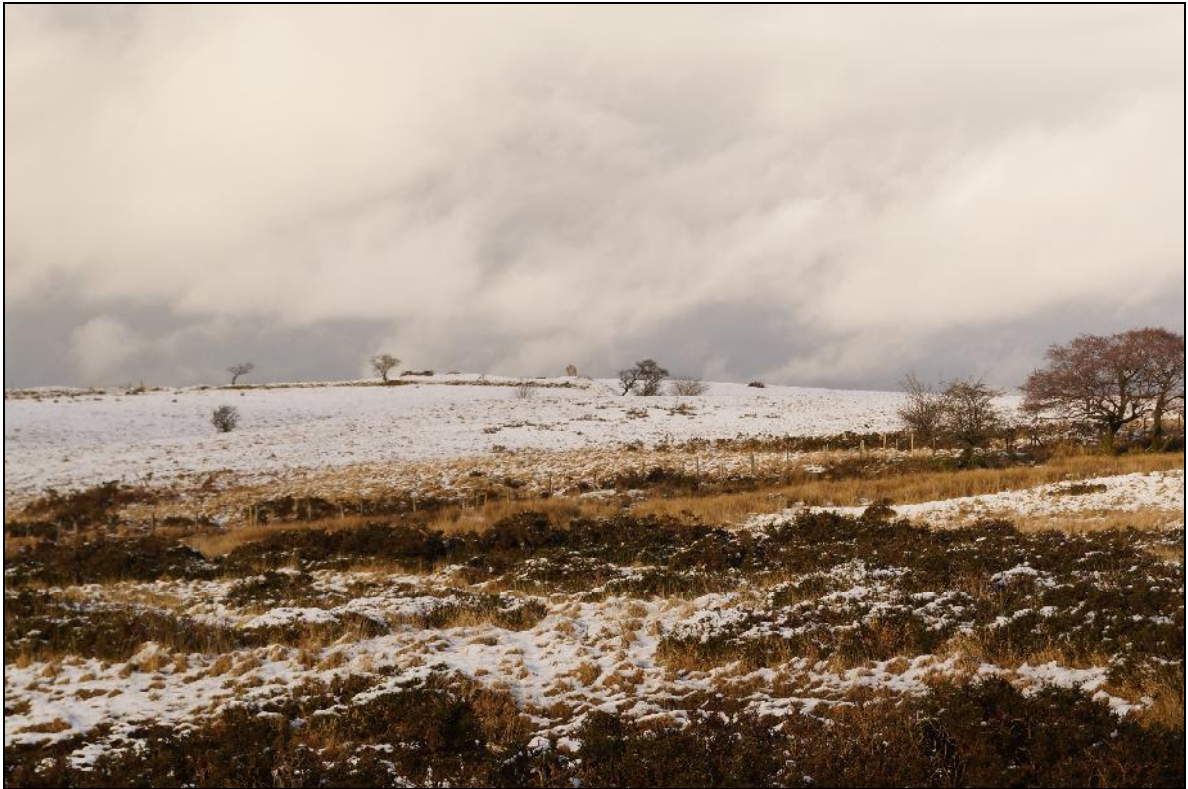
*Plate 15: PYT2019\_015 – a view towards the Tyle Pengam Standing Stone (ID number 3) seen on the horizon in the centre of this photograph. A slight mound on the horizon to its left in this image is the scheduled round barrow ID number 2). The proposed development would have no impact on these monuments. Looking north.*

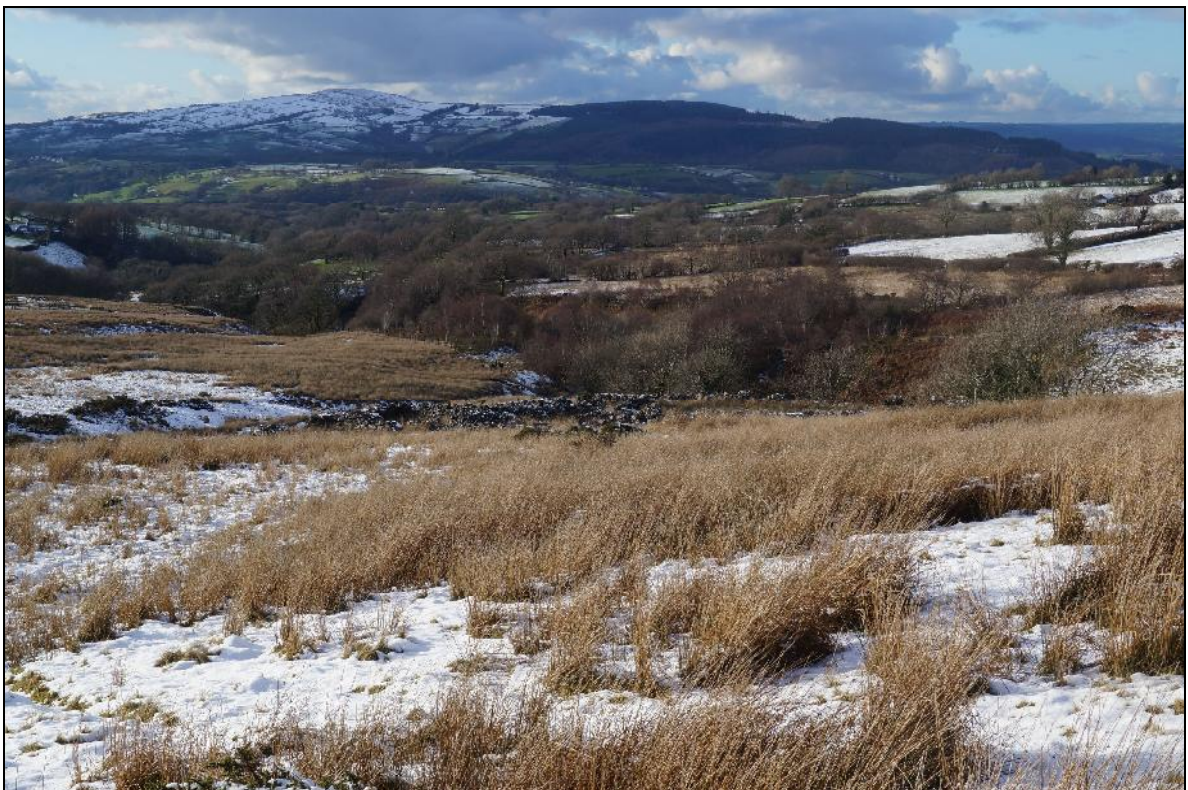
*Plate 16: PYT2019\_016 – a view of the drystone sheep fold ID number 14 which stands close to the edge of the common. Looking west.*

Although the proposed development would not directly impact on the sheep fold, the proximity of pipe-laying activity means that some vehicular activity may occur close to the fold. It is important that this activity does not unintentionally damage the fold, which is presently in good condition but could be easily damaged by contact with vehicles.

**Management Recommendations:**

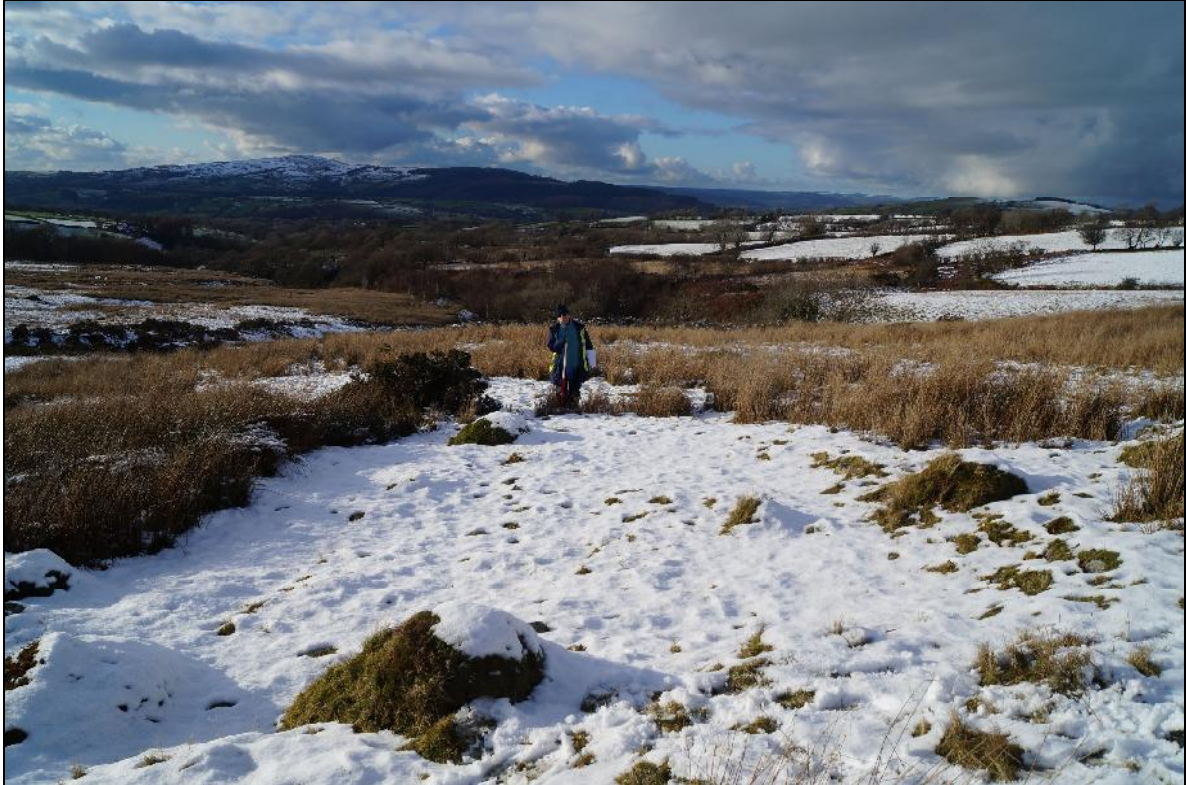
*Plate 17: PYT2019\_017 – a view of the newly identified platform ID number 15, with the sheep fold ID number 14 in the background. Looking west-northwest.*

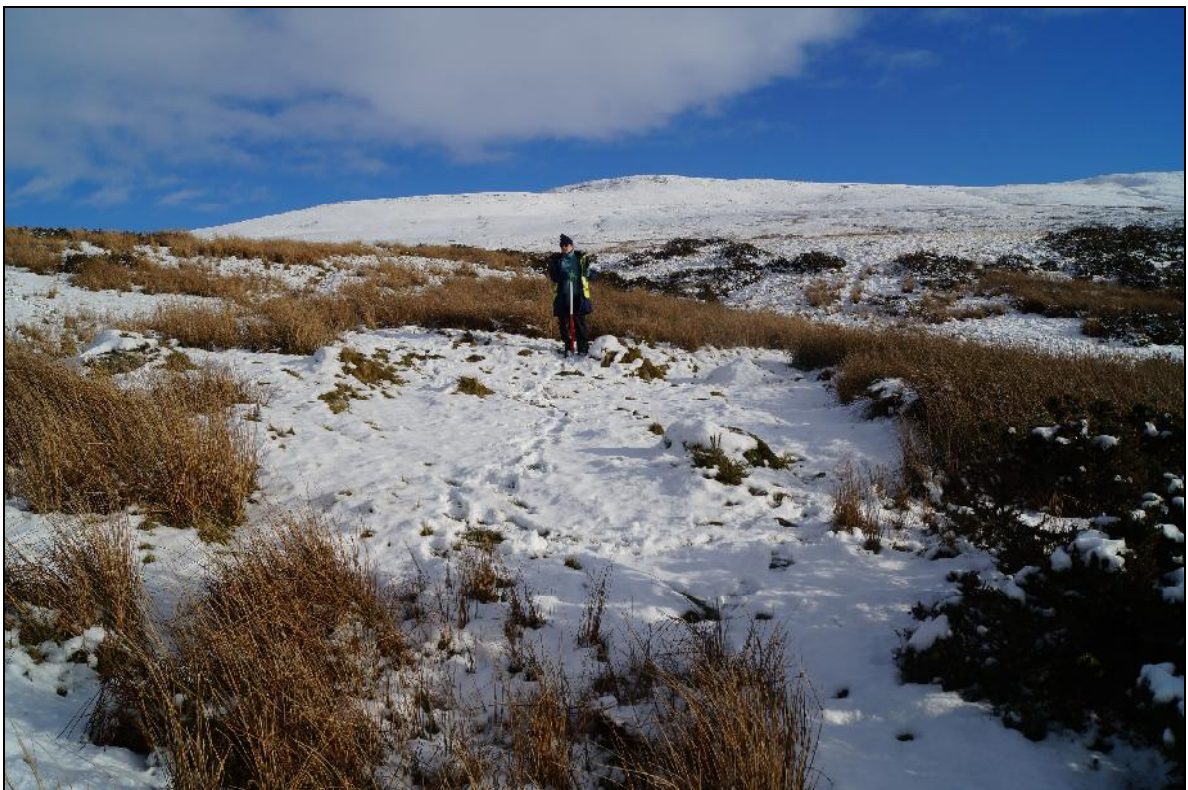
*Plate 18: PYT2019\_018 – a view of platform ID number 15. Looking east-southeast.*

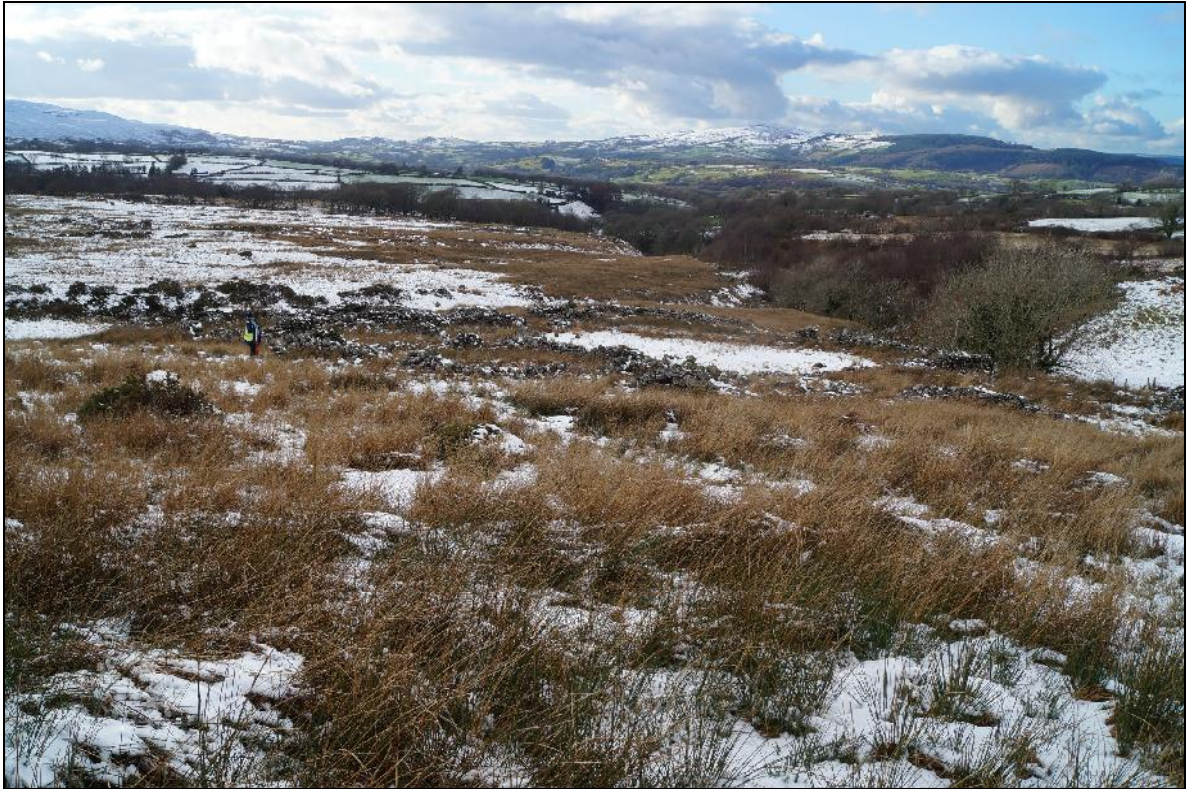
*Plate 19: PYT2019\_019 – a view of sheep fold ID number 14. Looking west.*

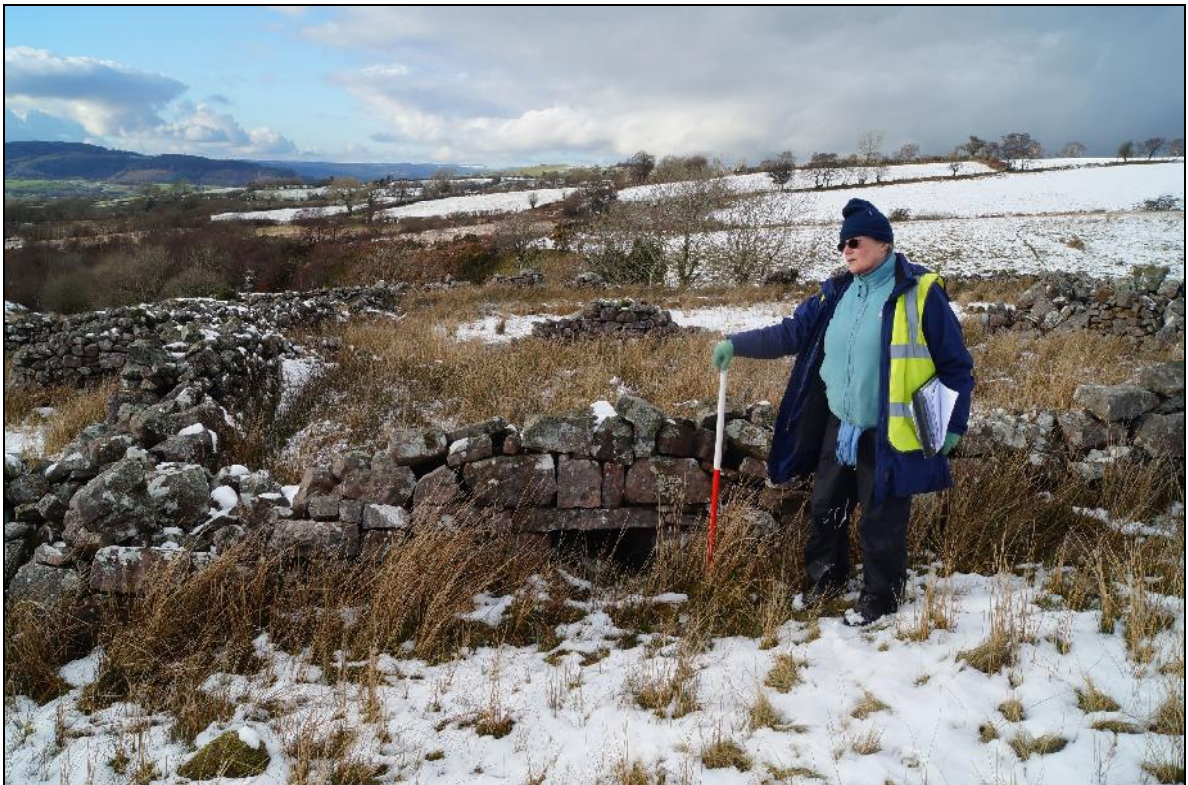
*Plate 20: PYT2019\_020 – a closer view of the southeast side of sheep fold ID number 14, showing a sheep creep which gave access into one of the cells of the fold complex. Looking northwest.*

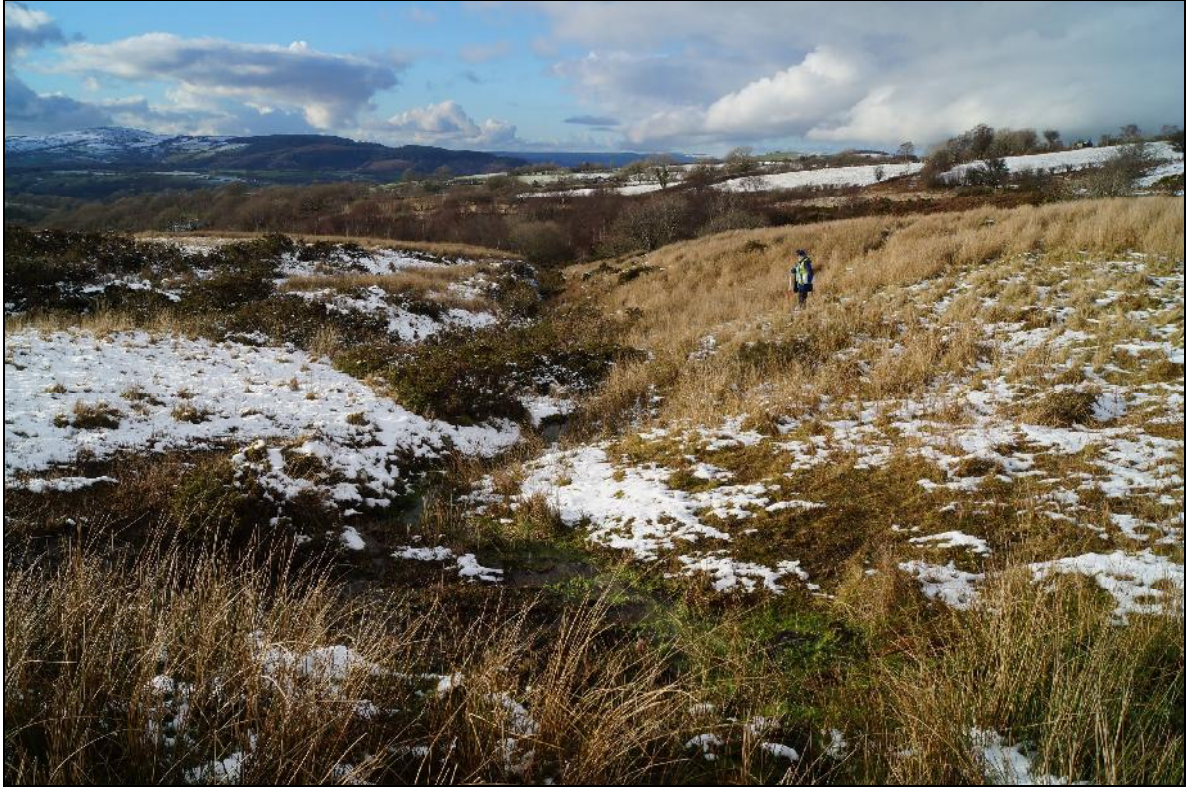
Plate 21: PYT2019\_021 – a view of the lower part of the main rill of the Nant Ffynnonwen stream as it approaches the common boundary to the west of sheep fold ID number 14. Looking northwest.

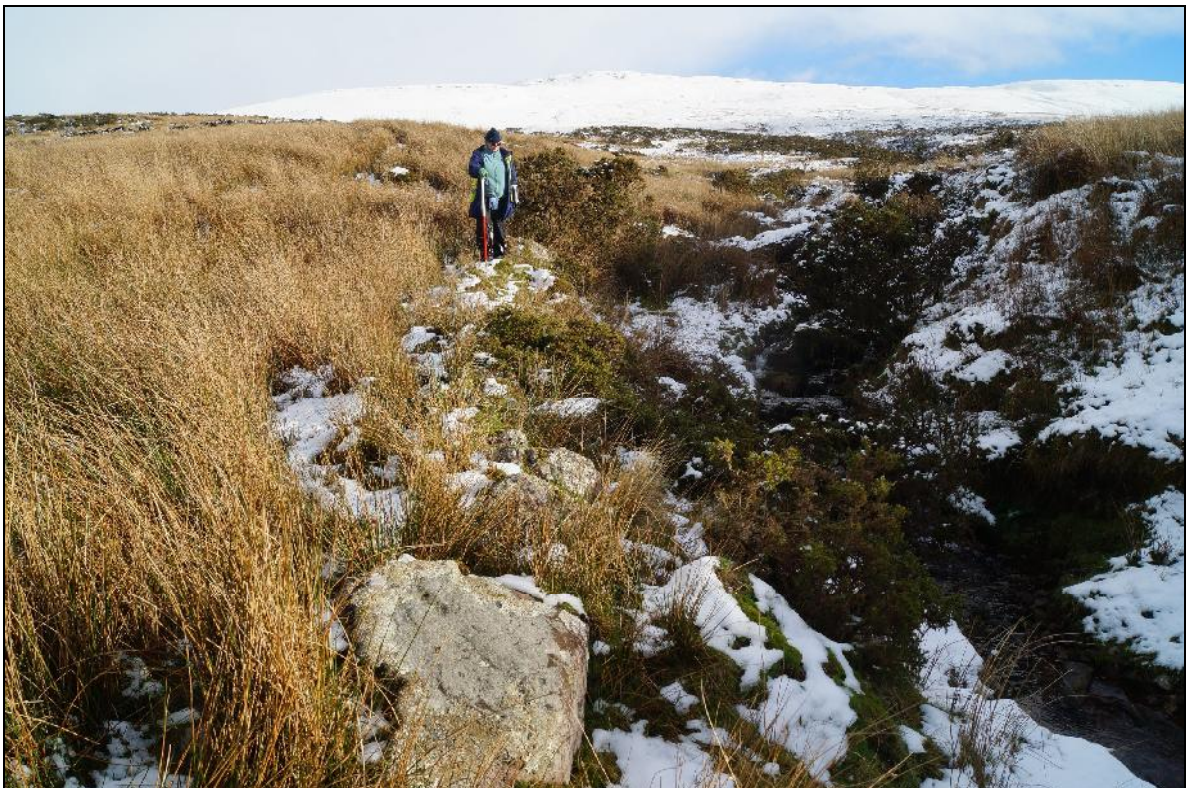
Plate 22: PYT2019\_022 – a view of the lower part of the main rill of the Nant Ffynnonwen stream as it approaches the common boundary. The walls of sheep fold ID number 14 can be seen top left. The stone wall left of centre is a continuation of boundary bank ID number 14. Looking southeast.
