**Micro Hydro Scheme,  
Pant y Turnor, Llanddeusant  
Carmarthenshire  
18/16877/FUL (BBNPA)  
Historic Environment  
Desk-based Assessment**

February 2019

Trysor Project No. 2019/656  
DAT HER Event Record PRN: 114814

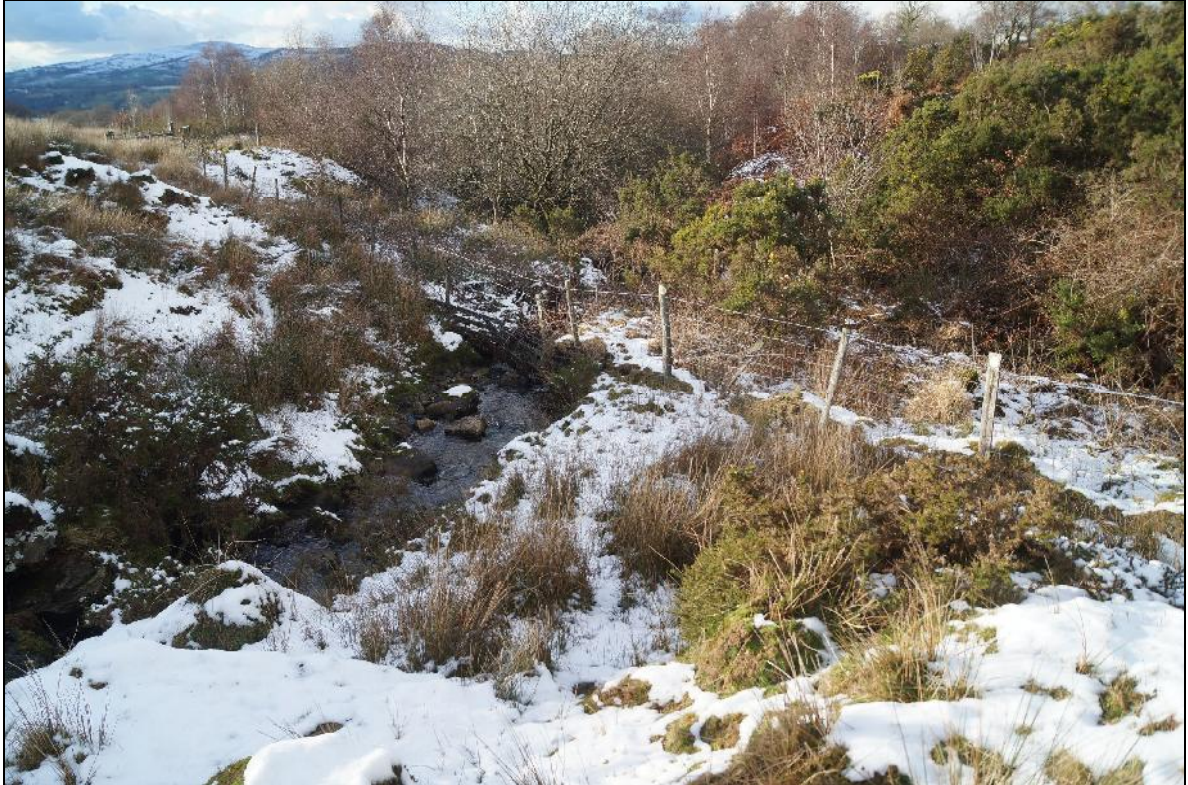
Plate 23: PYT2019\_023 – a view of the point where the main rill of the Nant Ffynnonwen crosses the common boundary. The valley beyond the common boundary is both steep-sided and heavily obscured by trees and ground vegetation. Looking northwest.

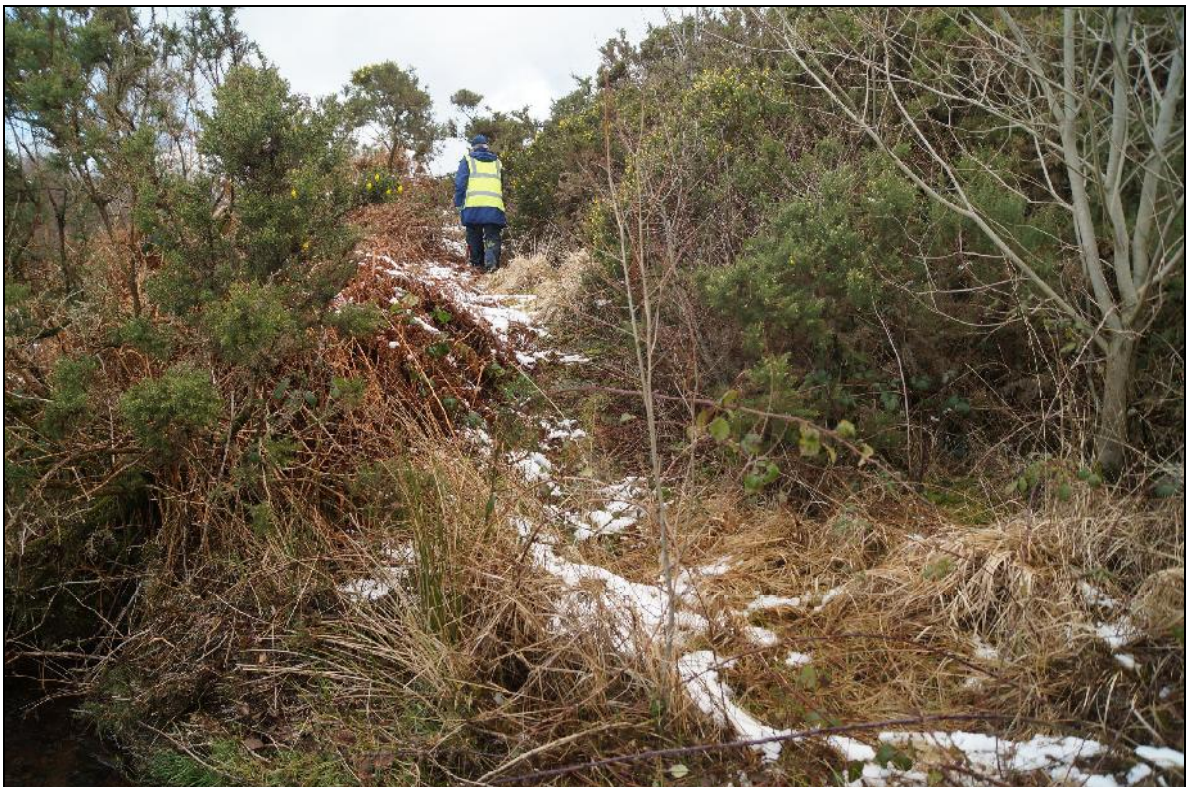
Plate 24: PYT2019\_024 – following the line of the proposed pipe along the Nant Ffynnonwen valley is difficult due to the ground vegetation and tree cover. No features of archaeological interest could be discerned. Looking northwest.

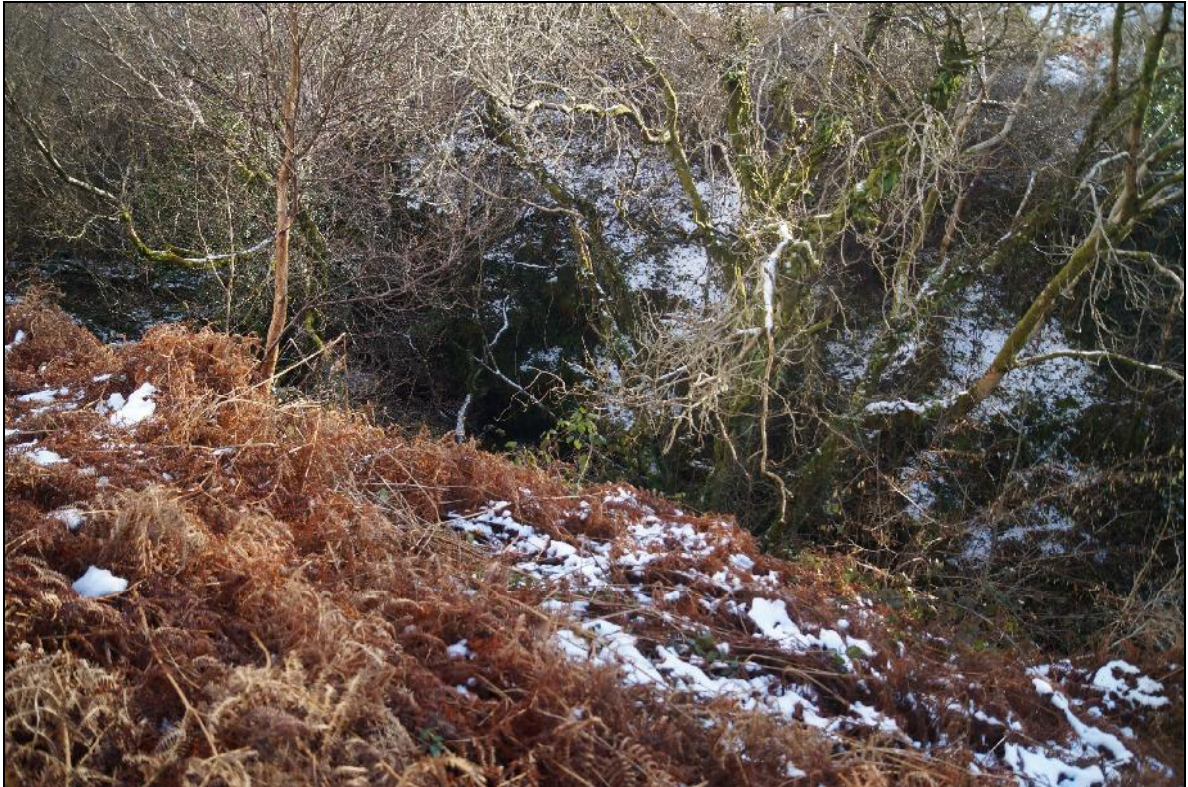
*Plate 25: PYT2019\_025 – a view into the Nant Ffynnonwen valley shows how narrow and steep-sided much of the valley is. The main pipeline will run along the valley side below this point. Looking west.*

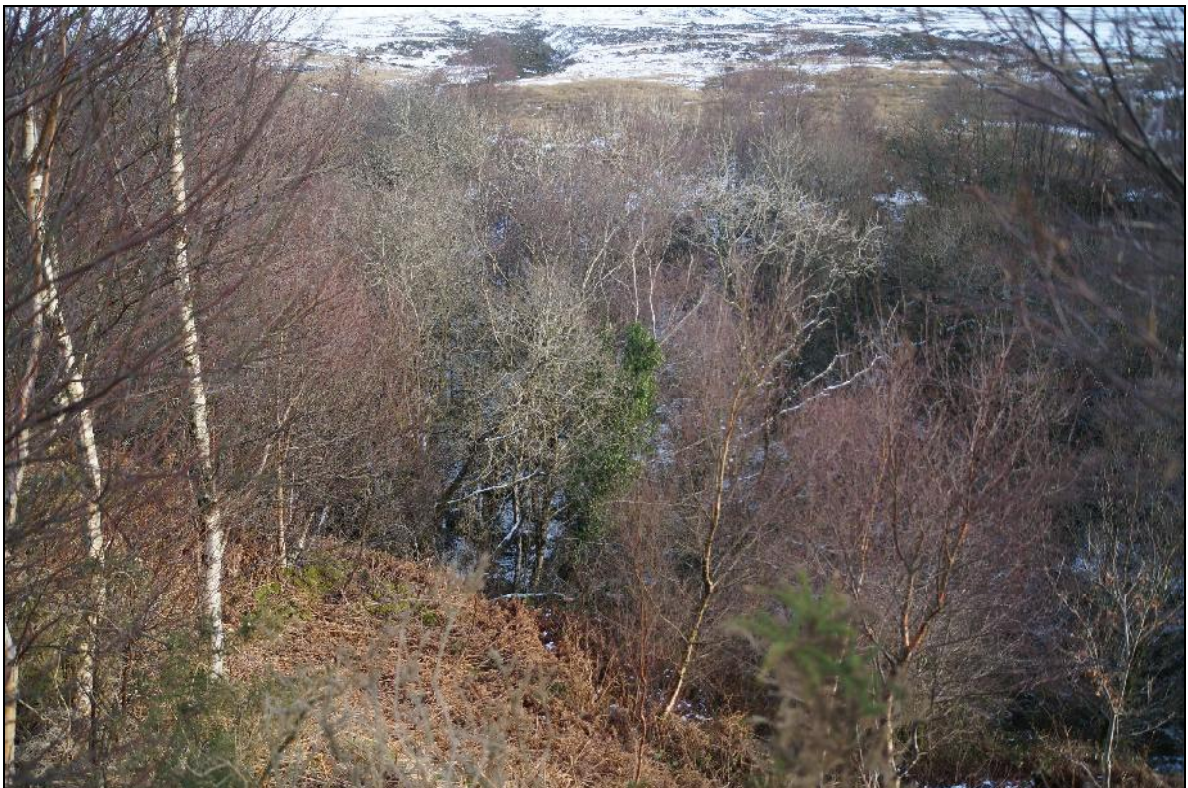
*Plate 26: PYT2019\_026 – another view into the main part of the Nant Ffynnonwen valley. The rill where the main pipeline would begin is visible left of centre at the top of the image. Looking southeast.*

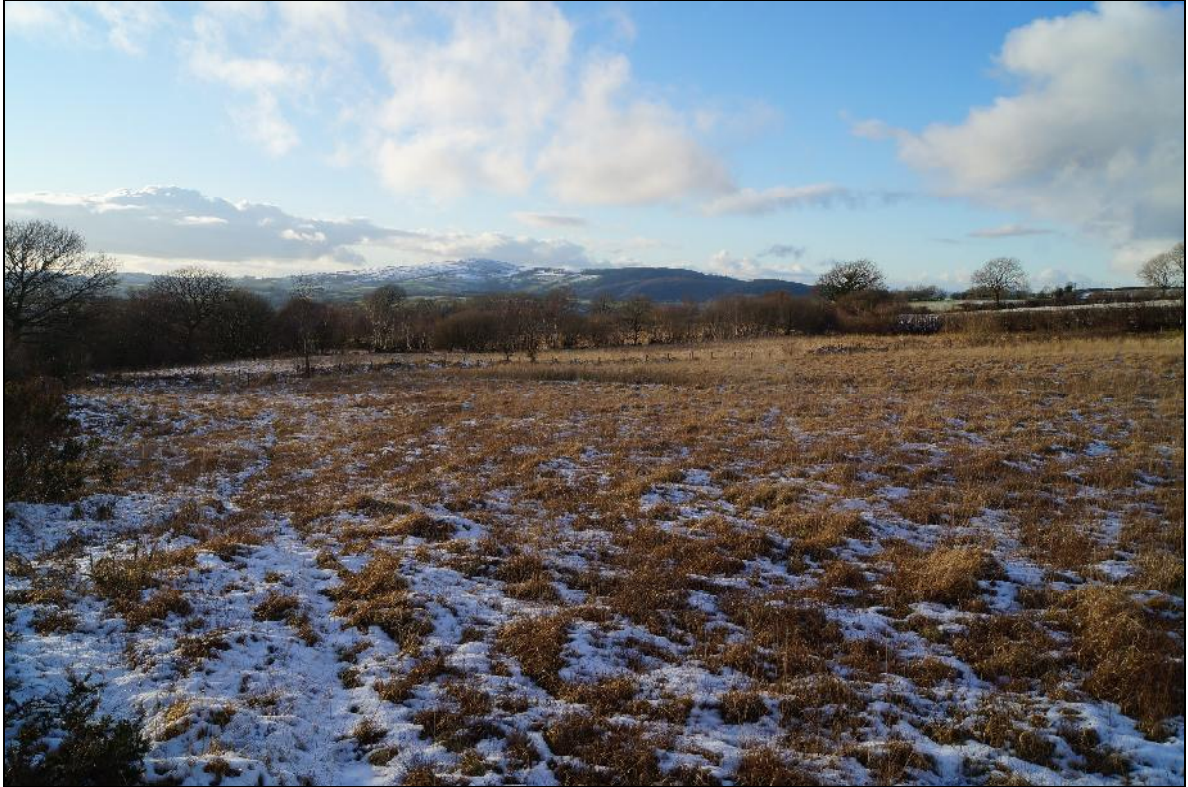
Plate 27: PYT2019\_027 – a view of the fields immediately above the northern side of the Nant Ffynnonwen valley. Despite being enclosed in the 19<sup>th</sup> century, this part of the holding has been allowed to remain as, or return to, rough pasture and Molina (purple-moor grass) now dominates the fields. Looking west-southwest.

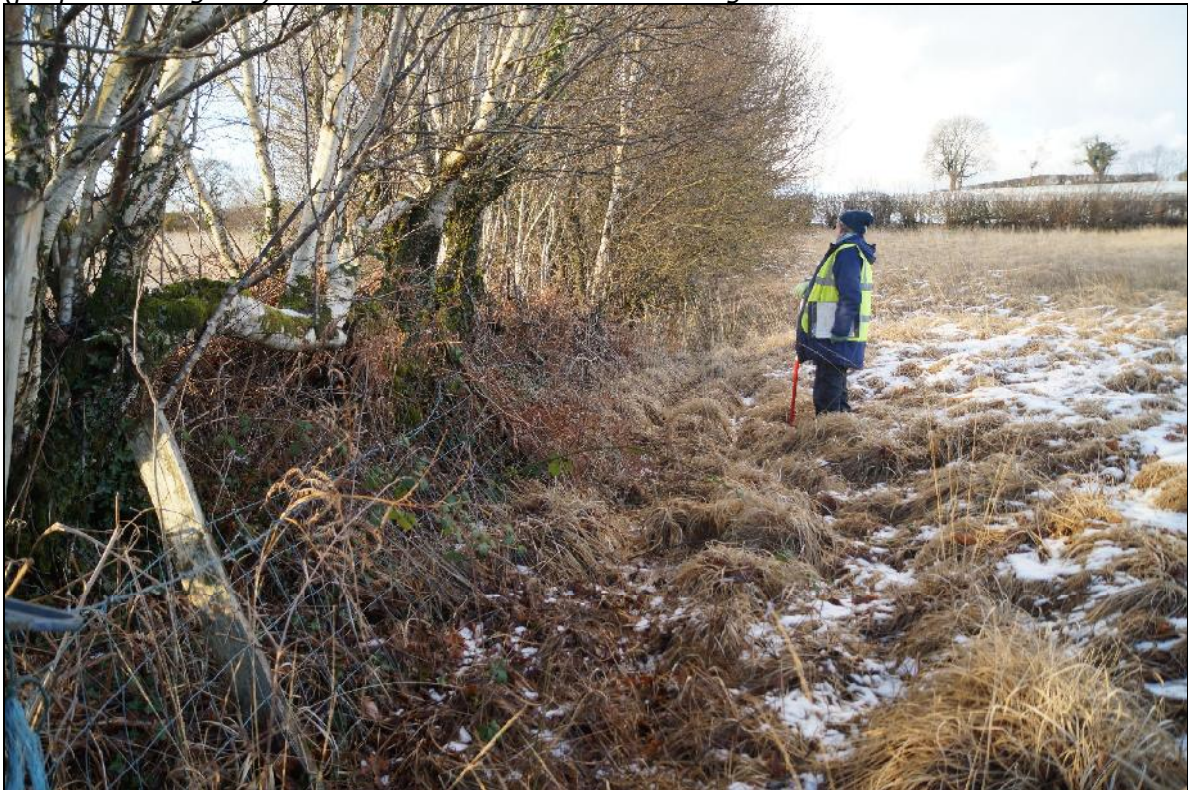
Plate 28: PYT2019\_028 – a view of a boundary bank within the area of Molina. The boundary bank is double-fenced suggesting that it has been protected from grazing animals in modern times. The electricity cable to Pant y Turnor from the turbine house will run along the opposite side of this bank, buried beneath the surface. Looking north-northwest.

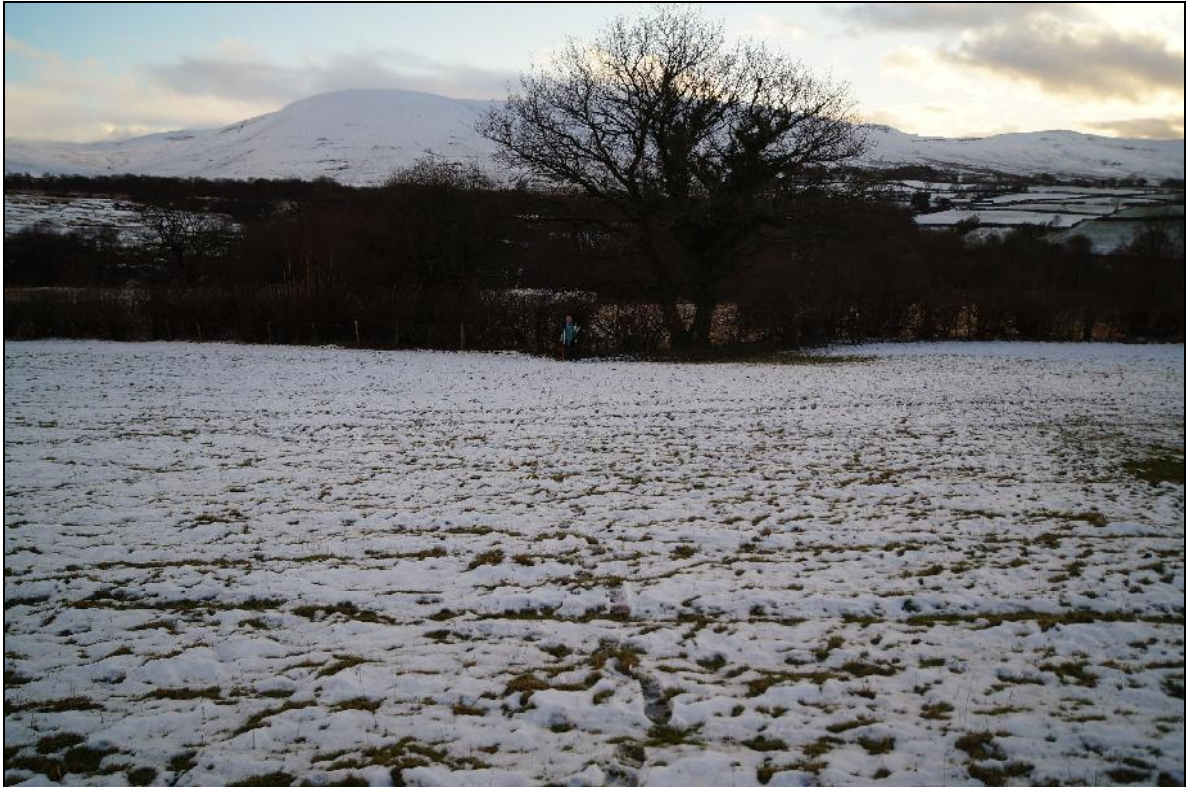
*Plate 29: PYT2019\_029 – proceeding from the area of Molina grazing, the electricity cable would be buried beneath clean pasture fields en route to Pant y Turnor. No features of archaeological interest were seen in the fields here. Looking south-southwest.*

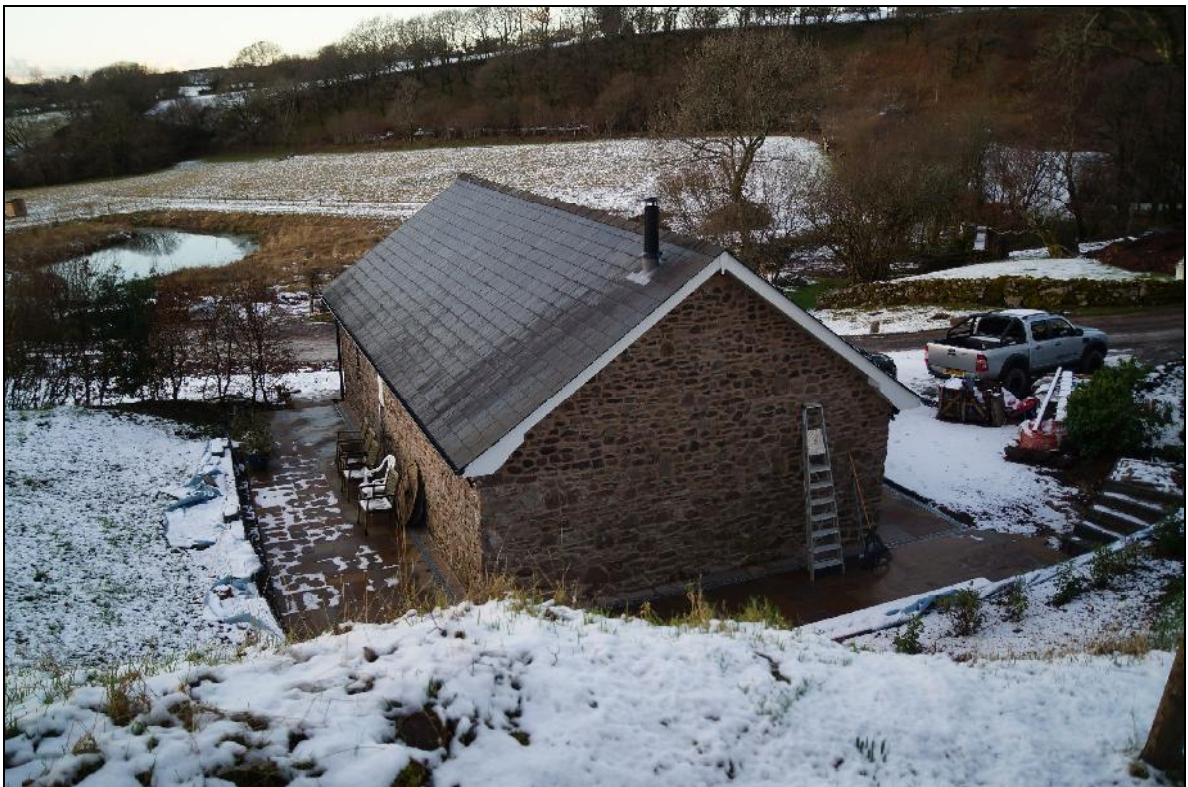
*Plate 30: PYT2019\_030 – the electricity cable would end at this former barn, now converted for residential use, on the farmyard at Pant y Turnor. Looking north-northwest.*

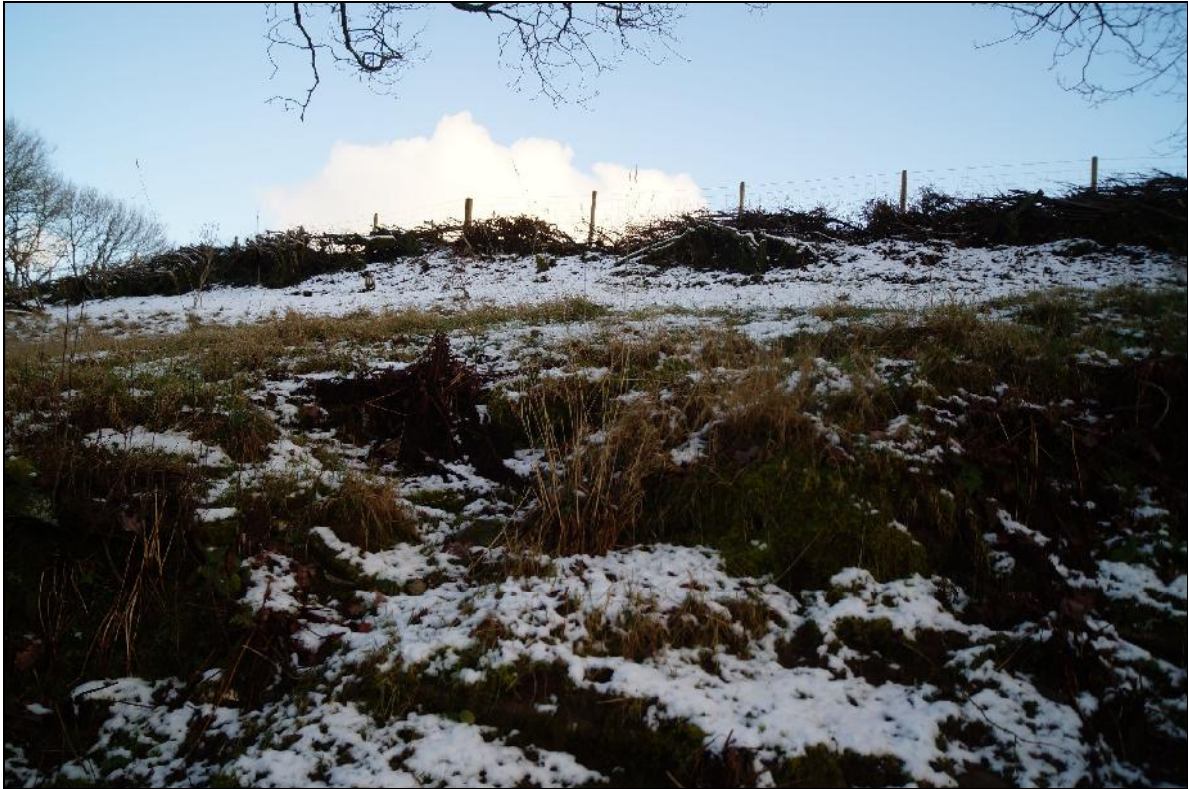
Plate 31: PYT2019\_031 – the electricity cable would pass through a low earth bank and modern post and wire fence before descending a steep slope to the former barn at Pant y Turnor. The post-medieval field boundary here is not of historical significance. Looking southeast.

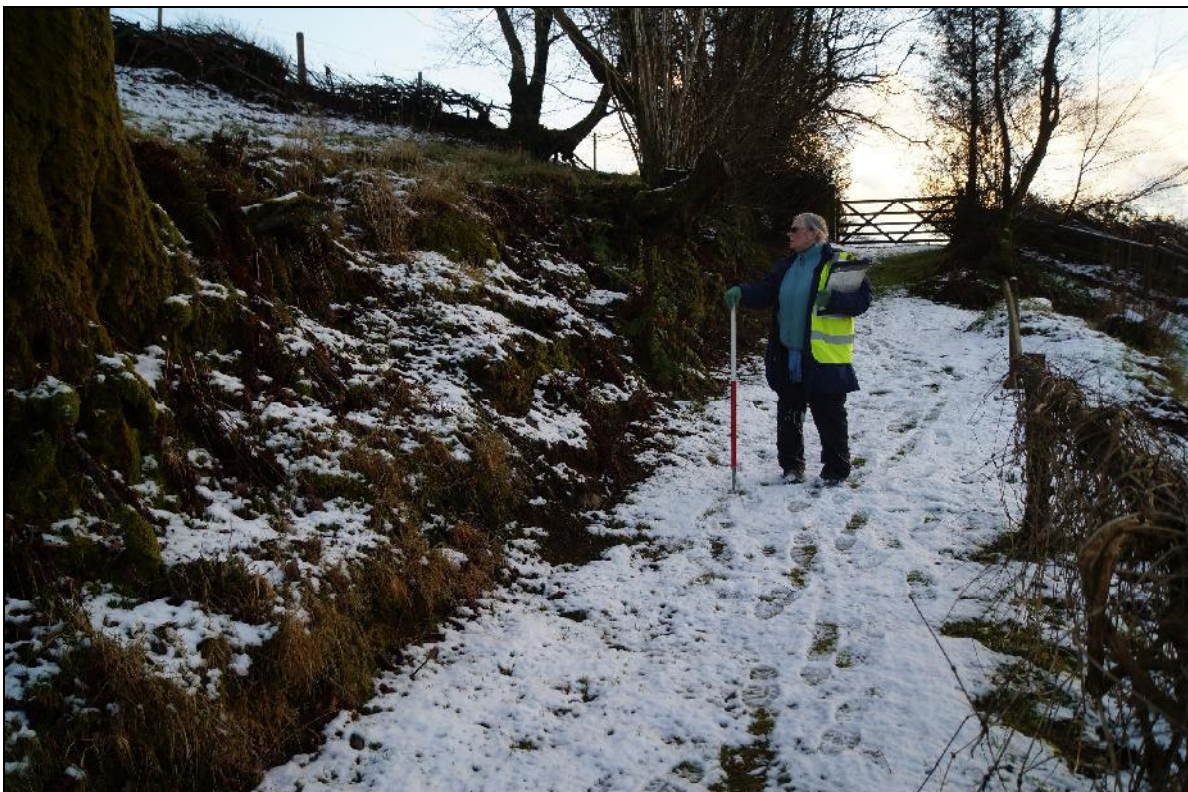
Plate 32: PYT2019\_032 – another view of the steep slope down which the electricity cable would run approaching the former barn. It would then cross this modern track before reaching the barn. Looking south-southwest.
