**WATCHING BRIEF DURING GROUNDWORKS  
RELATING TO THE CONSTRUCTION OF A  
NEW HOUSE IN A PLOT ADJACENT TO 39  
GOAT STREET, ST DAVIDS, SA62 6RF  
PLANNING APPLICATION:  
NP/18/0683/S73  
(variation of NP/13/0370 PCNPA)**

May 2019

Trysor Project No. 2019/659  
Event Record HER PRN: DAT 114824

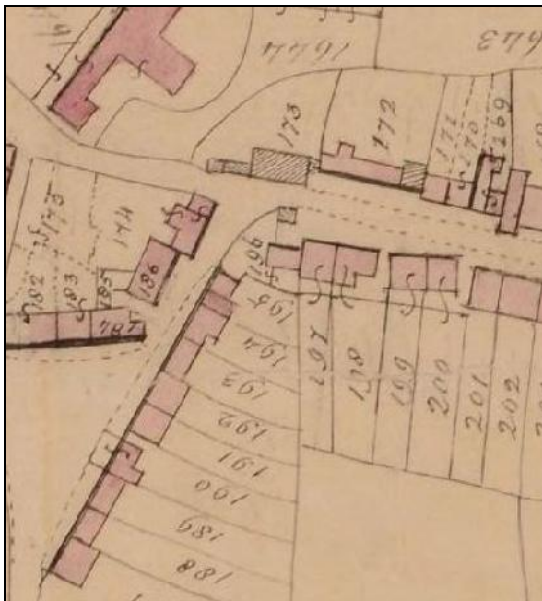
*Figure 2: An excerpt from the St. David's parish tithe map (Map A), 1840.*

6.1 The St. David's parish tithe map of 1840, Map A, one of three drawn to cover this large parish) shows that three cottages stood on the development site adjacent to the present house at 39, Goat Street, see figure 2.

6.1.1 These cottages are numbered on the tithe map in association with garden plots 196, 197 and 198. The accompanying tithe apportionment shows that these three properties, as well as the adjacent cottages numbered 199 and 200, were all cottages with gardens in the ownership of the prominent county figure John Hill Harries (1783-1857) of Priskilly Forest, Castlemorris, Pembrokeshire. The cottage numbered 199 on the tithe map stands on the site of the part of the present 39, Goat Street.

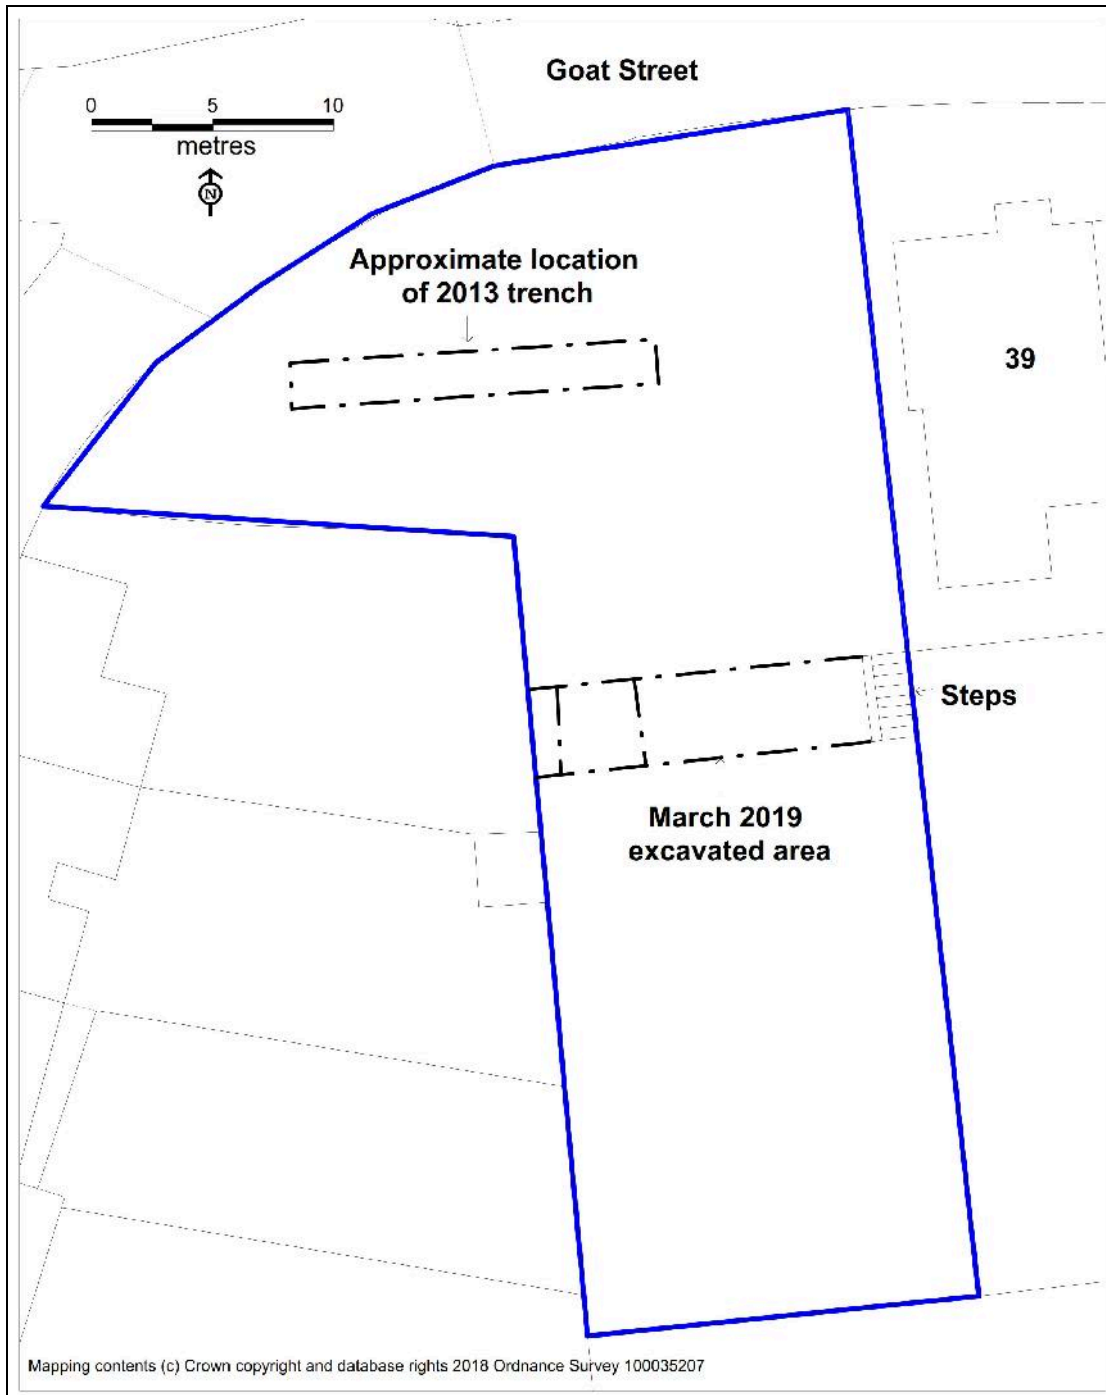
*Figure 4: The location of the trench excavated by Dyfed Archaeological Trust in 2013 (P, Poucher, 2013), and the location of the area mechanically excavated area in 2019 and subject of this watching brief.*

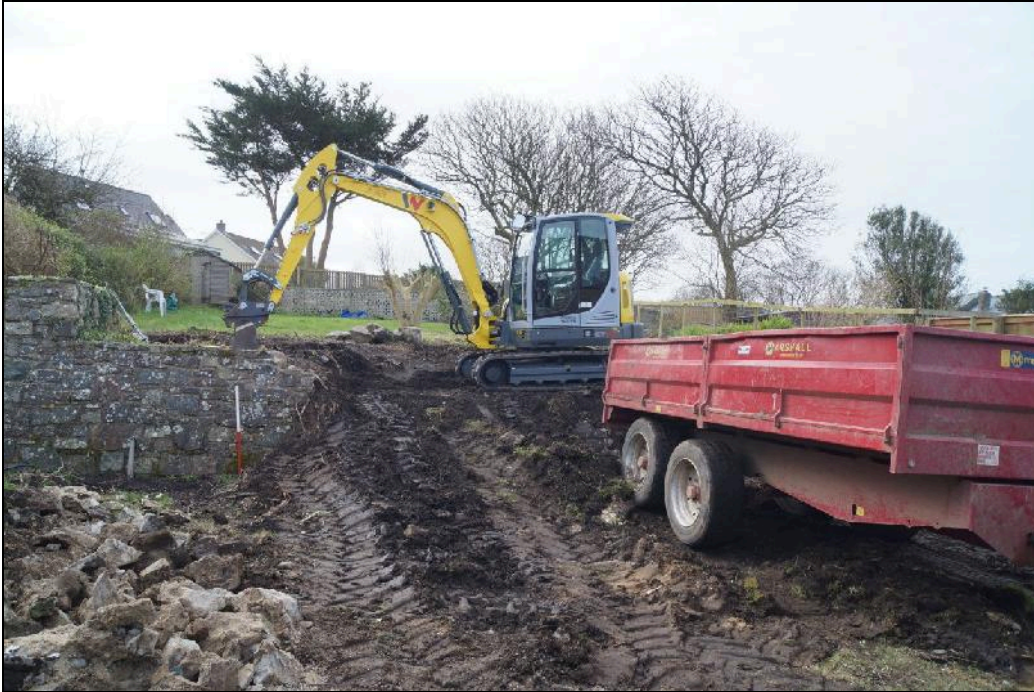
Plate 1: GOS2019\_101. The removal of the garden soil (001) of No.39 Goat Street in progress. The remains of the modern retaining wall defining the north edge of the garden can be seen to the left. Looking south-southeast.

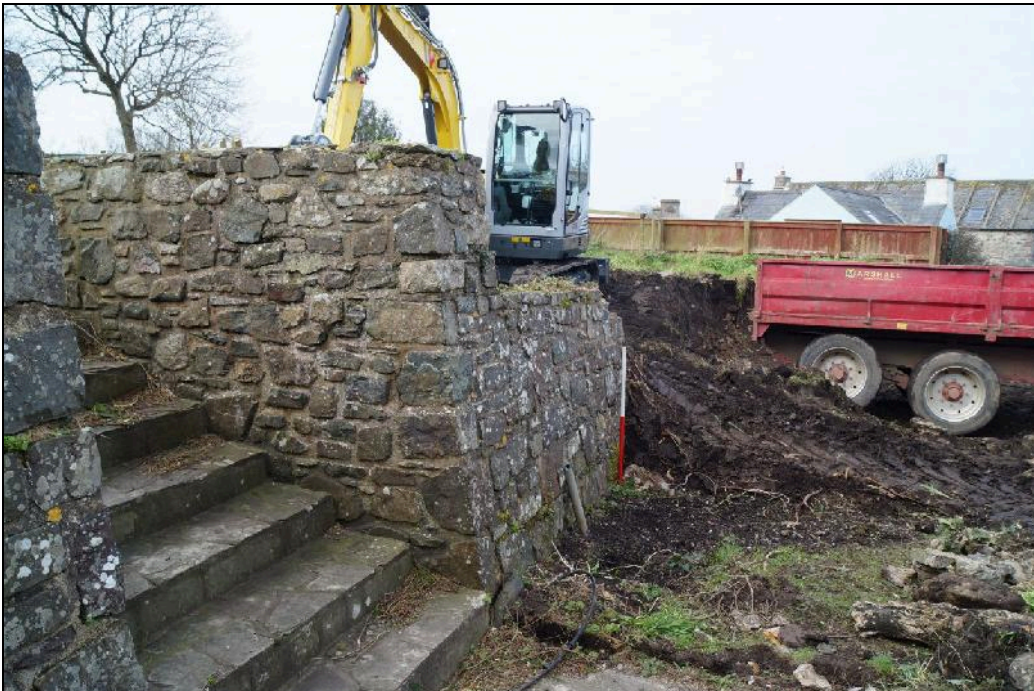
Plate 2: GOS2019\_102. The steps up into the garden of No.39 Goat Street and a section of garden wall still stand at this stage. They represent a truncation of the north end of the garden in the second half of the 20<sup>th</sup> century. Looking west-southwest.

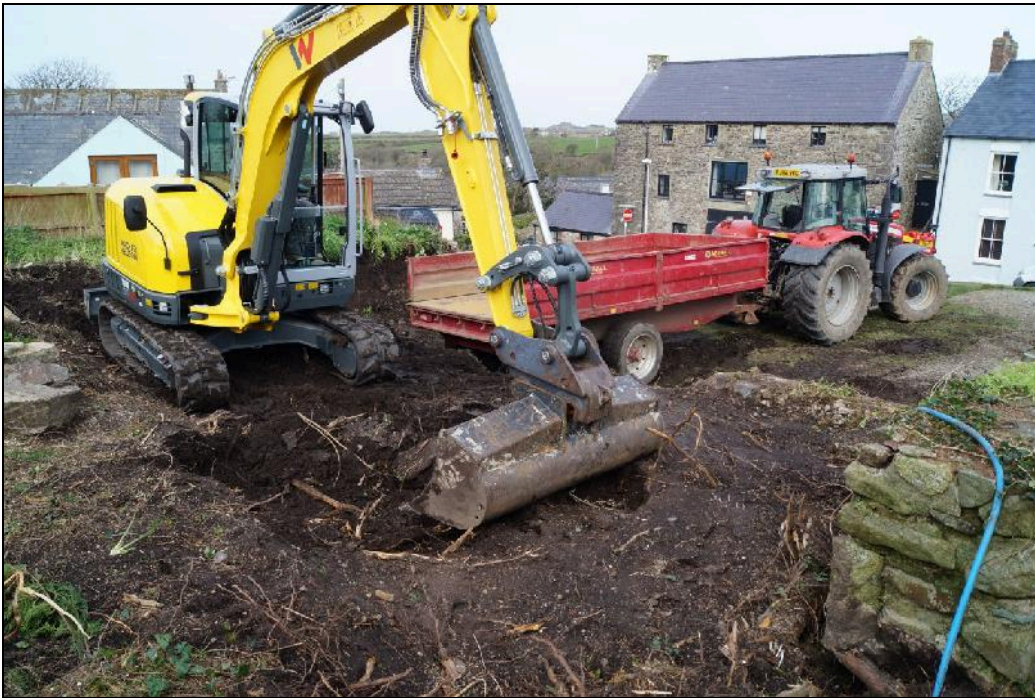
*Plate 3: GOS2019\_103. A view showing the very dark brown garden soil (001) being removed. Goat Street is seen in the background. The tractor is parked on the site of the cottages shown in plot 197 on the parish tithe map, which is the area excavated by Poucher in 2013. The top of the garden steps is visible bottom right. Looking northwest.*

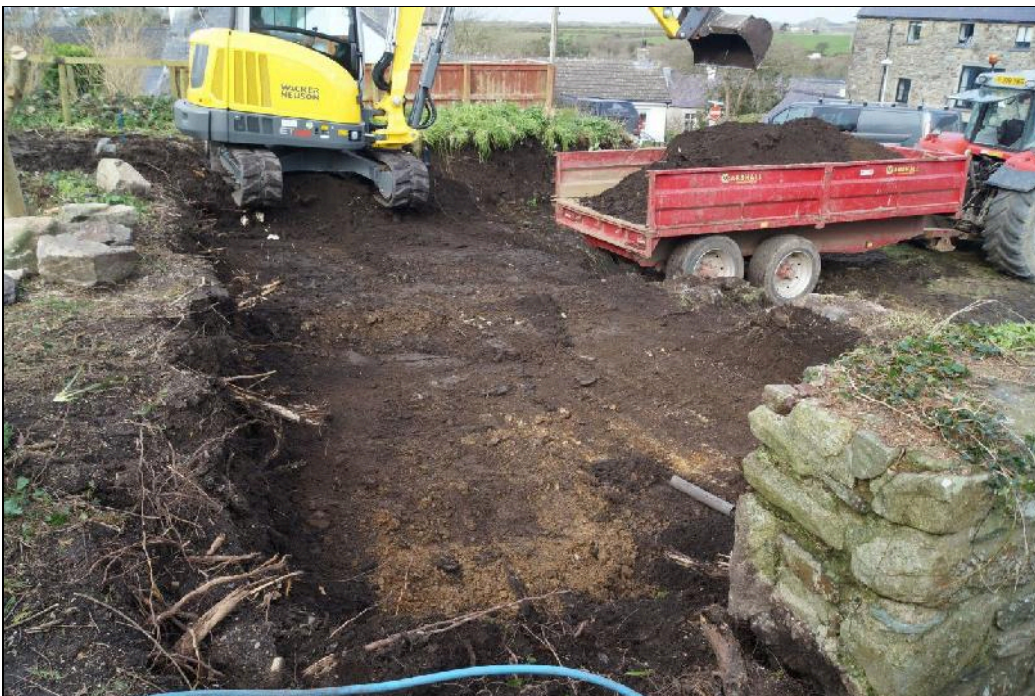
*Plate 4: GOS2019\_104. A view of the area stripped of garden soil (001) showing the buried soil (002) and the more orange-coloured natural subsoil (007) being revealed at the development site. Looking west.*

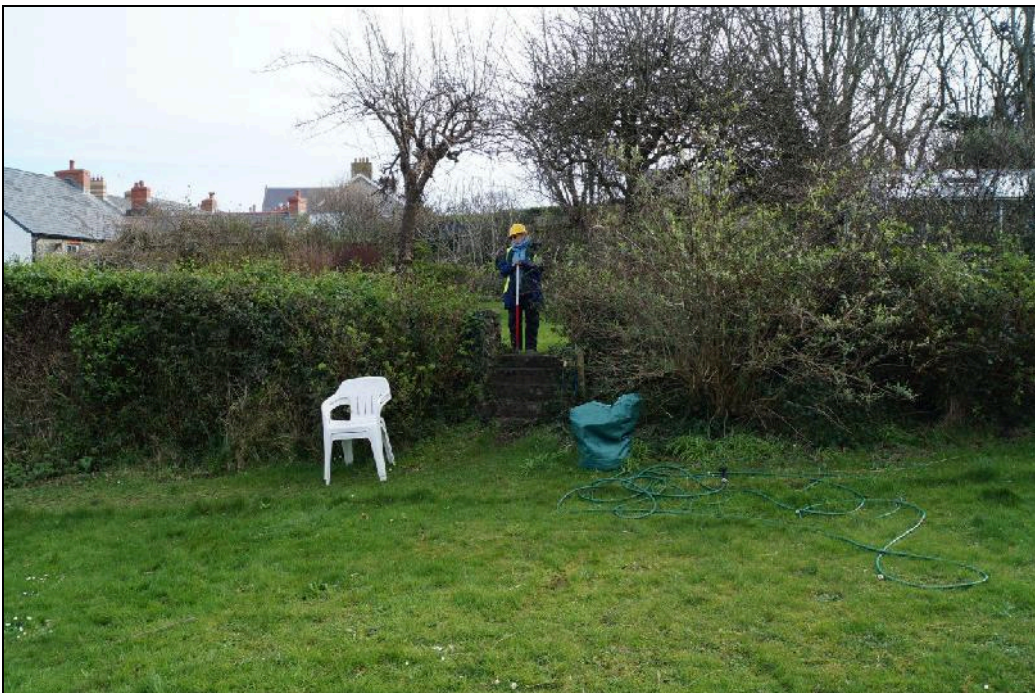
*Plate 6: GOS2019\_106. A view of the step up from the western part of the garden of No.39 to the eastern part of the garden. The former was once the located of the gardens of the plots numbered 197 and 198 on the parish tithe map, the latter belonging to plots 199 and 200. Looking east.*

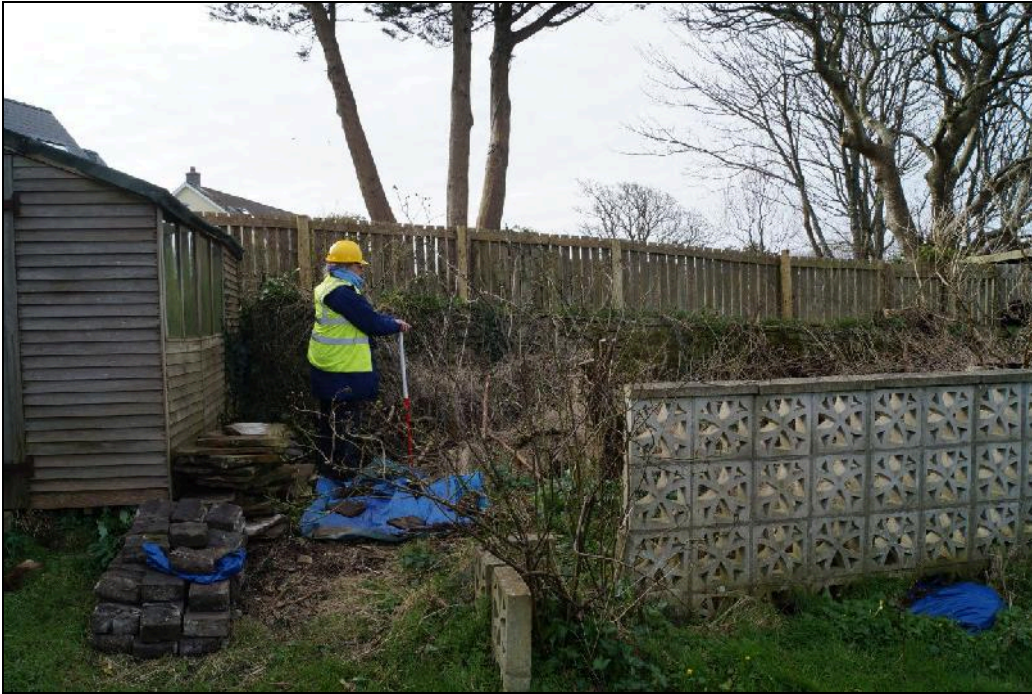
*Plate 7: GOS2019\_107. A view of the step up from the western part of the garden of No.39 to the adjacent garden to the south. Like plate 6, this shows that the gardens have been terraced into the slope and artificially levelled. Looking south.*

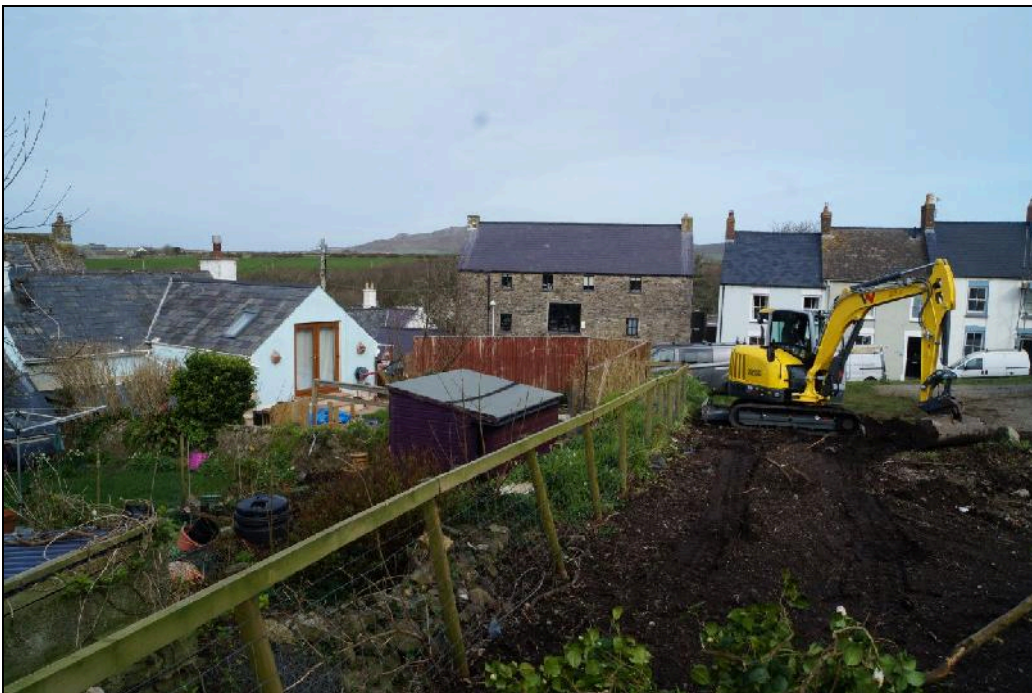
*Plate 8: GOS2019\_108. A view along the western edge of the garden of No.39, showing a relict stone boundary wall and a step down into the gardens of the cottages to the west. Looking north.*

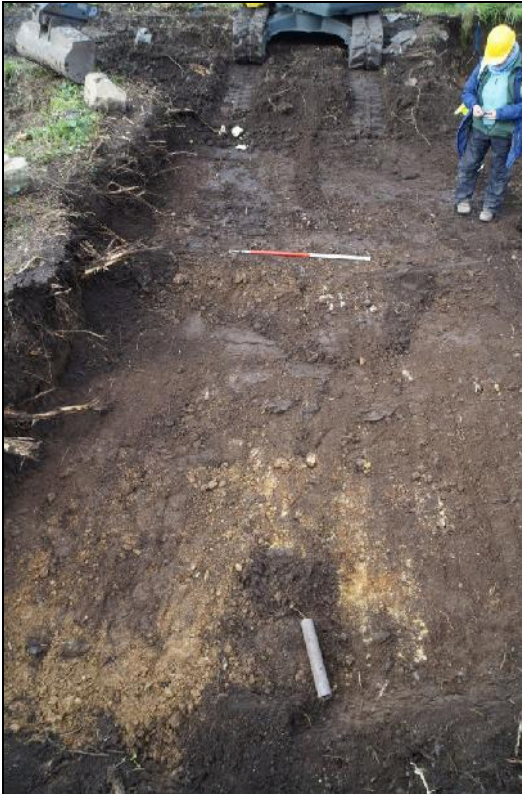
*Plate 9: GOS2019\_109. A view of the area reduced at the north edge of the garden of No.39 as the subsoil 007 becomes visible after the removal of the garden soil 001 and buried soil 002. Looking west.*

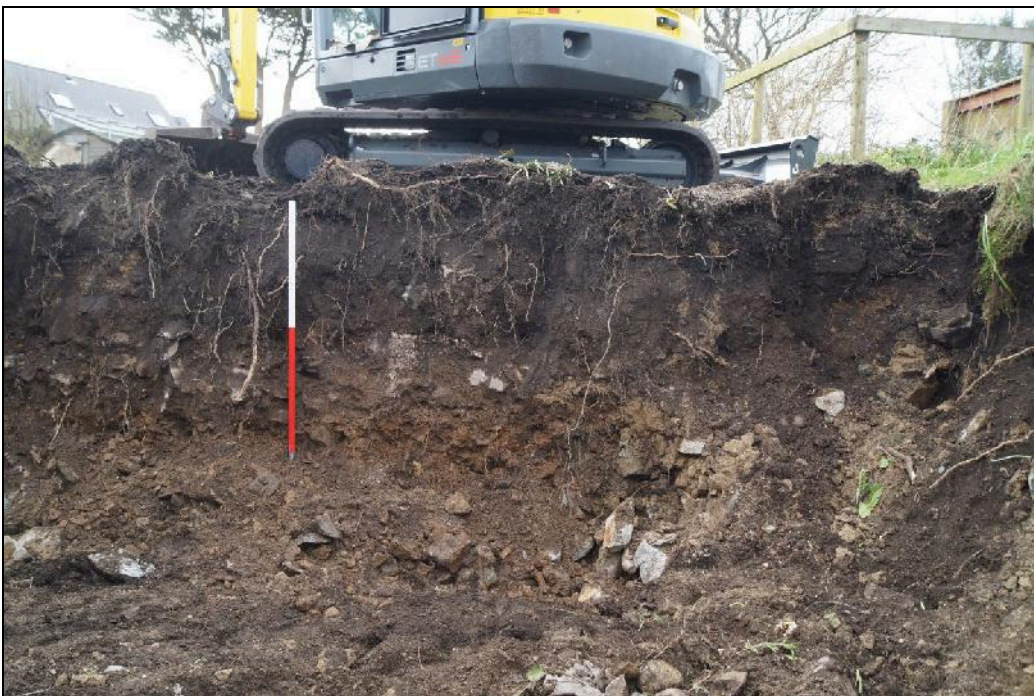
*Plate 10: GOS2019\_110. The section revealed when the stone retaining wall at the north edge of the garden of No.39 was removed. The very dark brown garden soil 001 is seen at the top of the section, with a lighter brown buried soil 002 below. A stony band overlying the orange-brown subsoil (007) proved to include wall 006. Looking south.*

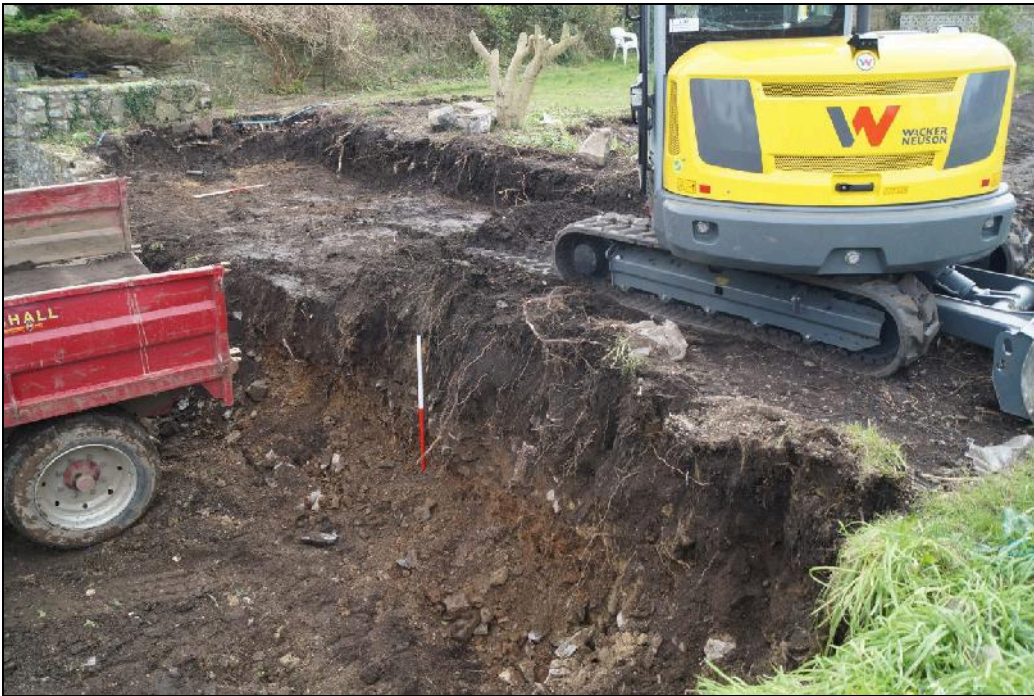
*Plate 11: GOS2019\_111. A view of the section shown in Plate 10, also showing the strip of garden to be removed as part of the development. The excavating machine has removed the garden soil (001) from the eastern end of the development area. Looking southeast.*

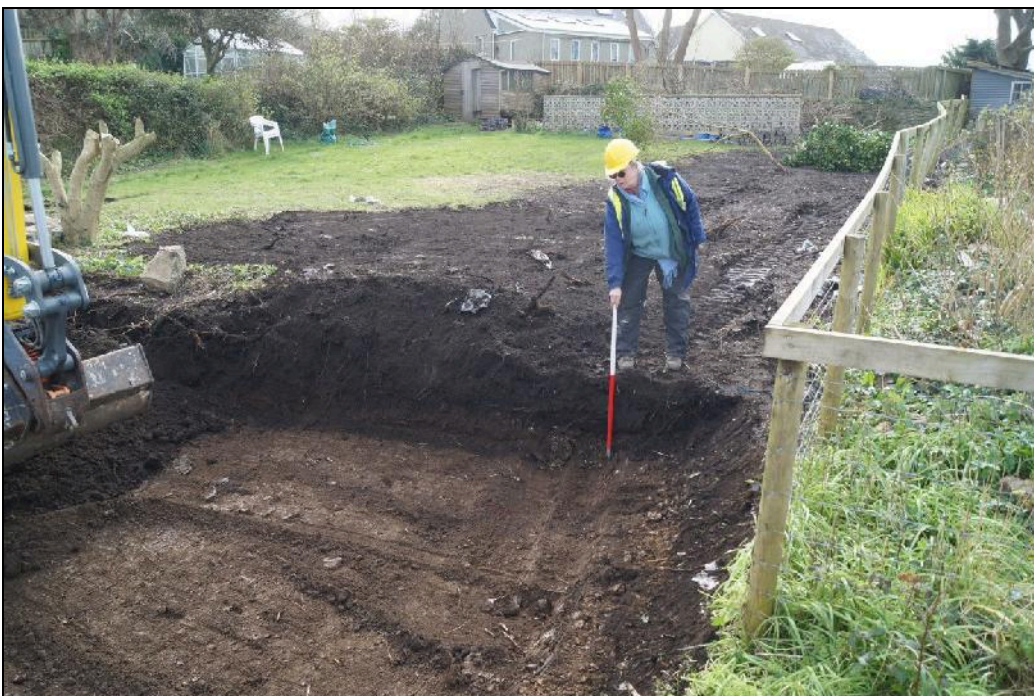
*Plate 12: GOS2019\_112. A view of the eastern end of the strip being cleared as the garden soil (001) and buried soil (002) are stripped. Wall 006 was found buried beneath this part of the garden and this shows that pre-19<sup>th</sup> century activity had occurred here before the garden soil was laid down. Looking south-southeast.*

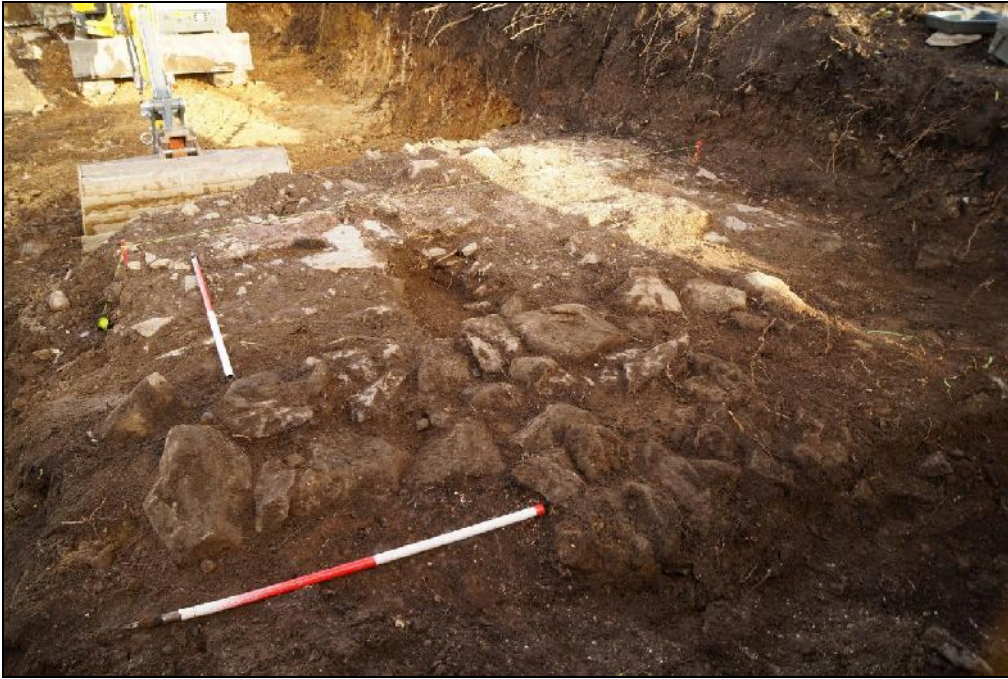
Plate 13: GOS2019\_113. Beneath the buried soil 002 the remains of a wall (006 - in the foreground) and spread of lime (005) were uncovered, associated with another buried soil (003). Pottery from 003 was of 18<sup>th</sup> century date and shows that this activity predated the cottages which stood just to the north, which produced only later 19<sup>th</sup> century pottery when excavated by Poucher in 2013. Looking southeast.

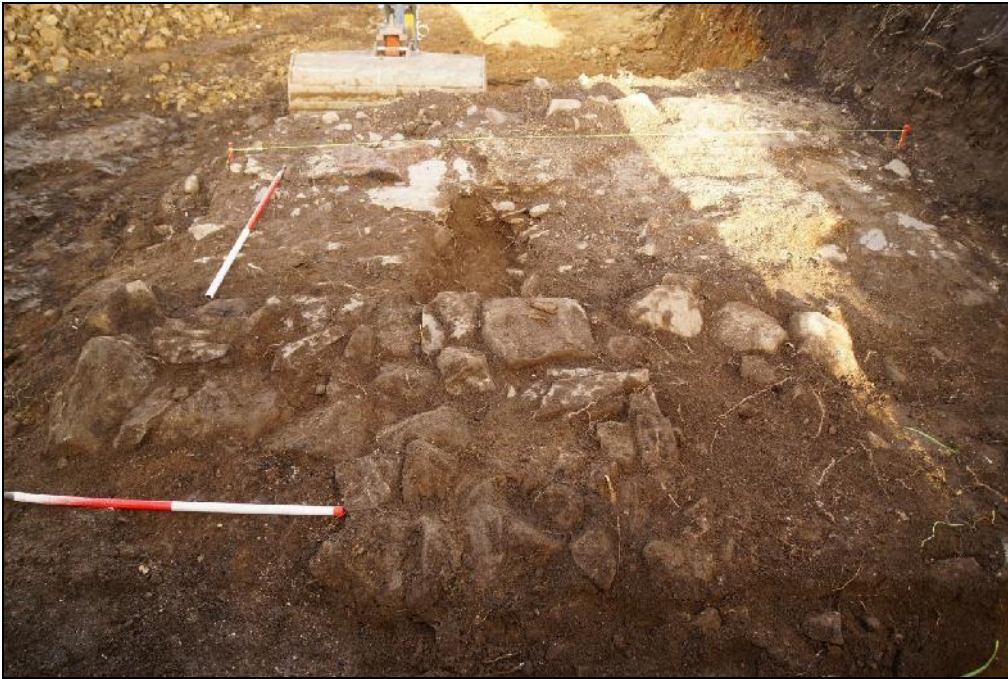
Plate 14: GOS2019\_114. Another view of the wall 006. A small trench in is visible at the centre of the photograph. This was opened to prove the depth of the subsoil (007) and thickness of soil 003. Looking east.

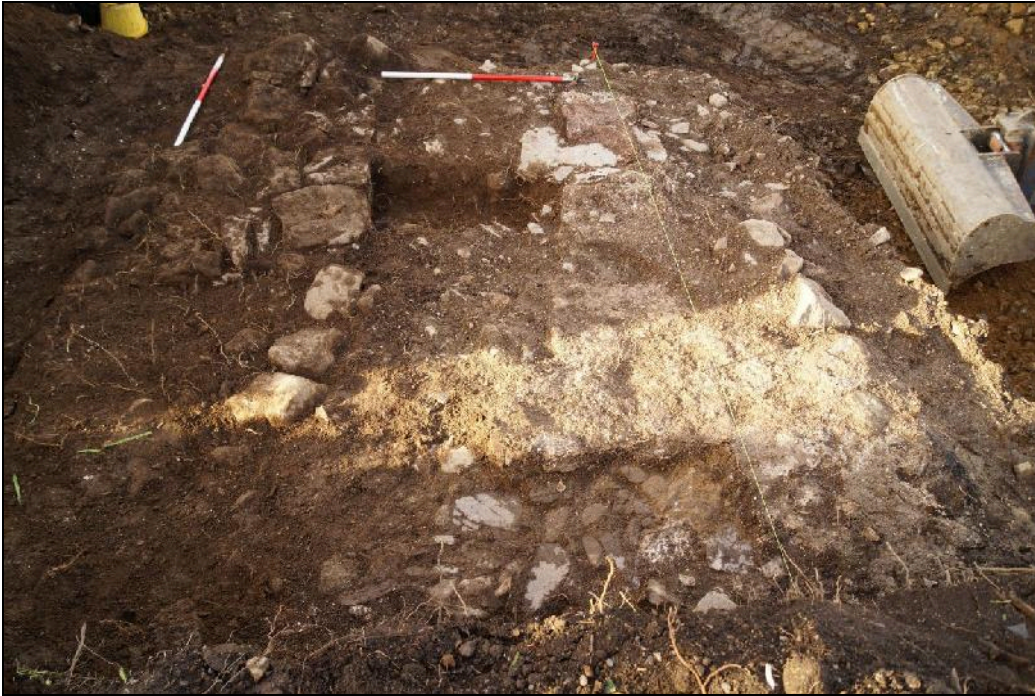
*Plate 15: GOS2019\_115. A view of wall 006, to the right and the lime spread (005) to the left, with the small exploratory trench just above centre. Looking north.*

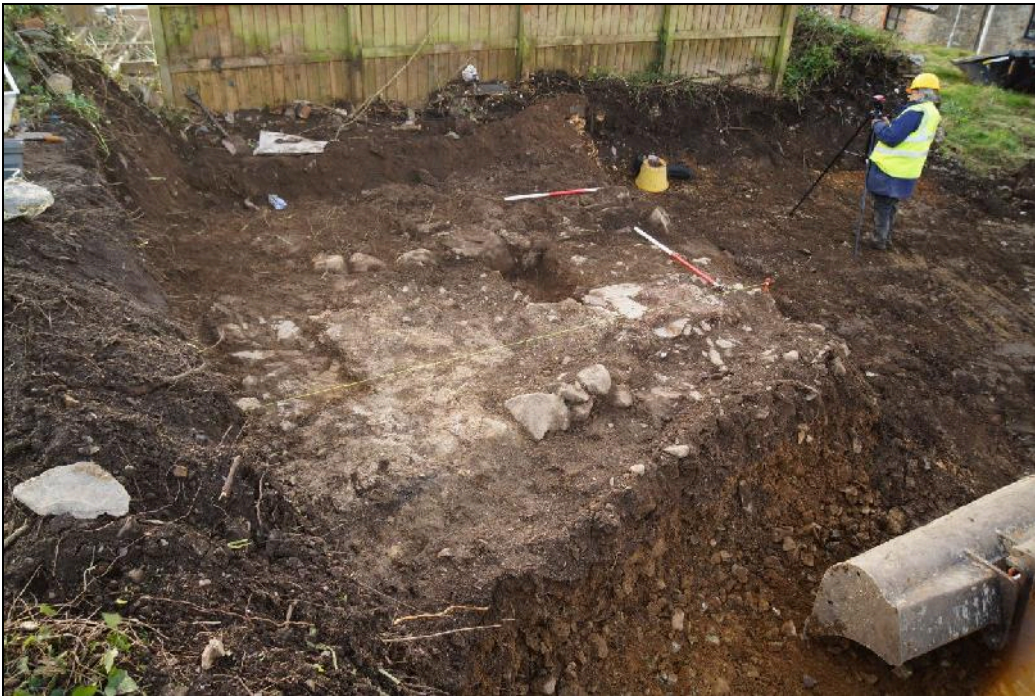
*Plate 16: GOS2019\_116. A view of the small exploratory trench just above centre, with wall 006 just above it and lime spread 005 just below it in the photograph. Looking northwest.*

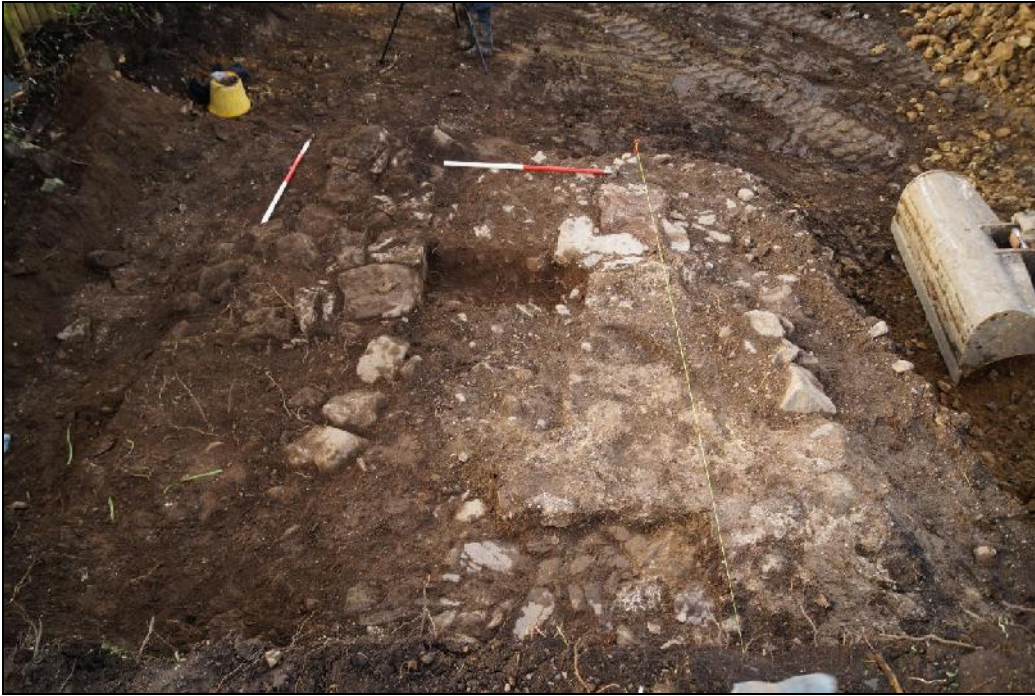
*Plate 17: GOS2019\_117. Another view of wall 006, to the right and the lime spread (005) to the left, with the small exploratory trench just above centre. Looking north.*

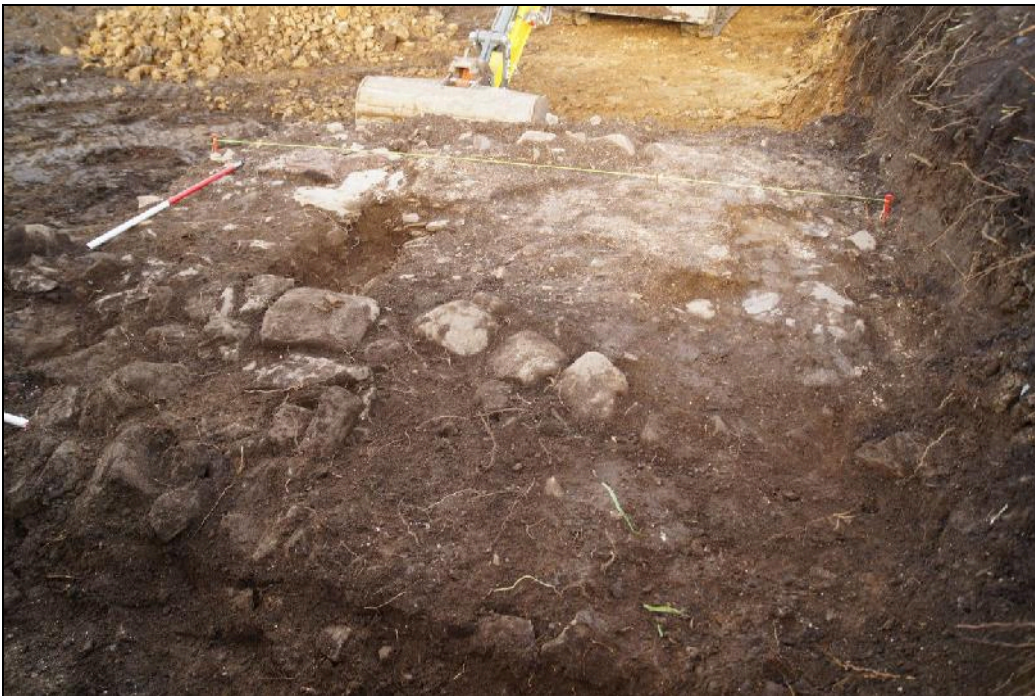
*Plate 18: GOS2019\_118. Another view of wall 006, in the foreground and the lime spread (005) beyond it, with the small exploratory trench just left of centre. Looking east-northeast.*

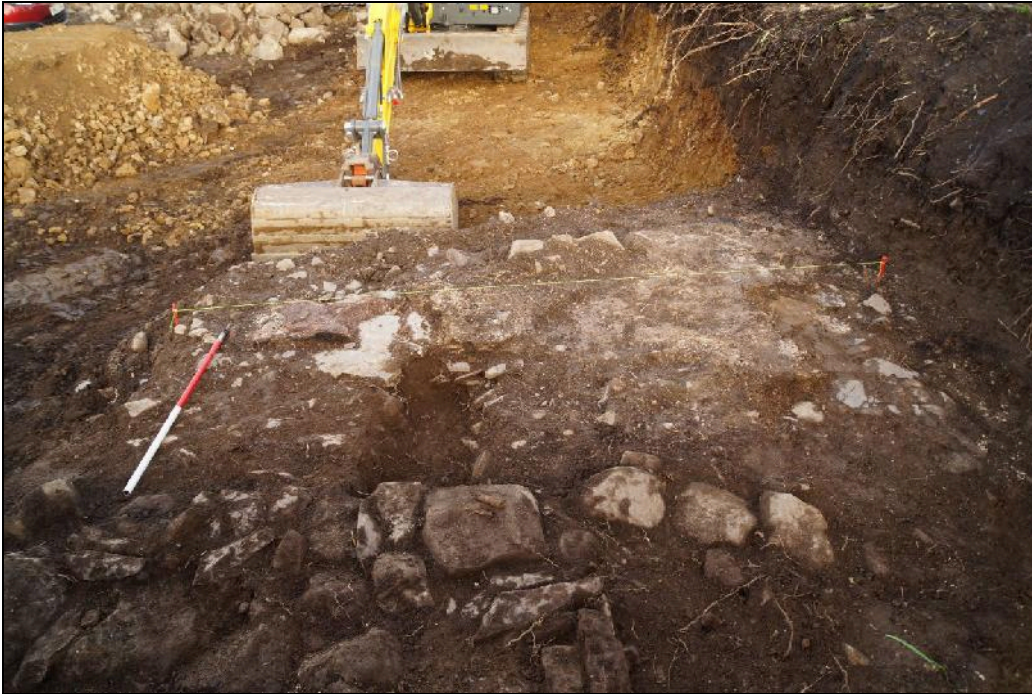
*Plate 19: GOS2019\_119. Another view of wall 006, in the foreground and the lime spread (005) beyond it, with the small exploratory trench just left of centre. Looking east.*

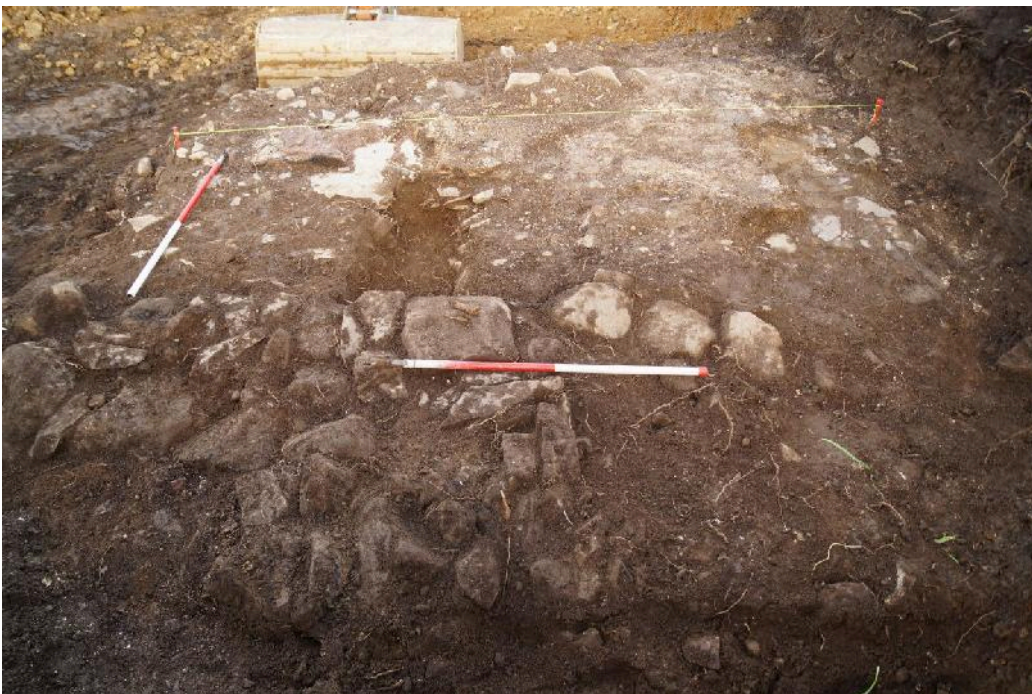
*Plate 20: GOS2019\_120. Another view of wall 006, in the foreground and the lime spread (005) beyond it, with the small exploratory trench just left of centre. Looking east.*

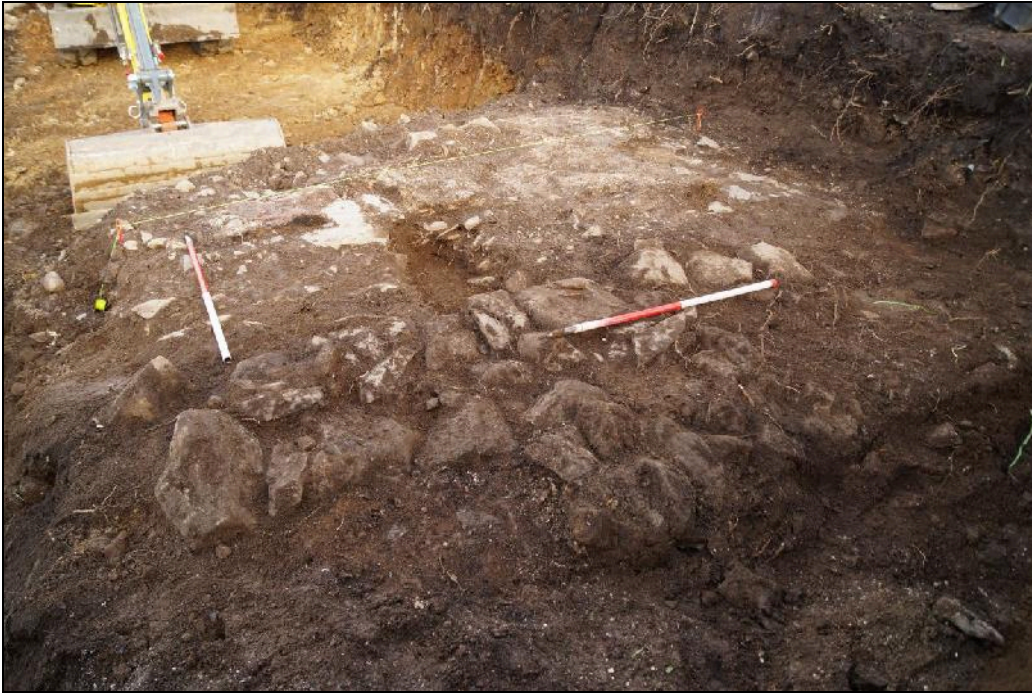
*Plate 21: GOS2019\_121. Another view of wall 006, in the foreground and the lime spread (005) beyond it, with the small exploratory trench just left of centre. Looking east-southeast.*

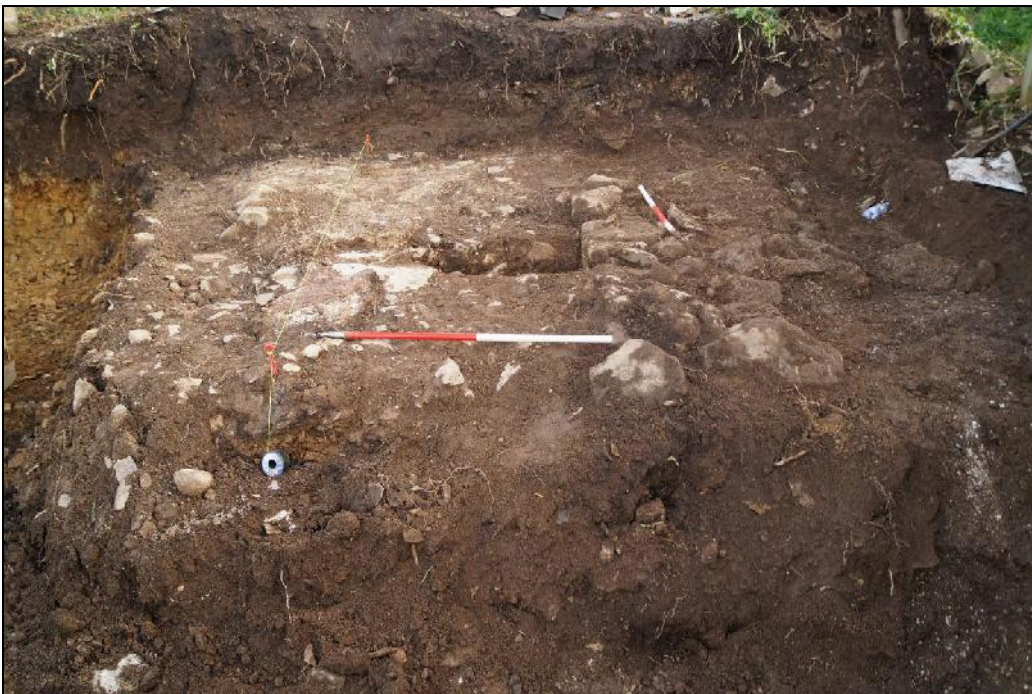
*Plate 22: GOS2019\_122. Another view of wall 006, to the right of centre and the lime spread (005) to the left of centre, with the small exploratory trench in the centre. Looking north.*

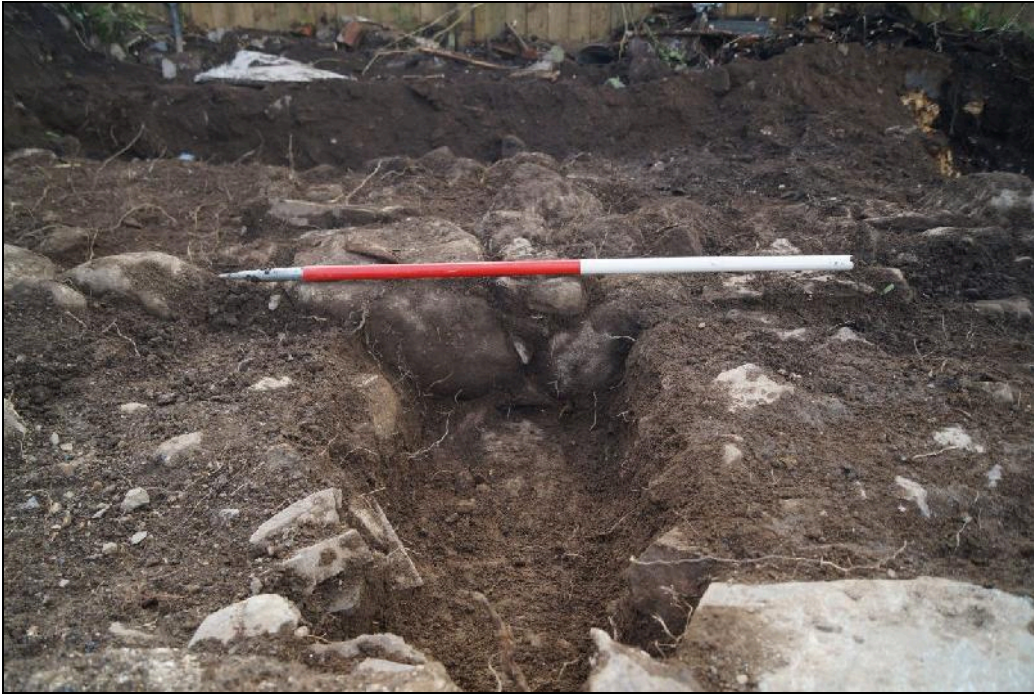
*Plate 23: GOS2019\_123. A view into the small exploratory trench through context 003 which shows the depth of the wall at its western end. The remaining part of the wall did not extend more than 30 centimetres deeper. Its purpose is not known. Looking west.*

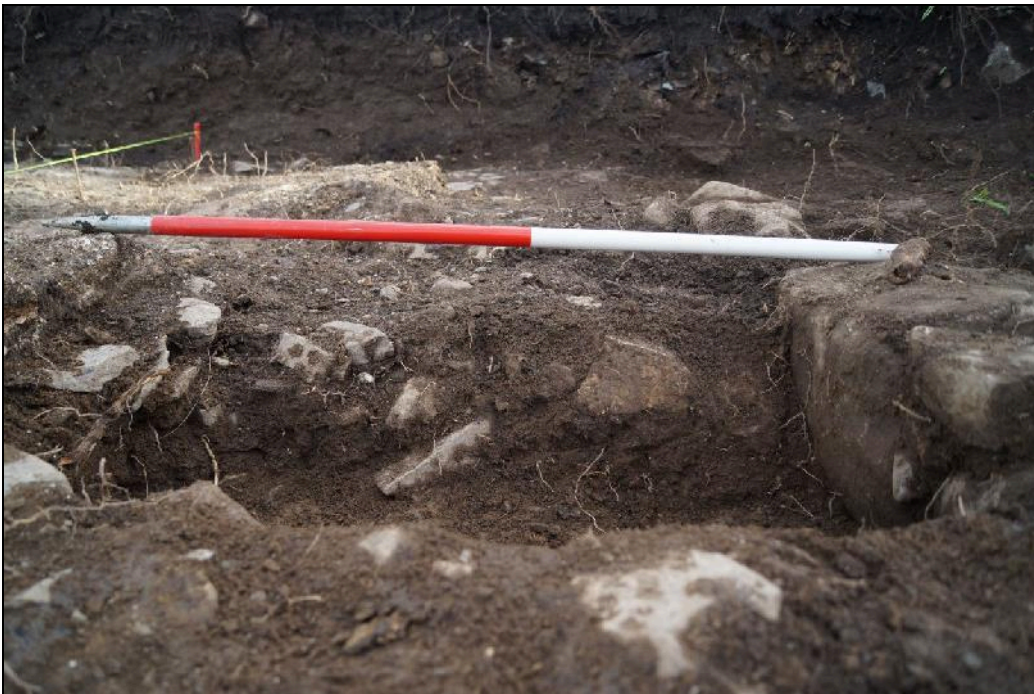
*Plate 24: GOS2019\_124. A view into the small exploratory trench through context 003 which shows its southern side and demonstrates the stony character of the soil 003 which surrounds wall 006 and the lime spread 005. 18<sup>th</sup> century pottery was found within 003 and at the interface with buried soil 002 which overlay it. Looking south.*

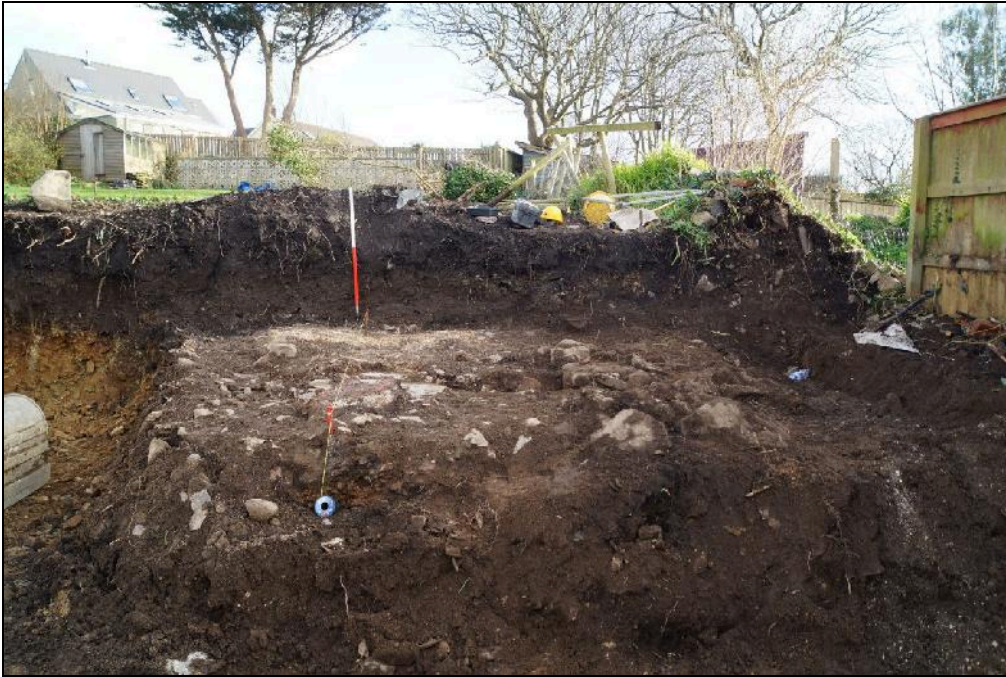
*Plate 25: GOS2019\_125. A view of the baulk retained for the excavation of wall 006 and lime spread 005. Note the section behind, in which the garden soil 001 and buried subsoil 002 are clearly visible, as is the stony band 008 (left of centre). The orange-brown subsoil is seen to the left of the image. Looking south.*

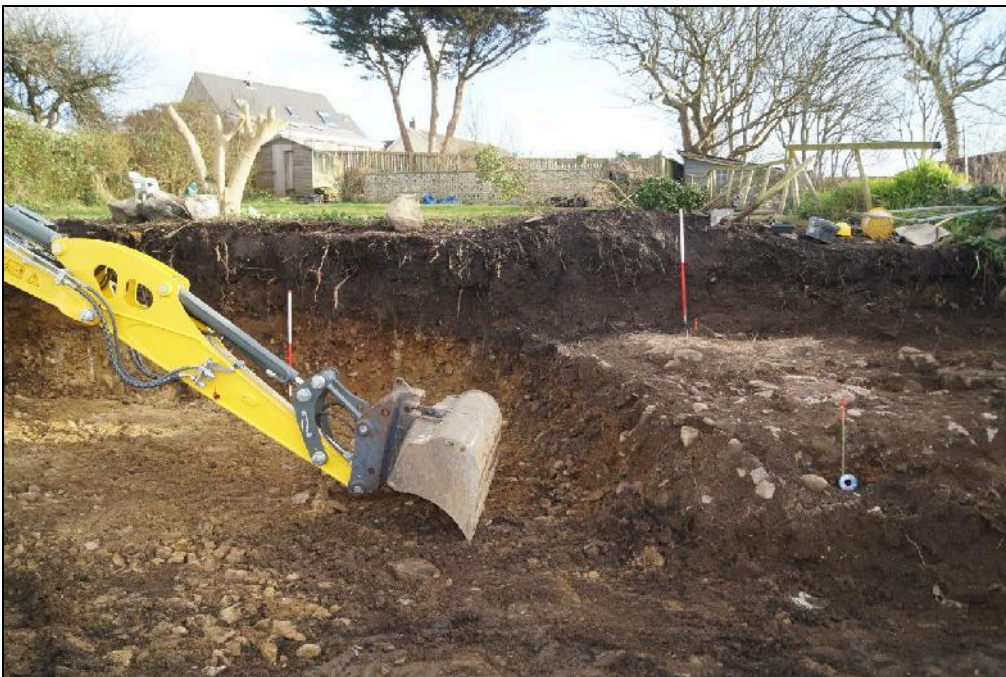
*Plate 26: GOS2019\_126. Another view of the section created by the removal of the northern edge of the garden of No.39. The stratigraphy to the left is simple, but more complicated to the right where contexts 008 and 003 appear, the latter being associated with wall 006 and lime spread 005. Looking south.*

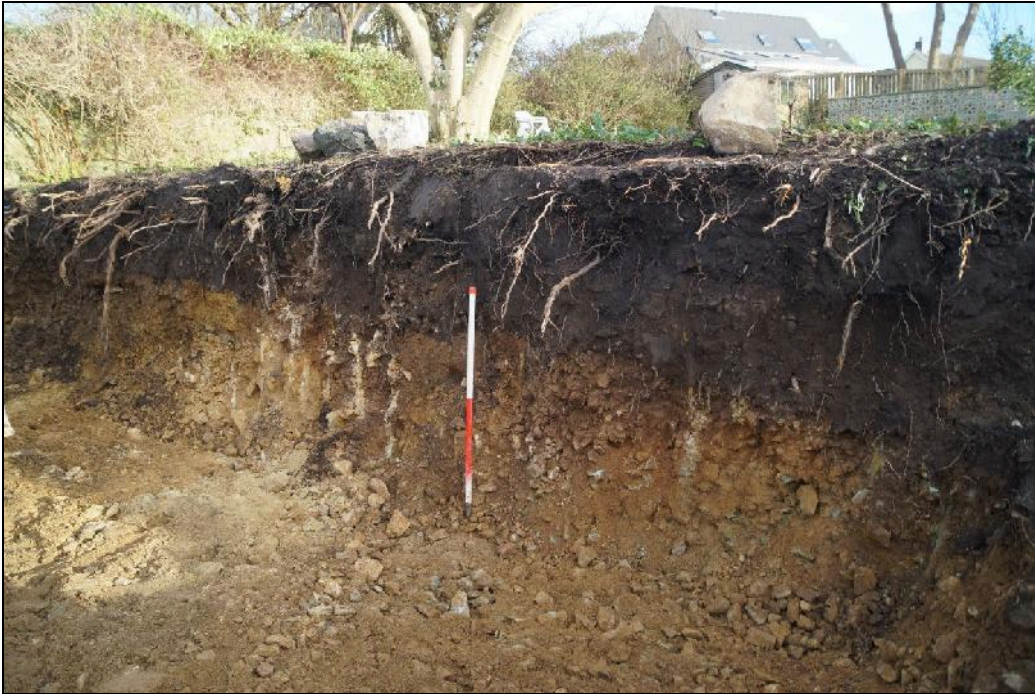
*Plate 27: GOS2019\_127. A view of the western part of the section revealed by the removal of the north edge of the garden of No.39. Looking southeast.*

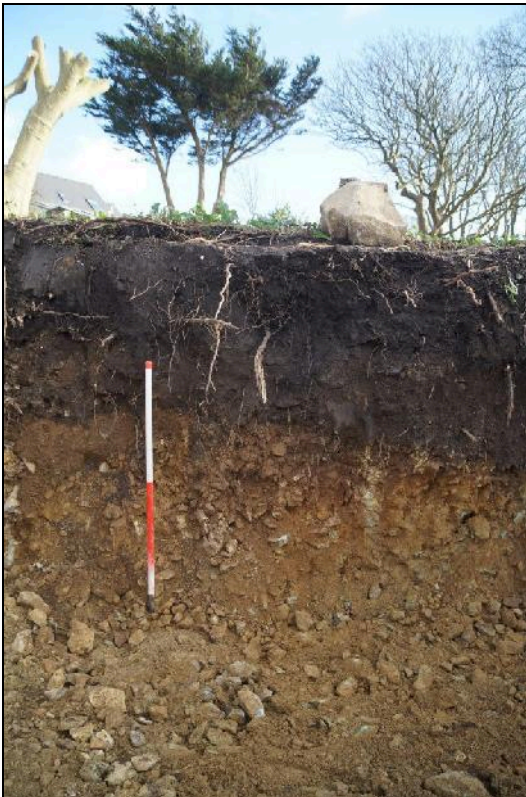
*Plate 28: GOS2019\_128.  
Another view of the western  
part of the section revealed by  
the removal of the north edge  
of the garden of No.39. Looking  
south.*
