**WATCHING BRIEF DURING GROUNDWORKS  
RELATING TO THE CONSTRUCTION OF A  
NEW HOUSE IN A PLOT ADJACENT TO 39  
GOAT STREET, ST DAVIDS, SA62 6RF  
PLANNING APPLICATION:  
NP/18/0683/S73  
(variation of NP/13/0370 PCNPA)**

May 2019

Trysor Project No. 2019/659  
Event Record HER PRN: DAT 114824

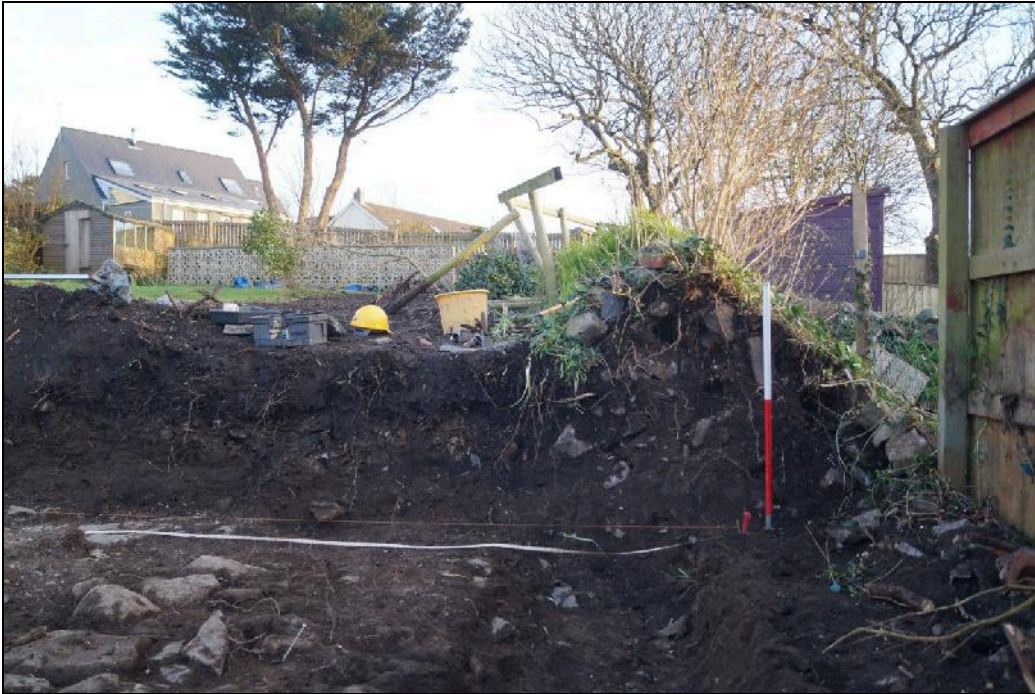
*Plate 29: GOS2019\_129. A view of the western edge of the garden of No.39, showing the earth and stone boundary bank (009) along the western edge. Note the stony band 008 centre left, which seems to have been dumped in a hollow adjacent to the bank. Looking south.*

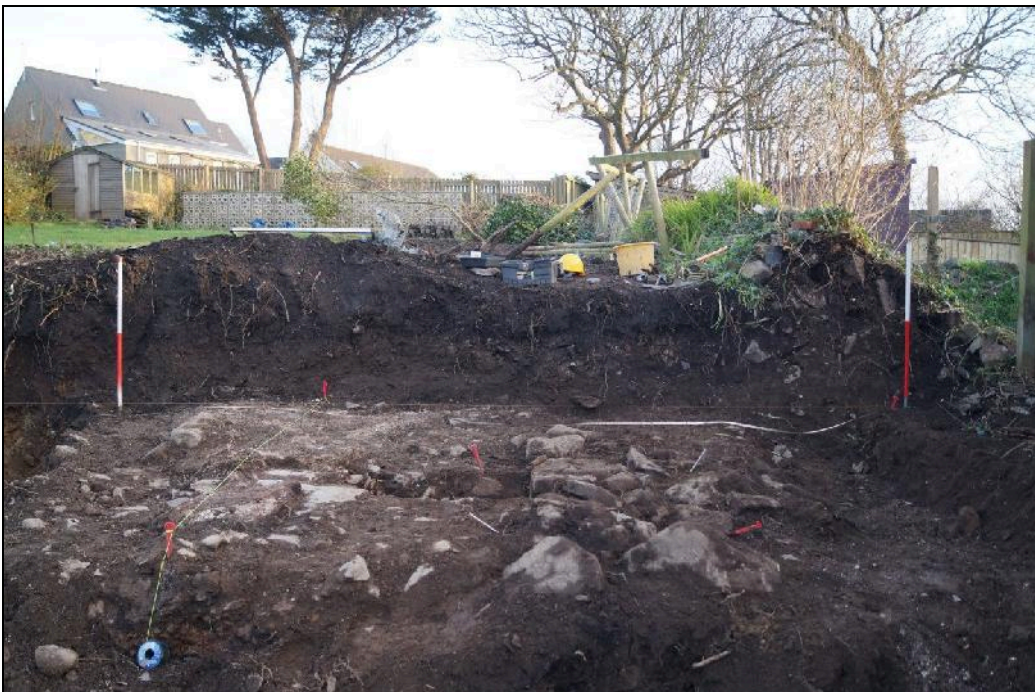
*Plate 30: GOS2019\_130. The area of wall 006 and lime spread 005, with the section beyond and bank 009 to the right. Looking south.*

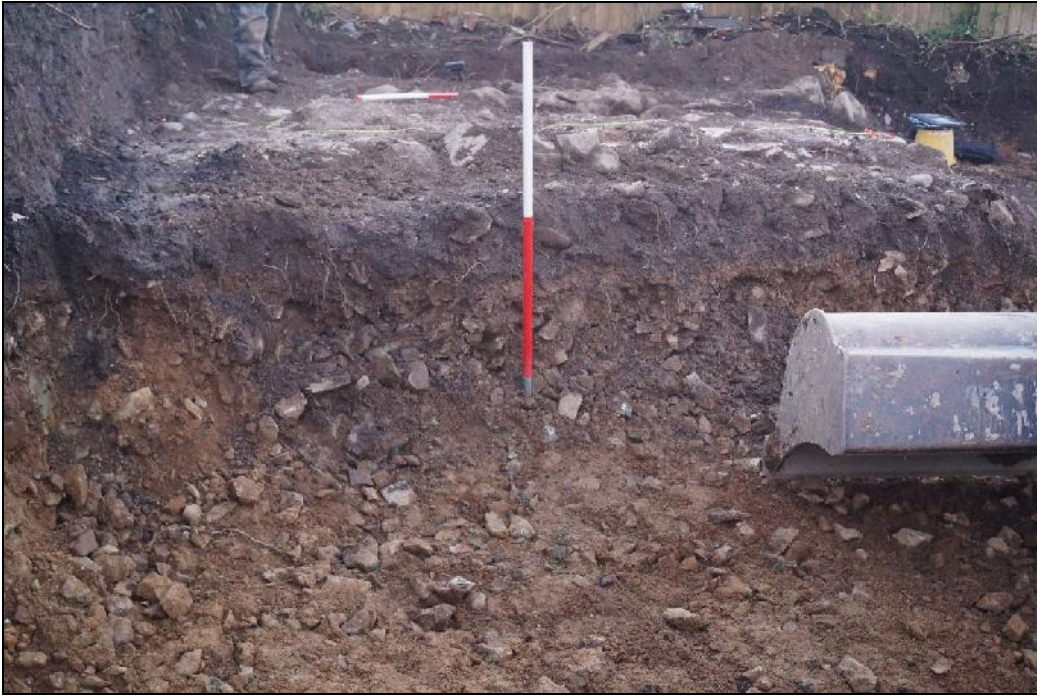
*Plate 31: GOS2019\_131. A view of the eastern edge of the baulk retained to excavate wall 006 and lime spread 005, showing that they lay no more than 25 centimetres above the natural subsoil and that the wall may well have been laid on an area artificially terraced or levelled. Looking west.*
