**OLD POTTERY, KING STREET
LAUGHARNE, CARMARTHEN, SA33 4RY
WATCHING BRIEF
SN3018010935
Planning application – W/38778
(Carmarthenshire)**

**OLD POTTERY, KING STREET
LAUGHARNE, CARMARTHEN, SA33 4QE
WATCHING BRIEF
SN3017510935
Planning application – W/38778
(Carmarthenshire)**

RHIF YR ADRODDIAD - REPORT NUMBER: Trysor 2019/698
EVENT RECORD HER PRN: DAT 114830

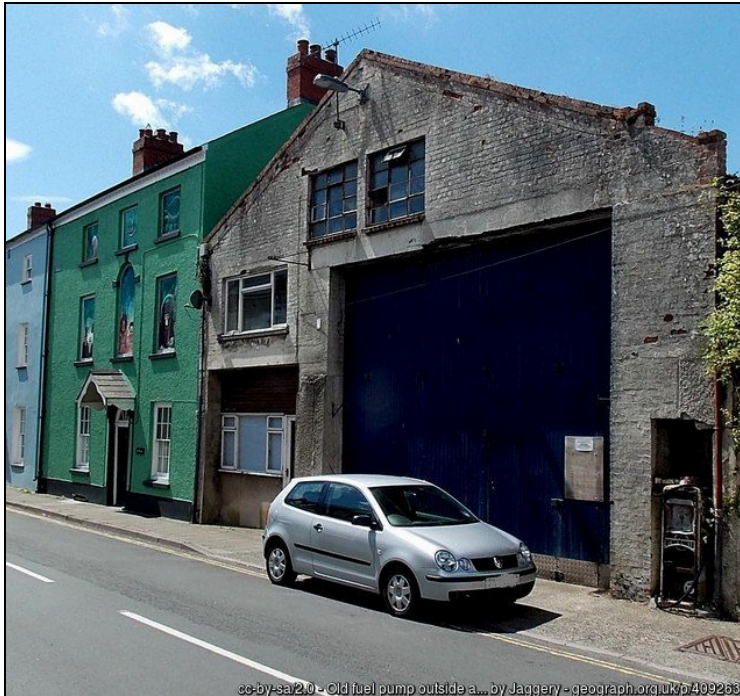
Figure 3: This photo taken by Jaggery in 2014 shows the bus depot building before it was demolished.

6.9 The bus depot was demolished before the archaeological watching brief but a photo from 2014, see figure 3, shows the front of the bus depot was built of brick.

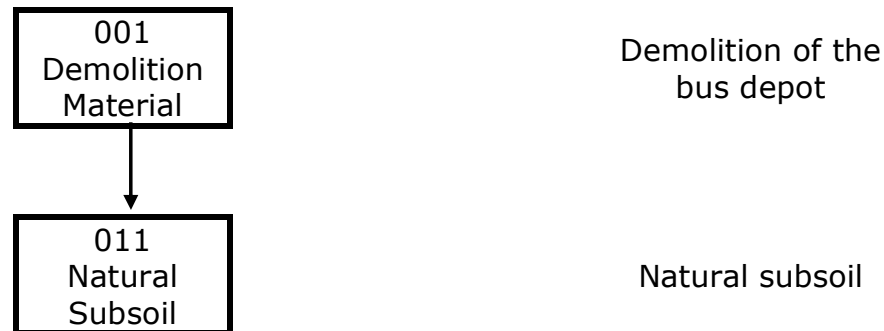
Diagram 2: Trench B

8.5.1 Demolition material (001) lay above the natural subsoil (011).

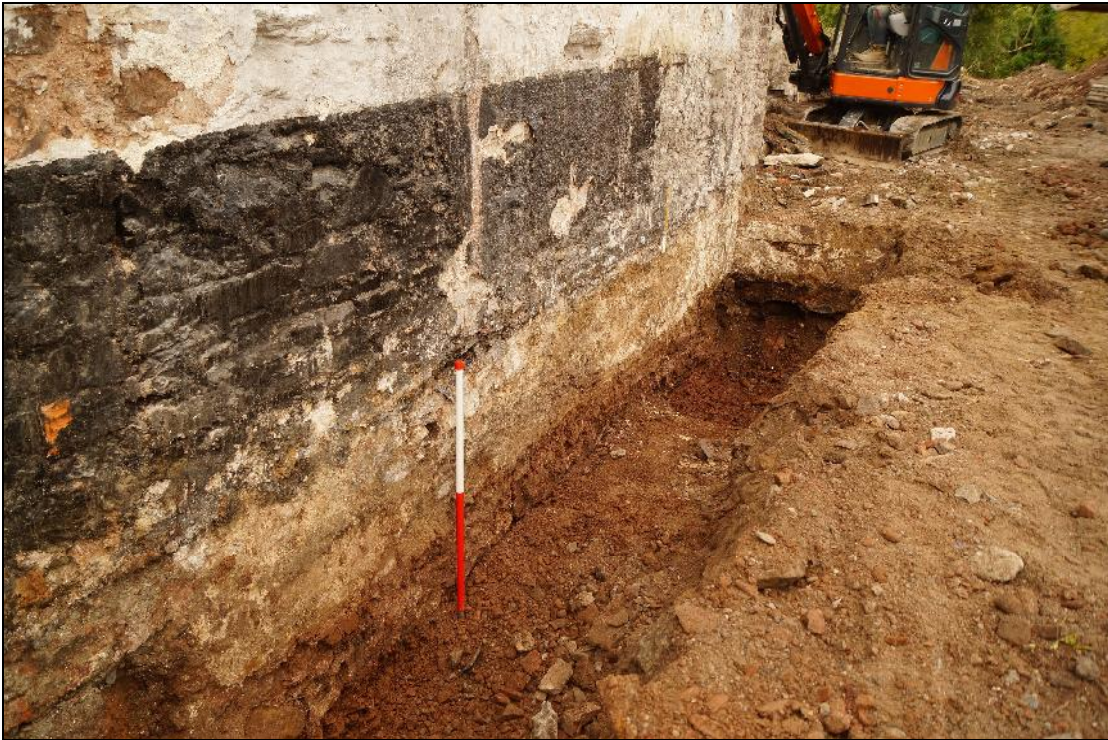
Plate 5: OPL2019_105, Trench A excavated alongside the adjoining wall of The Pelican to the south, looking west-southwest. Wall (008) can be seen across the far end of the trench abutting the north gable wall of The Pelican.

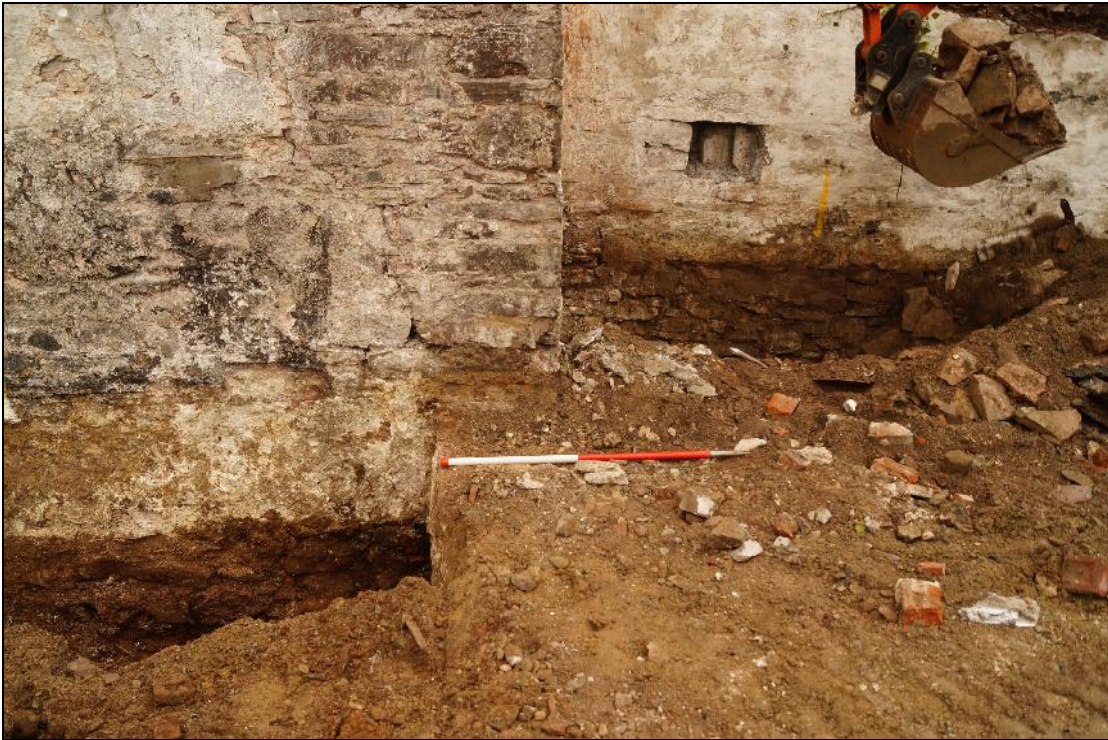
Plate 7: OPL2019_107, Western end of Trench A excavated alongside the adjoining wall of The Pelican to the south showing (008) looking south-southeast.

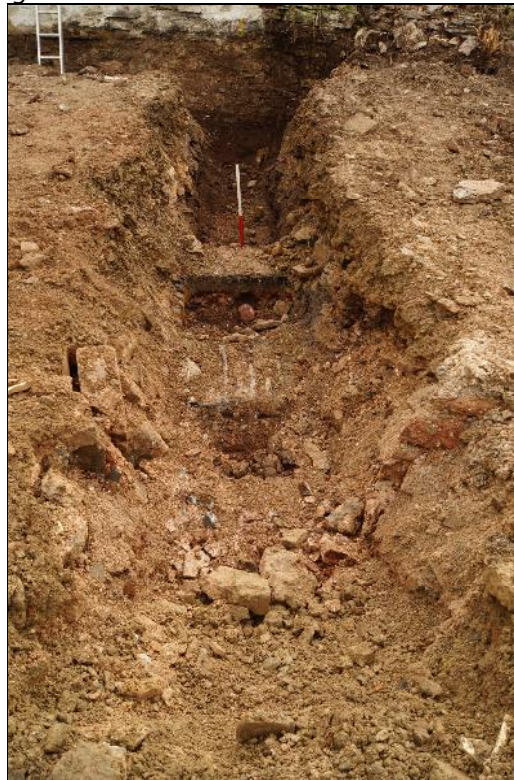
Plate 10: OPL2019_110, Trench C showing (001), tarmac (002) and concrete strips (003), looking south-southeast.

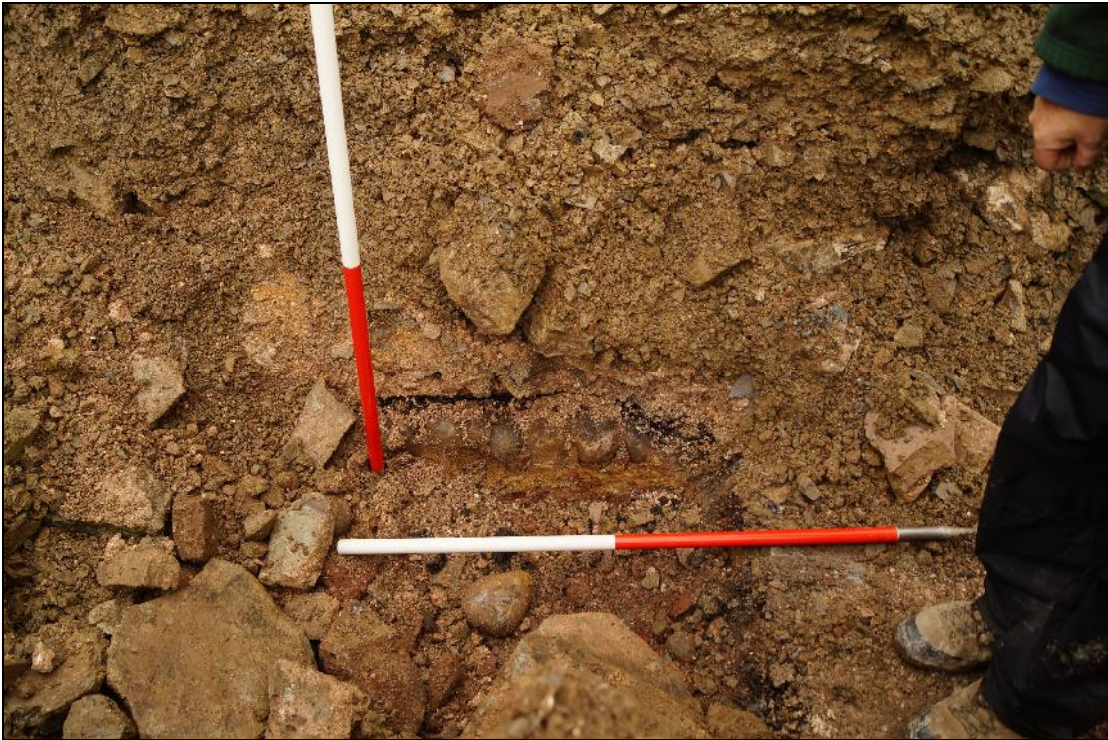
Plate 11: OPL2019_111, Detail of part of the eastern section of Trench C, looking east-northeast showing the northern concrete strip (003) on which the person is standing in the trench and (101) demolition, (102) tarmac, (104) cobbles, and (105) clay in the section, looking east.

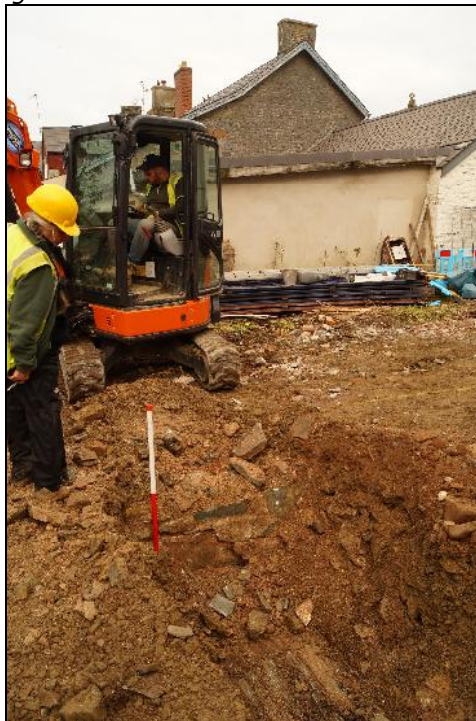
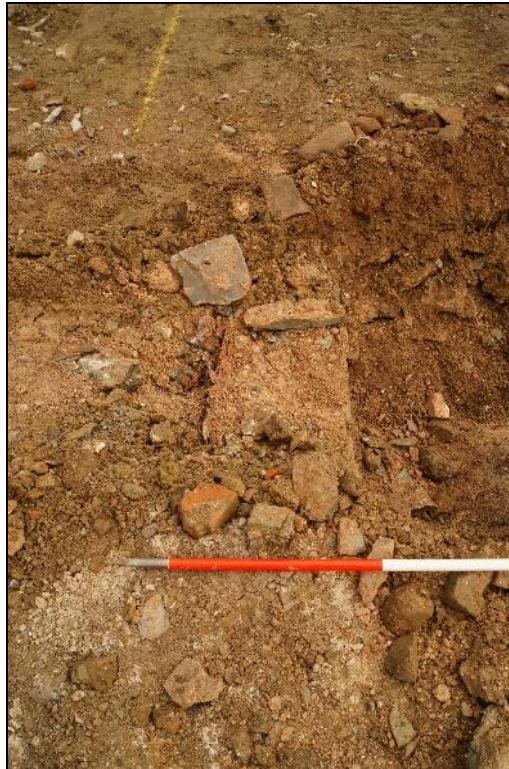
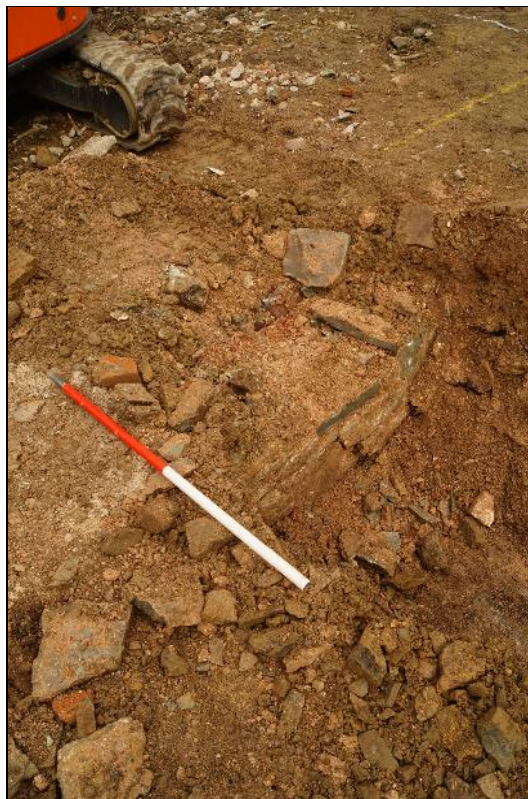
Plate 12: OPL2019_112, Stone wall (112) in Trench C, looking north-northeast.

Plate 13: OPL2019_113, Stone wall (112) in Trench C, looking east-northeast.

Plate 14: OPL2019_114, Stone wall (112) in Trench C, looking northeast.

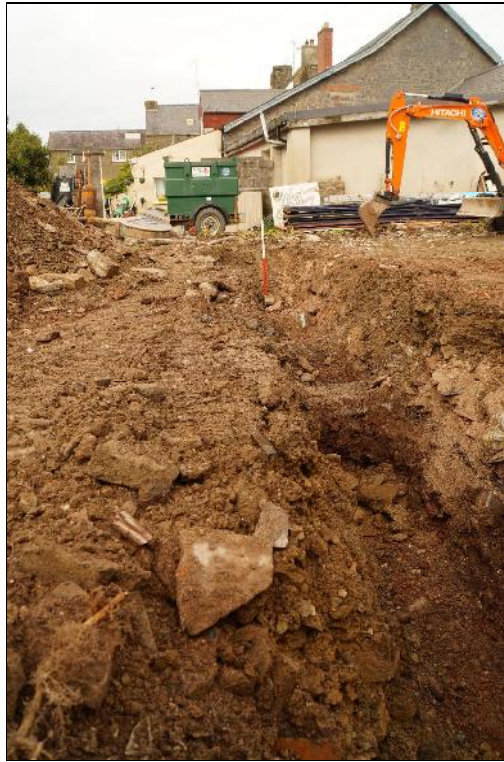
Plate 15: OPL2019_115, (003) Trench C showing concrete strips (003), and (006) below and in base of section, looking north.

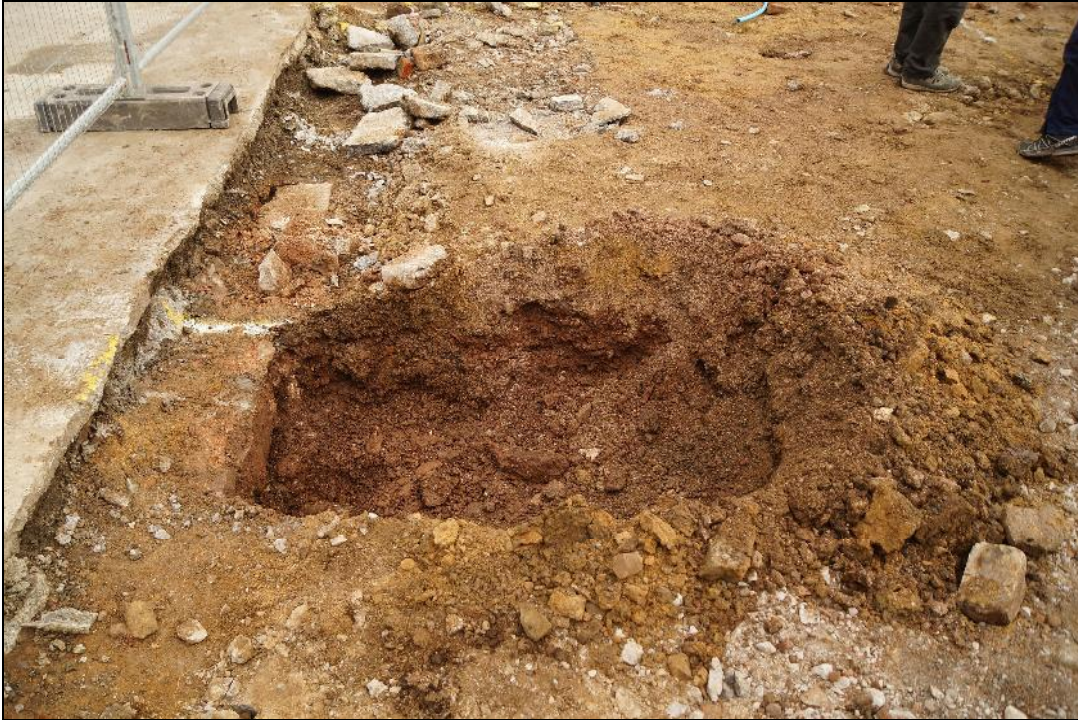
Plate 17: OPL2019_117, Test Pit E showing wall (010) running parallel to the front of the plot, looking south-southeast.

8.8.1 In Test pit E demolition material (001) overlay wall (010). This mortared stone wall ran along the front of the plot and may have been a boundary wall, or part of a former building. A metal pipe was seen entering the edge of the trench below wall (010). Excavation of the test pit was stopped at 0.50 metres.
