# Nevern Castle Excavations

## Interim Report 2018 Summer Excavations

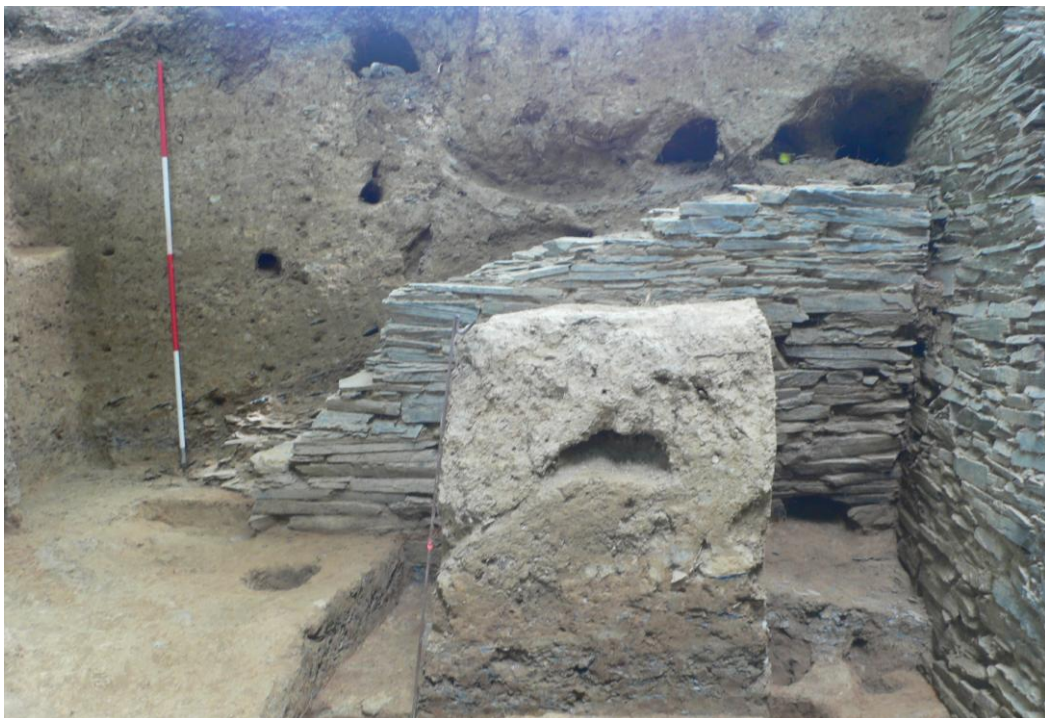
Figure 6: Photographs of the blocking wall (LN13) (supported by a block of earth since the wall is slightly tipped forward) and the south side wall (LN4) of the west entrance to the castle. The ranging rod marks the position of the dismantled northern side wall (LN14). Old burrowing activity by badgers is evident.

(LN22/LN23, LN26/LN27, LN28/LN29) indicating that the entranceway was deliberately blocked up with a wooden palisade, presumably to make the castle safe after the gateway had been damaged or burnt. Subsequently a blocking wall (LN13) was built across the passageway closing the entrance (Figure 6). This was constructed of clay mortared slate (which may for speed have been taken from the backs of the adjacent north and south entrance walls) and butted up against the front half of the north and south entrance walls, effectively sealing the entrance passage. However, this blocking wall was subsequently badly damaged and the northern entrance wall completely demolished. The only reason for such damage would appear to be to gain access into the castle. If besiegers are protected with sturdy mobile roof structures, known as mantlets (also known as cats, Welsh cats or sows) (J. Bradbury 1992 *The Medieval Siege*, 271-2), it is relatively easy to disassemble a clay mortared slate wall with a crowbar. The evidence would suggest that this entrance suffered one or two sieges; an initial damage of burning of the wooden gate which was subsequently protected with a wooden palisade and a later blocking wall which was then damaged and partially mined away. Eventually this entrance was buried under a large deposit of clay so reforming the line of the original bank. The weight of this large volume of earth moved the remnants of the hastily built blocking wall, pushing and tipping it forward and partially skewing it round, so it no longer sits in its original position. The western edge of the south entrance wall (LN4) was then deliberately slighted so it matched the contours of the bank and was not visible. Presumably the wooden bridge was also removed, so all evidence of this entrance had been obliterated. The weakness of such entrances is why complex highly defensible gateways and eventually gatehouses evolved in the 13<sup>th</sup> century.
