**New Wellhead Structure
over Borehole BH8
Princes Gate Springwater
SA67 8JD
Historic Environment
Desk-Based Assessment**

For: Princes Gate Water Ltd

September 2018

Trysor Project No. 2018/629

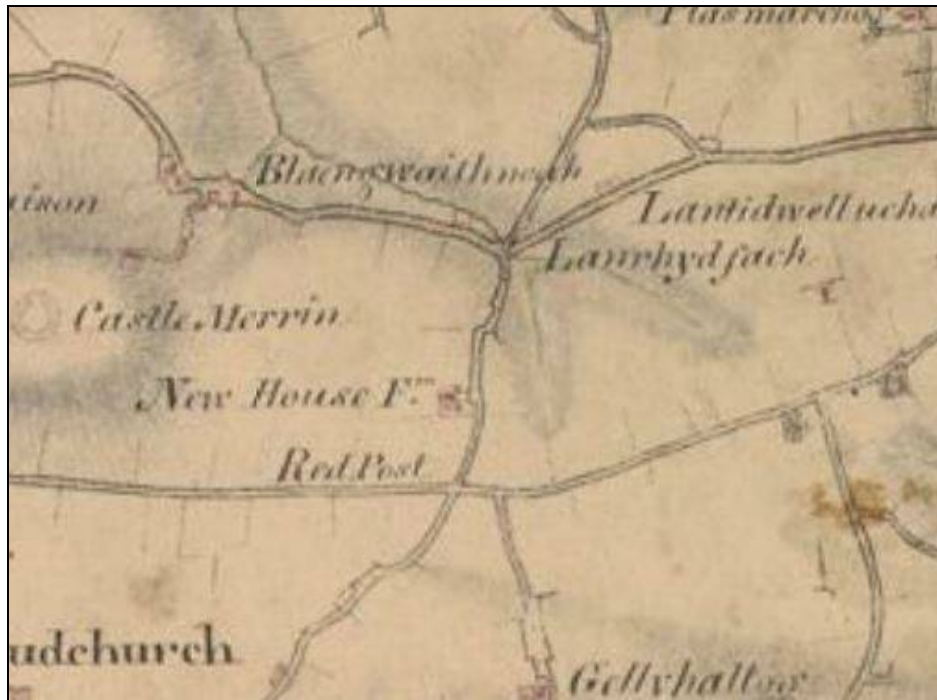
Figure 2: The 1809 Ordnance Survey Original Surveyors Drawing shows a New House Farm and indicates that the land around the development site was enclosed by the post medieval field system. The stream valley to the north of the development site is clearly visible as a shaded area.

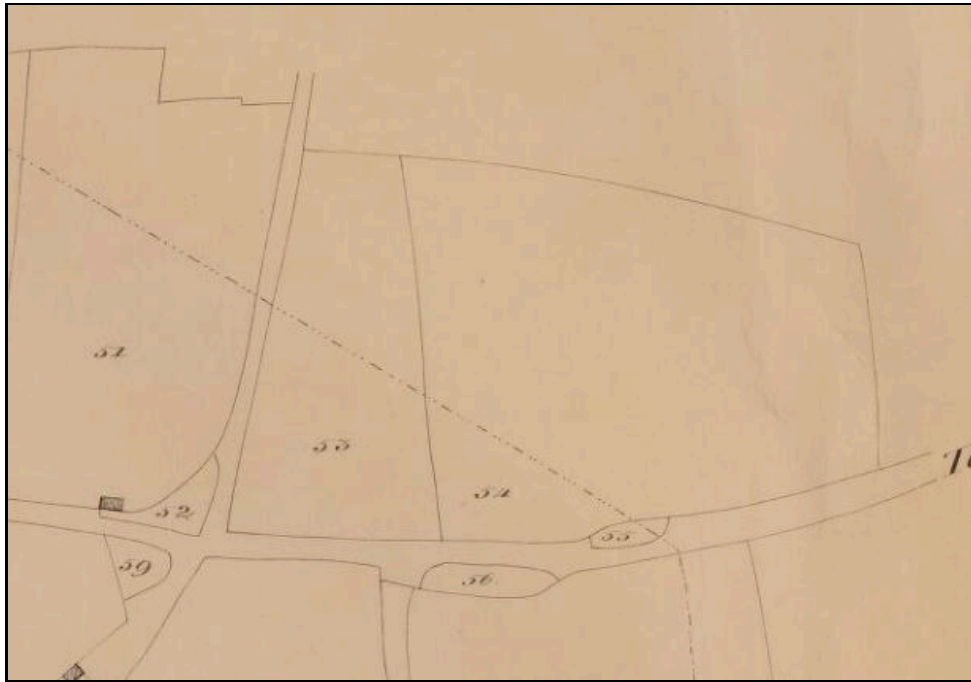
Figure 4; An excerpt from the Ludchurch parish tithe map of 1841. The development site falls within field parcel number 53, which is named as Waun Fach on the tithe schedule.

- 10.14 There are no field names of archaeological significance at the development site. The field in which the development is located was two fields when the tithe survey was undertaken in the 1840s. The smaller western field in which the development will be located was known as *Waun Fach* on the Ludchurch 1841 tithe map. The eastern field was *Park y Bank*.

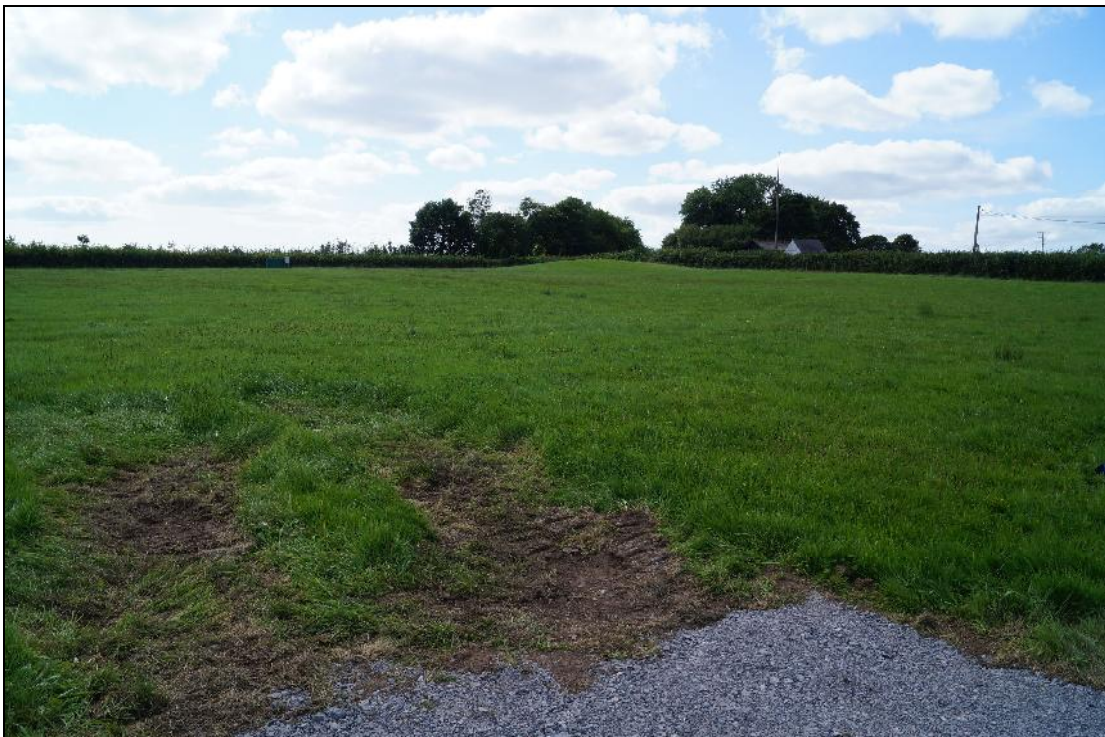
Plate 2: PRG2018_002, a view towards the western round barrow (ID number 1), looking south-southwest from Borehole 8.

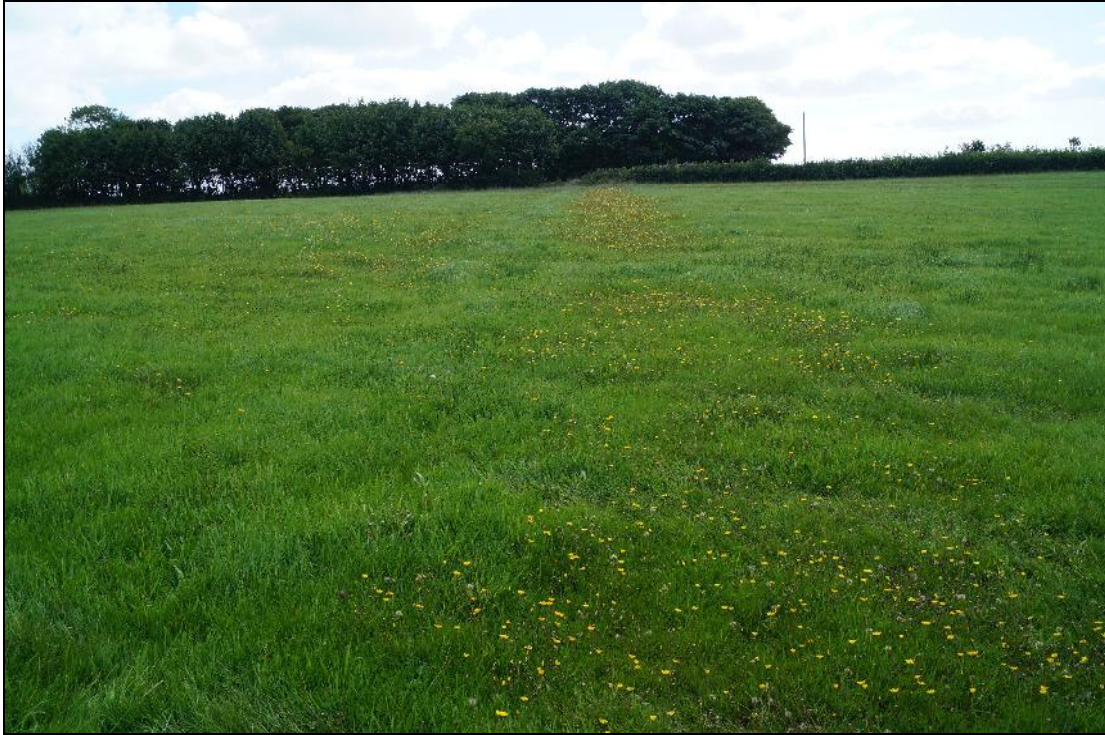
Plate 3: PRG2018_003, a view of the cropmark (a broad line of buttercups) which shows the line of the field boundary which was removed in the later 20th century to amalgamate two fields into the single, large field where the proposed development would take place. Looking south-southeast.

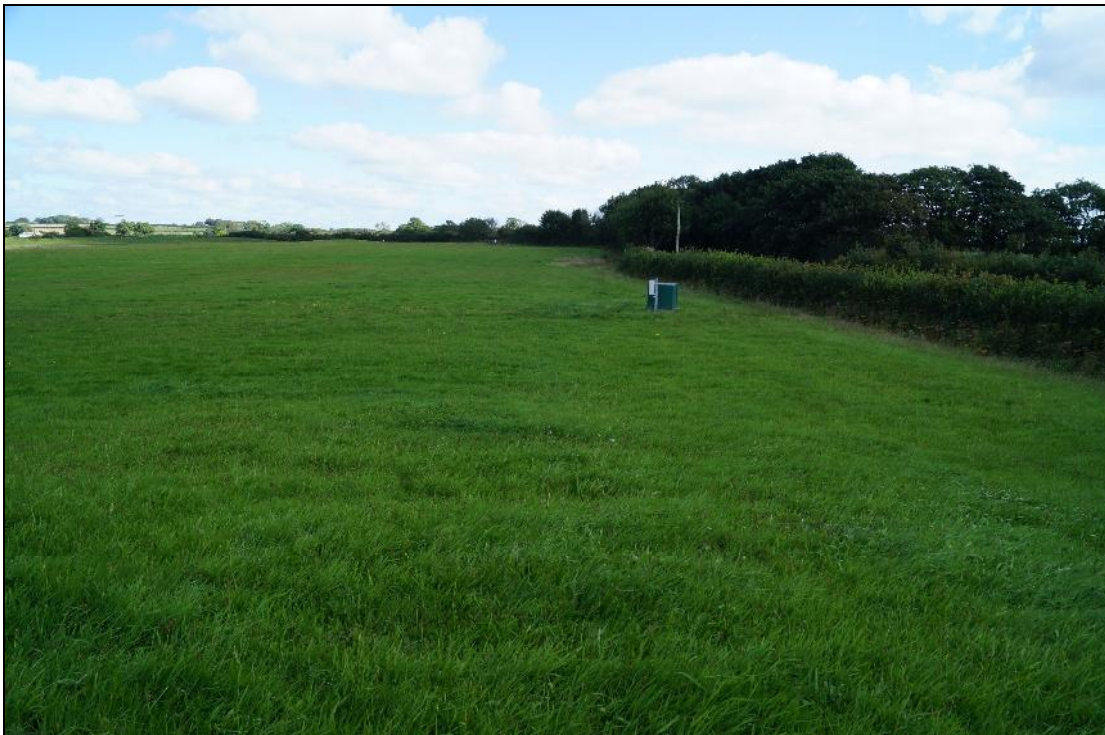
Plate 8: PRG2018_008, a view looking east-northeast from the west barrow in the barrow cemetery PE178, towards the east barrow which can just be seen in front of the hedgerow at the other side of the field. The well-head cabinet at Borehole 6 is visible centre-right.

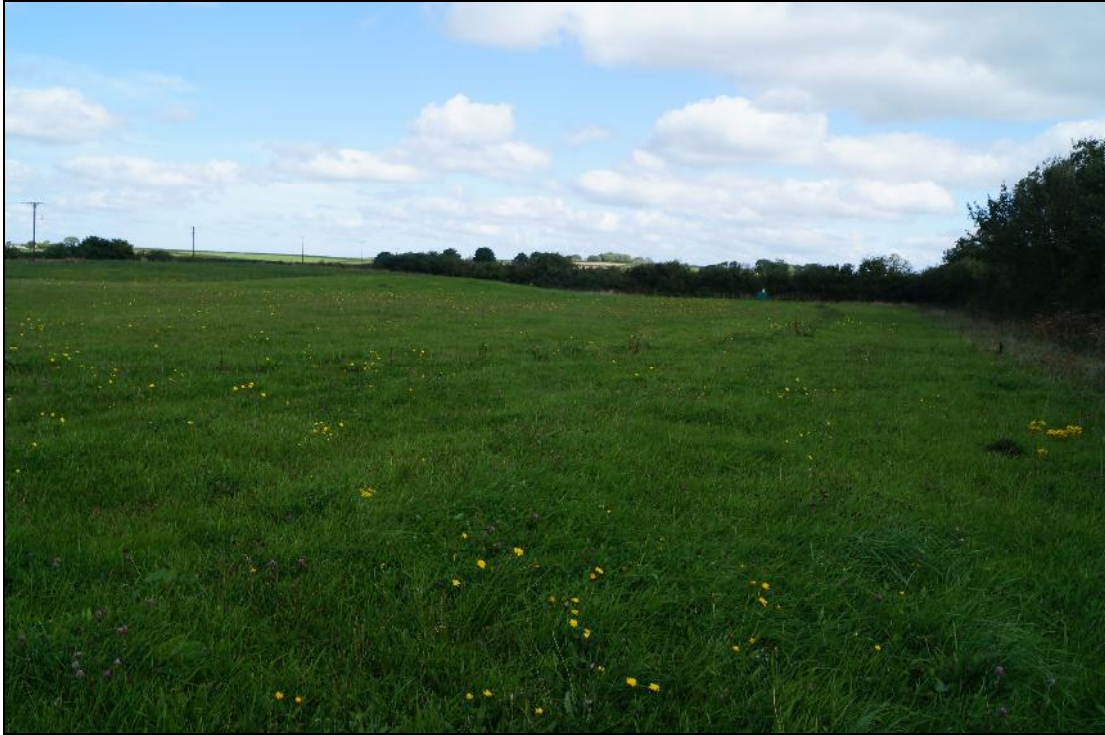
Plate 9: PRG2018_009, view of the eastern barrow, looking east-northeast.

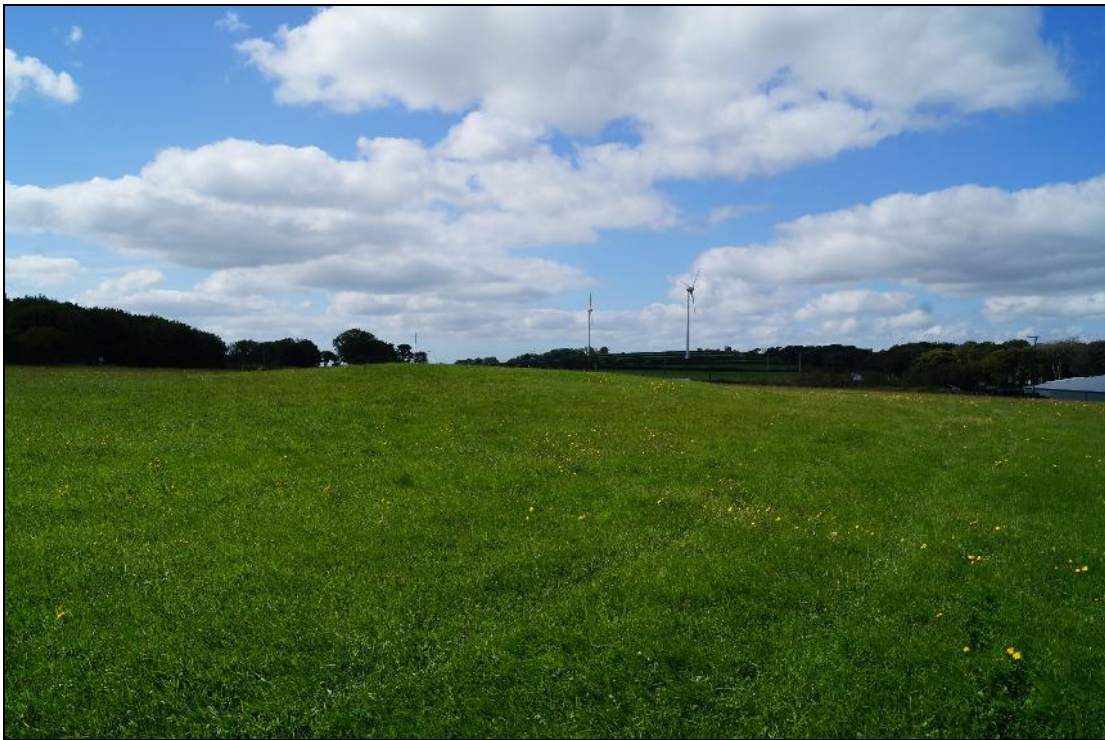
Plate 10: PRG2018_010, a view of the eastern barrow, looking west-southwest. The Castell Meherin wind turbines are visible in the background and the water factory to the far right.

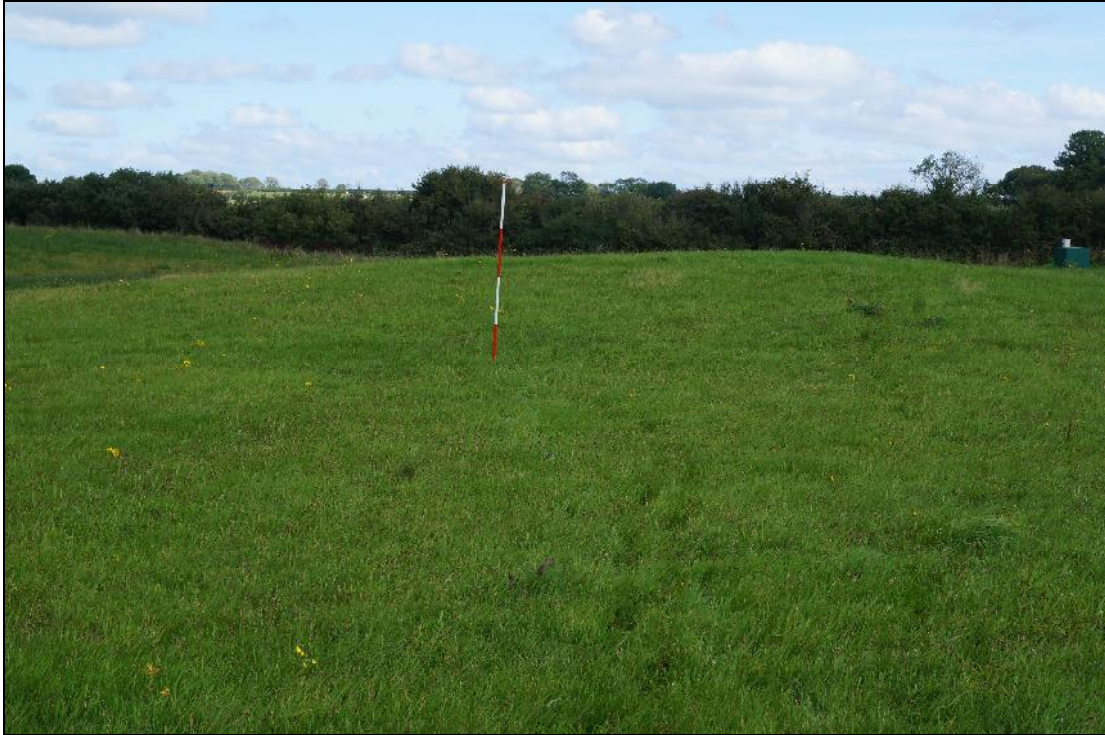
Plate 11: PRG2018_011, a closer view of the eastern barrow, looking east-northeast. A well-head cabinet is visible in the background, far right. The barrow is best appreciated when in close proximity.

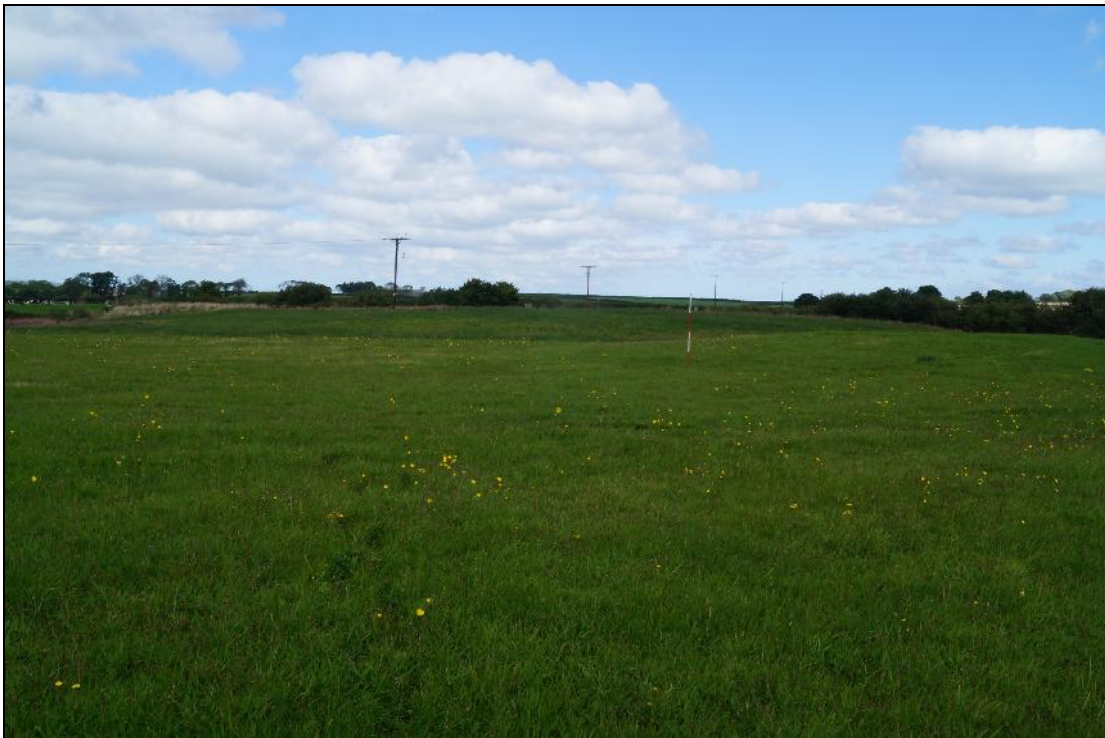
Plate 12: PRG2018_012, a view of the eastern barrow, looking northeast. This image shows how the terrain undulates within the field and also how high ground surrounding the development site truncates views of the wider landscape.

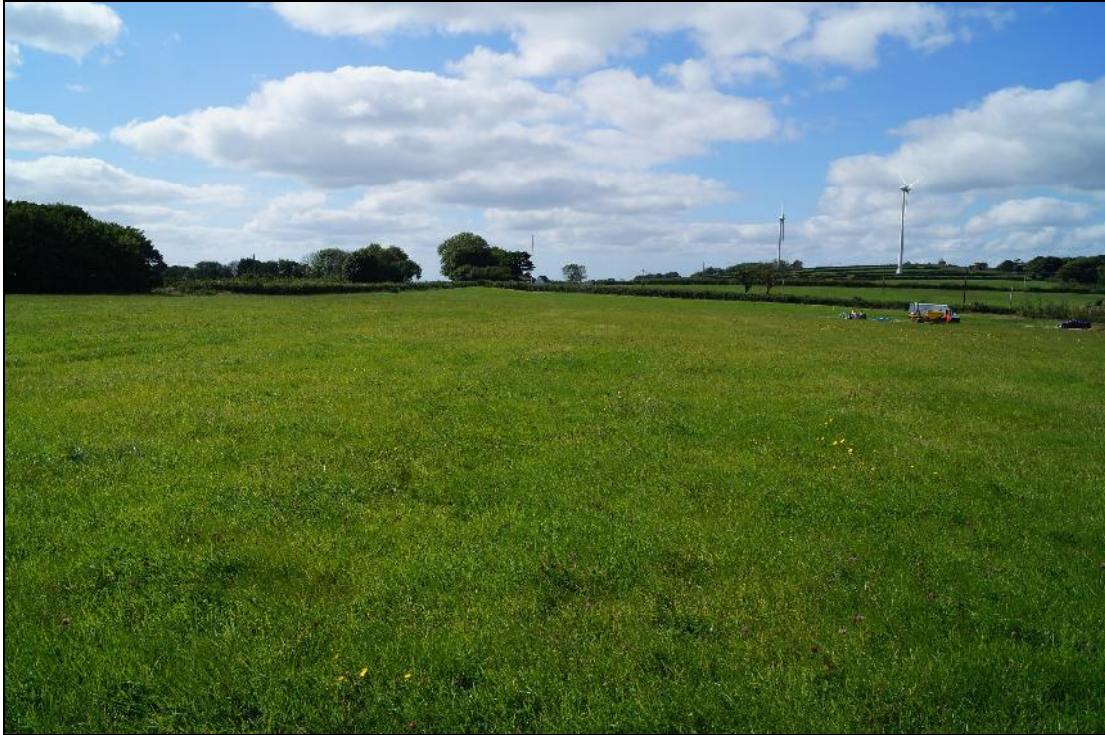
Plate 13: PRG2018_013, a view towards the western barrow, looking west-southwest. Borehole 8 is to the right of the white van to the right. The Castell Meherin wind turbines stand in the background.

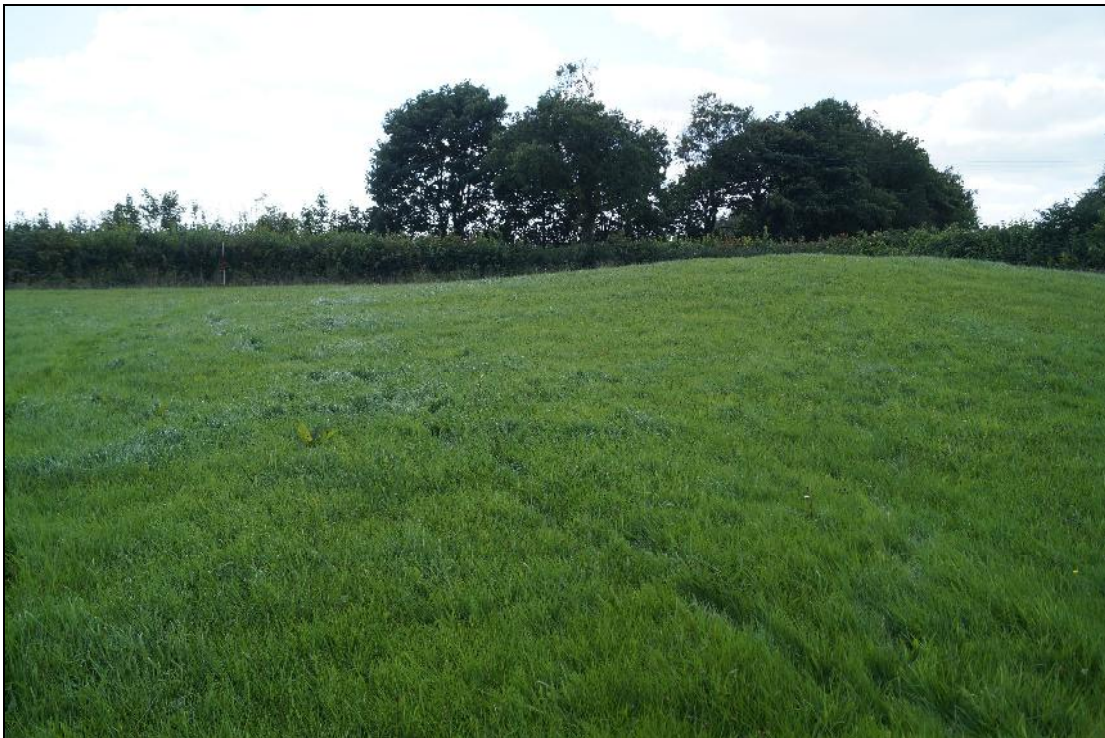
Plate 14: PRG2018_014, a closer view of the western barrow, looking southwest. The barrow is best appreciated when in close proximity.

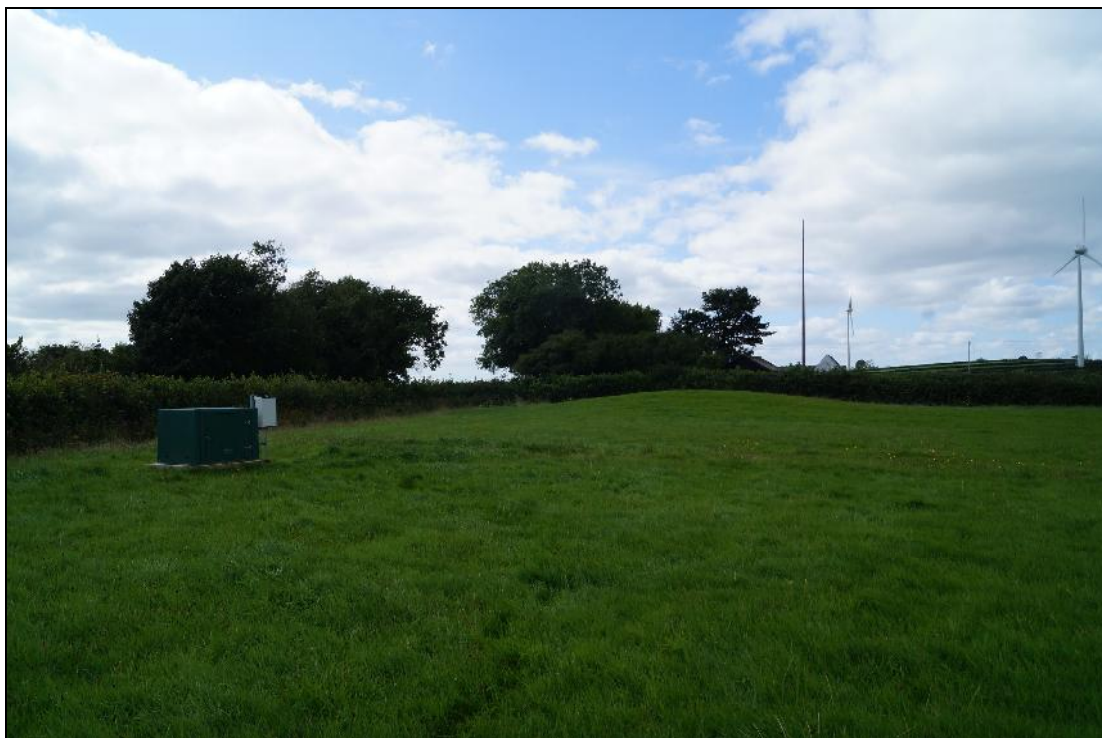
Plate 15: PRG2018_015, a view of the western barrow, looking southwest. The cabinet for Borehole 6 is to the left, the telephone exchange and mast can be seen behind the barrow, with the Castell Meherin wind turbines to the right.

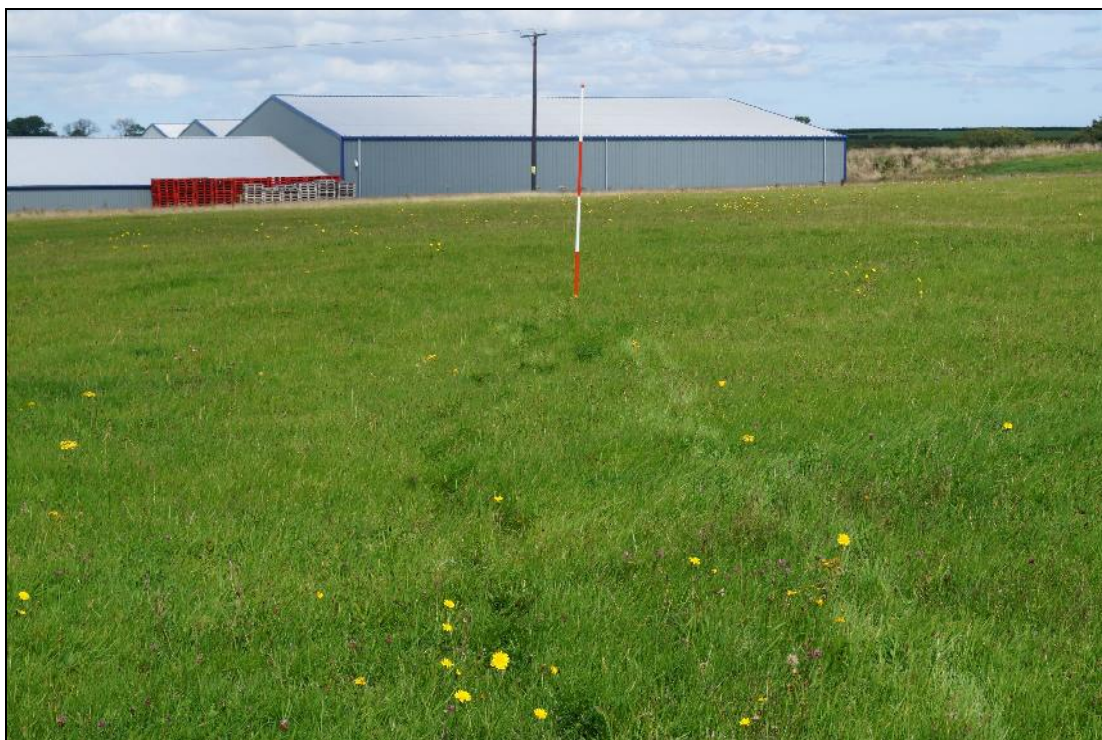
Plate 16: PRG2018_016, the central round barrow, looking north-northeast, with the water factory behind. This barrow is very denuded and is best experienced at very close range. It is not highly visible in the landscape.
