Monument Survey Form

NAME:		Gilfach Goch Standing Stone I				LOCATION (NGR):		SM 98148 37334		
MONUMENT TYPE:		Standing stone/former gatepost			MONUMENT PERIOD:		Unknown			
SM No.	N/A		NPRN:	N/A		PRN:	N/A		NTPRN:	N/A

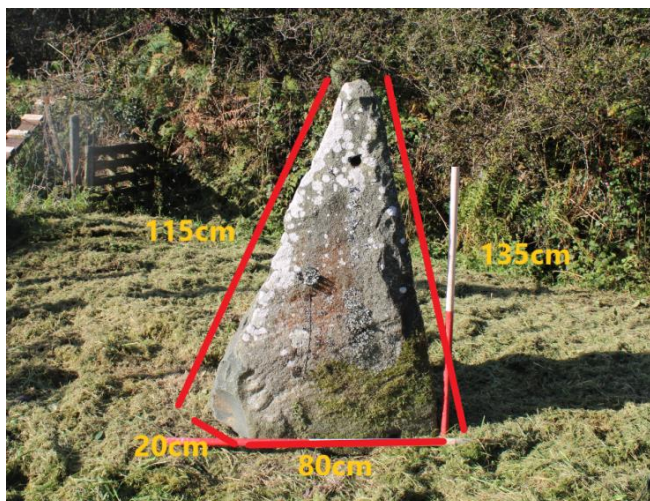
Southern face

The monument comprises a triangular shaped standing stone which appears to have been used as a gate post more recently (indicated by two hanging posts on the southern face of the stone). The fact that lichen is only found in the top half of the monument indicates it has been moved from its original location and would have been positioned at a deeper level below current ground level. The standing stone is not noted on the 1889 county survey map, suggesting that it was moved after this time. The length of lichen coverage also suggests that the stone was in place for a long period of time in its original location.
