**HISTORIC ENVIRONMENT
DESK-BASED ASSESSMENT AND
WALKOVER SURVEY FOR A
ONE PLANET DEVELOPMENT AT
COEDTALYLAN, CARMARTHENSHIRE
23-22338-PAYPRE (BBNP)
COEDTALYLAN, PLOT 2**

June 2024

Trysor Project Number: 2024/900

RHIF YR ADRODDIAD - REPORT NUMBER: Trysor 2024/900

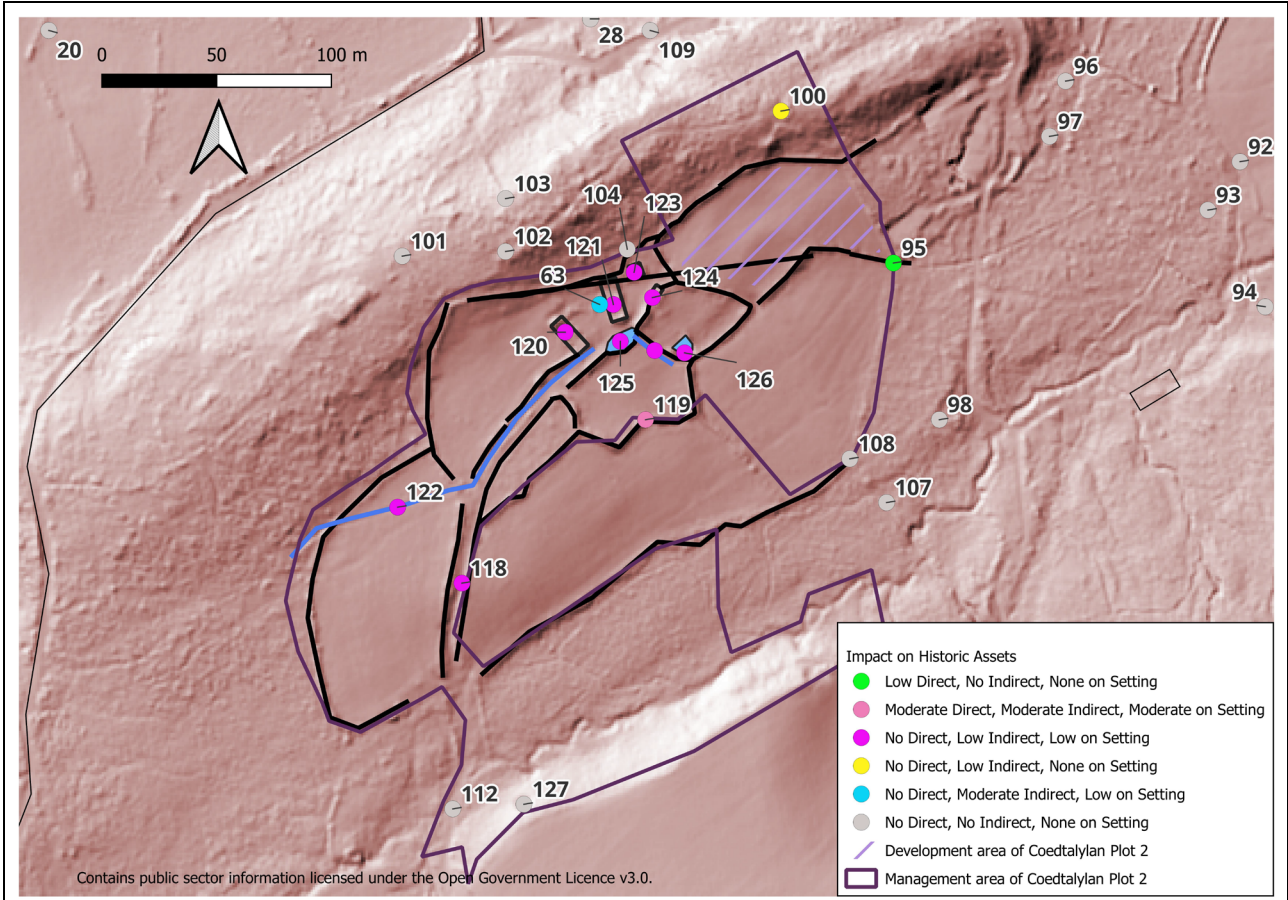
Figure 9: Detail showing the historic assets assessed within the development and management areas and the impact on them

12.1.1 There are no historic assets recorded within the Coedtalylan Plot 2 Development Area itself but historic assets in the wider management area contains the remains of the locally important Carreg y Gath farmstead, including farmhouse, farm buildings, trackway, field system, earthwork banks, ponds and leats. These are all of local importance and in fair condition, see Figures 7 and 9.

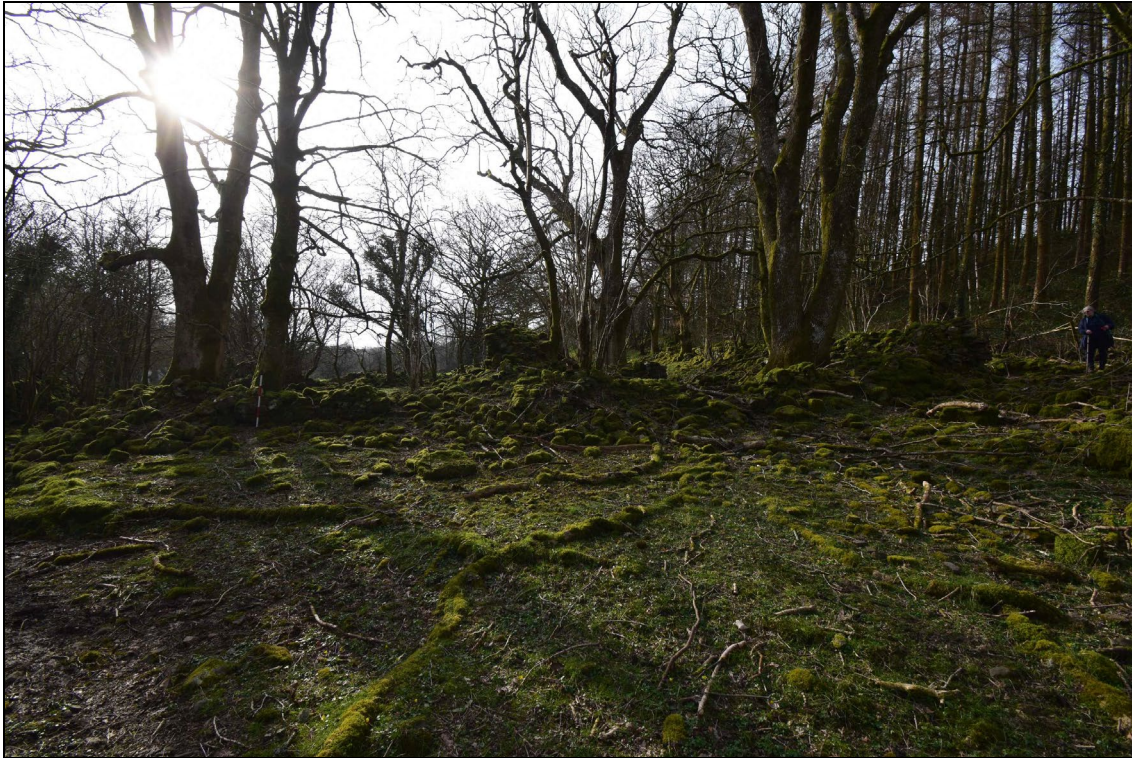
Plate 1: CTD2018_001. The ruins of Carreg y Gath farmhouse (ID number 121). Looking west-southwest.

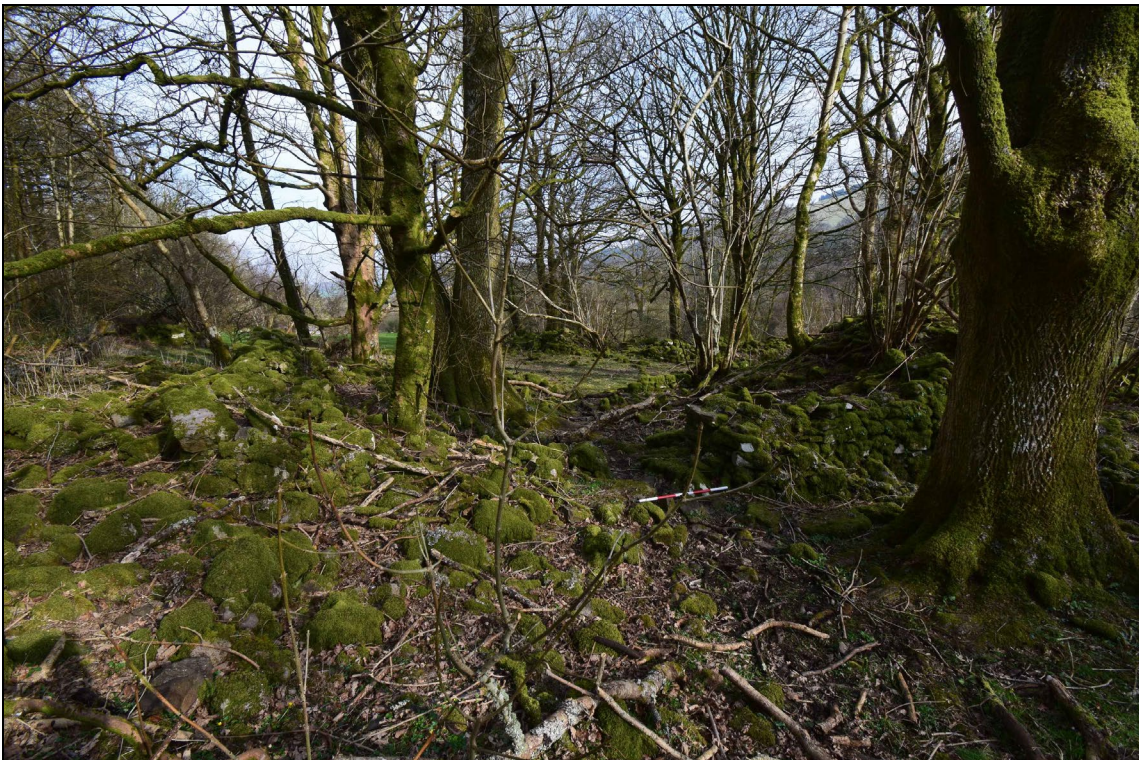
Plate 2: CTD2018_002. The north-northwest end of Carreg y Gath farmhouse (ID number 121). Looking east.

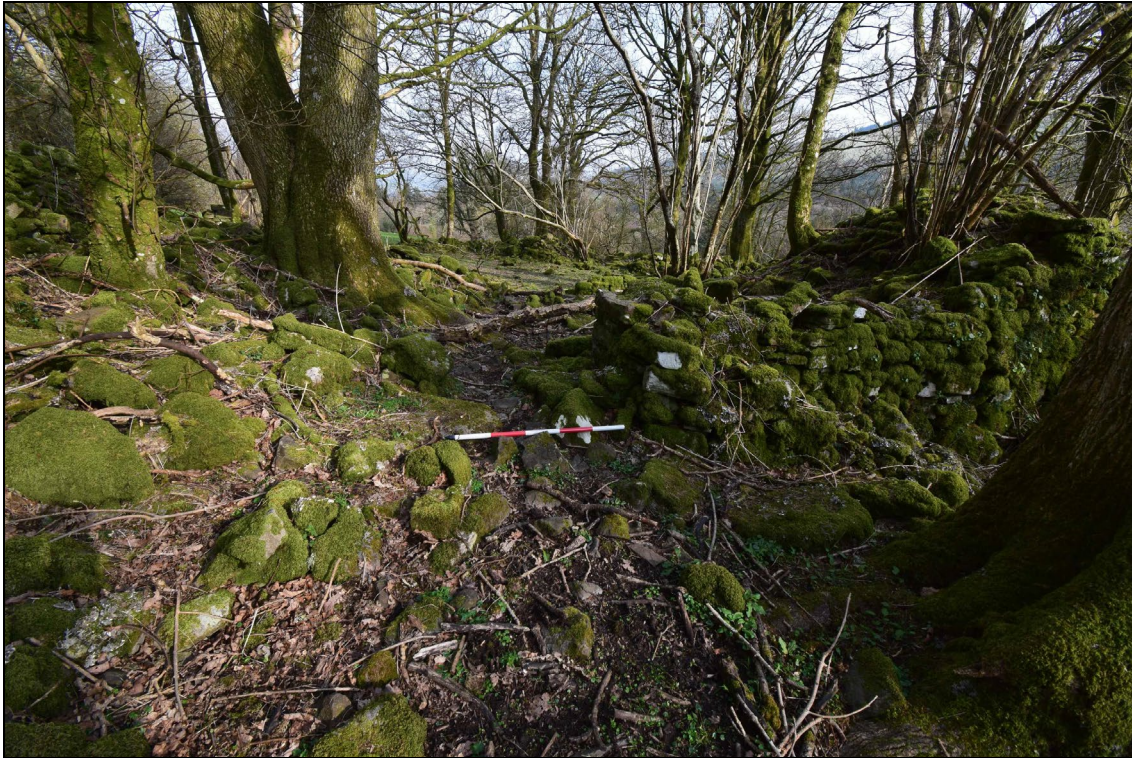
Plate 3: CTD2018_003. The doorway leading into the ruined Carreg y Gath farmhouse (ID number 121). Looking east-southeast.

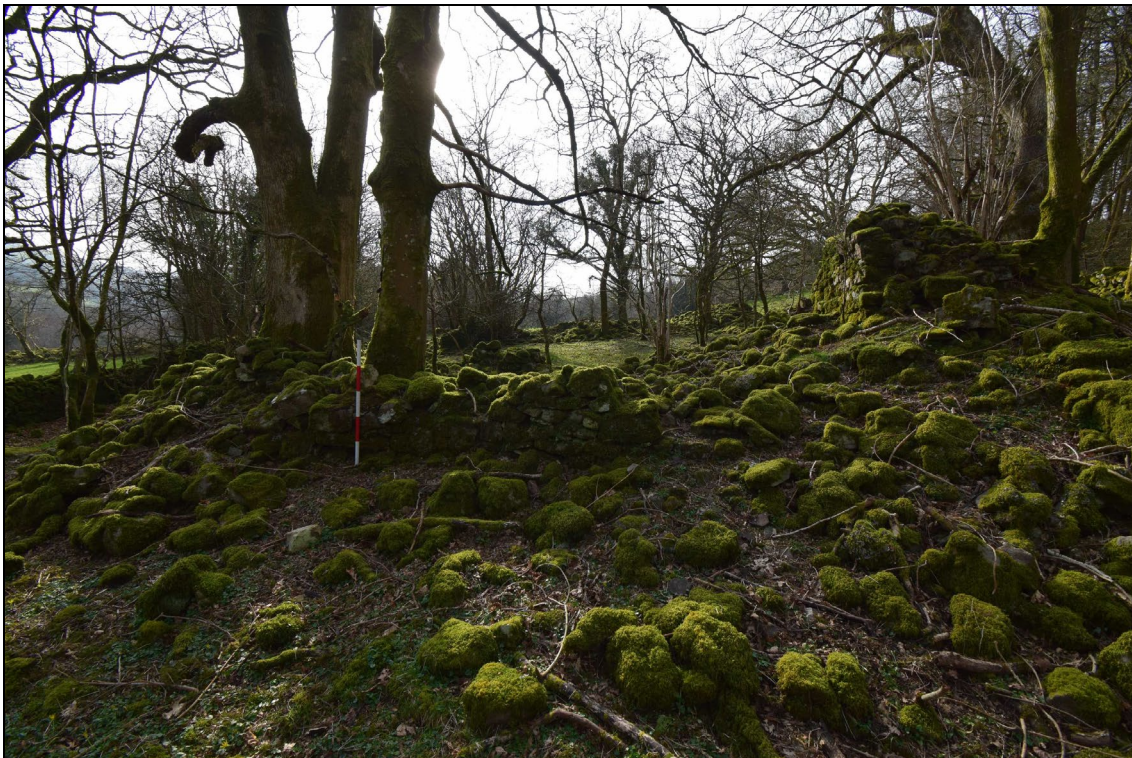
Plate 4: CTD2018_004. The south-southeast end of Carreg y Gath farmhouse (ID number 121). Looking west-southwest.

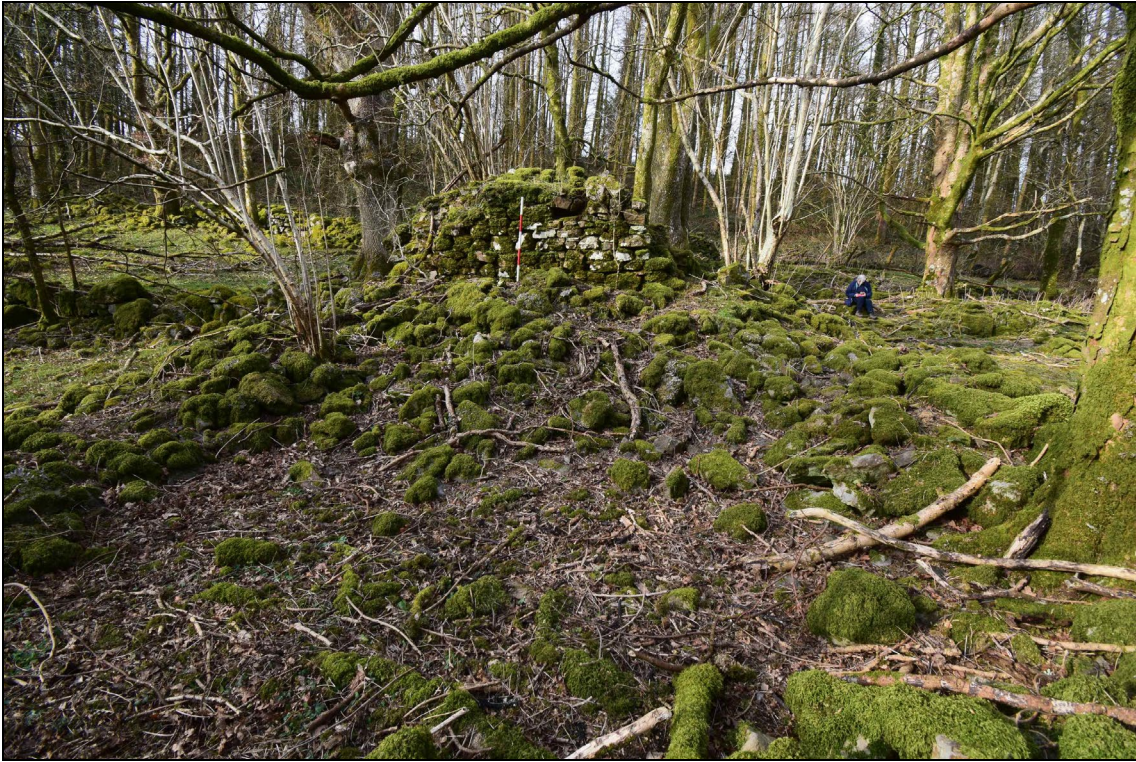
*Plate 5: CTD2018_005. A view of Carreg y Gath farmhouse (ID number 121).
Looking north-northwest.*

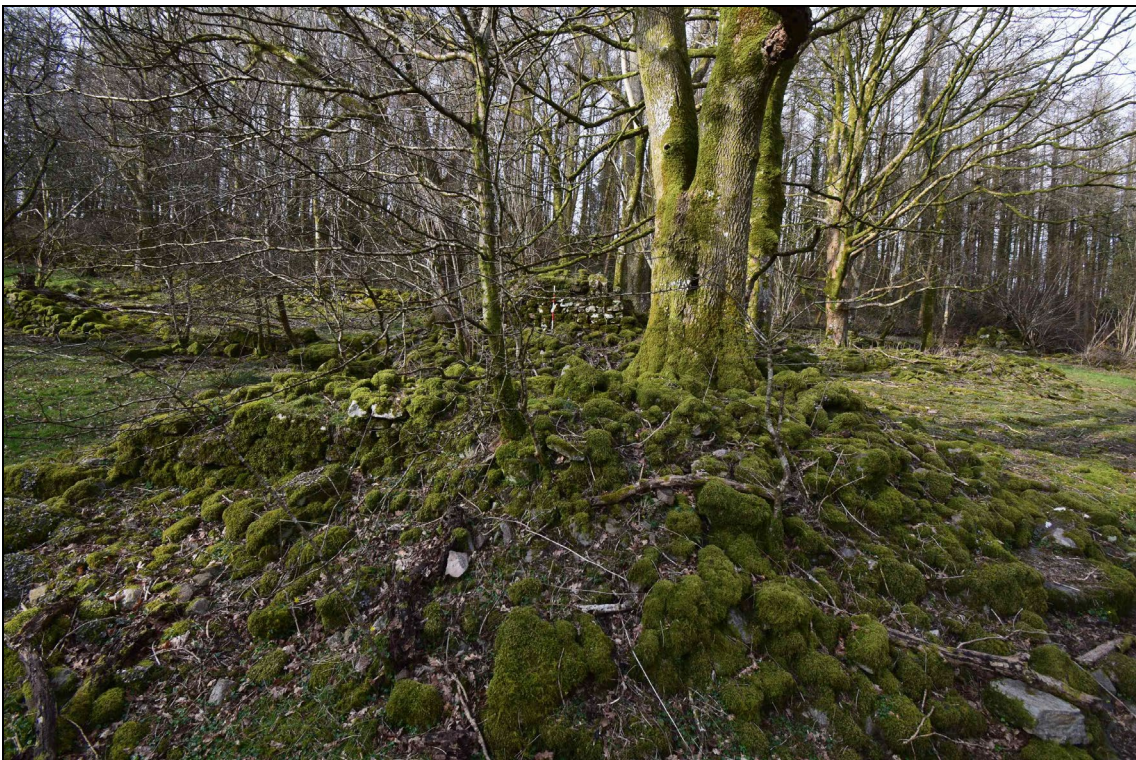
*Plate 6: CTD2018_006. A view of Carreg y Gath farmhouse (ID number 121).
Looking north-northwest.*

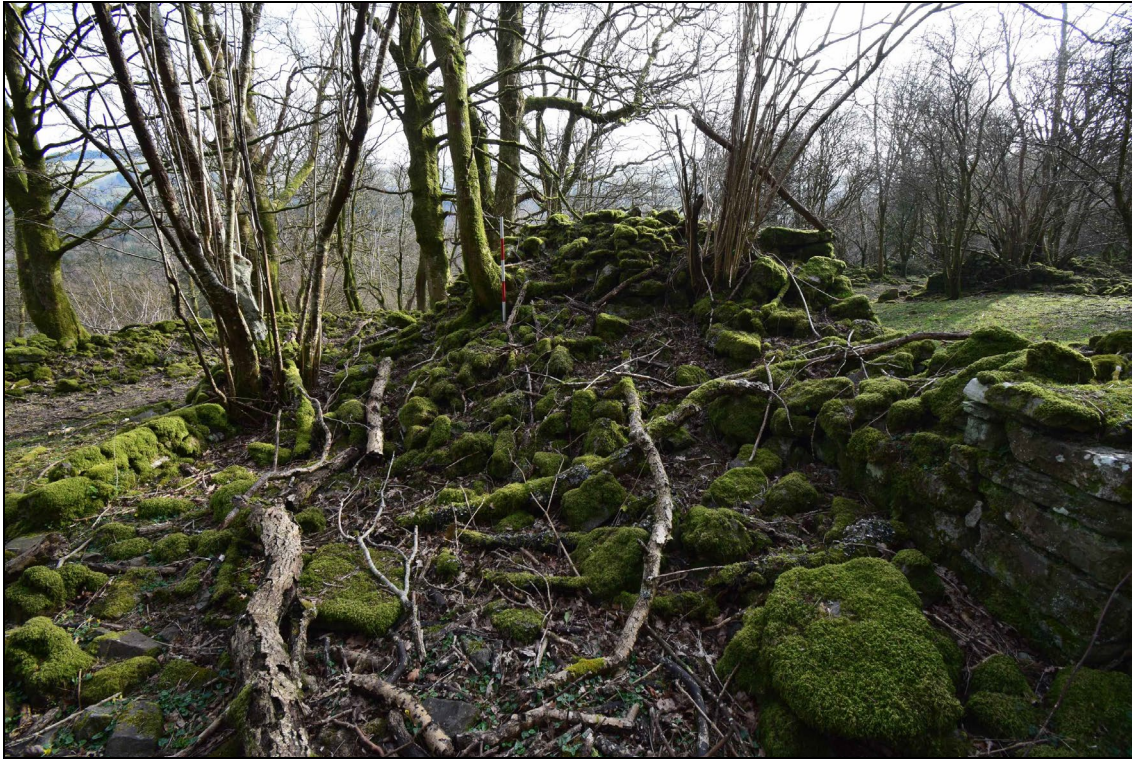
Plate 7: CTD2018_007. A view inside the north-northwest end of Carreg y Gath farmhouse (ID number 121), looking towards the mound at the site of the former inglenook fireplace and chimney. Looking south-southeast.

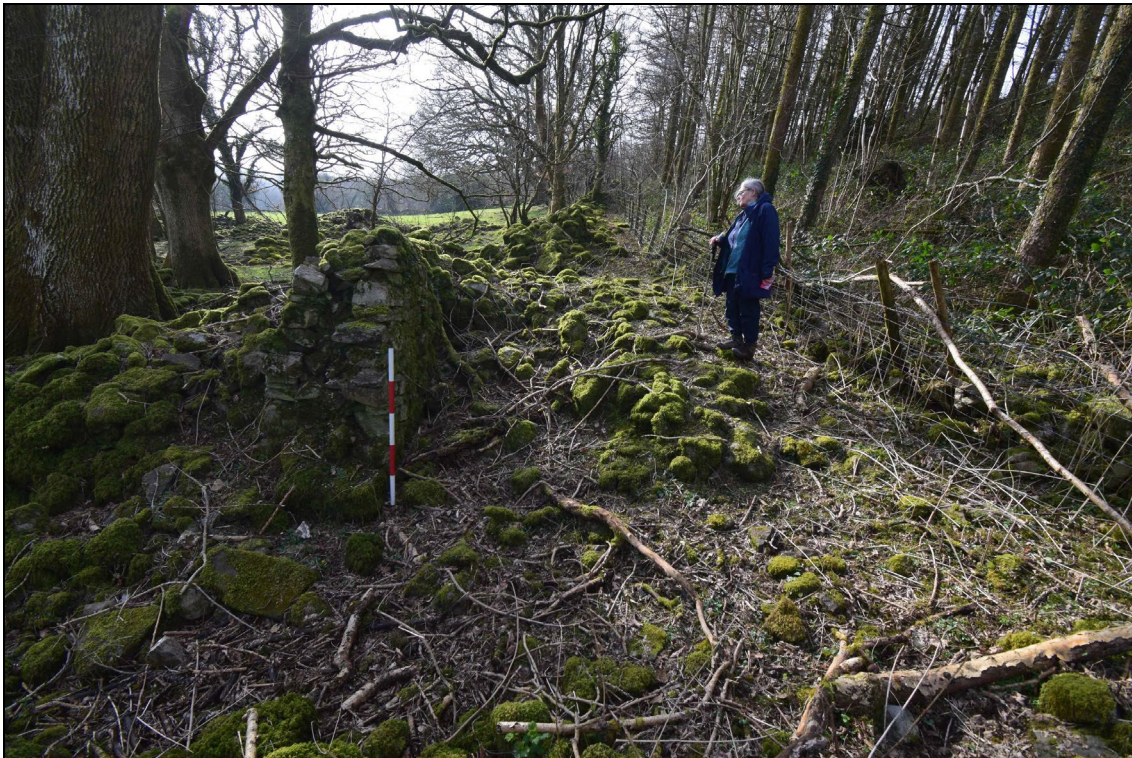
Plate 8: CTD2018_008. A view of a small lean-to or store against the north-northwest gable end of Carreg y Gath farmhouse (ID number 121). Looking west-southwest.

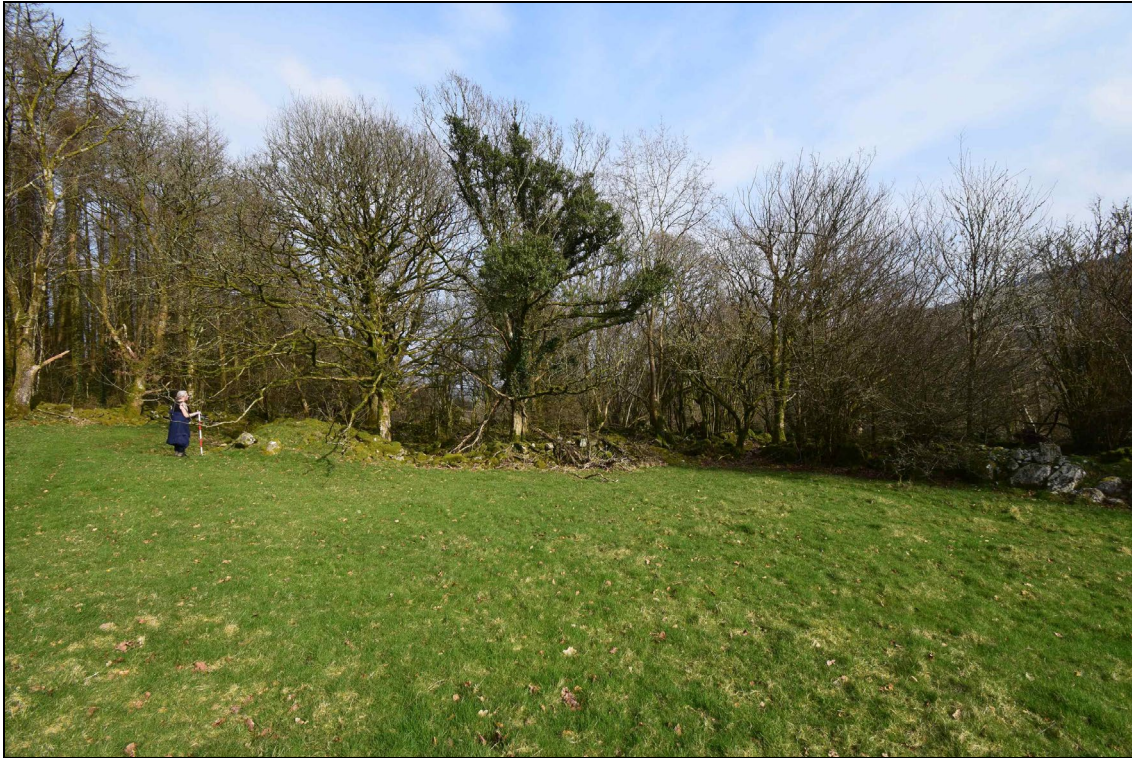
Plate 9: CTD2018_009. A view towards the ruined former barn at Carreg y Gath, showing the wooded area beyond which now covers the farmyard area. Looking northeast.

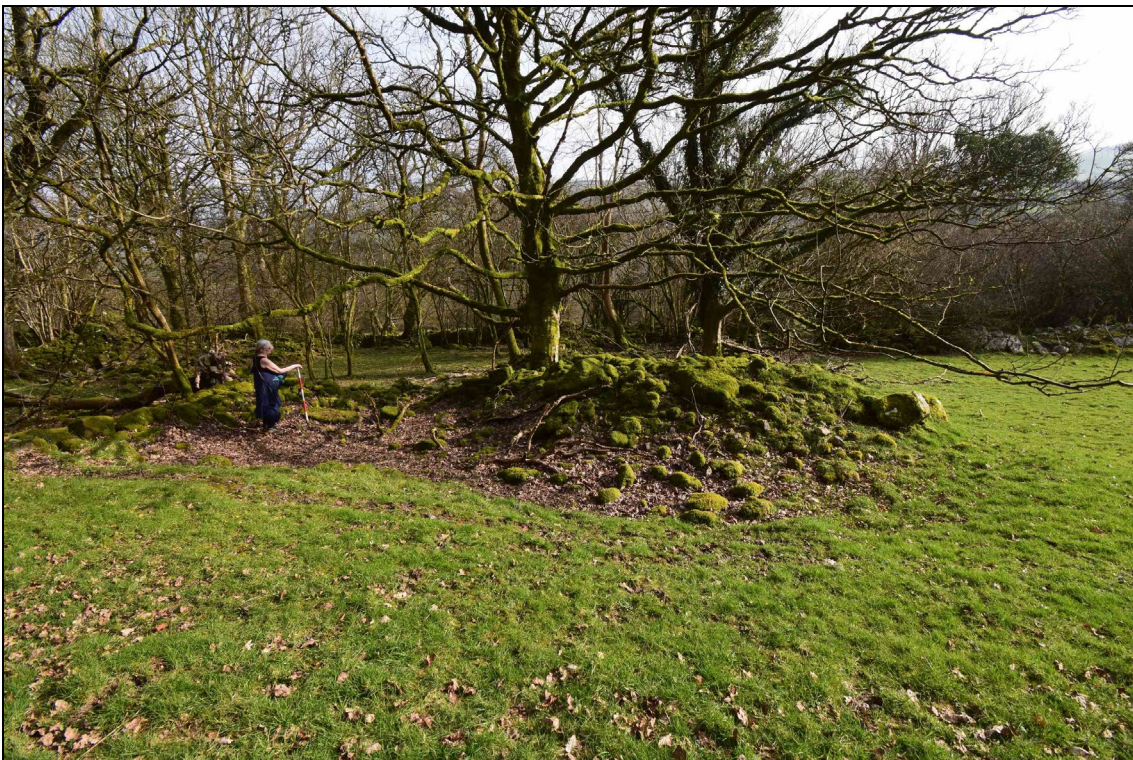
Plate 10: CTD2018_010. A view of the northwest gable end of the ruined former barn at Carreg y Gath. Looking southeast.

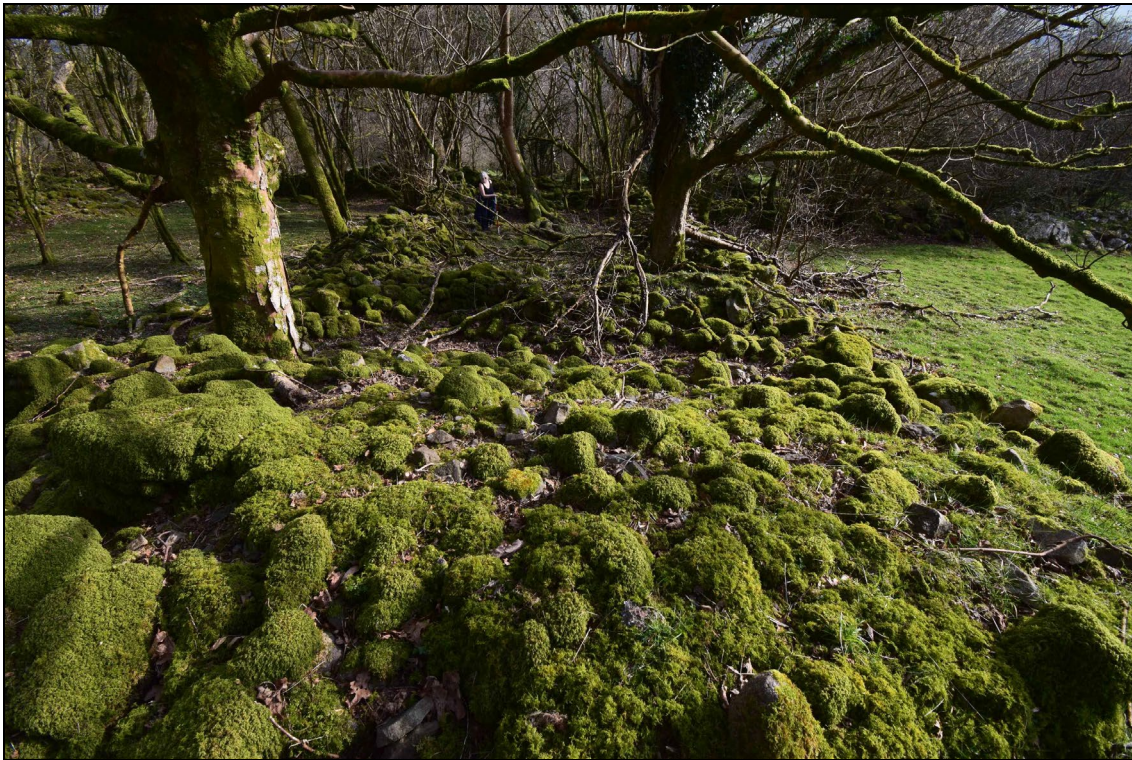
Plate 11: CTD2018_011. A view from the northwest gable end, looking over the ruined former barn at Carreg y Gath. Looking southeast.

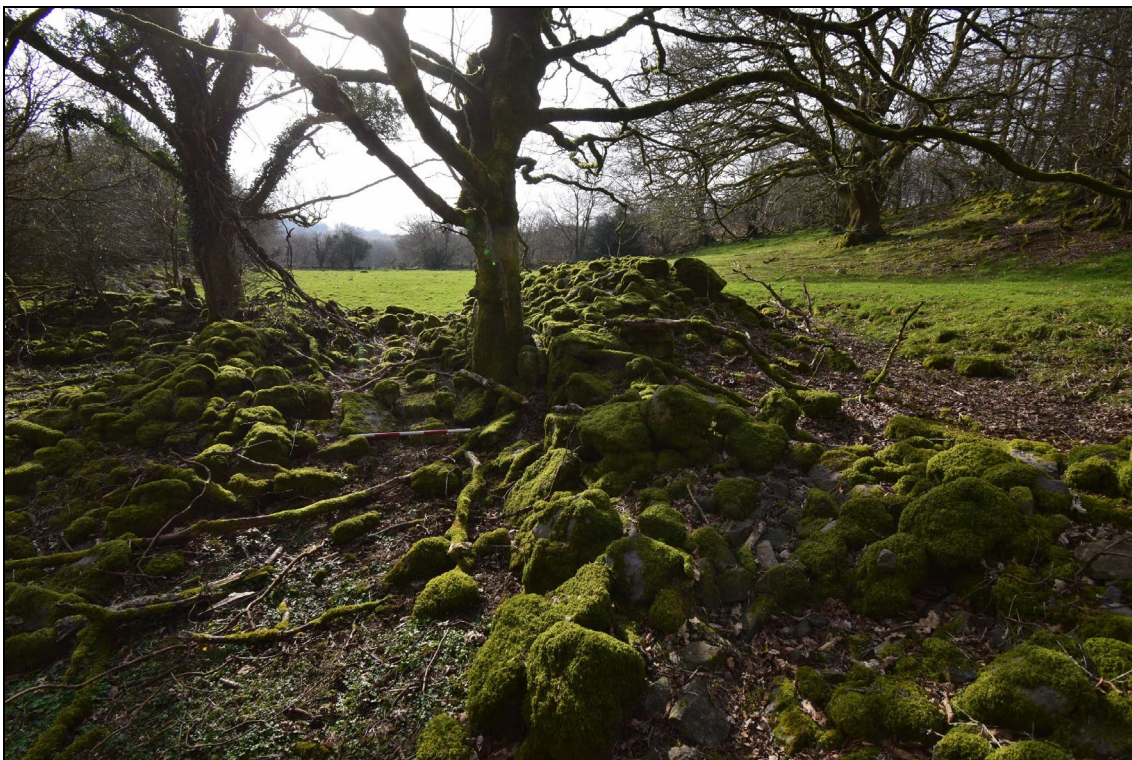
Plate 12: CTD2018_012. A view of the northwest end of the ruined former barn at Carreg y Gath, showing the mound of the collapsed gable wall and the narrow upper bay inside the building. Looking southwest.

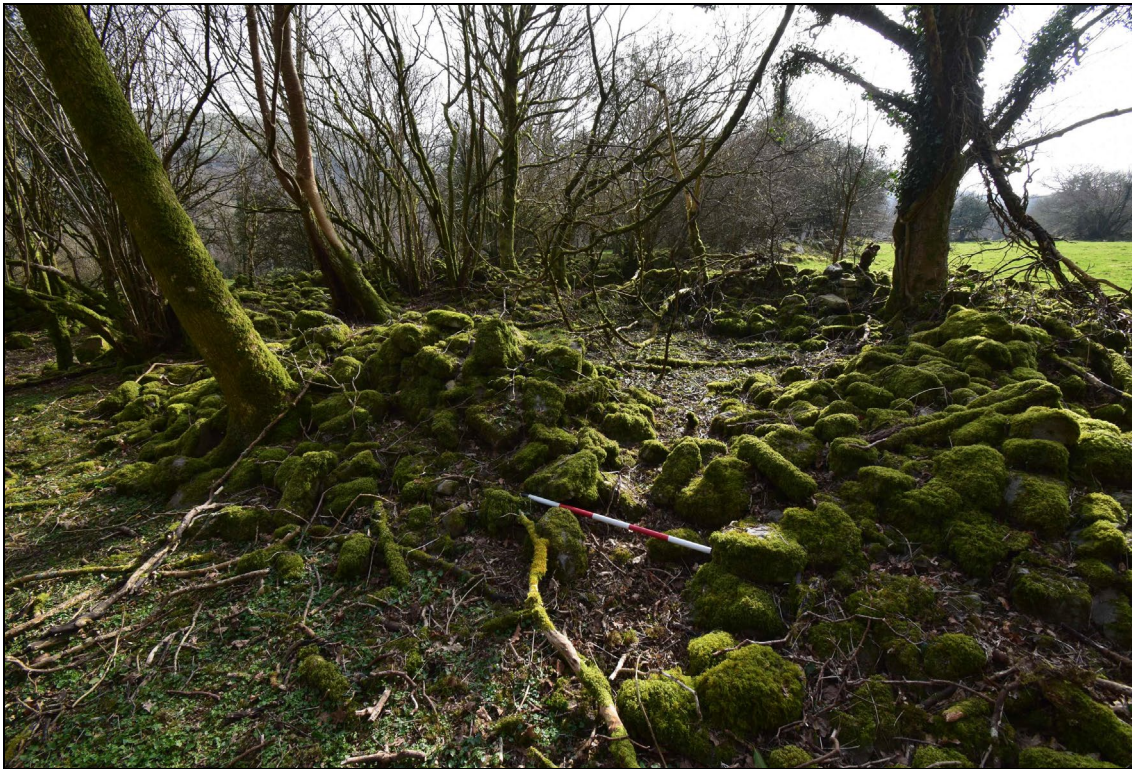
Plate 13: CTD2018_013. A view of the northwest end of the larger, lower bay within the ruined former barn at Carreg y Gath, showing the entrance through the northeast-facing lateral wall. Looking southwest.

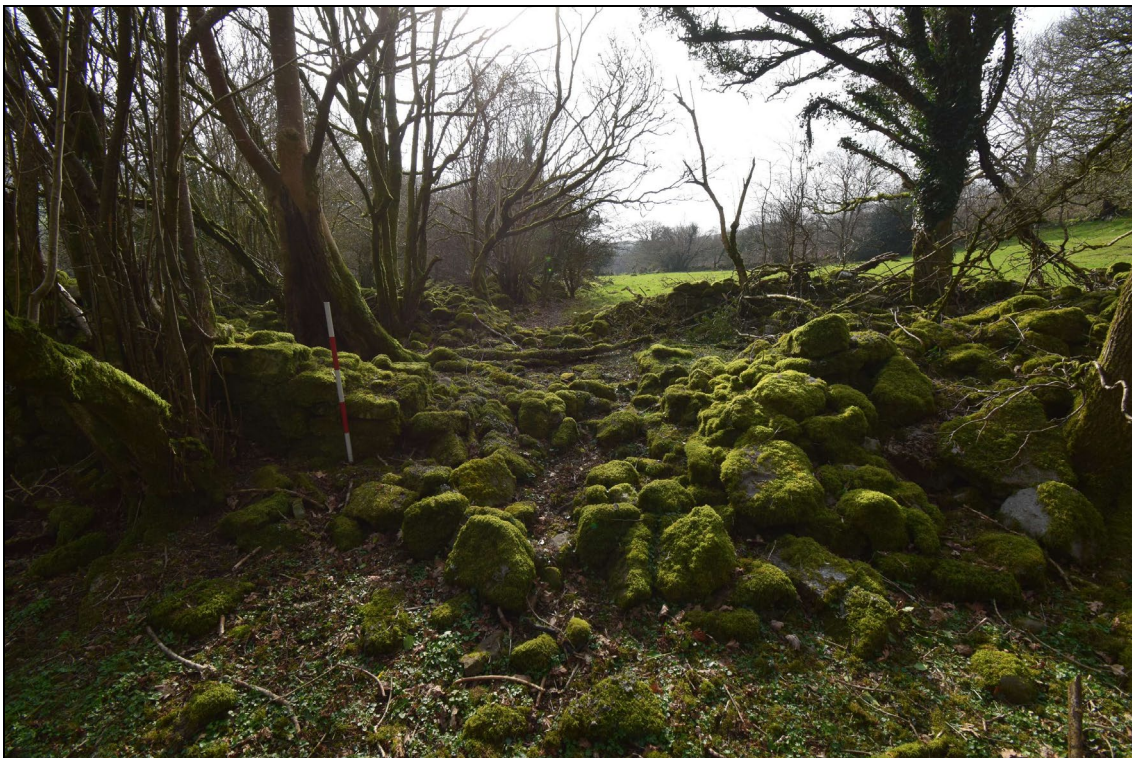
Plate 14: CTD2018_014. A view across the ruined former barn at Carreg y Gath, showing the opposed doorways in the lower bay of the barn, indicating that it was a threshing barn. Looking southwest.

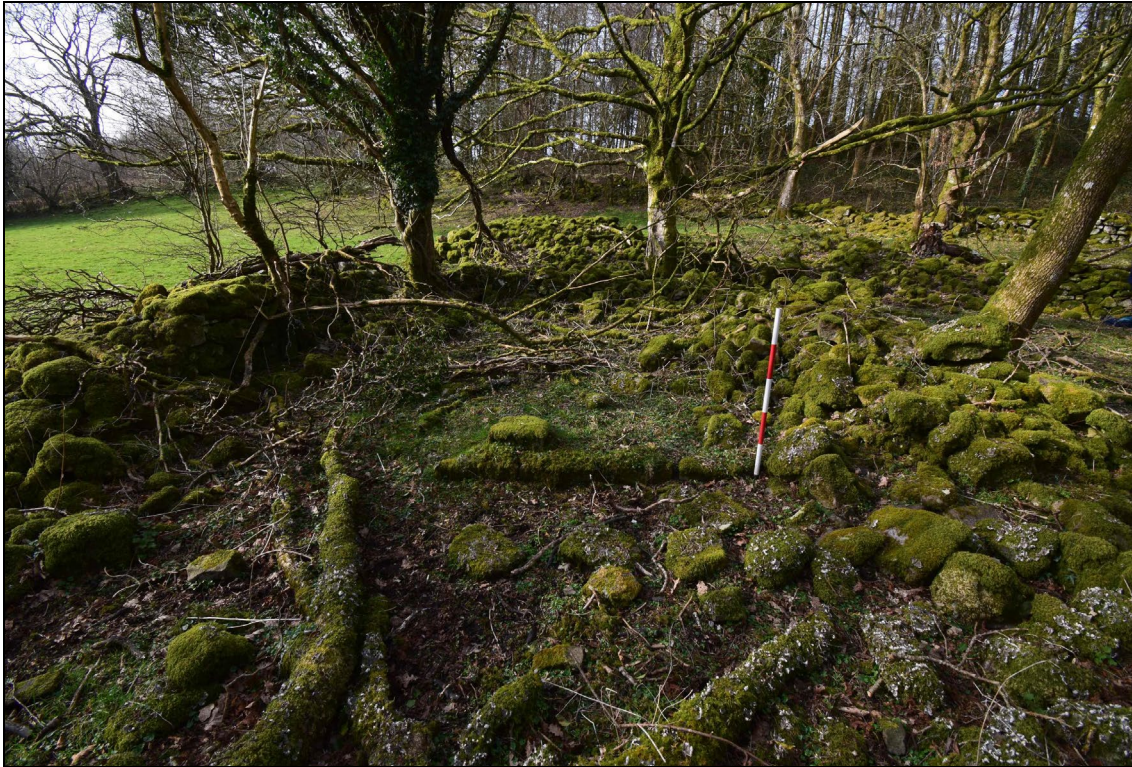
Plate 15: CTD2018_015. A view of the ruined former barn at Carreg y Gath, looking inside the lower bay with the step down in floor level within the bay visible to the left of the ranging rod. Looking northwest.

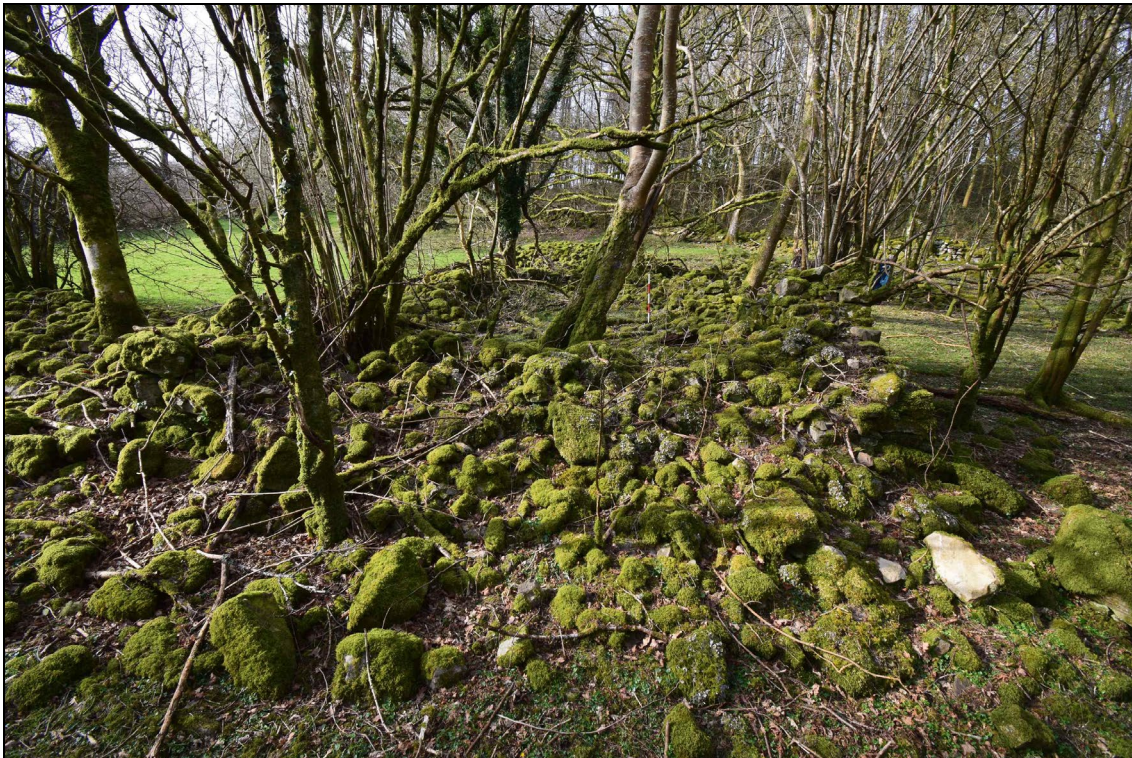
Plate 16: CTD2018_016. A view of the ruined former barn at Carreg y Gath, seen from the southeast gable end. Looking northwest.

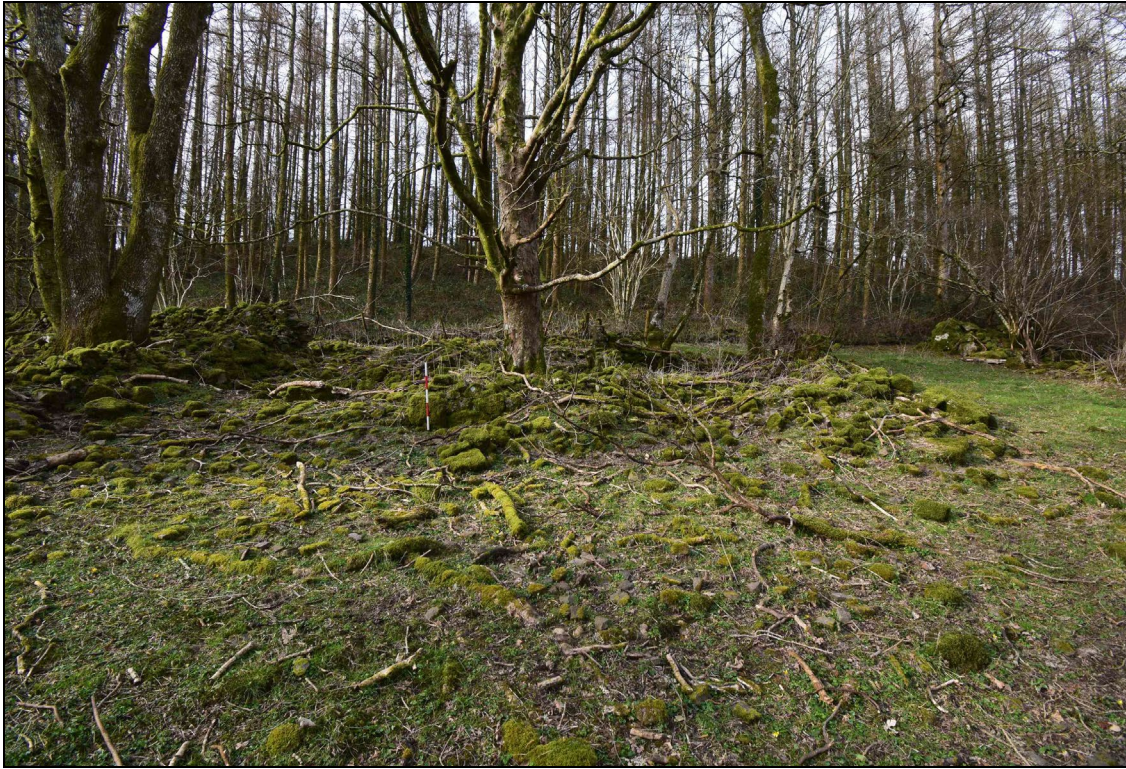
Plate 17: CTD2018_017. A view of the small outbuilding (ID number 123) to the northeast of the former farmhouse at Carreg y Gath. Looking north-northwest.

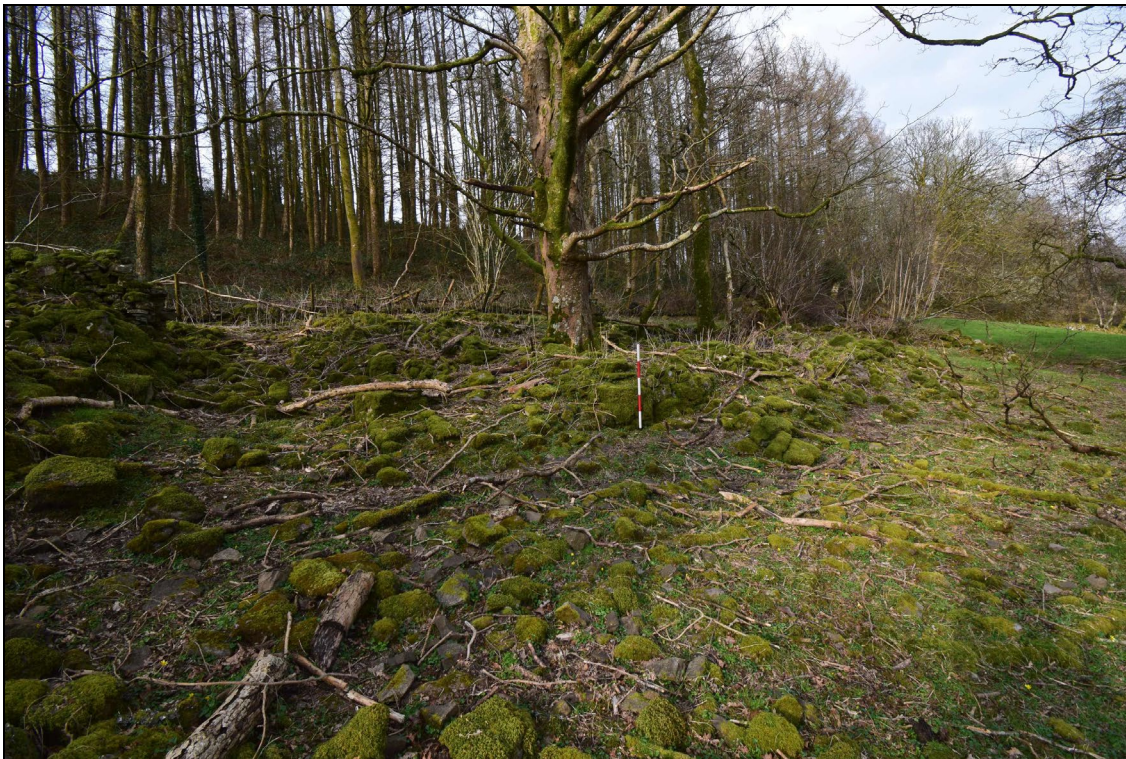
Plate 18: CTD2018_018. A view of the small outbuilding (ID number 123) to the northeast of the former farmhouse at Carreg y Gath. Looking north-northeast.

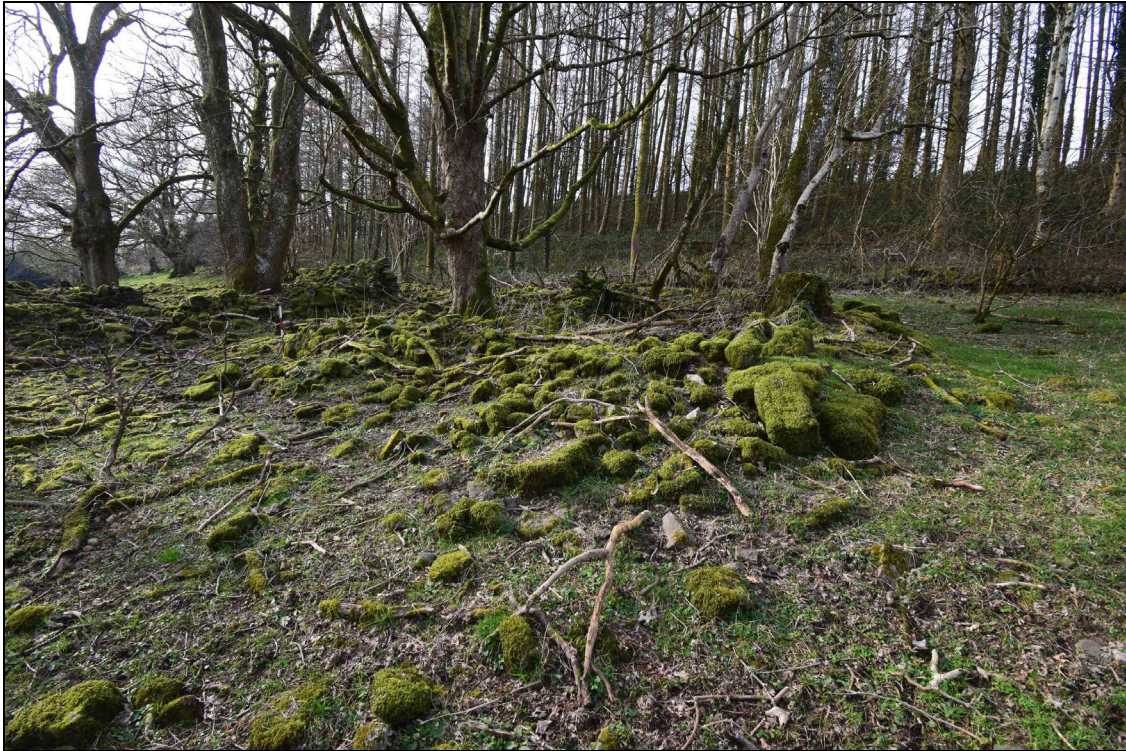
Plate 19: CTD2018_019. A view of the small outbuilding (ID number 123) to the northeast of the former farmhouse at Carreg y Gath. Looking northwest.

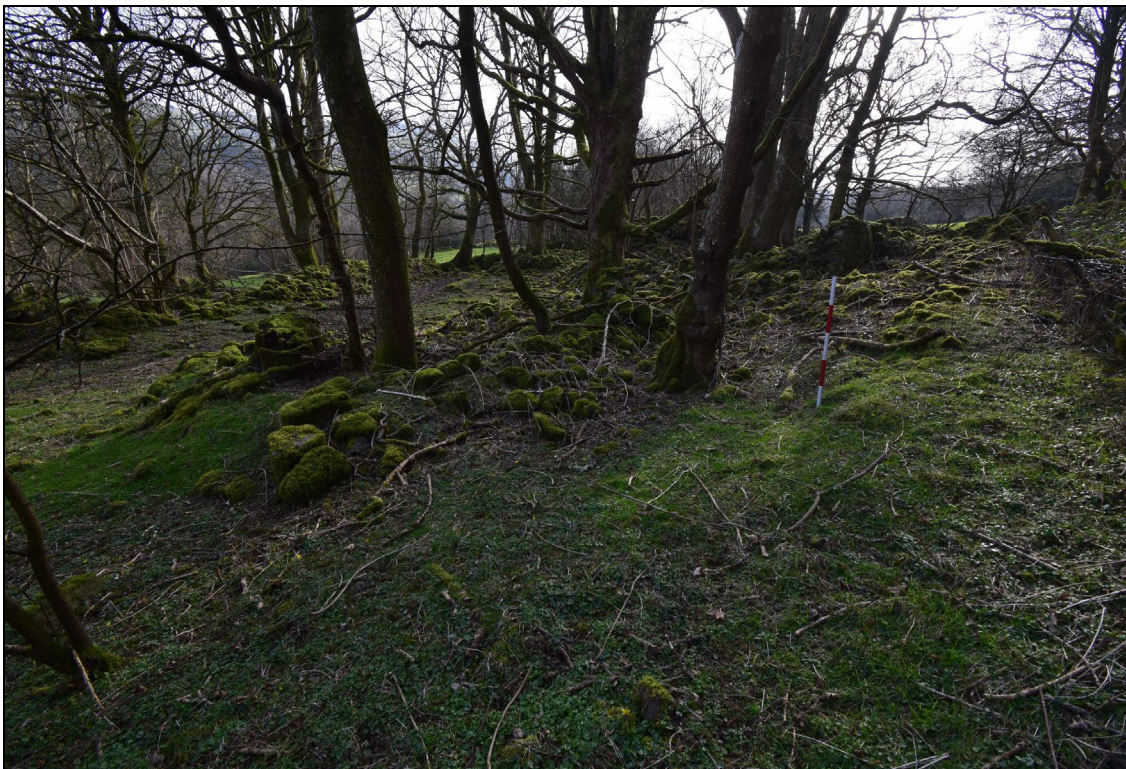
Plate 20: CTD2018_020. A view of the small outbuilding (ID number 123) to the northeast of the former farmhouse at Carreg y Gath. Looking southwest.

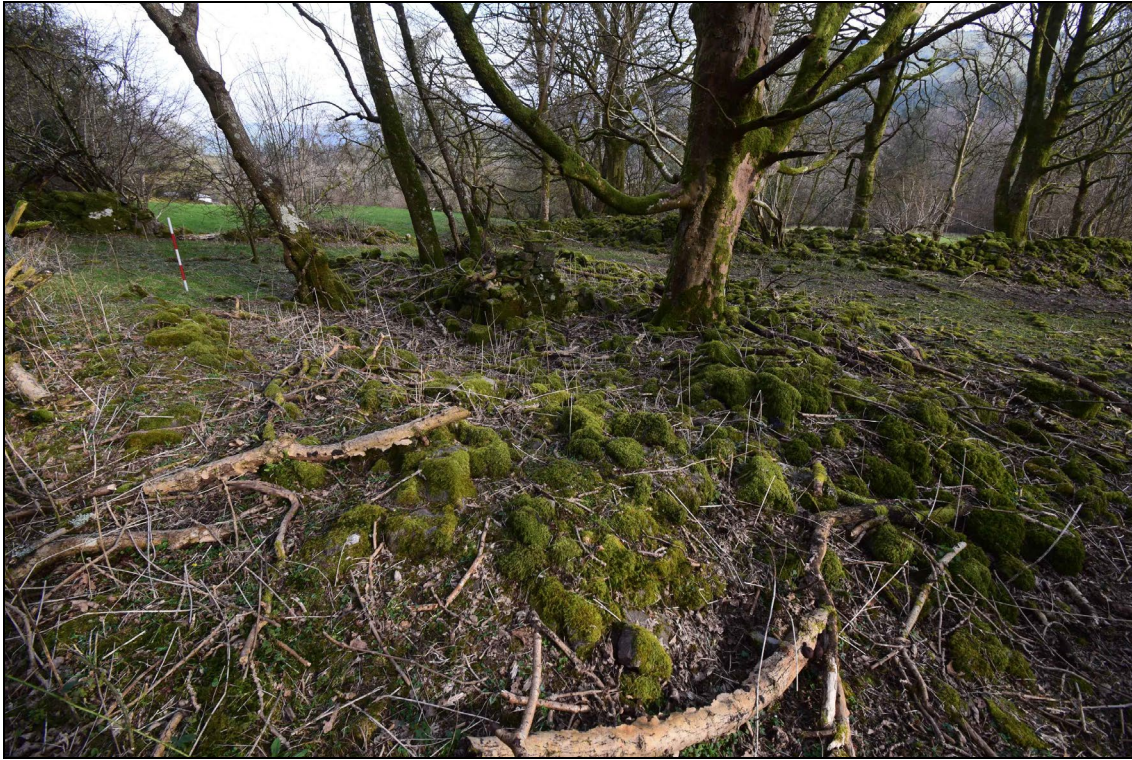
Plate 21: CTD2018_021. A view of the small outbuilding (ID number 123) to the northeast of the former farmhouse at Carreg y Gath. Looking southeast.

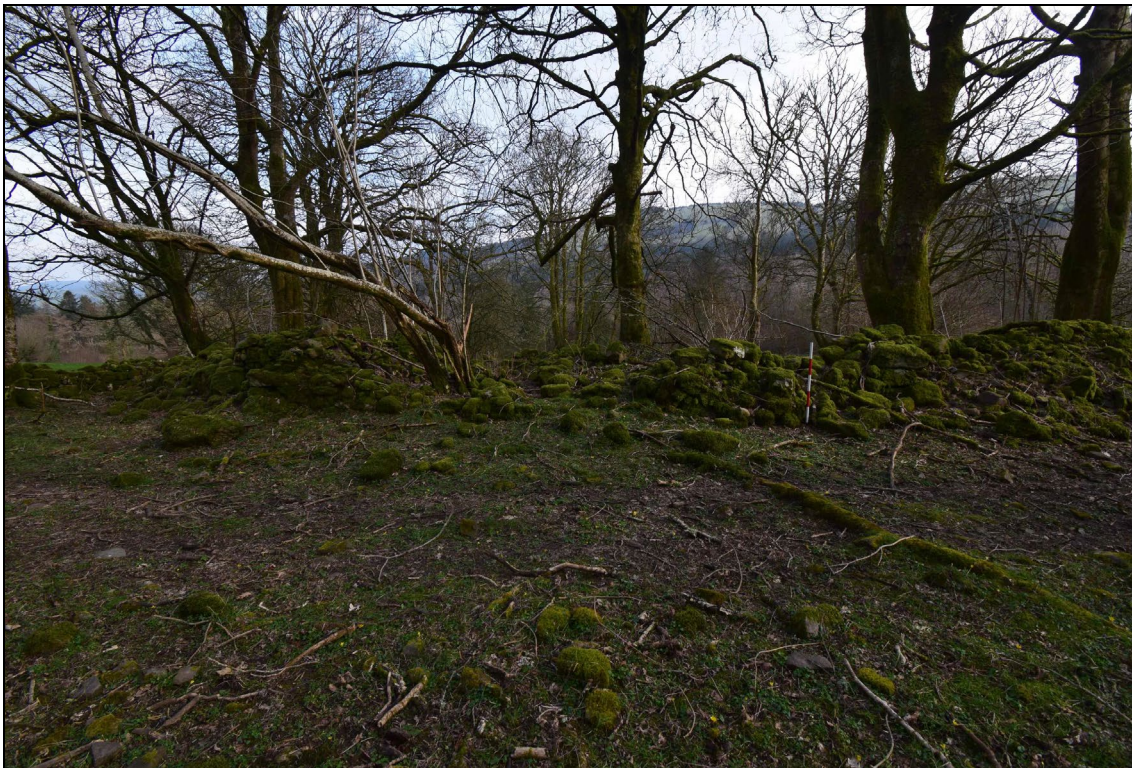
Plate 22: CTD2018_022. A view of the small outbuilding (ID number 124) to the east of the former farmhouse at Carreg y Gath. Looking southeast.

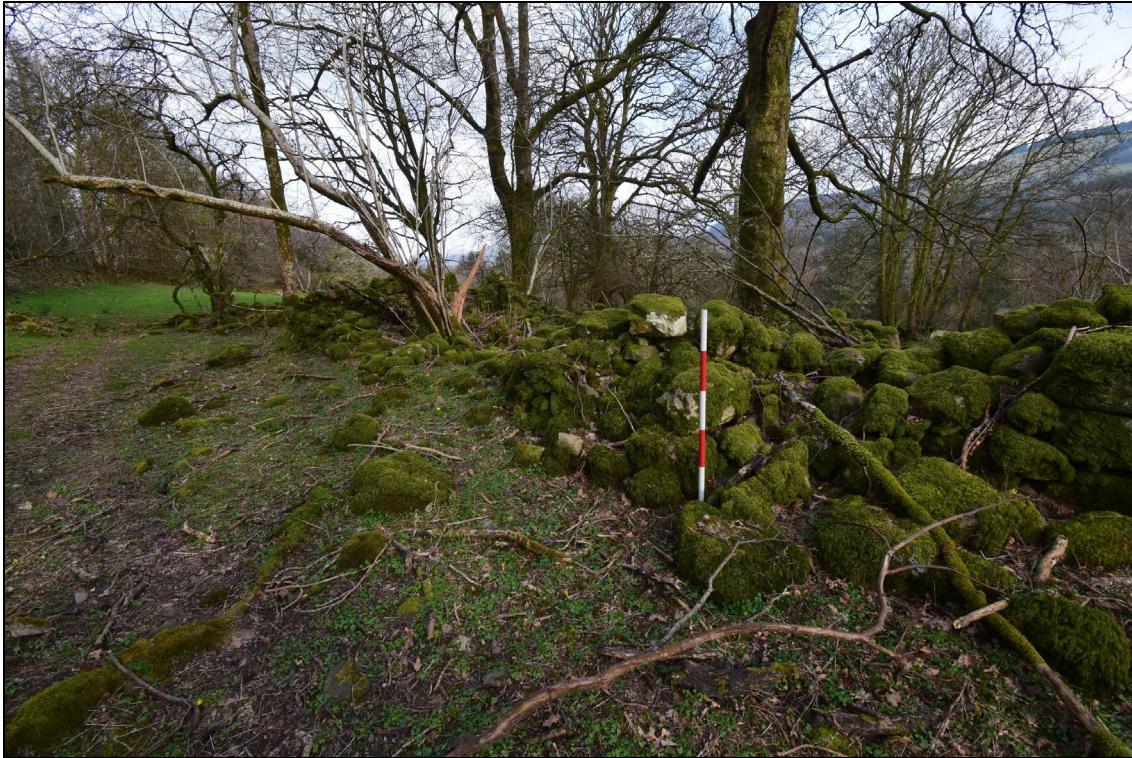
Plate 23: CTD2018_023. A view of the small outbuilding (ID number 124) to the east of the former farmhouse at Carreg y Gath. Looking northeast.

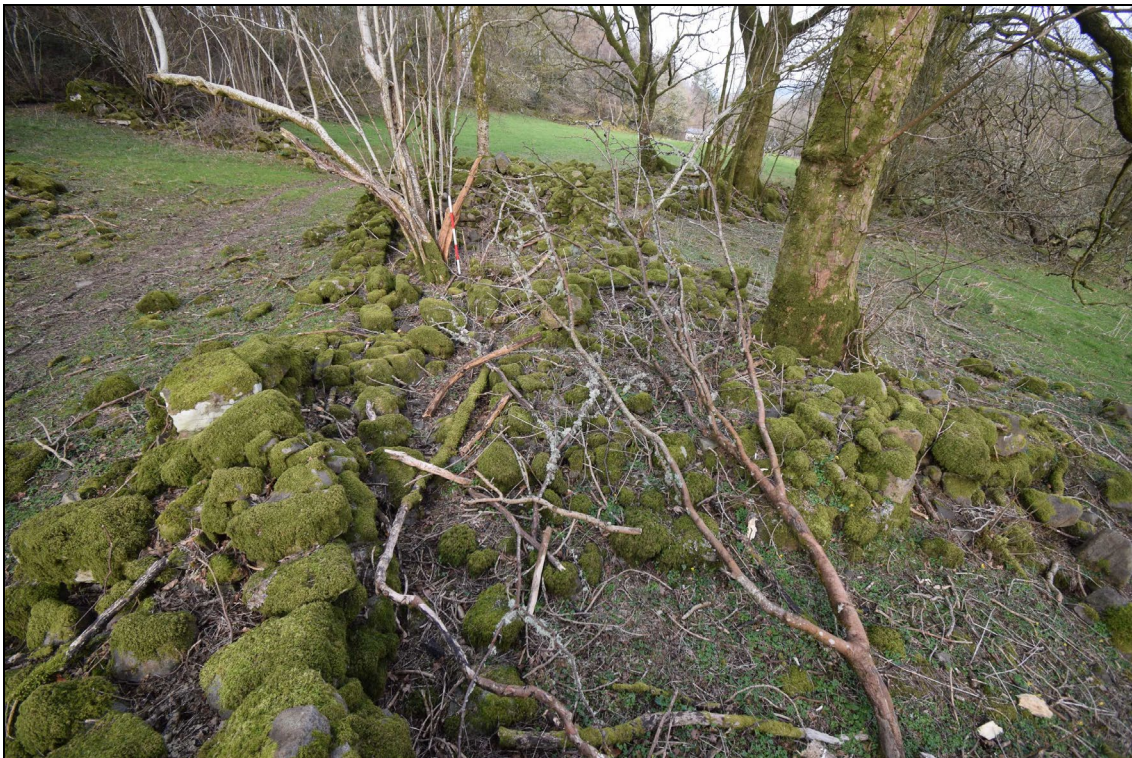
Plate 24: CTD2018_024. A view of the small outbuilding (ID number 124) to the east of the former farmhouse at Carreg y Gath. Looking north-northeast.
