**HISTORIC ENVIRONMENT
DESK-BASED ASSESSMENT AND
WALKOVER SURVEY FOR A
ONE PLANET DEVELOPMENT AT
COEDTALYLAN, CARMARTHENSHIRE
23-22338-PAYPRE (BBNP)
COEDTALYLAN, PLOT 2**

June 2024

Trysor Project Number: 2024/900

RHIF YR ADRODDIAD - REPORT NUMBER: Trysor 2024/900

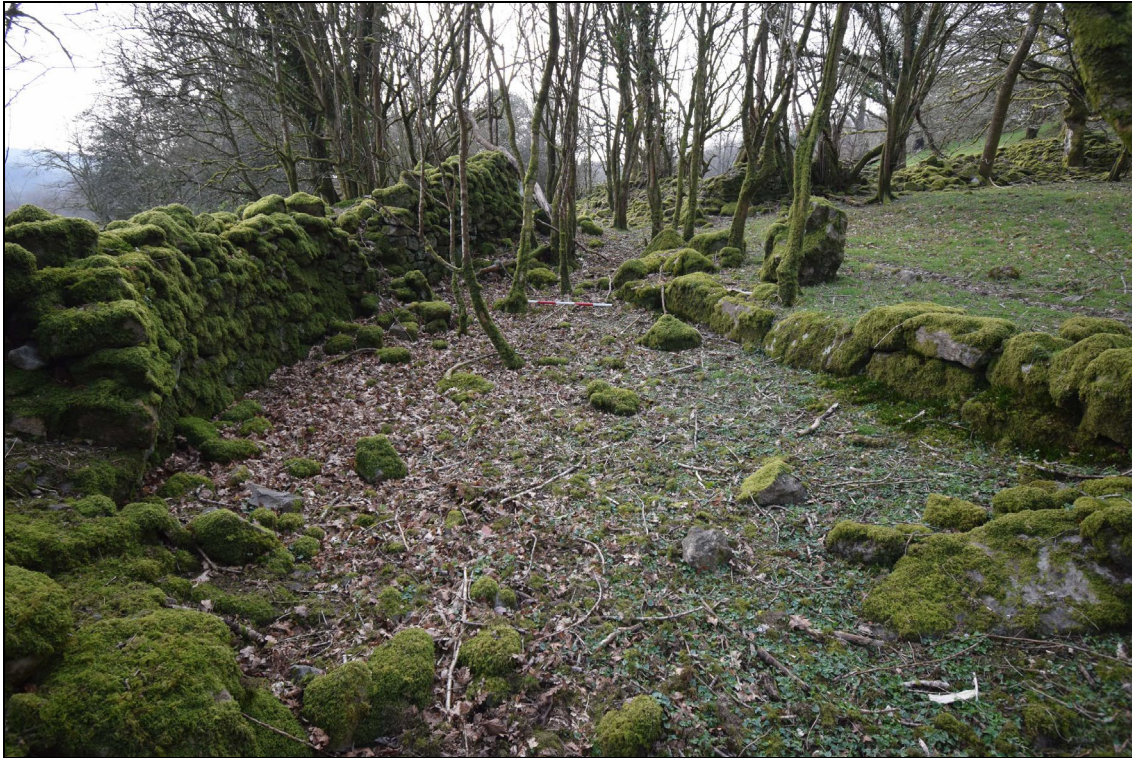
Plate 25: CTD2018_025. A view of the former pond (ID number 125) to the south of the former farmhouse at Carreg y Gath. Looking southwest.

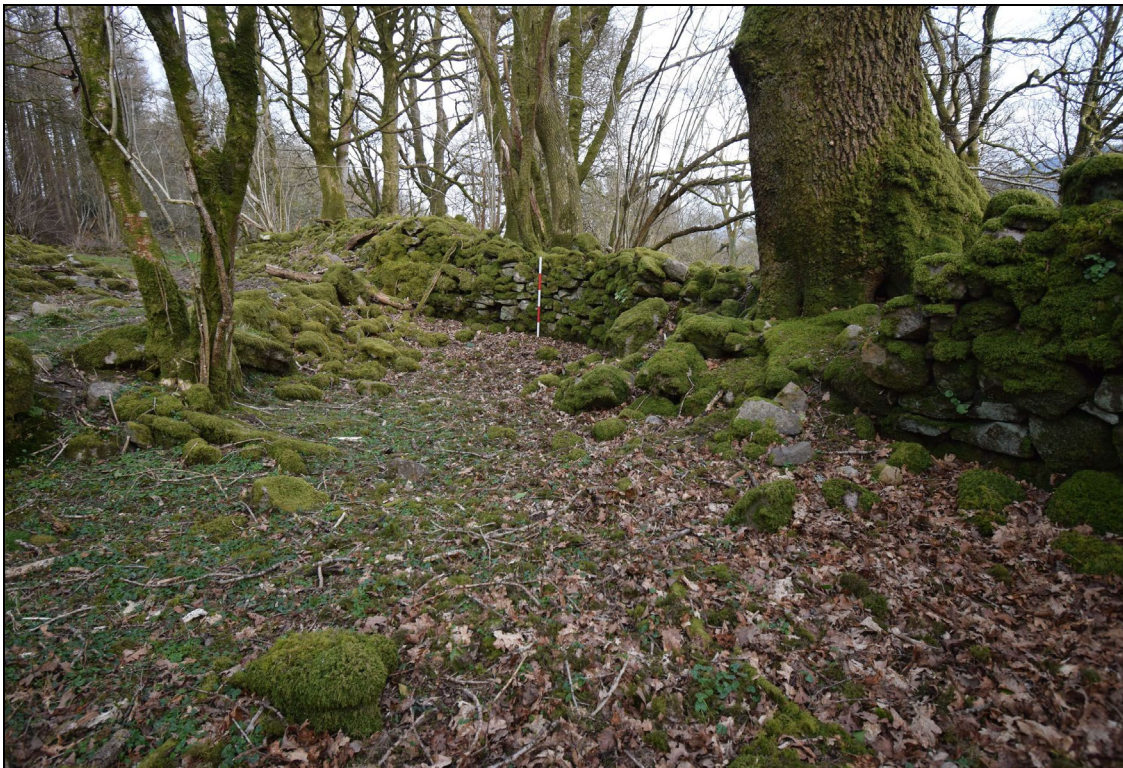
Plate 26: CTD2018_026. A view of the former pond (ID number 125) to the south of the former farmhouse at Carreg y Gath. Looking northeast.

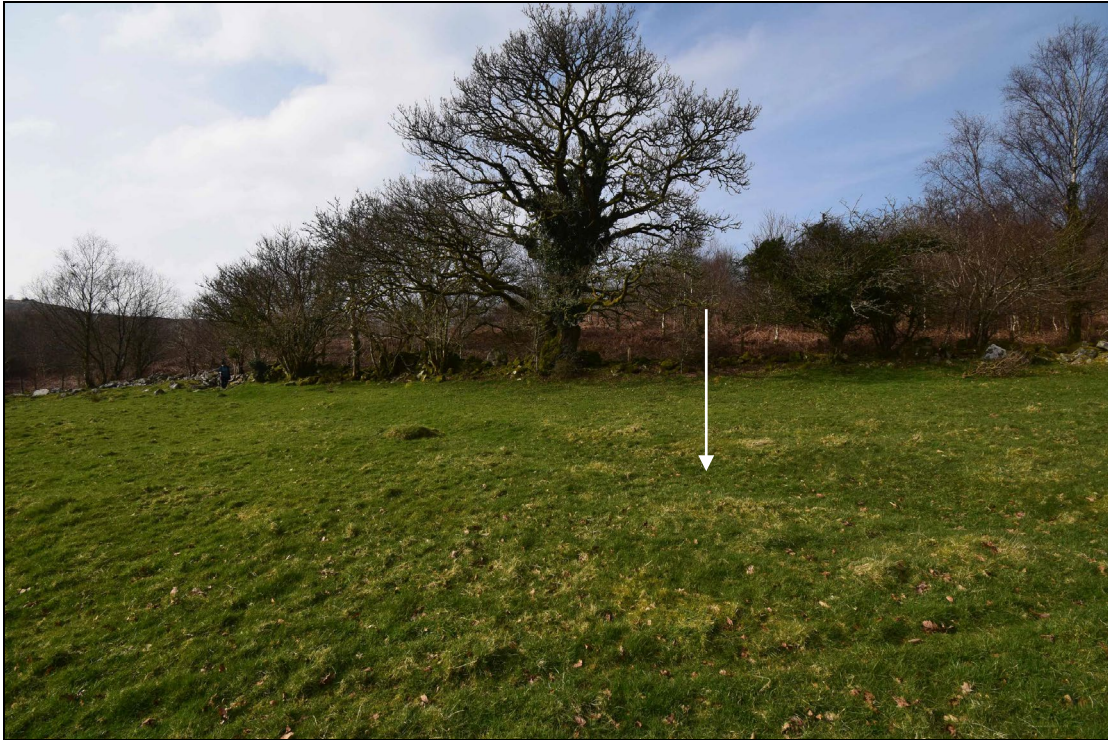
Plate 27: CTD2018_027. A view of leat ID number 122 running across a pasture field to the southwest of Carreg y Gath farmstead. The leat which supplied water to pond ID number 125. Looking northwest.

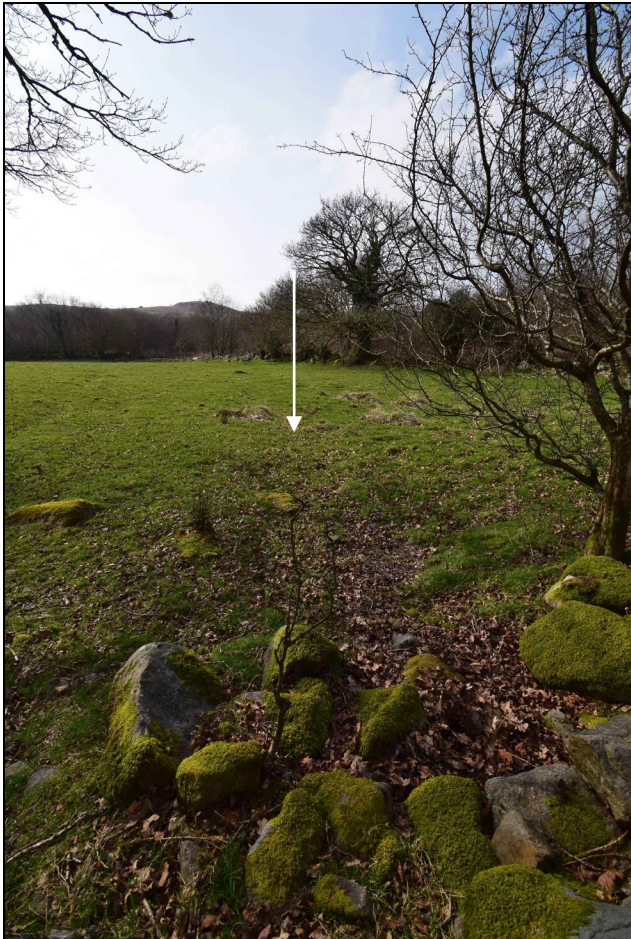
Plate 28: CTD2018_028. A view of leat ID number 122 running across a pasture field to the southwest of Carreg y Gath farmstead. The leat which supplied water to pond ID number 125. Looking west-southwest.

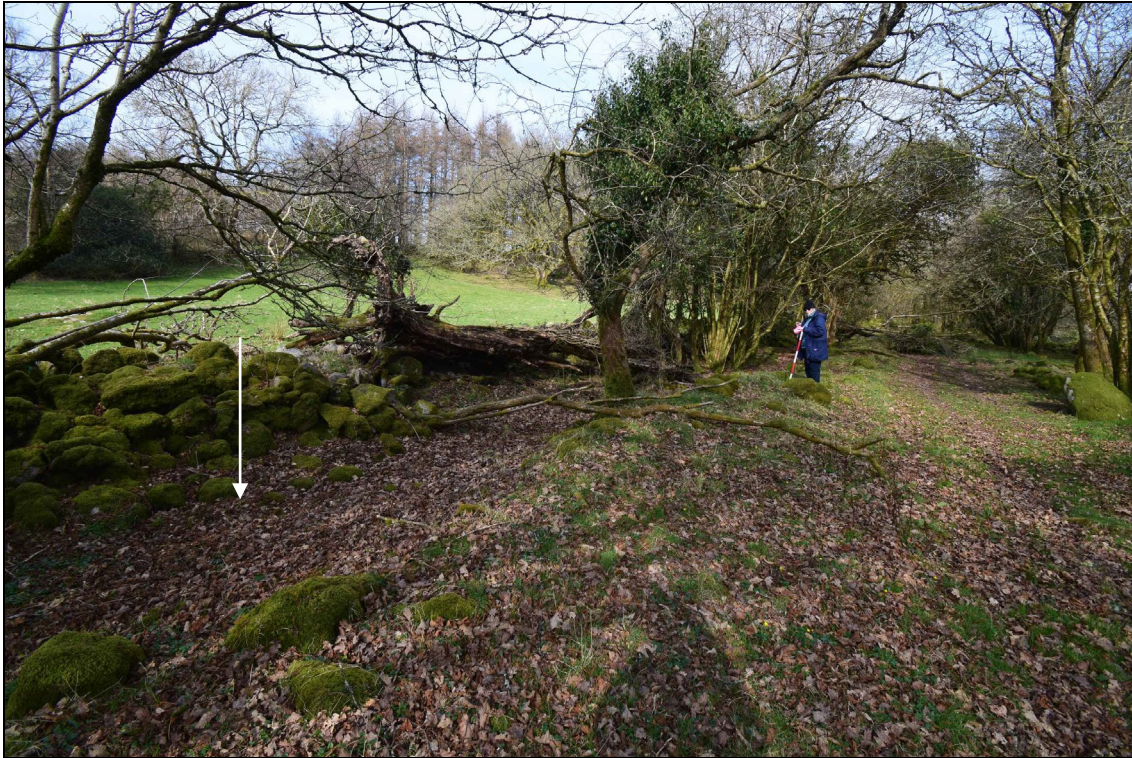
Plate 29: CTD2018_029. A view of leat ID number 122 which runs parallel to the trackway leading towards the farmyard of Carreg y Gath farmstead. Looking north.

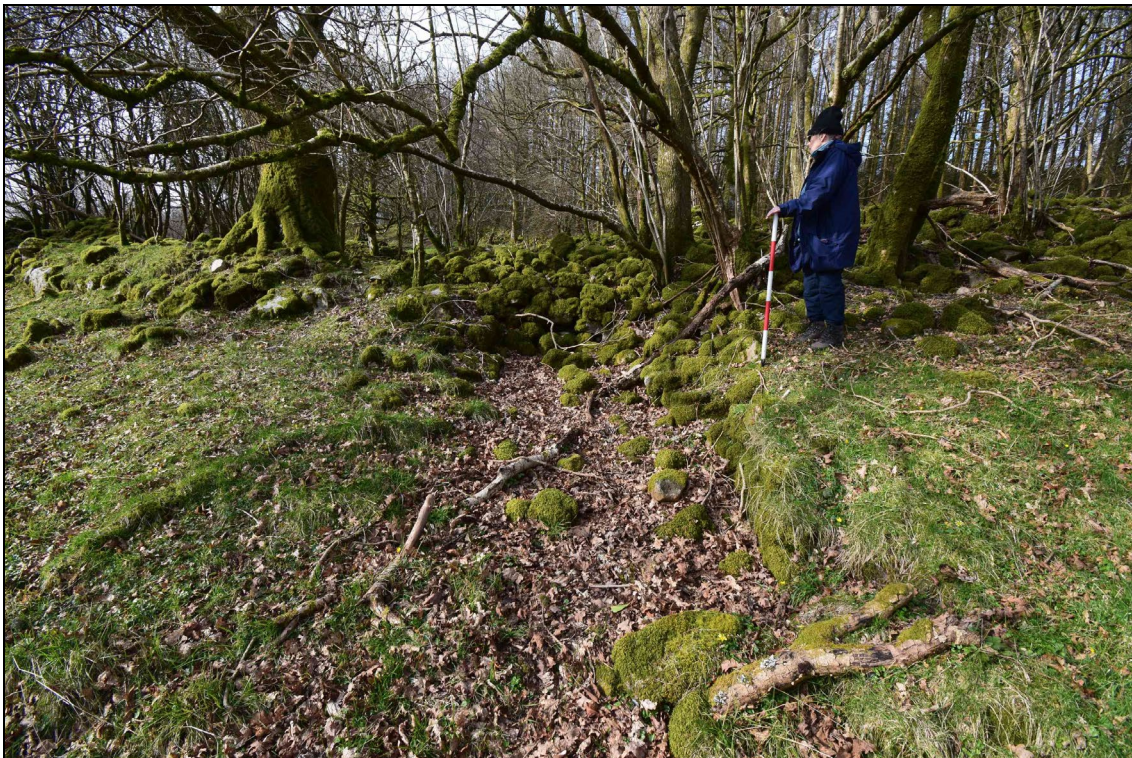
Plate 30: CTD2018_030. A view of the sluice of pond ID number 125 which let water into leat ID number 128. Looking northwest.

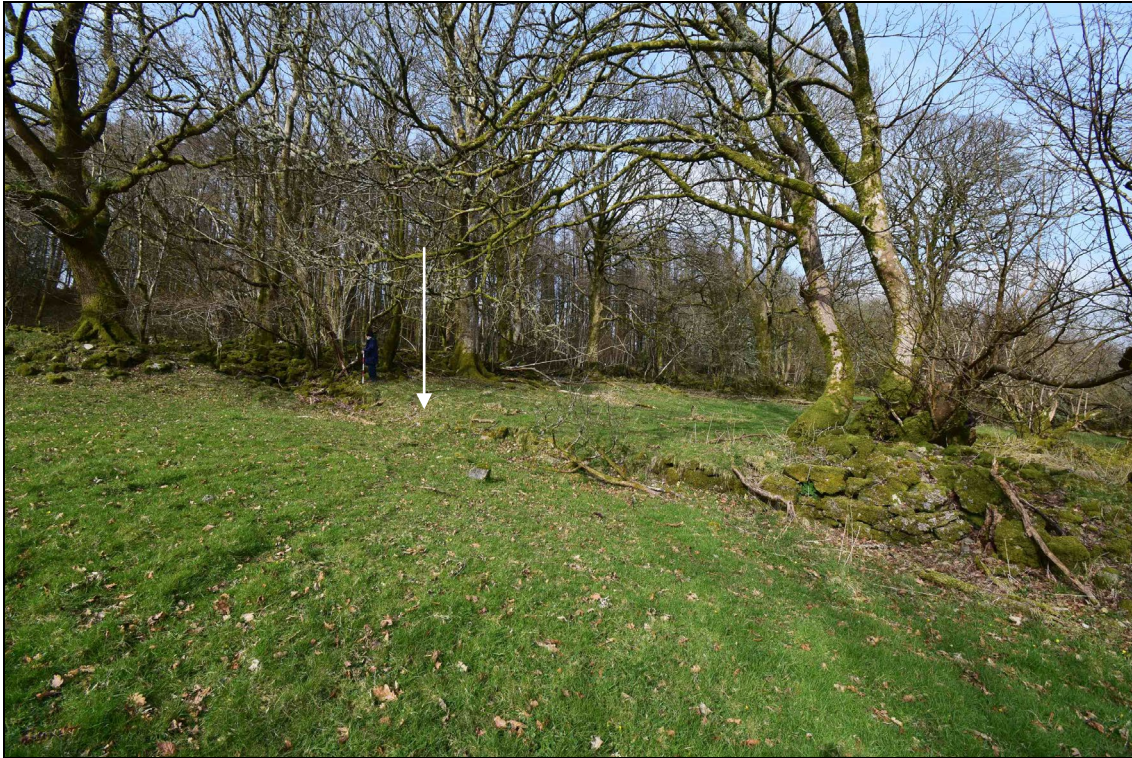
Plate 31: CTD2018_031. A view towards leat ID number 128, which ran parallel to a now denuded field boundary. Looking north.

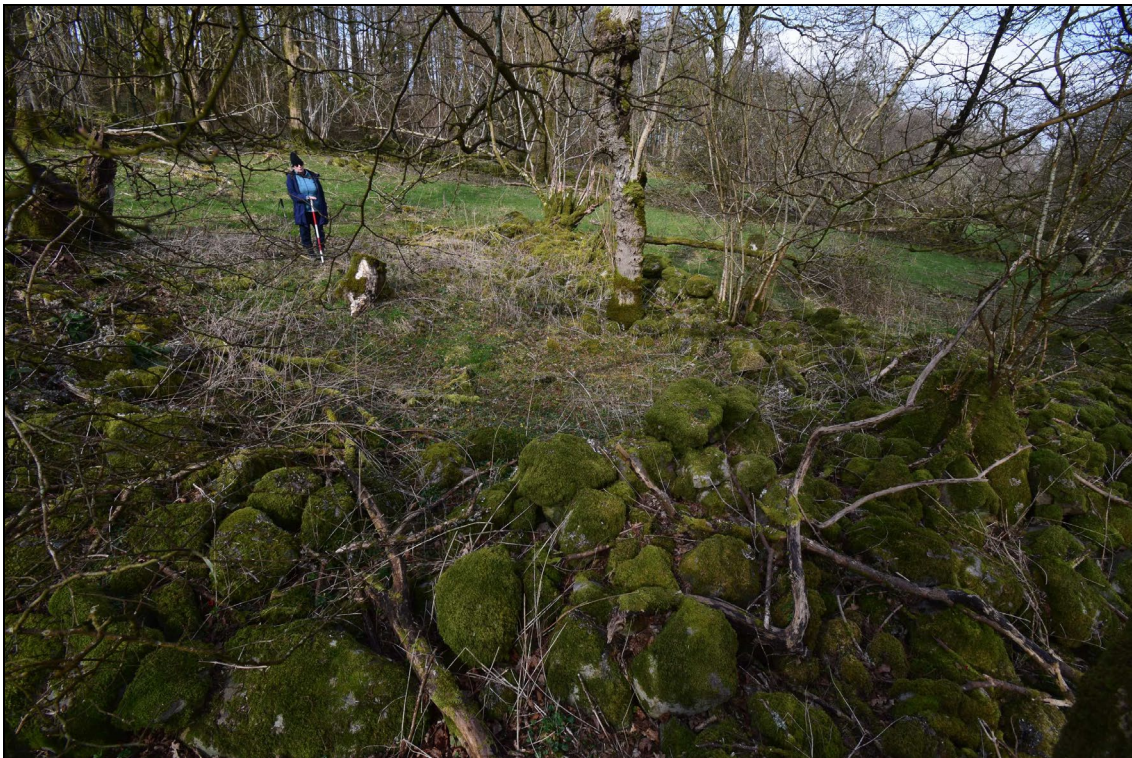
Plate 32: CTD2018_032. A view of pond ID number 126, looking north.

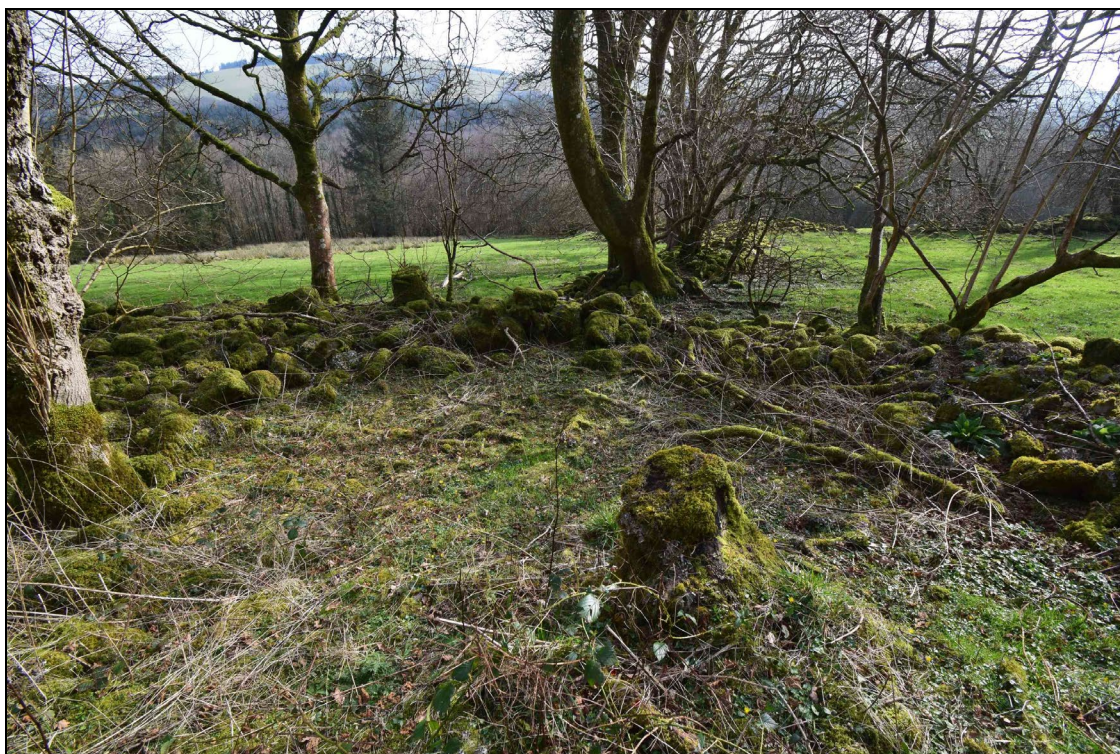
Plate 33: CTD2018_033. A view of pond ID number 126, looking southeast.

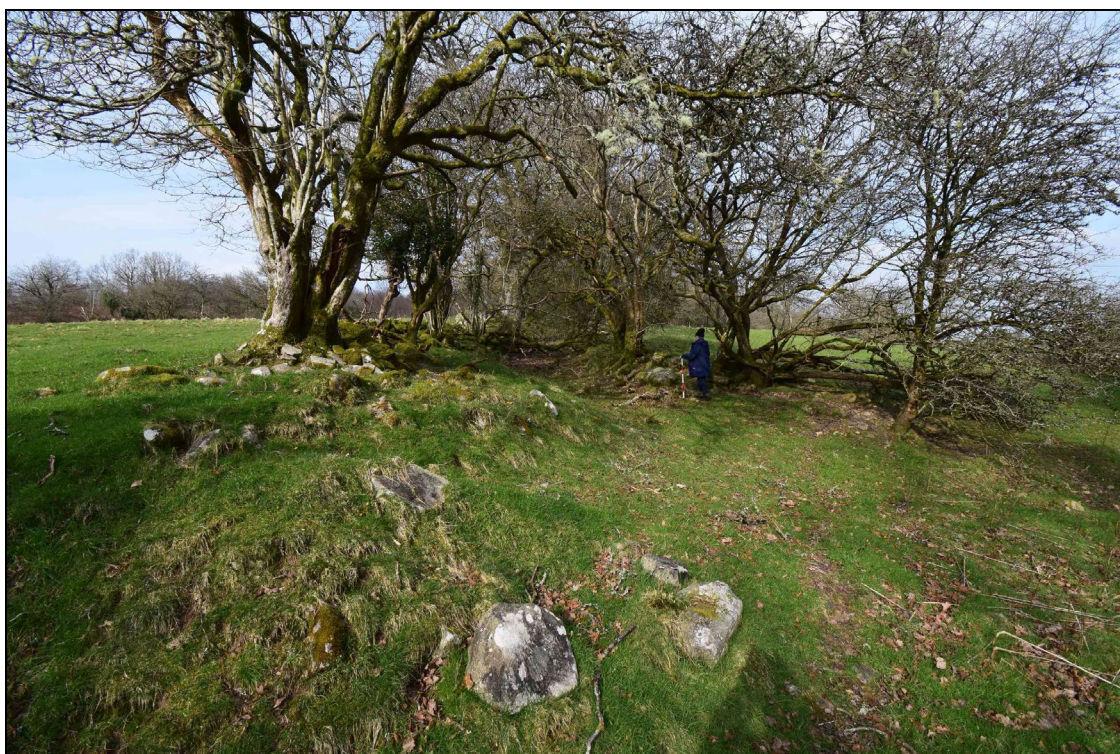
Plate 34: CTD2018_034. A view towards the hollow way section of trackway ID number 118. Looking north.

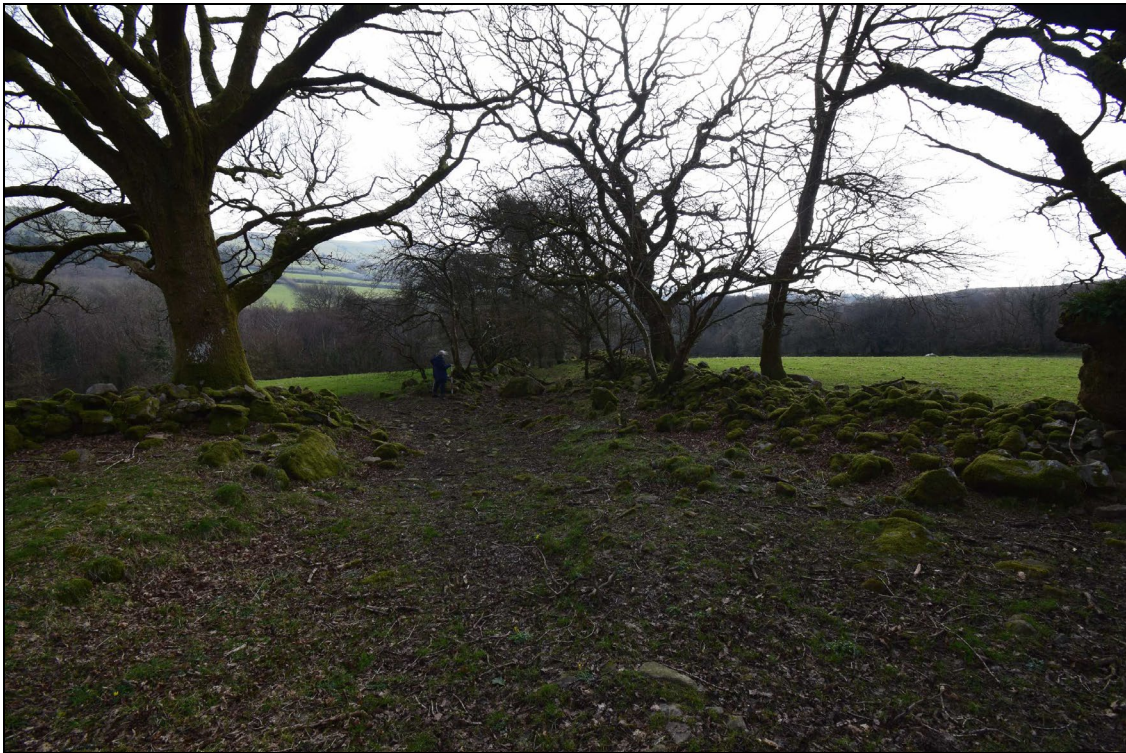
Plate 35: CTD2018_035. A view towards the holloway section of trackway ID number 118. Looking south-southwest.

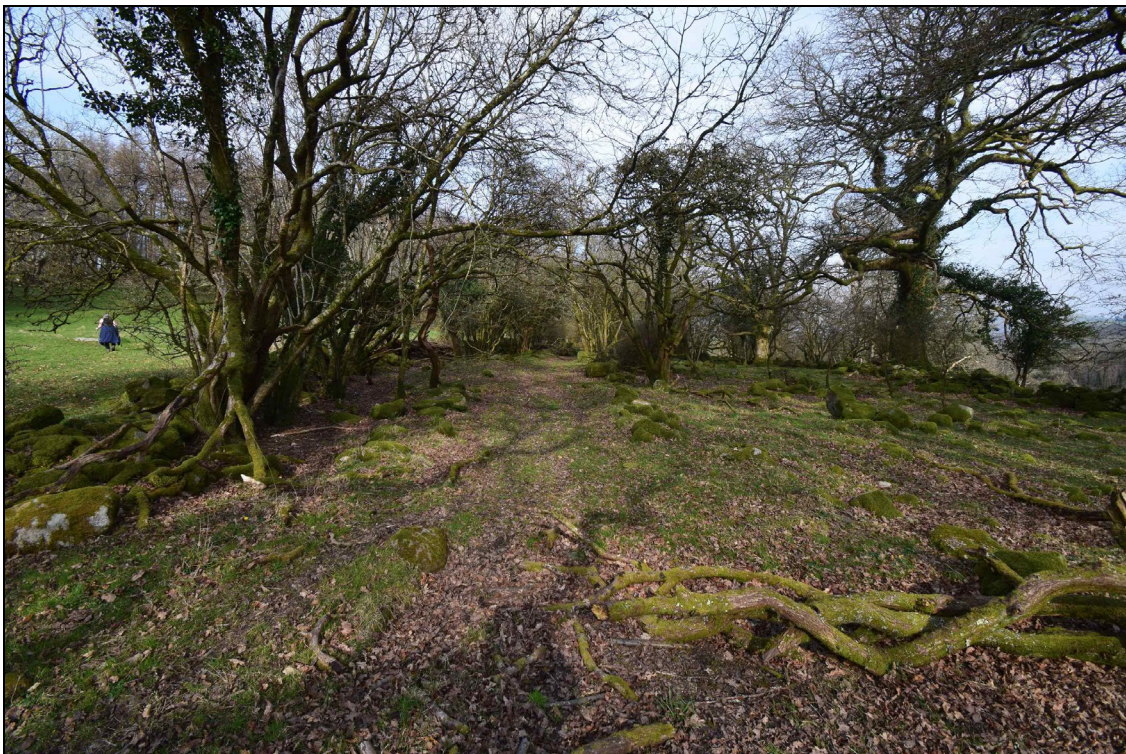
Plate 36: CTD2018_036. A view of the northern section of trackway ID number 118 as it approaches the farmyard of Carreg y Gath. Looking northeast.

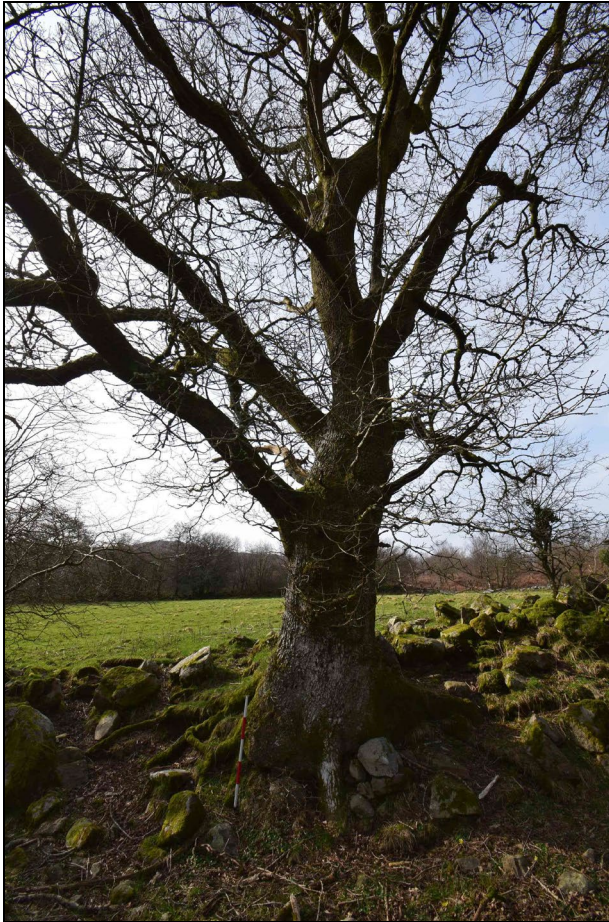
Plate 37: CTD2018_037. A view of a mature tree growing in the side of the Holloway of trackway ID number 118. Looking west.

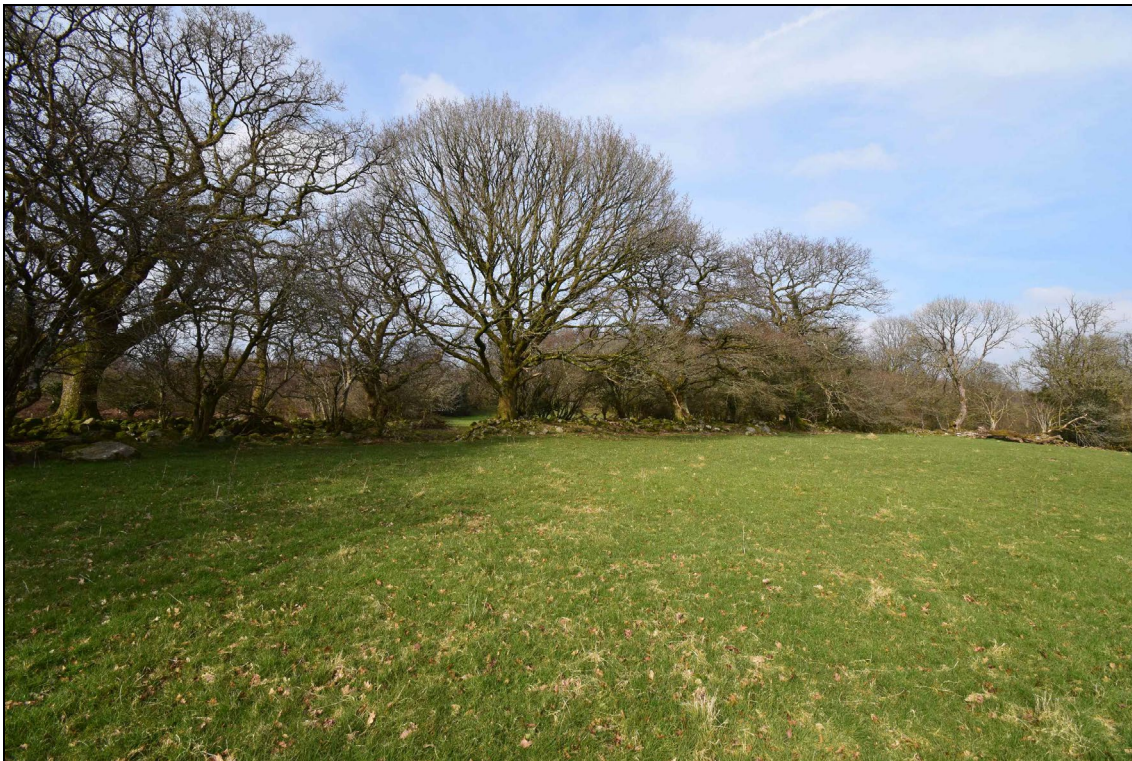
Plate 38: CTD2018_038. A view towards trackway ID number 118. Looking north-northwest.

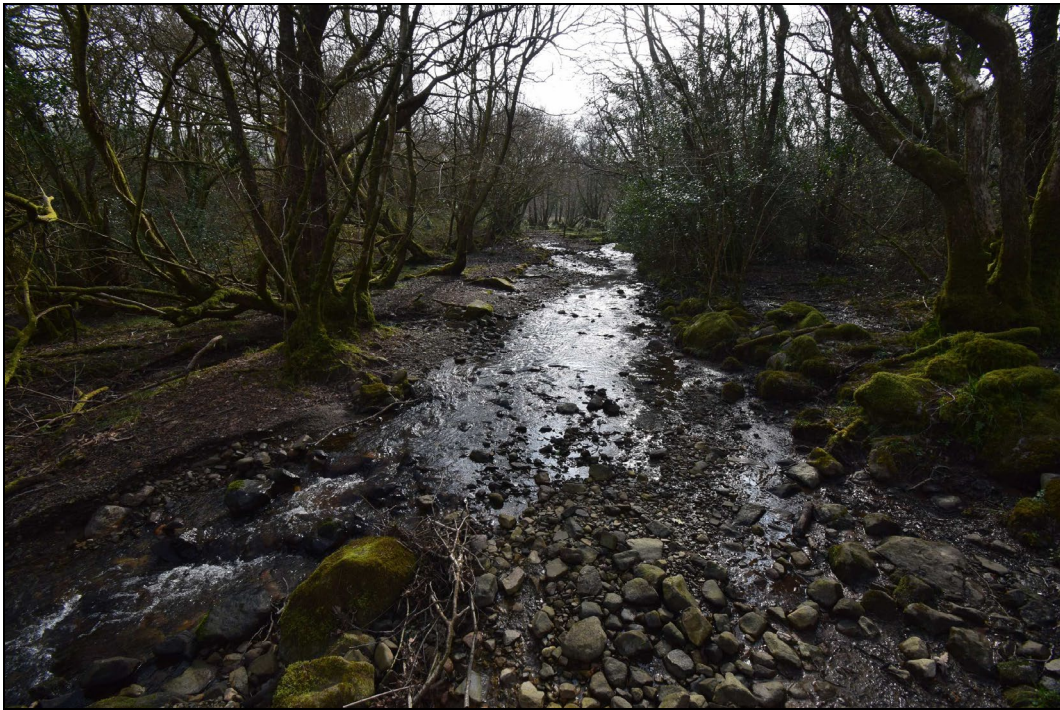
Plate 39: CTD2018_039. A view of ford ID number 112. Looking south-southeast.

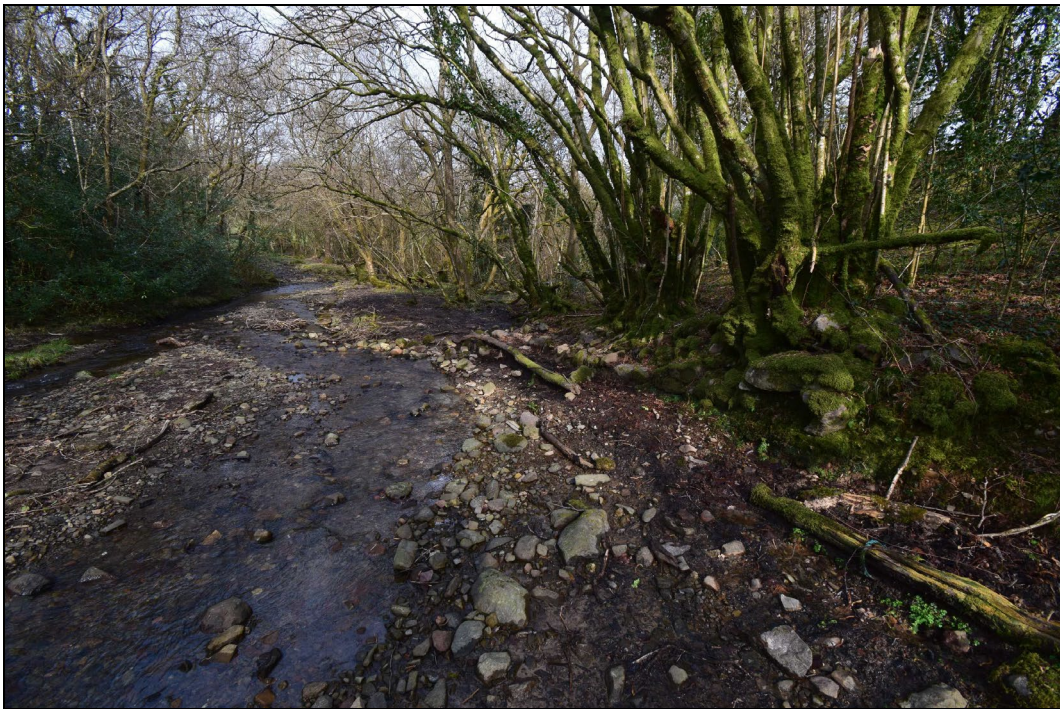
Plate 40: CTD2018_040. A view of ford ID number 112. Looking north-northwest.

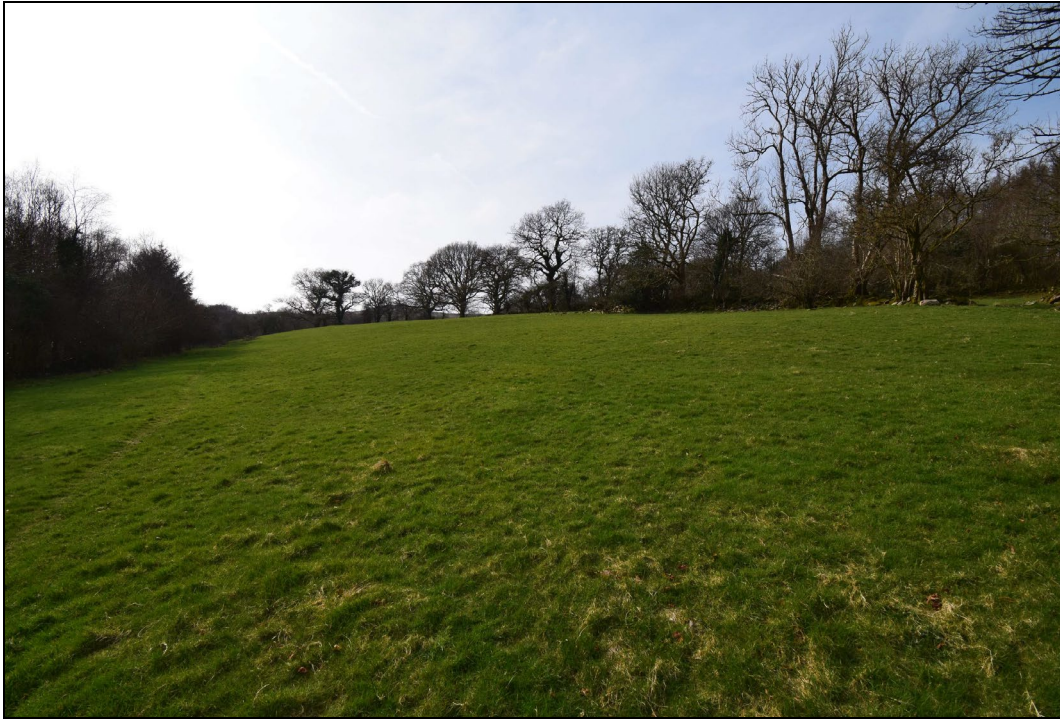
Plate 41: CTD2018_041. A view of field system ID number 119, now obscured by mature trees growing along the field boundaries to the right of centre, as seen from the field to the south. Note that the Iron Age hillfort of Garn Goch is just visible through the trees left of centre. Looking west-southwest.

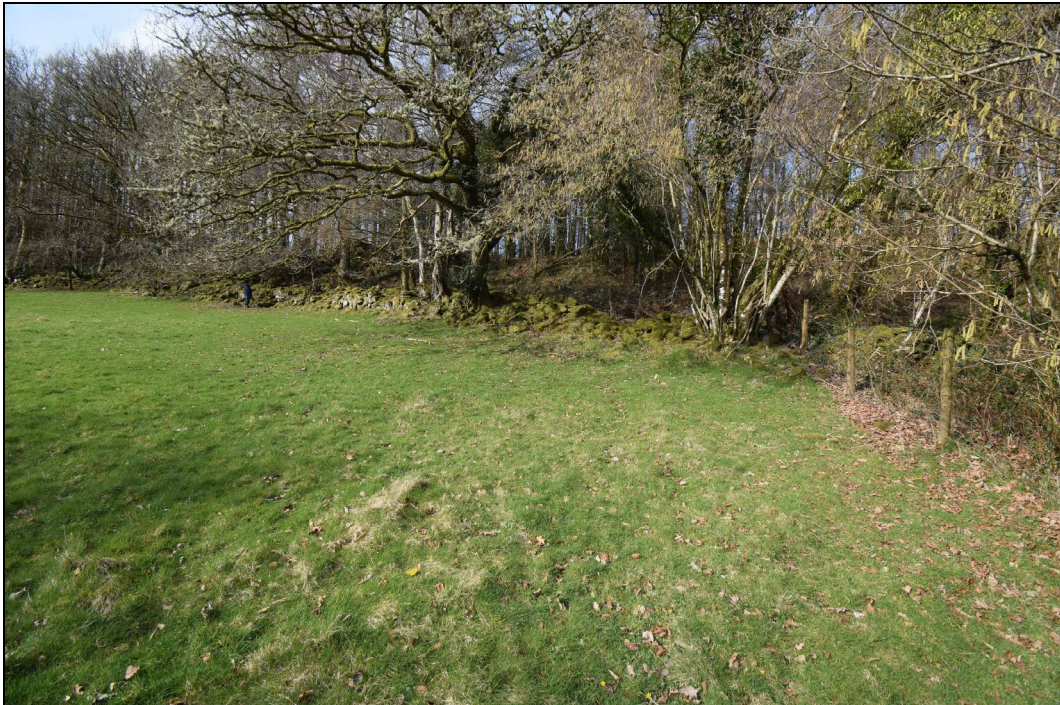
Plate 42: CTD2018_042. A view of the northeast boundary of the Coedtalylan Plot 2 area and field system ID number 119. Looking west-northwest.

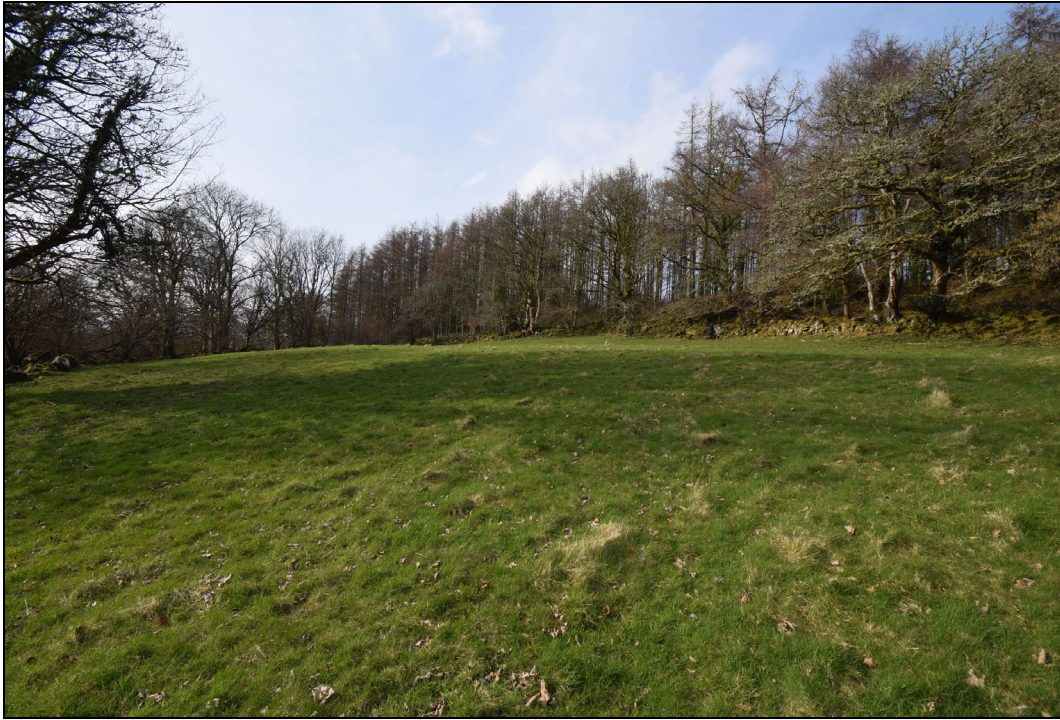
Plate 43: CTD2018_043. A view of the northeast boundary of the Coedtalylan Plot 2 area and field system ID number 119. Looking west.

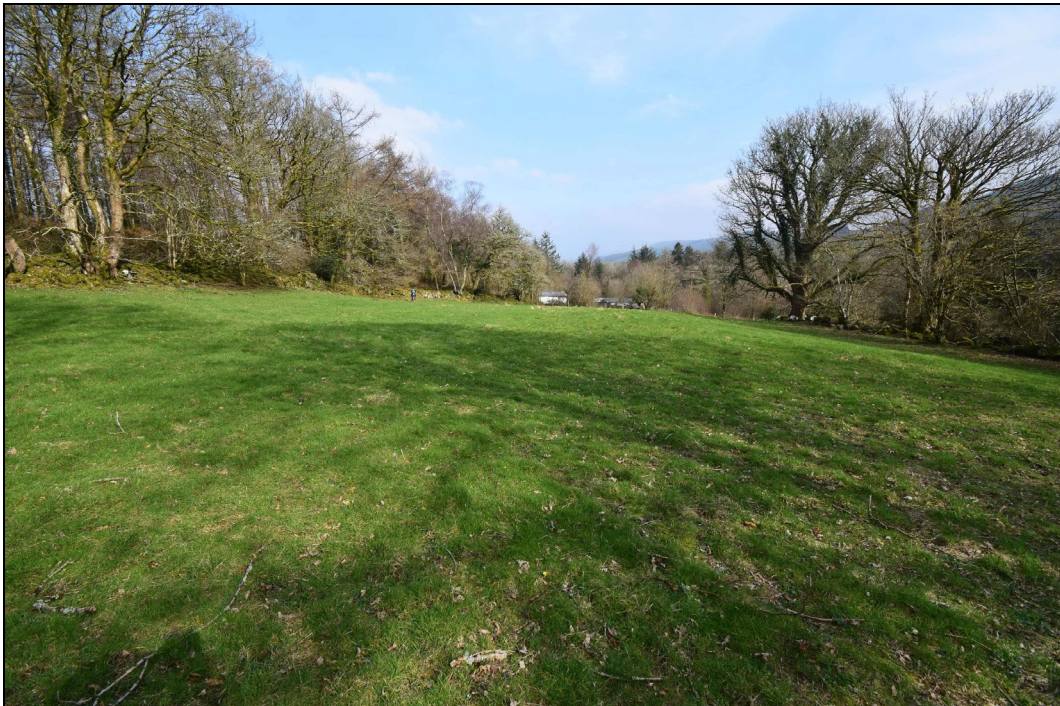
Plate 44: CTD2018_044. A view of the eastern boundary of the Coedtalylan Plot 2 area, from within field system ID number 119. The proposed dwelling would be built on the level ground in the foreground. Looking east-northeast.

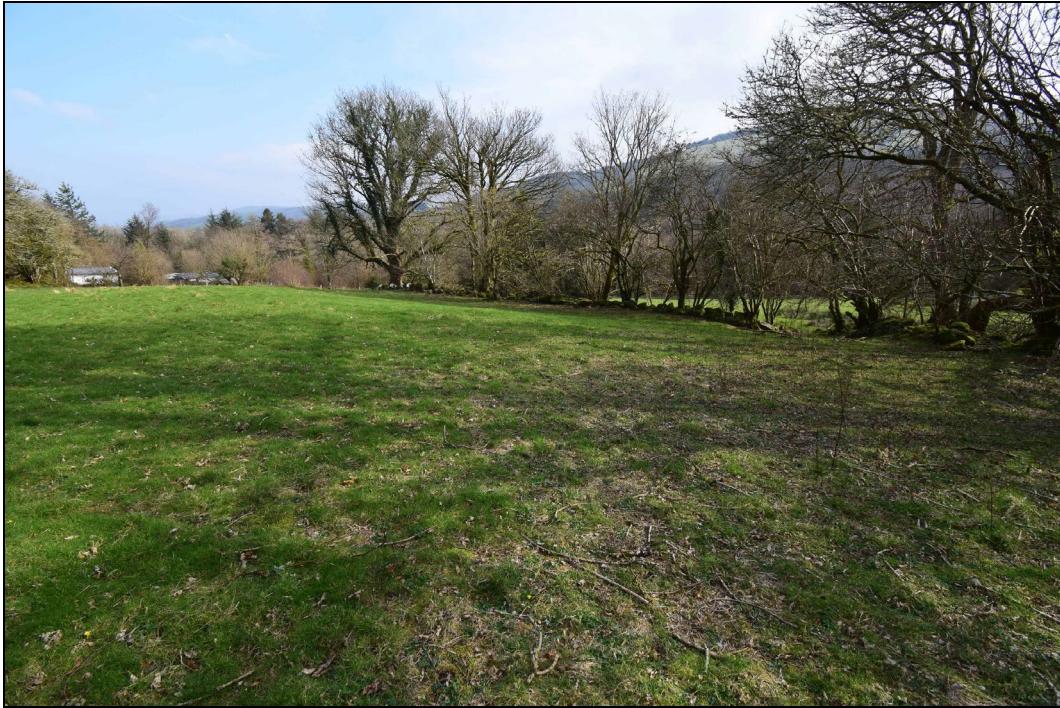
Plate 45: CTD2018_045. A view towards the eastern boundary of the Coedtalylan Plot 2 area, from within field system ID number 119. The proposed dwelling would be built on the level ground left of centre. Looking east-northeast.

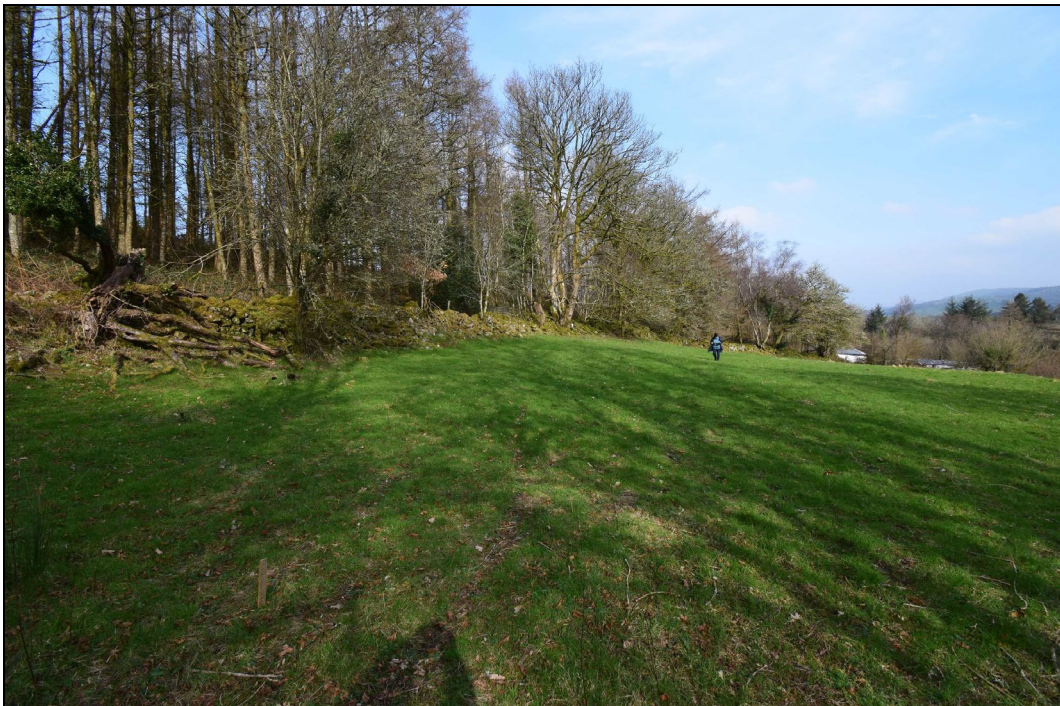
Plate 46: CTD2018_046. A view of the northeastern boundary of the Coedtalylan Plot 2 area, from within field system ID number 119. The proposed dwelling would be built on the level ground right of centre. Looking northeast.

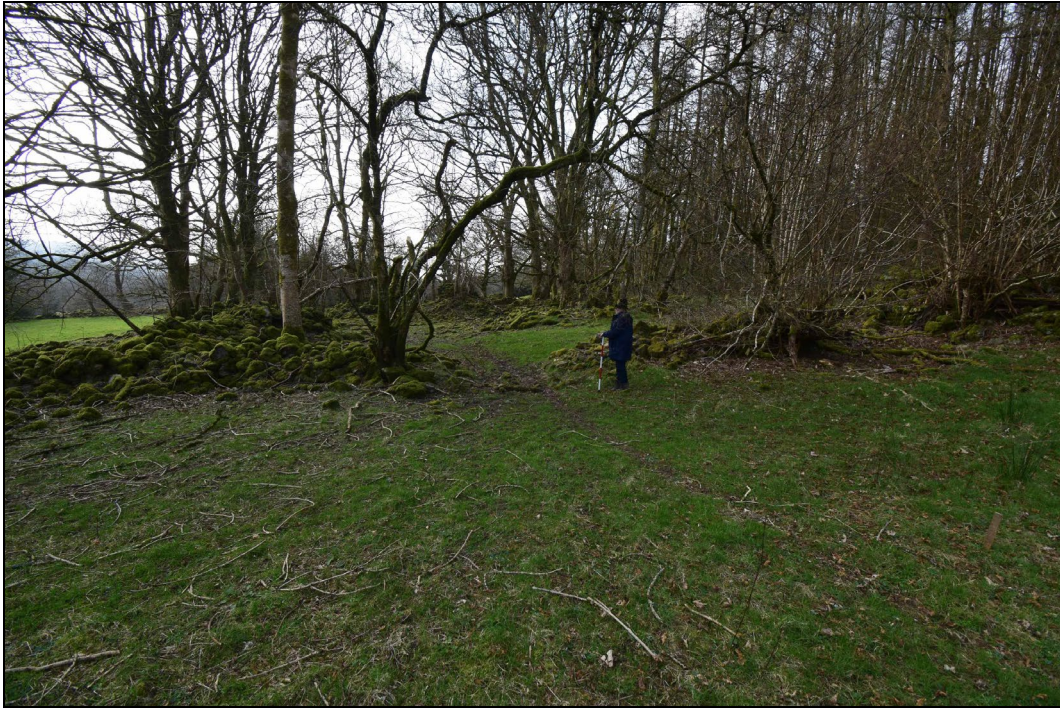
Plate 47: CTD2018_047. A view inside field system ID number 119, looking towards the ruins of Carreg y Gath farmstead. Looking west-southwest.

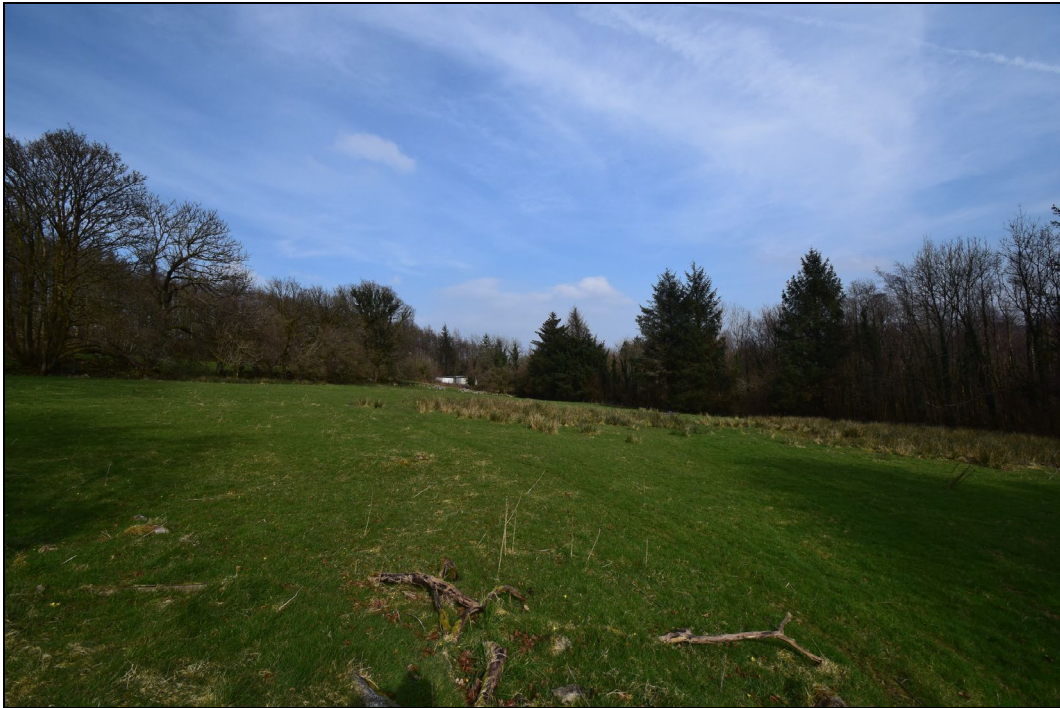
Plate 48: CTD2018_048. A view towards the eastern boundary of Coedtalylan Plot 2. The new access trackway would enter Plot 2 approximately at the location of the first conifer on the boundary to the right centre. Looking northeast.

13.3.2 A more specific recommendation is that the proposed new access track to the development area does not cause disturbance of field boundary bank ID number 95.

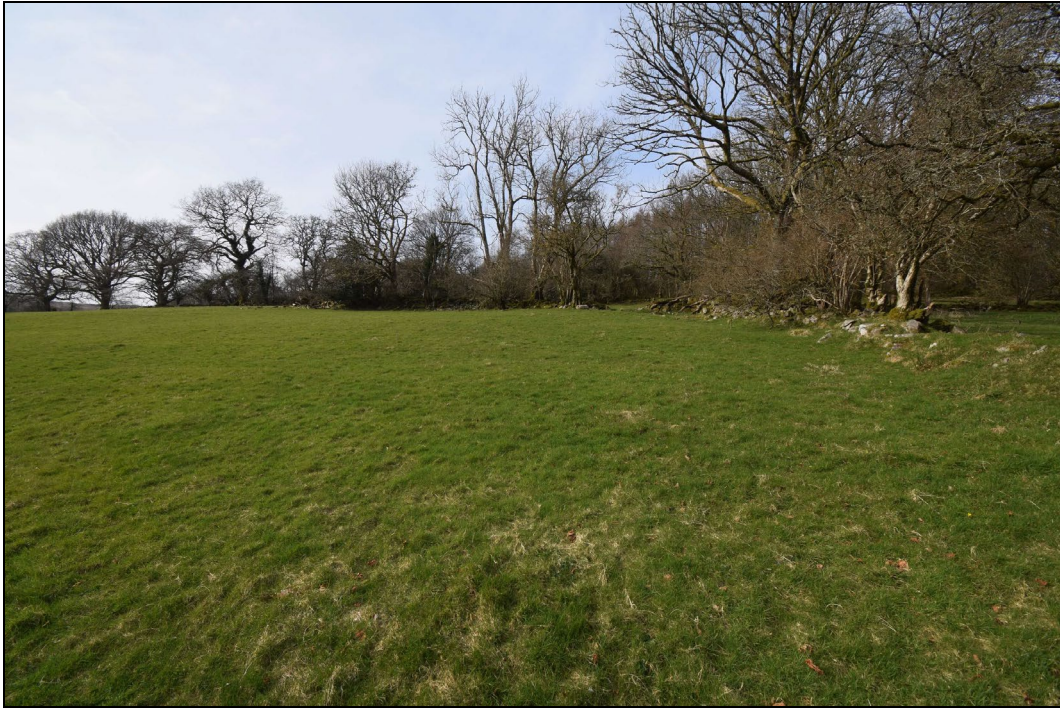
Plate 49: CTD2018_049. A view of the southern side of field system ID number 119, seen to the right. Looking west.

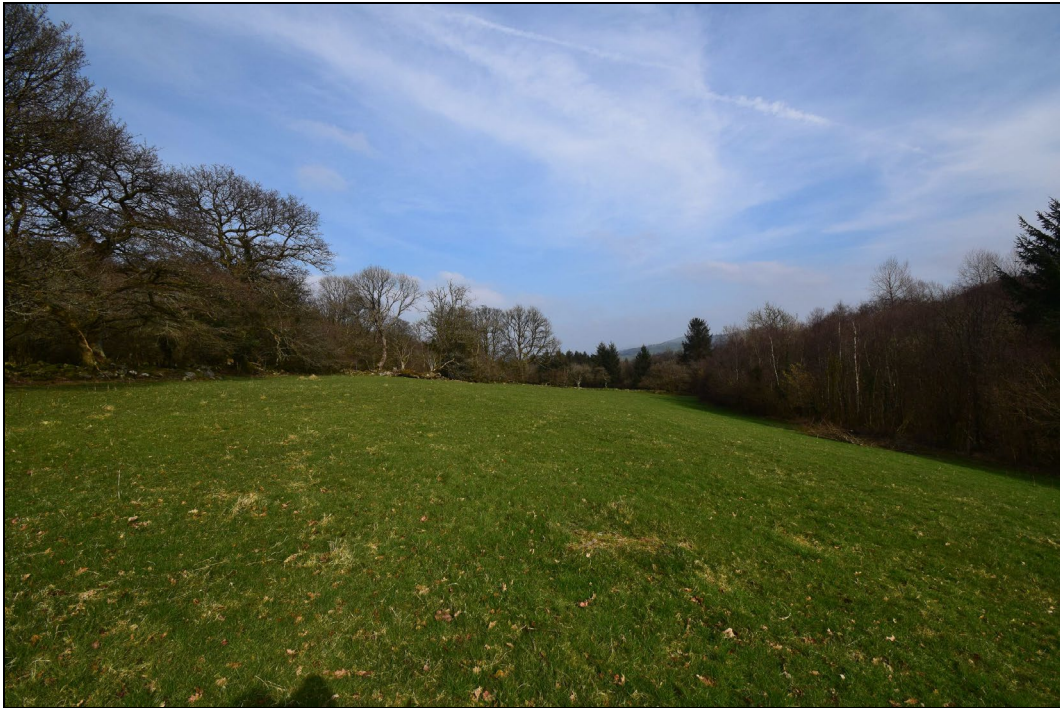
Plate 50: CTD2018_050. A view showing the southern side of field system ID number 119, seen to the left. Part of the woodland to the right is also included in Coedtalylan Plot 2, although this field is not included. Looking northeast.

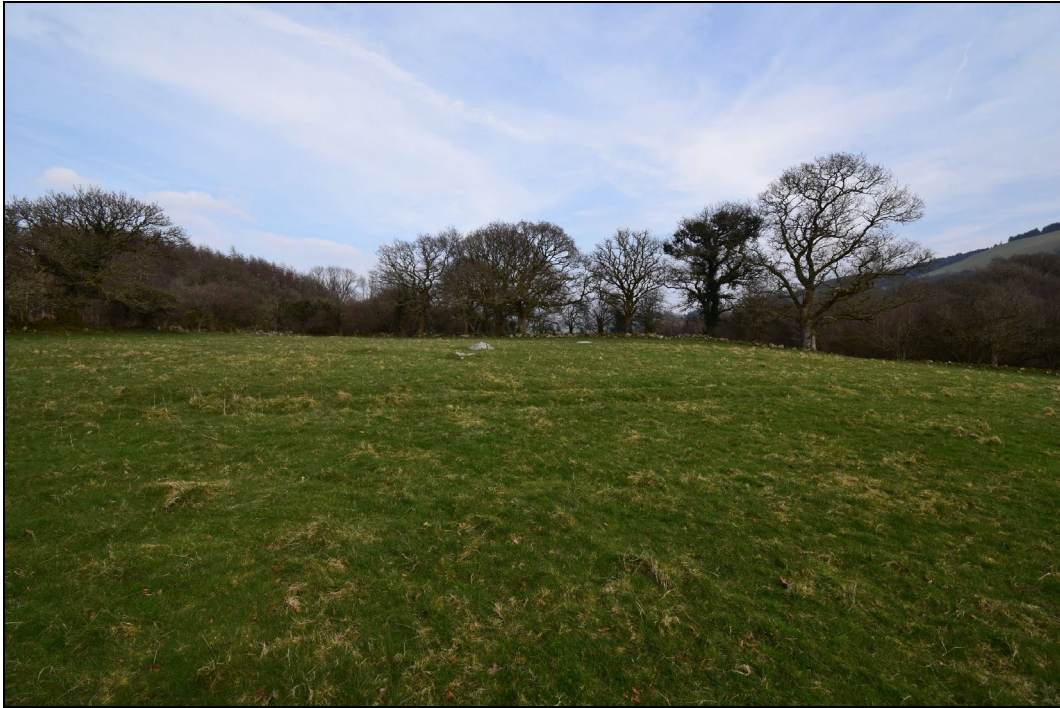
Plate 51: CTD2018_051. A view towards the trackway ID number 118 leading to Carreg y Gath, running below the trees across the centre of the image. Looking east-northeast.

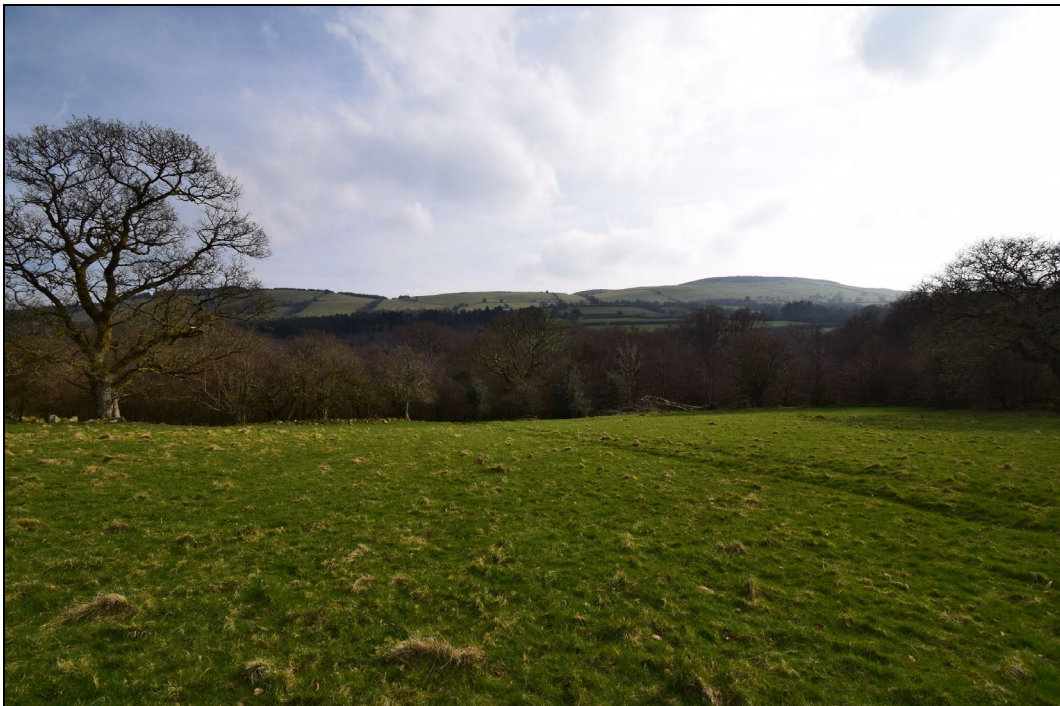
Plate 52: CTD2018_052. A view to the south, with trackway ID number 118 to the left. The Bronze Age cairns on Trichrug are just visible on the highest hill to the right of centre, over 1.5km away. Looking south.
