**HISTORIC ENVIRONMENT
DESK-BASED ASSESSMENT AND
WALKOVER SURVEY FOR A
ONE PLANET DEVELOPMENT AT
COEDTALYLAN, CARMARTHENSHIRE
23-22338-PAYPRE (BBNP)
COEDTALYLAN, PLOT 2**

June 2024

Trysor Project Number: 2024/900

RHIF YR ADRODDIAD - REPORT NUMBER: Trysor 2024/900

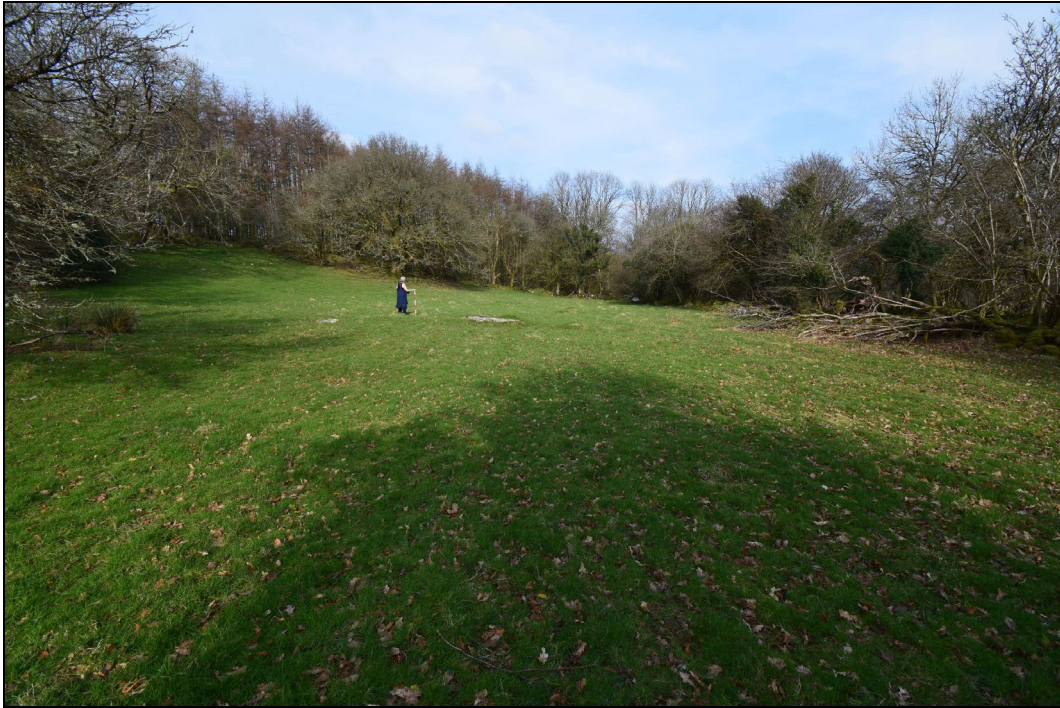
Plate 53: CTD2018_053. A view of Cae Ysgubor, the field to the east of the ruined barn of Carreg y Gath farmstead within field system ID number 119. Carreg y Gath ridge rises to the left. Looking north-northeast.

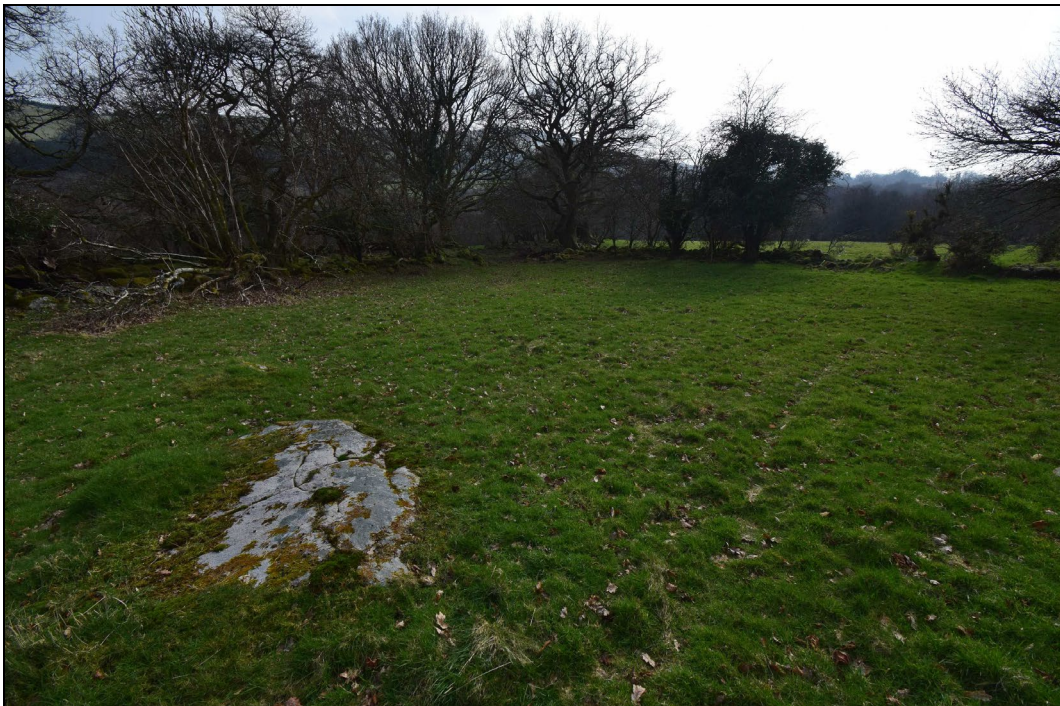
Plate 54: CTD2018_054. A view within Cae Ysgubor, the field to the east of the ruined barn of Carreg y Gath farmstead within field system ID number 119. A slab of bedrock protrudes through the grass. Looking southeast.
