# The Strand and Carriers Lane, Cardigan, Wales

## Archaeological Watching Brief

on behalf of Welsh Water Capital Delivery Alliance

Draft v.1  
27/07/2022

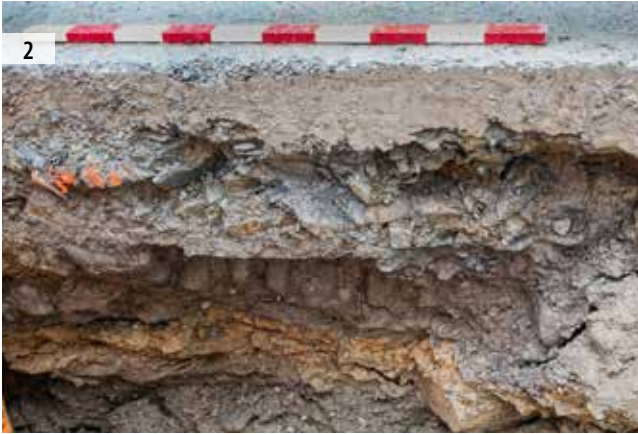
**ILLUS 2** Photo showing intact cobbling surface (1007) in west facing section at CH083

Directly beneath these deposits, at approximately Chainage location 100, was a short length of intact cobbling (1007). This was 7.0m long truncated by a modern service feature. The deposit comprised a single layer of rounded cobbles all measuring approximately 0.12m x 0.07m which lay on their sides within a grey, clayey coarse sand matrix (Illus 2). This deposit was encountered directly underneath the Tarmac and bedding layers and sitting on top of (1006). No finds were recovered from this deposit.

One small area of cobbles (1007) was seen directly below the modern tarmac and bedding layer which was only a single course thick and most likely part of a former phase of road construction.

| 1007 | St | small cobbles of same approximate size (L0.12m, W0.07m) laid vertically within a grey clayey coarse sand matrix. Cobbling of a road surface. | 7m Length in section |

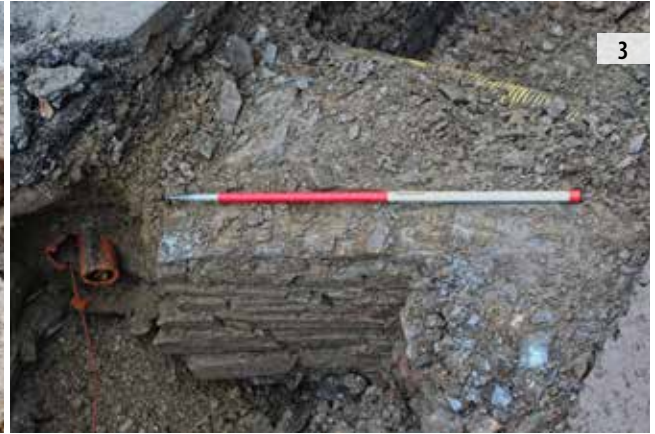
**ILLUS 3** Photo showing dry stone wall (1009) crossing the trench at CH120

At approximately chainage location 120, where Carriers Lane intersects with The Strand, a drystone wall (1009) was encountered which crossed the trench and ran parallel with The Strand road to the east (Illus 3). Orientated northwest to southeast, measuring 1.5m long, 0.5m wide, and 1.0m deep this wall was left in situ. The wall was butted by the deposit to the north (1006) and that to the south (1010). It overlay deposit (1008). This indicates that deposits (1010) and (1006) and the upper tarmac and bedding deposits post-dated the construction of this wall.

There were two small walls identified during the works, only one of which was fully uncovered. Wall (1009) ran across the trench on a northwest to southeast orientation and cuts across the current alignment of The Strand. The orientation and location of the wall appears to correlate with a building visible on The Ordnance Survey 25" map

(1892-1914) which appears to have been demolished as part of road realignment in the 20<sup>th</sup> Century. The material of the wall was slate slabs which correspond with the building material used in the local area. Wall (1012) was also made of the same materials and corresponds to the location of a further building visible on historic OS mapping and subsequently demolished.

| 1009 | St | Dry stone wall running NW/SE with no wall cut. No mortar present. Possible retaining wall for river bank | 1.5m long, 0.5m wide, 1.0m depth |
