Waun Maenllwyd, Ceredigion

Archaeological Watching Brief Report

Waun Maenllwyd Wind Energy Hub Ltd

January 2023

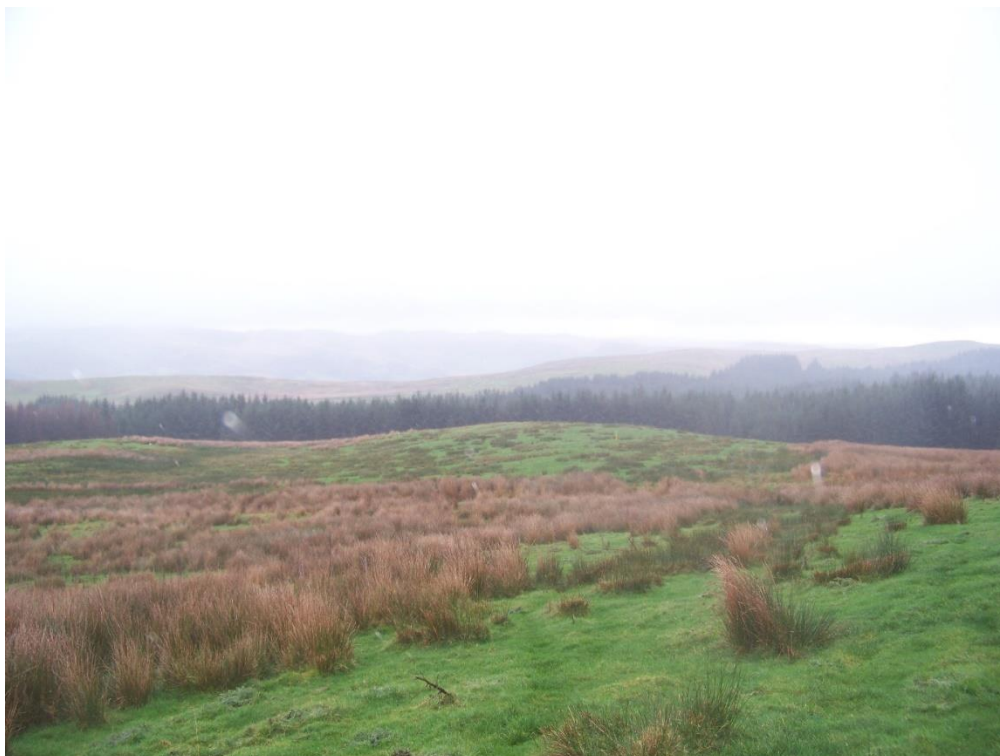
Figure 3 General Shot looking North East

The planning application located the site (the proposed development area) at “*Land 3km South East of Mountain Road (Unclassified Road U1518), Llanddewi Brefi, Tregaron*”. The permitted mast is to be erected on localised moorland at Rhysgog in Ceredigion, 3km east of Llanddewi-Brefi and 14km northeast of Lampeter (National Grid Reference SN 68168 52825) (Figure 1). It is surrounded by commercially operated forestry, and the land is currently used for rough grazing (Figures 3-6).

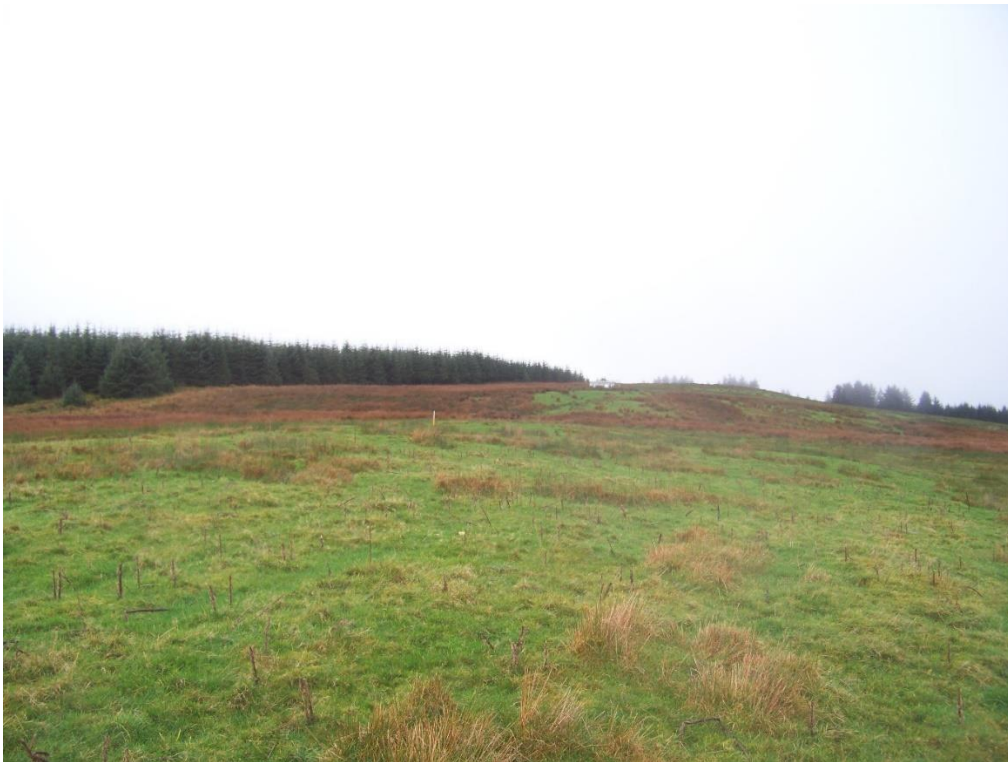
Figure 5 General shot looking South West. Solar equipment in distance denoting mast location

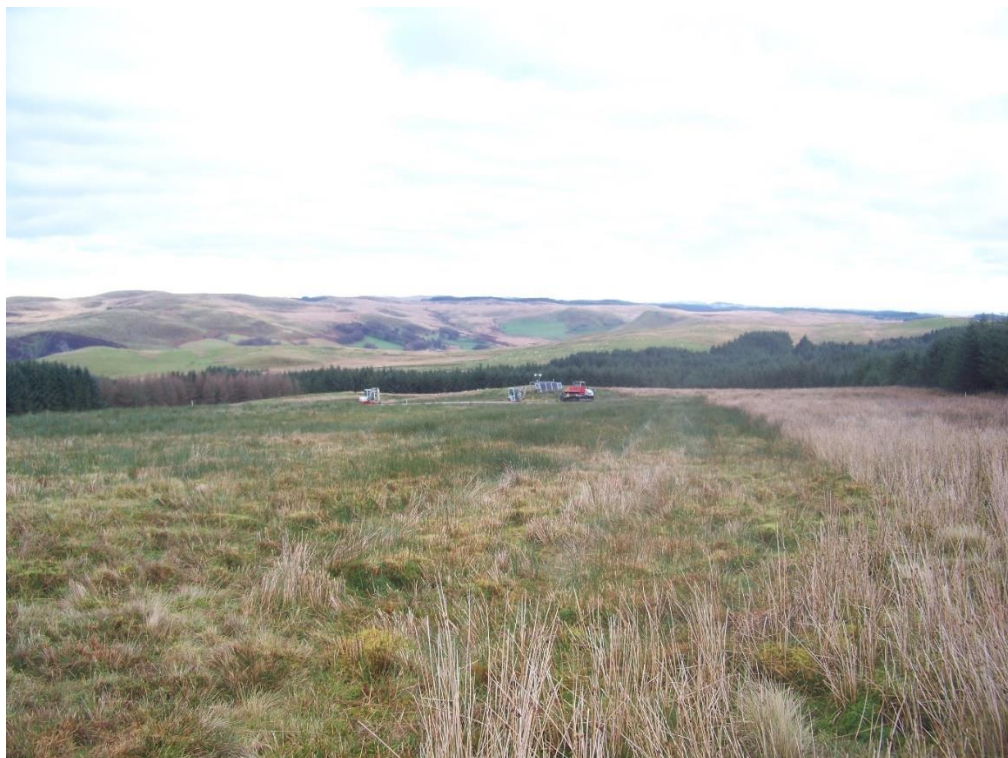
Figure 6 General shot looking North East. Note solar equipment in the distance

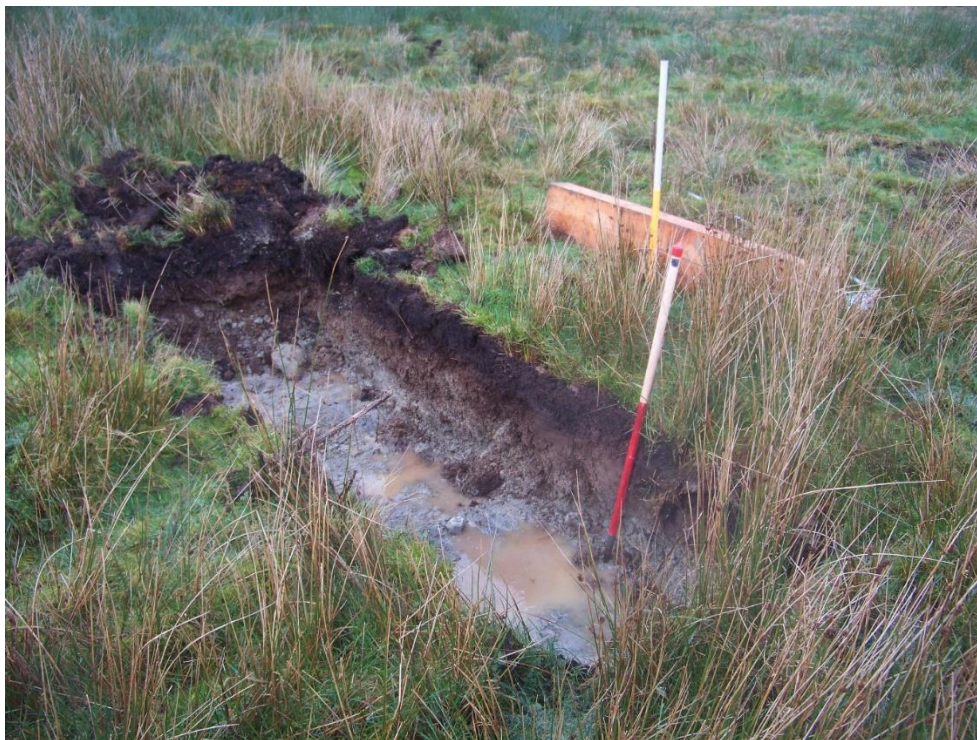
The northern pits revealed a grey clay which seemed to continue down to 2m, albeit becoming stonier as the depth increased (Figures 7-8). In the southern pits, excavation to the full 2m depth revealed a mixture of solid bedrock and a harder, less brittle shale (Figures 12-14).

Figure 7 North outer anchor pit. The peaty topsoil around 0.10m deep is clearly visible as is the yellowy grey clay beneath that and the shale 0.30m below the surface.

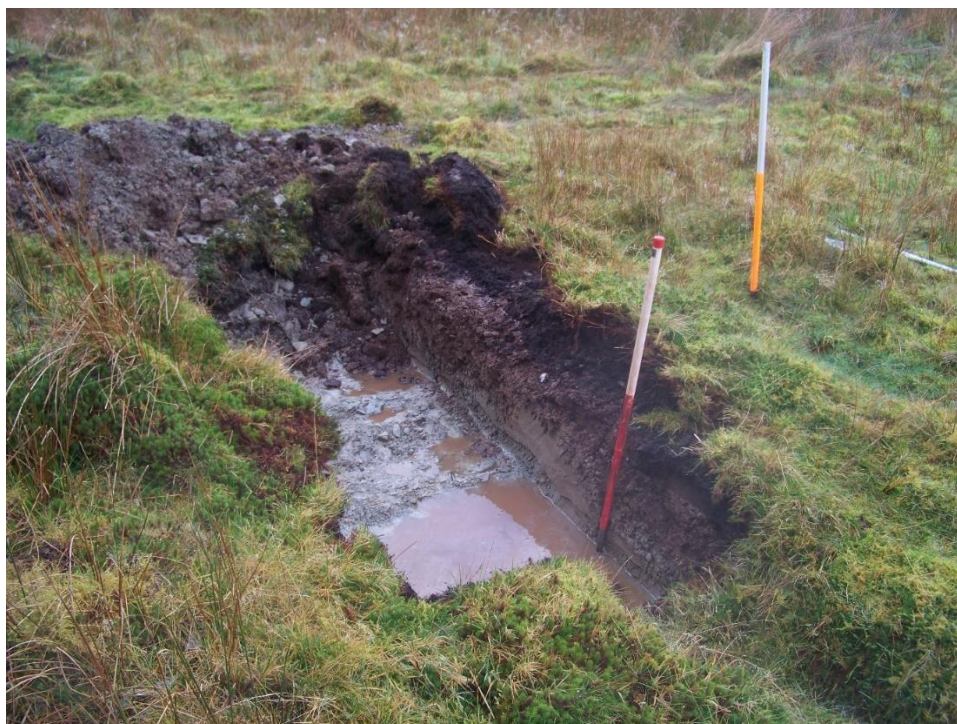
Figure 8 North Inner anchor Pit. The peaty topsoil around 0.10m deep is clearly visible as is the yellowy grey clay beneath that and the shale 0.30m below the surface

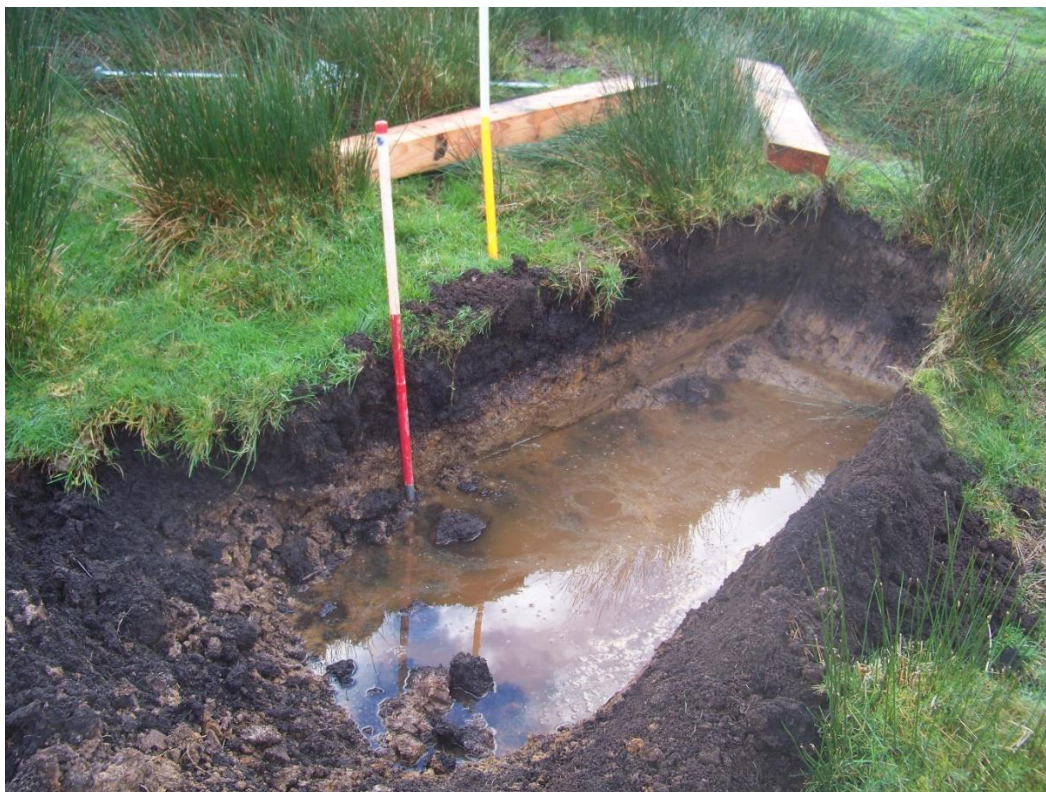
Figure 9 East Inner anchor pit. The peaty topsoil around 0.10m deep is clearly visible as is the yellowy grey clay below that

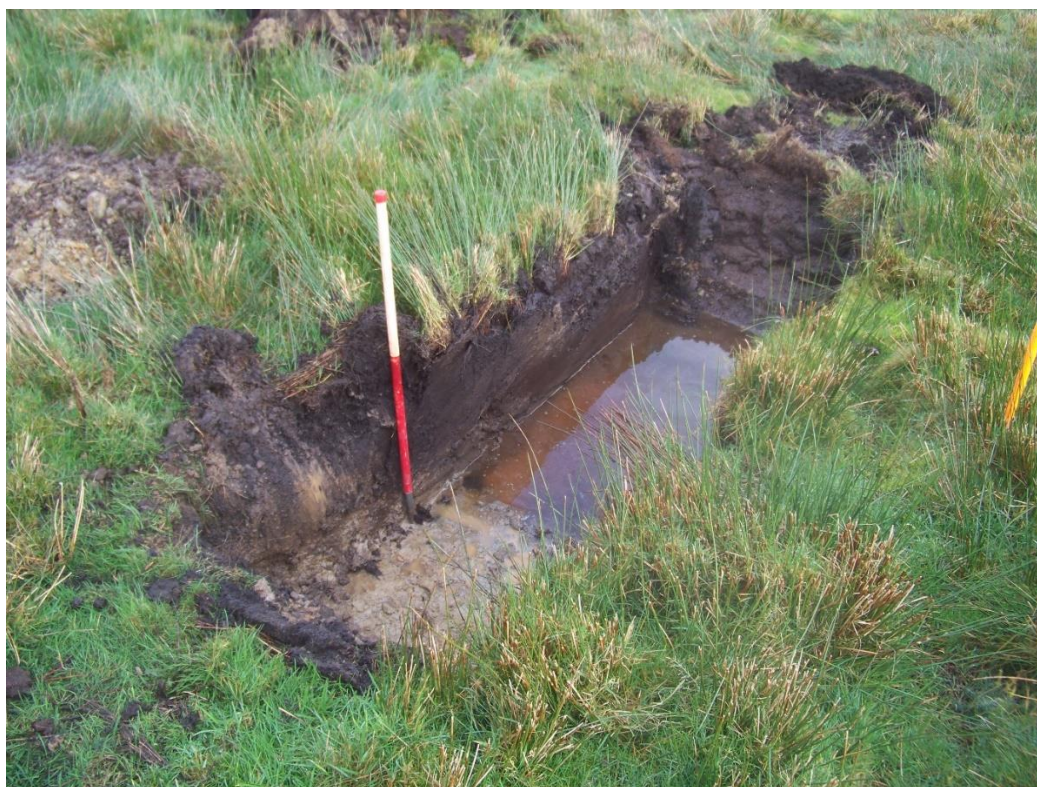
Figure 10 East outer anchor pit. The peaty topsoil up to 0.50m deep is clearly visible as is the yellow grey clay below that

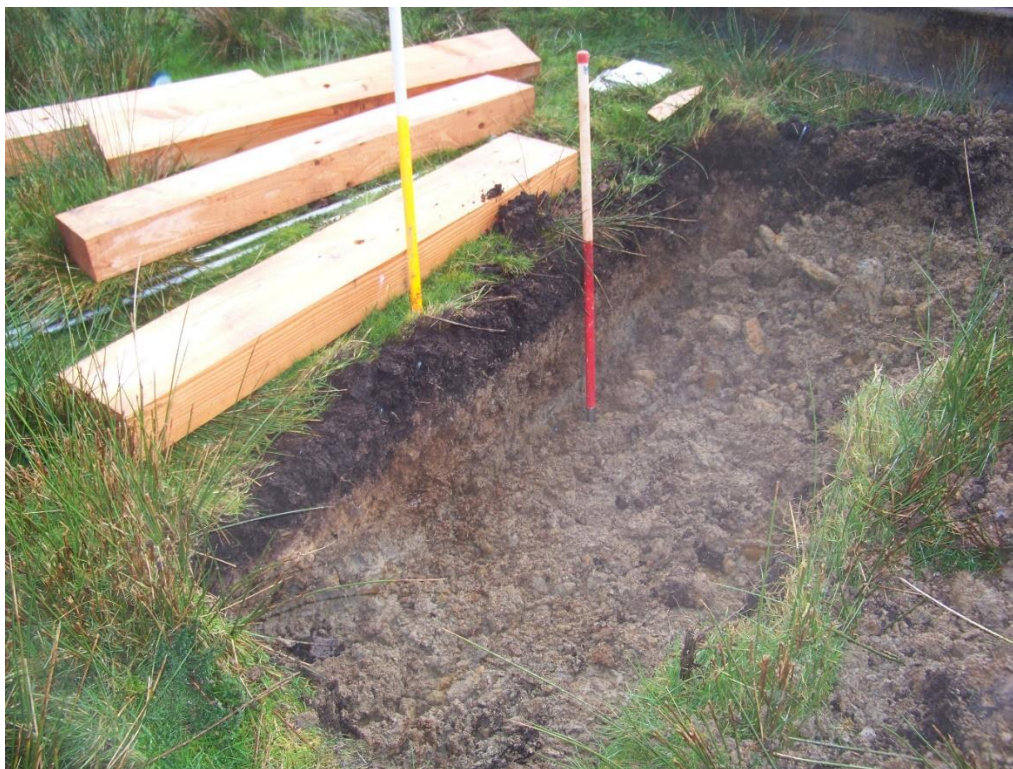
Nine pits were excavated. Throughout, each pit was approximately 2m long, by 1m wide. All pits were excavated to an initial depth of 0.40m and then recorded photographically. All pits, except the central mast location (Figure 11), were subsequently excavated to a depth of approximately 2m.

Figure 11 Main Mast Pit. The peaty topsoil around 0.10m deep is clearly visible as is the yellowy grey clay beneath that

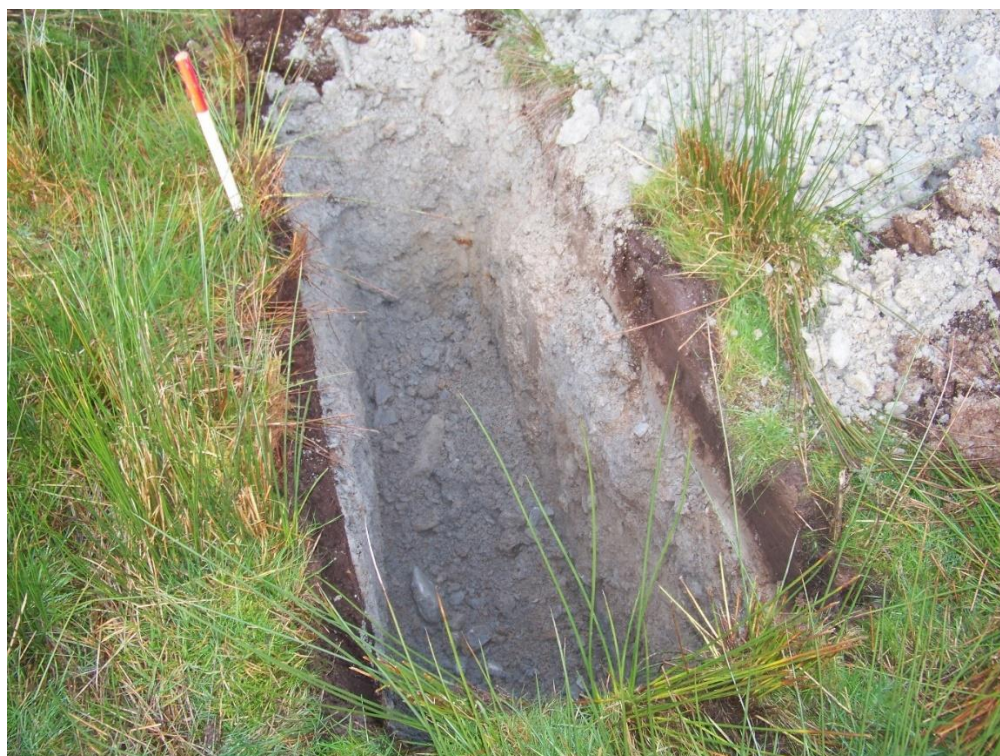
Figure 12 South Inner anchor pit at full depth. The peaty topsoil around 0.10m deep is clearly visible with a band of clay beneath just above the shale

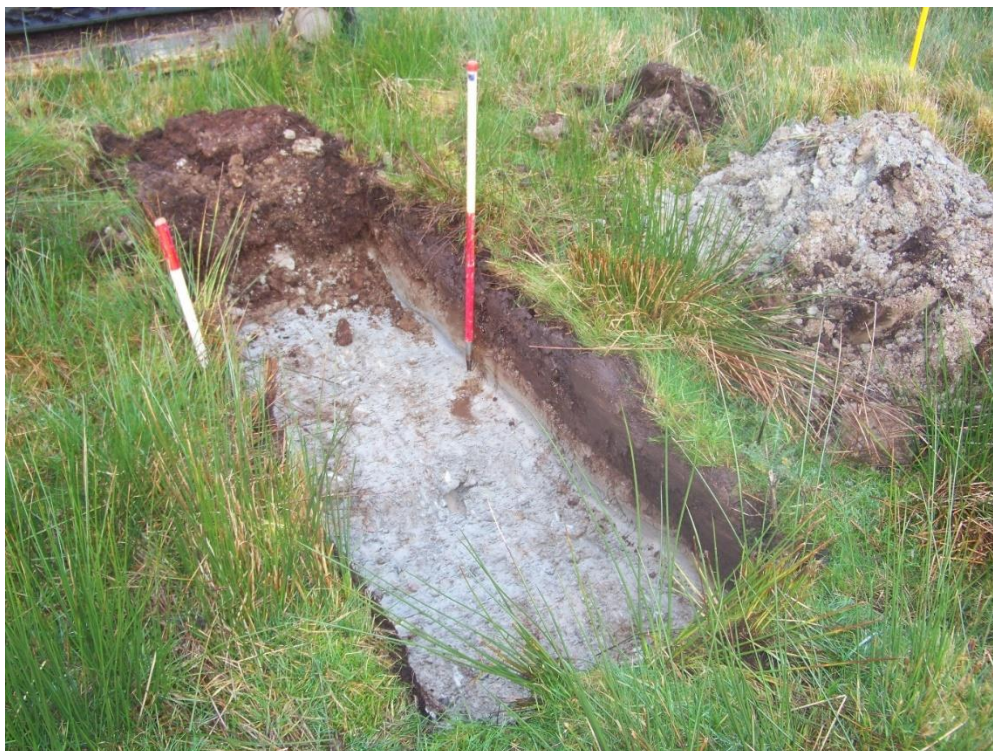
Figure 13 South inner anchor pit. Also shows the peaty topsoil around 0.10m deep and the shale beneath that

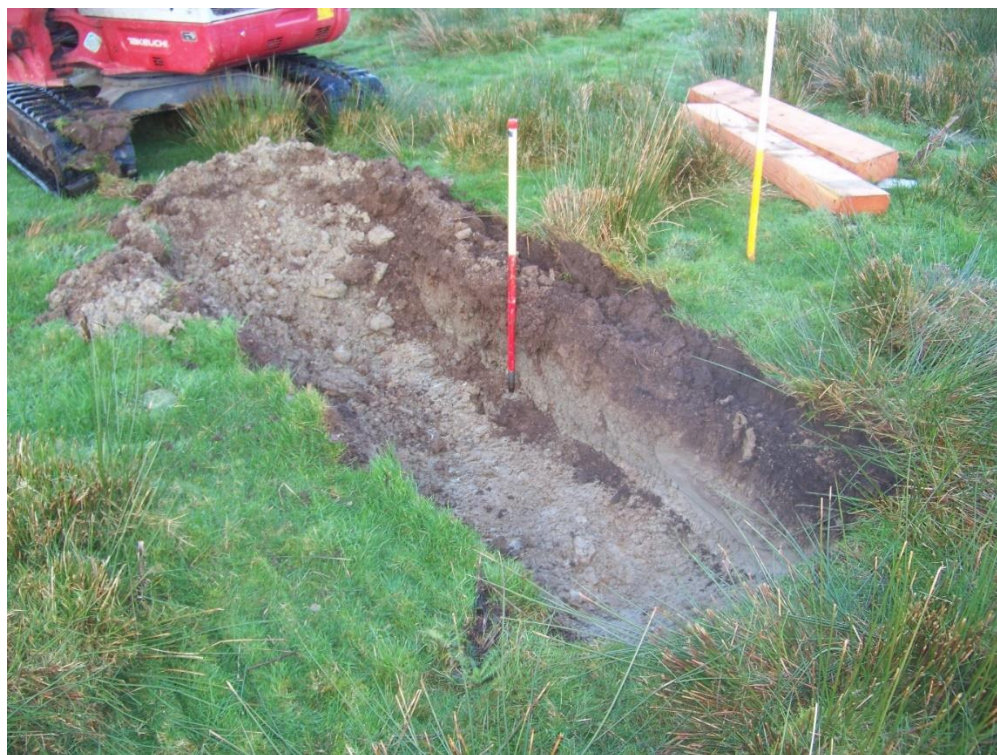
Figure 14 South outer anchor pit. The peaty topsoil around 0.10m deep is clearly visible as is the shale beneath that

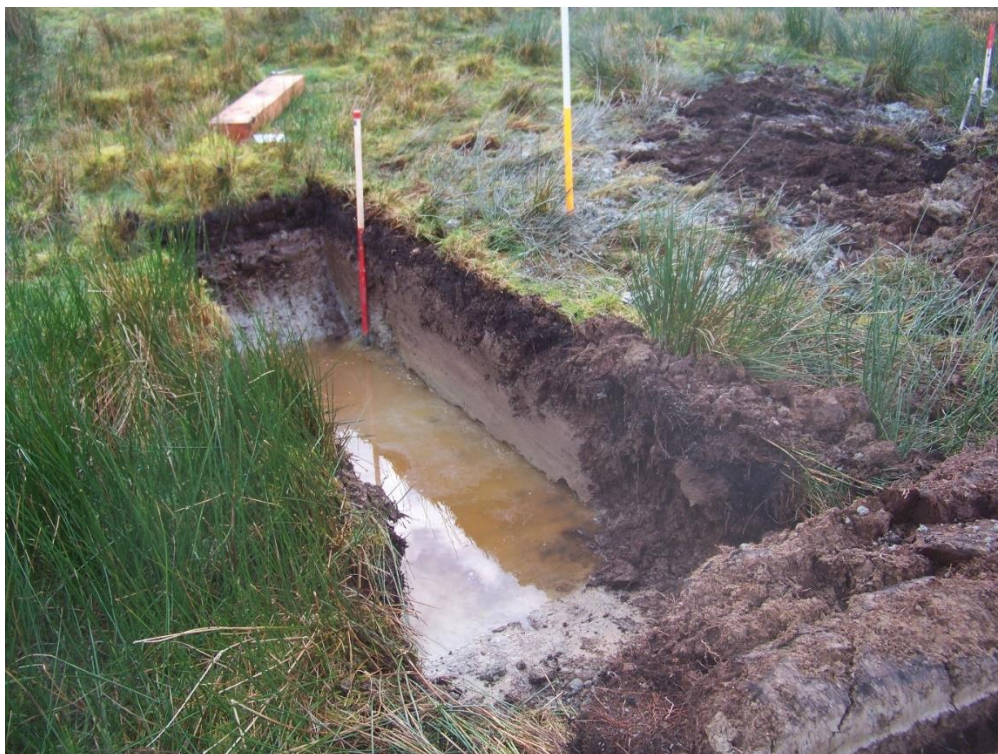
Figure 15 West Outer anchor pit. The peaty topsoil around 0.10m deep is clearly visible as is the yellowy grey soil clay beneath that

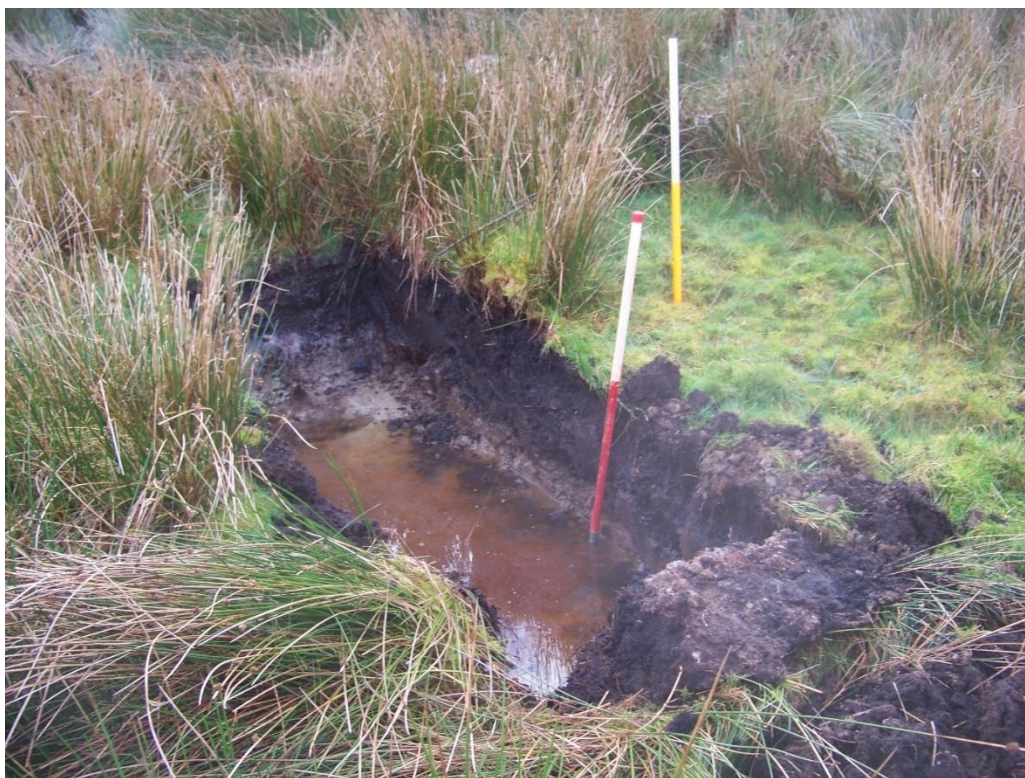
Figure 16 West Inner anchor pit. The peaty topsoil around 0.10m deep is clearly visible as is the yellowy grey clay soil beneath that
