**King Street Buildings,  
Old College,  
Aberystwyth University**

**Historic Building  
Recording (Level 3)**

Prepared by:  
**The Environmental Dimension  
Partnership Ltd**

Report Reference  
**edp7672\_r004a**

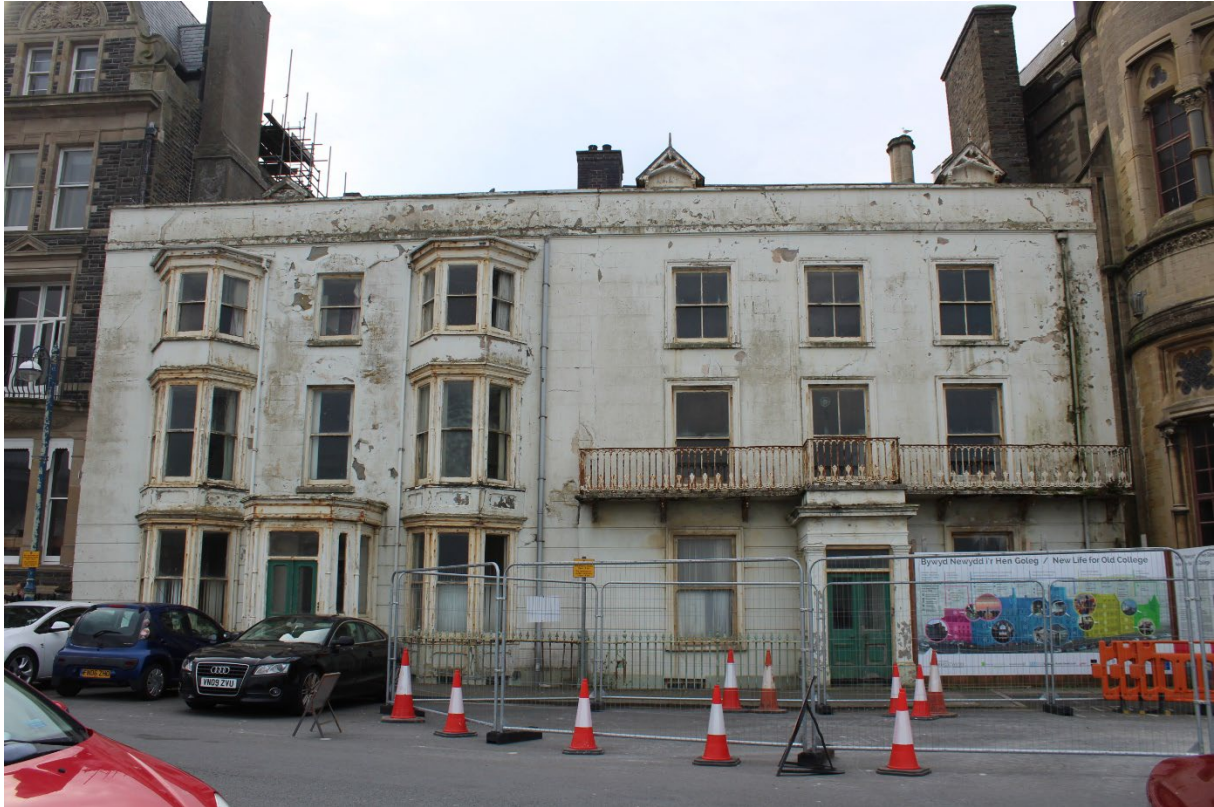
**Image EDP 6.1:** The exterior of Marine Villas from New Promenade, in a state of some decay.

- 3.23 Marine Villas present as two Regency double fronted seaside villas on New Promenade, set back behind a narrow area with iron railings, in a state of decay (**Image EDP 6.1**). Number 2 features a projecting timber porch and full height canted timber bay windows. Number 1 is devoid of bay windows but has a projecting stone porch with classical detailing and a cantilevered slate balcony with iron railings at the first floor. Both properties are rendered in an imitation of rusticated stone at the ground floor beneath a flat horizontal architrave, with imitation ashlar above.

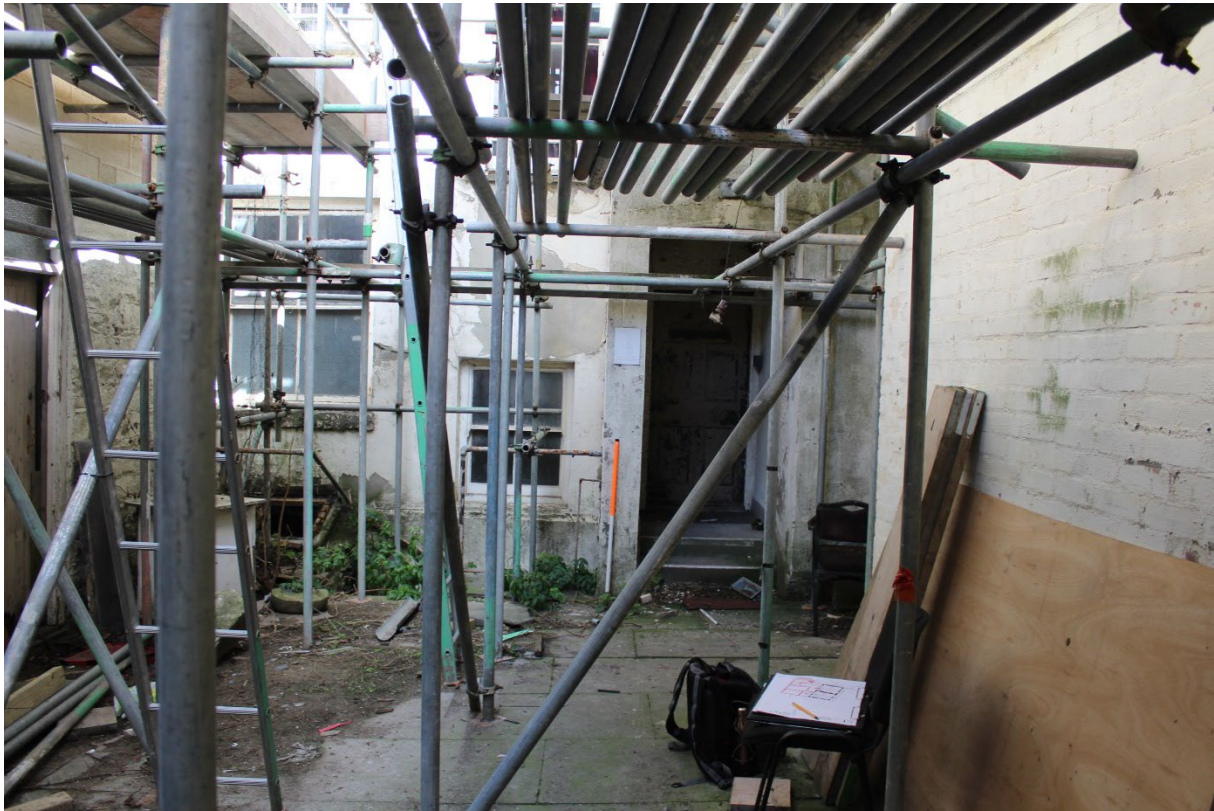
**Image EDP 6.2:** The rear entrance of Marine Villa No.1 within the courtyard. To the left is The Stables.

- 3.25 The rear elevation of both properties is utilitarian in nature (**Images EDP 6.2–6.3**), simply rendered with central outriggers. Number 2 has a glazed sunroom at first floor level with original timber casements with stained glass; this has been modified to accommodate a bridge link to the rear mews properties. Number 1 retains some original sash windows in their original configuration, number 2 has been modified due to the construction of the sunroom. The properties facing onto King Street are rendered but have been heavily altered with modern picture windows to the building behind Number 1.

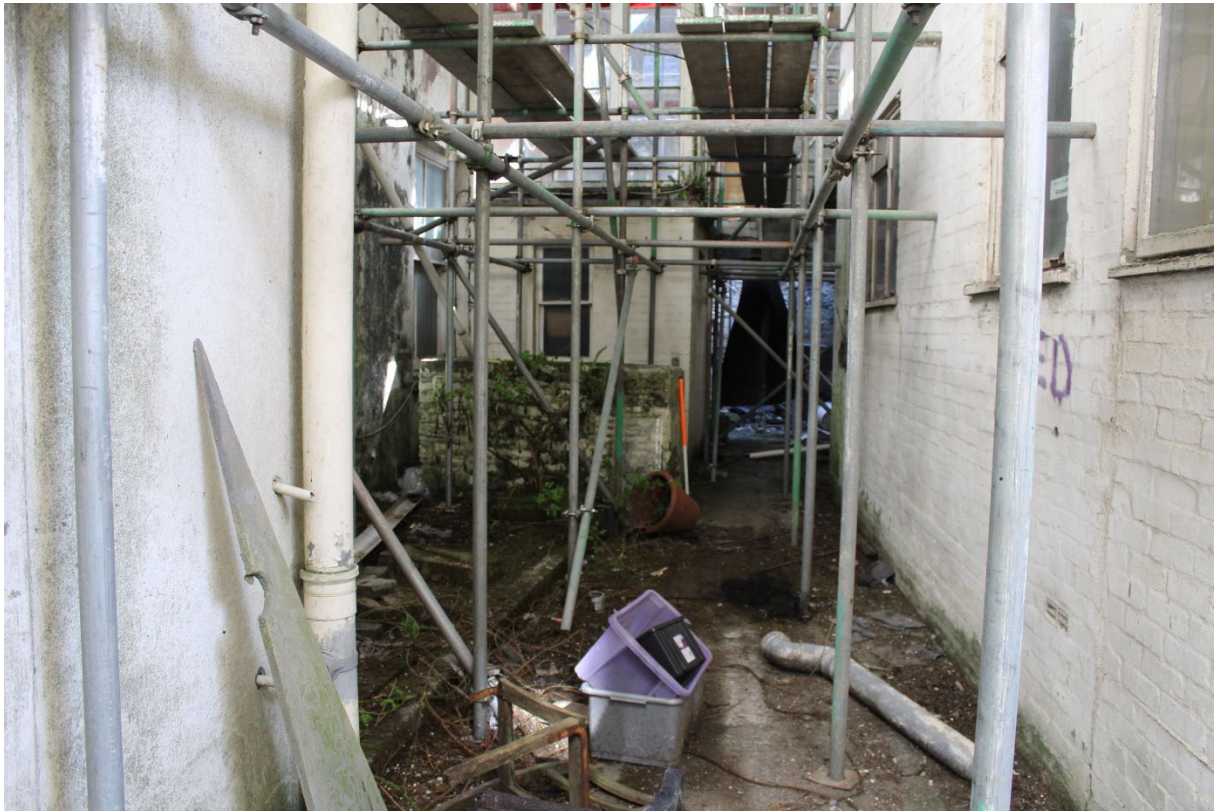
**Image EDP 6.3:** The rear outrigger of Marine Villa No. 2 and short wall. To right of image is the Estates Offices

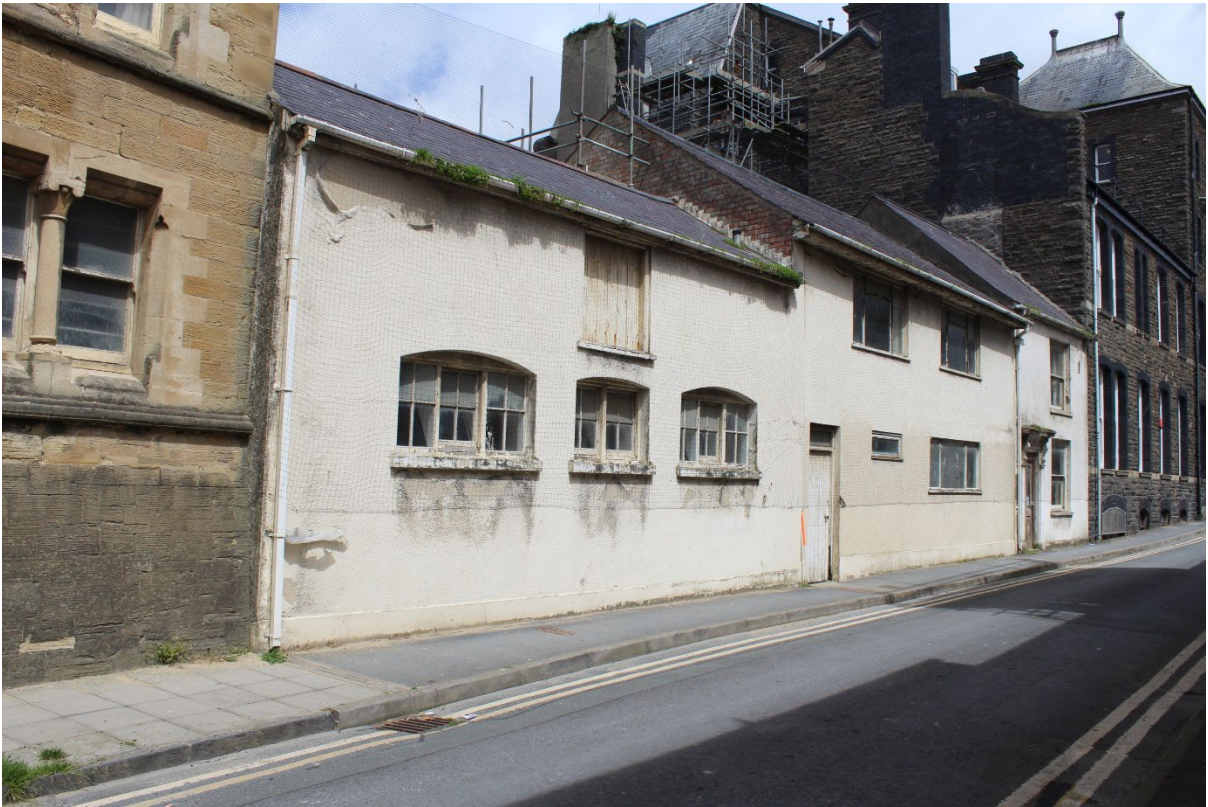
**Image EDP 6.4:** The King Street elevation is finished with painted render, which tries to present the three buildings as a block, however each building unit has different roof heights, with the Old College Extension having the lowest, Estates Offices the middle, and the Cottage, the highest.

- 3.27 Along King Street, three of the buildings in question can be noted, which are located between Old College and The Cambria, and are dominated by these two flanking large buildings (**Images EDP 6.4–6.5**). These are the Cottage, Estates Offices and Old College Extension. The King Street elevation is finished with painted render, which tries to present the three buildings as a block, however each building unit has different roof heights, with the Cottage the highest, Estates Offices the middle, and Old College Extension having the lowest.

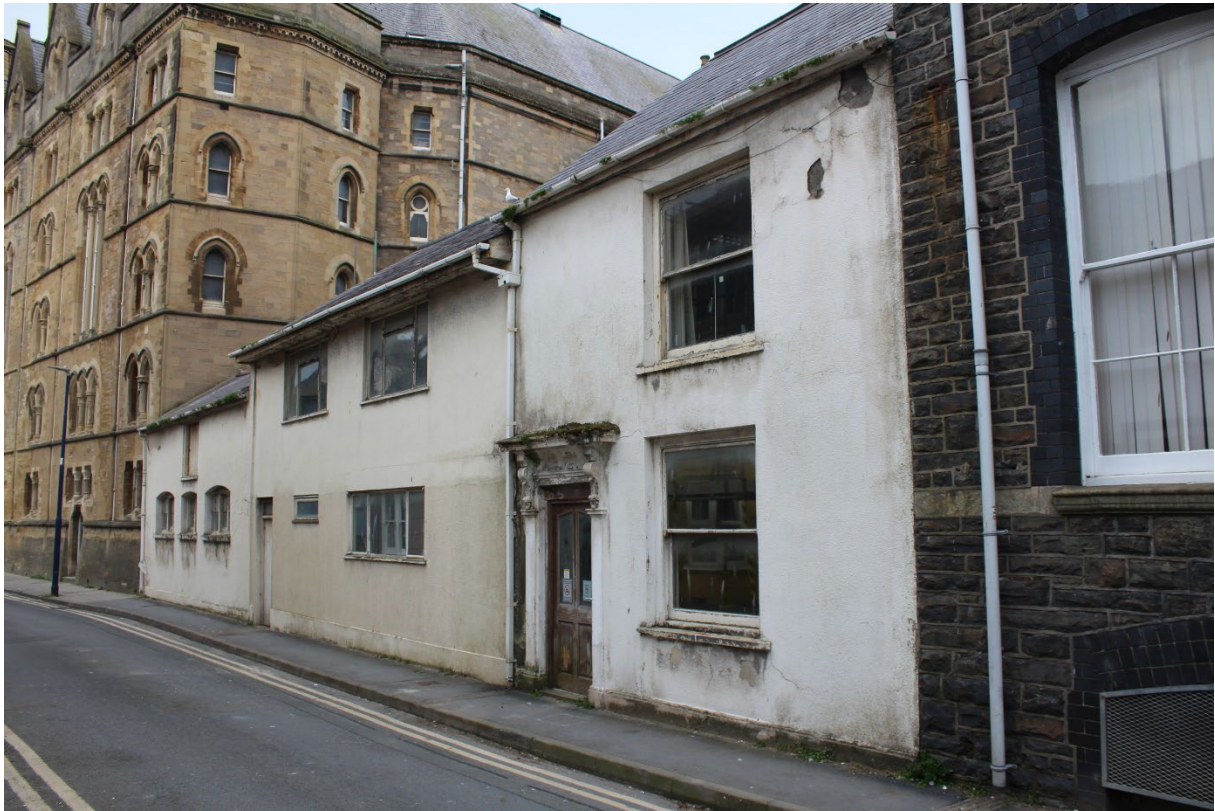
**Image EDP 6.5:** Along King Street, three of the buildings can be noted, which are located between Old College (to left) and The Cambria (to right). The King Street Buildings are dominated by these two large buildings.

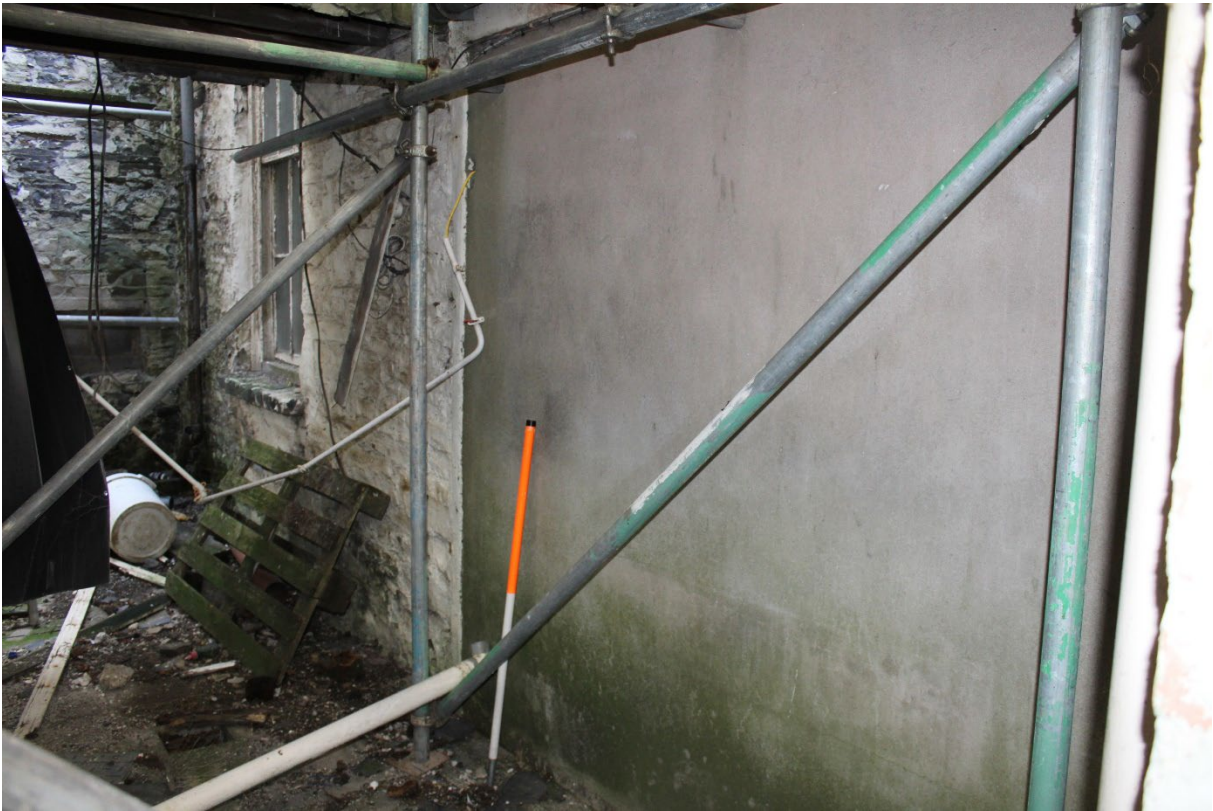
**Image EDP 6.6:** Just seen is the rear elevation of the Cottage, formed of a mixture of stone rubble. The rear ground floor contains an original six-over-six sash, which was not updated when the front windows were converted to plate glass in the late 19<sup>th</sup> century.

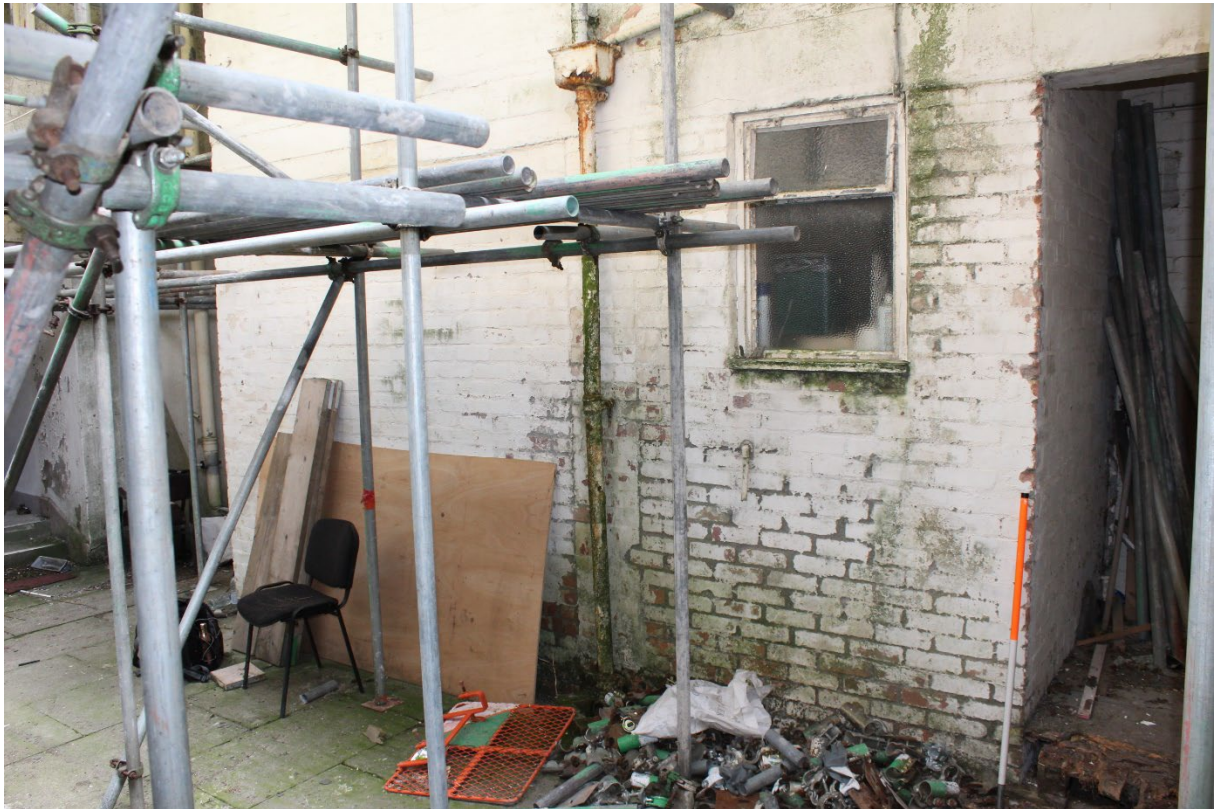
**Image EDP 6.7:** The ground floor of the Estates Offices features a bricked-up window and a single casement with hopper window above, and metal glazing bars. To the right of the image is the dogleg access route from the courtyard towards the Estates Offices main entrance and King Street.

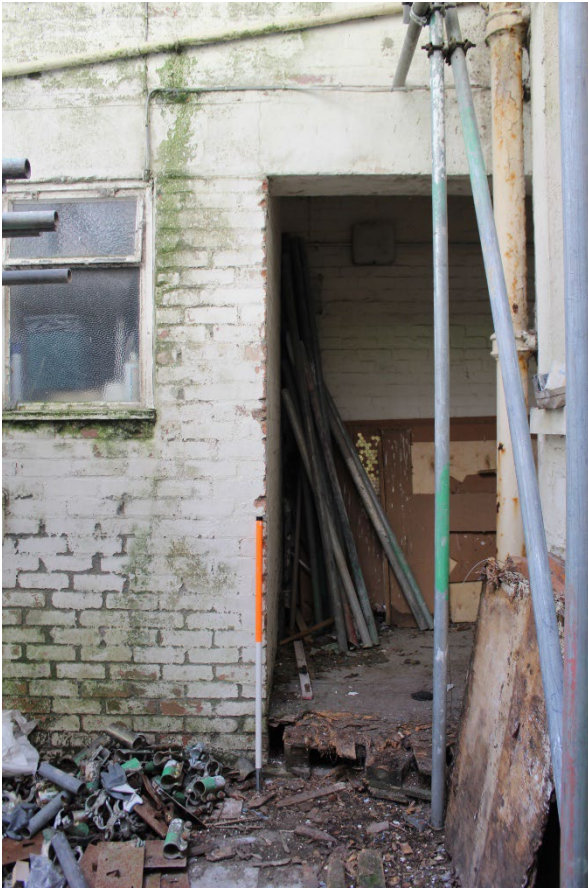
**Image EDP 6.8:** The north-western elevation of the Estates Offices and open passage from the courtyard towards King Street.

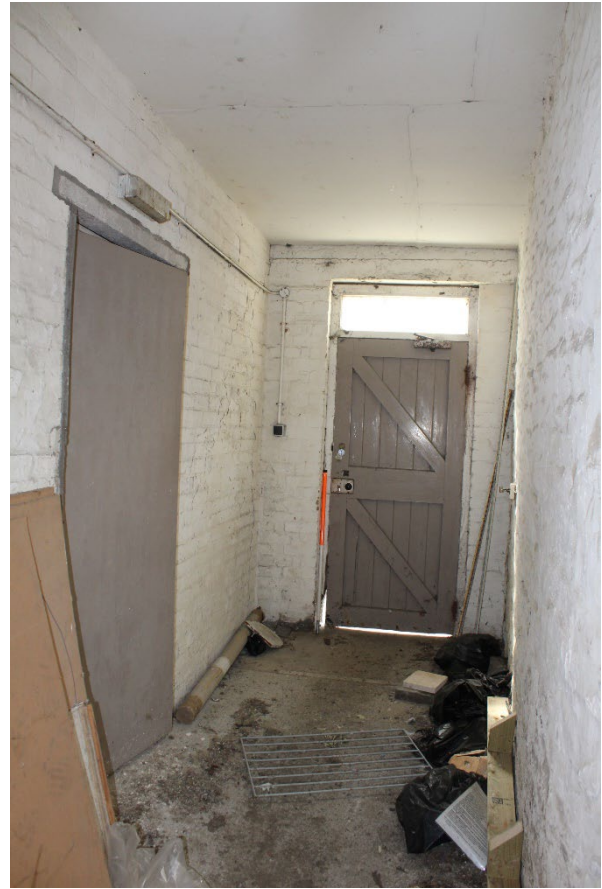
**Image EDP 6.9:** The curved passageway between the Old College Extension (right) and Estates Offices access (left), with panelled door leading to King Street.

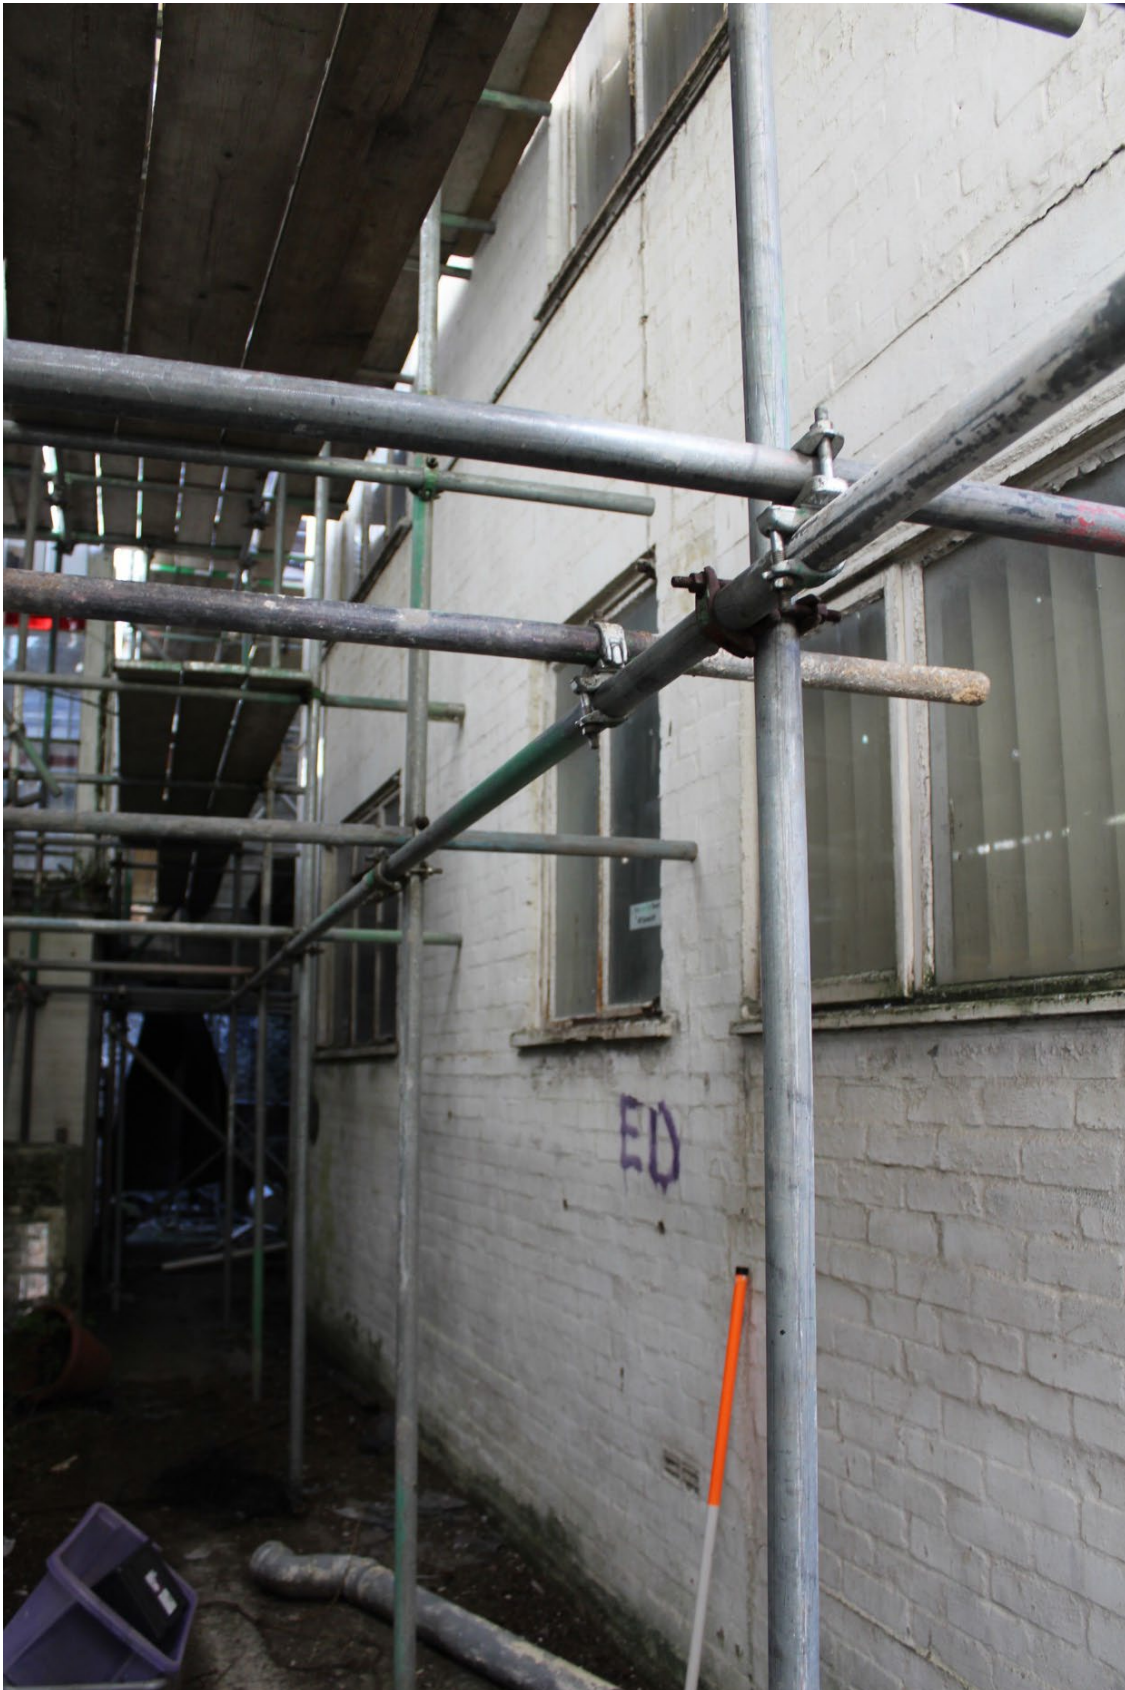
**Image EDP 6.10:** The southern elevation of the Estates Offices features a narrow passage between it and Marine Villas. It contains three sets of modern casement windows of two- and three-lights on the ground floor, and two sets of casements on the first floor.

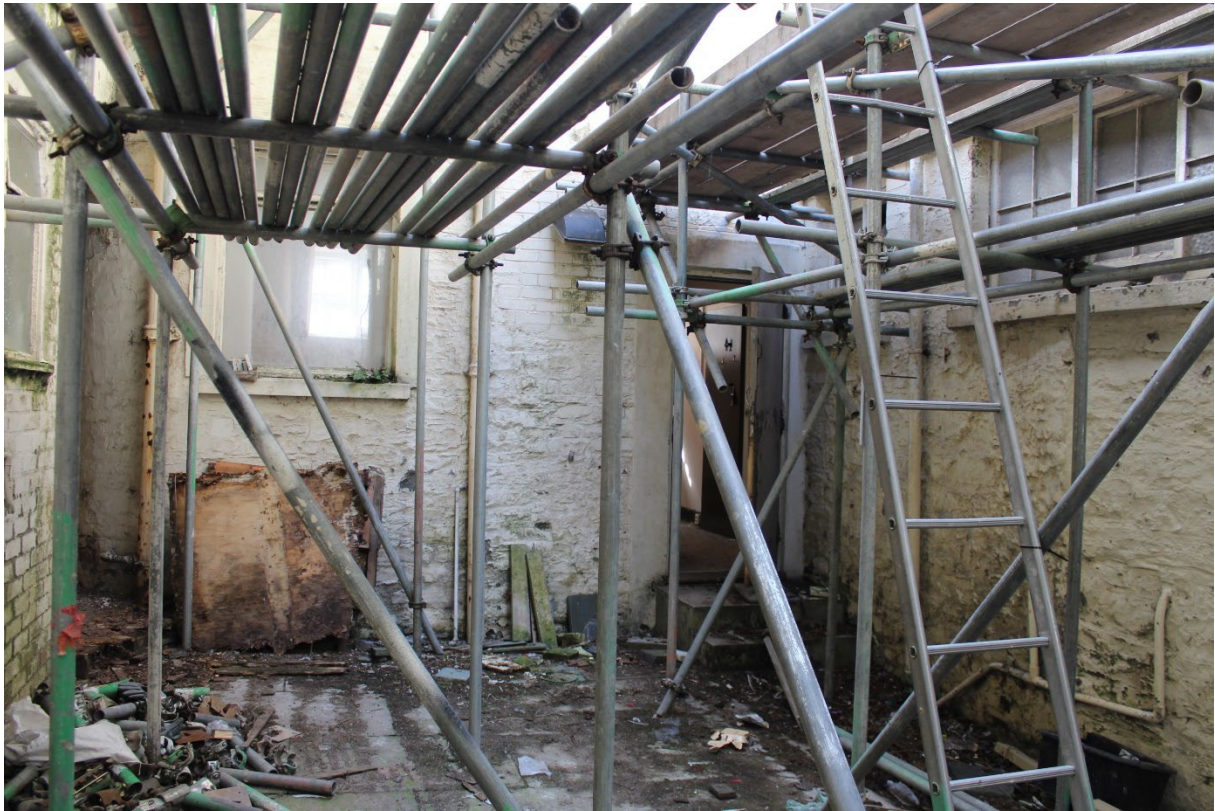
**Image EDP 6.11:** The rear elevation of Old College Extension, which opens out into the courtyard. The Stables are to the right, Estates Offices to the left via a roofed passageway.

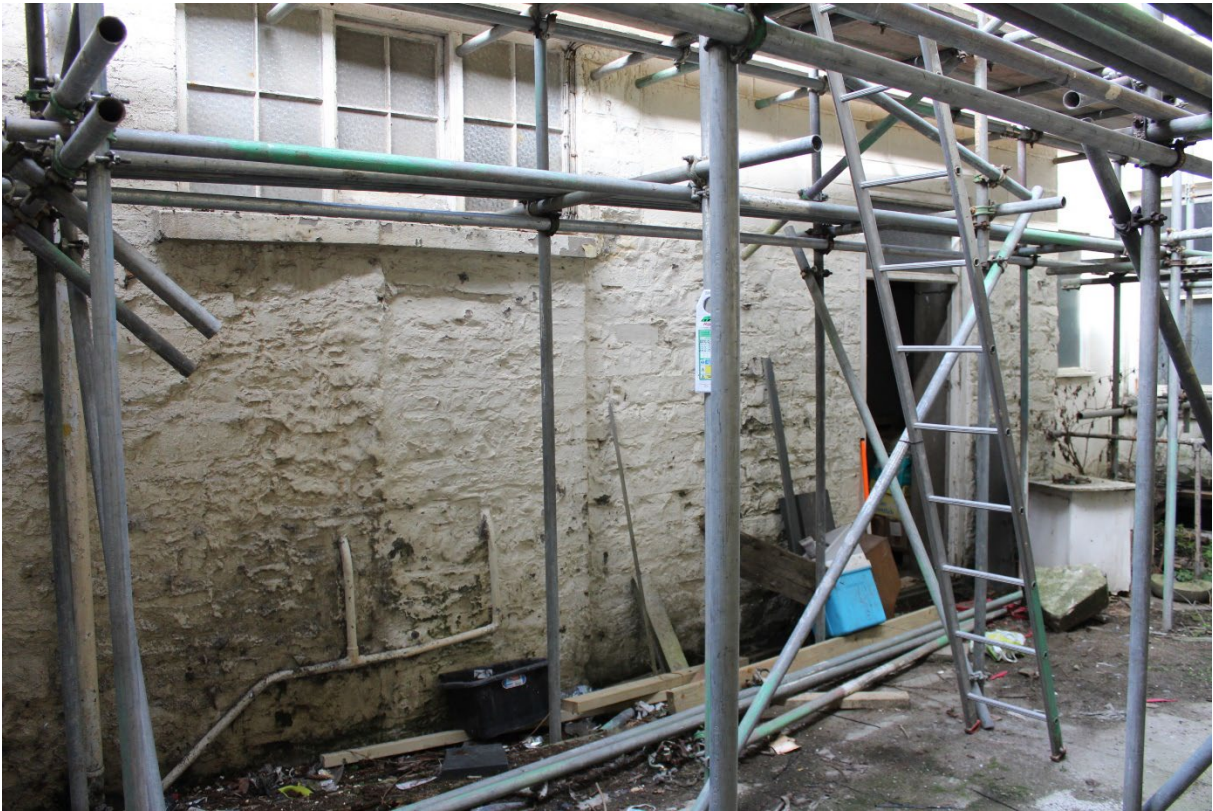
**Image EDP 6.12:** The Stables once contained two doorways (one now blocked up) and extended the full length of the courtyard. Now used as toilets as part of The Old College Extension.

- 3.64 Although historic mapping would suggest that The Stables were in place in the 19<sup>th</sup> century, there are no historic features retained today. The Stables has a mixture of exposed blockwork on the eastern and southern wall and render (**Images EDP 6.43–6.44**). The roof is exposed to the underside of the attic floor and contains modern machine cut marks; therefore has been replaced in more recent times.

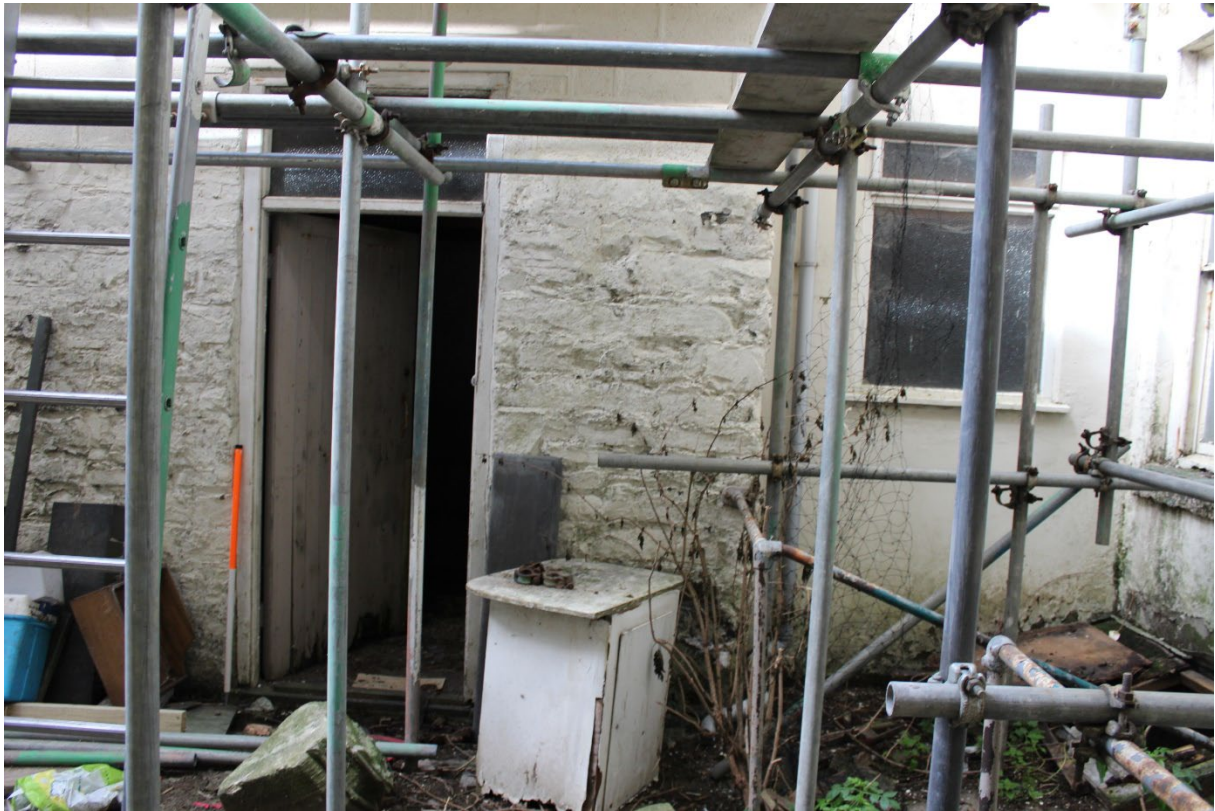
**Image EDP 6.13:** The Stables abuts No. 1 Marine Villas.

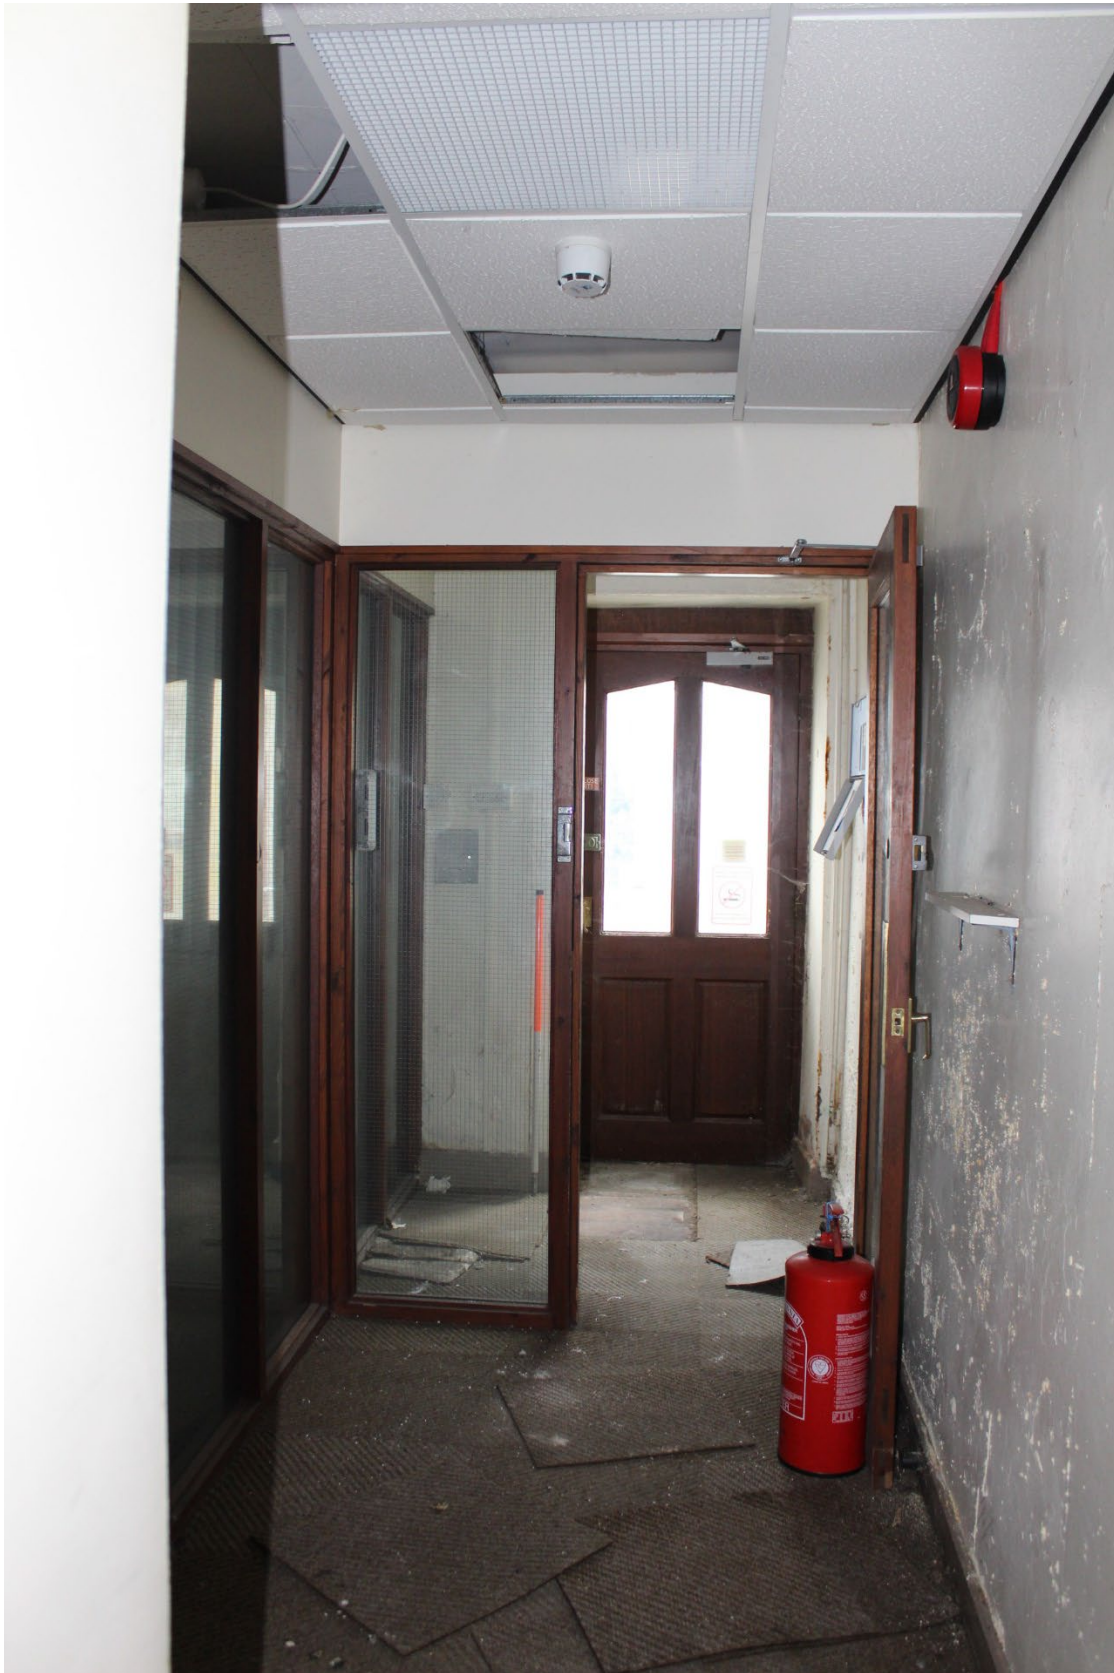
**Image EDP 6.14:** The front entrance of the Cottage which now has glass partitions to create a hallway. The ceiling has suspended grid tiles installed.

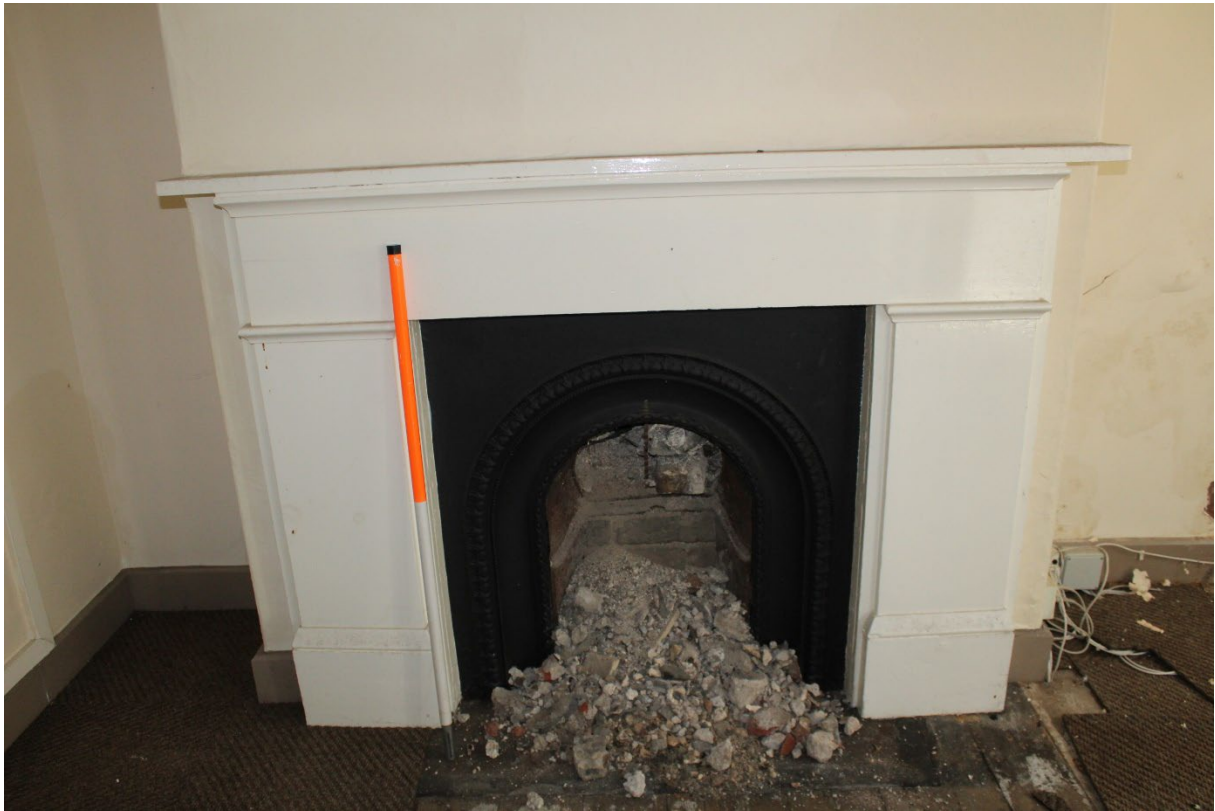
**Image EDP 6.15:** The post 1860 register grate in the Cottage in G5.

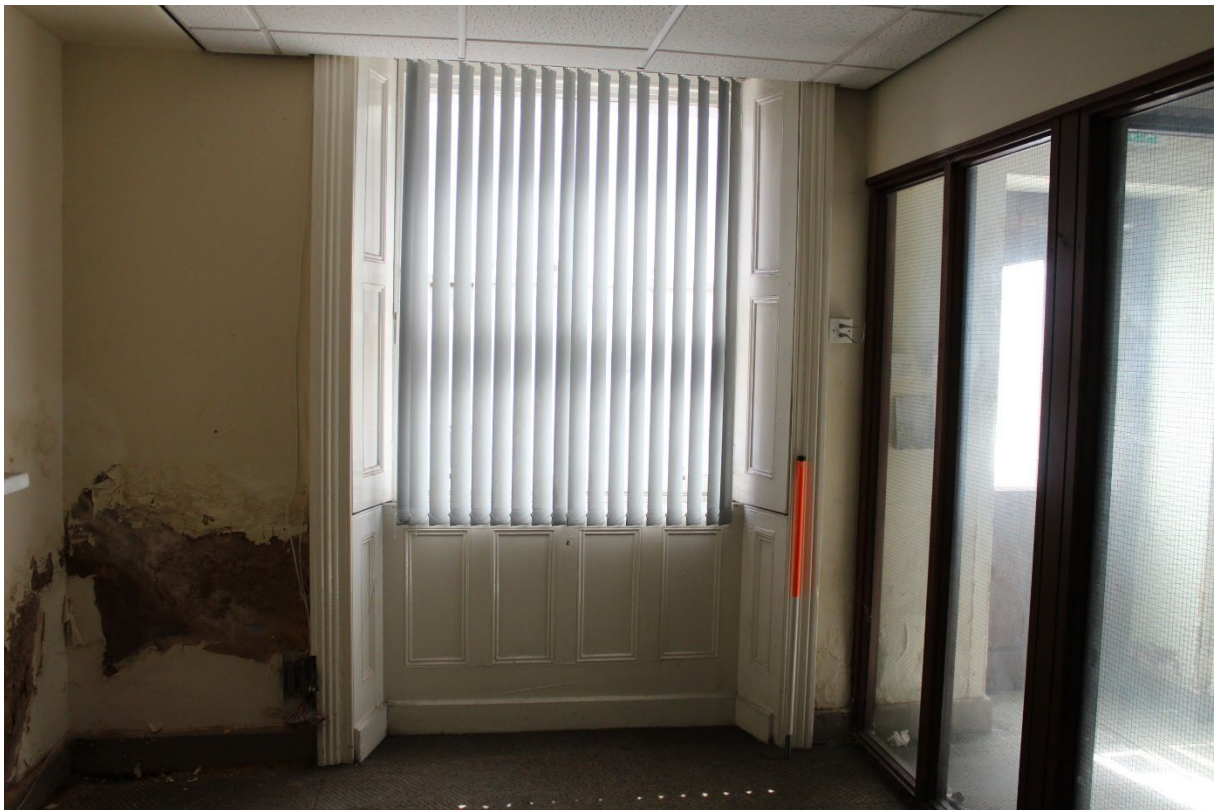
**Image EDP 6.16:** The original early 19<sup>th</sup> century shutters in room G5.

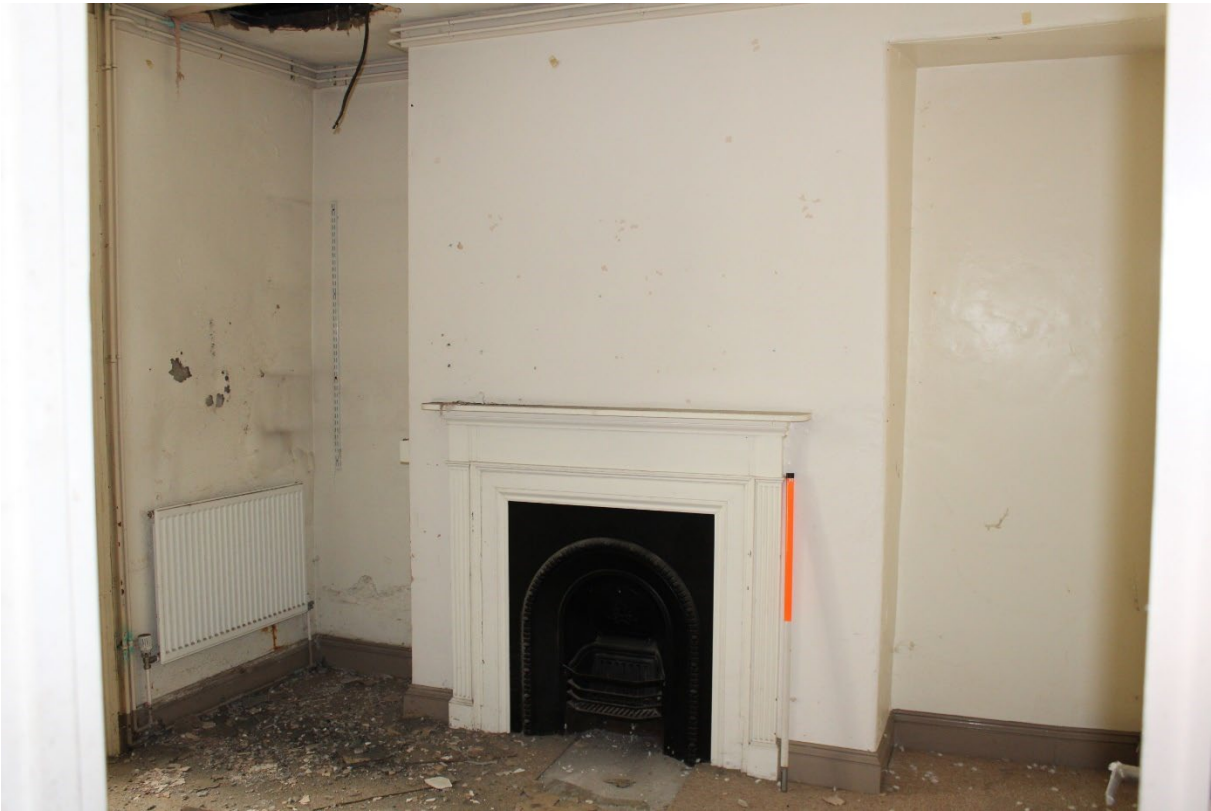
**Image EDP 6.17:** The post 1860 register grate in room G4.

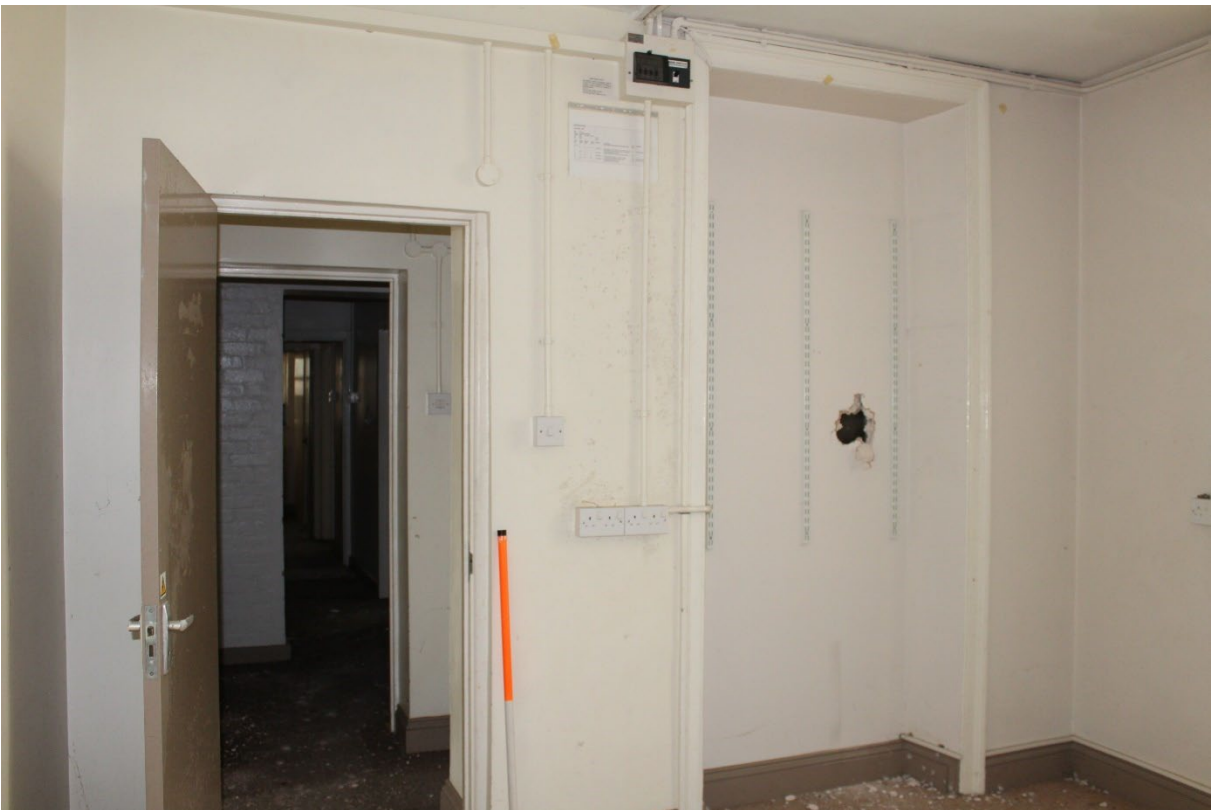
**Image EDP 6.18:** The western wall of room G4 in the cottage, which features a blocked-up doorway (right) and a modern doorway from which the Estates Offices is accessible via a dogleg.

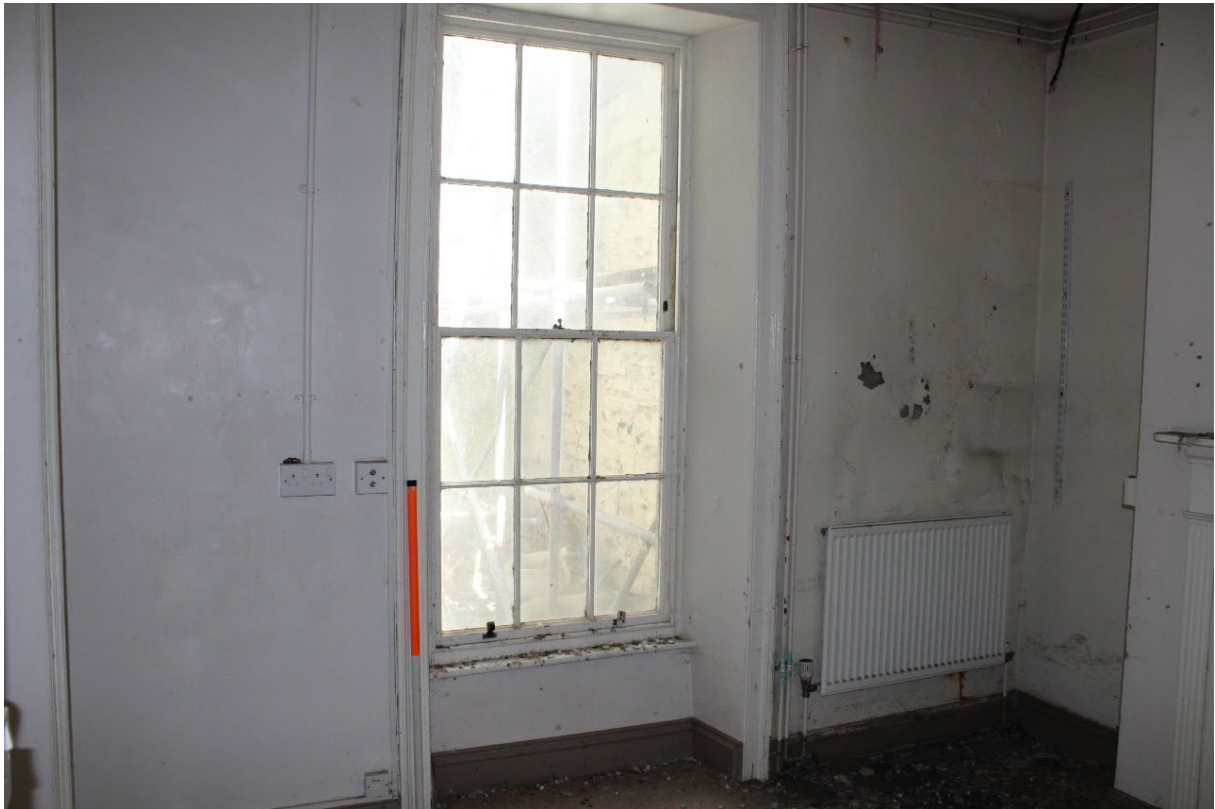
**Image EDP 6.19:** The original (pre-1860) sash window with thin glazing bars and no horns.

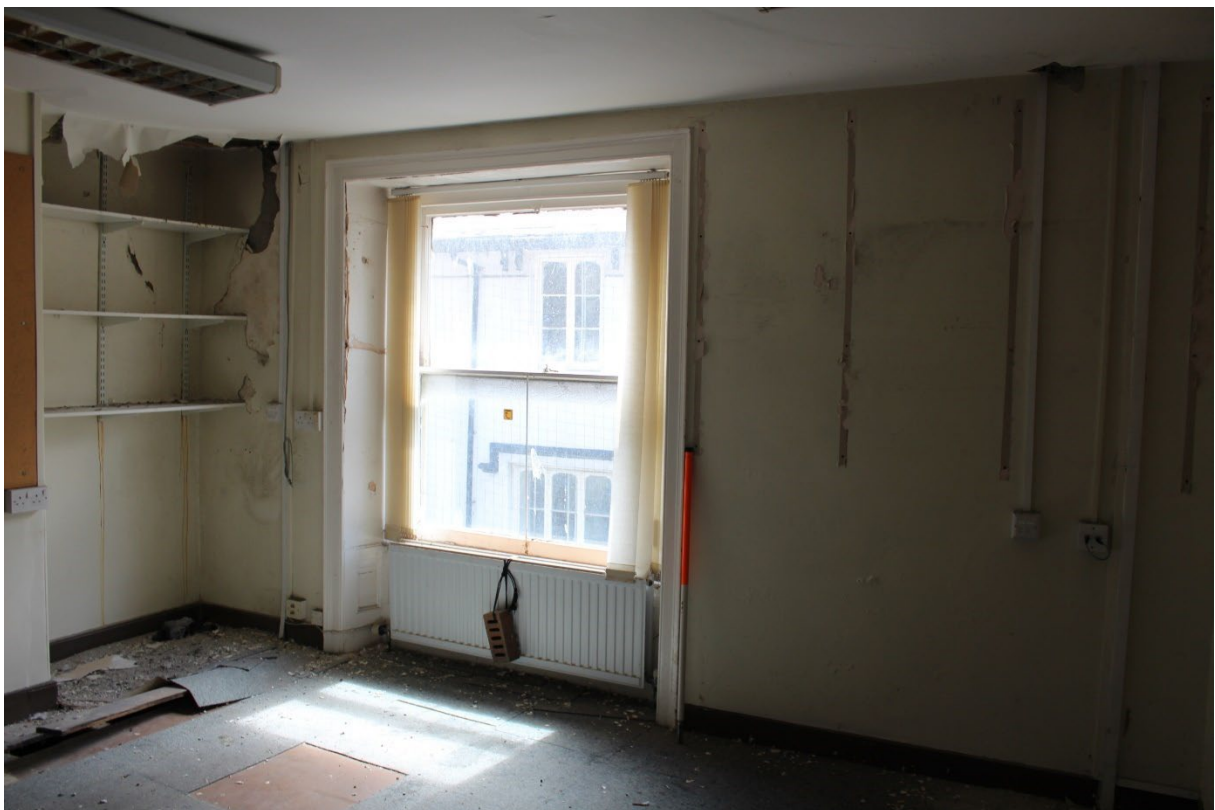
**Image EDP 6.20:** Reception room F5 retains no historic features apart from the post 1860 plate glass sash window.

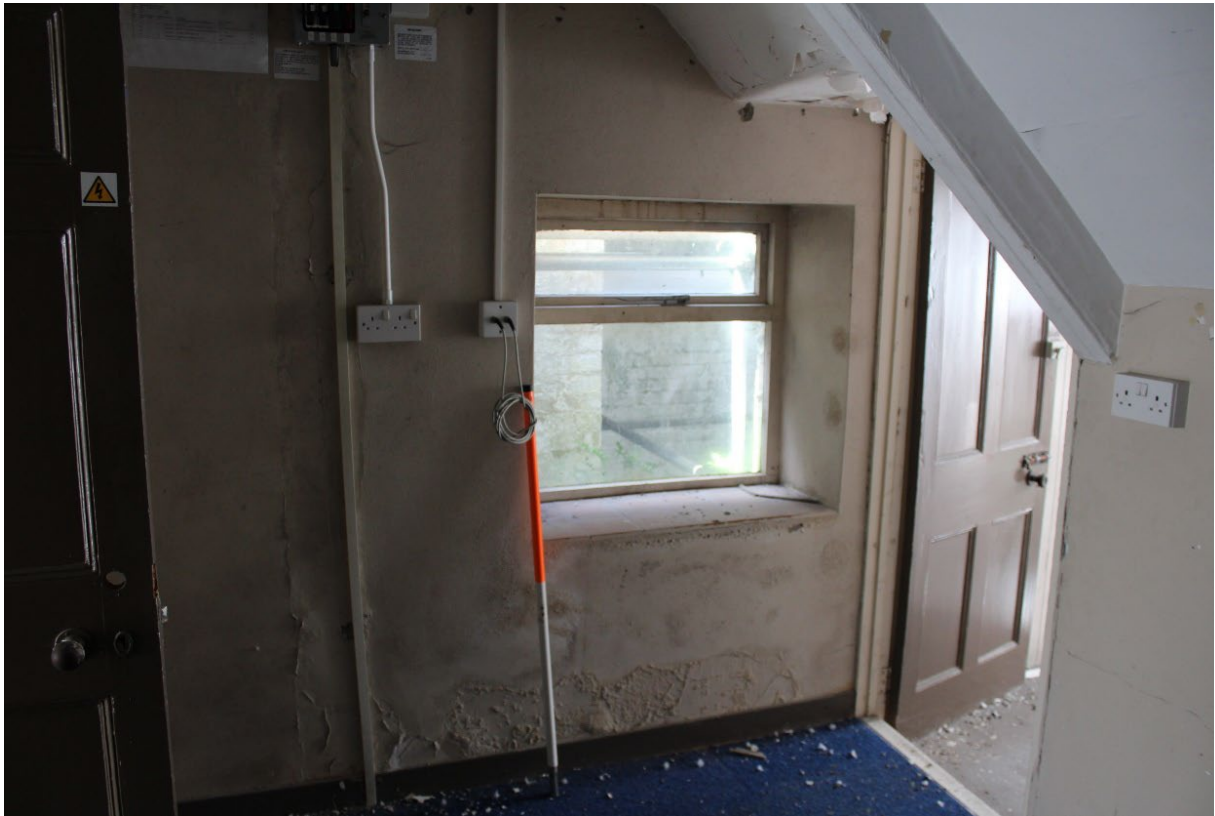
**Image EDP 6.21:** The rear room of F5 has been adapted mostly as an access route for the glazed link bridge into Marine Villas No. 2.
