**King Street Buildings,  
Old College,  
Aberystwyth University**

**Historic Building  
Recording (Level 3)**

Prepared by:  
**The Environmental Dimension  
Partnership Ltd**

Report Reference  
**edp7672\_r004a**

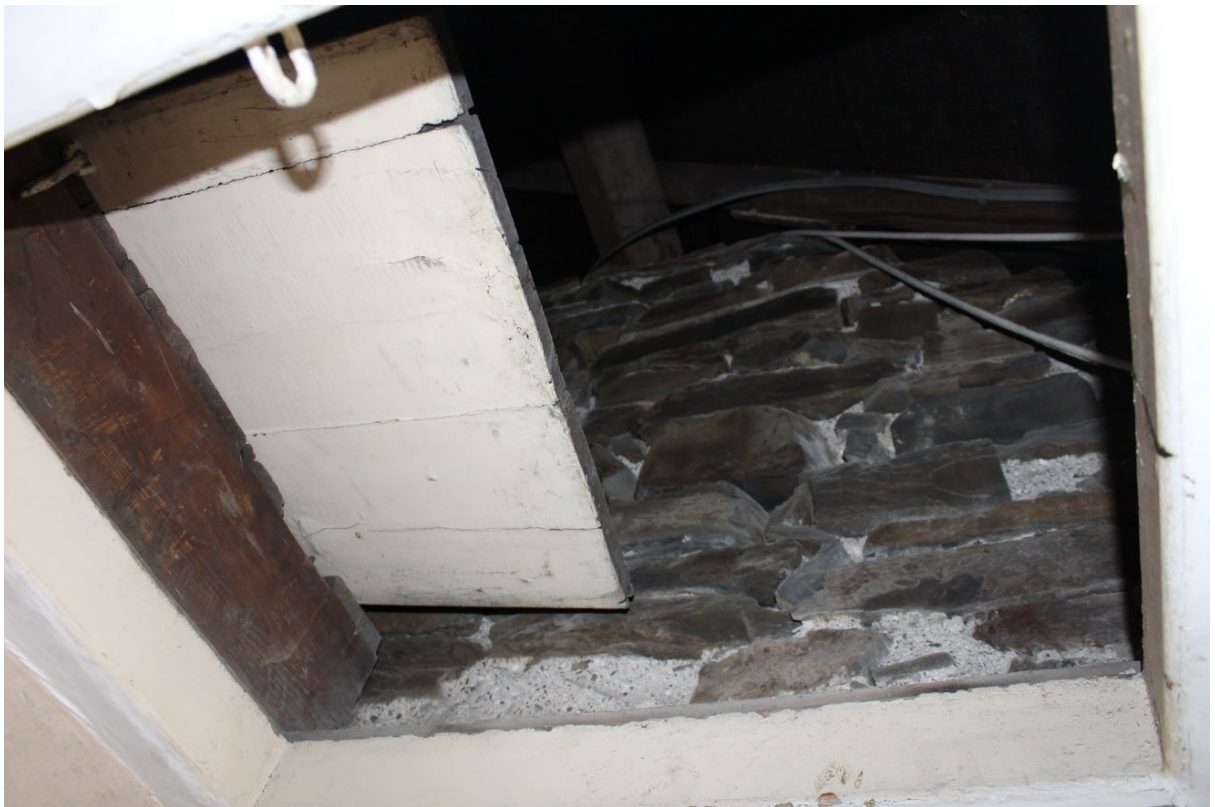
**Image EDP 6.22:** The ceiling of F4 contains an attic space which shows the dressed stone internal gable end of the cottage.

- 3.54 The ceiling of F4 contains an attic space which shows the dressed stone internal gable end of the cottage (**Image EDP 6.22**).
- 3.55 As noted above, the cottage is now linked to the glazed conservatory F10 of Marine Villa No. 2 via a short flight of steps to a wooden bridge F9 (**Images EDP 6.23–6.24**). The bridge link is lined with tongue and groove panelling and a pitched glass roof. The conservatory is enclosed by floor to ceiling glazed timber screens, the floor above supported on decorative cast iron columns. There are some panes of stained glass remaining.

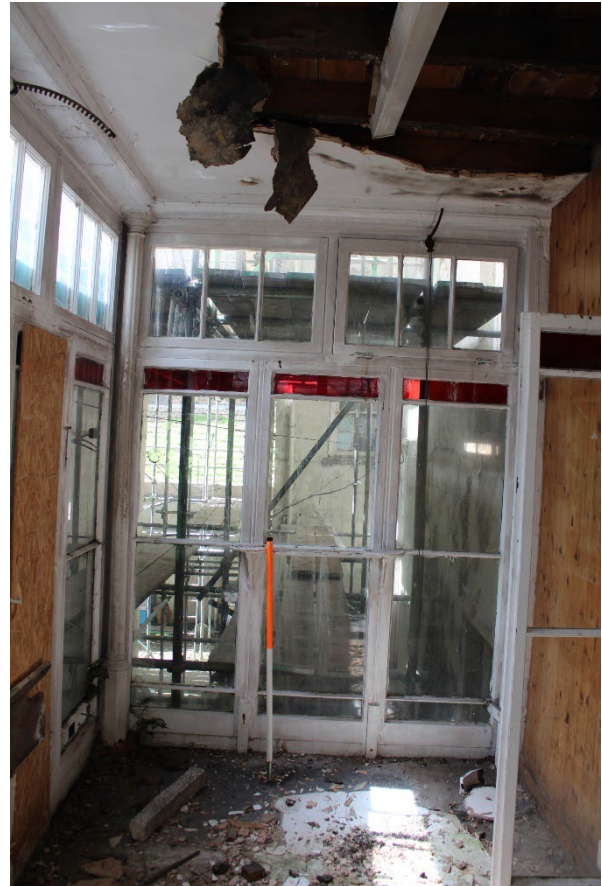
**Image EDP 6.26:** Interior of conservatory F10 looking west towards the outrigger of Villa No. 1.

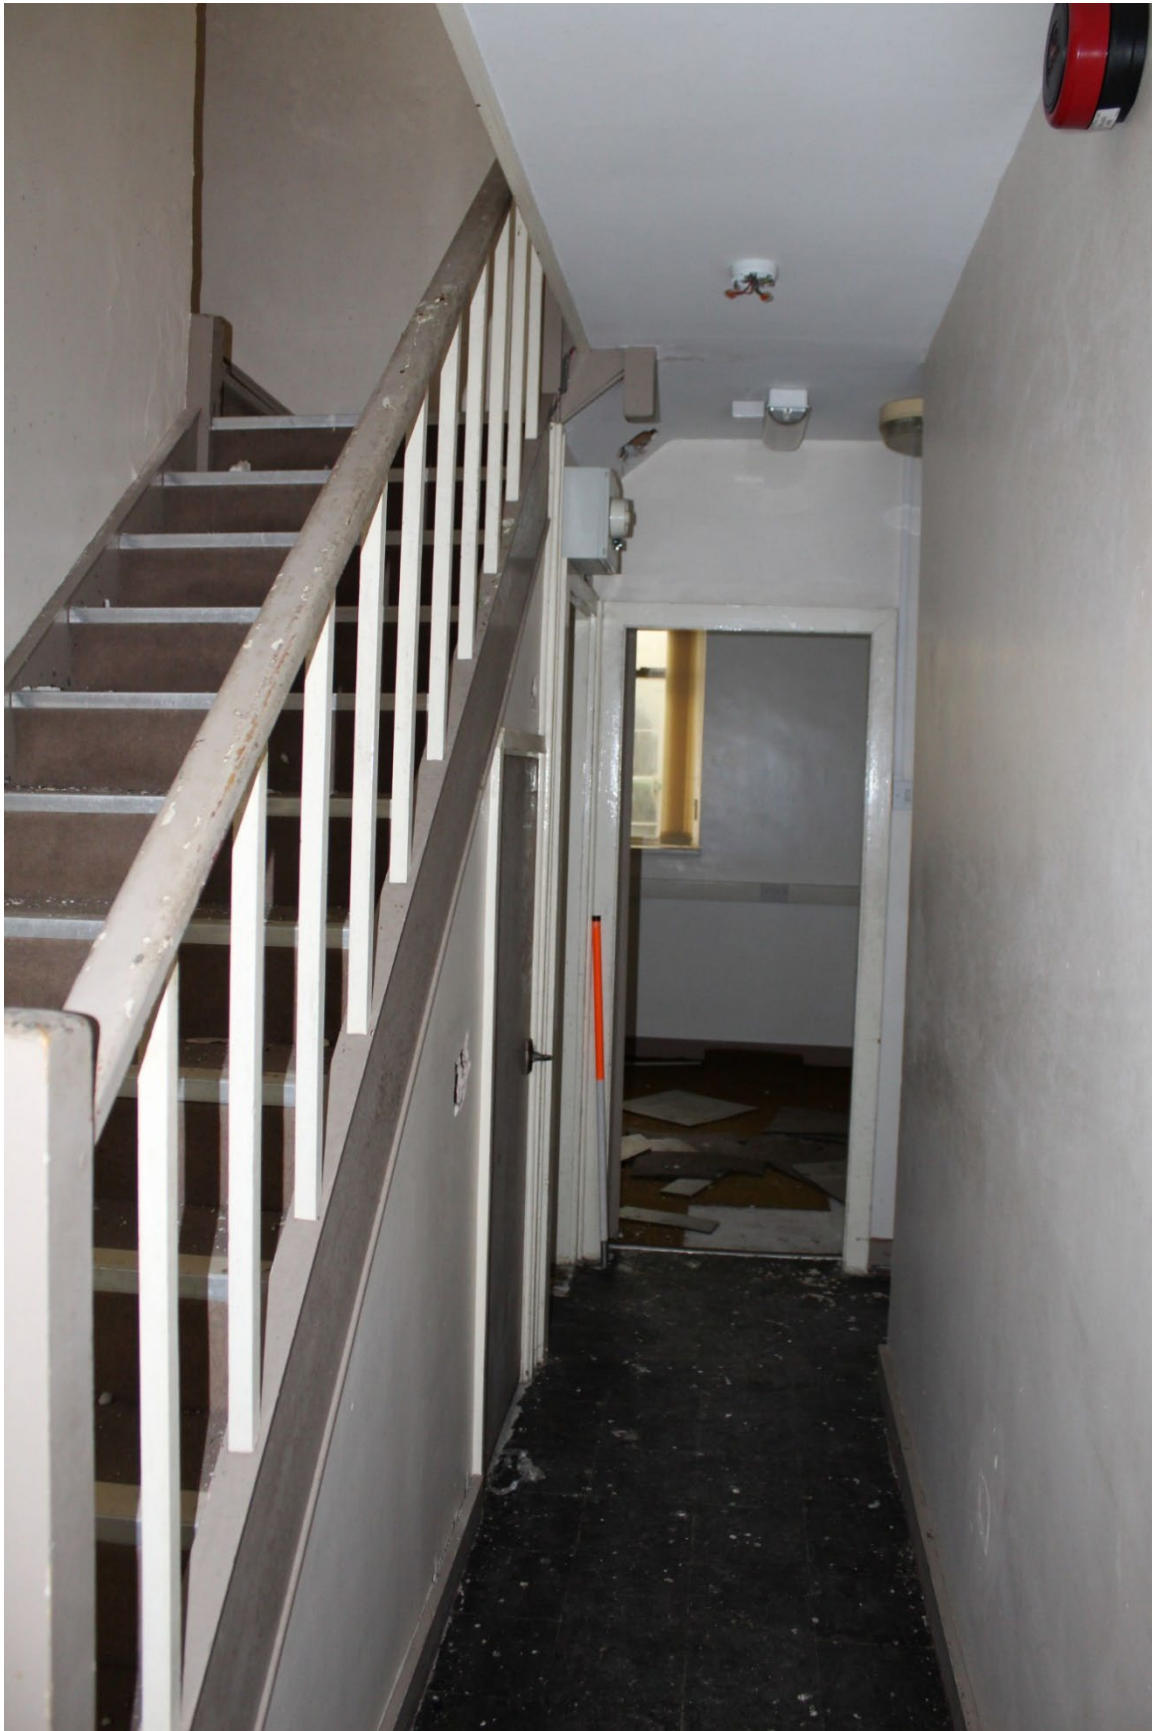
**Image EDP 6.27:** The stairwell and hallway within The Estates Offices, which leads towards rooms G1 and G2, to the right is the narrow corridor that leads to the cottage.

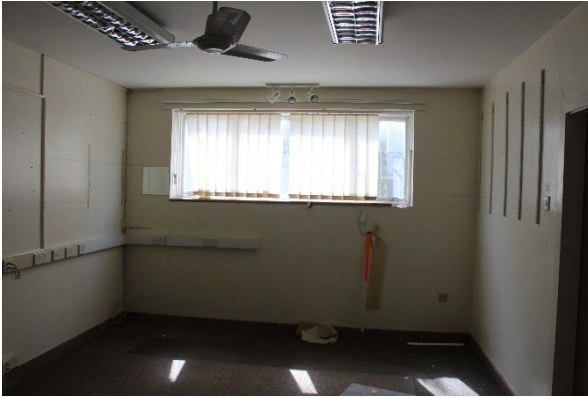
**Image EDP 6.28:** The large windows within room G7 of the Estates Offices.

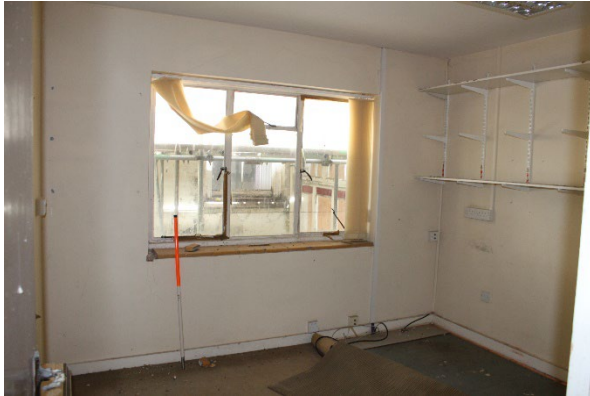
**Image EDP 6.34:** Interior of office F2 which overlooks the conservatory of Marine Villa No. 2.

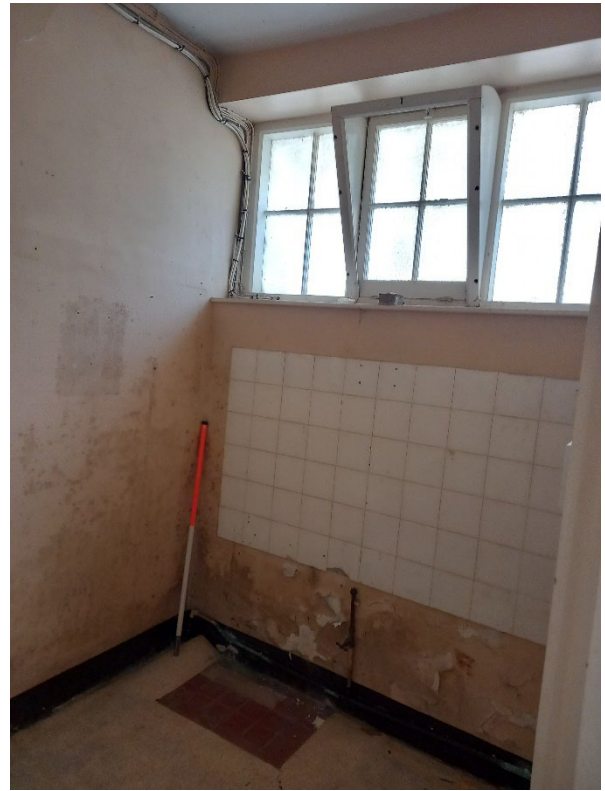
**Image EDP 6.40:** The windows within G13 (previously part of The Stables).

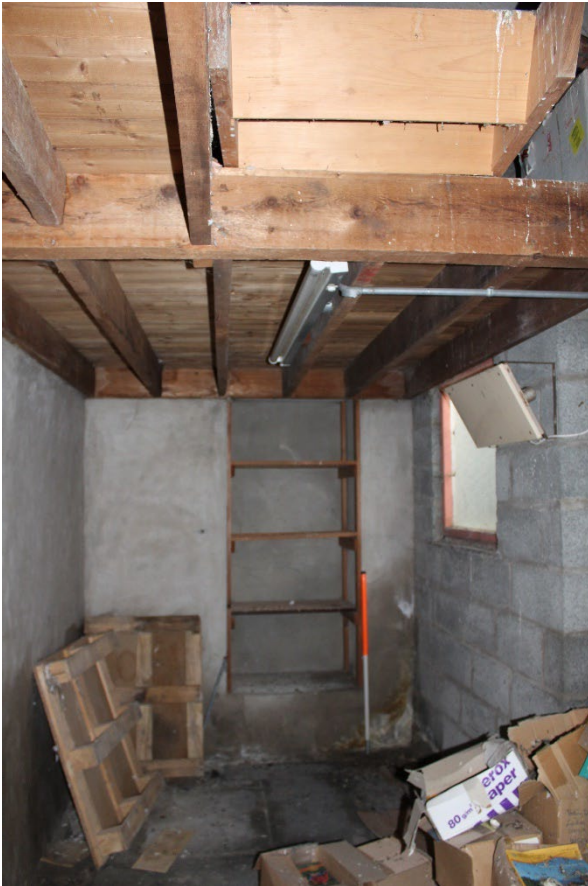
**Image EDP 6.43:** The interior of The Stables looking north-west, note the modern breeze blocks to the right.

- 3.64 Although historic mapping would suggest that The Stables were in place in the 19<sup>th</sup> century, there are no historic features retained today. The Stables has a mixture of exposed blockwork on the eastern and southern wall and render (**Images EDP 6.43–6.44**). The roof is exposed to the underside of the attic floor and contains modern machine cut marks; therefore has been replaced in more recent times.

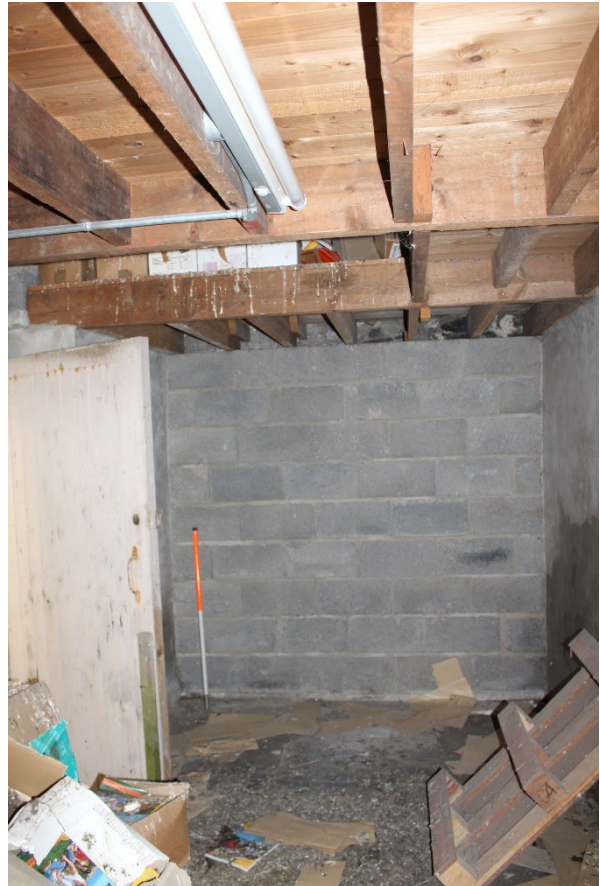
**Image EDP 6.44:** The interior of The Stables looking south-east. The roof has been replaced.

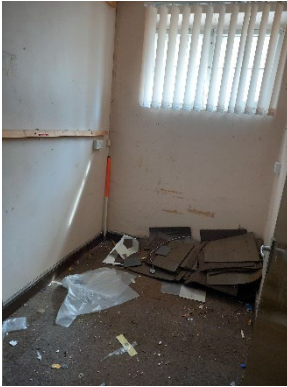
A photograph showing the interior of a room, likely G10. The room has light-colored walls and a dark floor. There is a window with vertical blinds on the right wall. The floor is covered with debris, including cardboard boxes and plastic bags.
Photo EDP C154 (IMG 20220421_131618)	The exit door towards the courtyard	NW

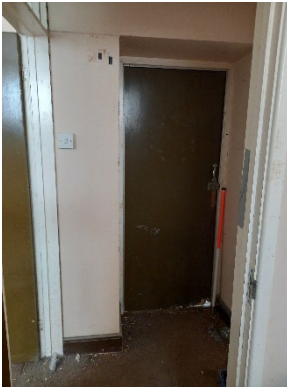
A photograph of a dark-colored door set within a white frame. The door is slightly ajar, revealing a dark area outside. The floor is dark and appears to be made of wood or a similar material.
Photo EDP C155 (IMG 20220421_131630)	The corridor from G9 looking towards G10 and G11	NE

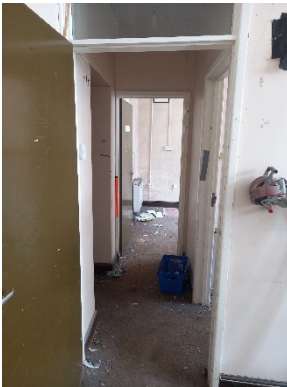
A photograph of a narrow corridor with light-colored walls and a dark floor. The corridor leads to a brighter area at the end, where a blue bag is visible on the floor. The walls are slightly worn and there are some electrical outlets visible.

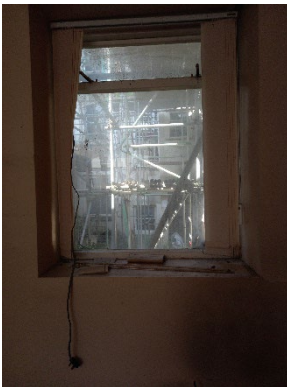
A photograph of a small window with a wooden frame. The window is looking out onto a building with a glass facade. The interior of the room is dark, and the window is the main source of light.
