Plwmp Development,
Plwmp, Ceredigion

Strip Map Record

Planning No.: W/32038

Project No.: AD186

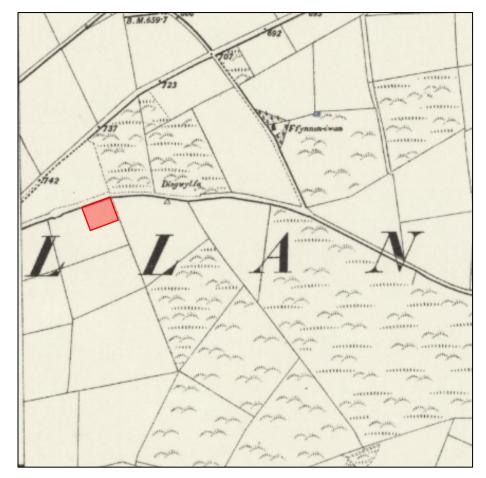
- 3.9.1 The first clear depiction of the development area appears on the Tithe Map of 1844 for the Parish of Llandissiliogogo. At this time, the large field in which the development area is located is shown as divided into four separate fields. The field in which the development is located is recorded in the Apportionment under entry 1317 as Crygie Lands of some 3 acres, 3 rood and 1 perch. It was owned by Rees David and leased by Thomas Thomas, with no individual tithe valuation given.
- 3.9.2 The 1887, 1904, and 1948, 6-inch maps show no change to the boundaries of the field from the production of the Tithe map. The First Edition of 1887 demonstrated that the banked hedgerow was in existence by this time.
- 3.9.3 The four fields shown of the earlier maps was removed sometime between 1948 and the present.

Fig. 5 - 1887, 6 Inch to One Mile, OS. Development area shown. © Reproduced with the permission of the National Library of Scotland 2024.

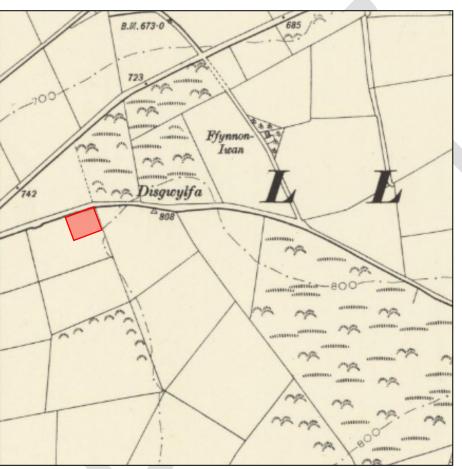
Fig. 6-1904 6 Inch to One Mile, OS. Development area shown. © Reproduced with the permission of the National Library of Scotland 2024.

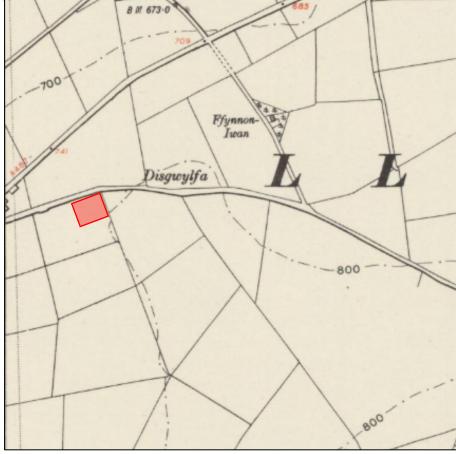
Fig. 4 - 1948 6 Inch to One Mile, OS. Development area shown. © Reproduced with the permission of the National Library of Scotland 2024.

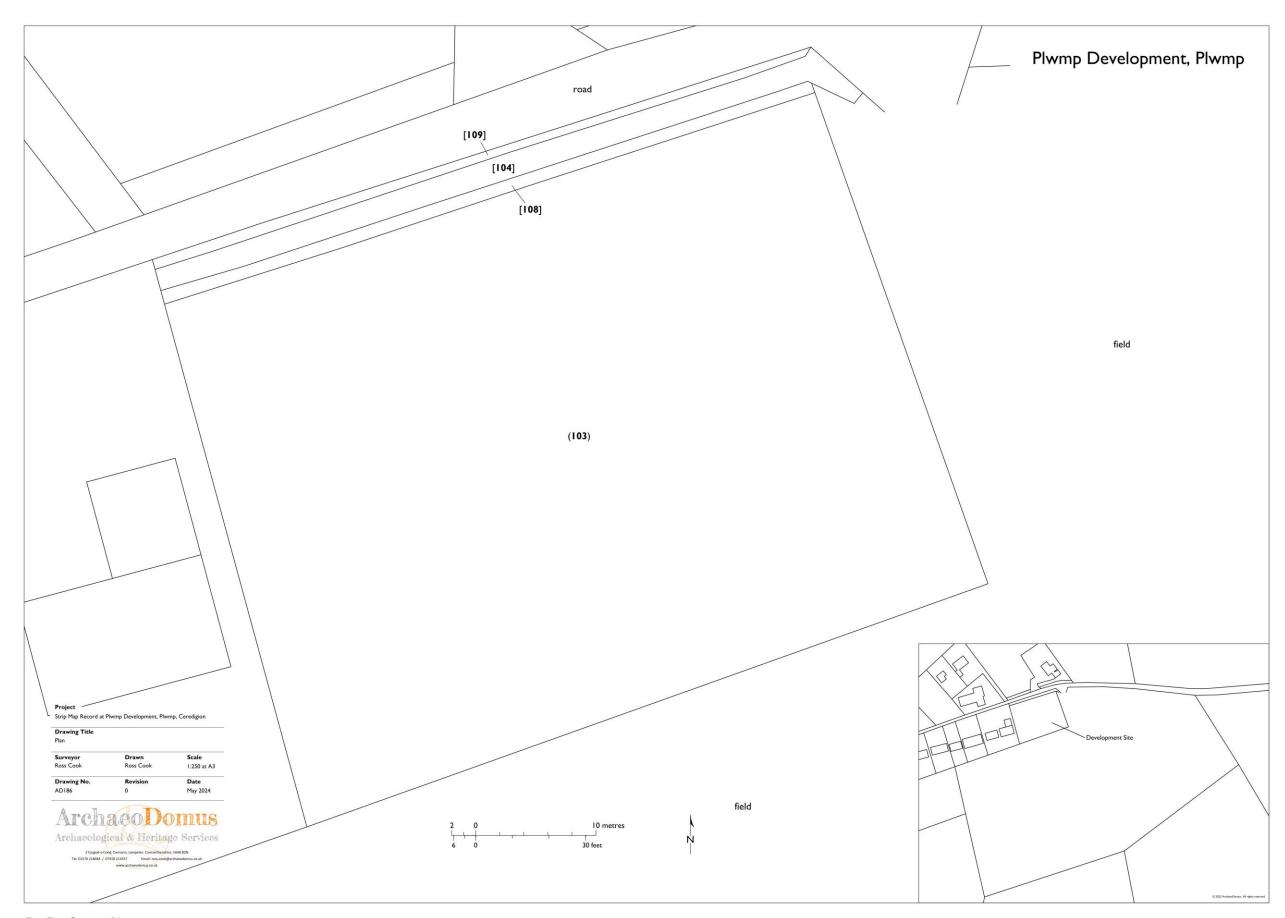
Fig. 7 – Context Plan

- 7.3.1 An area of *circa* 61 x 47m was opened during the course of the SMR. The area was aligned to the unnamed road immediately to the sites north. The area of excavation is presented in **Appendix II**.
- 7.3.2 Excavations removed the turf and humus (101), and brown topsoil (102), which exposed the natural brown to orange shaley subsoil (103).
- 7.3.3 Removal of the banked hedgerow [104] showed this to be formed of turf and humus (101) overlaying a banked deposit of subsoil (105). This sat on a historic ground surface (106). To the north and south of the hedgerow were drainage ditches [108; 109]. Within [108] was a thin deposit of fine earth and silt.
- 7.3.4 No further archaeological materials or deposits were identified.

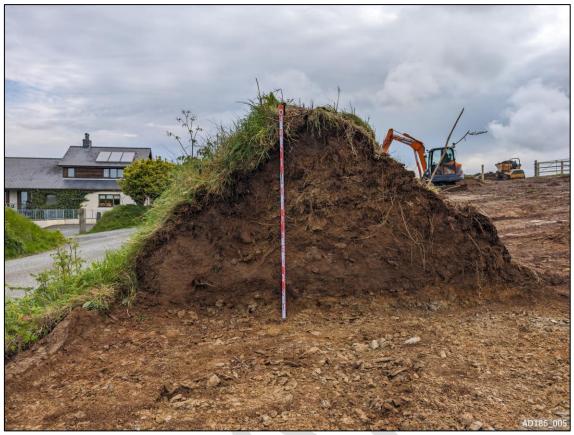
- 8.1.1 The strip map record demonstrated that there were no significant archaeological features or deposits within the development.
- 8.1.2 Stratigraphic evidence suggests the banked hedgerow [104] and its associated drainage ditches were formed sometime in the 19th century. The mound of subsoil (105) to create the bank sat on a deposit of topsoil, similar in depth to the rest of the field, and suggests this was a late, rather than early, development. Its construction from subsoil, with no other material intermixed. This may have come from materials excavated for the improvement of the adjacent road, though this is speculative.

Plate 5 – View east, showing banked hedgerow section.

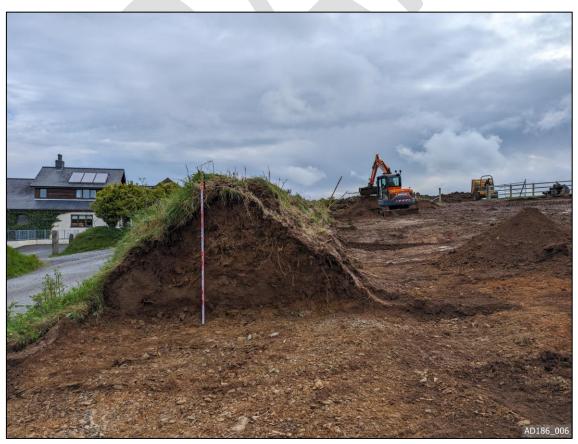
- 8.1.3 The drainage ditch [108] to the south of the banked hedgerow was not visible before excavation, and was shown to be broad and relatively shallow, measuring c.680cm wide by c.400mm deep. The drainage ditch contained no obvious stratigraphy, other than a thin lens of fine earth/silt across its bottom.

Plate 6-View east, showing banked hedgerow section and ditch cut into subsoil.

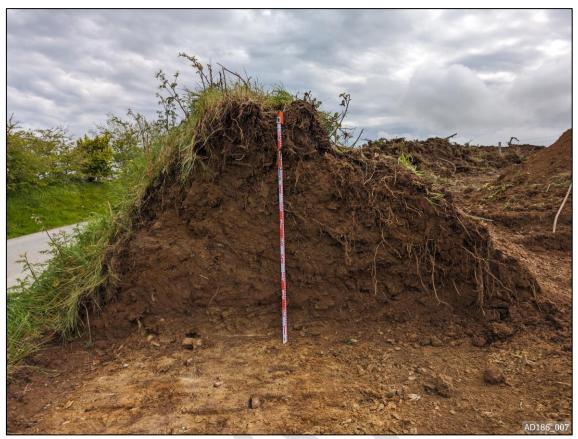
Plate 7 – View east, showing banked hedgerow section.

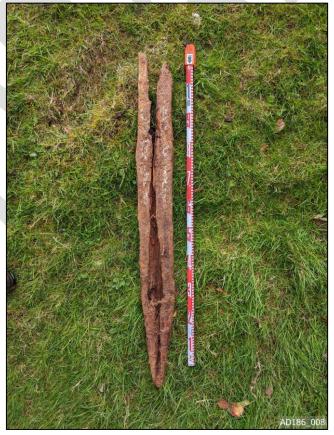
- 7.4.1 A half round pine fencepost (**Plates 8-9**) was recovered from the drainage ditch to the north of the banked hedge.
- 7.4.2 No further archaeological finds were found or recovered during the SMR.

- 8.1.4 The drainage ditch [109] to the north of the banked hedgerow was clear before excavation and had been maintained for drainage.
- 8.1.5 The half round pine fencepost was found in drainage ditch to the south of the banked hedgerow, where it it was found resting on the subsoil (**103**). The posts form suggests it is of 19th or 20th century origin.

Plate 8 – Half round pine fencepost, cut face.

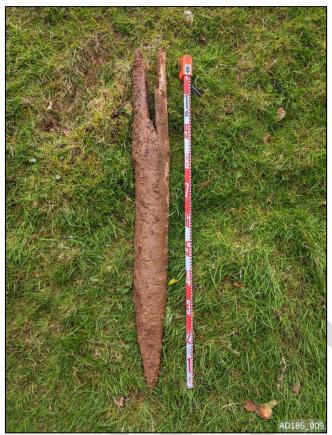
Plate 9 – Half round pine fencepost.
