POYERS ARMS FARM, TEMPLETON, PEMBROKESHIRE:

ARCHAEOLOGICAL WATCHING BRIEF

CAP Report No. 101

**Date: 12th August 1999**

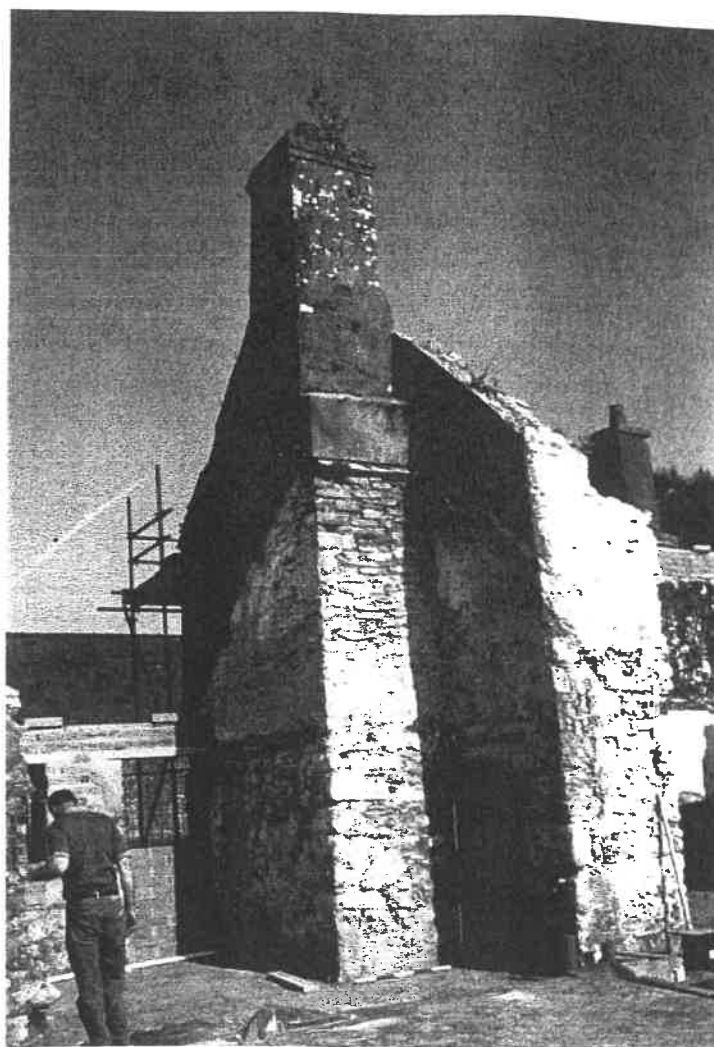
**Plate 2 The large external chimney on the south wall - camera facing NW.**  
 Note:- a) external pink limewash to ground floor height b) top of 'Flemish' chimney to right.

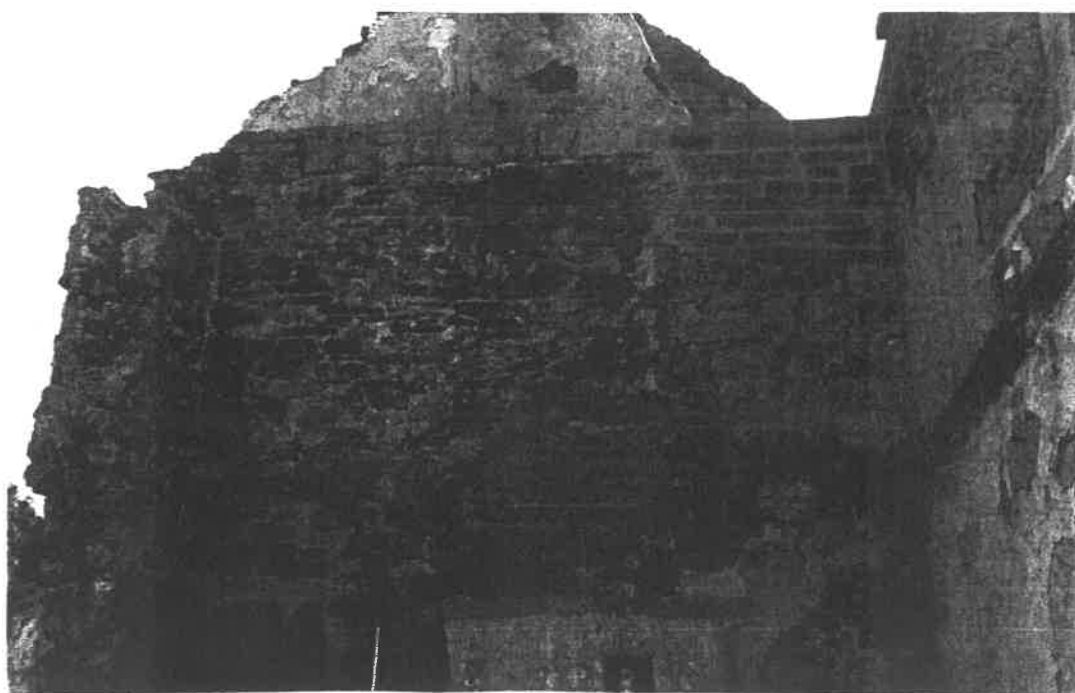
**Plate 3 The upper part of interior of south wall (U) - camera facing south.**  
 Note:- a) change in masonry above ranging pole showing 'ghost' of chimney flue in wall  
 b) blocked-in hearth and also old concrete filling old lintel position

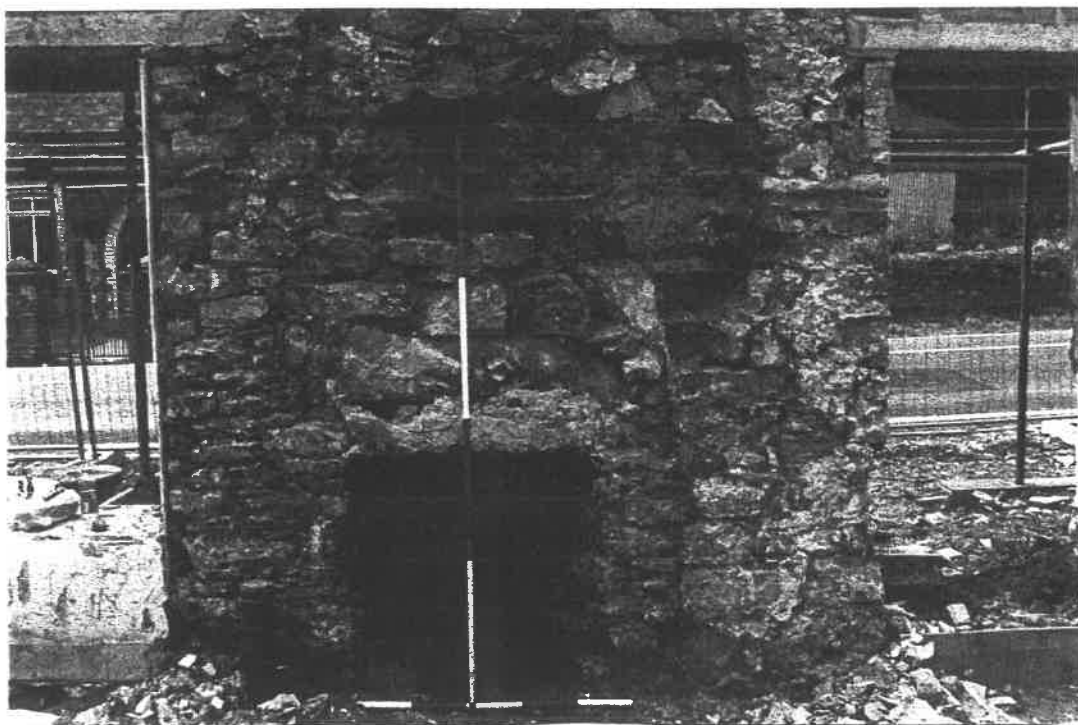
**Plate 5** The hearth opening of the Flemish chimney (wall S) - camera facing west.

The north side of the original hearth opening had been blocked with rubble and grey white mortar (*see plate 5*) to narrow the opening. The old shape could be detected on the north side as a thin line of mortar plaster going into the splay under the blocking. At a later date there had been several phases of lintel, the trend being to continually lower the height of the opening. Early this century, much of the internal wall of the flue was removed at around the height of the ceiling and replaced with poor materials (*see plate*).

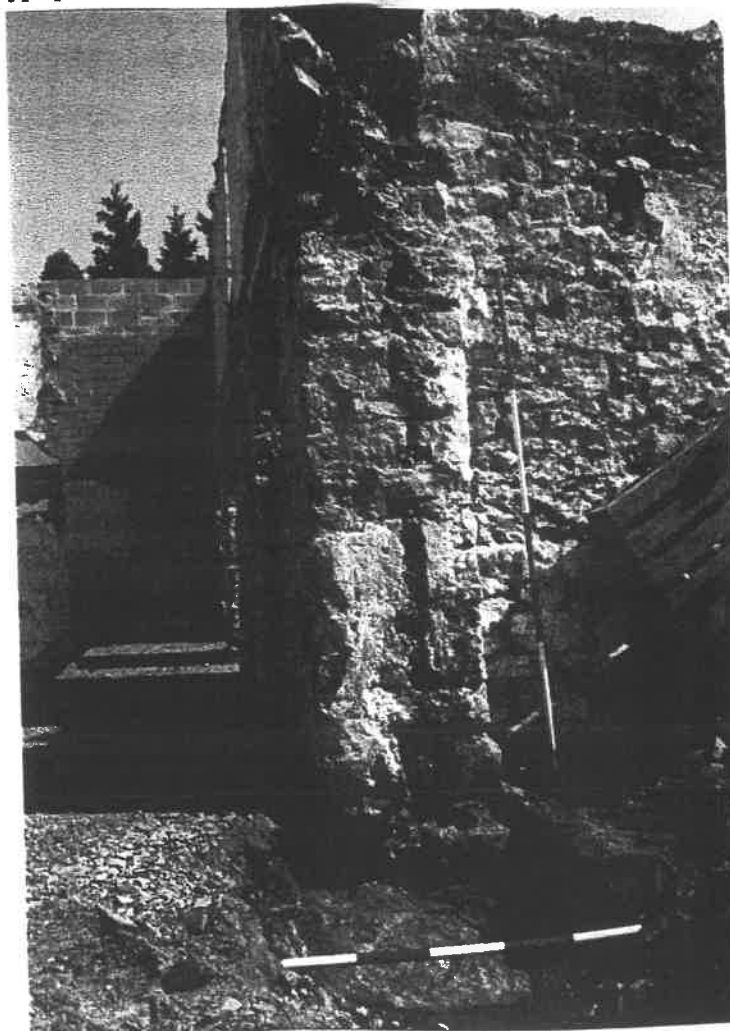
**Plate 7** The southern end of wall (R) with wall (X) removed - camera facing north  
 Note:- a) old lime plaster finish indicating that this was the north side of an opening  
 b) yellow/orange bedrock in base of foundation cut (10).

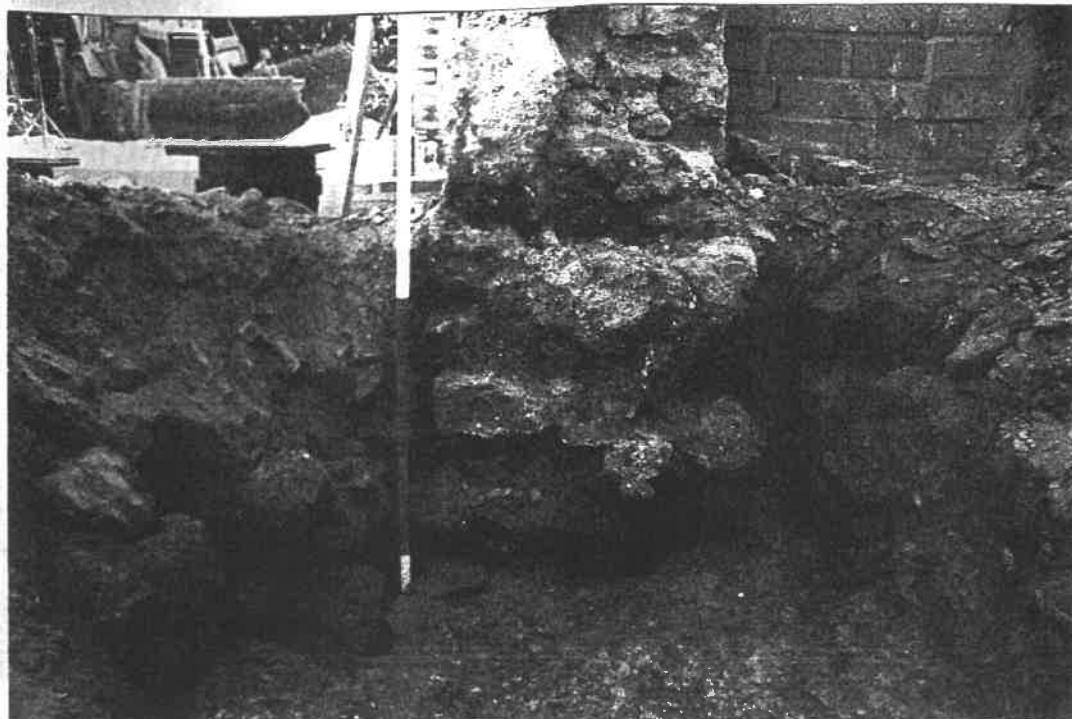
**Plate 8** The base of the northern end of wall (W) - camera facing south.

Note:- a) the hard pink mortar in foundation courses

b) old white lime plaster finish above indicating that this was the south side of an opening (see also plate 7)

c) yellow/orange bedrock in base of foundation cut (10) d) scale inserted c. 0.5m into rubble fill of cut (15)
