THE RED COW, BRIDGE STREET, CARMARTHEN:

Standing building recording and archaeological watching brief

CAP Report No. 47

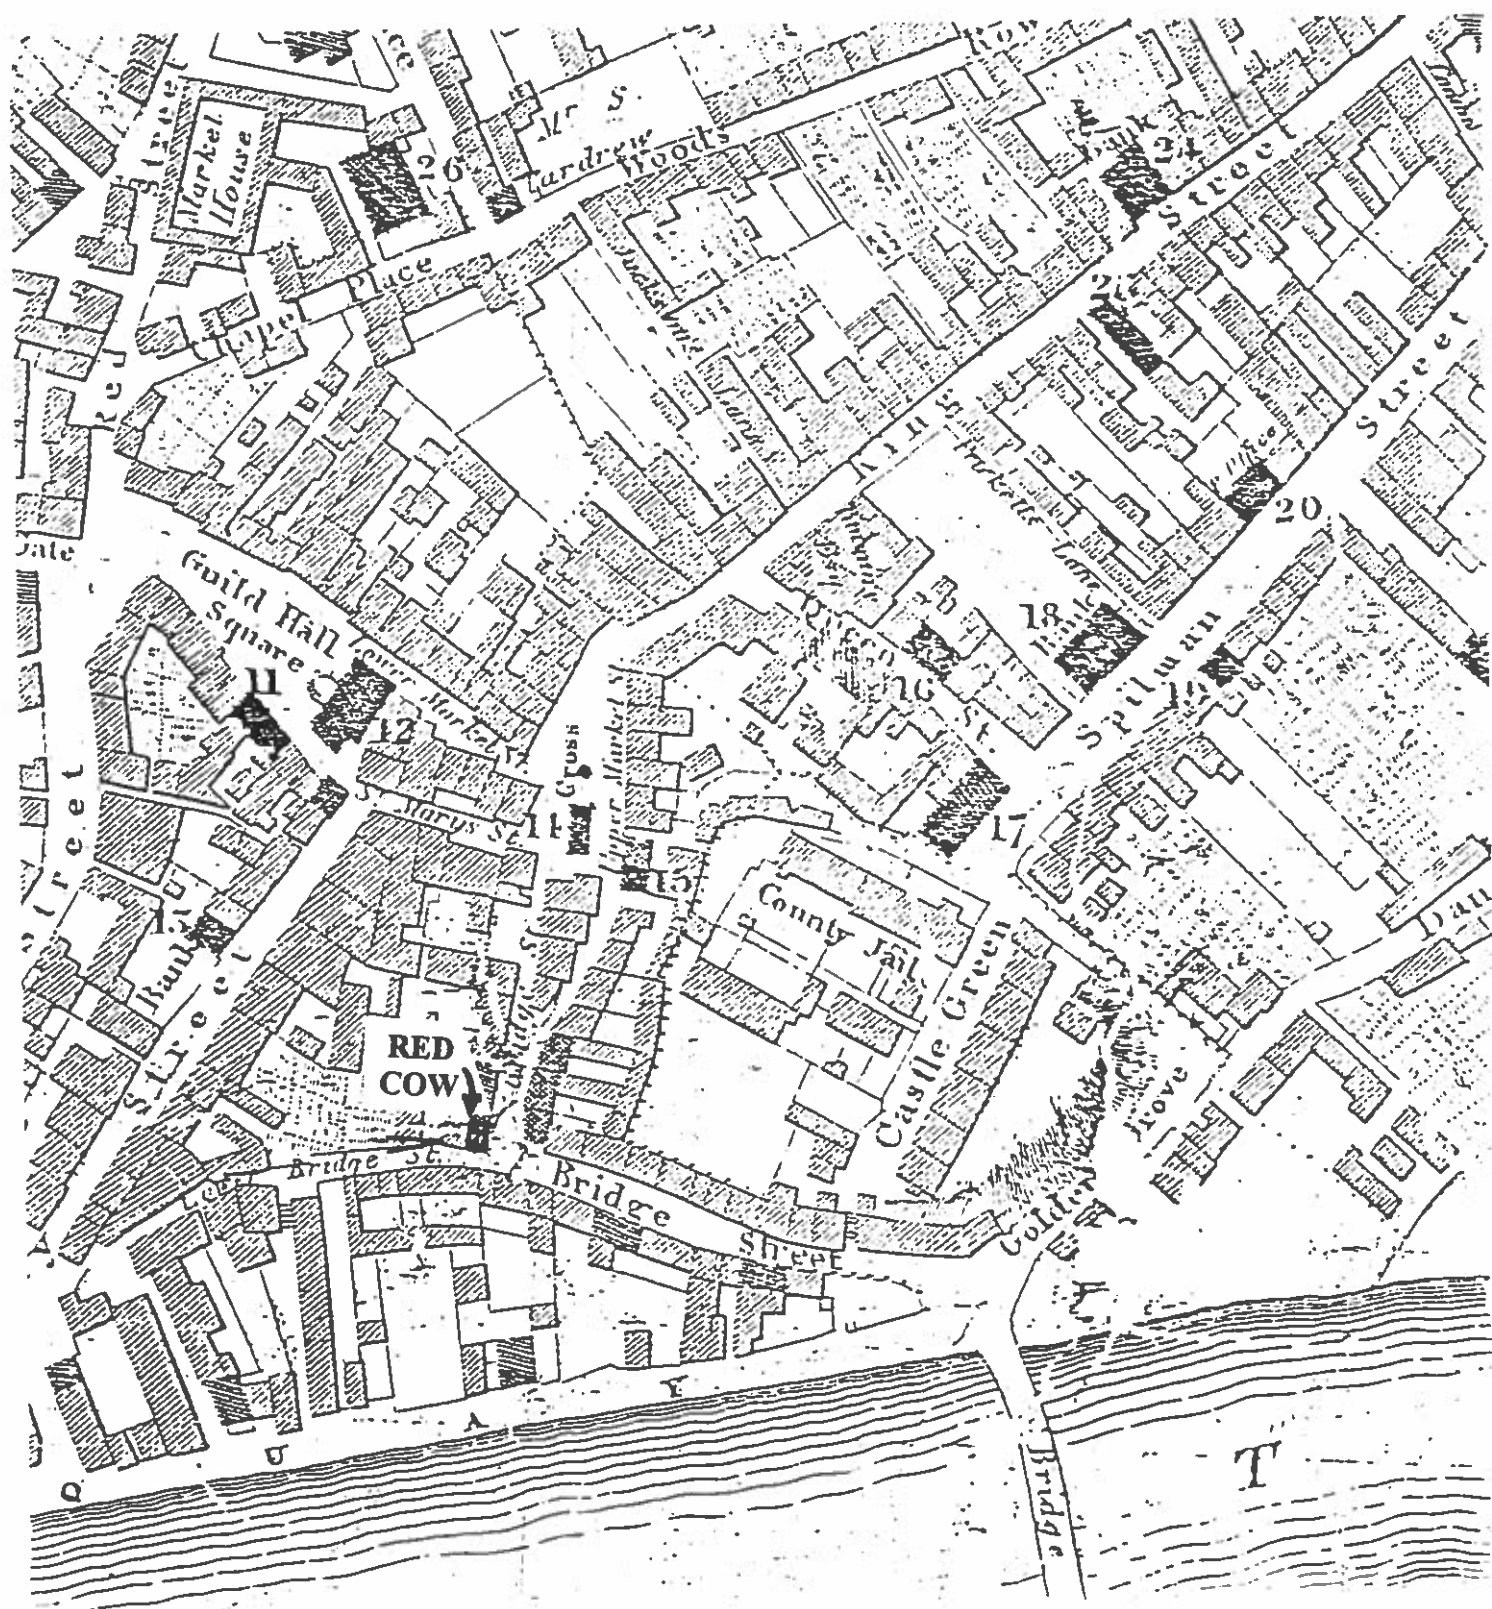
Fig. 2 Part of John Woods map of 1834

5.4 The watching brief in the garden revealed that the western end of the plot had been occupied until fairly recent times by a structure of almost equal ground floor plan to the Red Cow. This information is confirmed by map evidence of 1834 (*Fig. 2*), which also appears to show the Red Cow as an existing structure.
