CAMBRIAN ARCHAEOLOGICAL PROJECTS

ON THE RECORDING OF THE STABLE BLOCK BUILDINGS

AT MIDDLETON HALL, CARMARTHENSHIRE

CAP Report No: 114

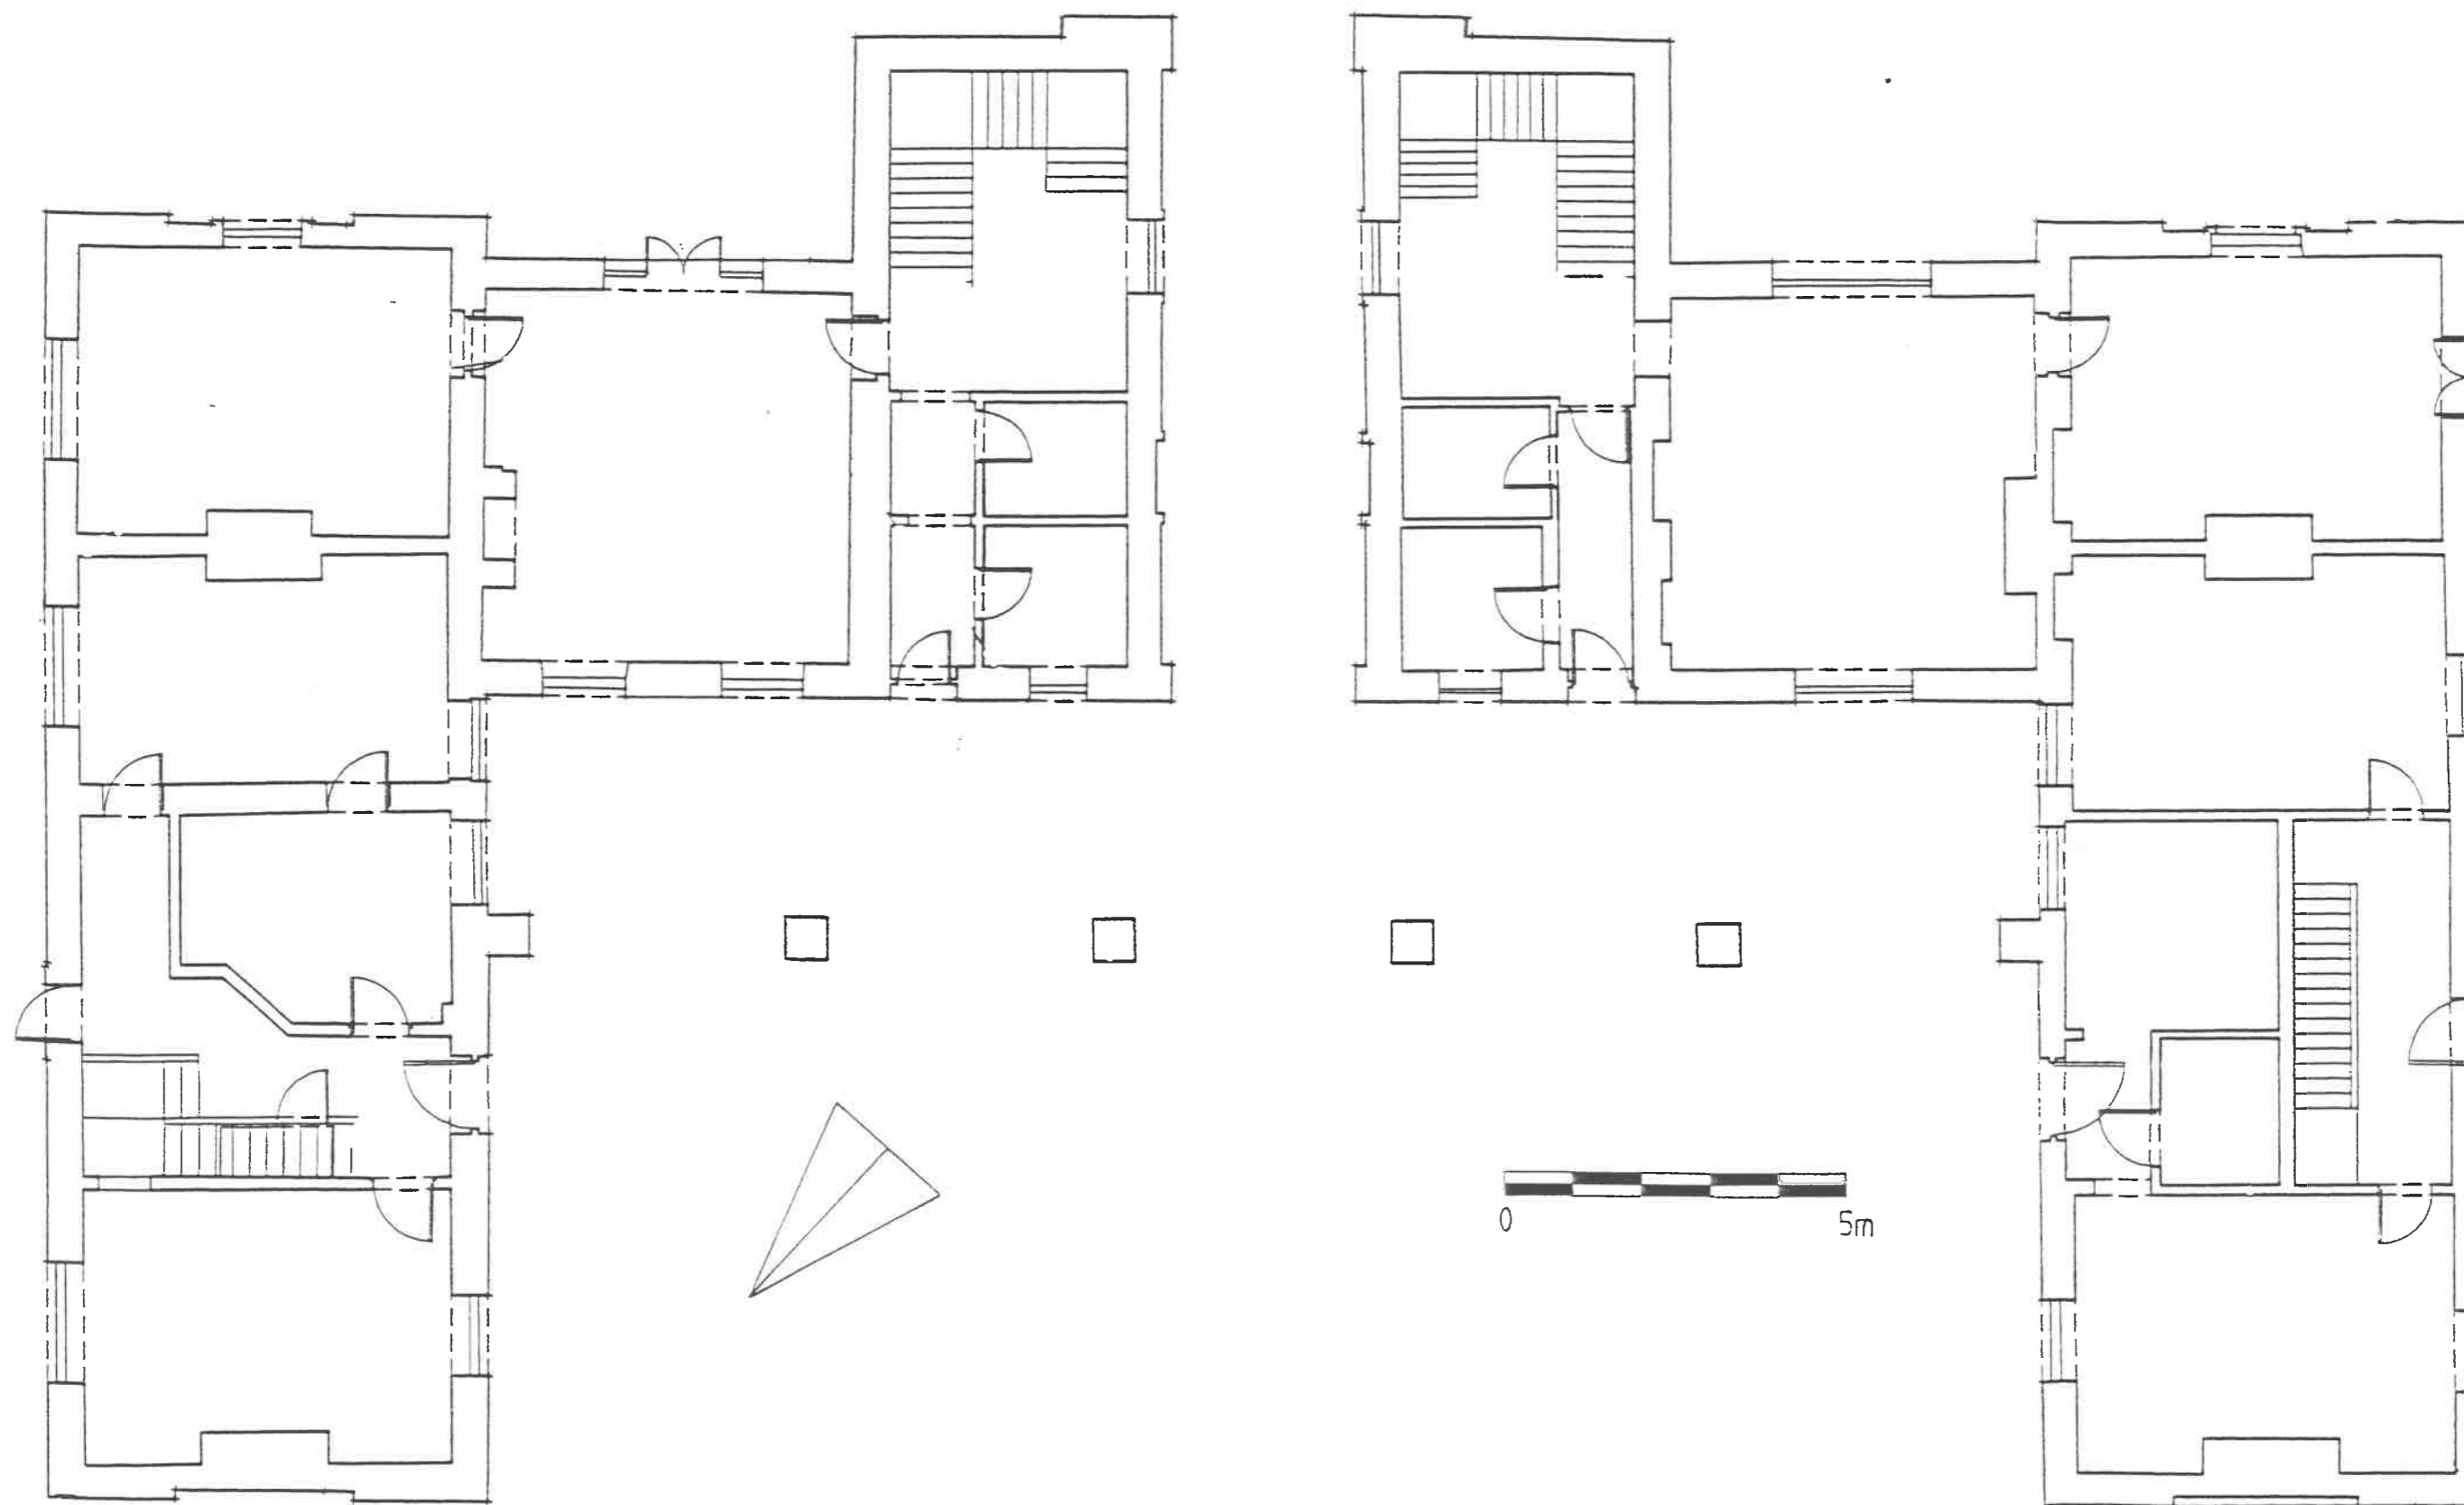
FIGURE 1:

All the other internal walls of red brick or stud work are later modifications from when the stables were converted to domestic accommodation (see figure 1). With the exception of additional doorways, there was no surviving evidence of any original internal divisions that were subsequently demolished. All the fireplaces that exist at present are later, brick built additions. There is no evidence for any original fireplaces.

GROUND FLOOR PLAN OF THE STABLE BLOCK
(ARCHITECTS DRAWING)

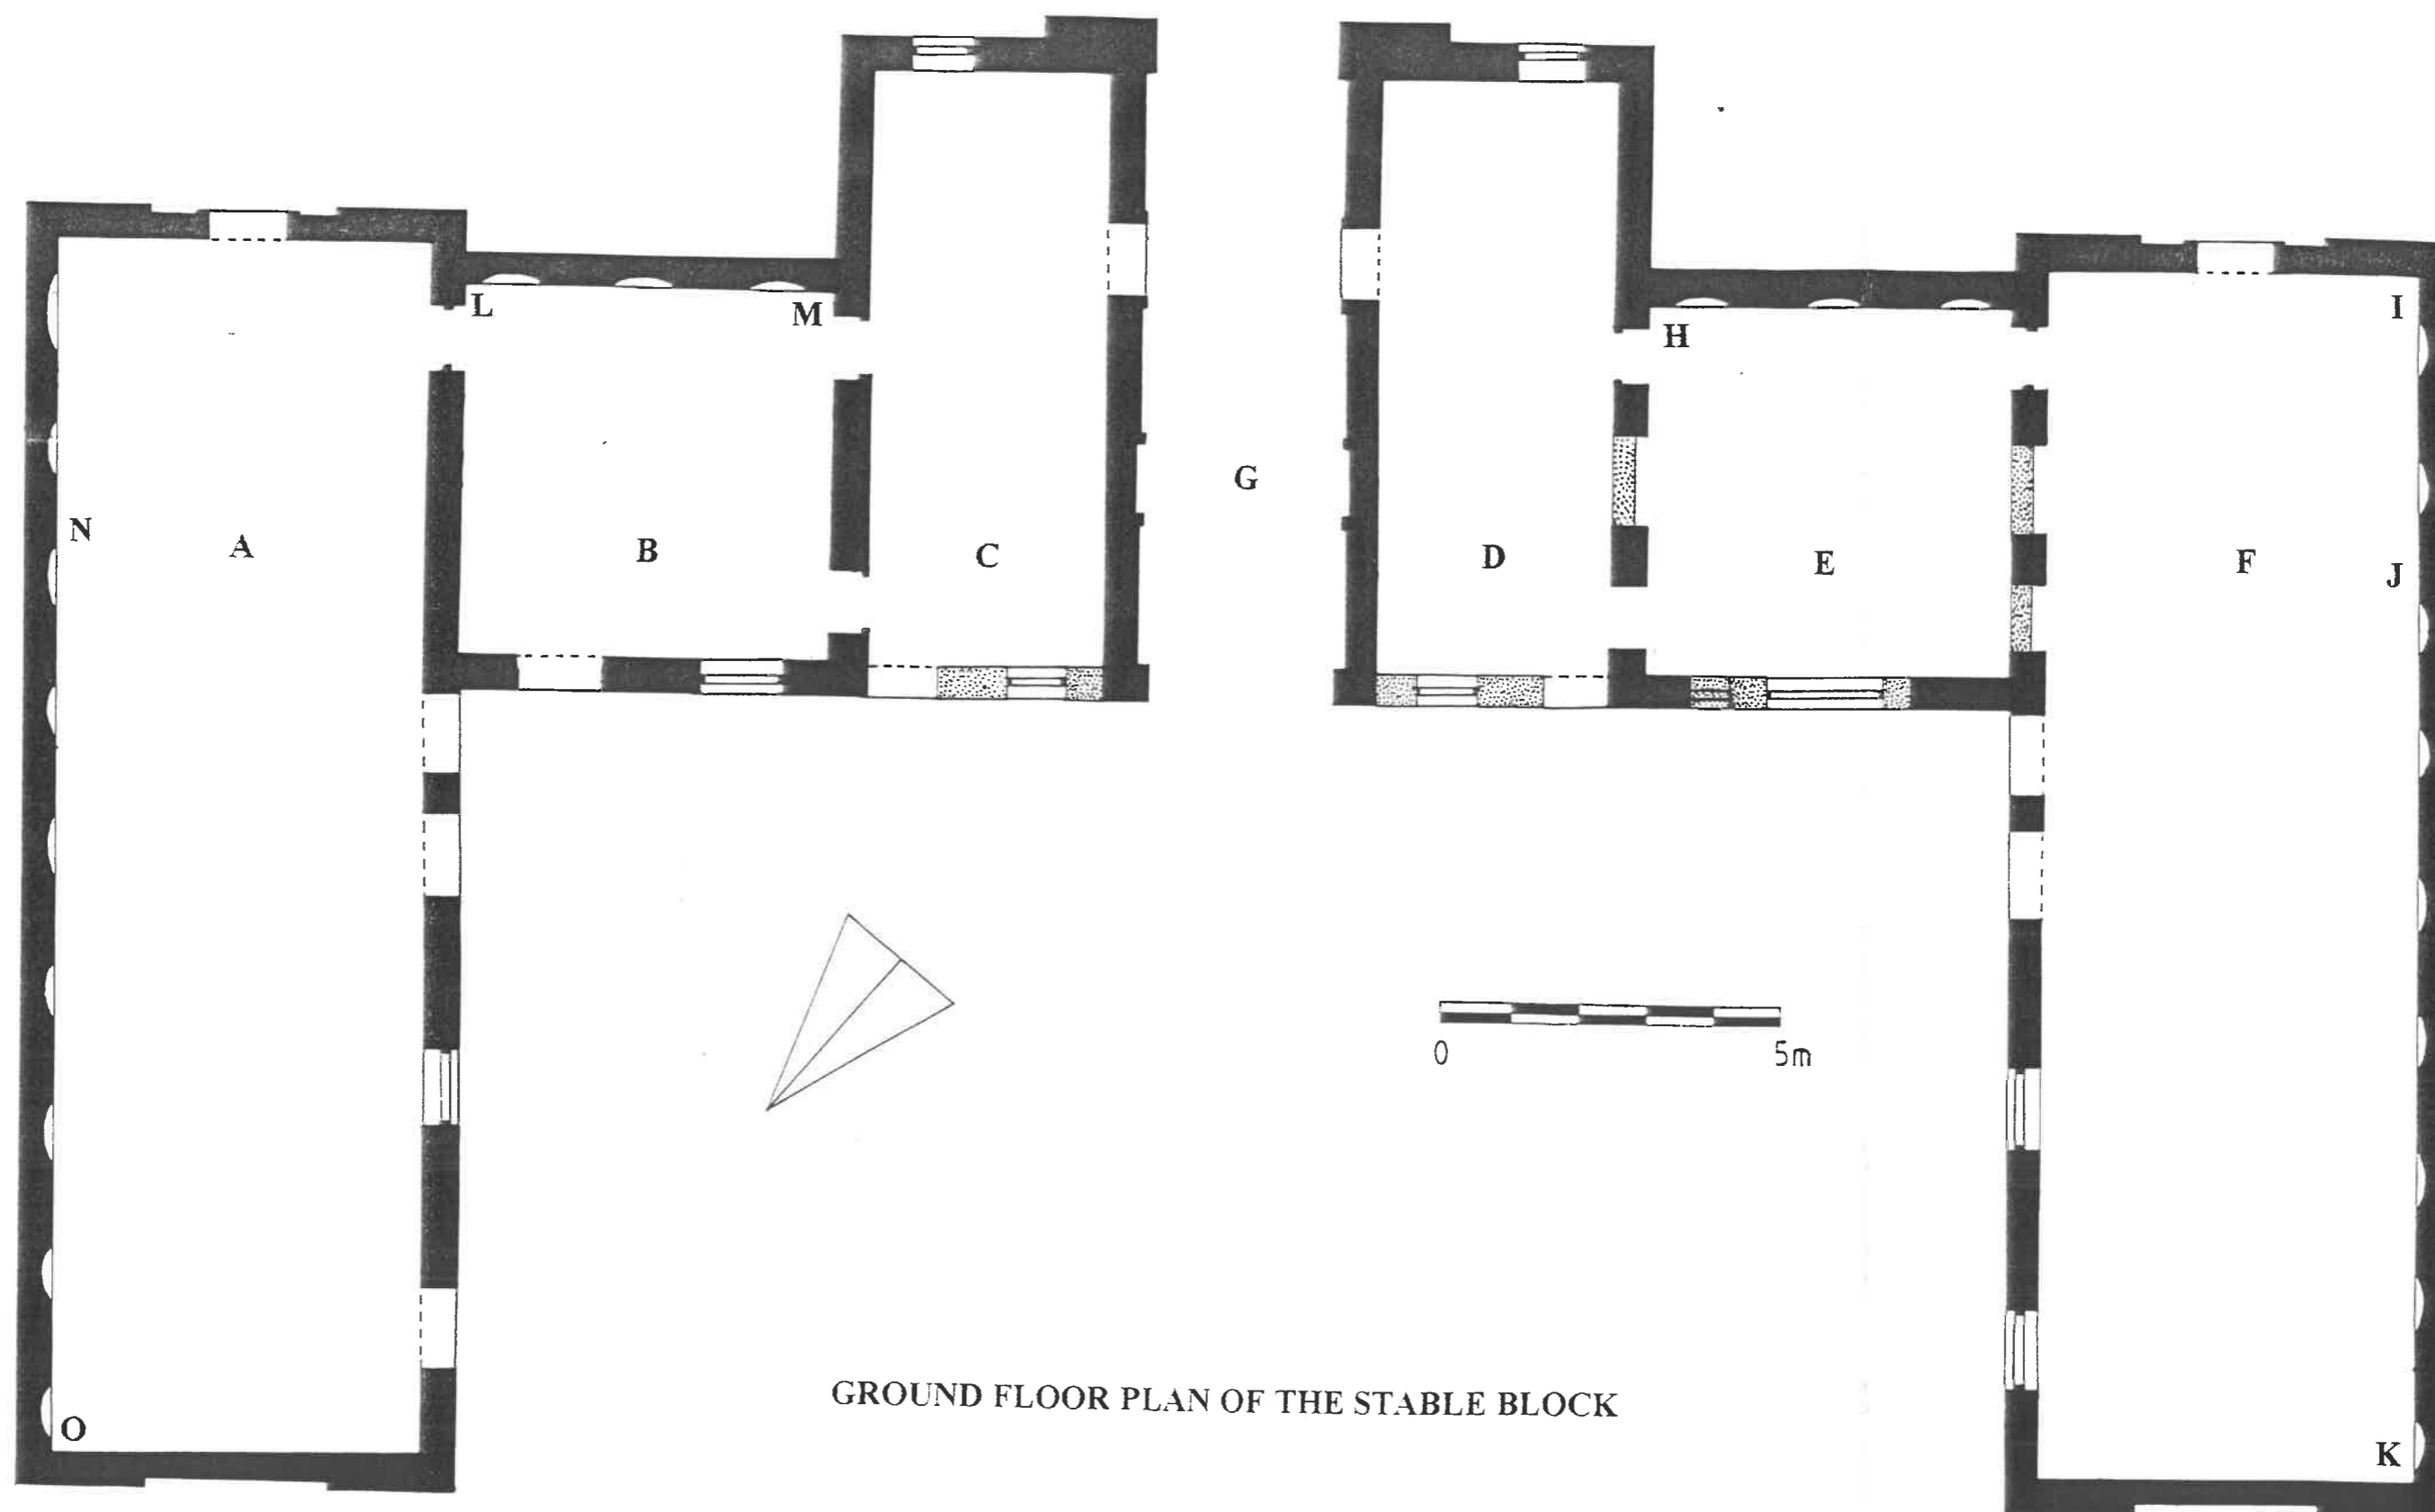
FIGURE 2:

The external walls of the building all appear to be of one building phase. The two wings appear to have been the main stables. The only original internal divisions are those between rooms A, B, and C, and between D, E, and F. The Doorways between rooms A, B, and C, are probably in their original positions, while several doorways have been added and blocked in at various times between rooms D, E, and F.

smartly appointed. From the number of oval recesses, each wing would have had stabling for up to nine horses (see figure 2).

GROUND FLOOR PLAN OF THE STABLE BLOCK

In order that the circular windows of the Stable Block could light wings (A) and (F), and rooms (B) and (E)(figure 2), there could not have been a first floor in the original building. There were, however, attics within the roof-space. Only the semi-circular window above the archway (see north west elevation) lights this attic space.

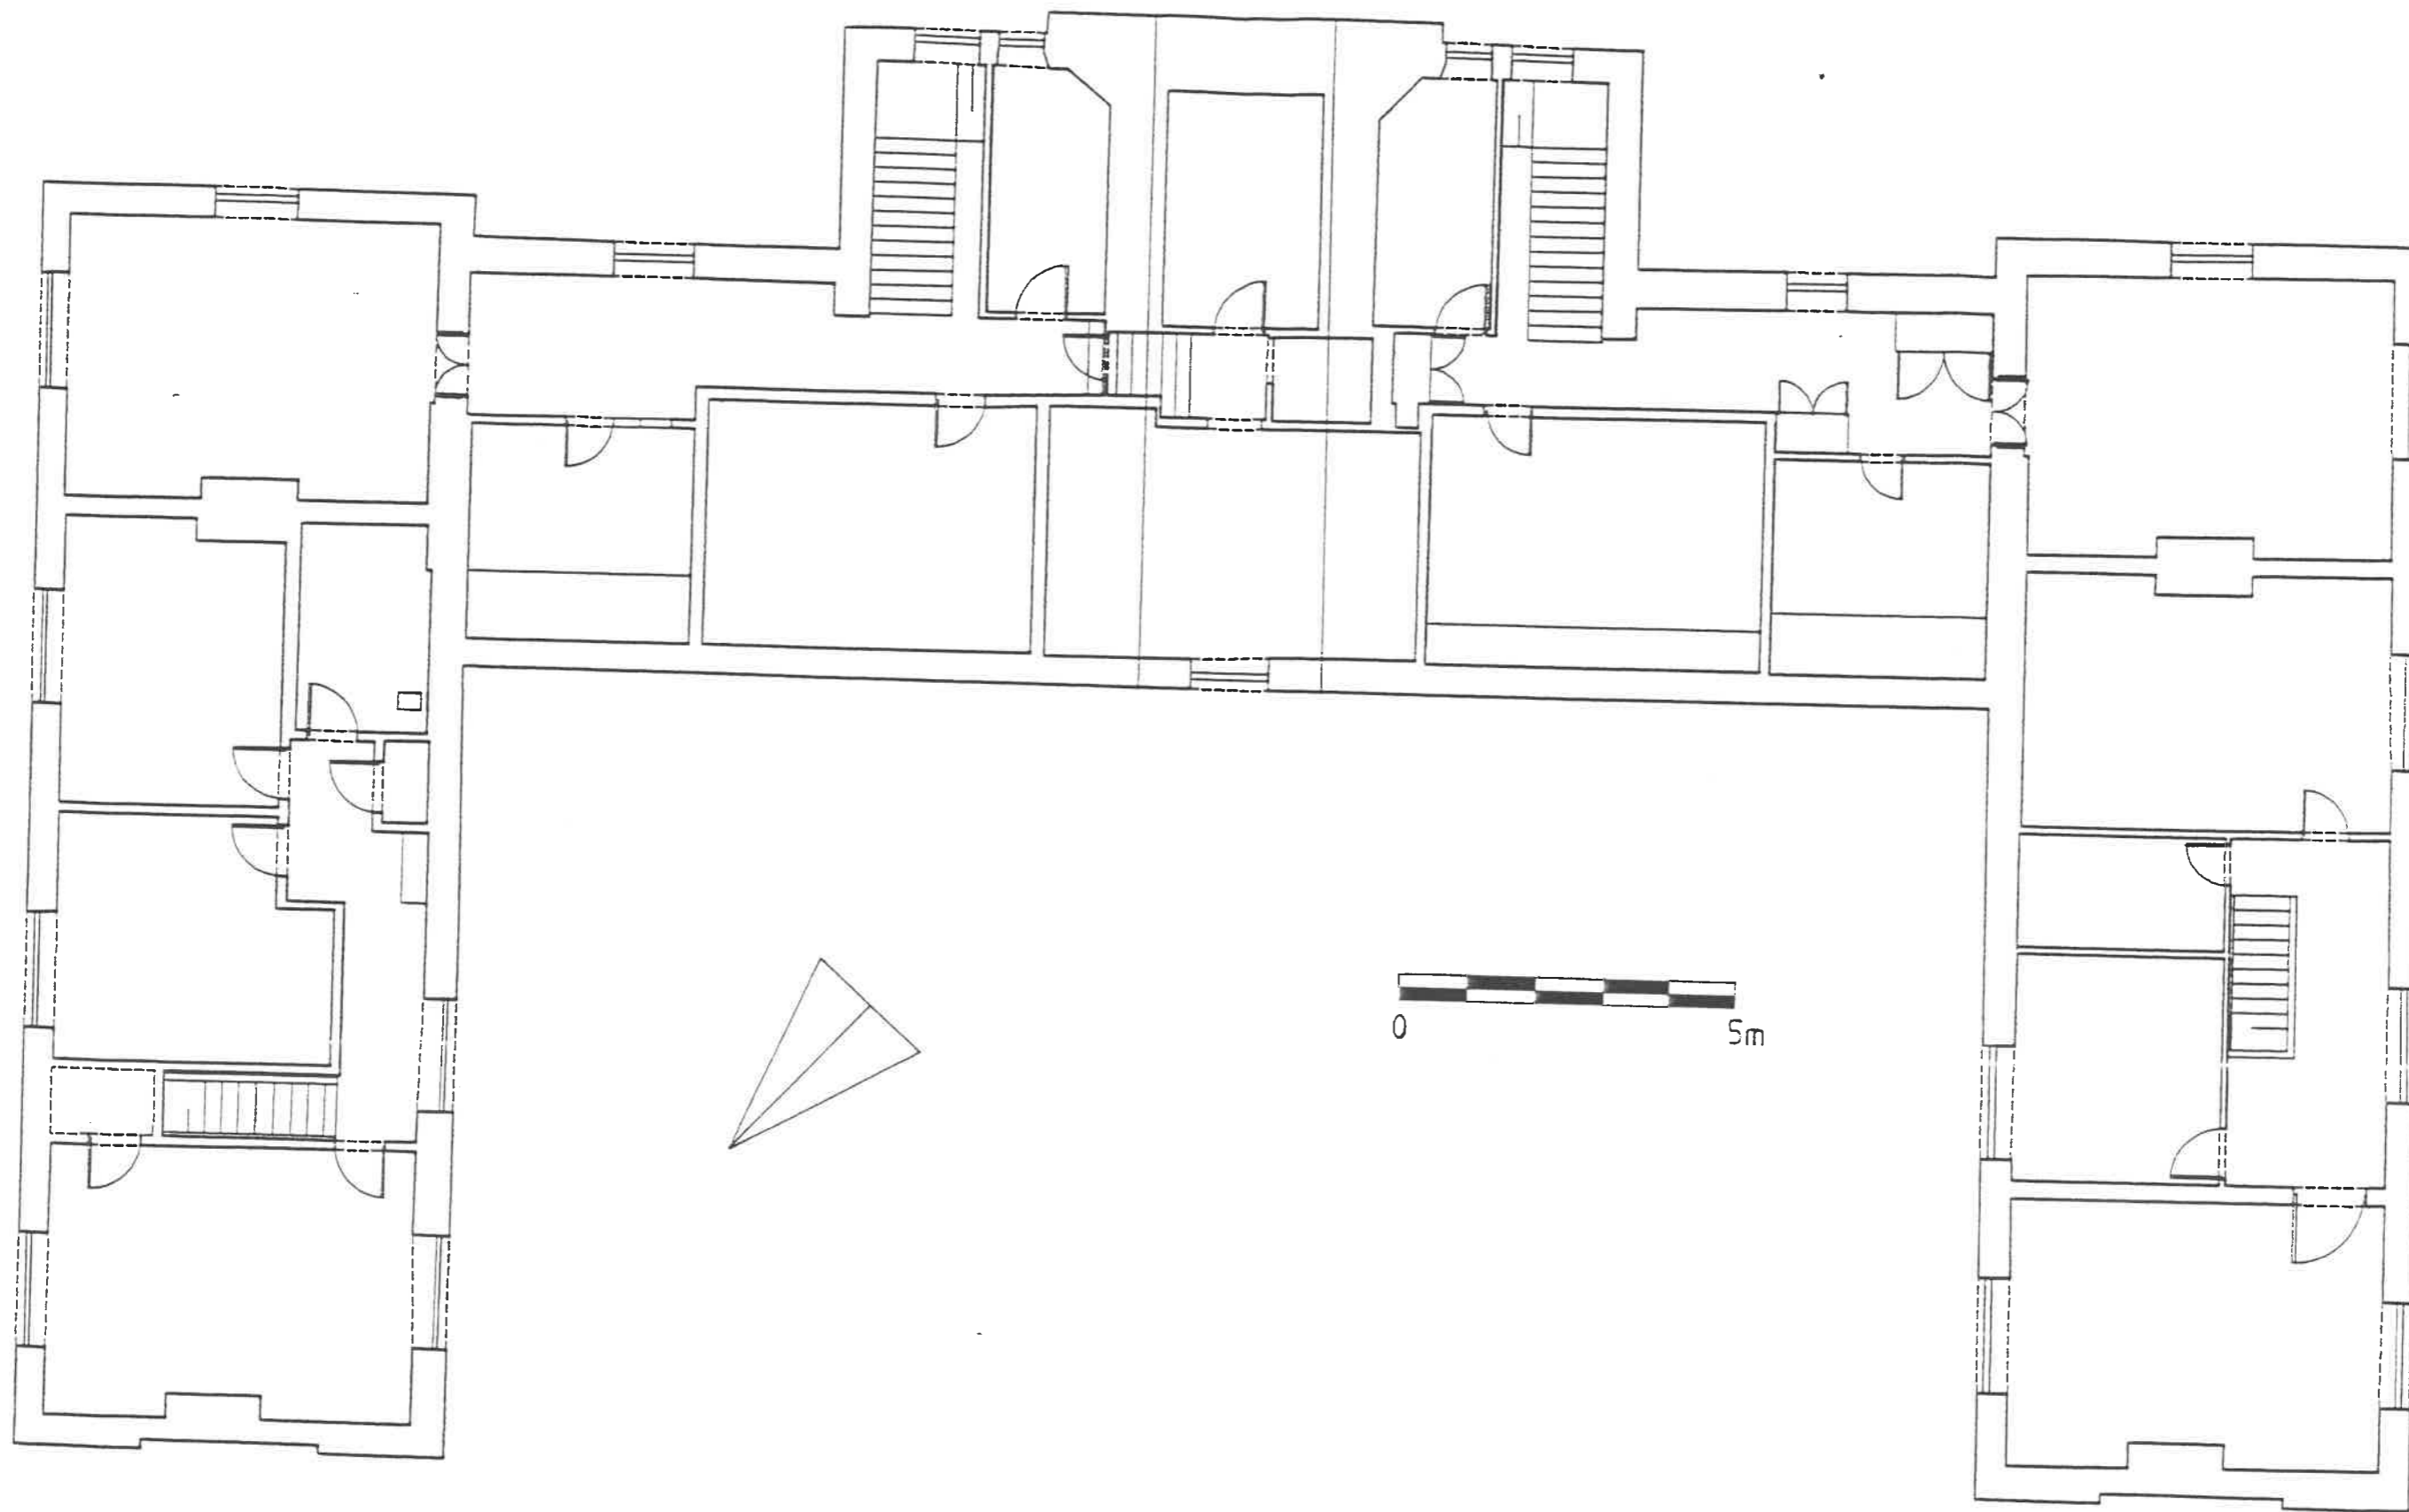
FIGURE 3:

FIRST FLOOR PLAN OF THE STABLE BLOCK
(ARCHITECTS DRAWING)

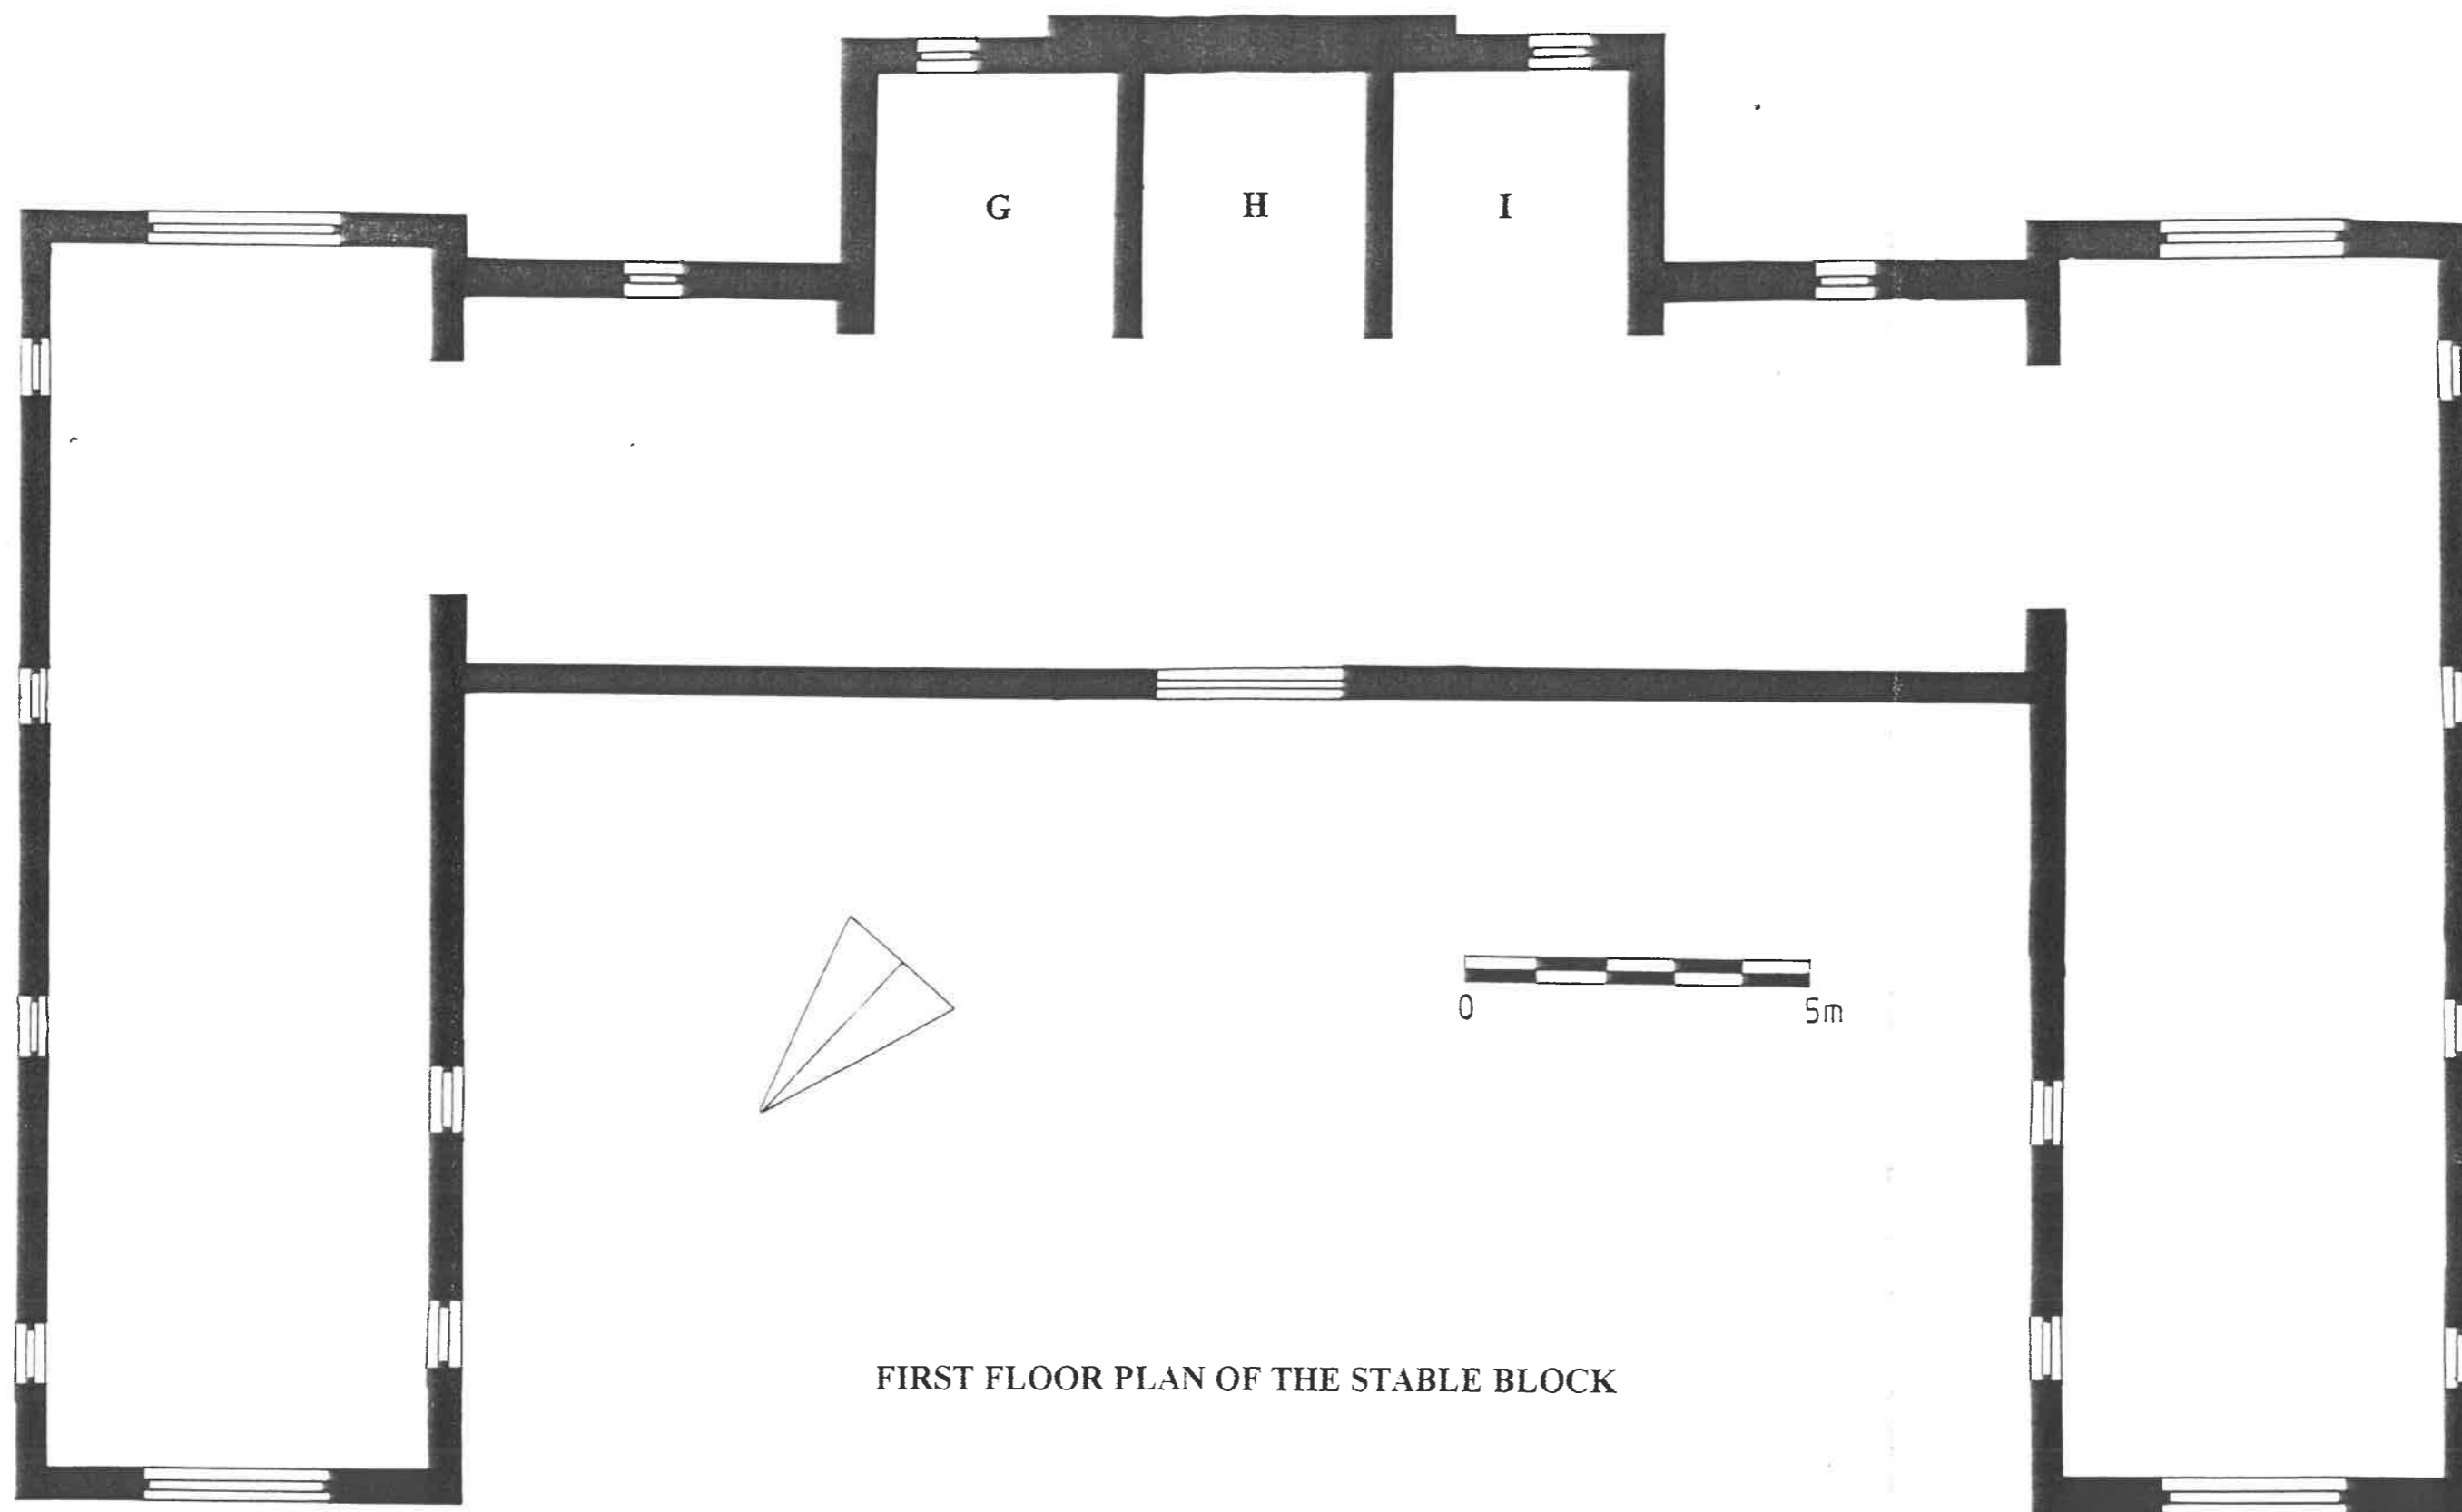
FIGURE 4:

Although there is evidence that the original stairs to the first floor were not in their present position, their original layout is not certain. Whatever the arrangement, areas (G) and (I) are most likely to have contained the stairwell, leading to the roof-space at the level of the pigeon loft (H). The present stairs lead to the first floor which is a later modification, with a further flight of stairs leading up to the level of the pigeon loft and attic space. The existing first floor level dates from when the building was converted to domestic accommodation.

FIRST FLOOR PLAN OF THE STABLE BLOCK

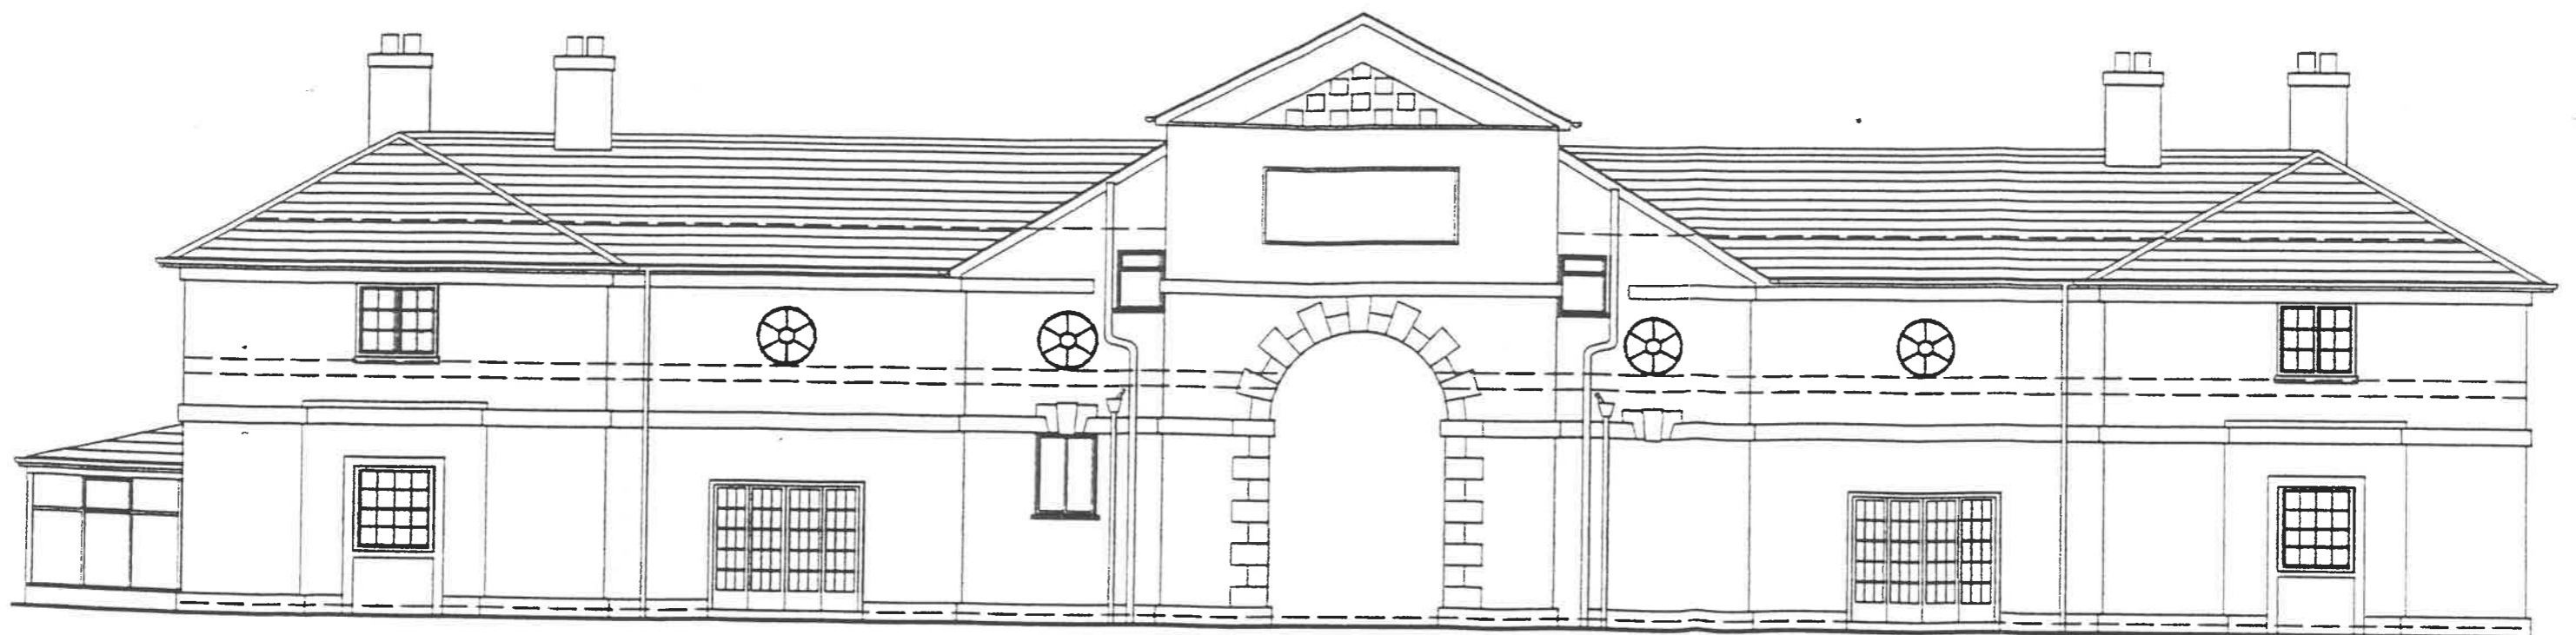
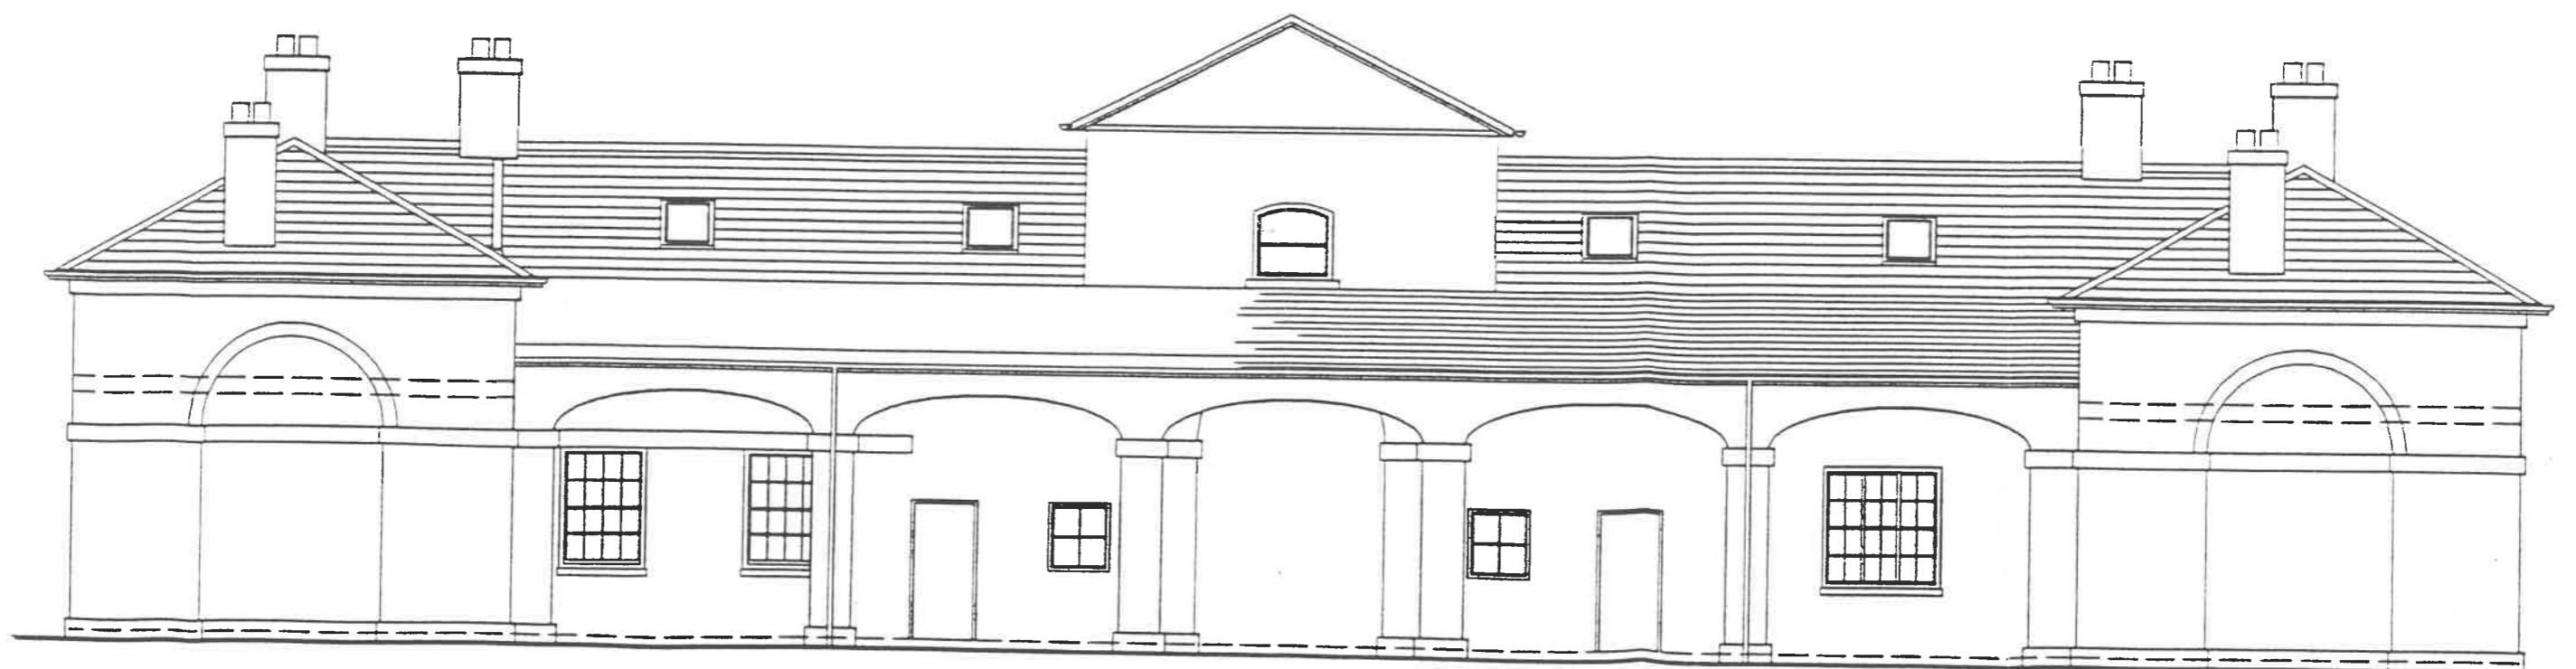
Several alterations have been made to this facade, reflecting changes in the use of the building. Doorways at the ends of the wings (A) were later converted to windows. Originally these doorways would have been the primary entrance to the stable wings from the outer face of the block. Between the wings and the central archway (E) there were originally no windows on the ground floor. Evidence on the interior of the building (see figure 18) indicates that this area was also used for stabling. The windows on either side of the archway (D) appear to be original and suggest that this part of the building had a different function to the other rooms. There is no evidence that they were ever doorways. These windows were the only ones on this side of the building giving a view of approaching traffic from the Hall and Trawscoed.

Unless all the stabling areas were open to the rafters, there would have been insufficient light and ventilation in these parts. The two semi-circular windows (B) and the circular windows (C), were the primary source of light and ventilation for the stabling areas. Windows (B) were later bricked up (when the first floor was inserted). Alternatively, features (A) and (B) may never have been intended to be functional. They may have formed decorative facades (as may have been the case on the north east elevation) to mirror the central archway. If this were so, however, it seems unlikely that the features would have been constructed to have been functional.

SOUTH EAST ELEVATION OF THE STABLE BLOCK
(ARCHITECTS DRAWING)

NORTH WEST ELEVATION OF THE STABLE BLOCK
(ARCHITECTS DRAWING)
