CAMBRIAN ARCHAEOLOGICAL PROJECTS

ON THE RECORDING OF THE STABLE BLOCK BUILDINGS

AT MIDDLETON HALL, CARMARTHENSHIRE

CAP Report No: 114

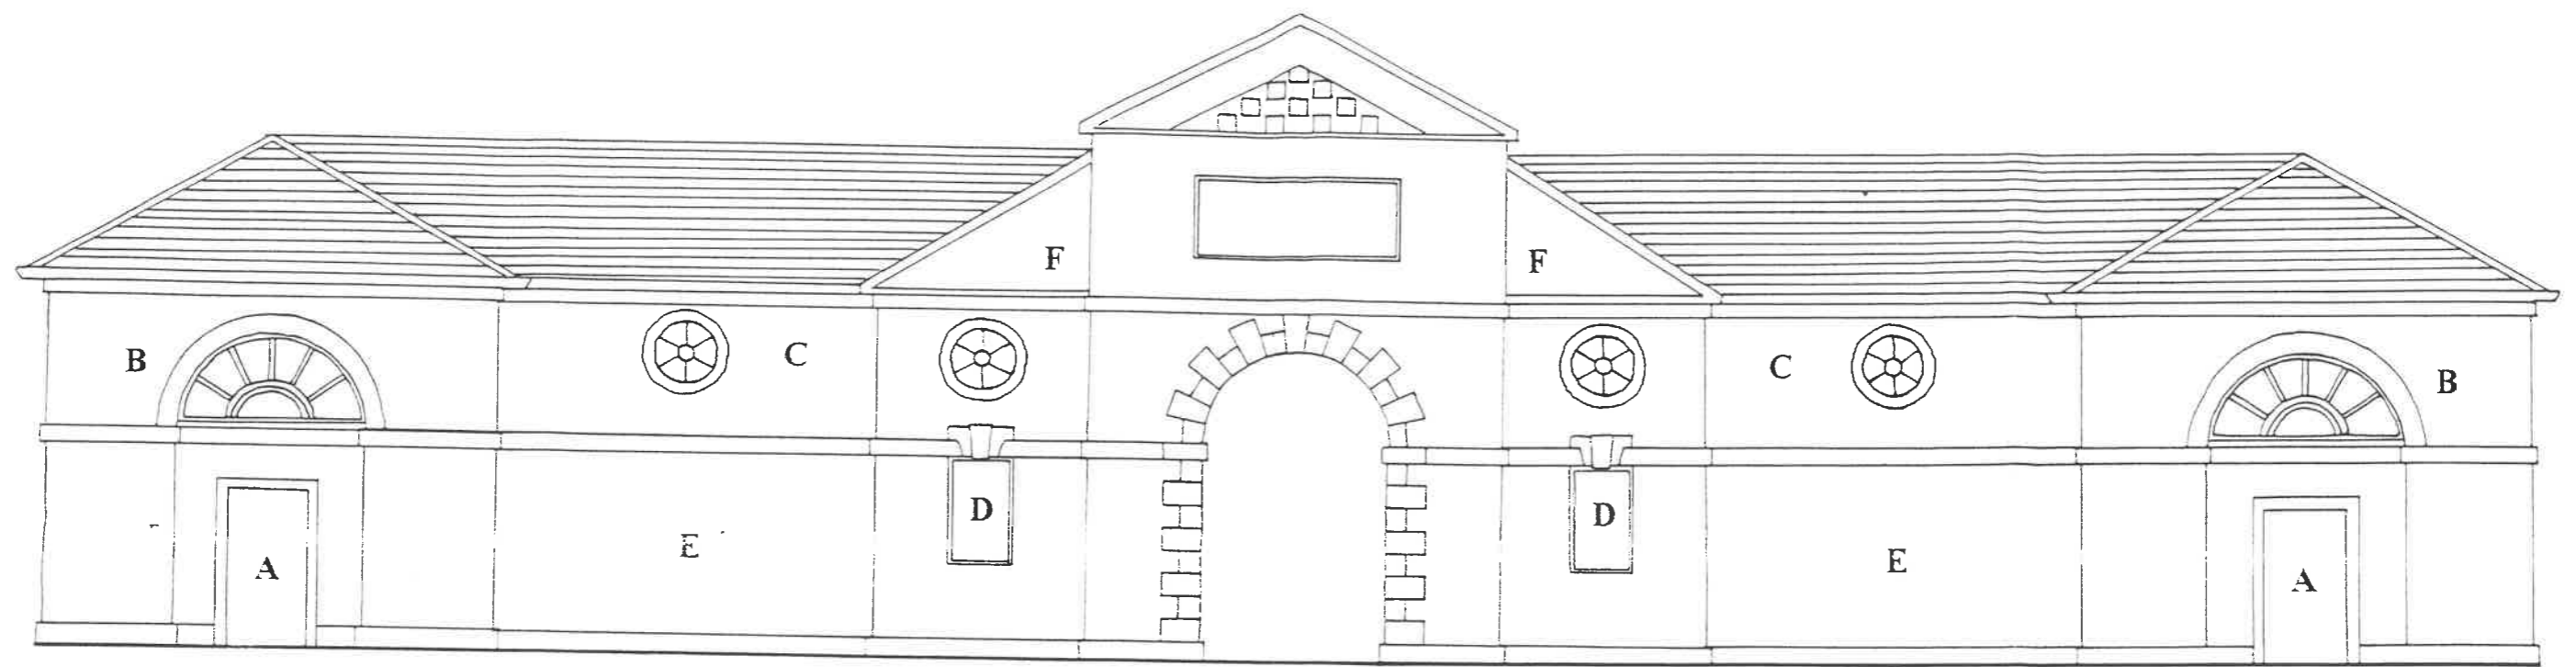
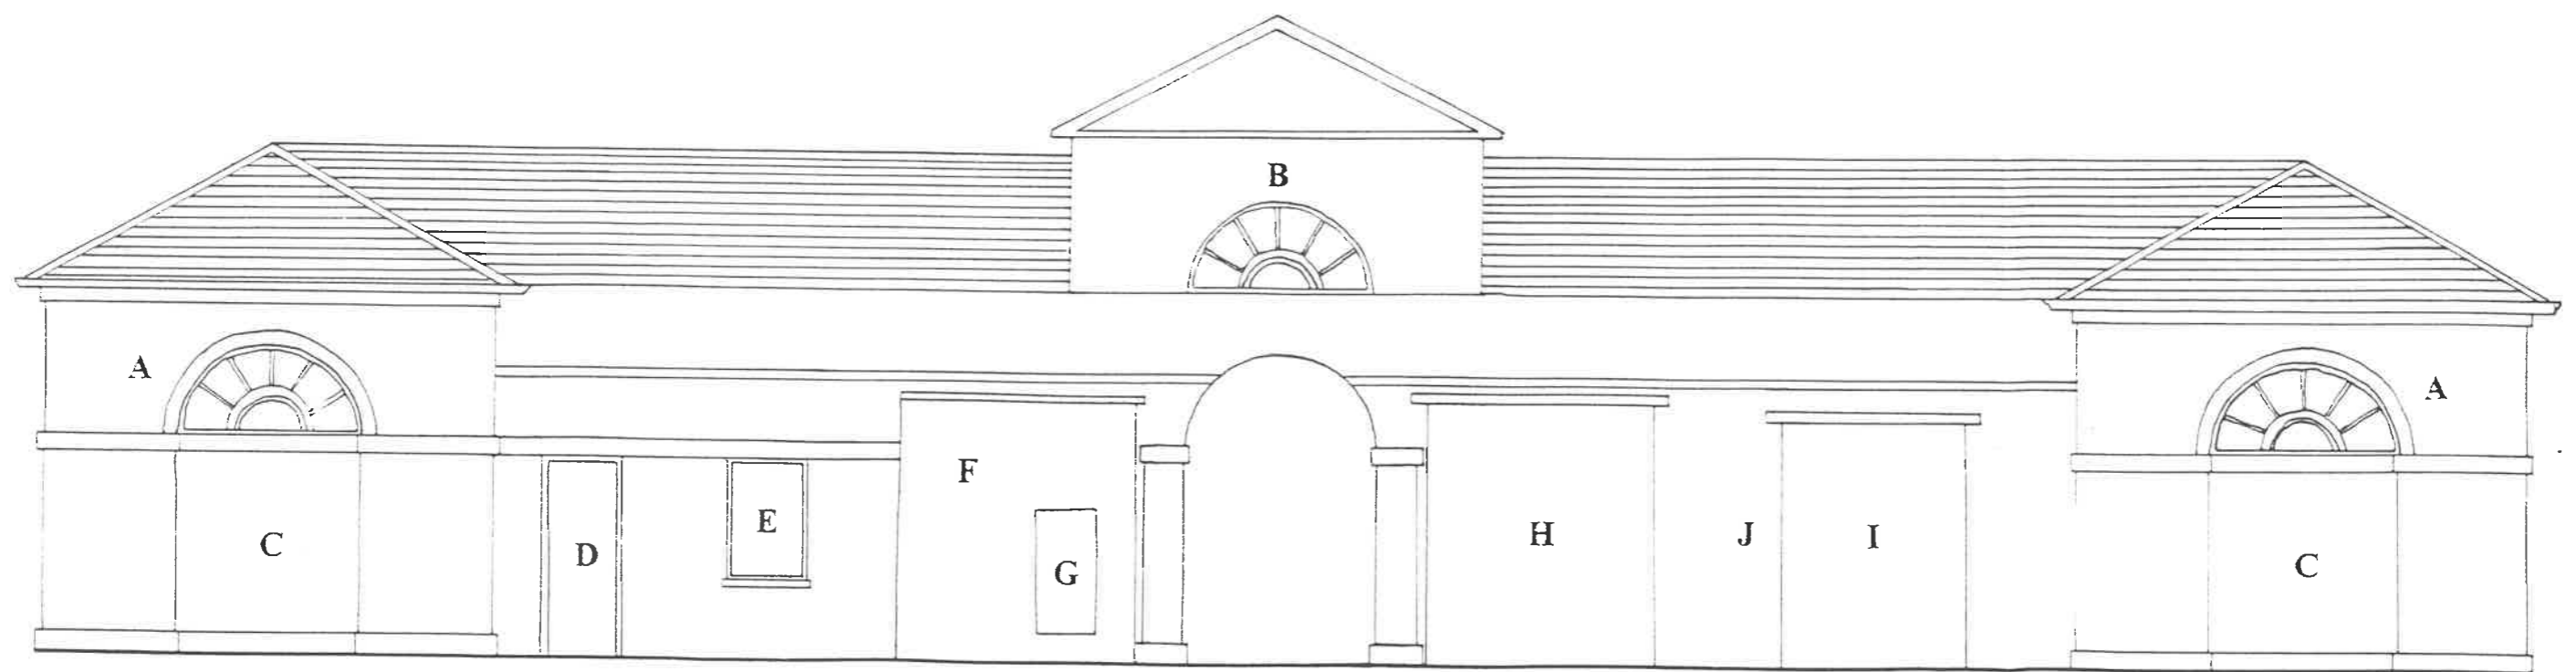
FIGURE 6:

The ends of the two wings of the stable block (C) do not appear to have had doorways (as was the case with the south east elevation). Although there was a semi-circular window (B) above the archway, it is uncertain whether there were similar windows on the wings (A) as illustrated. Features (A) and (C) may have been a decorative façade, but it seems more likely, that they must have been open in order to light the stables sufficiently.

The central section of the façade appears to have undergone several alterations, making its original appearance uncertain. These alterations reflect changes in the use of the building. Originally a doorway with a dressed stone surround, (D) was later converted to a window. Window (E) may be an original feature since there is none of the red brick that surrounds other inserted windows, and no evidence that it was ever a door.

Assuming that the exterior of the building originally had a symmetrical appearance, original features such as (D) and (E) ought to be mirrored on the other side of the archway. In position (J) there is evidence of a window, probably symmetrically opposed to window (E). There is no evidence of an original doorway to mirror doorway (D).

The absence of a cornice on this side of the façade suggests that it was removed during the various alterations. Although barn door (I) was blocked, and a later window inserted, it is probably itself a later modification, since it is not mirrored on

Similarly, (F) and (H) were barn doors (subsequently blocked, with symmetrically positioned doors and windows inserted). (F) has a dressed stone surround (possibly the remains of an original feature) though barn door (H) does not. (G) is a small raised doorway that was present after (F) was blocked but before the later window and door (see figure 5) were inserted.

SOUTH EAST ELEVATION OF THE STABLE BLOCK

NORTH WEST ELEVATION OF THE STABLE BLOCK

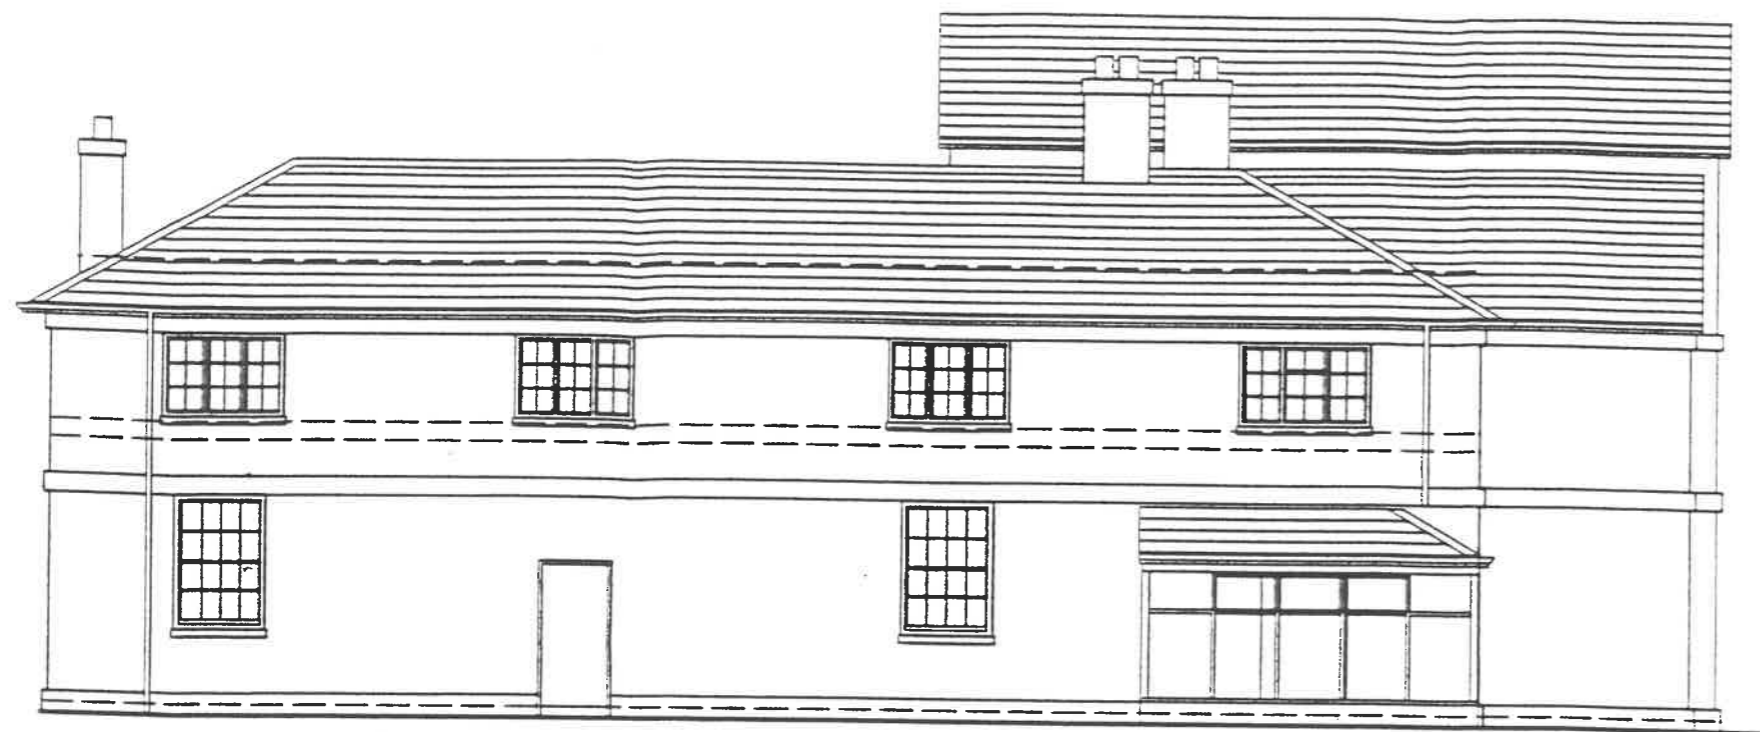
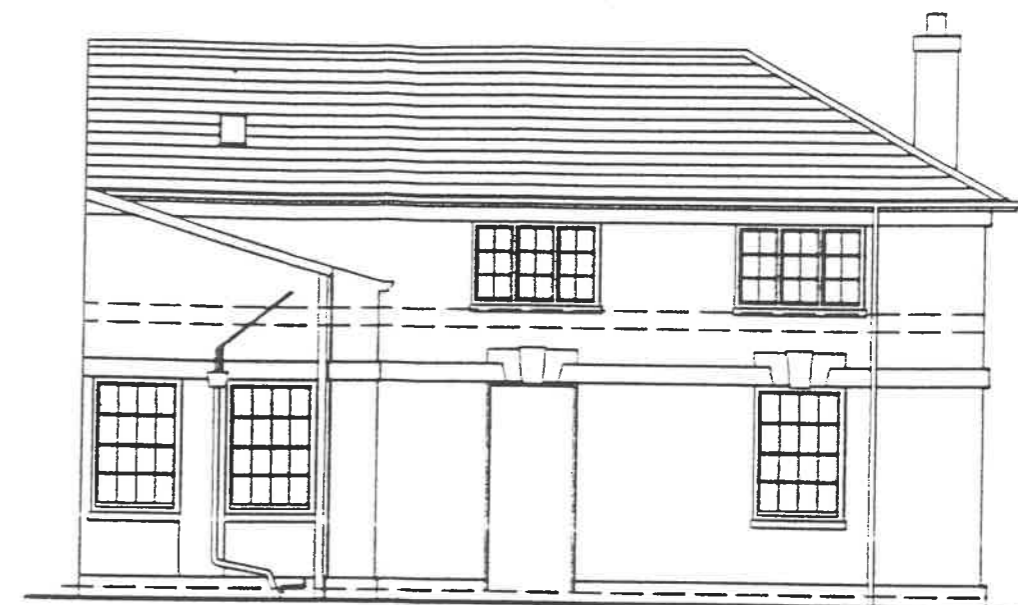
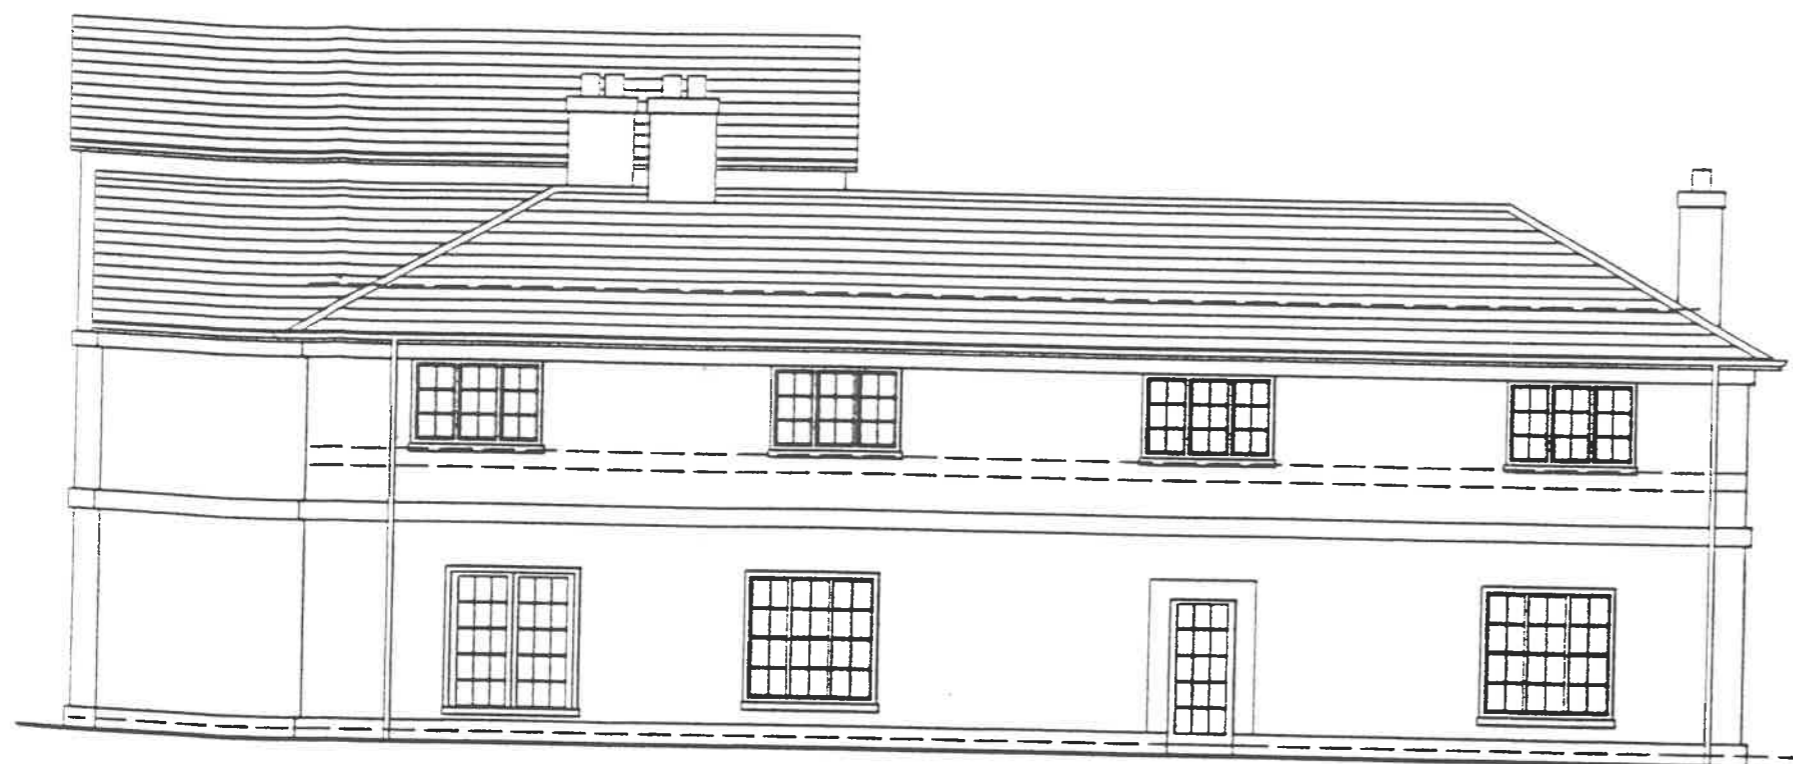
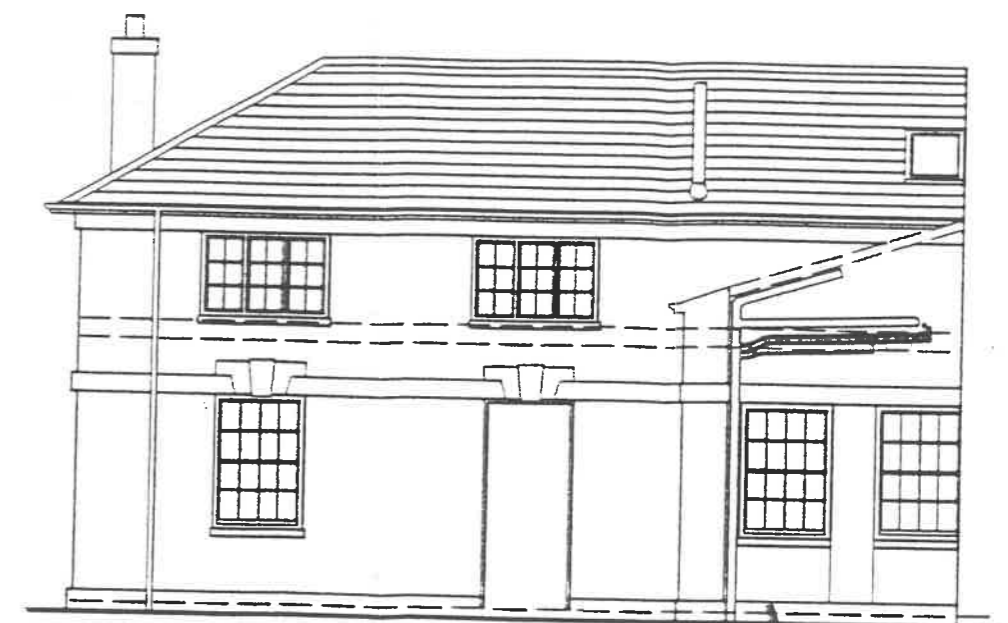
FIGURE 7:

The ground floor south west elevation (A) originally seems not to have had any windows. Before the first floor was added, the four circular windows (B) would originally have lit and ventilated the stables.

Twin doorways (C) appear to be original. Both were later blocked up and converted to windows. Originally a window, (D) was later converted to a doorway. Window (E) appears to be original. This facade is presumably where there was main access for horses and people into the stable wings from the courtyard. Two circular windows (F) on the first floor, were later replaced with rectangular windows.

As with the south west wing, the north east elevation originally had no ground floor windows (B). The stable was lit by the four circular first floor windows (C).

Features (A), are of dressed limestone. They may have been vents, but were not visible on the interior of the building. Alternatively they were sockets for a structure on the exterior of the building.

Twin doorways (F) mirror those on the opposing face of the south west wing (C). Originally a window, (E) was later converted to a doorway. Unlike its opposite feature on the south west wing, (D) appears to have been a doorway with a dressed stone surround, before it was converted to a window. The evidence suggests that this elevation was always different to its reflection on the south west wing. It is not known what the significance of this apparent asymmetry in the location of doors and windows might be.

SOUTH WEST WING OF THE STABLE BLOCK
(ARCHITECTS DRAWING)

NORTH EAST WING OF THE STABLE BLOCK
(ARCHITECTS DRAWING)

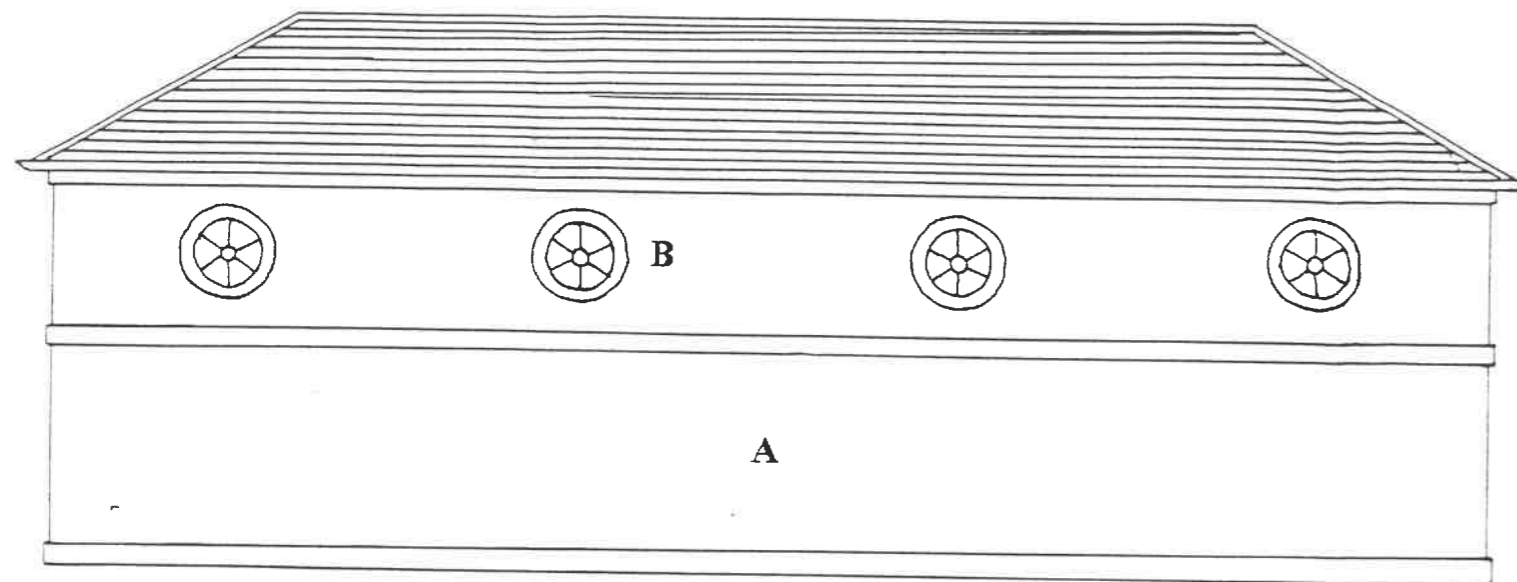
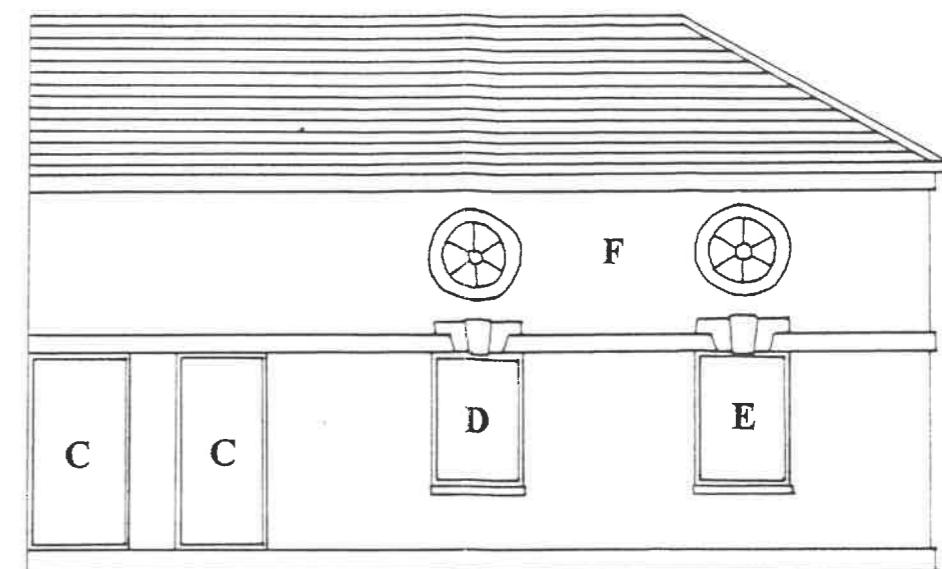
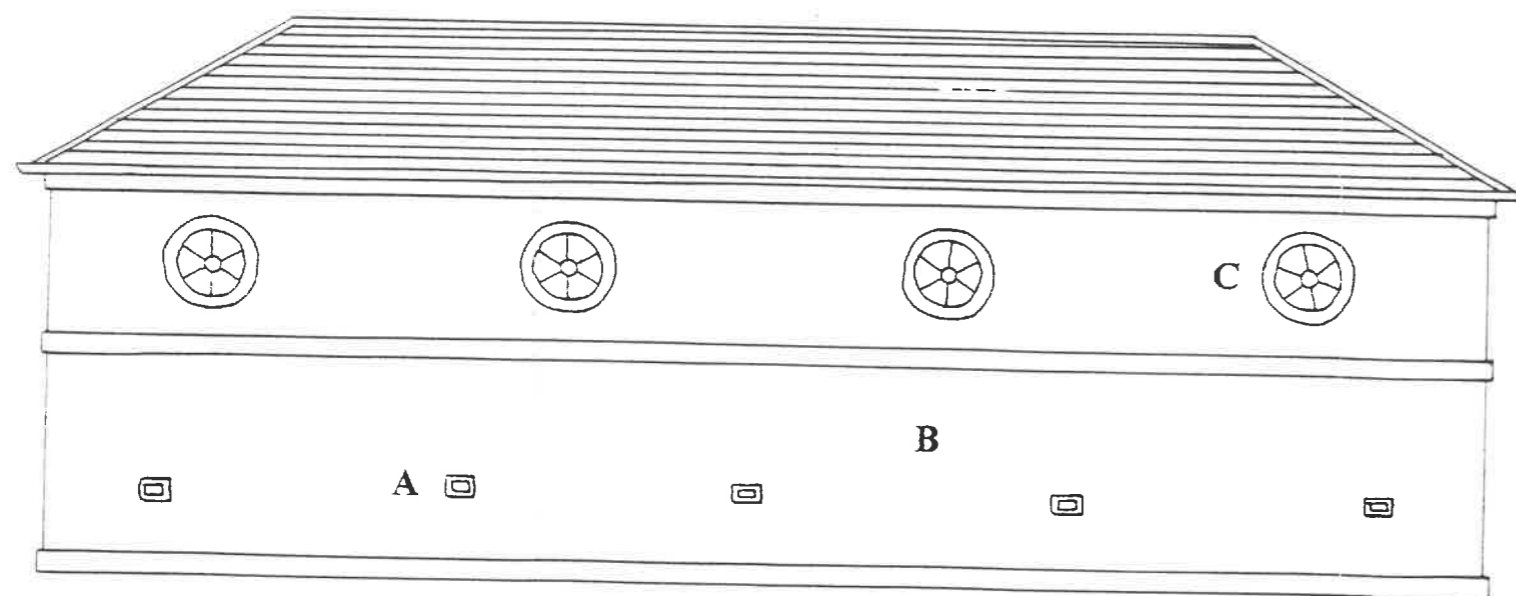
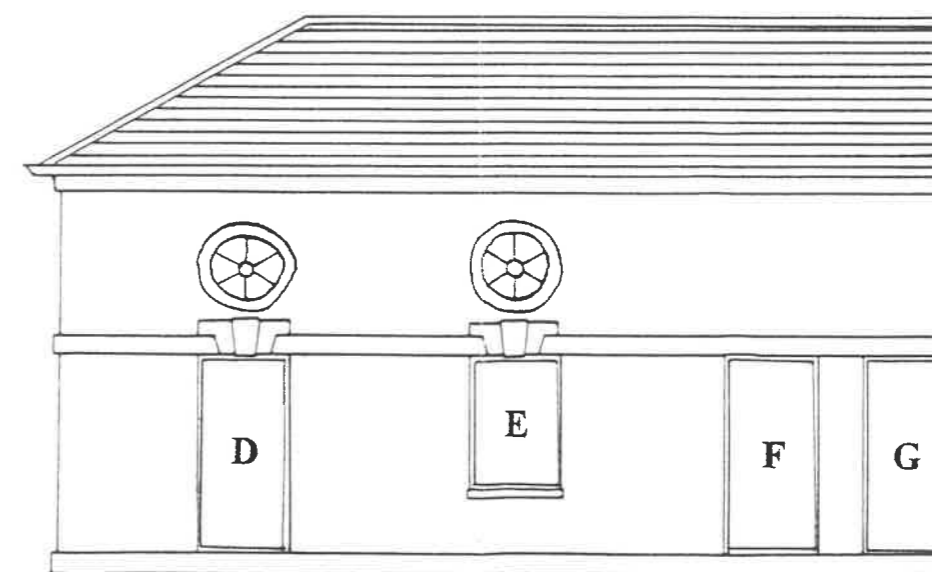
FIGURE 8:

SOUTH WEST WING OF THE STABLE BLOCK

NORTH EAST WING OF THE STABLE BLOCK

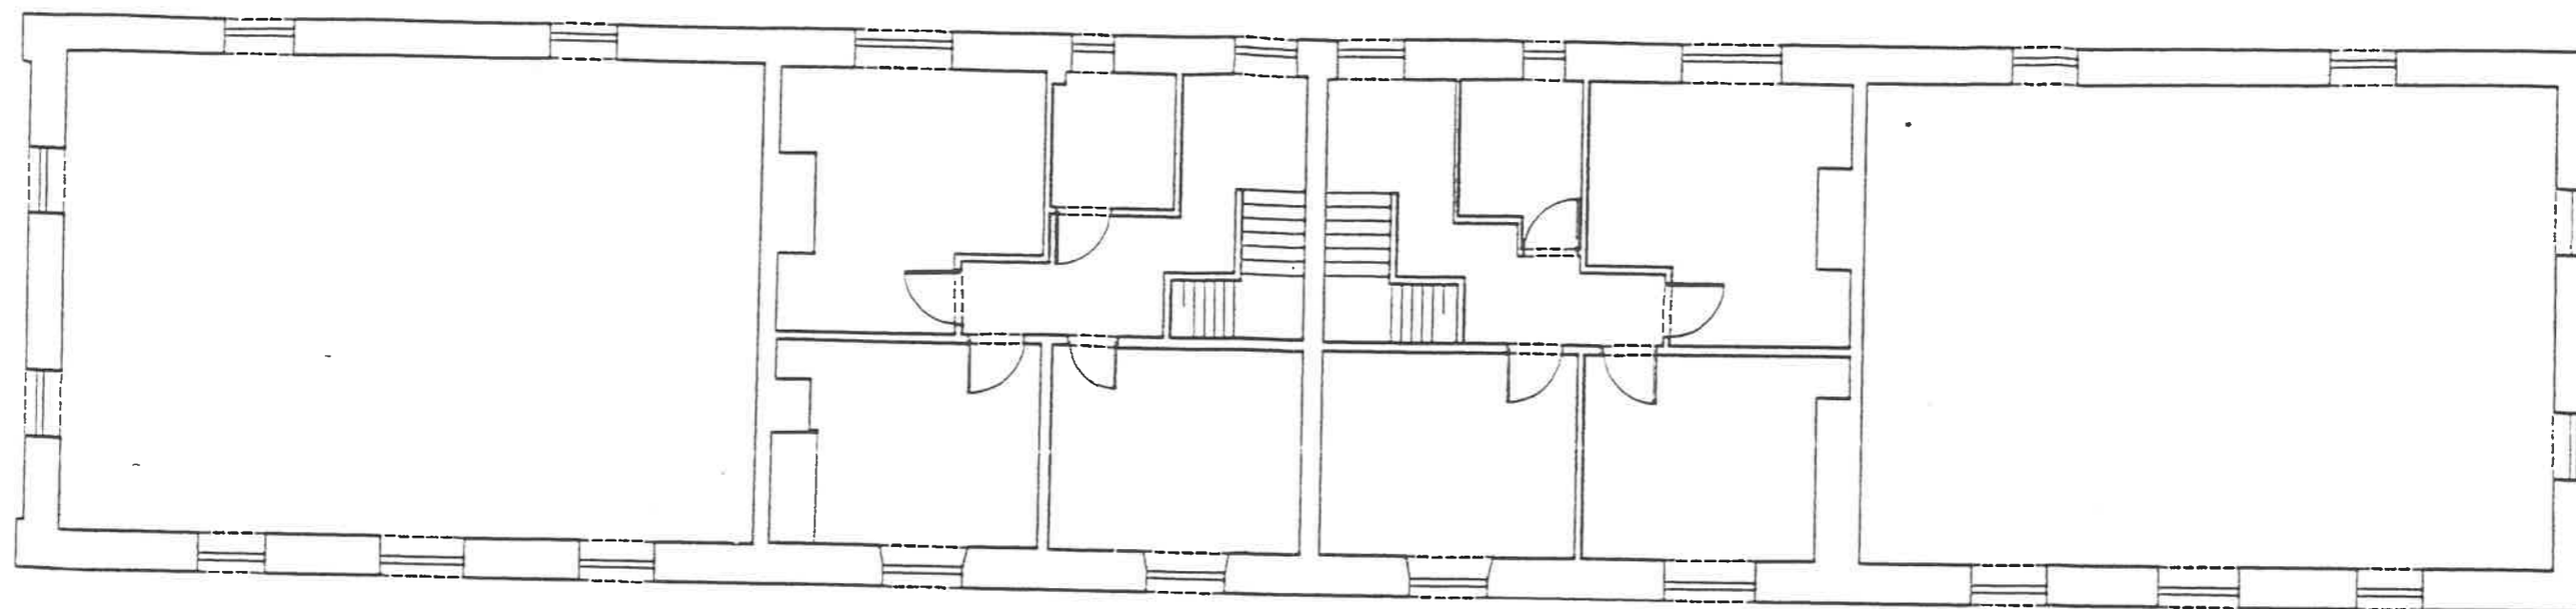
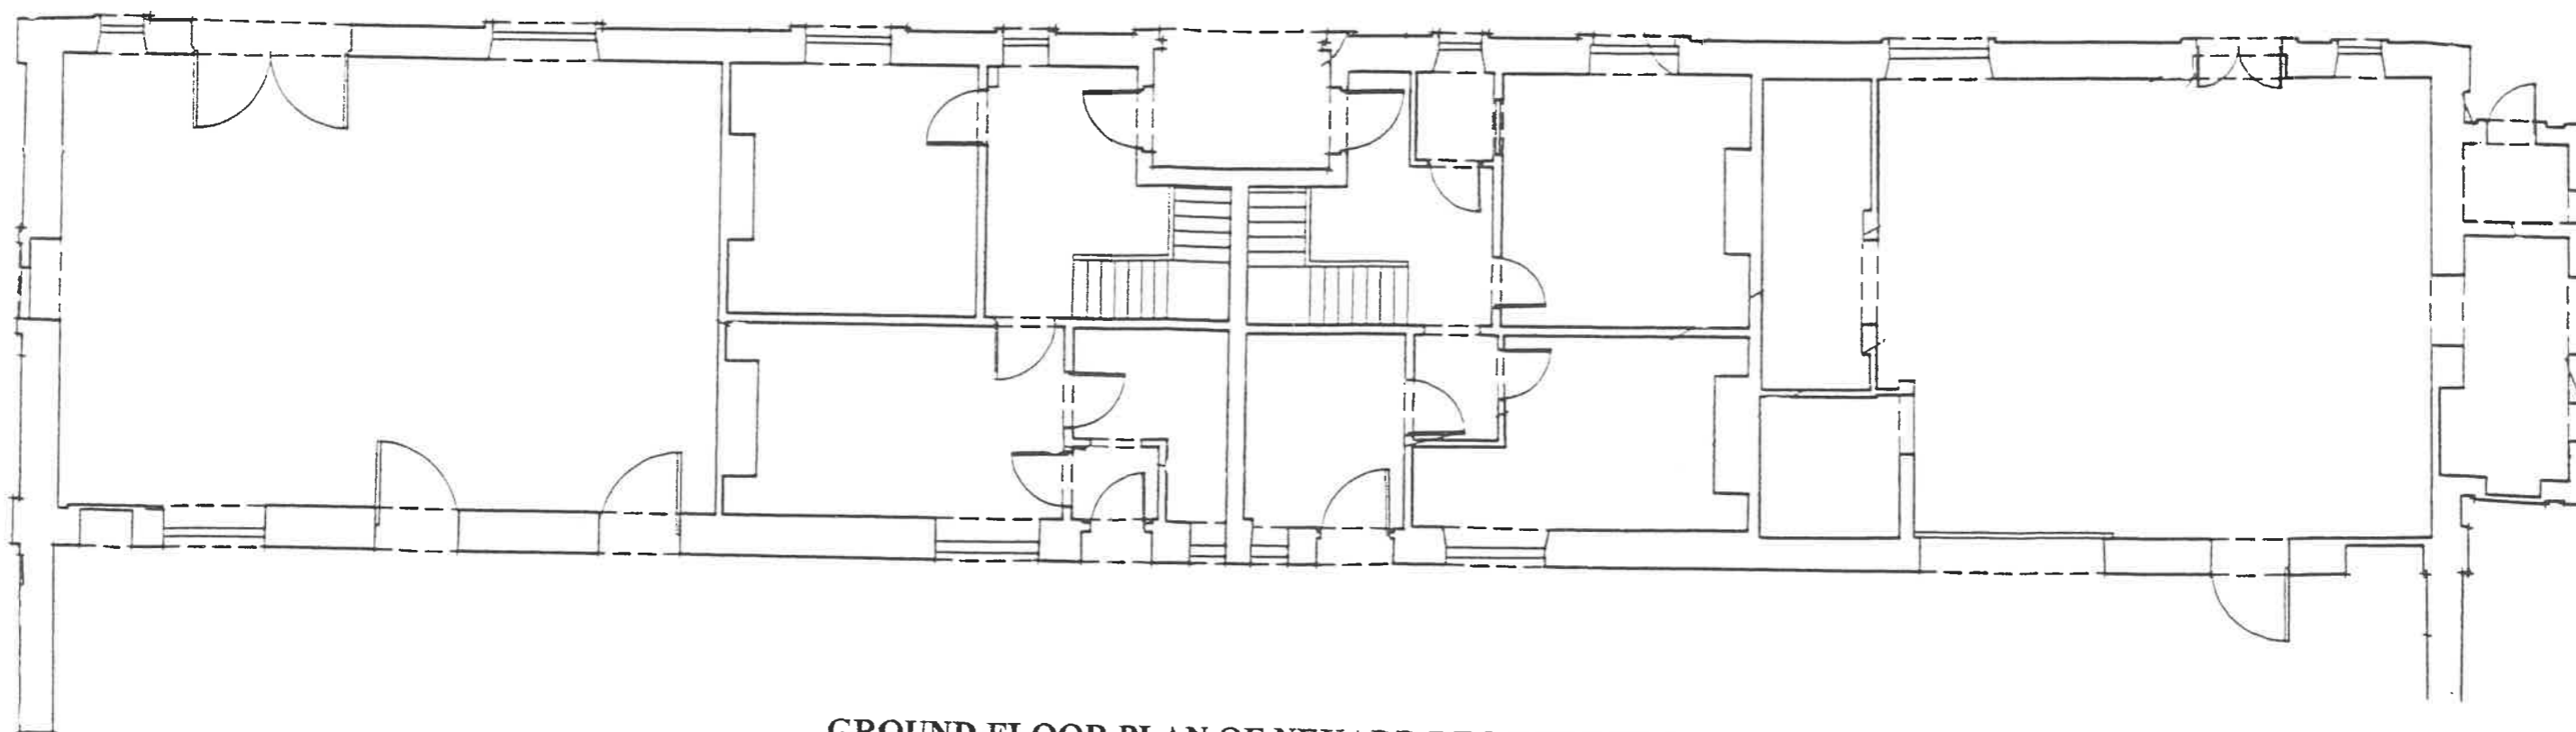
FIGURE 9:

The five arched entrances (A), suggest the building originally functioned as a coach house. Due to the absence of the original internal fixtures and fittings, the exact way in which the building functioned is unclear.

The existing internal divisions are all of red brick and relate to the conversion of the central third of the building to domestic accommodation. Any original internal divisions were probably of wooden construction, of which the only surviving evidence visible at the time of this survey was a vertical line of three voids in the stonework (in position F). These may originally have held timbers.

As with the Stable Block, it seems most probable that there was originally no first floor to this building. Beam-slots above the first floor windows at both ends of the building suggest there were probably attics in the roof-space along the entire length of the building.

**FIRST FLOOR PLAN OF NEUADD DEG DERWEN LAS
(ARCHITECTS DRAWING)**

**GROUND FLOOR PLAN OF NEUADD DEG DERWEN LAS
(ARCHITECTS DRAWING)**

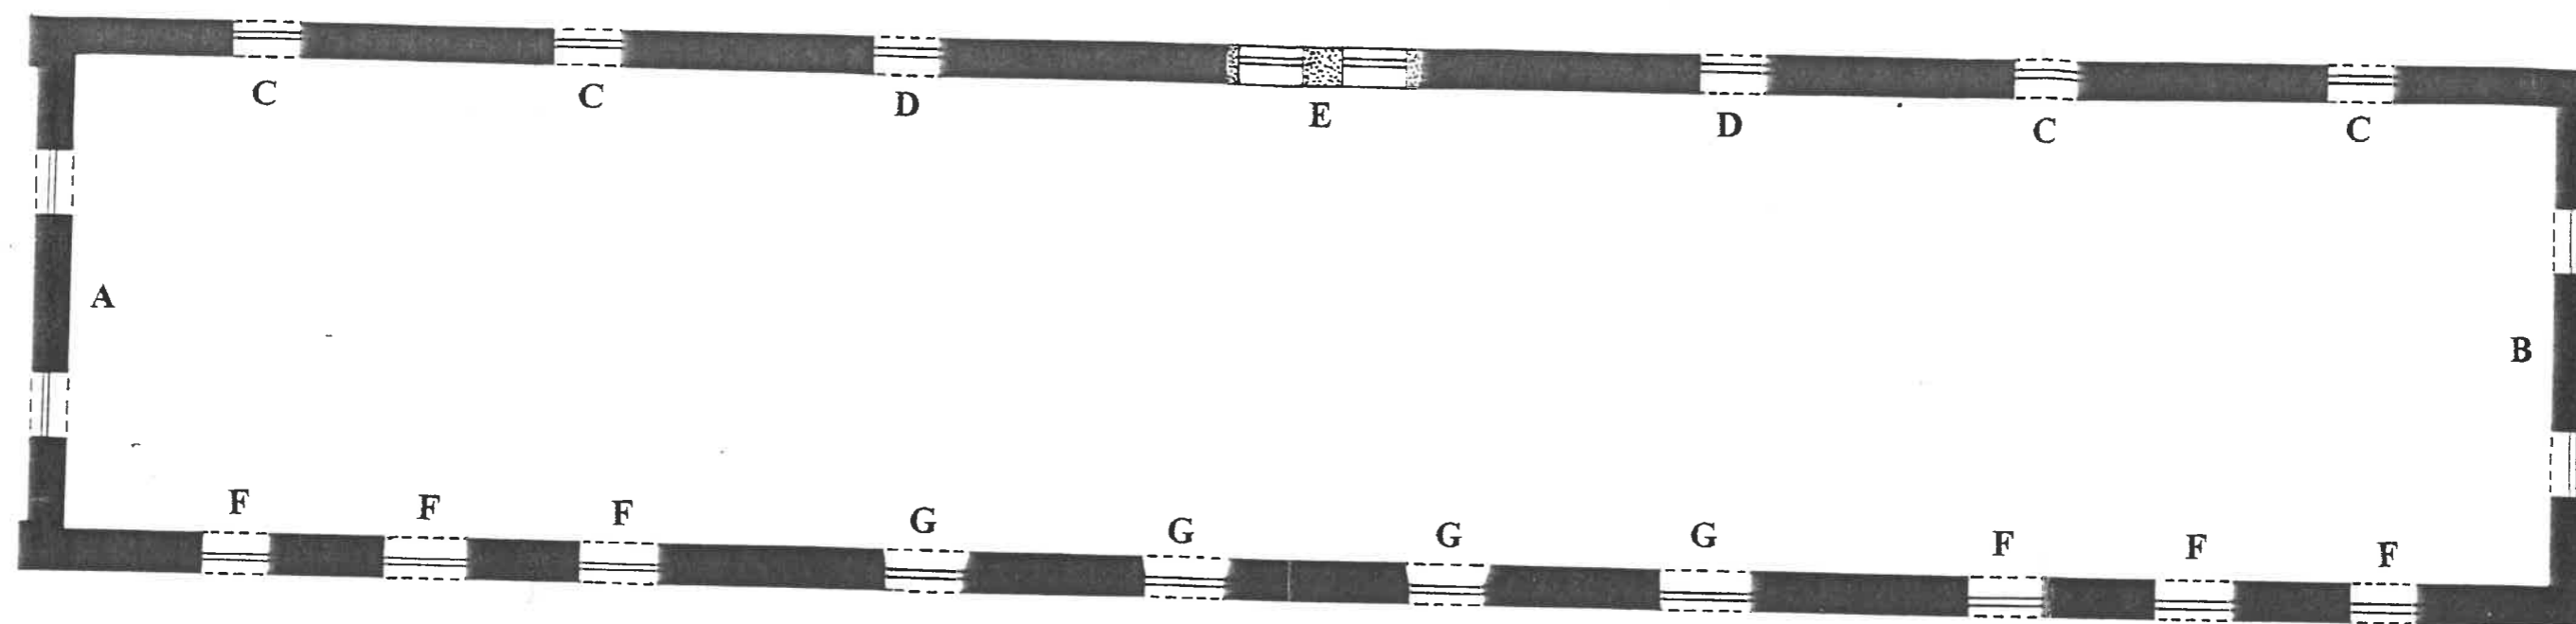
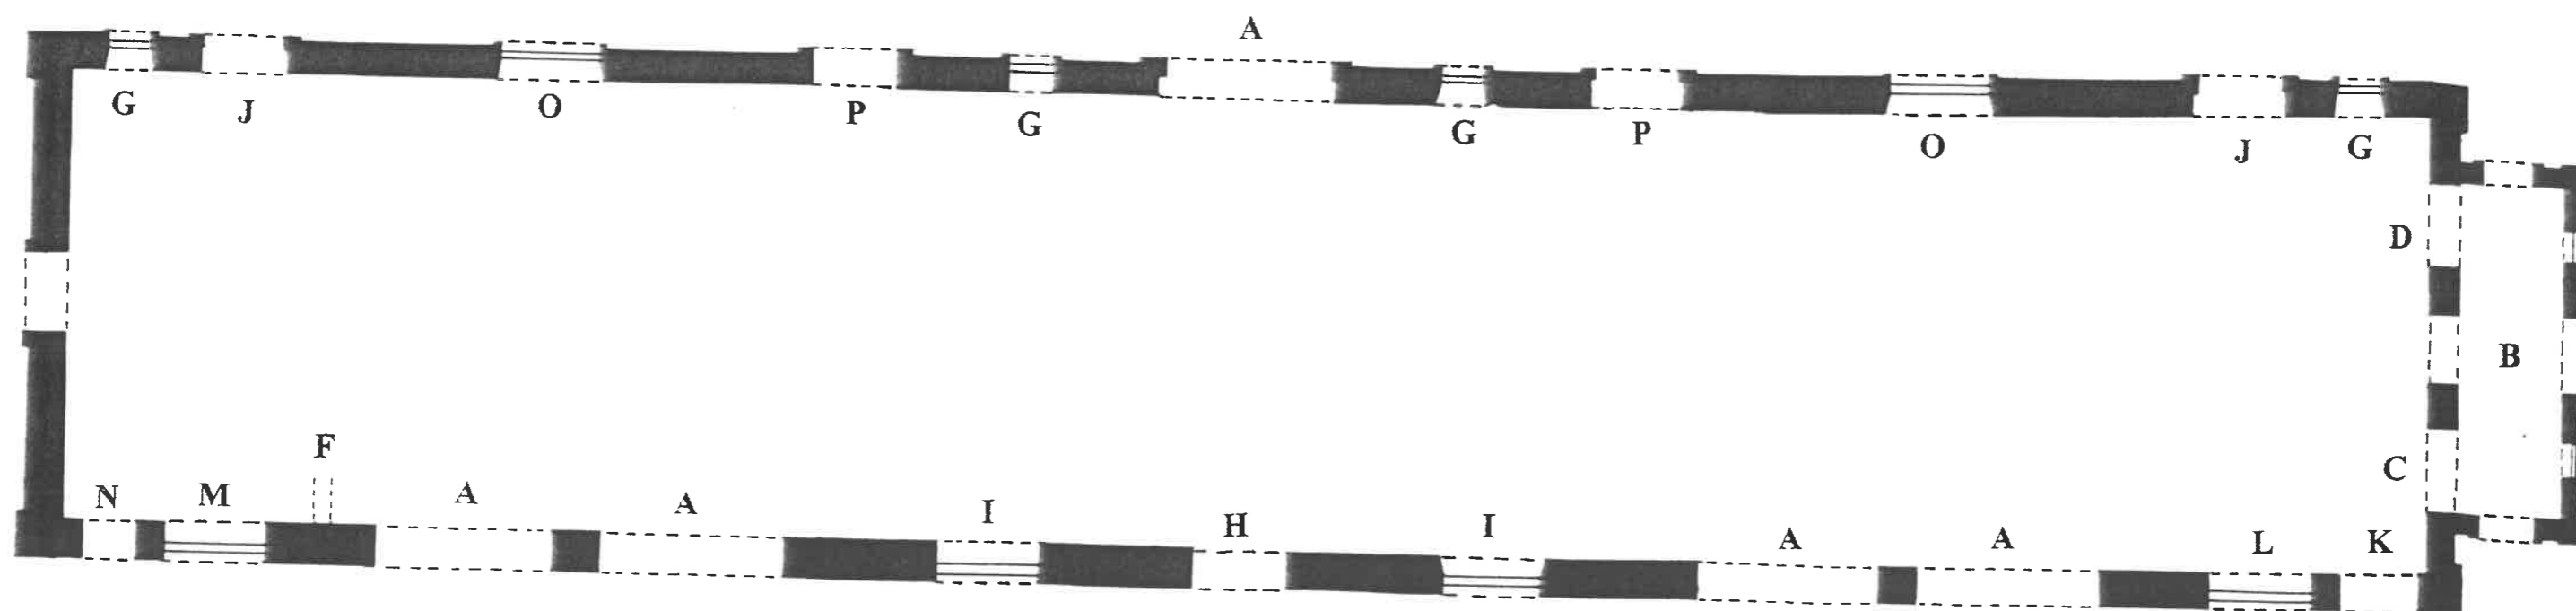
The existing doors and windows on the ground floor are not all original. The only features with original stonework lintels are windows (O) and doorways (P). Windows (G) are presumed to be later additions. It is assumed that if present at all, doorways (J) were similar to doorways (P). All the existing door and window frames are later additions replacing earlier features in the same locations.

On the north west side, stonework lintels suggest that doorways (N) and (K) are original. Window (L), later converted to a doorway was originally the same as window (M). Doorway (H) was later converted into two windows. Windows (I) were originally smaller.

While circular windows (B) appear to be in their original positions, windows (A) appear to have been re-set at some stage (see figure 14).

Circular windows (C) are in their original positions. Windows (D) are thought likely to have existed, but any evidence was destroyed by the insertion of later windows.

Window (E) is a later addition but it is unclear whether it replaced an earlier window or not.

FIRST FLOOR PLAN OF NEUADD DEG DERWEN LAS

GROUND FLOOR PLAN OF NEUADD DEG DERWEN LAS

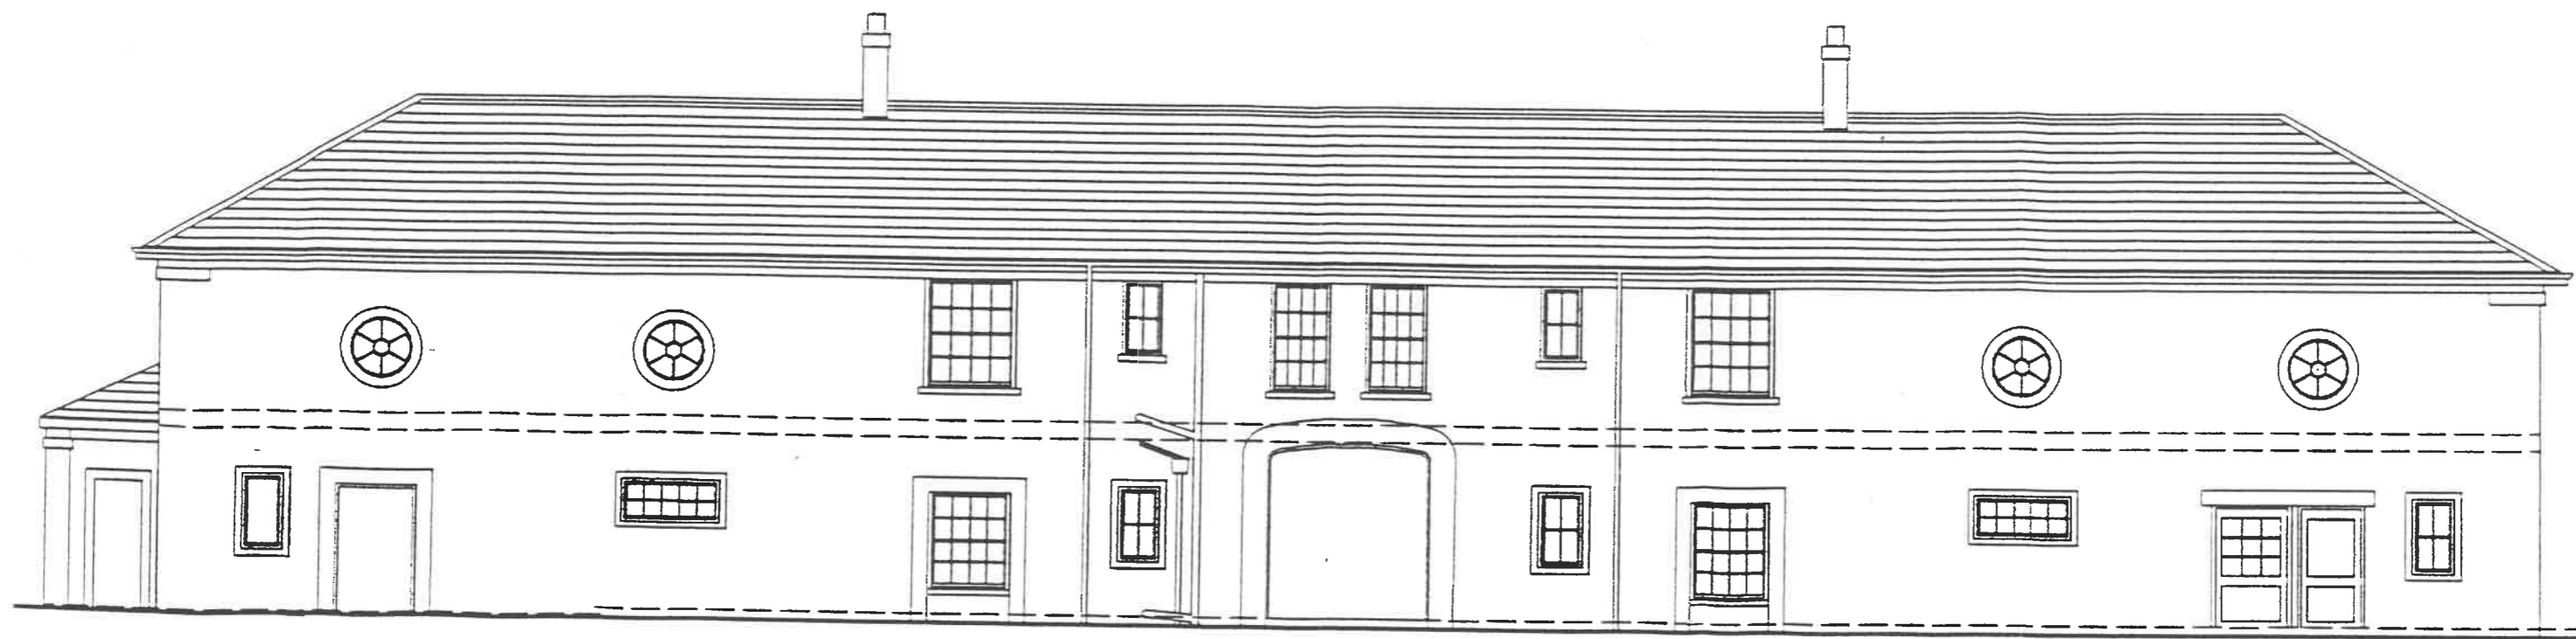
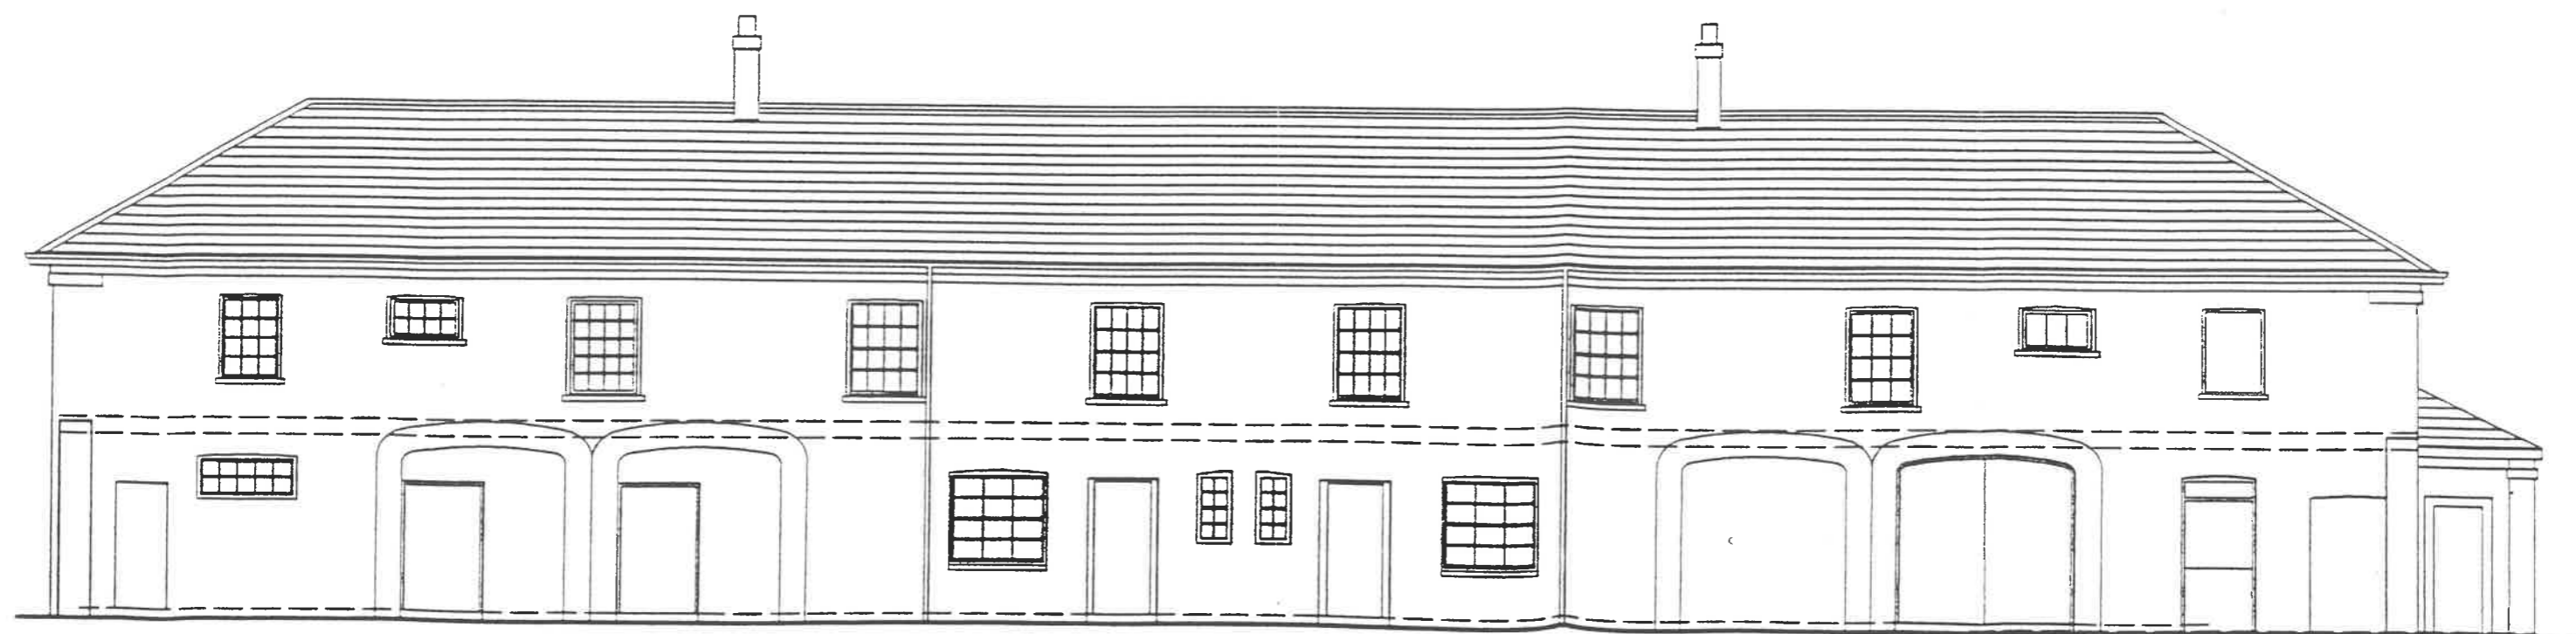
The south east elevation, overlooking the central courtyard, retains four first floor circular windows (A) like those of the Stable block. It is probable that there were an additional two circular windows (in position (B)), although the size of the later windows would have destroyed any evidence of these. The position occupied by later windows (C) probably did not contain a circular window, since there would have been a wider distance between (C) and (B) than between (B) and (A). It also seems unlikely that there would have been a semi-circular window in position (C).

The ground floor doors and windows all appear to be later alterations. Stone lintels above windows (D) and doorways (E), however suggest that there were earlier features in these positions. Windows (F) are thought to be later additions, since they do not have stonework lintels. It is unclear whether doorways (G) are original features, since no evidence of earlier features survives.

There is no evidence that the existing first floor windows occupy the positions of earlier circular windows. The stone lintels of the existing windows (A) suggests they are not later insertions into the facade. Red brick blockings indicate that the four central windows (B) were originally smaller than the present ones.

**SOUTH EAST ELEVATION OF NEUADD DEG DERWEN LAS
(ARCHITECTS DRAWING)**

**NORTH WEST ELEVATION OF NEUADD DEG DERWEN LAS
(ARCHITECTS DRAWING)**
