CAMBRIAN ARCHAEOLOGICAL PROJECTS

ON THE RECORDING OF THE STABLE BLOCK BUILDINGS

AT MIDDLETON HALL, CARMARTHENSHIRE

CAP Report No: 114

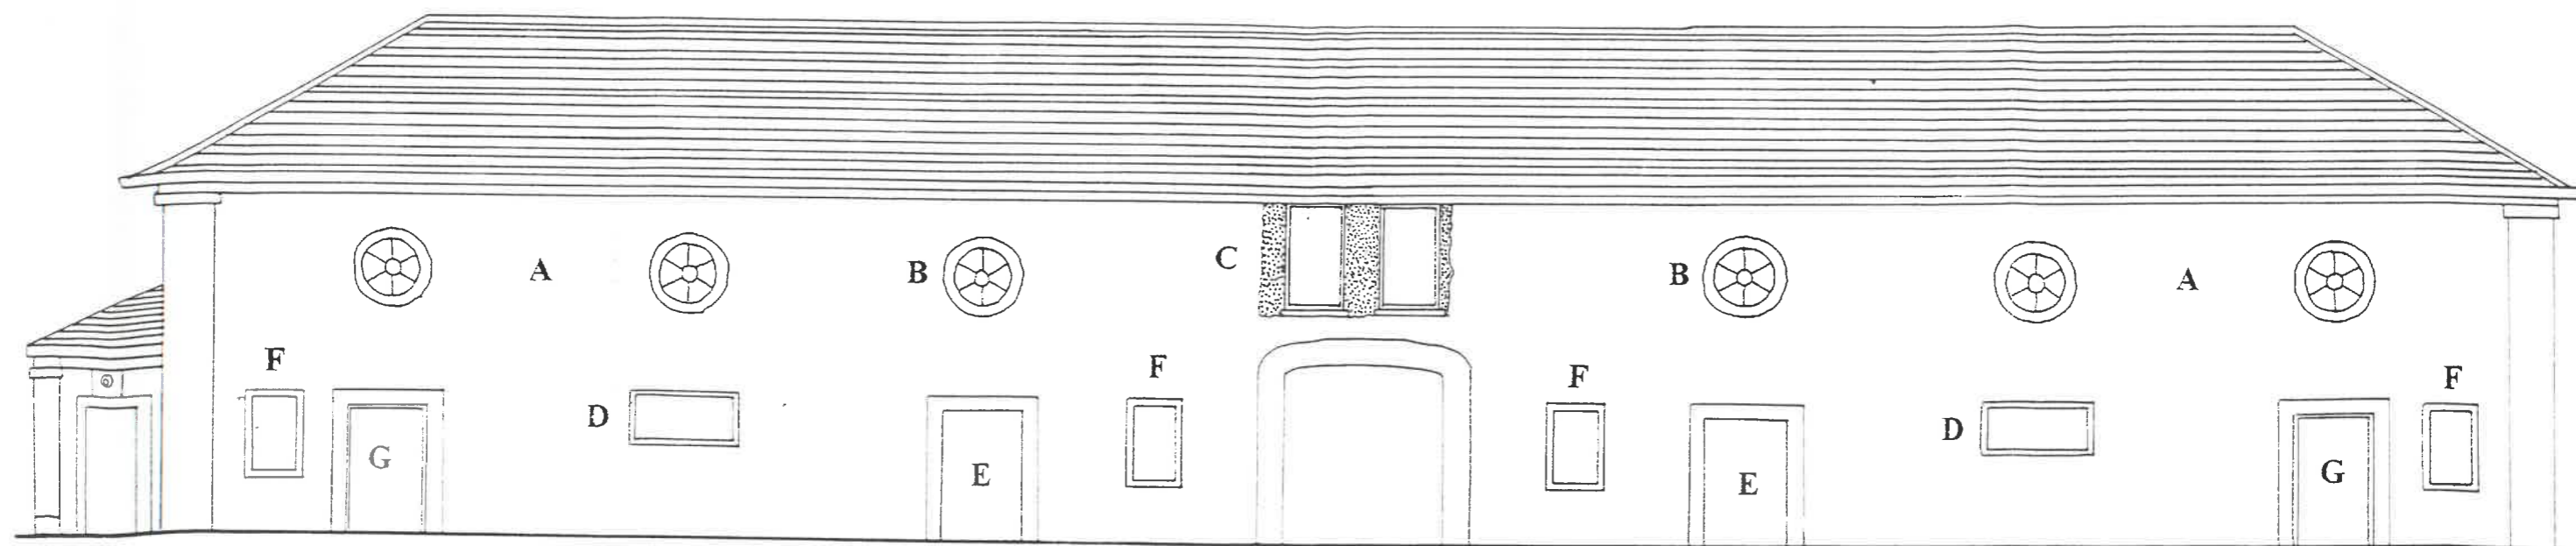
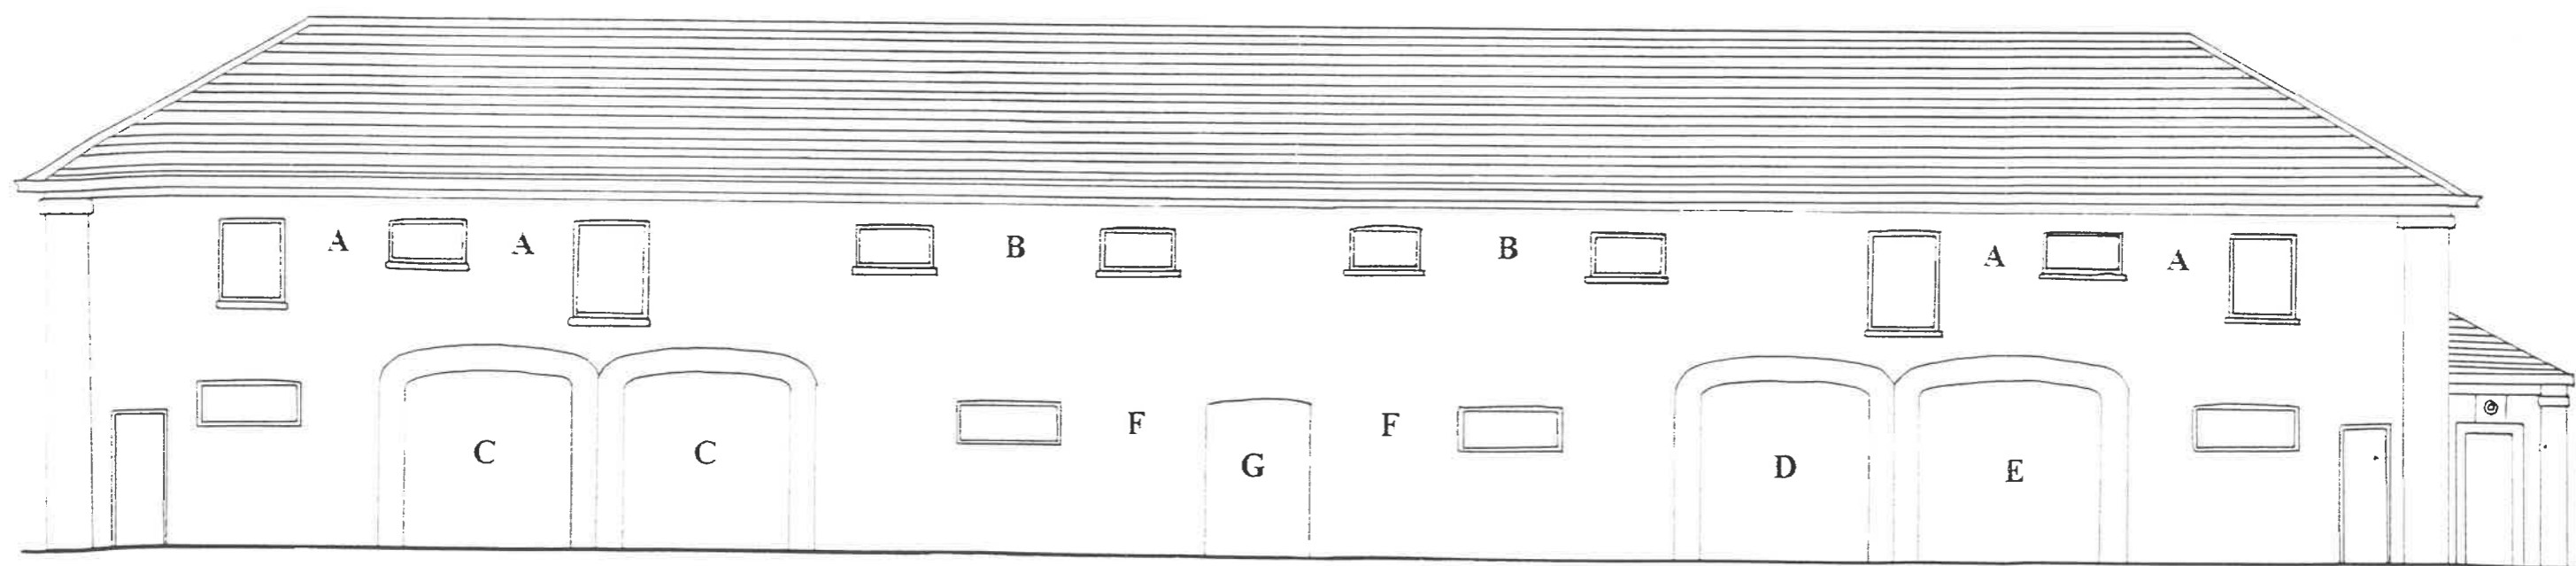
The south east elevation, overlooking the central courtyard, retains four first floor circular windows (A) like those of the Stable block. It is probable that there were an additional two circular windows (in position (B)), although the size of the later windows would have destroyed any evidence of these. The position occupied by later windows (C) probably did not contain a circular window, since there would have been a wider distance between (C) and (B) than between (B) and (A). It also seems unlikely that there would have been a semi-circular window in position (C).

The ground floor doors and windows all appear to be later alterations. Stone lintels above windows (D) and doorways (E), however suggest that there were earlier features in these positions. Windows (F) are thought to be later additions, since they do not have stonework lintels. It is unclear whether doorways (G) are original features, since no evidence of earlier features survives.

There is no evidence that the existing first floor windows occupy the positions of earlier circular windows. The stone lintels of the existing windows (A) suggests they are not later insertions into the facade. Red brick blockings indicate that the four central windows (B) were originally smaller than the present ones.

The ground floor features have also undergone considerable alteration. Again, the style and appearance of the facade are different from the rest of the stable block. From the existing evidence there were originally two sets of twin arches (C, D and E), presumed to be for coaches. All but one of these (E) were later blocked. This could perhaps coincide with the insertion of the barn doors to the main stable block.

As can be seen from the elevations, numerous alterations were made to the building. Windows (A) appear to be their original size and shape, while windows (B) originally smaller than the existing windows. Old doorways were blocked, and new doorways inserted in archways (C) and in area (F) on either side of blocked doorway (G).

SOUTH EAST ELEVATION OF NEUADD DEG DERWEN LAS

NORTH WEST ELEVATION OF NEUADD DEG DERWEN LAS

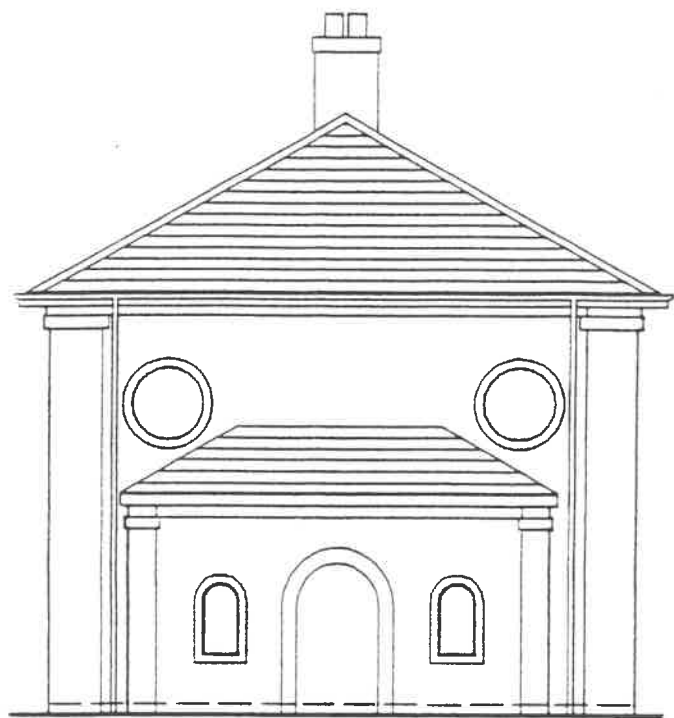
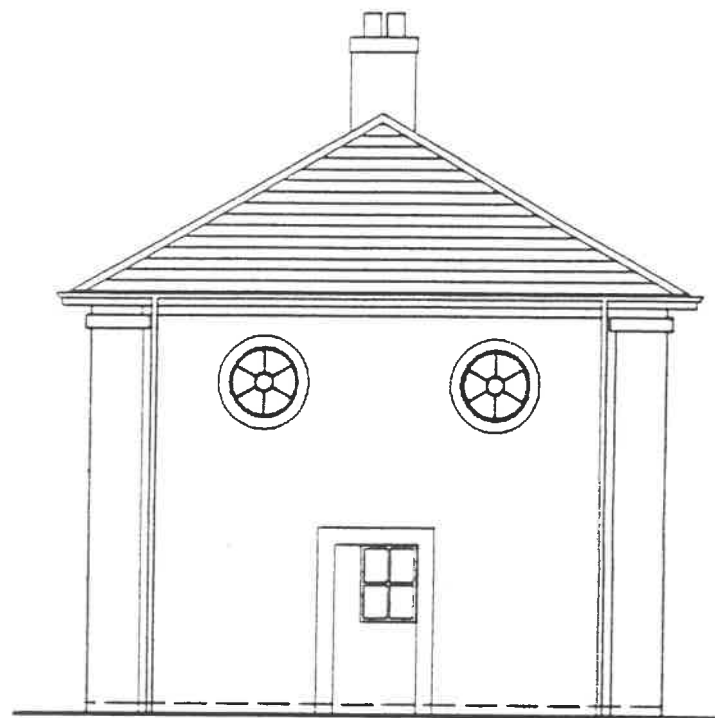
FIGURE 13:

**SOUTH WEST ELEVATION OF
NEUADD DEG DERWEN LAS
(ARCHITECTS DRAWING)**

**NORTH EAST ELEVATION OF
NEUADD DEG DERWEN LAS
(ARCHITECTS DRAWING)**

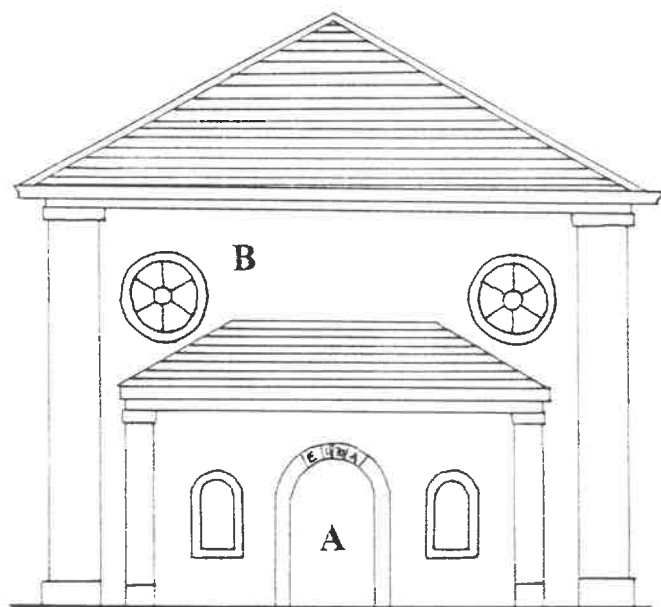
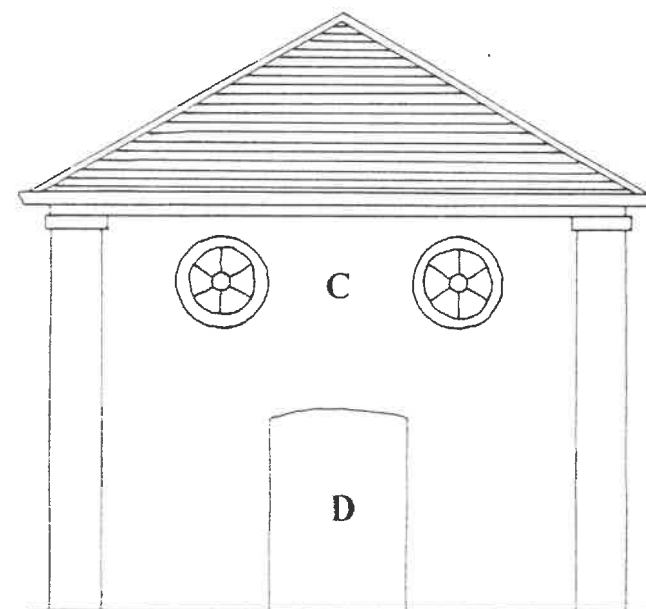
FIGURE 14:

The porch structure (B), appears to be contemporary with the rest of the building and is dated by an inscribed keystone to 1870 (see figure 14). Access from the porch was originally through arched doorway (C). There may have been a second arched

While circular windows (B) appear to be in their original positions, windows (A) appear to have been re-set at some stage (see figure 14).

SOUTH WEST ELEVATION OF
NEUADD DEG DERWEN LAS

NORTH EAST ELEVATION OF
NEUADD DEG DERWEN LAS

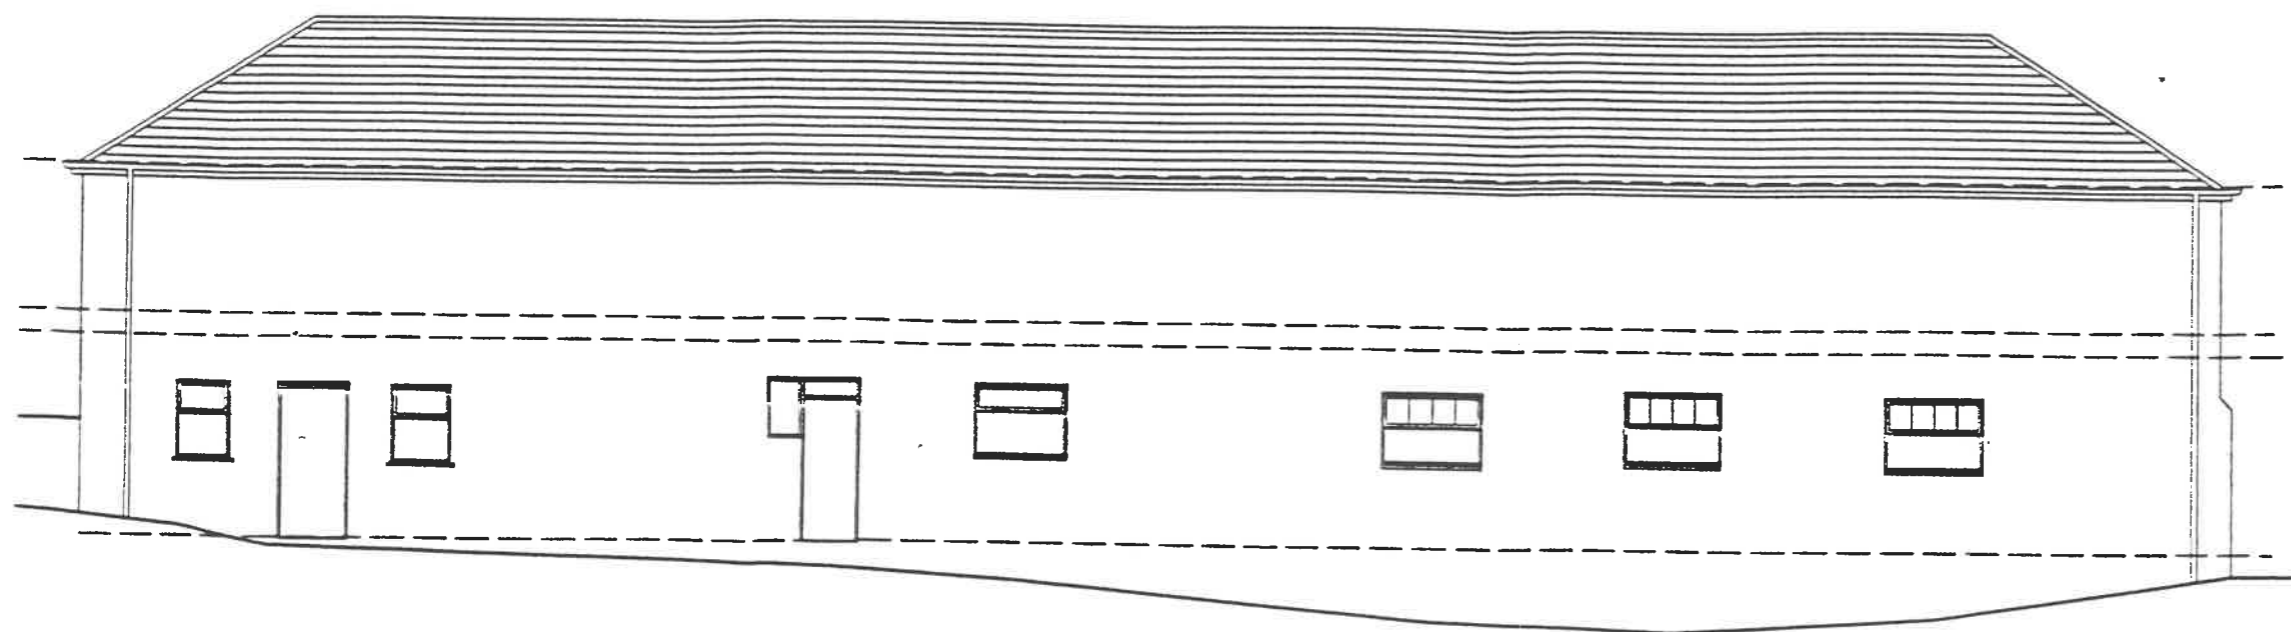
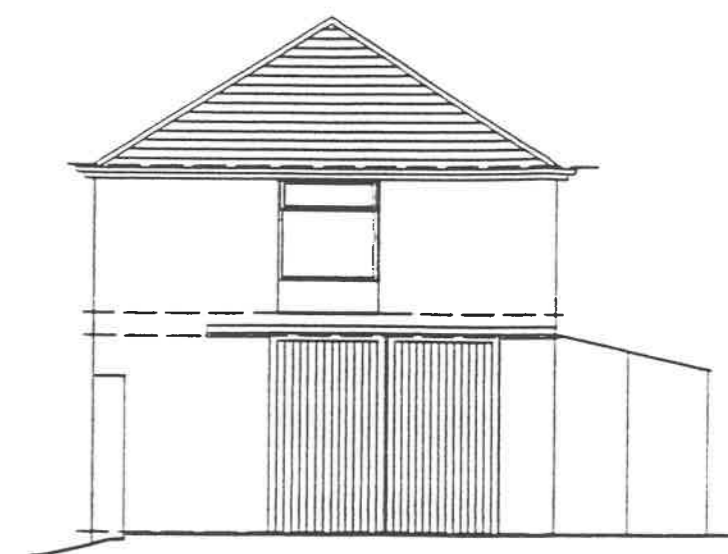
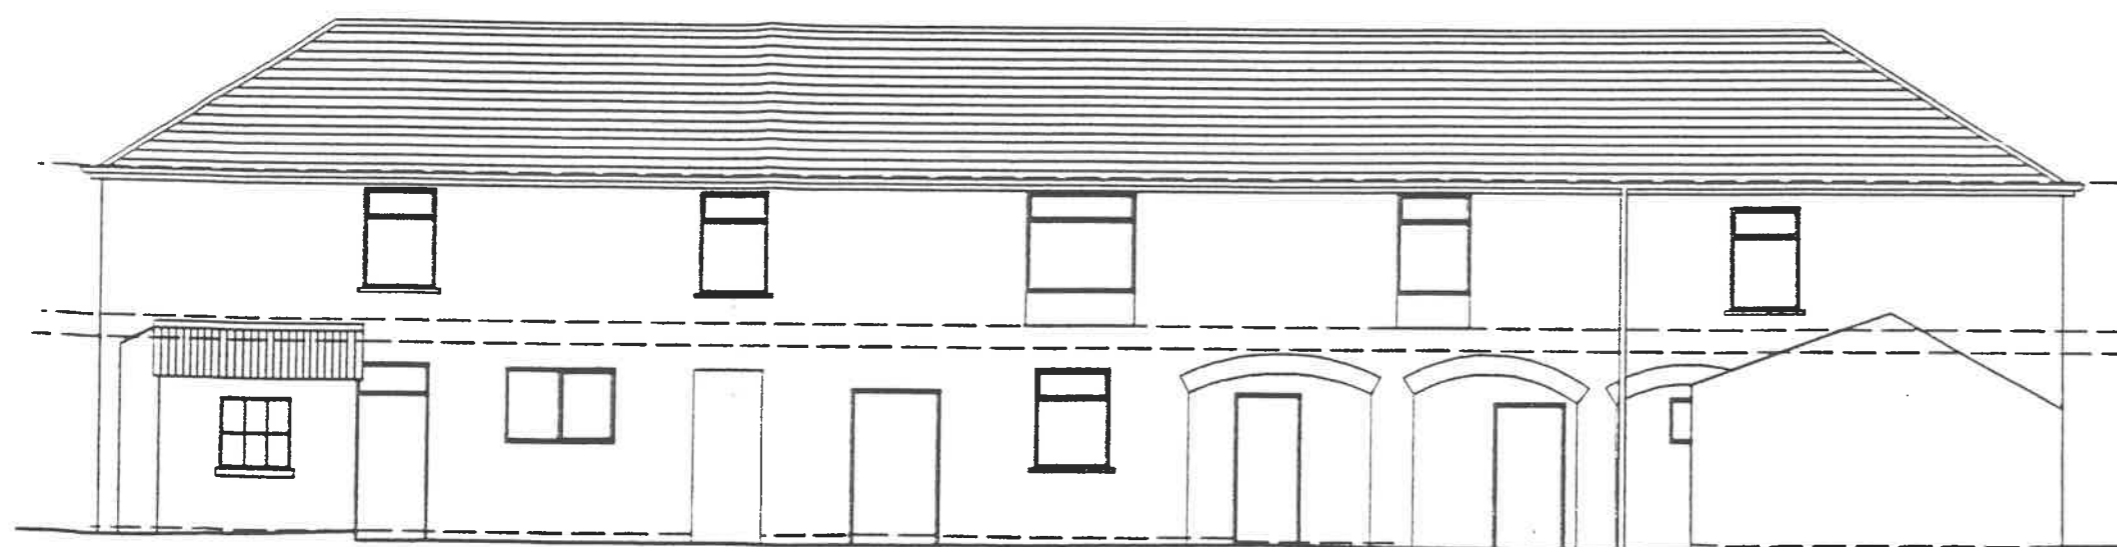
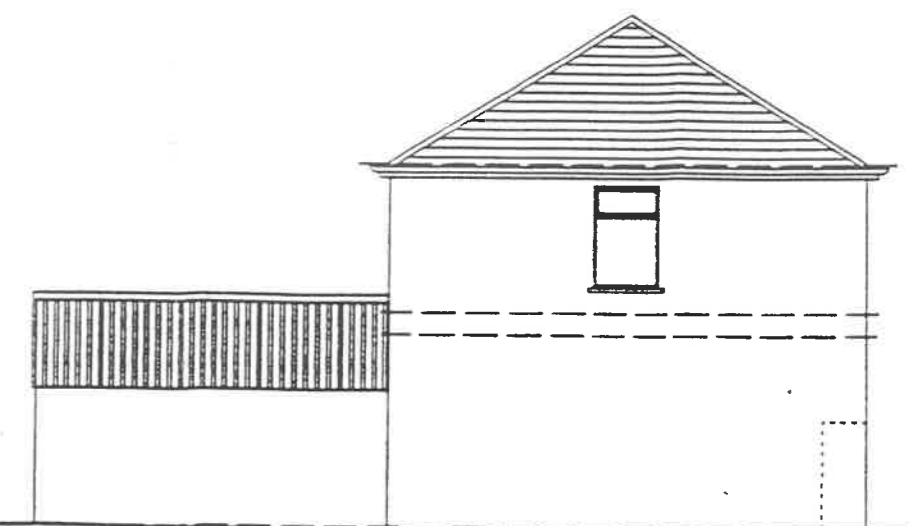
The only features that showed evidence of being part of the original building were doorways (B) and (C). Window (A) also appeared to be original. Other features in area (D) appear to be later modifications but may have destroyed evidence of earlier windows.

Door (C), and windows (B), (D), and (E), all appear to be original features with stonework lintels. (B) was later modified into a doorway, (C) was blocked up and changed to a window, and (D) was altered to become a doorway. An additional doorway was created between Windows (D) and (E). Archways (F), (G), and (H), are all original features. These were later blocked up and converted to smaller doorways. It is possible there may have been a fourth archway to the right of (H).

SOUTH WEST ELEVATION OF THE BARN
(ARCHITECTS DRAWING)

SOUTH EAST ELEVATION OF THE BARN
(ARCHITECTS DRAWING)

NORTH EAST ELEVATION OF THE BARN
(ARCHITECTS DRAWING)

NORTH WEST ELEVATION OF THE BARN
(ARCHITECTS DRAWING)

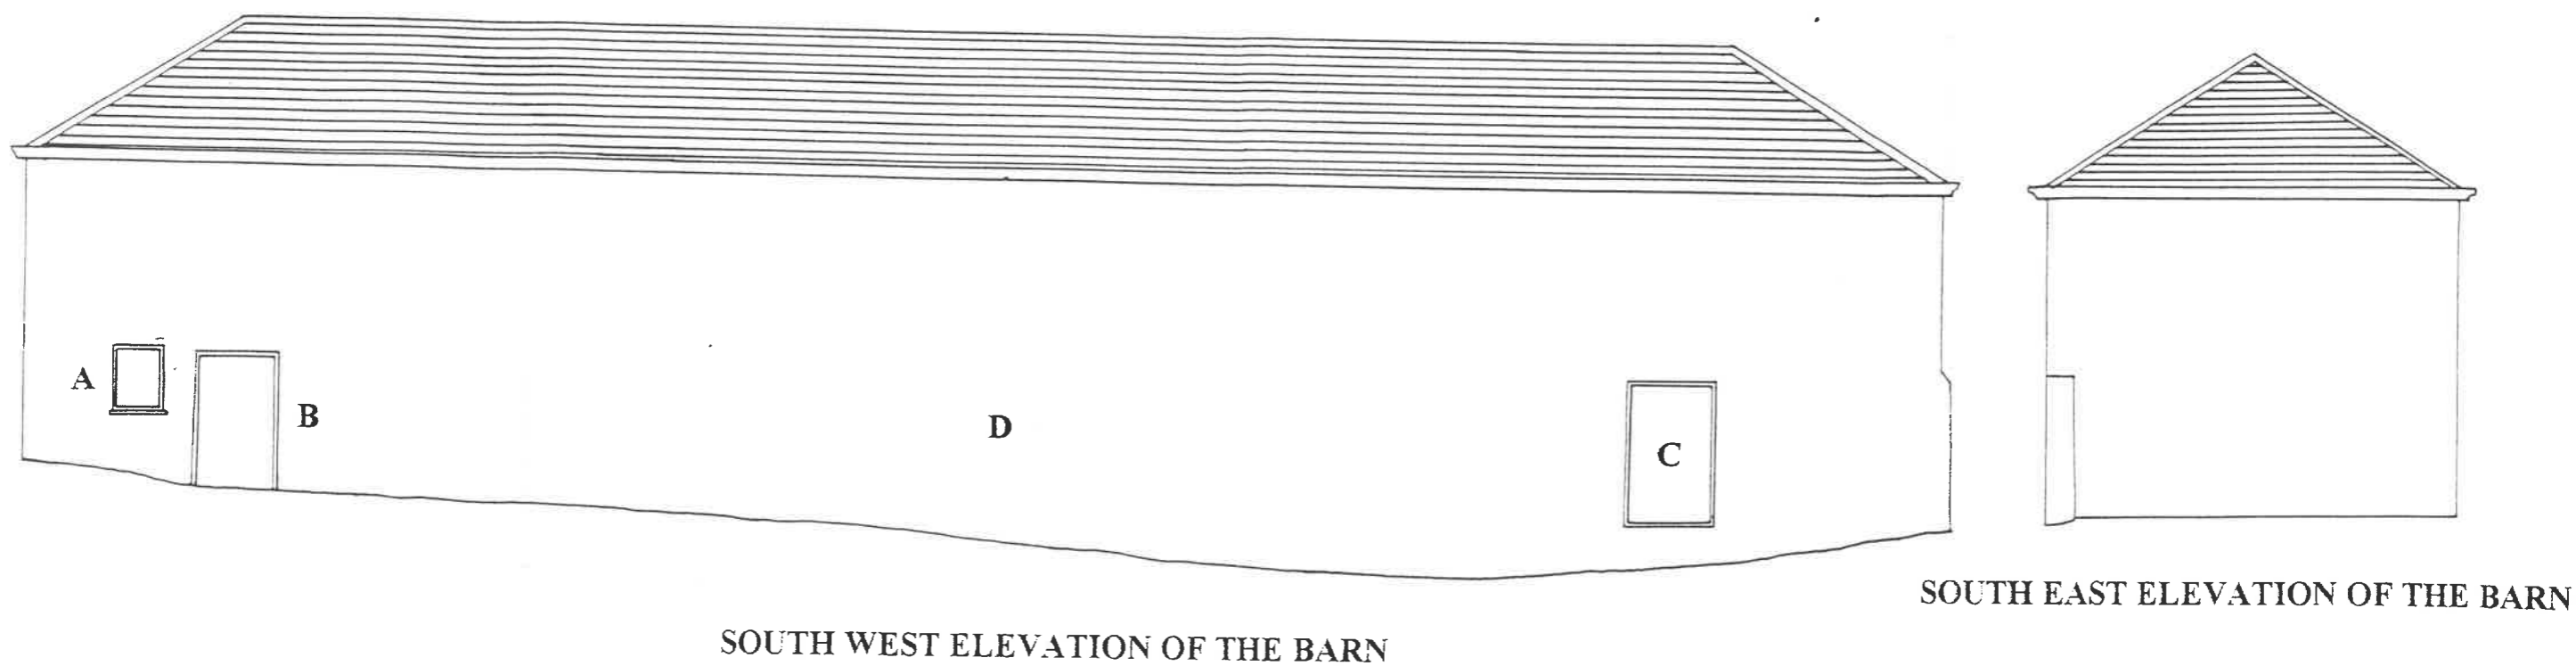
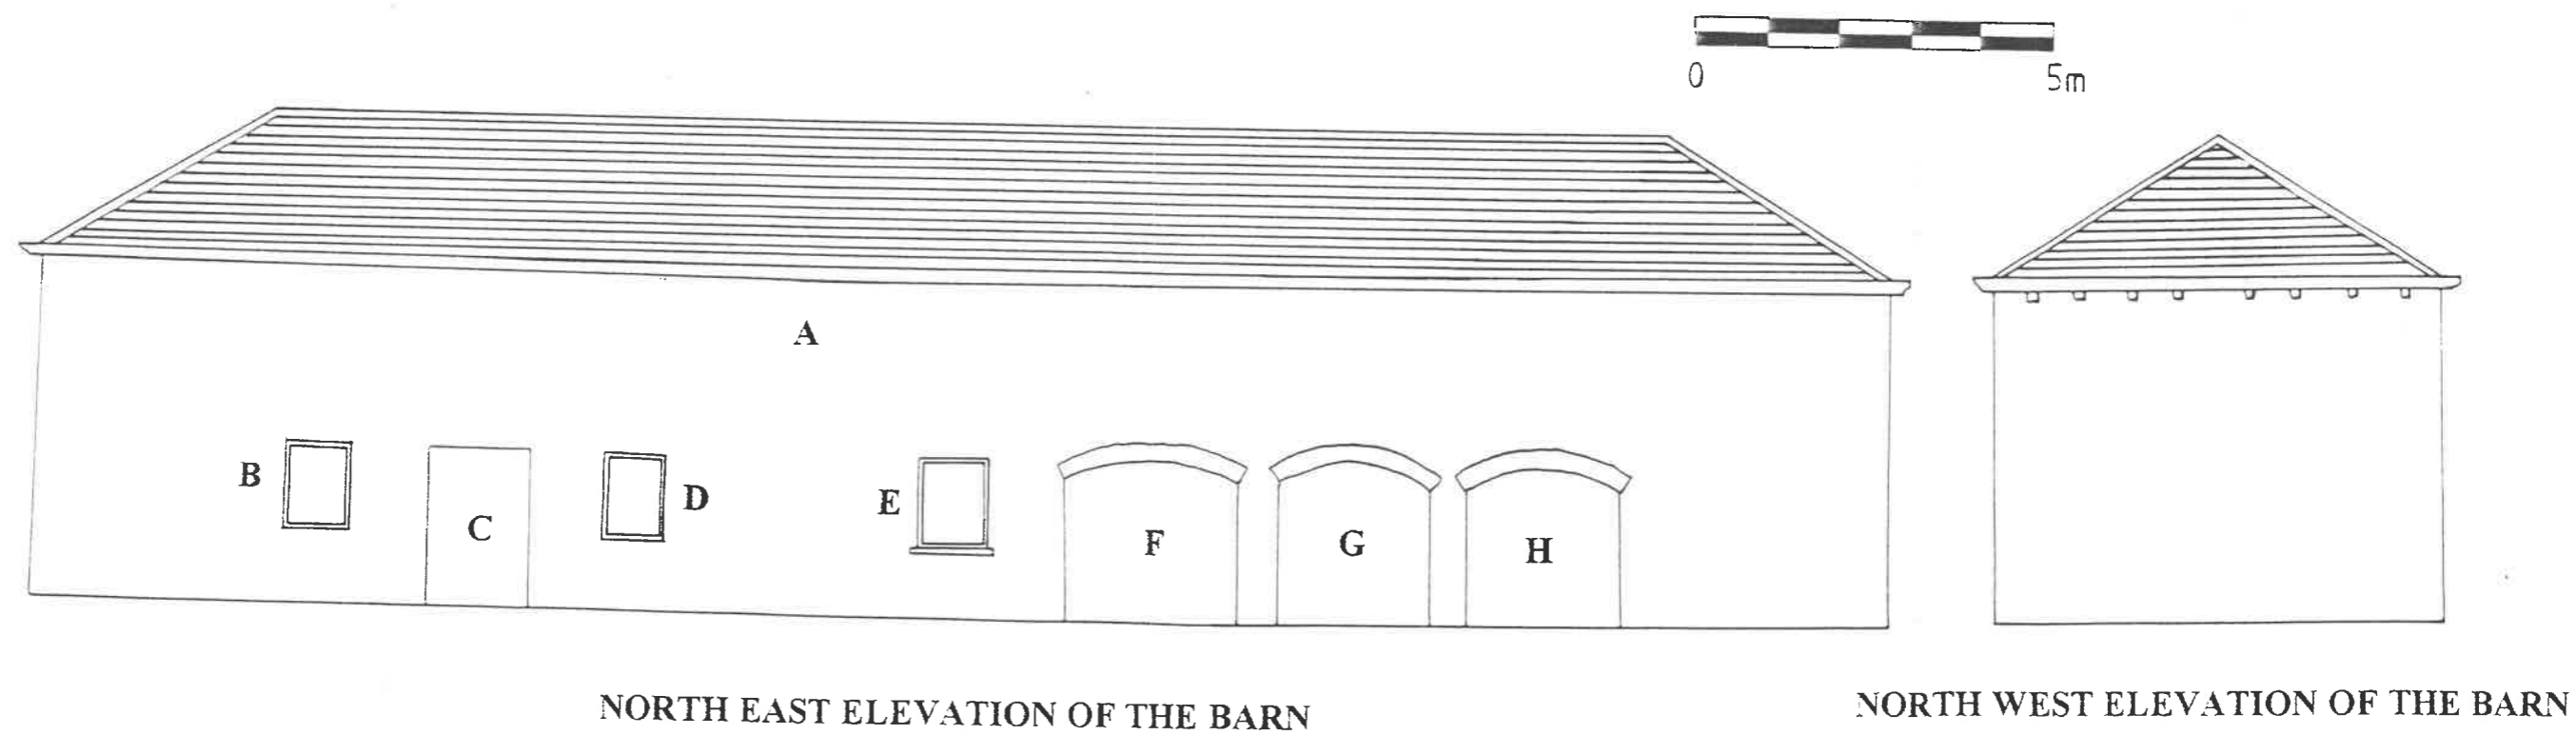
FIGURE 16:

Each end of this elevation was obscured by later additions to the exterior of the building. It is not known what features these additions may have obscured. The first floor windows that exist at present appear to be later alterations. It is not known whether in its original form there would have been any openings at this level (area A).

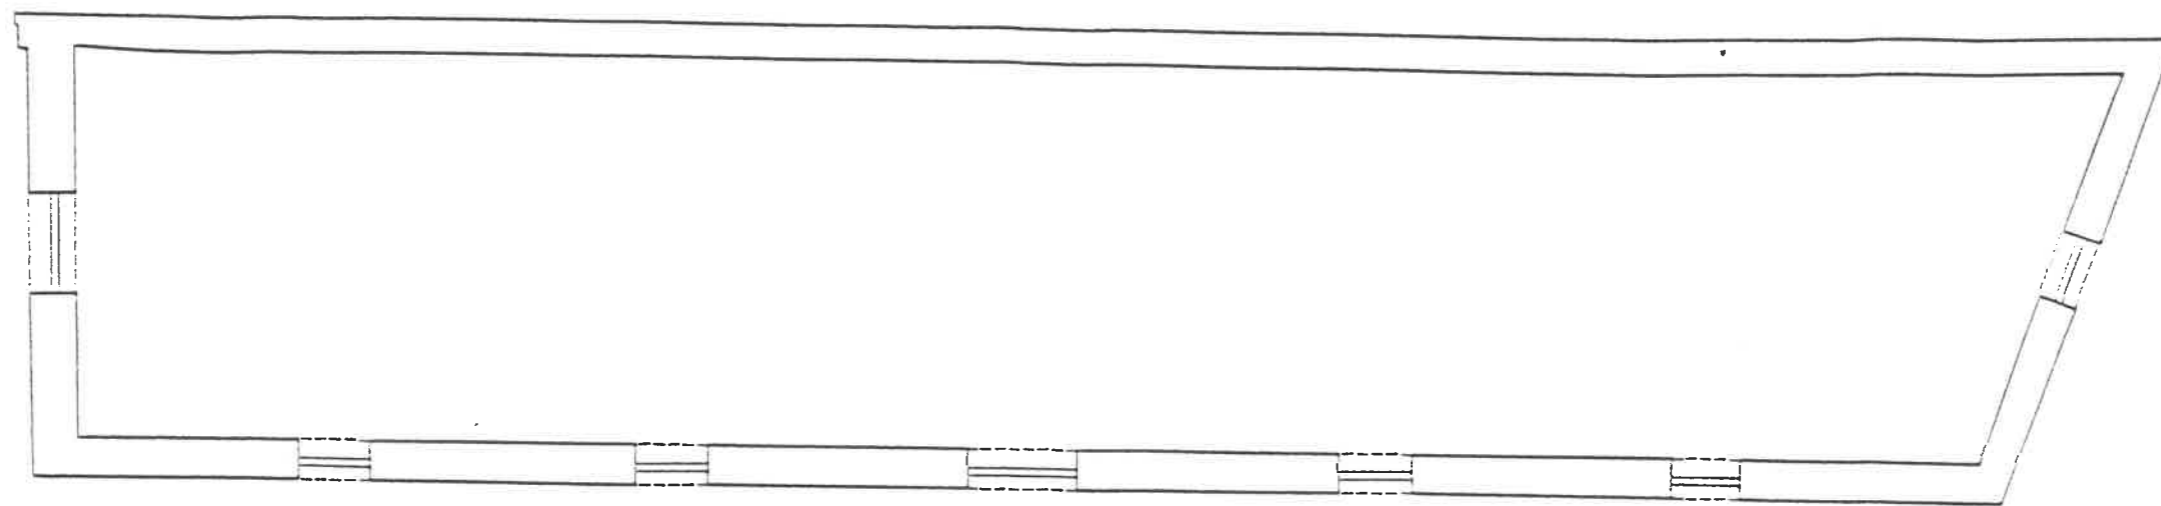
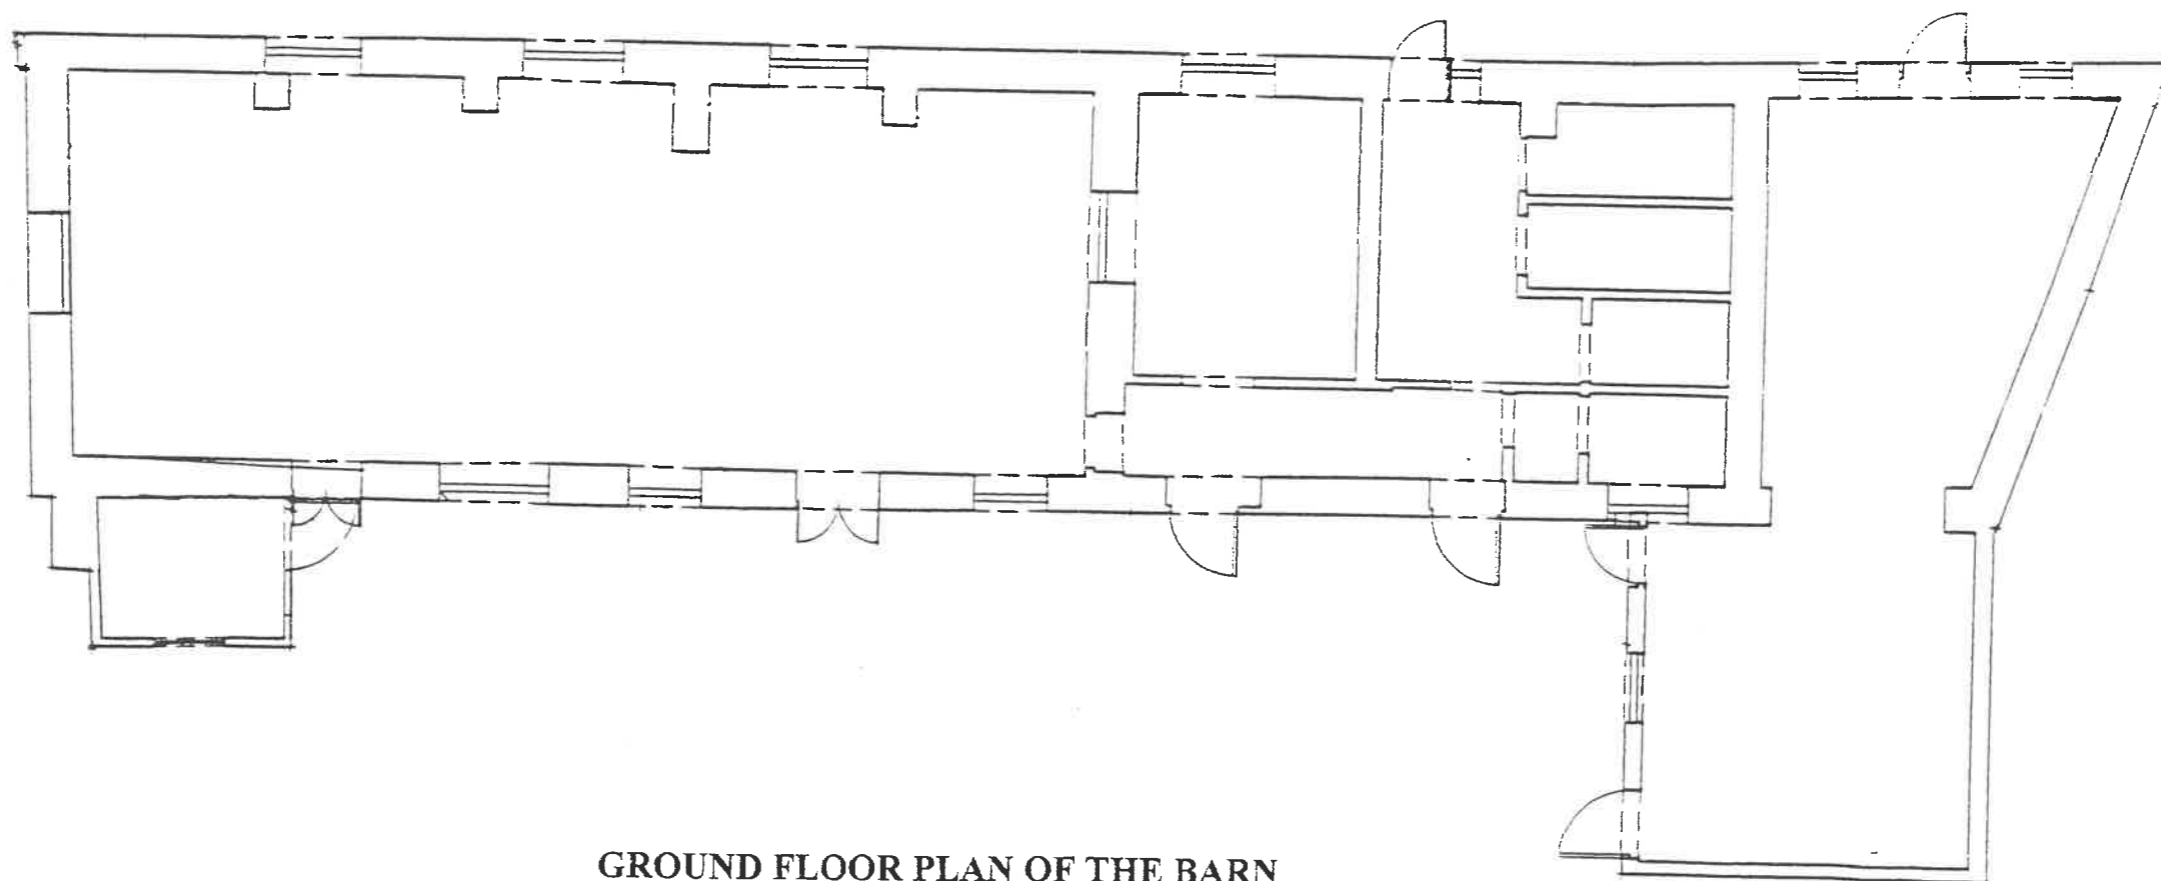
FIGURE 17:

It was not possible to investigate the inside of the building.

FIRST FLOOR PLAN OF THE BARN
(ARCHITECTS DRAWING)

GROUND FLOOR PLAN OF THE BARN
(ARCHITECTS DRAWING)

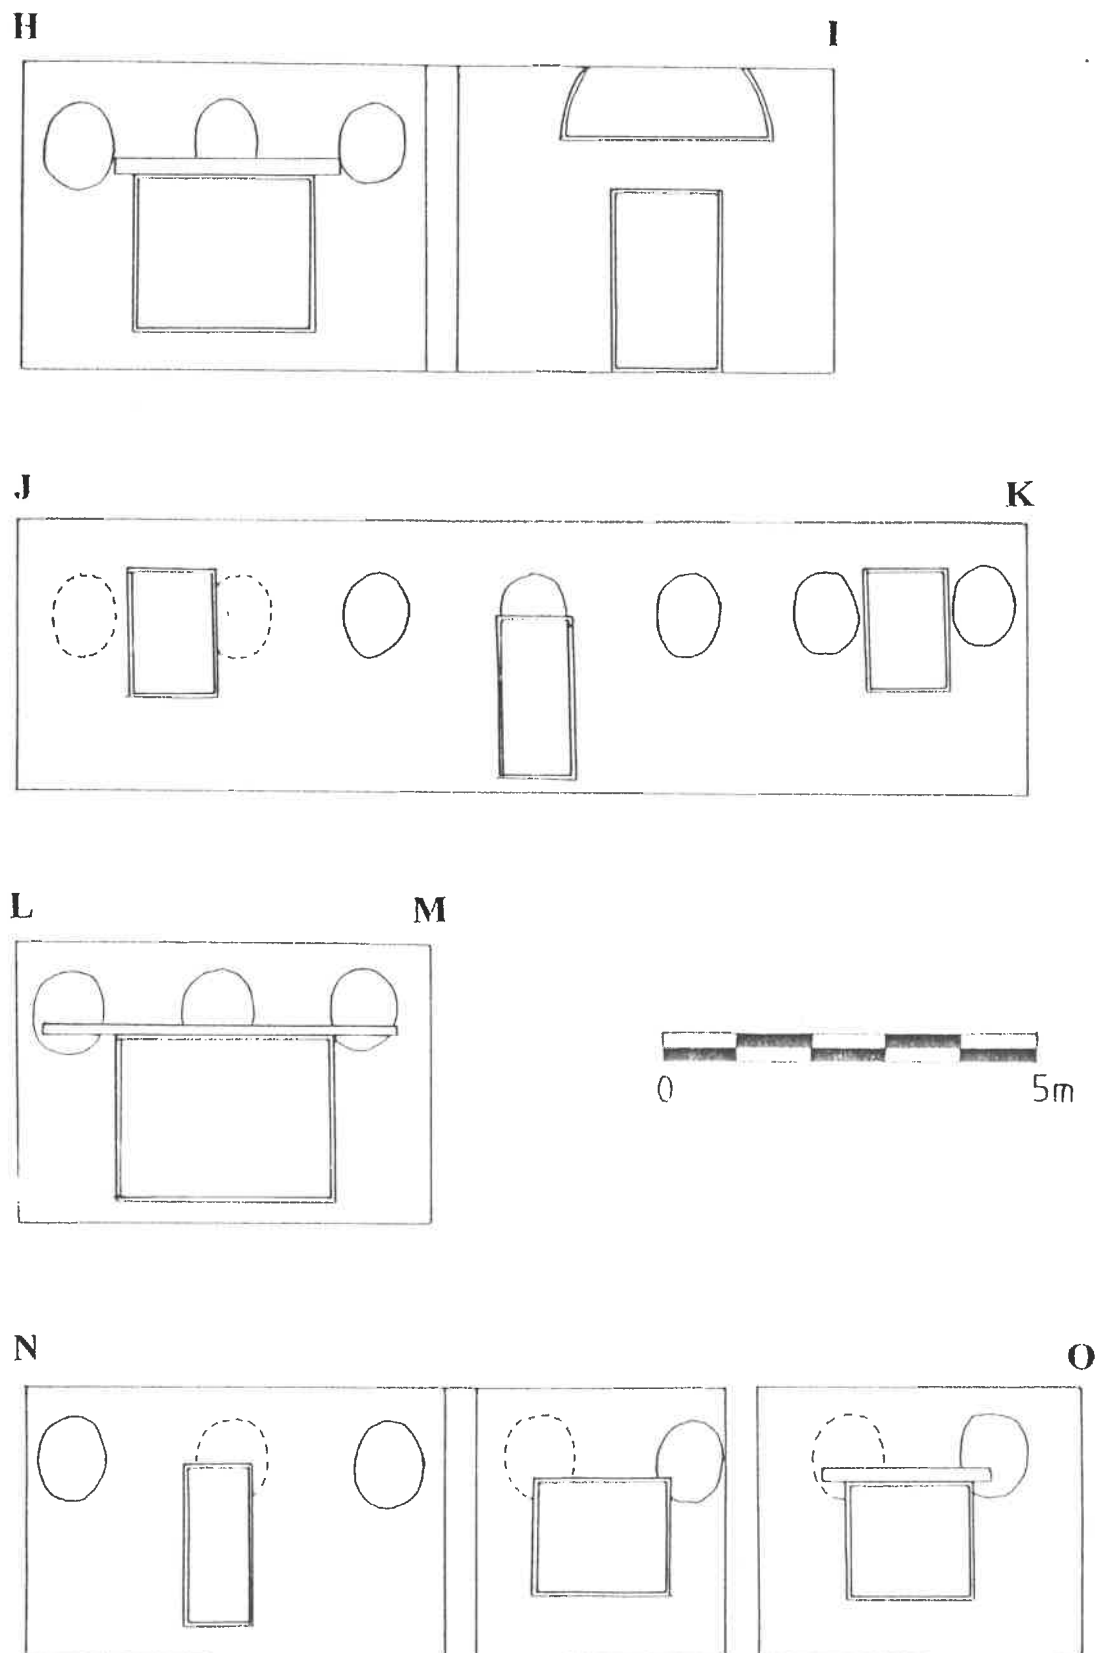
The need for light and ventilation suggests that originally there was no first floor in the stable wings, the circular and semicircular windows providing most of the light for the whole building. This is illustrated by the relationship between the level of the existing first floor and the semicircular window (see figure 18 H-I).

The only surviving stable features are a series of oval concave recesses (see figure 18, J-K and N-O). These are presumed to have held fodder for the stabled horses. Some of these recesses show evidence of having been plastered and painted yellow. If this decoration is original, it may suggest that the interior of the stables were rather

From the presence of more oval recesses (three in each), rooms (B) and (E) also appear to have been stabling areas (see figure 18, H-I and L-M). These were also probably open to the rafters. It seems likely that originally there would have been a single doorway between Rooms (E) and (F) as is the case between rooms (A) and (B). The barn door to room (E) is a later addition. The original arrangement of doors and windows in room (E) was probably the same as that of room (B).

INTERNAL ELEVATIONS OF THE STABLE BLOCK
(See Figure 1 for locations)
