# Middleton Hall, Carmarthenshire

Archaeological Watching Brief

CAP Report No. 200

**Date: 15th November 2001**

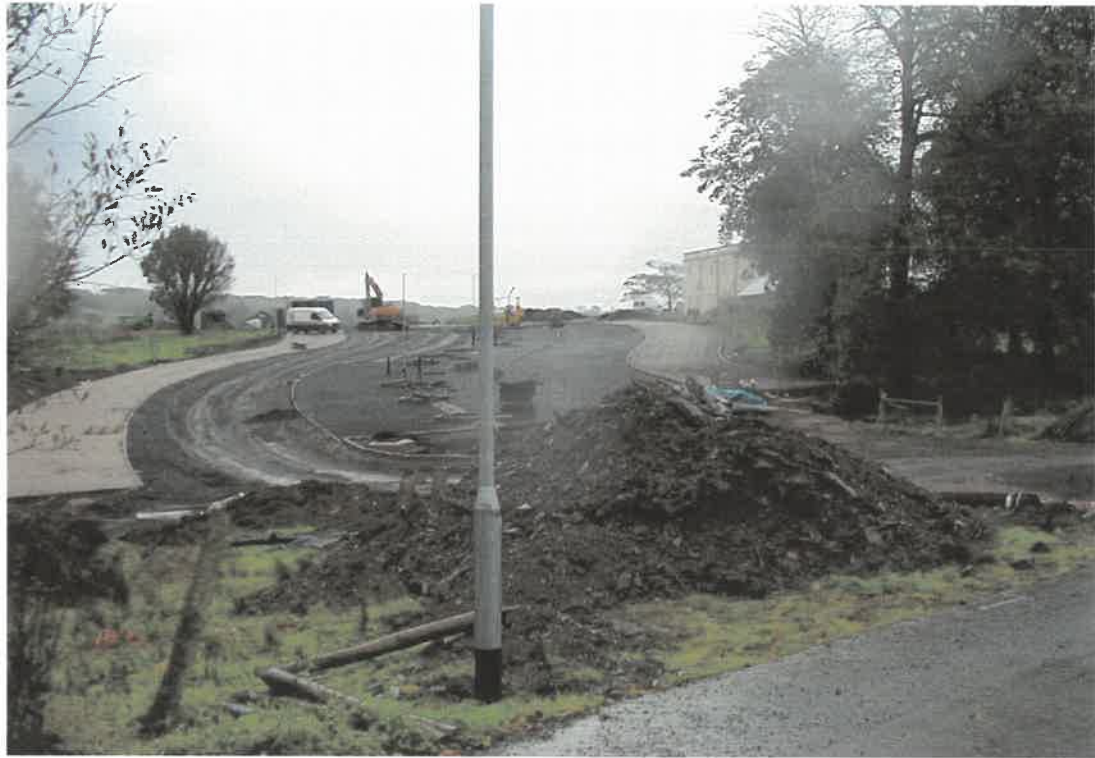
**Plate 01:** Extent of development at commencement of watching brief

Prior to contact being made with Cambrian Archaeological Projects Ltd. the developers had proceeded with ground works without the presence of an archaeologist. The stage at which the archaeological contractor first viewed the site can be seen in plate 1. At this stage the topsoil (01) had been removed to a depth of up to 0.40m below present ground level (PGL) in places. Within this, nine tree planting pits had been excavated, and a planting bed at the lower (west) end of the car park. These pits had been excavated to a depth of up to 0.60m below the level of topsoil removal. What remained to be seen of these excavations revealed them to have been cut into a natural greyish yellow boulder clay (07), which lay below c. 0.10m- 0.20m depth of (06). No features of archaeological significance were visible within these excavations.

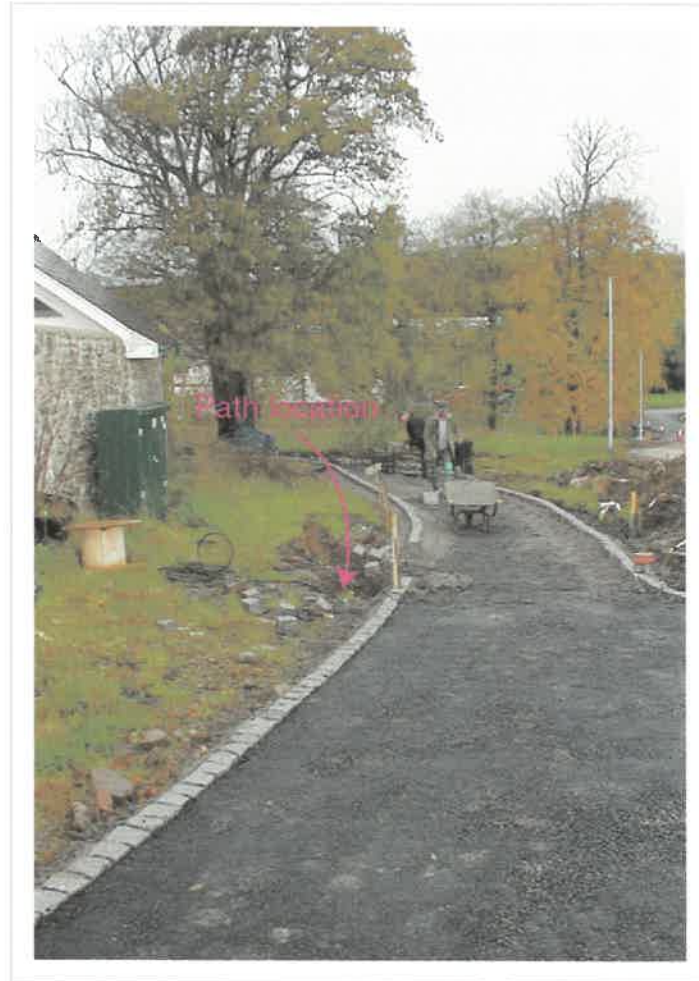
**Plate 02:** Showing position of service trench containing evidence of crushed red sandstone pathway.

Works on the path linking the car park to the rest of the gardens (see fig. 2) had also largely been completed, and again the topsoil had been removed to a depth of c.0.30m. A service trench had been excavated prior to laying the path (see fig. 2), in which could be seen a deposit (08) of crushed Old Red Sandstone chippings (see plates 02 and 03), probably representing an original pathway. This deposit only lay at a depth of 0.35m below PGL, and consequently had probably been disturbed by scraping works already carried out. The path's nature and direction would have been more fully understood had the archaeological contractor been informed of topsoil scraping works.

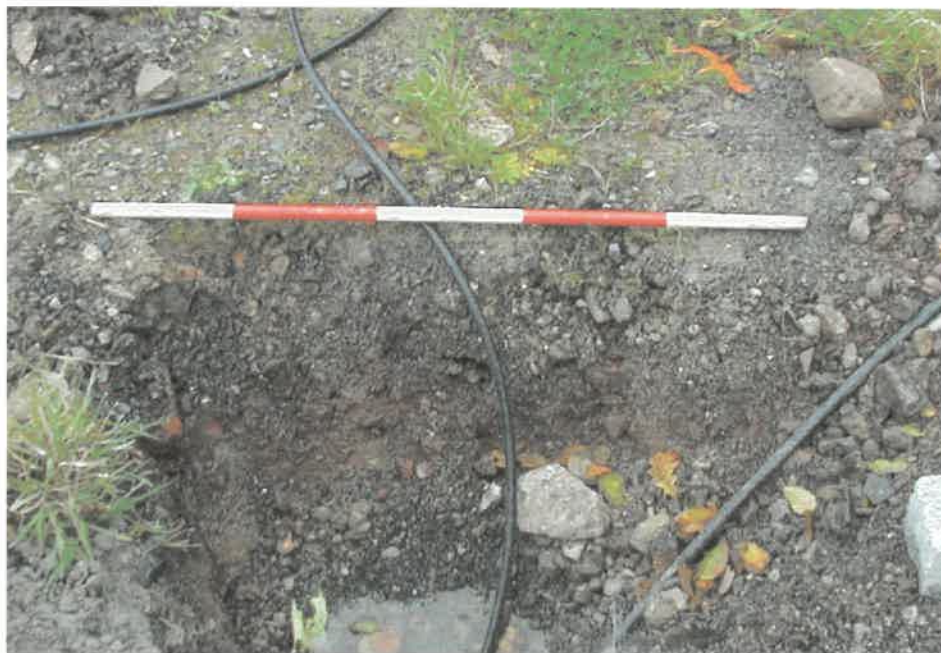
**Plate 03:** Detail of service trench containing crushed red sandstone pathway in section.  
(Scale 1m.)

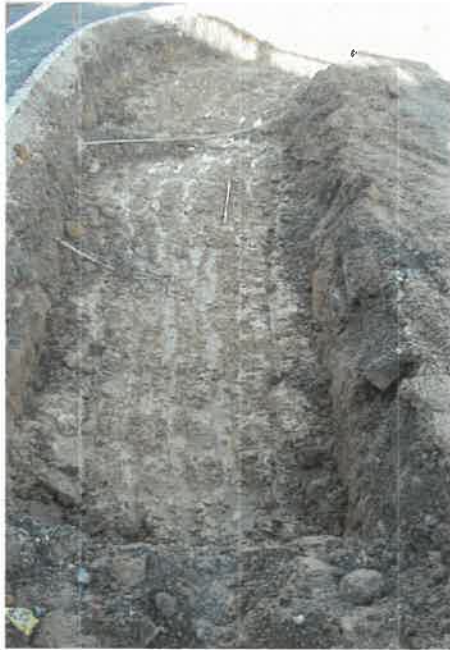
**Plate 04:** North-West area of plant bed excavation (Scale: 1m., looking east)

The main planting bed was excavated to an average depth of 0.85m, and was an irregular crescent shape in plan (see fig. 2). This bed was excavated with a toothed ditching bucket due to the rubbly nature of the overburden. The overburden (02) was dark grey and consisted of a layer in which brick, stone and concrete rubble was intermixed with food wrappers, consistent with recent development activity on the site. Beneath this, lower levels were less contaminated, but contained similar proportions of rubble (03). Within this deposit (03), at the northerly end of the planting bed, several large chunks of bricks mortared together were noted (plate 8). This context rested directly on a natural greyish yellow boulder clay (07), which was undisturbed except for occasional root activity, two cable trenches, and an earlier trench [04] containing a ceramic field drain and backfill (05), running east – west across the site (plate 06).

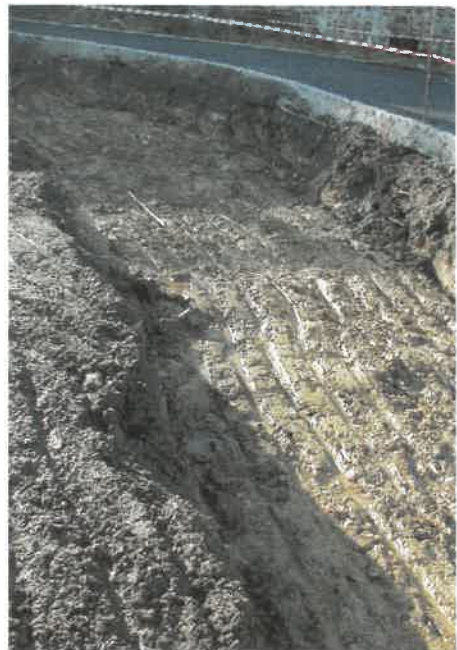
**Plate 05:** Central area of plant bed excavation (Scale 1m., looking west)

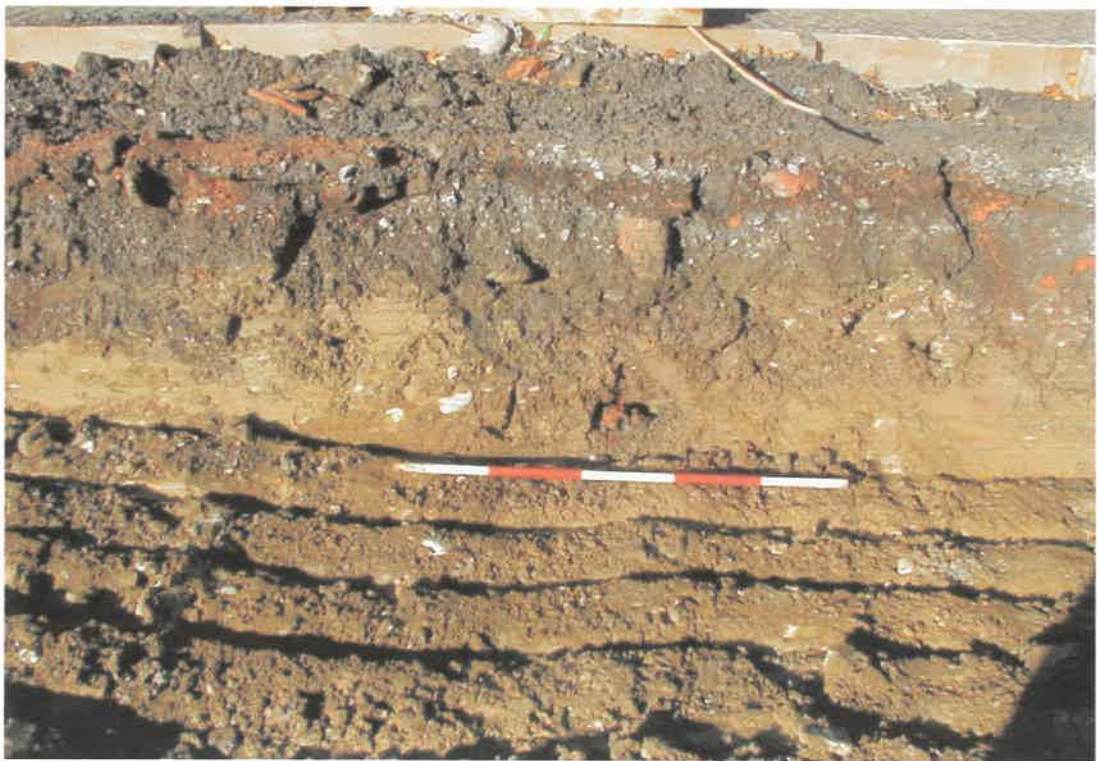
**Plate 06:** Part of South-East facing section of plant bed excavations, showing cut for ceramic field drain, and rubble overburden. (Scale 1m.)

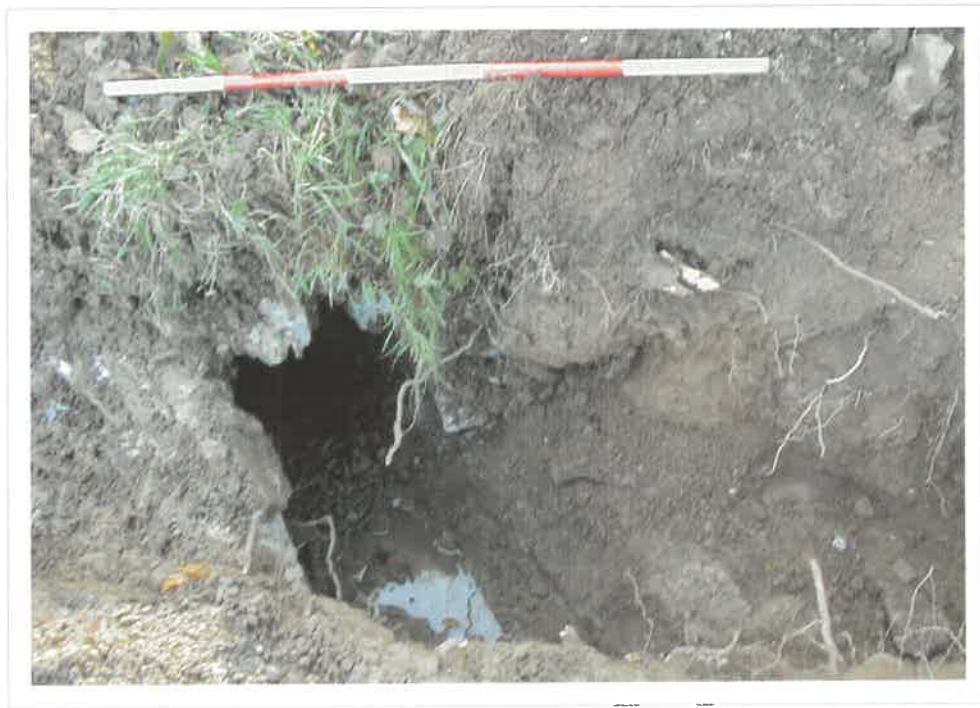
**Plate 07:** North-South culvert at West end of site. (Scale 1m. looking South)

The service trench which ran along the south side of the car park was 0.60m wide and excavated to a depth of c. 0.80m. In this trench a culvert constructed of angular limestone, and running north - south was uncovered. The exterior

was roughly constructed (width: av. 1.10m), and had collapsed revealing a well-constructed arched interior, with a diameter of c. 0.65m. Collapsed material made it impossible to gauge the level of siltation on the base, although it still appeared to be carrying a small amount of water.

The culvert revealed in the service trench on the south side of the car park was of indeterminate date, although its construction of angular limestone with lime mortar jointing might suggest a mid 19<sup>th</sup> century date at the latest.

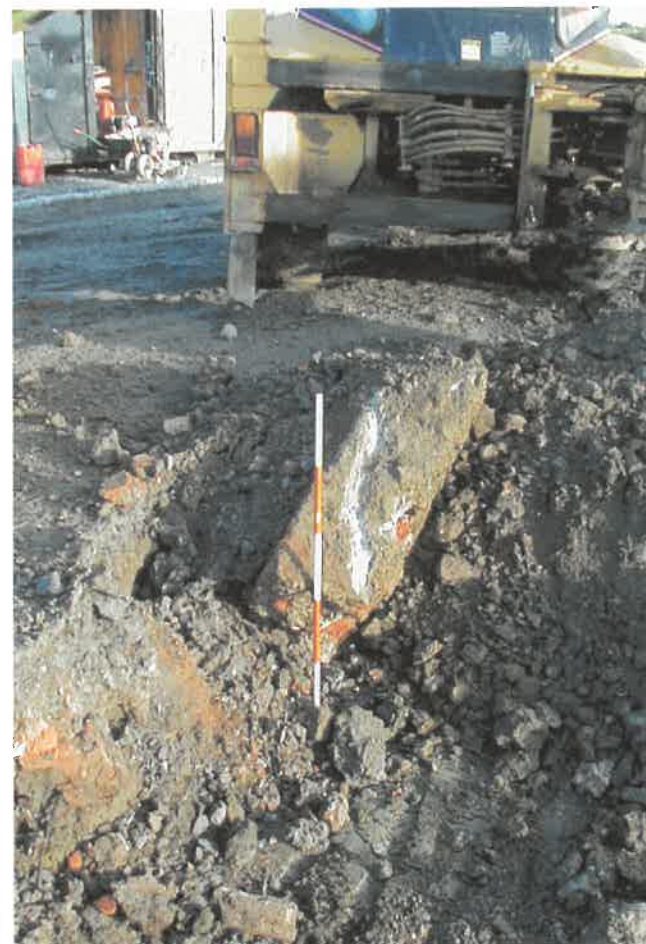
**Plate 08:** Intact piece of mortared brickwork (Scale 1m. looking East)

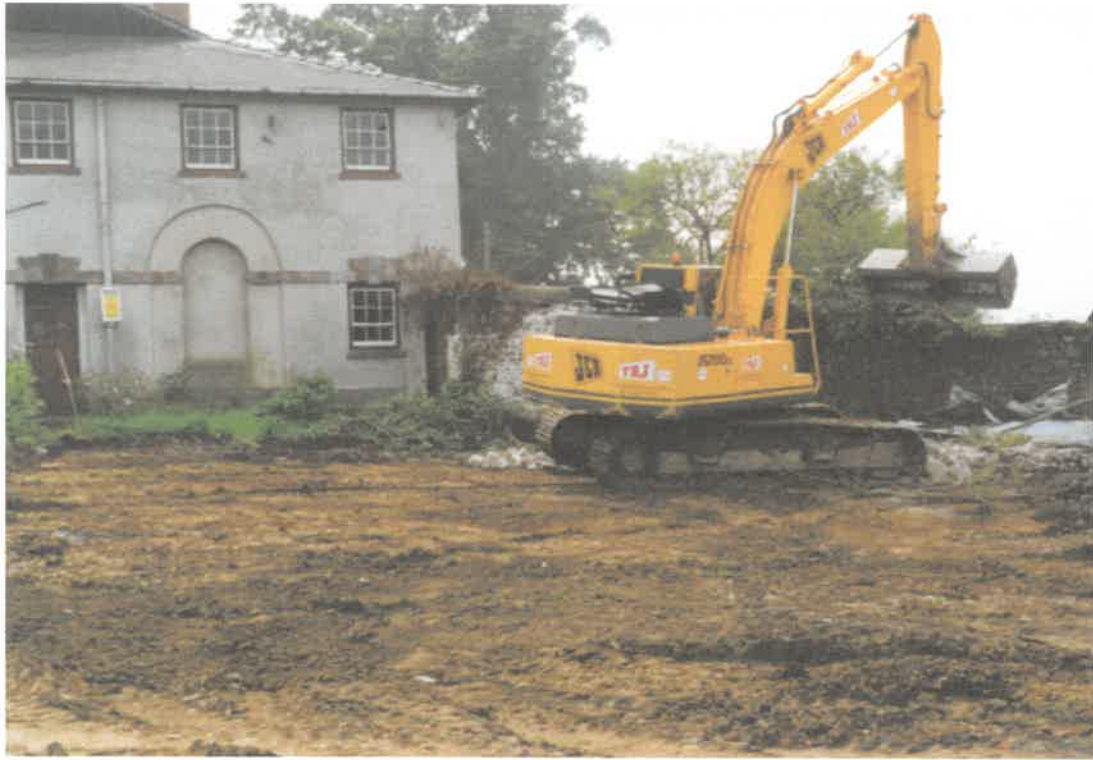
**Plate 09:** Area of current watching brief during 1997 (looking South)

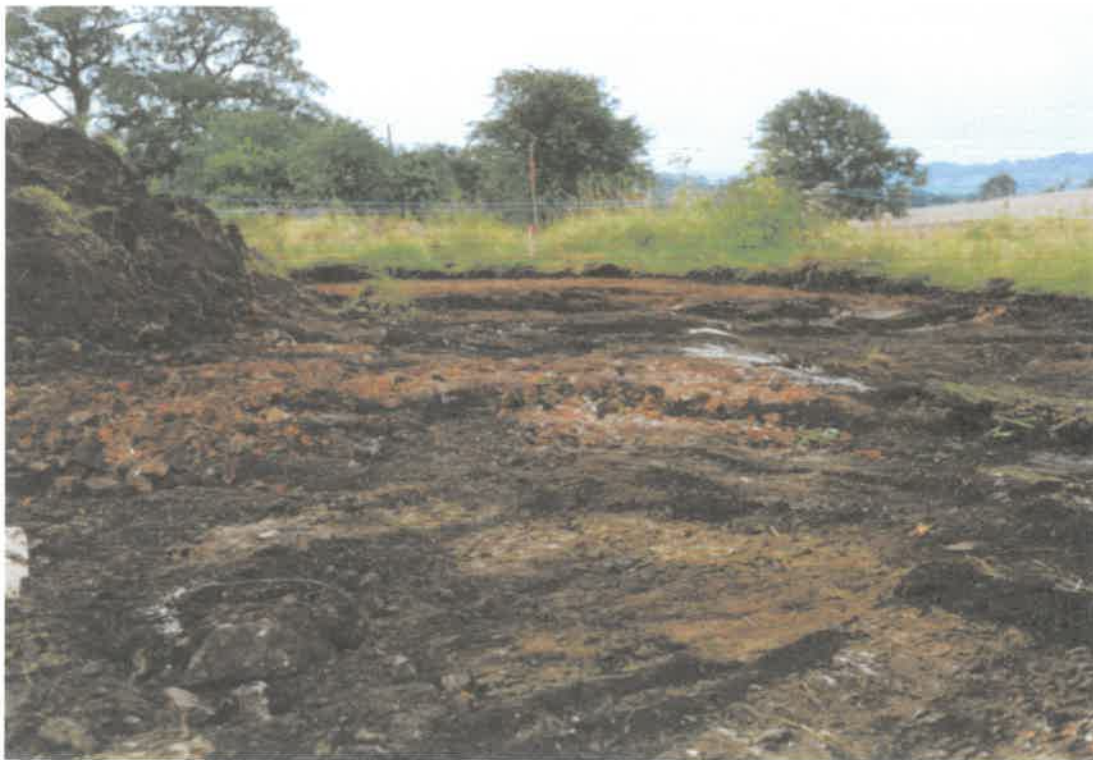
**Plate 10:** Area of current watching brief during 1997, showing rubble associated with demolished outbuildings
