# Cefn Croes Wind Farm, Ceredigion

ARCHAEOLOGICAL SURVEY AND WATCHING BRIEF

CPAT Report No 684

**R Hankinson**  
February 2005

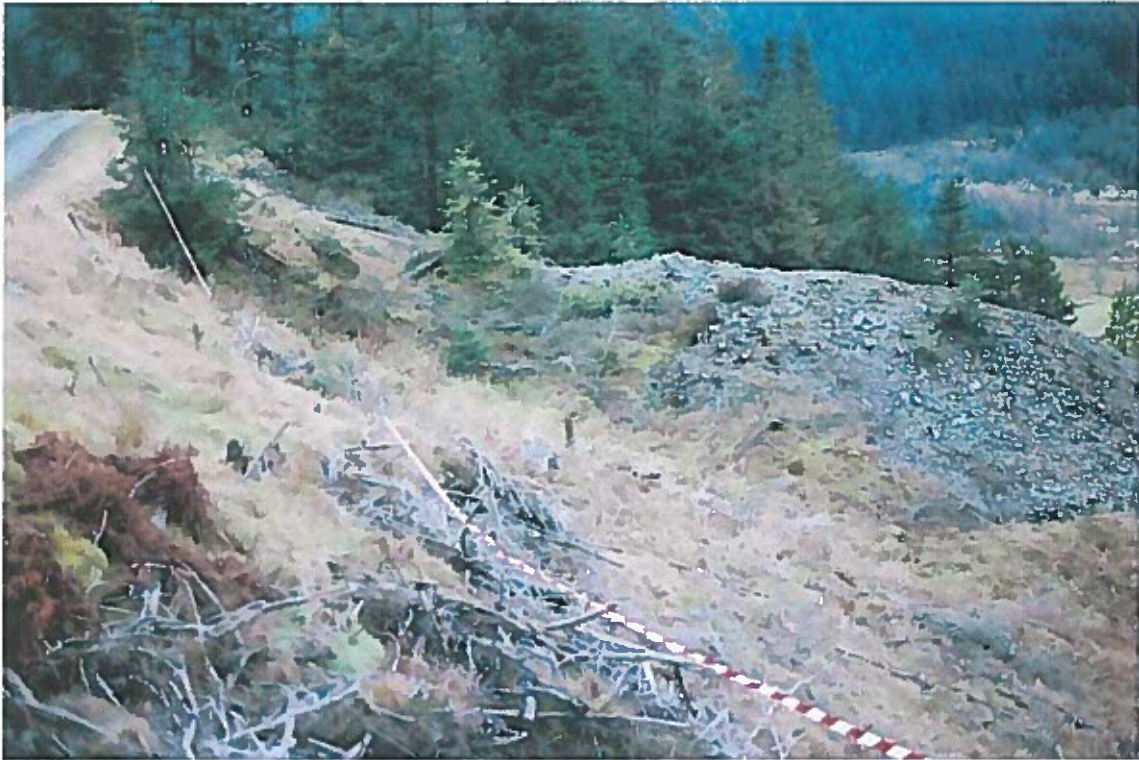
Plate 1 Old Esgairlle Mine workings marked off by bunting. Photo CPAT CS04-04-27

- 4.2 The group of sites which together form the mine complex known as the Old Esgairlle mine (PRN 25868) constituted the most significant element of the archaeological resource on the line of the main wind-farm access route. The main part of this mine is situated at NGR SN 795829, on the opposite site of the upper Castell valley to the wind farm entrance. To protect surviving features of this complex it was proposed in the Environmental Statement that the route of the track through the site should be tightly controlled.

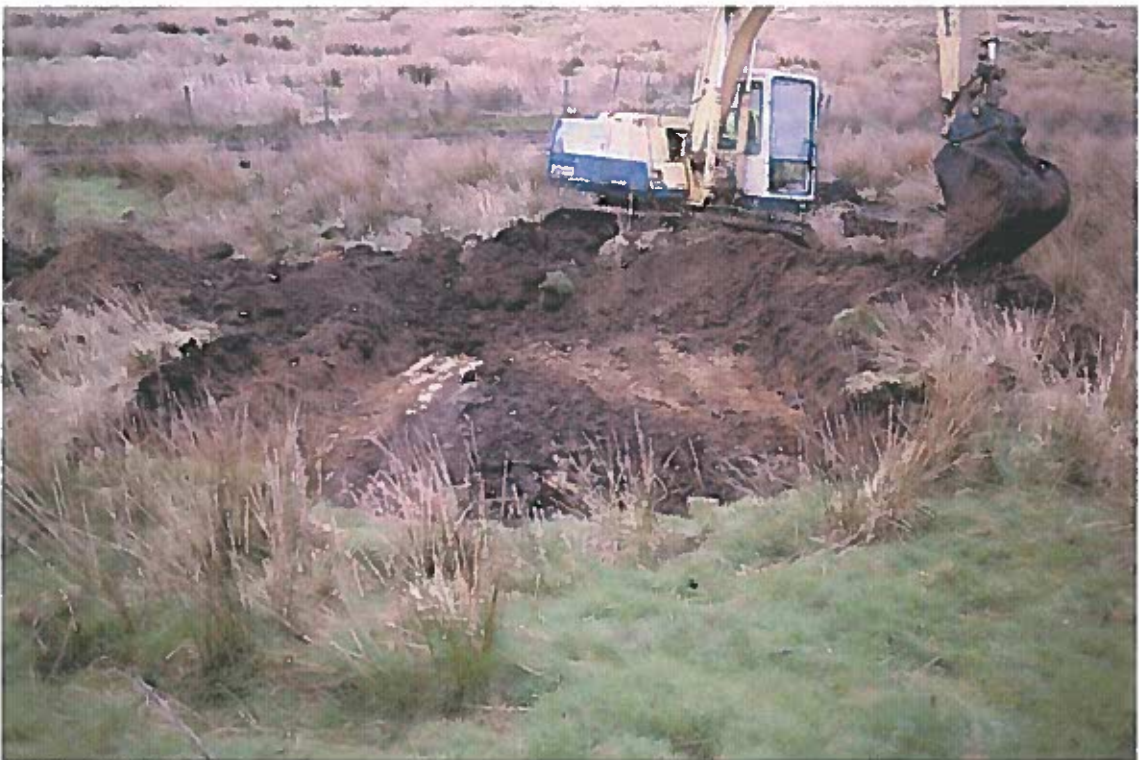
Plate 2 Machining of trial workings (PRN 33237) under close archaeological supervision. Photo CPAT CS04-22-27

- 5.4 The only archaeological site which suffered some inevitable damage due to the construction of the main access track was the group of scoop-shaped features (PRN 33237; Plate 2), believed to represent trial mine-workings. A watching brief was carried out on 20 April, during the removal of five of these features, with the agreement of the archaeological curator. The removal was undertaken by machining under close archaeological supervision, prior to the start of track construction. No mineral veins were evident in the base of the features, which had been cut into shale deposits, but it was evident from their shape and arrangement that the original interpretation as exploratory trial mine-workings was correct. The maximum size of the individual features, including the resultant spoil, was 13m by 8m, with depths up to 1.4m below the adjacent ground level being attained. During this work it became clear that PRN 33236, which had originally been interpreted as a possible structure or fold, represented a further trial working of this type. Minor damage subsequently occurred to this feature during the erection of grid connection pole No 118 (see Section 6, below).

- 7.2 One site, the series of exploratory trial mine workings (PRN 33237), was removed during construction of the wind-farm access road. The individual workings were photographed and described prior to their excavation by machine under close archaeological supervision, with the agreement of the archaeological curator. The results of this work confirmed the nature of the site. The main mine site in the locality, that of the Old Esgairlle Mine, was traversed by the access road. The access route followed that of an existing forestry road, but was tightly controlled as it passed through the mine area to ensure that no disturbance resulted. This was successfully accomplished.

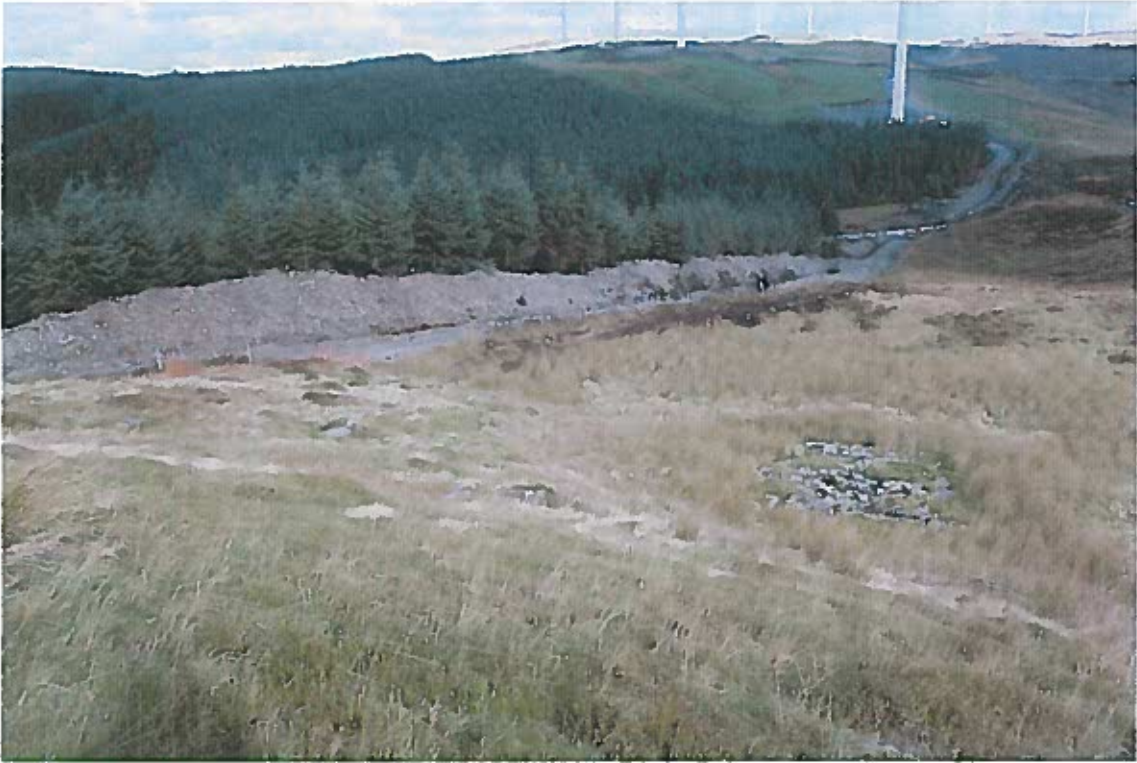
**Plate 3** Groundworks on cable route between Turbines 11 and 12, passing PRN 33266.  
Photo CPAT CS04-56-20

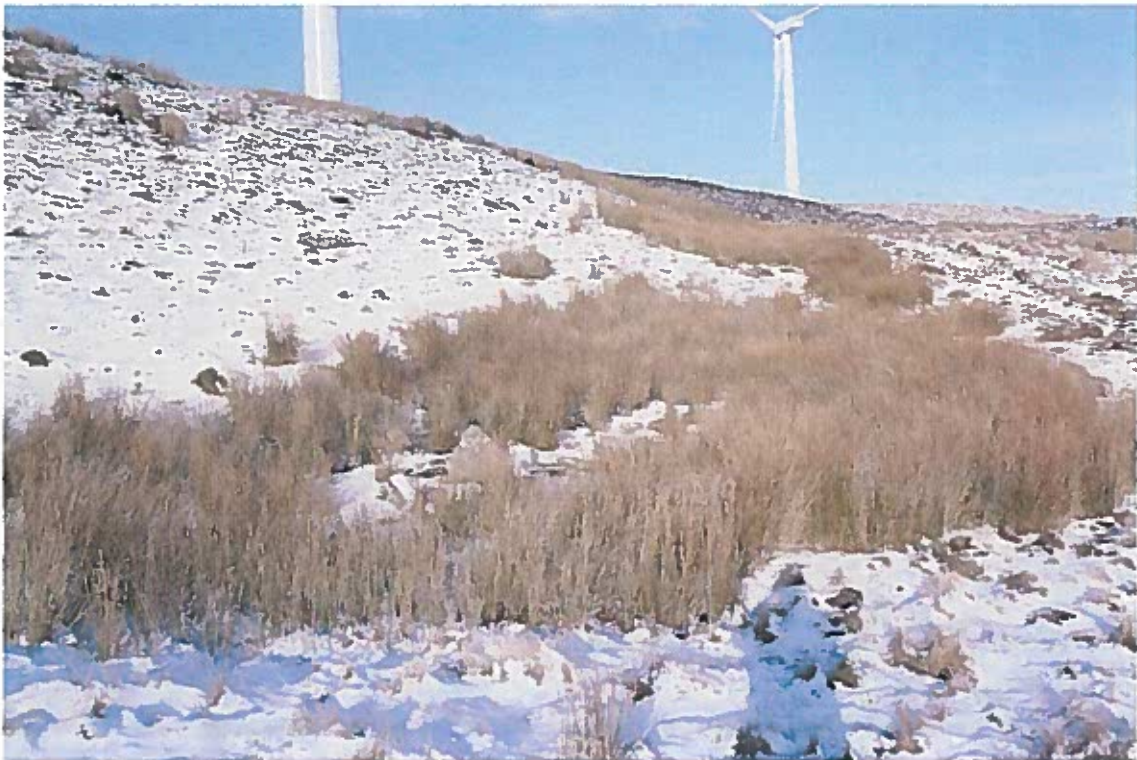
**Plate 4** PRN 33263 following completion of re-instatement works. Photo CPAT CS05-06-26

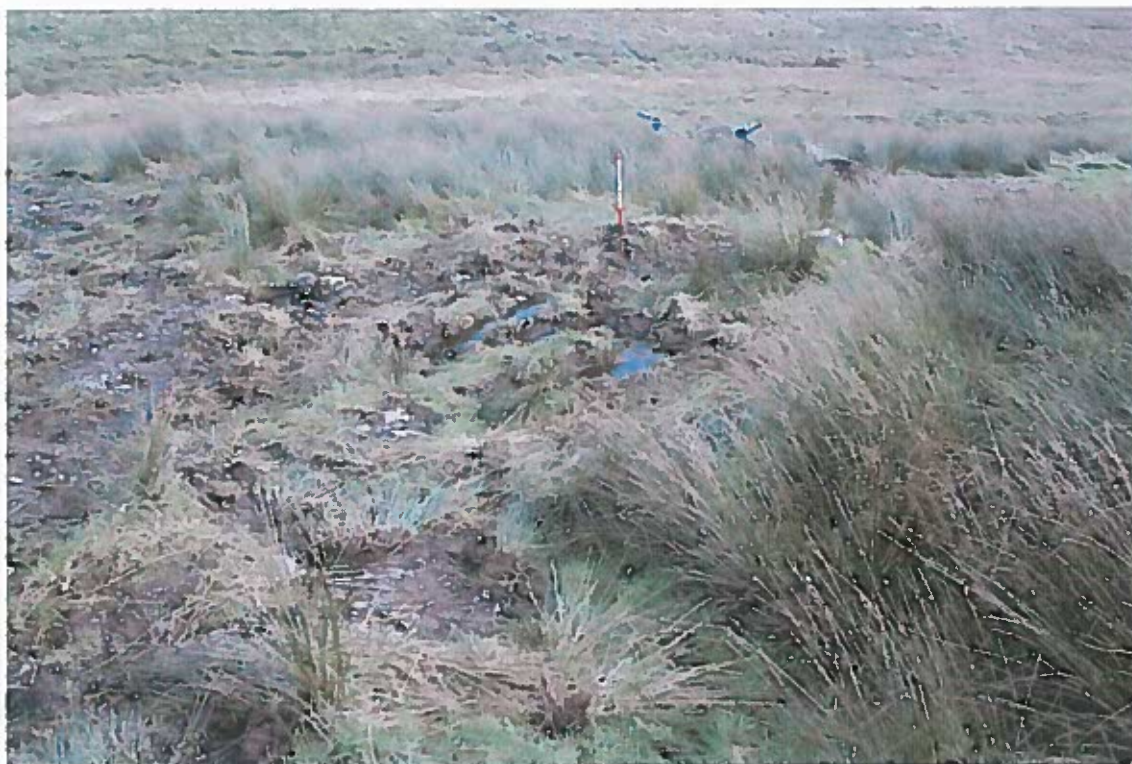
**Plate 5** Surface damage to trial working PRN 33236 at grid connection pole 118.  
Photo CPAT CS04-56-23

- 7.3 Two boundary stones, which had been previously recorded alongside the access road, were found to have been lost prior to the commencement of construction work. This may have been as a result of the erection of a fence to delineate a newly afforested area which borders the trackway whose line was followed by the access route. Two additional boundary stones in this area remain unaffected by construction work. A further site (PRN 33236) was avoided by track construction, only to be subject to minor damage during the erection of an electricity transmission line pole for the grid connection. The site was originally thought to represent an enclosure, but was re-assessed during the PRN 33237 watching brief, which covered the adjoining area. This examination suggested strongly that PRN 33236 was a further exploratory trial mine working.

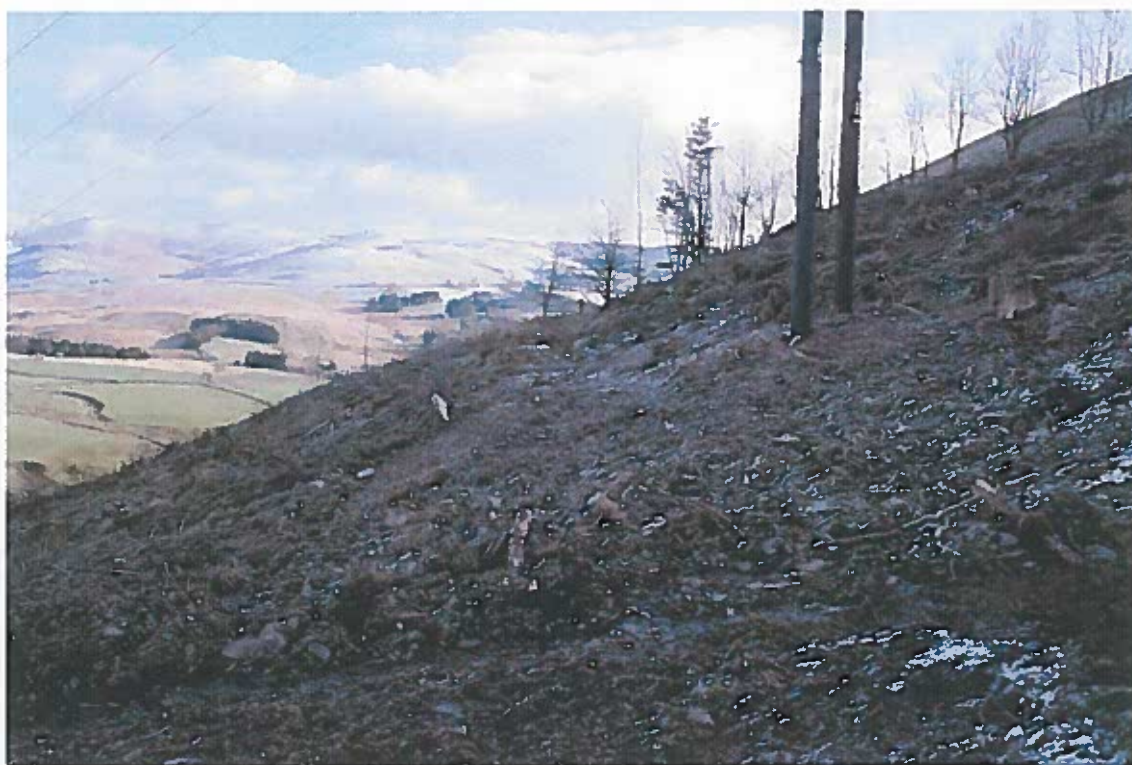
**Plate 6** Damage to unrecorded leat (Site 1) caused during erection of grid connection pole 22.  
Photo CPAT CS05-06-34

- 6.4 During the works on Mynydd Pont-erwyd, a mine leat or artificial watercourse (Site 1 in Appendix 2; Plate 6), which seems to have served the Llywernog Mine, was recognised. This had not been identified in the corridor assessment (see para 6.1), and one pole (no 22) was due to be sited on the course of the leat. Discussions with the contractor led to the slight repositioning of the pole, which was re-sited 4m upslope from the leat. The discovery of the leat at this late stage, when nearby poles had already been erected, did not allow pole 22 to be sufficiently re-sited to ensure that avoidance measures were effective. As a result, in the process of gaining access to the pole location with a machine excavator and the backfilling of the hole on this steep slope, some disturbance occurred to the line of the leat, approximately 40m of which has been affected to some degree (Plate 8). The leat proved to be a simple gully, c.1.5m wide overall, which contoured this north-east facing hillslope; it remains in a well-preserved condition in the field to the south of the area of forestry in which pole 22 is located.

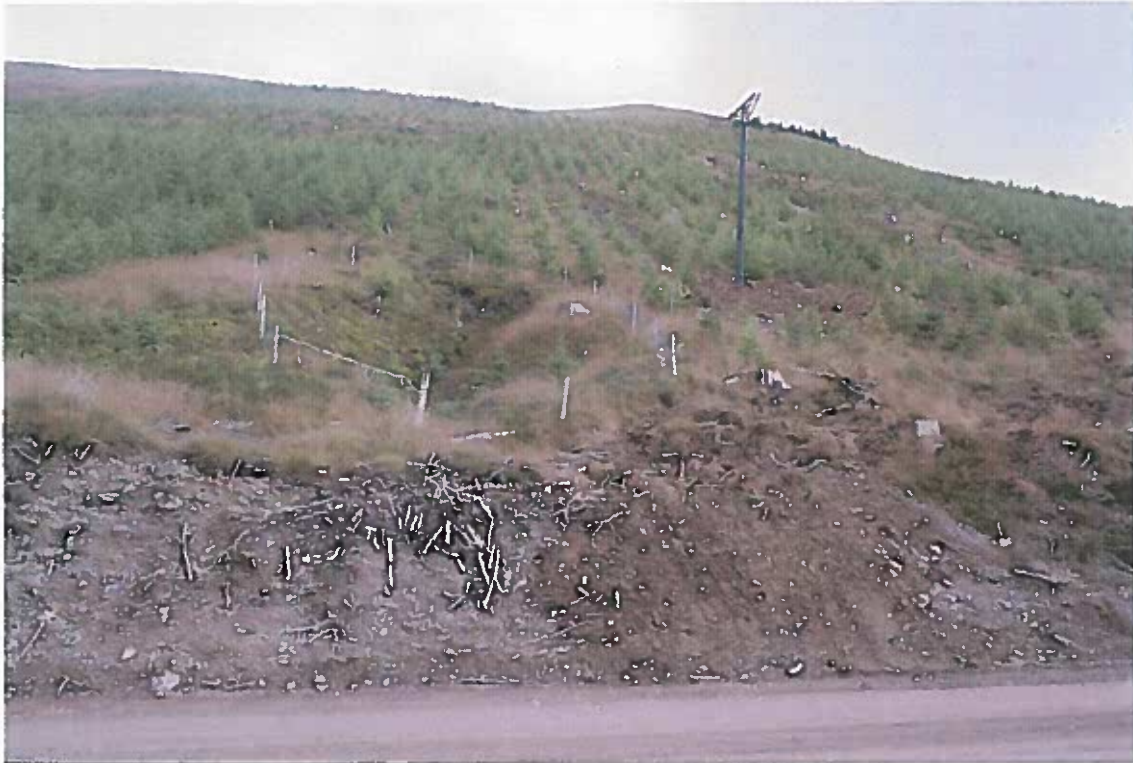
Plate 7 Mine level at Old Esgairlle Mine preserved by re-siting of grid connection pole 95.  
Photo CPAT CS04-56-20

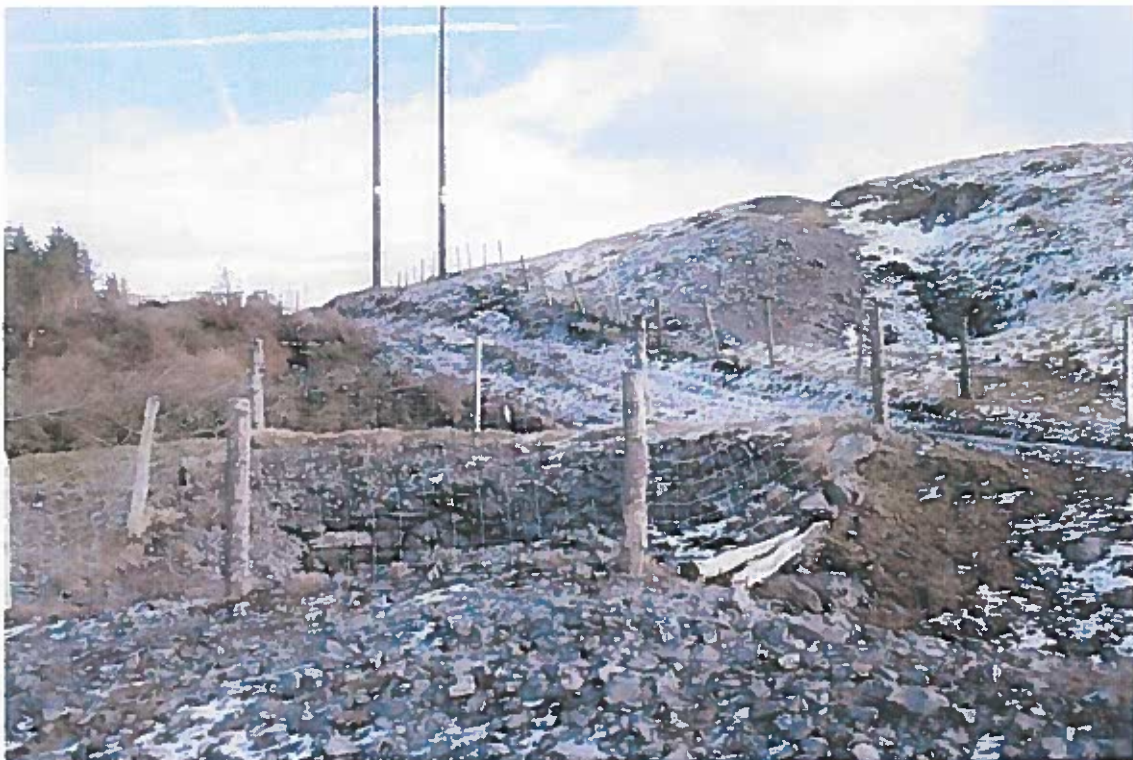
Plate 8 Vehicle route passing mine shaft at Craignant Bach Mine, near grid connection pole 18.  
Photo CPAT CS05-06-26

- 6.3 Unfortunately, the Craignant Bach mine area proved to be the only possible route of access for construction traffic used in the erection of poles 17 to 22. The importance of the mine workings was highlighted to the site representative of ESBI Ltd, during a visit to the workings. While the site traffic largely avoided direct interference with the mine workings and spoil tips, the trackways which were created by the passage of vehicles have not been re-instated (Plate 8). This has left the mine area looking particularly untidy and appearing as if it has been subject to a far greater impact than has actually been the case.

- 7.4 Work in relation to the erection of poles for the grid connection on Mynydd Pont-erwyd has left the Craignant Bach mine area looking particularly untidy, although the direct effect on the surviving elements of the mine has been minimal. Approximately 40m of a leat, which was not recorded in the archaeological assessment of the grid connection, has been affected by the erection of one of the poles in this area. Unfortunately, the discovery of the leat came too late to allow the re-siting of the pole. With the exception of this area and PRN 33236, mentioned above, the remaining sites alongside the grid connection were successfully avoided.
