ST DAVID'S AIRFIELD: Studying the Significance of Lost Landscapes in a Second World War Airfield Site in Pembrokeshire

Vivienne Blandford

A dissertation submitted to the University of Bristol in accordance with the requirements of the degree in Landscape Archaeology in the Faculty of Arts, September 2008.

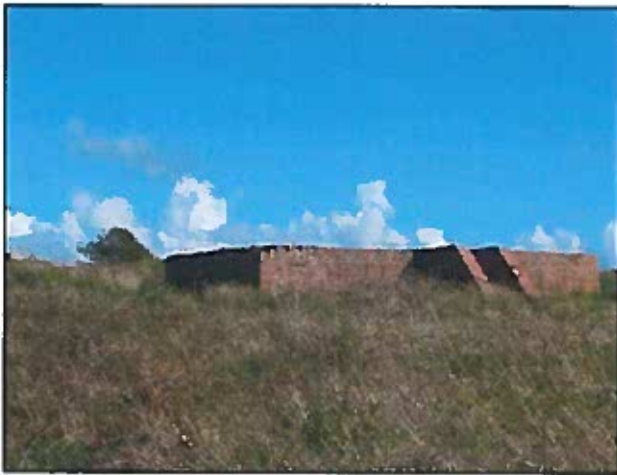
Figure 21 Blast Shelter Site 12 (SM 78842451)
(Recommended for conservation in 1993)

Whilst the Local Authority had attempted to remove many of the traces of the dispersed sites the bases of some remain today. The platforms of site 12, barrack huts, and substantial remains of the blast shelter are visible from the footpath leading down to the beach near Nine Wells. Some standing remains of Site 5, the WAAF, survive in poor condition are visible from site 12. At Llanwngar Fawr farm, in the corner of the garden survives a Picket Post (Guard House) and in the farm yard three Maycrete buildings are still used for storage. The former Transmitting Shed, privately owned as a workshop, survives in good condition. It is built of brick with an asbestos roof with some of the original paint, cream, green and black paint on the interior walls (*Figures 20-26*).

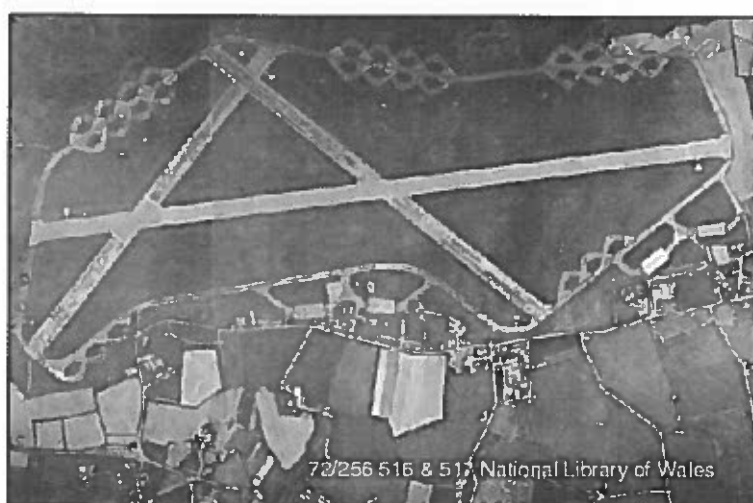
By 1970 the runways are still well maintained but the buildings have been demolished, leaving only the bases. The open nature of the airfield contrasts with the irregular field patterns and hedges of the agricultural land.

Figure 31 July 1972

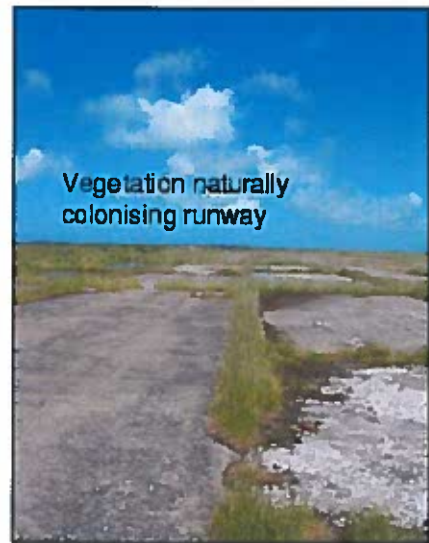
Figure 35 Runway Surface

Until 1996 the main runways had been maintained by the MoD for emergency use. Since 1996 the small expansion gaps between the poured mass concrete panels, of which the runways were constructed, surface faults and cracks within the panels have been colonised by a range of plant life and the invertebrate colonies which they support. The runway surfaces provide, warm dry roosting and resting conditions for a variety of birds, reptiles and small mammals. The airfield has become an important skylark breeding habitat which has coined the phrase ‘from Bombers to Skylarks’ (*Sanctuary, MoD Estates*).

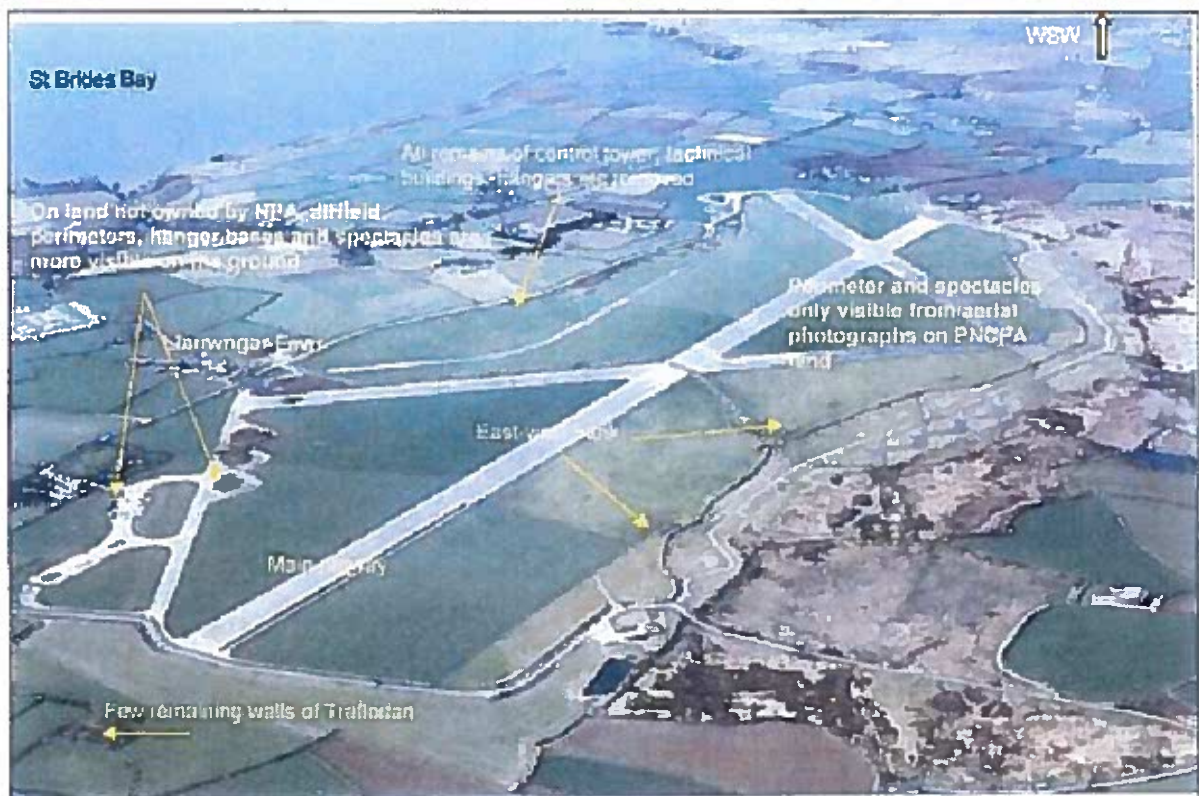
Figure 39 Aerial photograph , 2005, St David's Airfield

On the privately owned farm land to the south-east of the airfield, the full width of the perimeter track and one hangar base are visible. One set of dispersal points have not been intentionally covered in soil but, on the ground, they are difficult to visualise as the plant life spreads from the expansion joints. The differences are well illustrated in the aerial photograph (*Figure 39*).

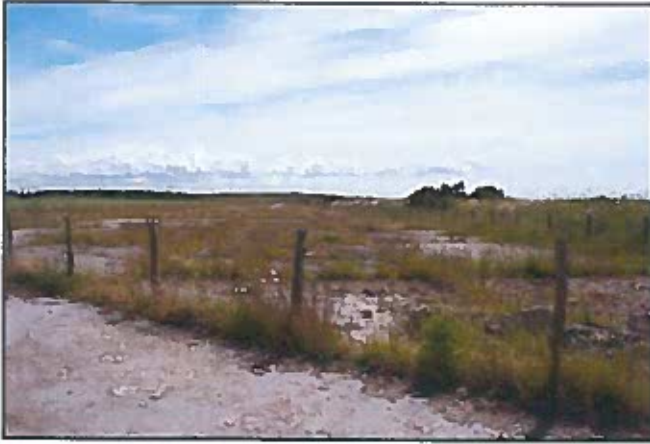
Figure 40 Secondary runway overgrown more overgrown than main runway

The runways remain complete, and are still a very visible statement in the landscape especially as it is not physically possible to see from one end of the runway to the other as the scale is so large. The main runway is noticeably clearer than the subsidiary runways, as a result of it being maintained as a RLG. These runways were constructed in sectional blocks with expansion joints and the surface has inevitably cracked in places. Plant life has taken advantage of these joints and cracks in the concrete and the main runway will eventually and inevitably be more heavily colonised with plant life and take on a different, softer and greener appearance which may lessen its impact. The middle section of the main runway was strengthened in the 1960's by adding an additional surface layer which is a different colour from the original (*Figures 40-42*).

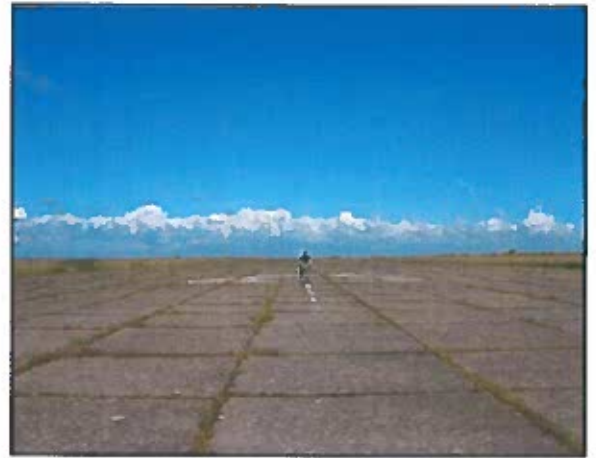
Figure 41 Main runway looking east

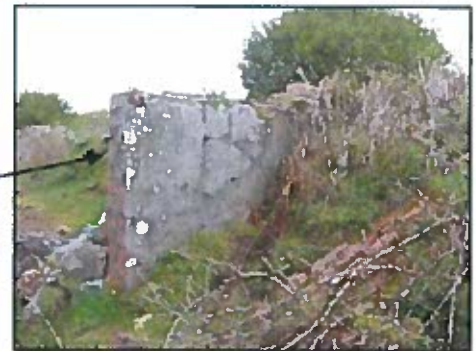
Figure 50 End wall standing

A second short diversion leads to what was the main incendiary and bomb stores. Only a very small fragment of what was once a large area survives as most of it was used as a landfill site by the local council until recently. A rectangular area about 5 metres by 3 metres with broken concrete faced brick walls survive as the shorter ends to high earth and stone banked walls. The high banked walls presumably built as safety features to absorb the impact of any explosion, a metal post is the only other feature now visible. In both bomb stores it is possible to see how the ground was built up, in some places to about 1.5 metres above the moorland (*Figures 49-53*). These bomb stores would have had the shortest period of use, possibly less than 6 months and no evidence exists as what appearance they would have taken.

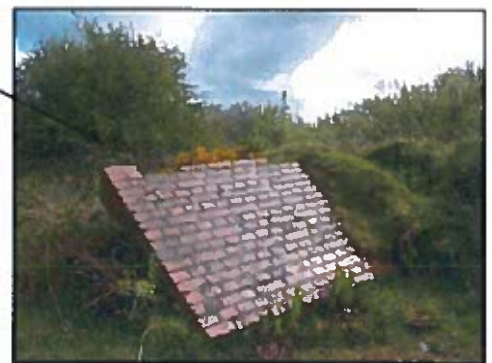
Figure 51 End wall collapsed

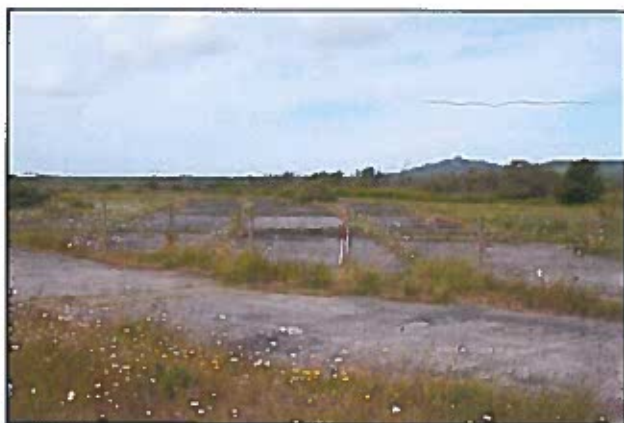
Figure 54 Spectacle Dispersal

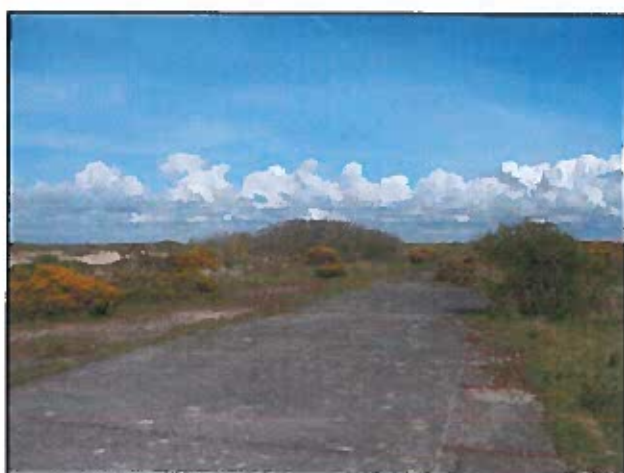
Figure 56 Track to Stores

A third, sectional concrete track is built out across the moorland which leads to the fallen remains of workshops, stores and battery charging rooms. The brick divisions and possible doorways of the various stores are visible in places in the concrete foundations. Here it is possible to see how the buildings and perimeter fencing were demolished by pushing the walls and fencing outwards to fall down over the lower moorland ground (*Figures 56-59*). Random piles of stones add to the confusion of the site, these piles of stones are habitat piles, marked on ecological management maps, created by the ecologists and should not be confused with archaeological ruins.

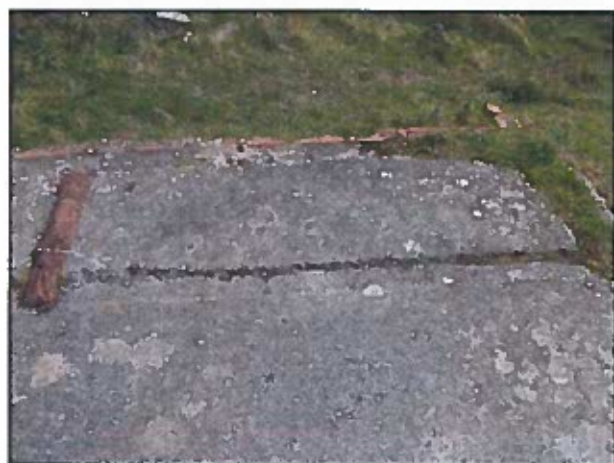
Figure 57 Detail of individual store

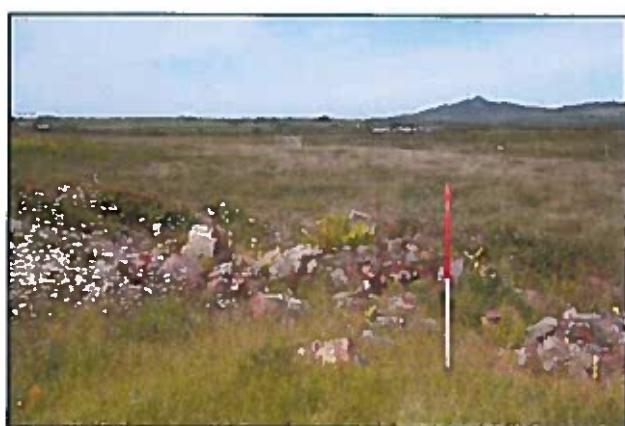
Figure 58 Walls pushed out over moorland
