# Archaeological Watching Brief and Photographic Recording

8 St Mary Street  
Cardigan  
SA43 1HA

February 2008

To meet a condition of Ceredigion County Council  
Planning Application A070533

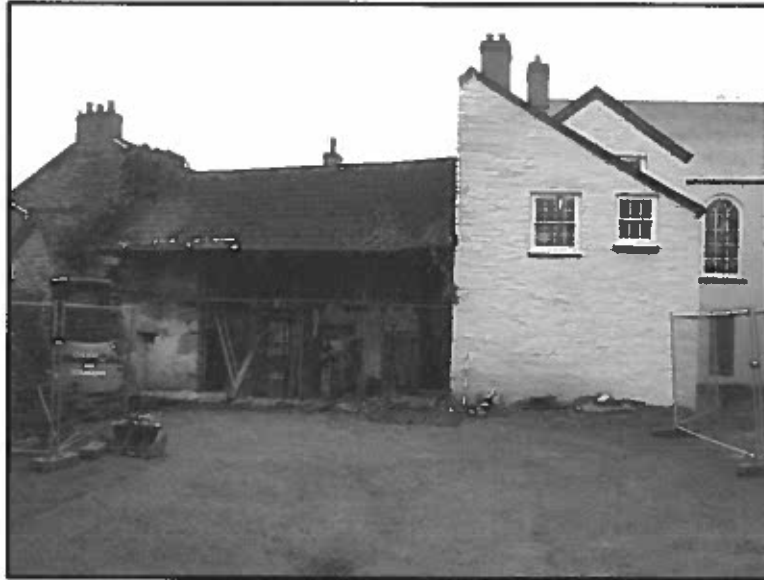
The cottage was tucked behind 8 St Mary Street. On its west side was a tall stone building with a single pitch roof (Figure 3).

Figure 3 View from the north

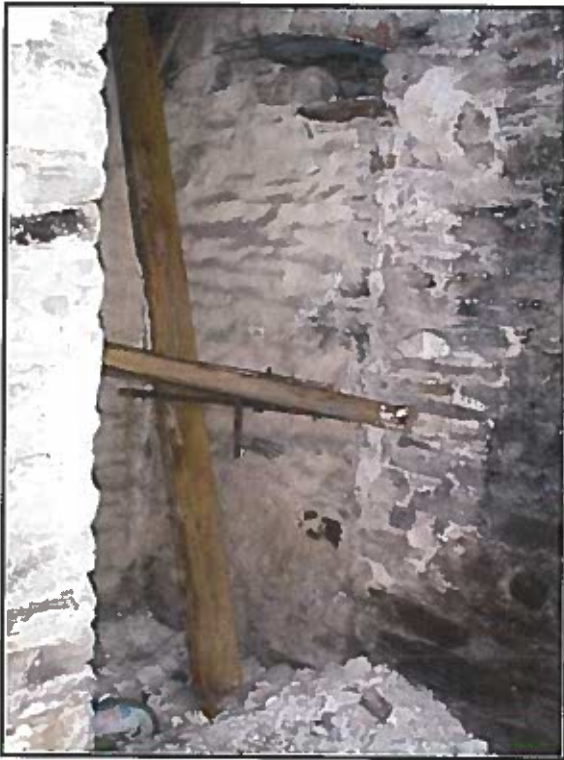
The east wall of the adjoining building forms the west wall of the cottage and a blocked door through the wall suggests there was once a connection between the two (Figure 4). At the east end of the cottage there is an impressive deep fireplace. It has a timber lintel that is slightly bowed and a smaller brick fireplace has been built into the corner. On the outer north side of the fireplace is a small chimney that links into the main flue (Figure 6 & Figure 7).

Figure 4 Blocked doorway in west wall

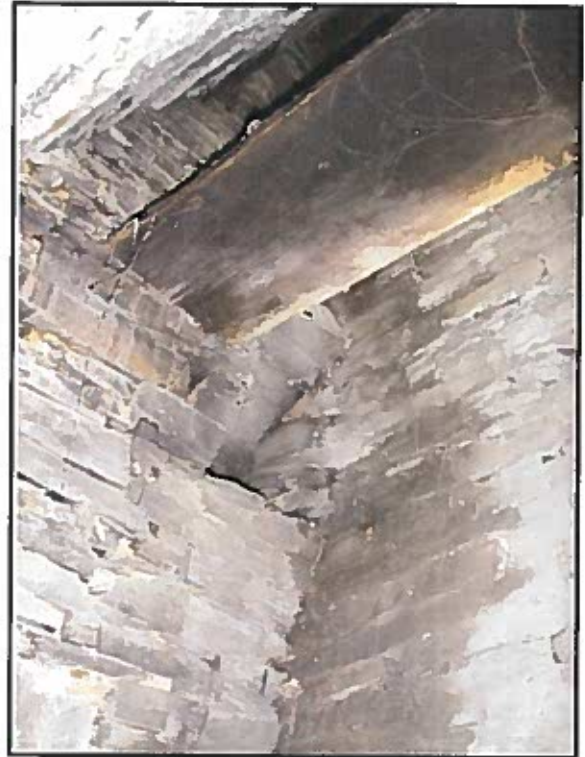
Figure 5 View up main fireplace chimney

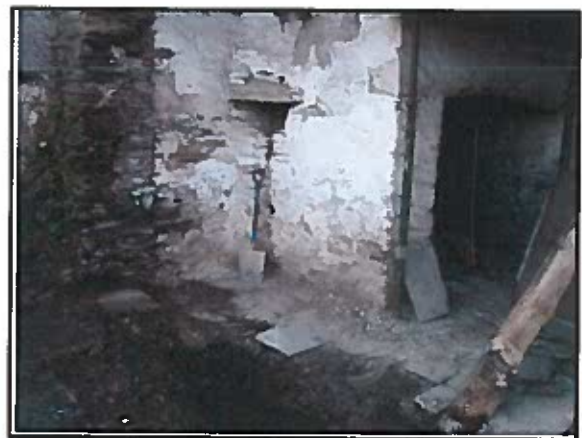
Figure 7 Small chimney on north side of fireplace

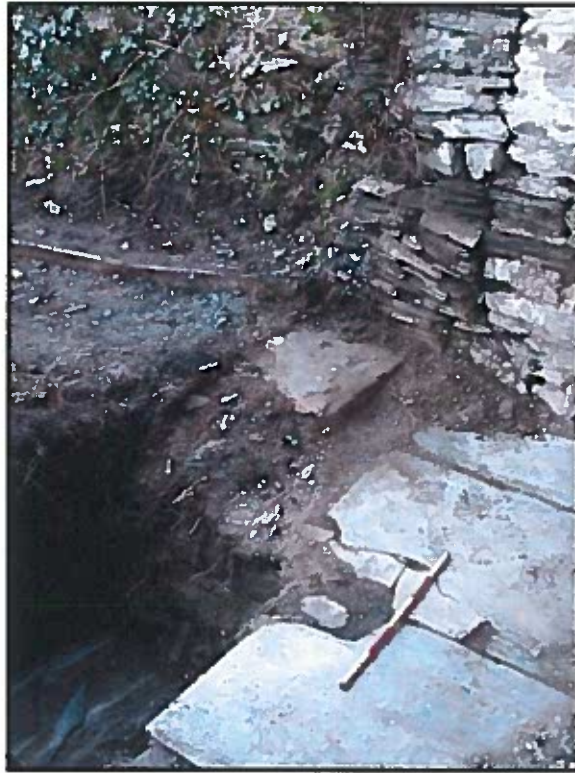
A doorway had opened into the cottage in this north east corner; the threshold stone was still in place with a square insert for the door post (Figure 8). It appeared that the north wall, now demolished, was not keyed into the east wall (Figure 8)

Figure 8 Door post hole and threshold at north east corner  
Note north wall not keyed in to east wall

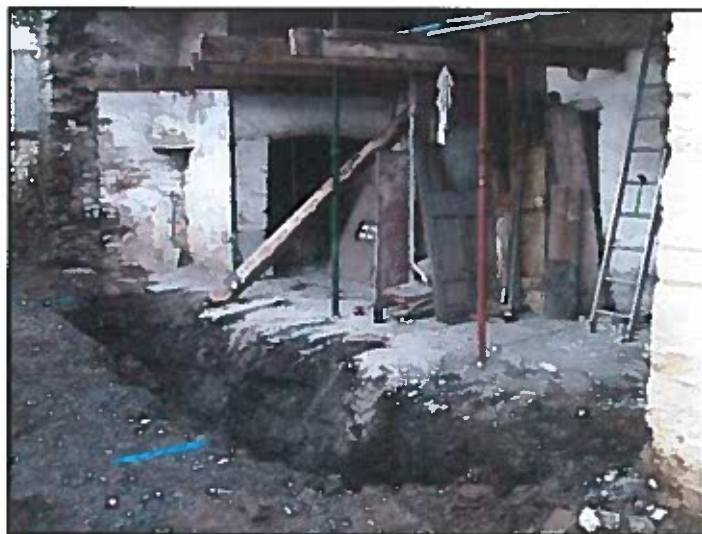
A small extension was to be built on the north side of the cottage in the tarmac area (001). The north wall of the building had been removed completely to ground level and the roof propped (Figure 9).

A trench (Trench 1) was dug by machine to a length of 6.4m along the line of the demolished wall leaving 1m at each end (Figure 9).

Figure 9 Trench along north wall

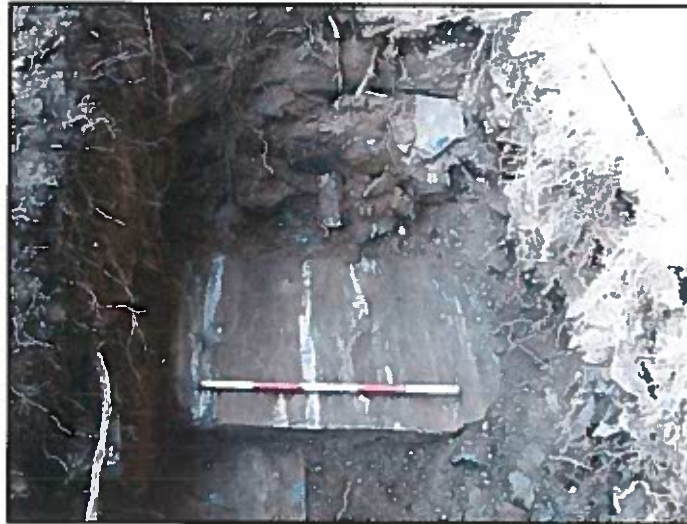
The foundations of the demolished wall (004) extended to a depth of at least 1.10m below the level of the internal slate floor (003). A very large slab of slate was encountered at a depth of 600mm at the east end (Figure 10).

Figure 10 Large slate slab at east end of Trench 1 (500mm scale)

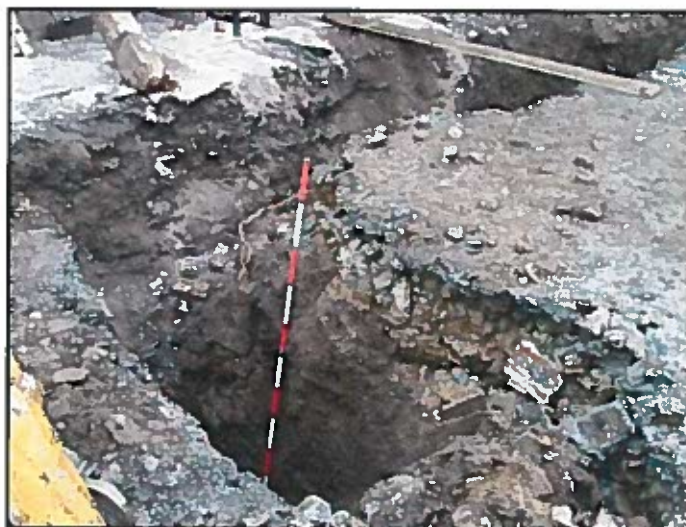
At the east end of Trench 1 a second trench was dug at right angles to it and parallel with the boundary retaining wall. Trench 2 revealed the ground to the west consisted of loose material (006), including slate and bricks, to a depth of over 1.75m (Figure 11). The remaining ground between Trench 2 and the boundary wall appeared to be clean. As a result the whole area of the extension was reduced by 40cm to investigate the ground conditions. This exposed a series of walls (Figure 15).

Figure 11 Trench 2 viewed from east (2m scale)

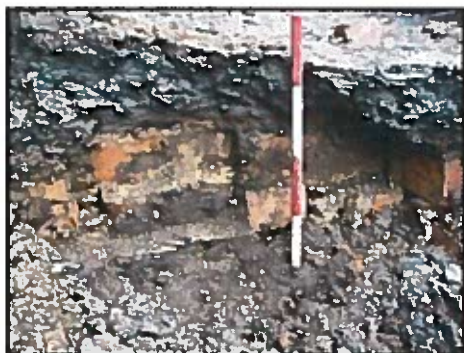
Figure 12 Bricks in situ below tarmac

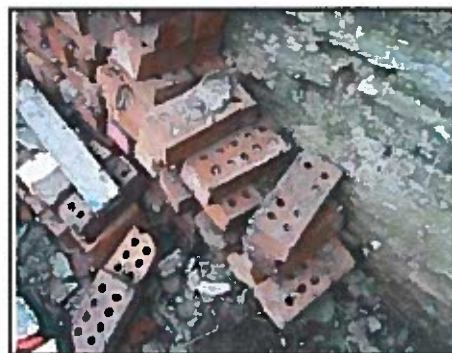
Figure 13 Bricks after removal

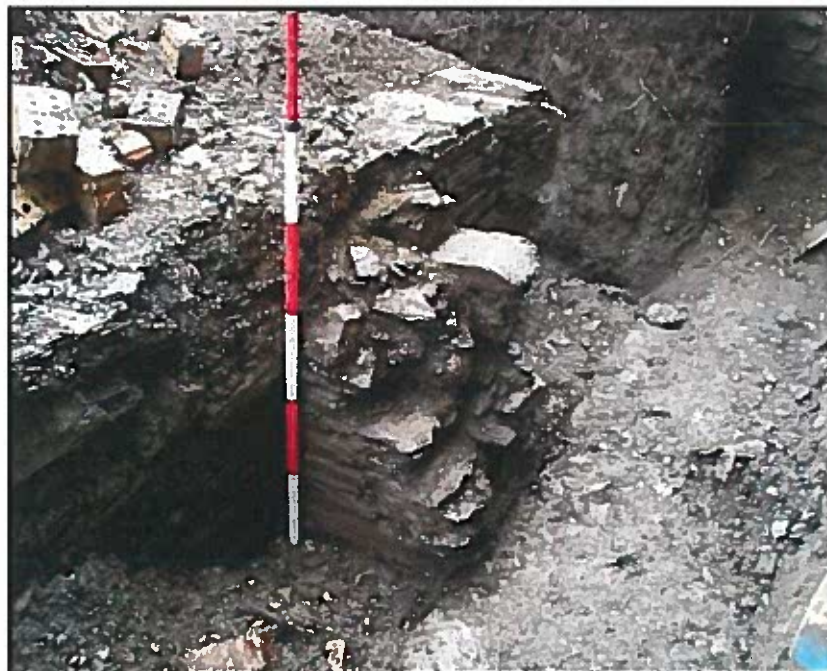
Running parallel to Trench 1 and only 460mm from the demolished north wall of the cottage were the remains of another stone wall (013, Figure 14). This extended to a depth exceeding

1.22m and was constructed of poor quality slate. There was no clear termination of this wall in the east end of Trench 1 and it did not appear in Trench 2. Between the foundations of the demolished north wall and the remains of wall 013 were two remnant walls and buttresses. (014 and 029, Figure 36)

Figure 14 Wall 013 and remains of 014 butting against the foundations of the demolished north wall of the cottage (600mm scale)

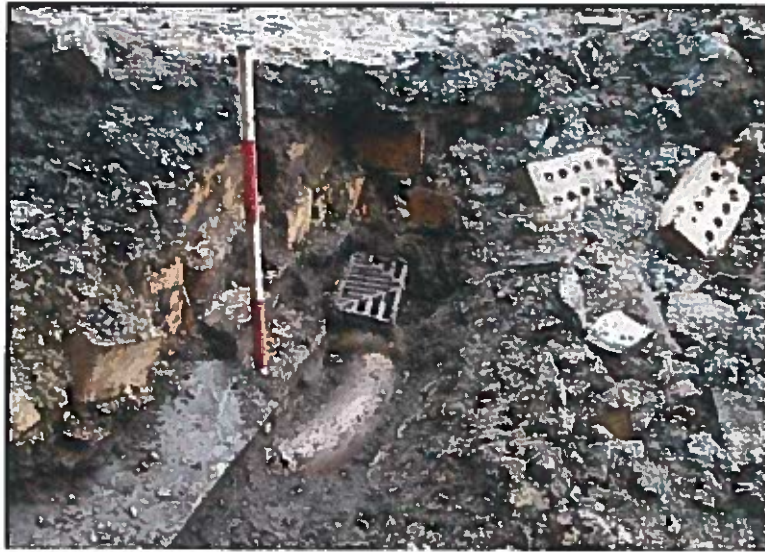
At the west end, the removal of the bricks (015) revealed a small iron grating (017) and associated salt glazed drain pipe (019 Figure 16). The drain (019) extended from below the iron grating and past under the stone slab (018) and appeared to have emptied into a stone chamber (023) at the corner of the adjacent occupied building (Figure 17)

Figure 16 Small iron grating 017 below bricks 015

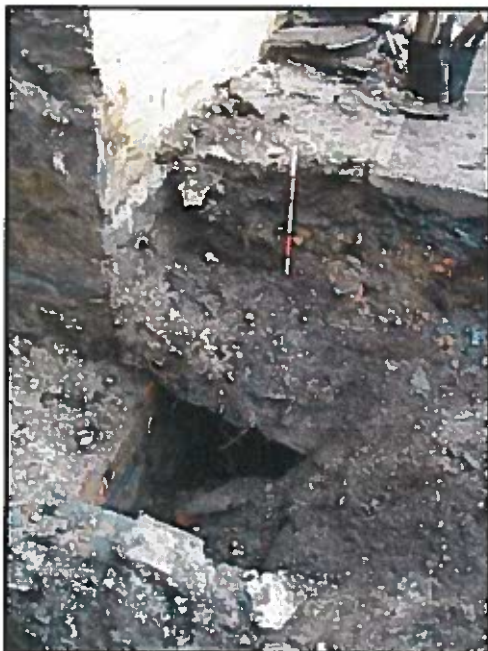
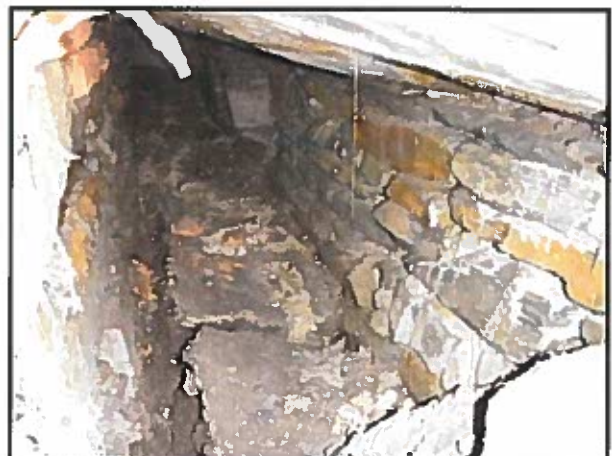
A second ceramic drain (020) was found close to the west end of Trench 1. This started between two bricks (021a/b) and extended in three sections of pipe through a brick wall (008), turned to the west, crossed over a stone wall (022), and into the stone chamber (023 Figure 17 & Figure 18)

The chamber (023) into which the ceramic drains 020 and 019 would have emptied measured 470mm x 480mm and was situated on the corner of the adjacent building. Running along the north wall of this building was a stone lined and covered channel culminating at the chamber (Figure 17). The west side of wall 022 had been utilised as the east wall of the chamber (023).

Figure 17 Chamber (023) and associated stone covered channel (025)  
(500mm scale)

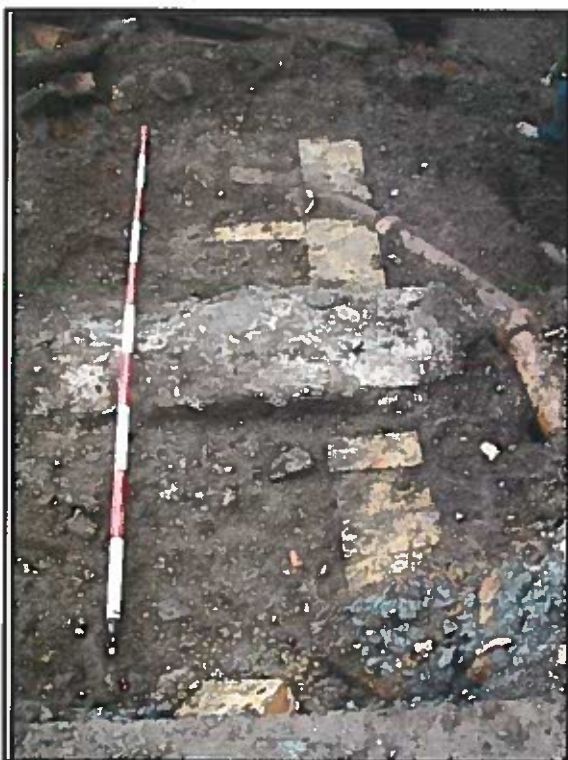
The second ceramic drain (020) had passed through a brick wall (008) that had been built on top of the stone wall 013 - but only at its west end (Figure 18). The extent of the surviving brick wall was 930mm from the east side of wall 022 and only a single brick depth remained. If the east arm of wall 024 had formed the north wall it would have created a small space 930mm x 910mm. Given the presence of the two drains in this space perhaps this had been a washroom or toilet. Any floor surface that may have covered the floor of this room had not survived. There was nothing to indicate an east wall - only the extent of the surviving brick wall 008.

Figure 18 Ceramic drain 020 viewed from west (2m scale)

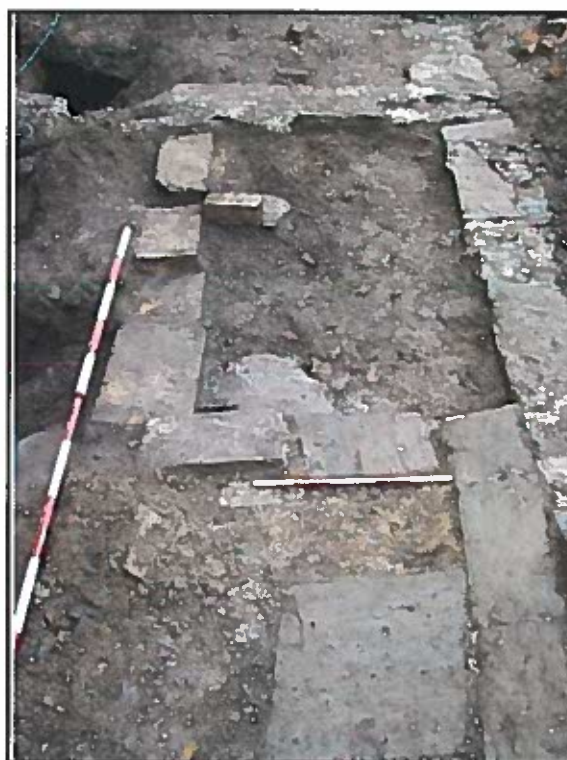
Figure 19 Viewed from east the same space with bricks and drains removed

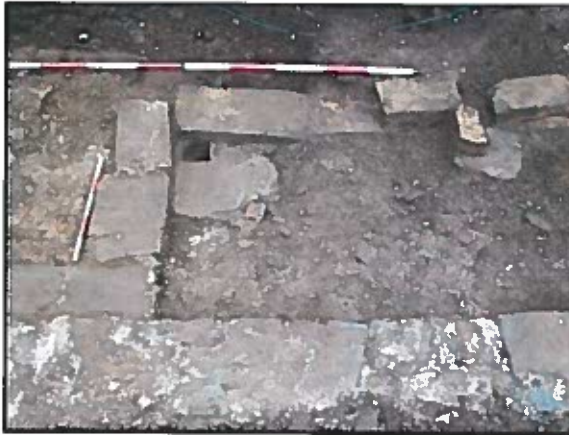
However, further investigation revealed a stone wall (026), running north/south in line with the nub end of truncated wall (029) on the south side of 013. This created a space 1.91m x 1.82m (Figure 19). In the east wall of this 'room' was a possible threshold (034) marked by three stones set across the line of the wall. Wedged in the south east corner of this 'room' a flat stone (027) had survived with a square hole, 100mm x 100mm cut into it (Figure 20 and Figure 21). The depth of this hole was investigated but it was found to contain an indeterminate depth of soft earth with no apparent sides to it. Its function was not

confirmed and it may have been a drain predating 019 and 020 or perhaps a hole to support an upright post.

Figure 20 Stone with square hole (027) 2m and 500mm scales

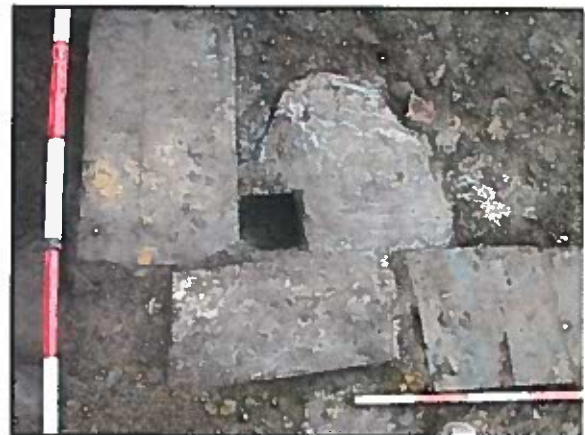
Figure 21 Stone with square hole 027 and possible threshold in lower right

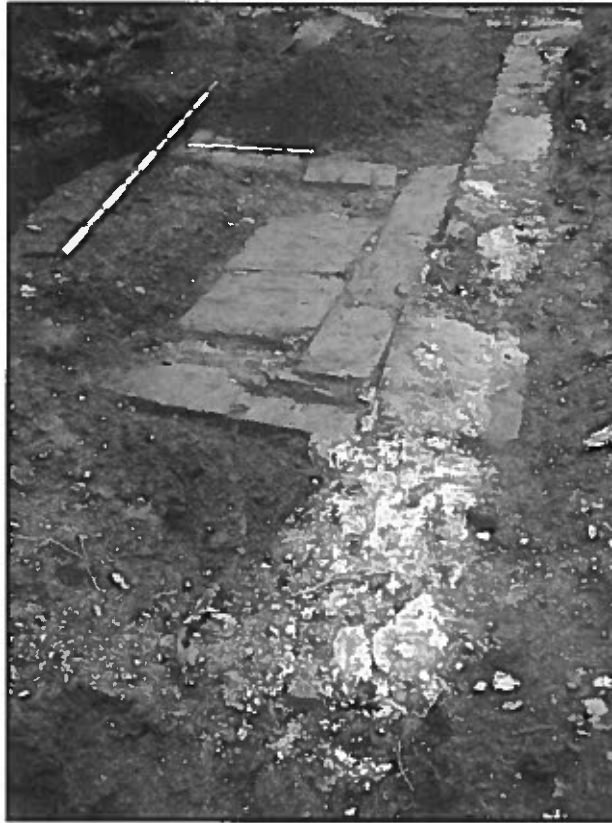
This central section had a surviving stone flagged floor (031) covering its northern half. These flags were bedded in bright orange clay (035 Figure 22). The southern half had no surviving floor surface and contained an homogenous mound (033) of slate and clay. The wall on the east side of this space appeared to be associated with the remnant wall (014). Both walls 027 and 032 were only 240mm wide and were constructed of narrow stones rather than the fragile slate used in the wall 013. Wall 024 formed the north wall of this space. On its exposed upper surface there was a distinct deposit of white lime mortar (029) that continued to the east end of the cleared area. The presence of this mortar suggests there was a structure of a later date using the wall 024 as a foundation - perhaps the porch shown in the survey (Figure 37 and paragraph 3.2).

Figure 22 Stone flagged floor (031) covering northern half of Area 2

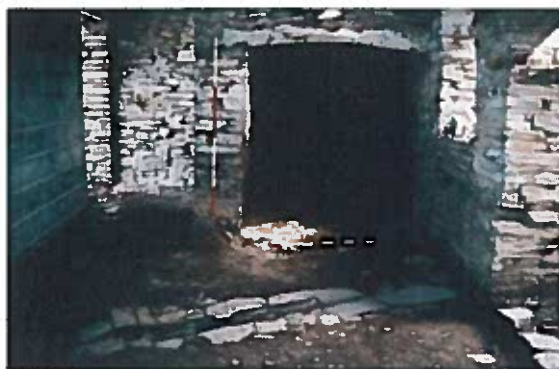
Figure 23 The hearth looking east. 1m scale

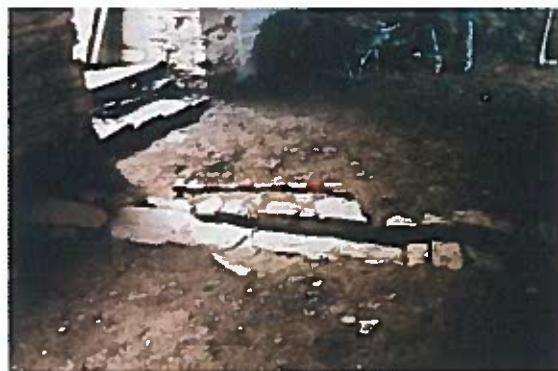
From a hole (037) in the south wall a stone lined gully (038) crossed the floor at an angle, south east to north-west, to the north wall (Figure 23). The gully had been carefully constructed with flat slates bedded in yellow clay as a base and edging slates to create a channel 200mm wide. Where it entered the building through the 150mm high x 100mm wide hole (037) the channel was 200mm higher than where it met the north wall (Figure 26). In its original condition slates had probably covered the gully and one remained at the north end (039). The gully contained the same material as was removed from the floor 005.

Figure 24 Threshold and gully looking west. 1m scale

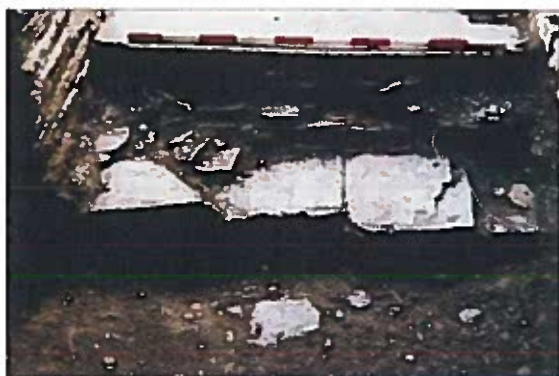
Below the threshold (040) of the door in the south wall there were layers of slates that suggested the floor level in the cottage had been lower at one time, presumably level with the slates that covered the gully.

Figure 25 South door threshold. 1m scale

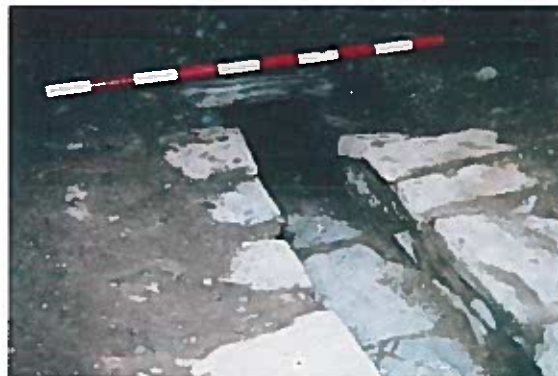
Figure 26 North end of gully with slab cover. 1m scale

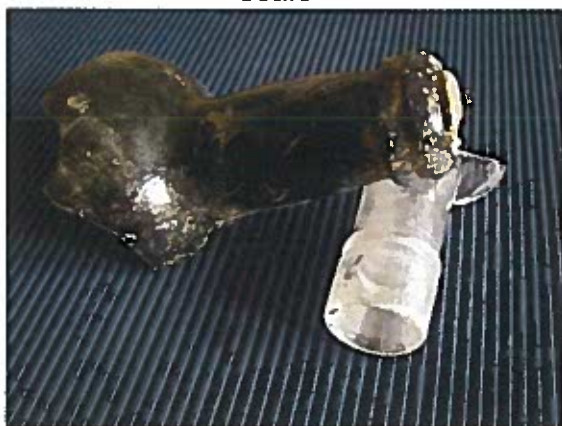
Figure 27 Finds from trench 1 with cork insitu

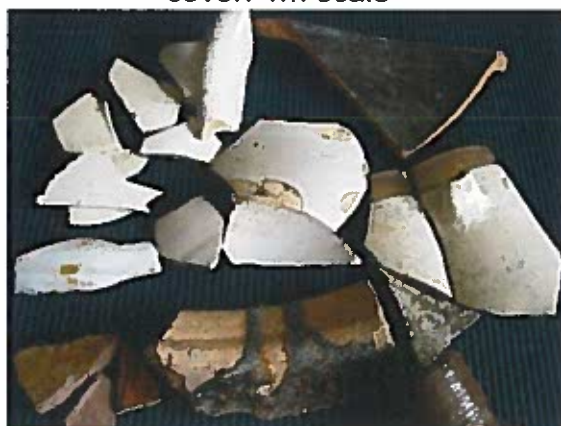
Figure 28 Finds from cottage floor 005

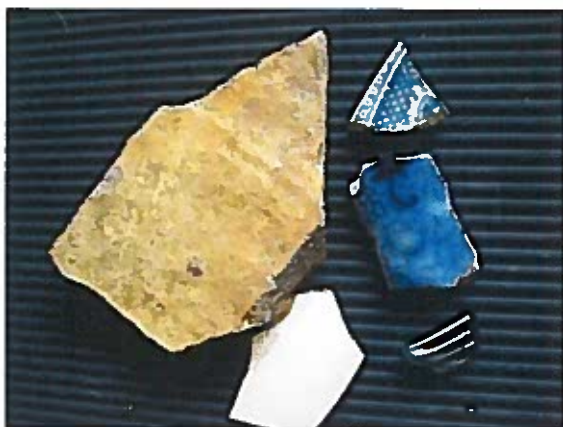
Figure 29 Fill of gully 038

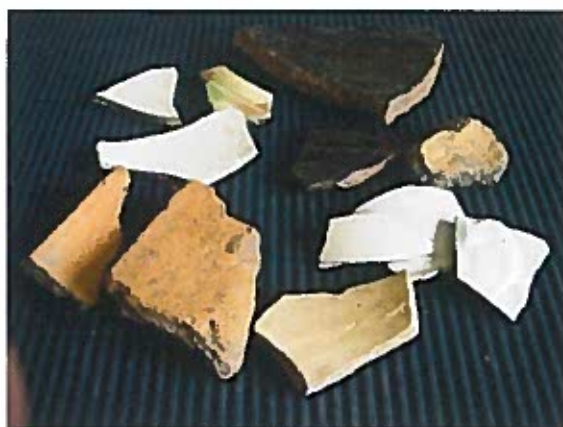
Figure 30 Pot from 028 in Area 2

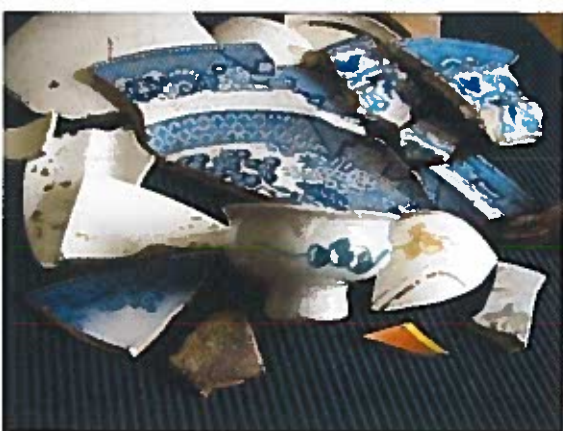
Figure 31 Finds from trench 2

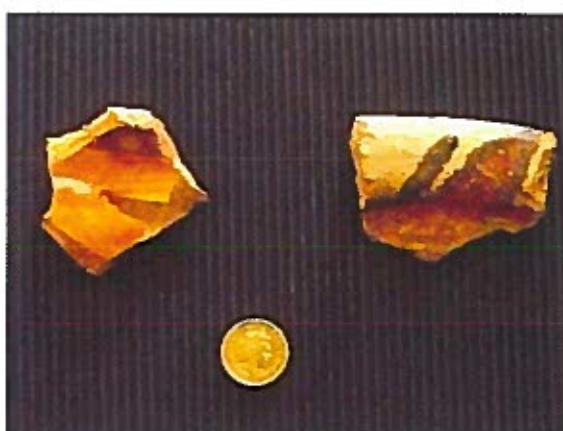
Figure 32 Slipware and pantheon from 016 in Area 1
