Blaenpant, Cwmbach, Carmarthenshire Historic Environment Appraisal

Trysor Project No. 2013/344

For: Richard Adams Associates

December 2013

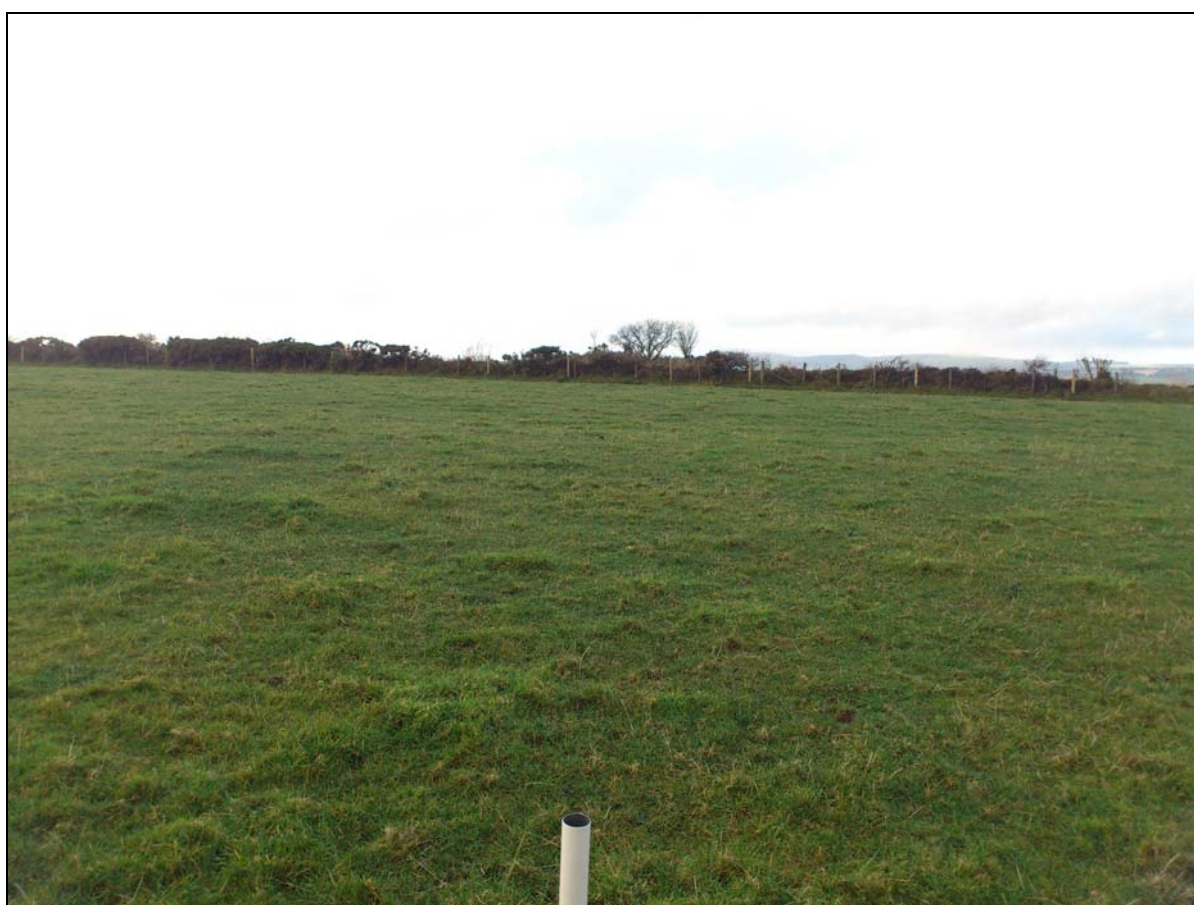
Cover photograph: From the approximate location of the proposed turbine, looking west towards Crug Elwin round barrow on the other side of the boundary.

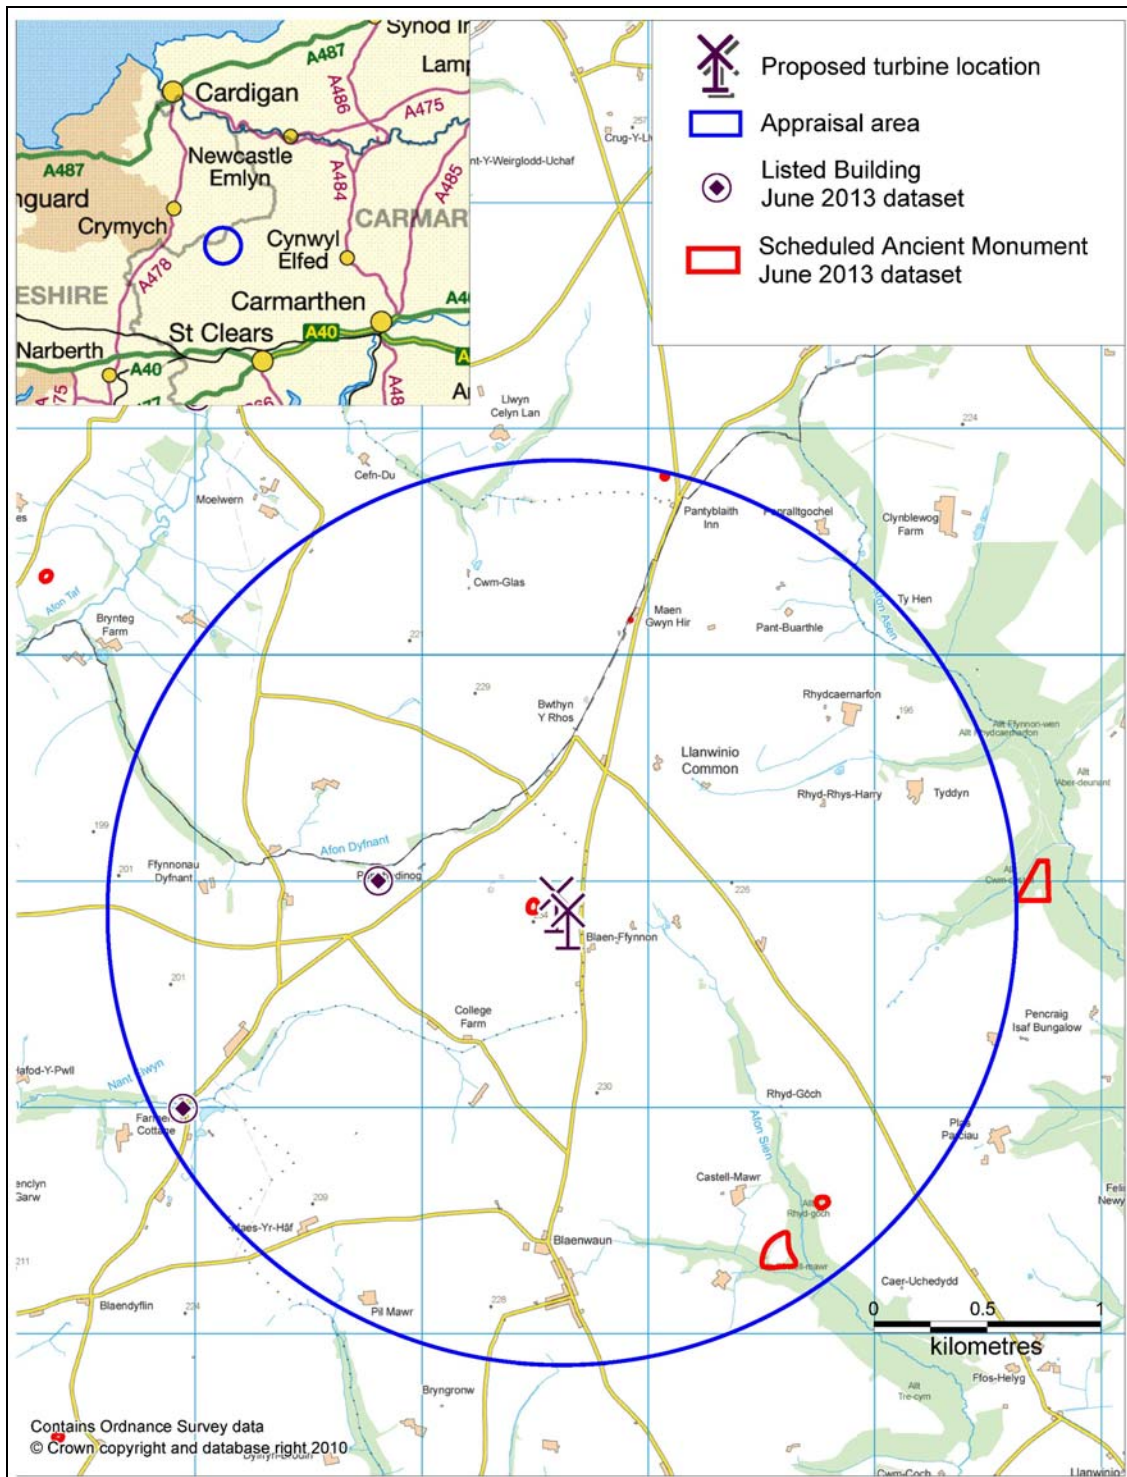
Figure 1: Location of the proposed turbine, showing the 2km radius appraisal area.

4.1 It is proposed that two turbines, standing to 34.5 m to the upright blade tip, will be located in a single field parcel at SN2359528890 and SN2364528815 on land north of Blaenpant, Cwmbach, Whitland, Carmarthenshire, SA34 0DU, see Figure 1.

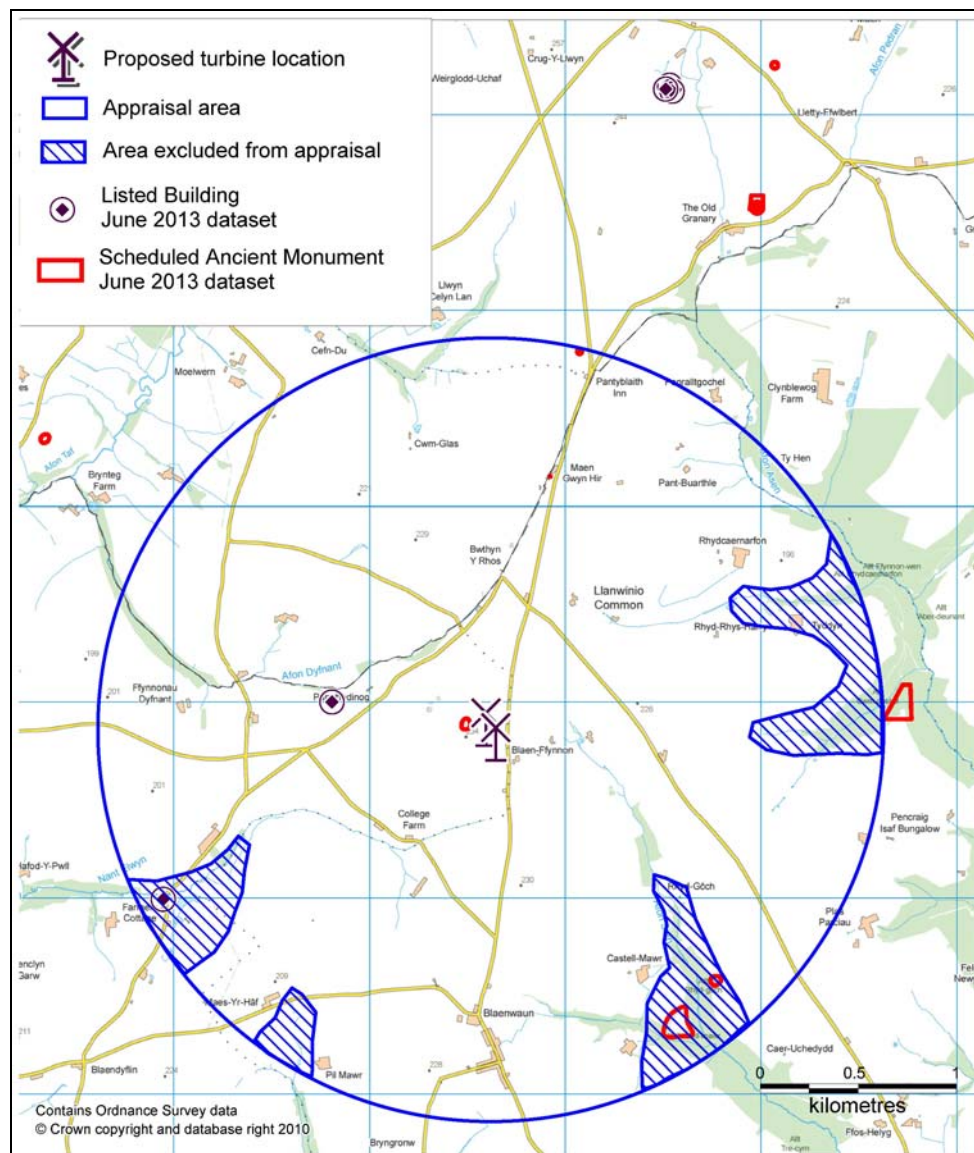
Figure 2: Showing the area excluded from the appraisal area as there would be no intervisibility with the proposed turbine.

5.1 A study area of 2km radius circle centred on SN2362028860, the location of the proposed turbine, was chosen for the initial appraisal of sites. This area was revised to exclude four areas within river valleys where there was no intervisibility or possibility of impact on setting of historic assets, see Figure 2.

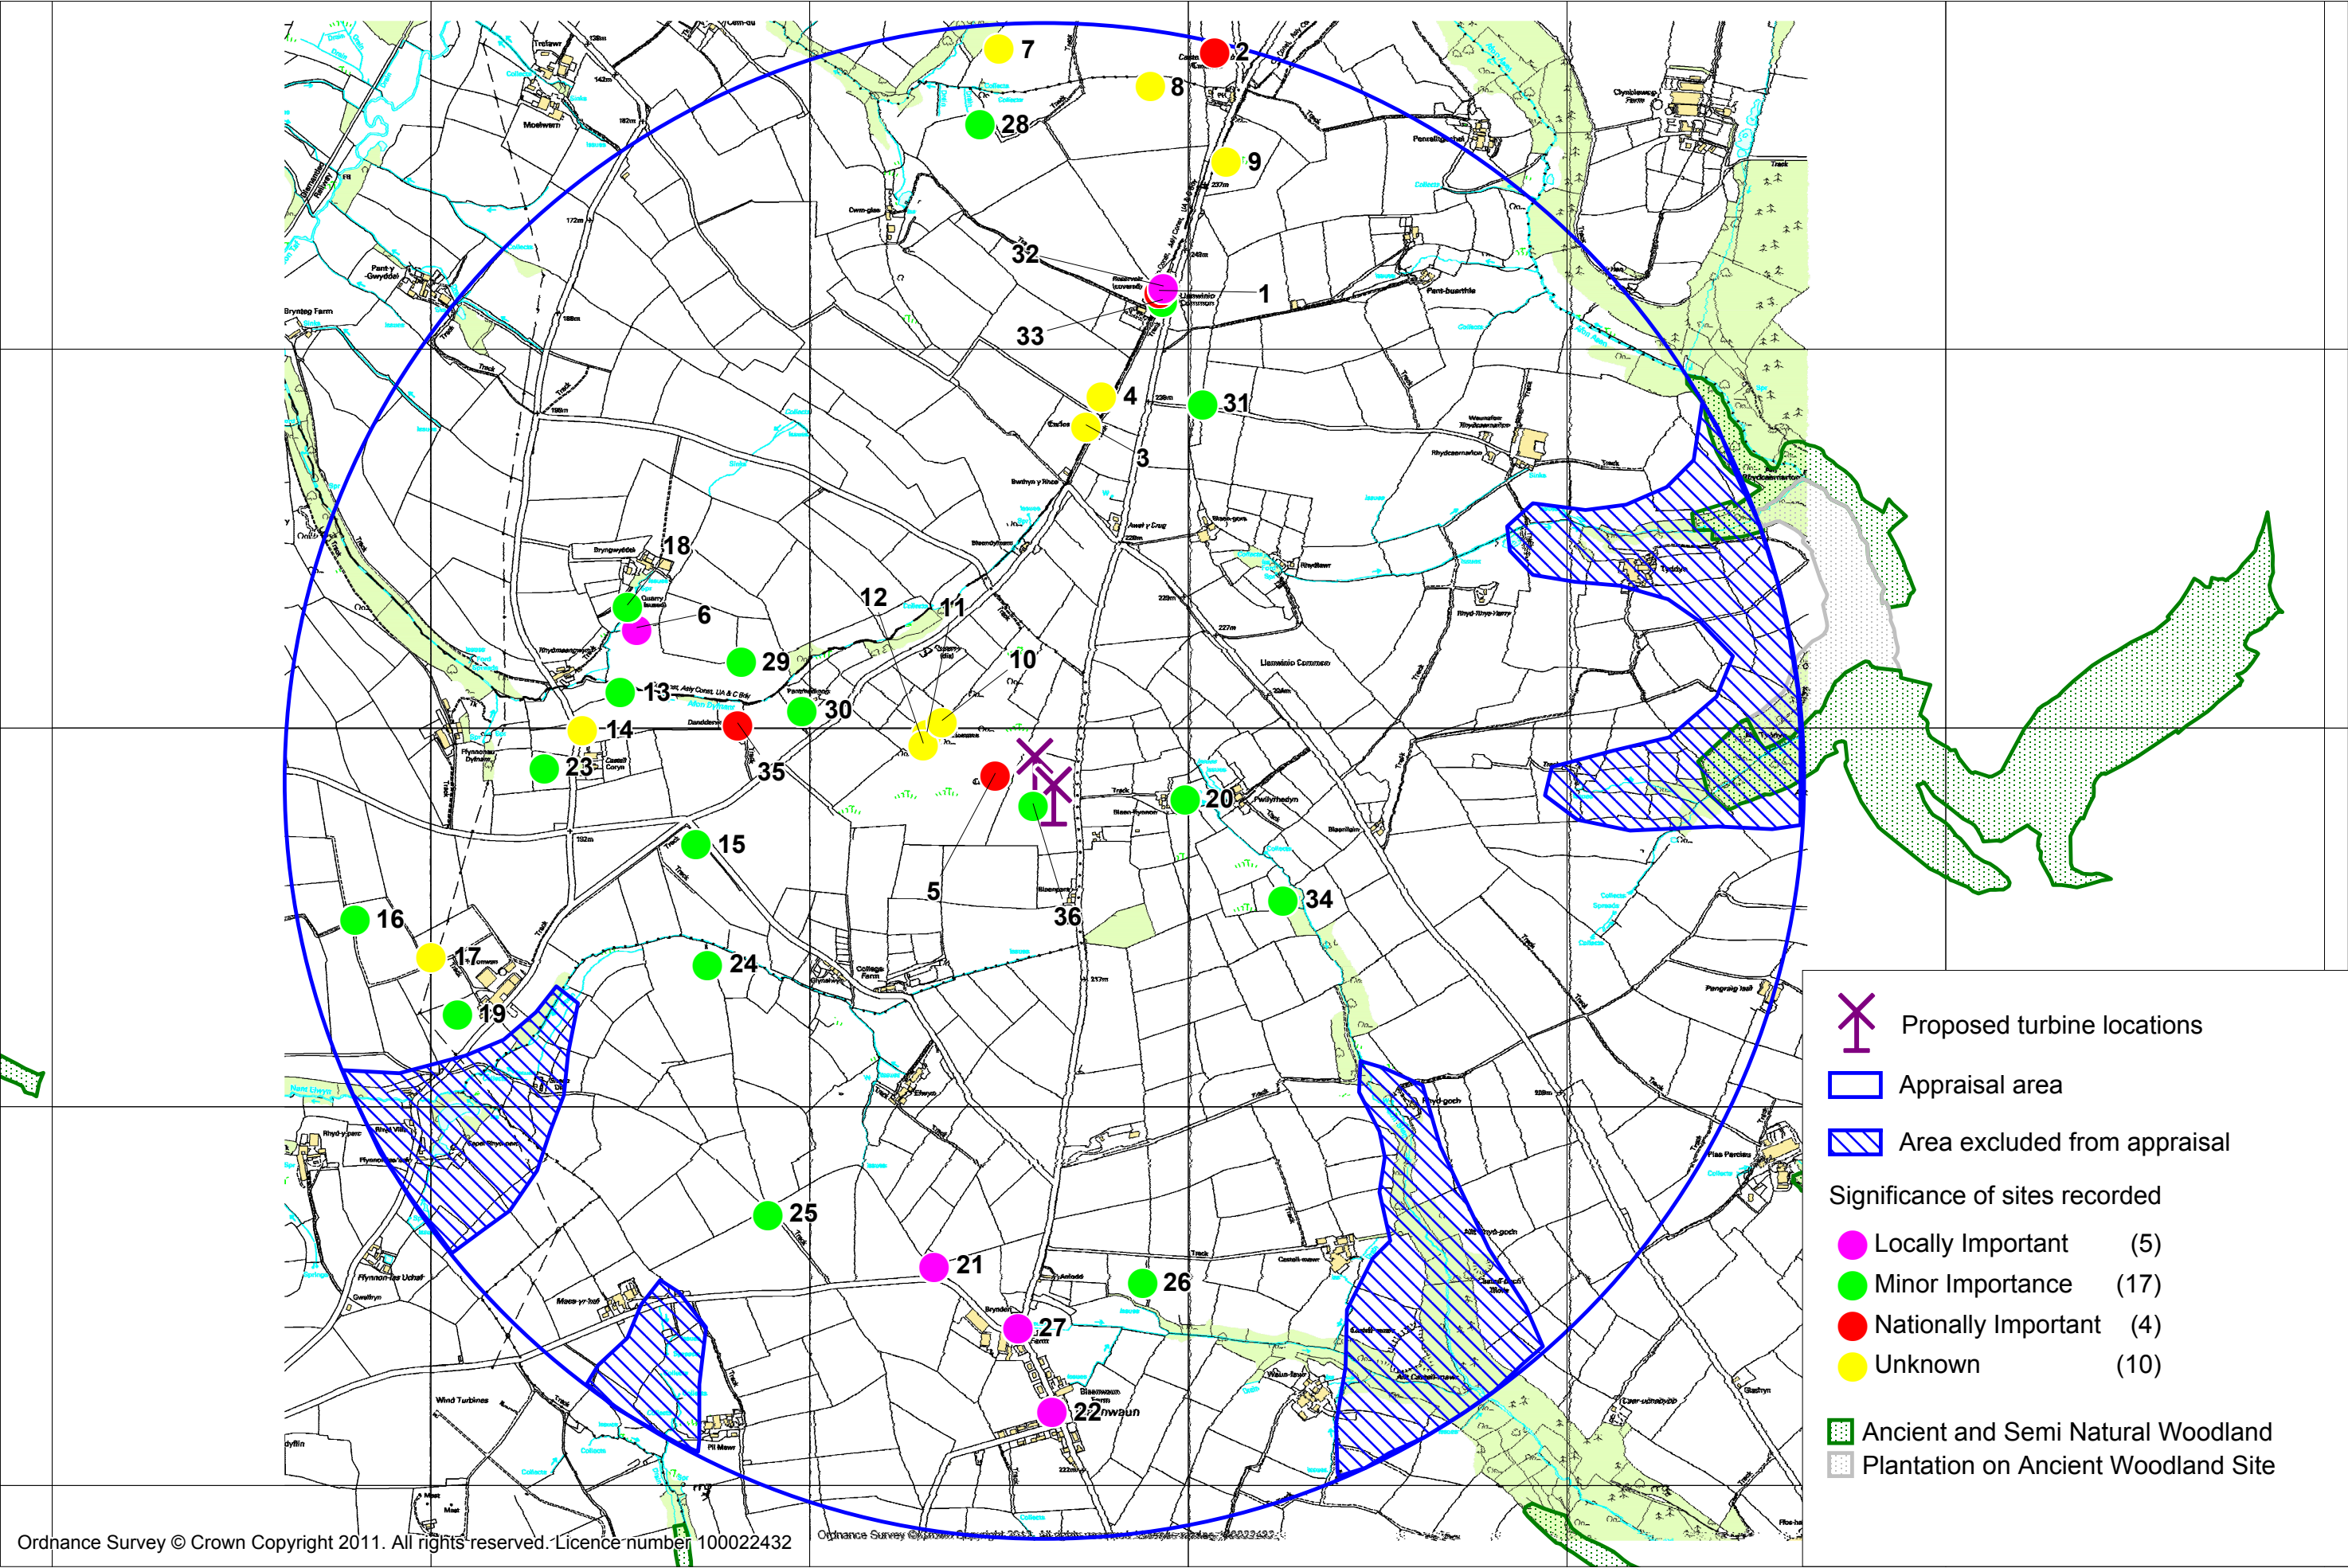
Figure 3: The 2km appraisal area showing significance of sites, labelled with Project ID number

5.9 Each of the records in the final appraisal dataset was assessed for Period, Rarity, Documentation, Group Value¹, as well as Evidential Value, Historical Value, Aesthetic Value, Communal Value². Once these had been considered the significance of each site was determined and scored in accordance with the categories adopted by the Welsh Archaeological Trusts i.e. Nationally Important, Regionally Important, Locally Important, Minor and Features Needing Further Investigation (Unknown), see Figure 3. Full details of this exercise are given in Appendix C.

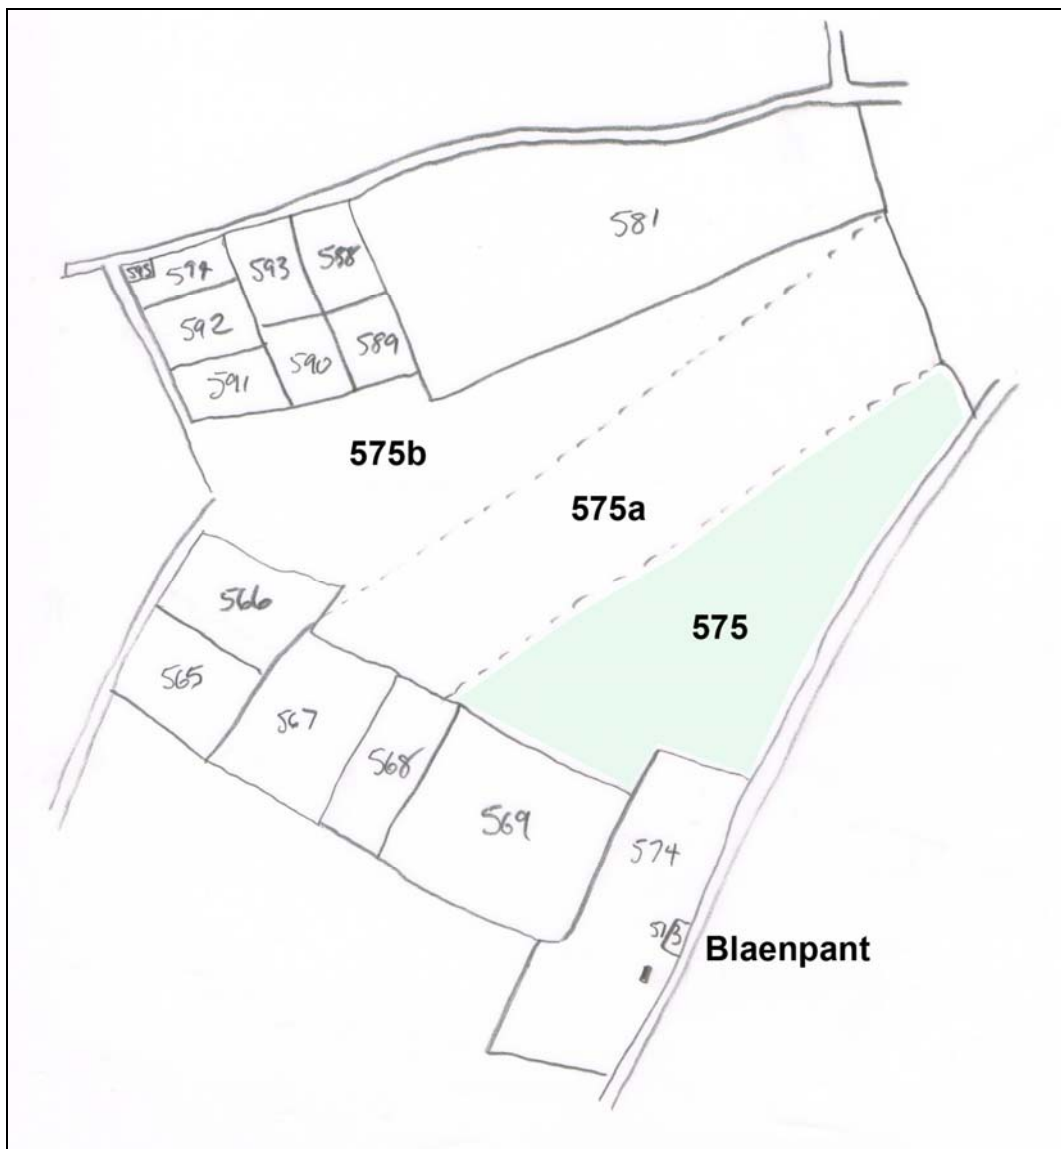
6.2 On tithe survey of 1843, the land was still probably unenclosed and divisions are shown by dashed lines rather than solid ones, see Figure 4. The proposed turbines would stand in land parcel 575, *Part of Rhos Elwin*, which at the time was owned by John Beynon and occupied by John Thomas of Blaenpant. Crugelwin round barrow (ID number 5) was in land parcel 575a, also *Part of Rhos Elwin*, was owned and tenanted by James Phillips of Llain.

Figure 4: Land parcels 575, 575a and 575b were part of Rhos Elwin, southern part of Llanwinio Common on the chapelry of Eglywsfair a Churig tithe map, part of Henllan Amgoed parish, 1843. Parcel 575 is where the turbines would be located, Crugelwin round barrow (ID number 5) stands in what was parcel 575a and the possible pond barrows (ID numbers 10, 11 and 12) on the boundary between 575b and 581.

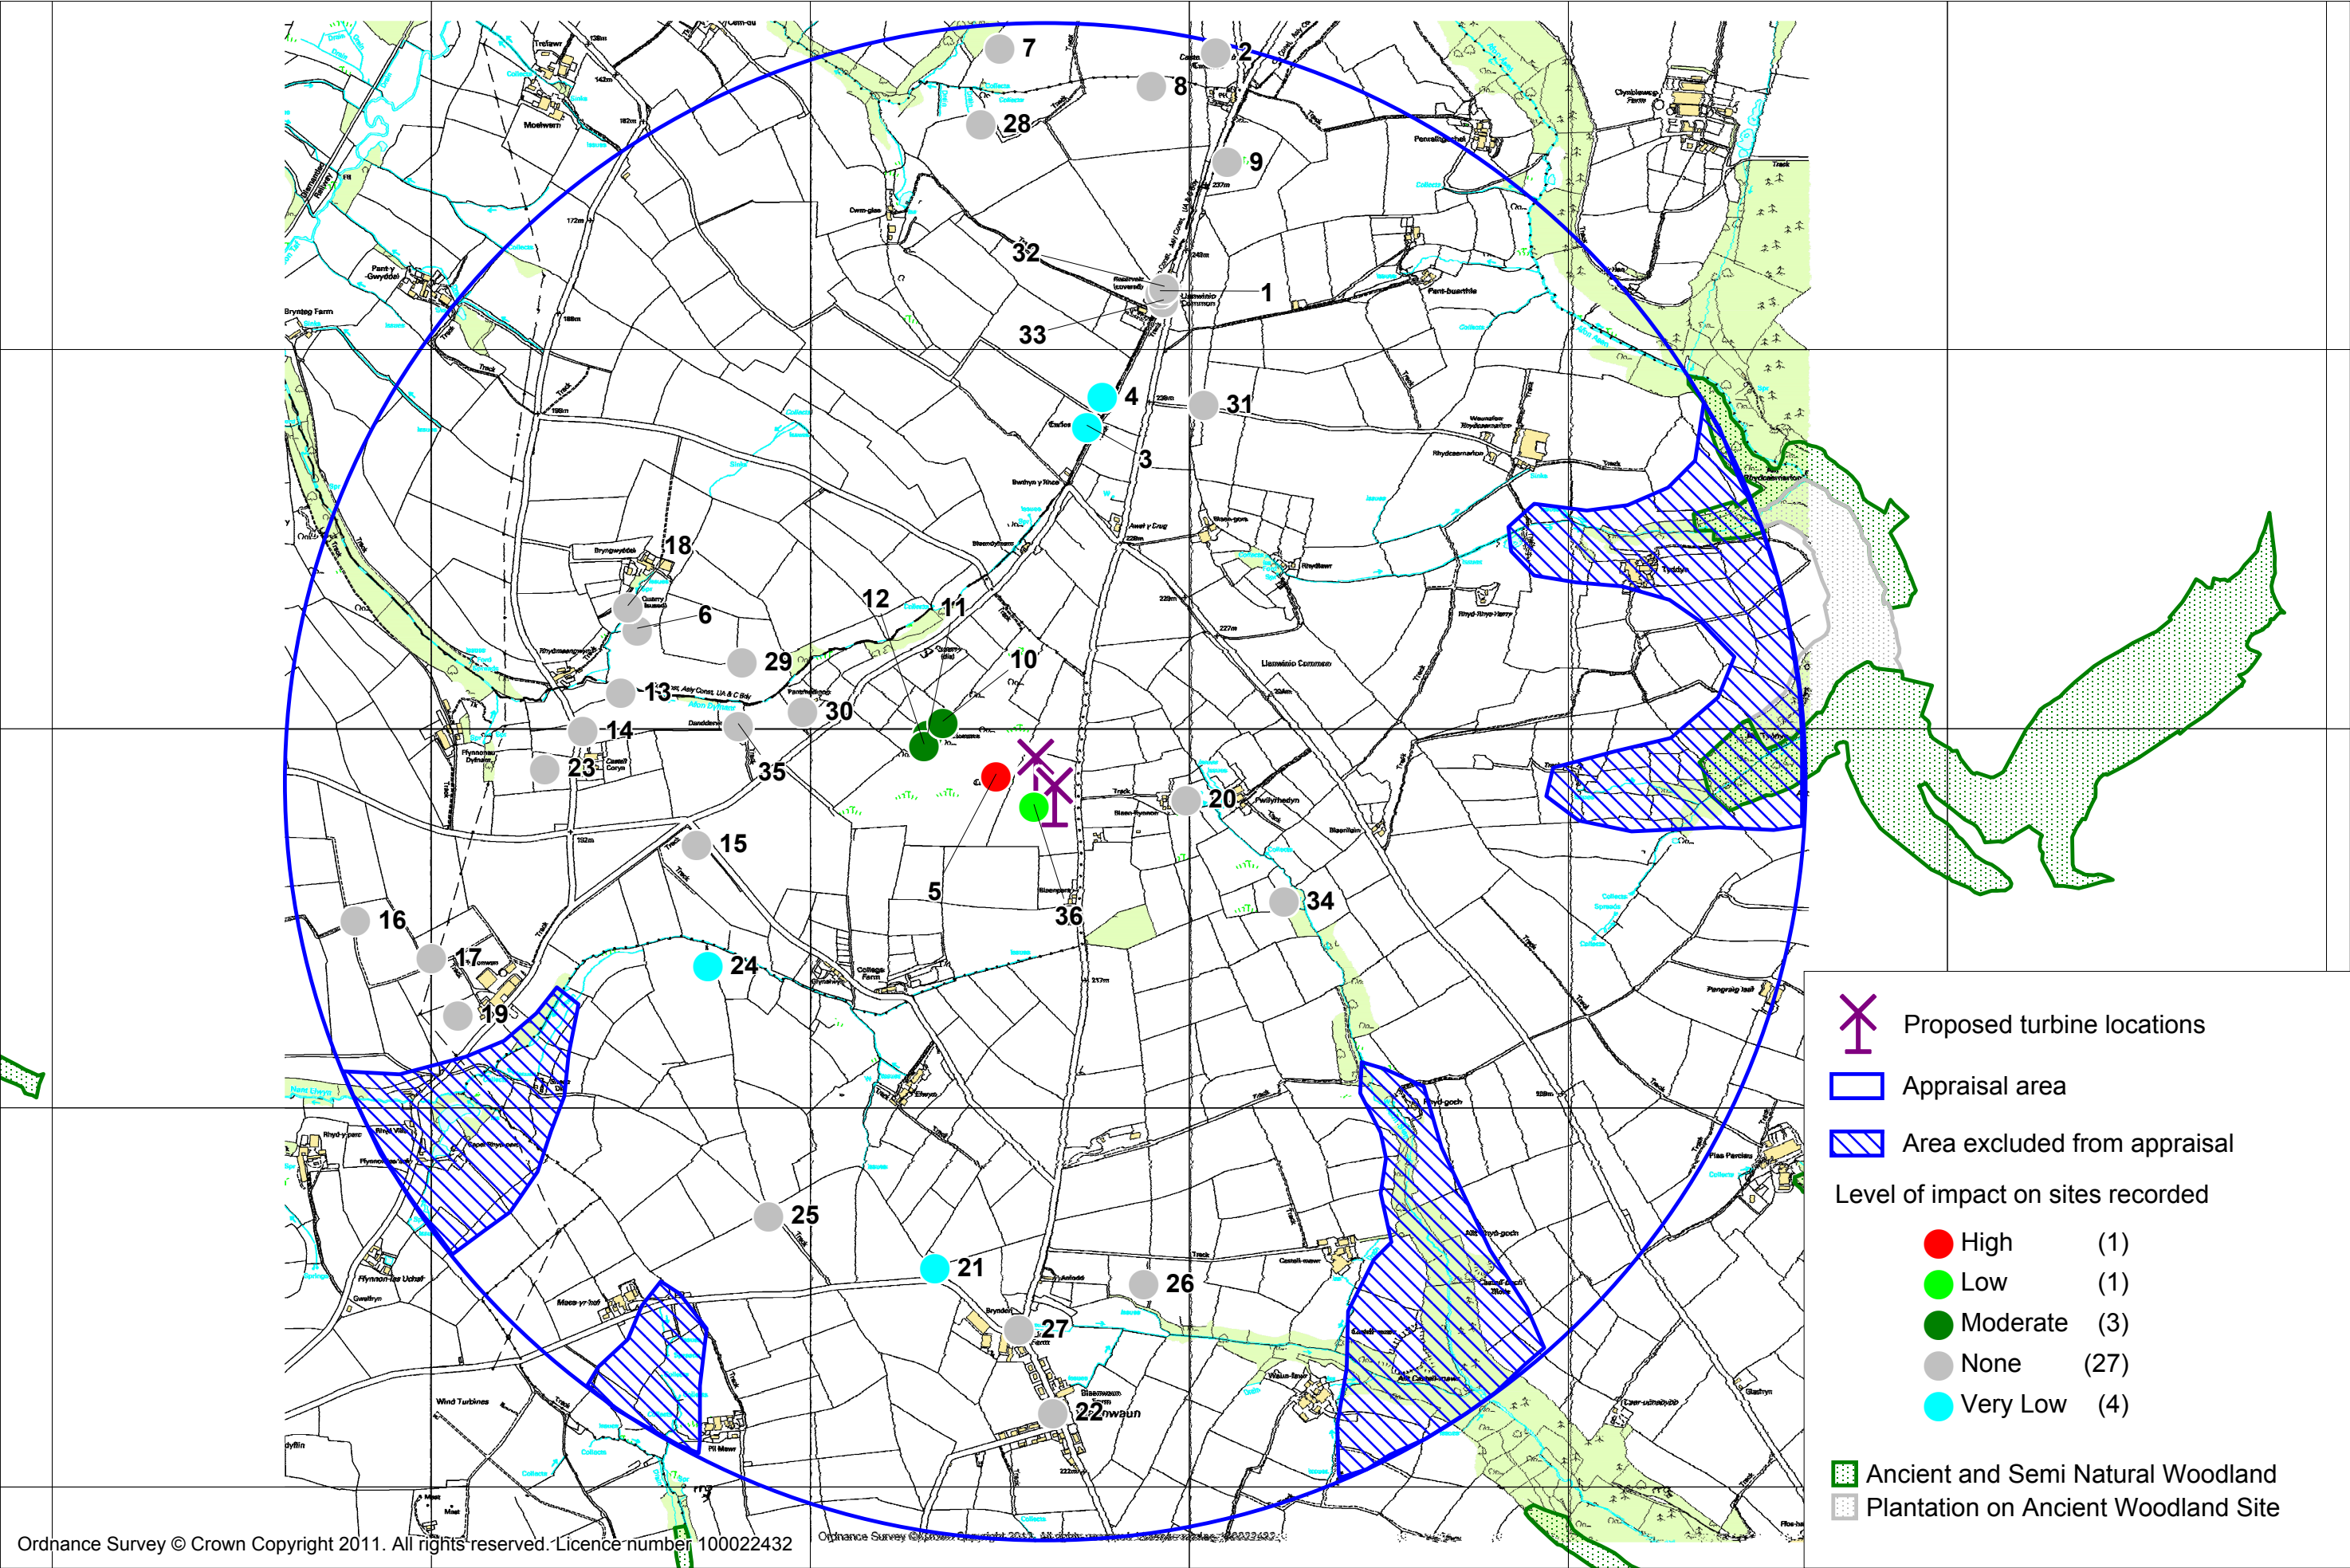
Figure 5: The 2km appraisal area showing the level of impact on sites, labelled with Project ID number

8.2 The Direct and Indirect impact on each site was assessed taking into account both physical and non-physical impacts. Each impact was assessed within the scale Very Low, Low, Moderate, High and Very High, taken into account the significance of the site and the nature of the impact. A full table is found in Appendix A but a summary is tabulated in Table 1 below and illustrated in Figure 5.

8.4 One historic asset, the Scheduled Ancient Monument of Crugelwin round barrow (ID number 5) was determined to be exposed to a High, indirect, visual impact from the proposed turbine development.

8.4 A further three historic assets were determined to be exposed to a moderate visual indirect impact (ID numbers 10, 11 & 12). (Details of the appraisal for direct and indirect impact for each of the sites in Table 1 can be found in Appendix A).

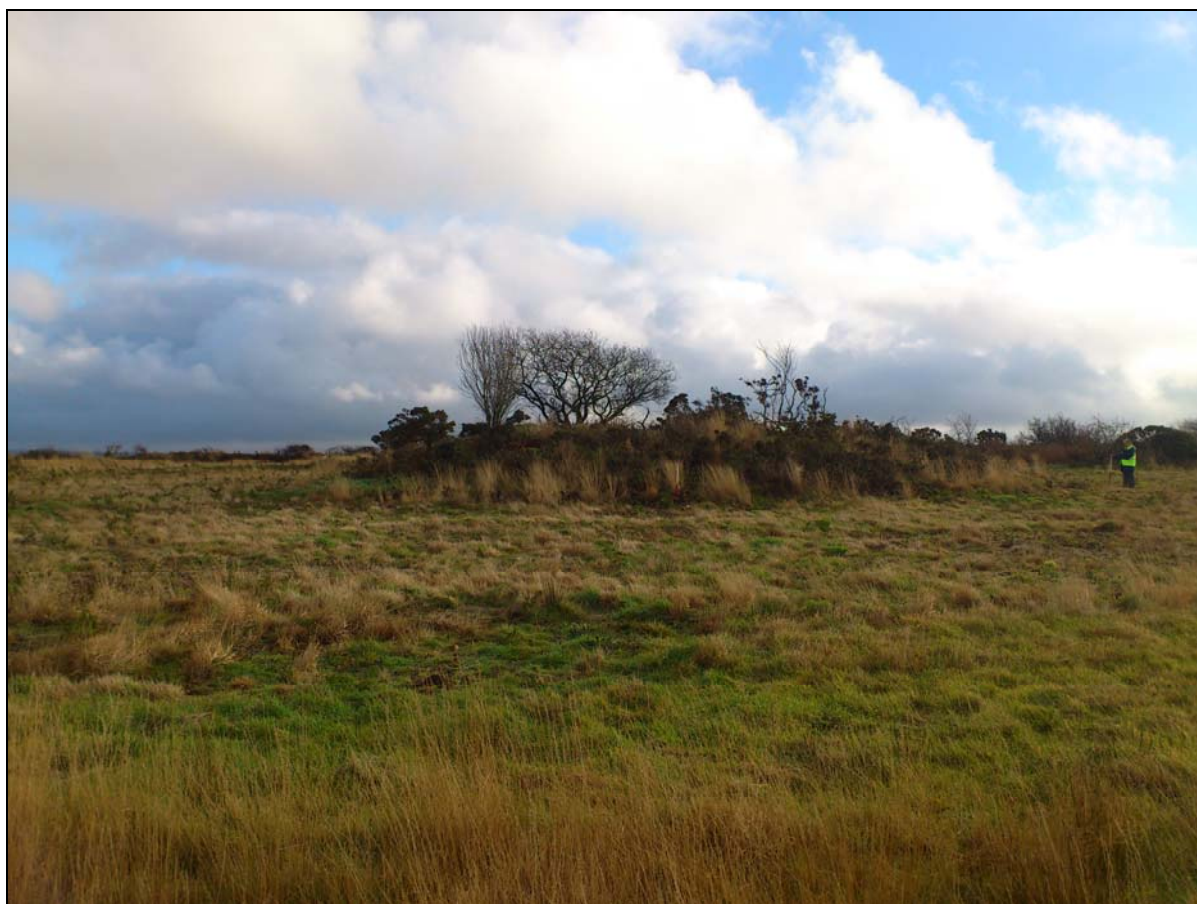
Plate 1: Crugelwin round barrow, looking east with the location of the northernmost of the proposed turbines beyond the boundary in the background.

The third Scheduled Ancient Monument is Crugelwin round barrow (CM130, ID number 5). The visible monument lies within 100 metres of one of the turbines, on land of a similar altitude, and within 160 metres of the other. The boundary of the scheduled area lies 80 metres and 145 metres away from the proposed turbines. A boundary bank with a low hedge on it and post and wire fencing on its eastern side divides the pasture field the turbines would be located in from the rough grazing ground in which Crugelwin stands.

1.9 On the basis of this appraisal, it is thought that some archaeological mitigation would be necessary for the proposed development, in the form of a watching brief during the excavation of the turbine base. Consideration needs to be given to the visual impact of the turbines on Crugelwin round barrow. Relocating the turbines further away from the round barrow would reduce this visual impact.
