Trysor Project No. 2013/311

Cover photograph: Location of the proposed turbine, looking east northeast.

Gellyolau, Clunderwen, Historic Environment Appraisal

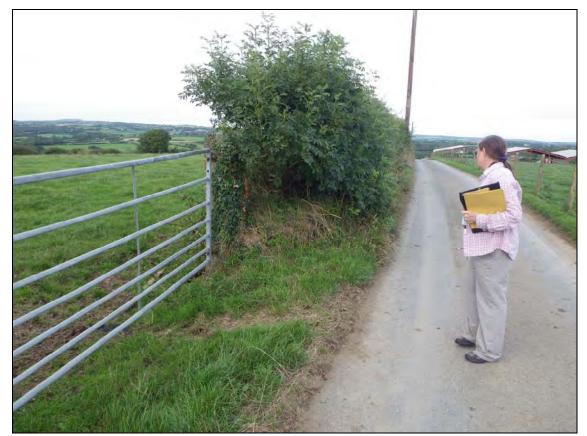
Plate 1: The gateway at the western end of field boundary bank, ID number 74, looking east northeast..

Two newly recorded sites of historic importance were noted for this appraisal at the turbine site. These were the farmstead at Gellyolau, ID number 75 and a field boundary bank (ID numbers 74). The farmstead is a still working and the turbine will lie in a field above the main buildings. The cable will run to a modern building to the north of the farm building complex. Impact is assessed as low as it will not affect the nucleus of buildings nor disrupt the field system. A small portion of the field bank will be removed to widen the existing gateway.

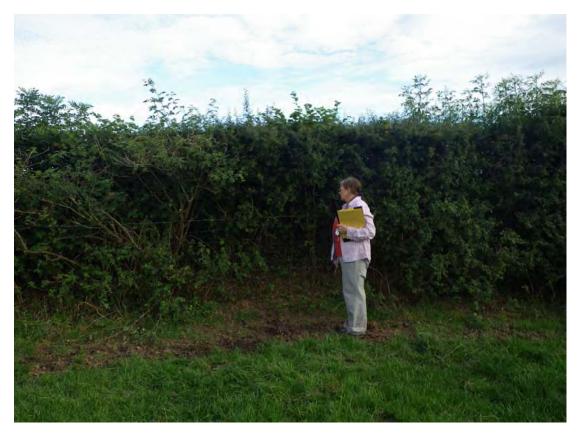
ID number:	74 C	GELLYOLAU	FIELD BC	DUNDARY
HER PRN:	NM	R NPRN: 0		
NGR:	SN0946219144	Grid reference taken at po	oint along linear site	
		Broadclass:	Agriculture and Subsistence	
Period:	Post Medieval			
Form:	Earthwork	Condition:	Intact	
Site Status:		SAM number:	LB number:	0 grade:
Description:	It currently has The bank is up gateway has co	s a gateway at its western e to 0.80 metres high and 1 porcrete gate pillars and a m	field to the north and the farm and. 5 metres wide at base with a lateral farm gate. The field bour and it may be that the bank was	hedge on top. The ndary is not shown
Rarity:	Comm	on		
Reference:				
Documentatio	on:			
Group Value:	Part of	the field system at Gellyo	lau	
Evidential Va	lue: Extant	earthwork		
Historical Va	lue: None			
Aesthetic Val	<i>ue:</i> None			
Communal V	alue: None

Minor Importance

The field boundary bank hidden by the hedge on top of it, looking south.
