**Land adjacent to Windy Ridge,  
7, Station Road, Letterston,  
Pembrokeshire  
Planning Application  
11/0008/PA  
Watching Brief**

Report by: Trysor

January 2012

Trysor Project No. 2012/229

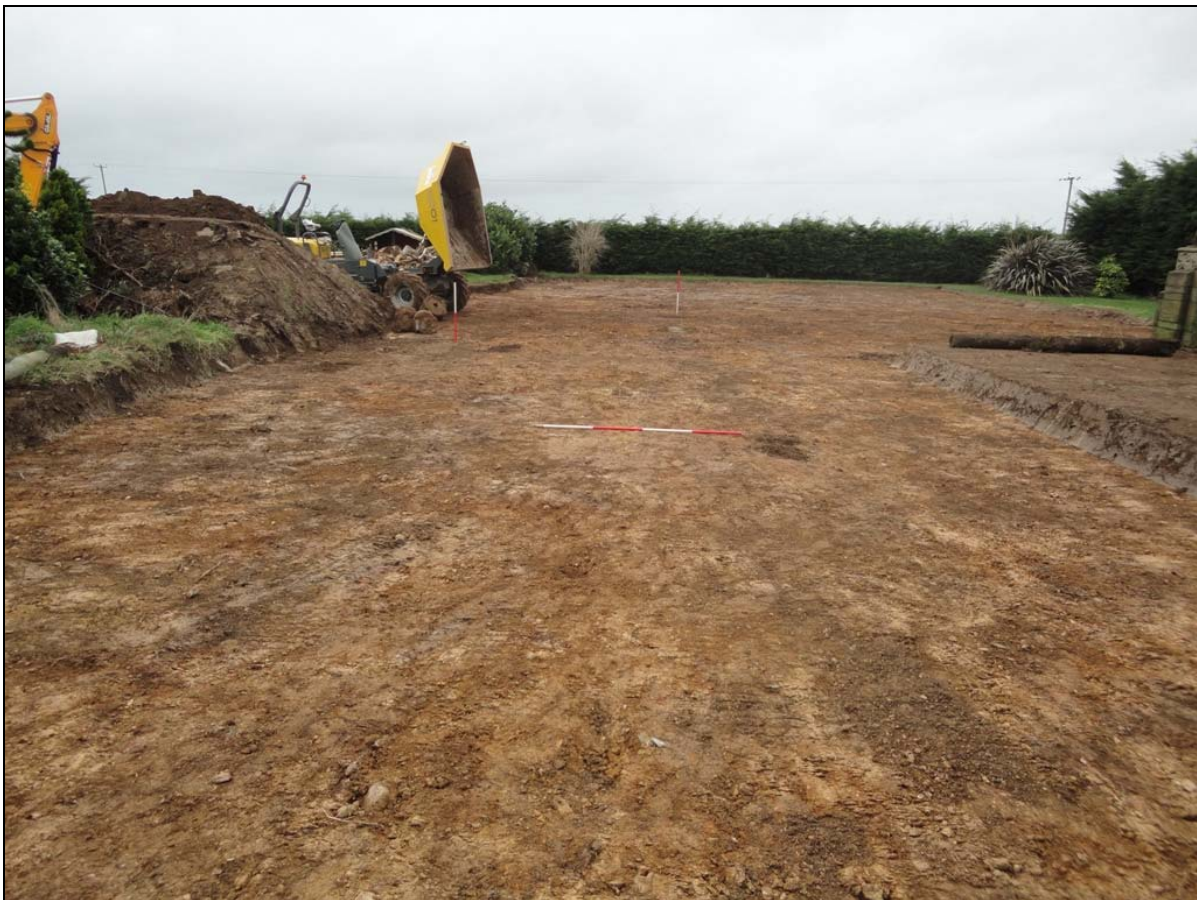
*Cover photograph: The development plot after topsoil stripping*

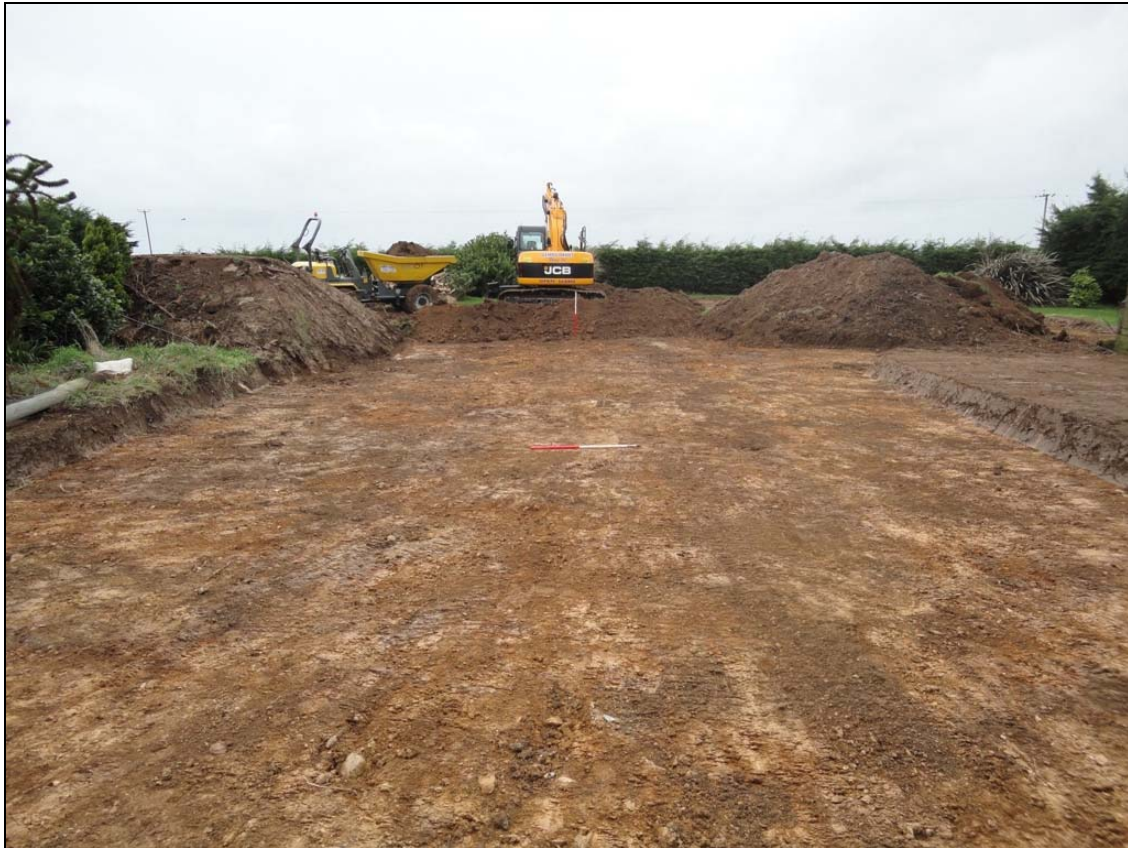
Plate 1: WRL\_001,

Photo Number	Description	Date Taken	Direction
<b>WRL_001</b>	The southern part of the development plot after context 1, the garden soil, had been removed exposing context 2, the natural subsoil.	04/01/2012	Looking north northwest
<b>WRL_002</b>	Detail of posthole 004, after half sectioning.	04/01/2012	Looking north northwest
<b>WRL_003</b>	Detail of posthole 006, after half sectioning.	04/01/2012	Looking north northwest
<b>WRL_004</b>	Detail of posthole 008, after half sectioning.	04/01/2012	Looking north northwest
<b>WRL_005</b>	The southern part of the development plot after context 1, the garden soil, had been removed exposing context 2, the natural subsoil and postholes 004, 006 and 008 had been half sectioned.	04/01/2012	Looking north northwest
<b>WRL_006</b>	Feature 010	04/01/2012	Looking south southeast
<b>WRL_007</b>	Section across feature 010	04/01/2012	Looking north northwest
<b>WRL_008</b>	One of the concrete fills from the modern postholes after removal by machine	04/01/2012	Looking north northwest

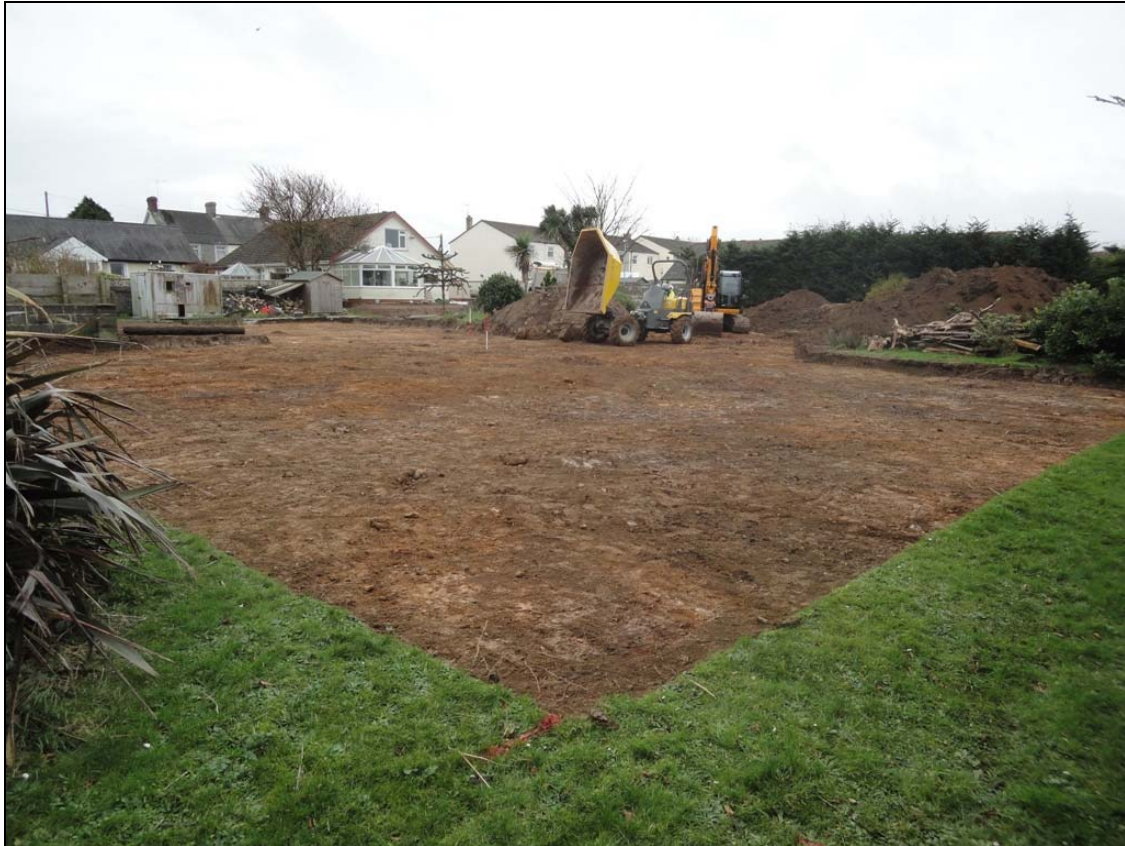
**Plate 9: WRL\_009**

<b>WRL_009</b>	The development plot after context 1, the garden soil, had been removed exposing context 2, the natural subsoil.	04/01/2012	Looking southwest
<b>WRL_010</b>	The southern part of the development plot after context 1, the garden soil, had been removed exposing context 2, the natural subsoil and postholes 004, 006 and 008 had been half sectioned.	04/01/2012	Looking southeast
<b>WRL_011</b>	The eastern part of the development plot after context 1, the garden soil, had been removed exposing context 2, the natural subsoil and postholes 004, 006 and 008 had been half sectioned.	04/01/2012	Looking east northeast
<b>WRL_012</b>	The development plot after context 1, the garden soil, had been removed	04/01/2012	Looking north northwest

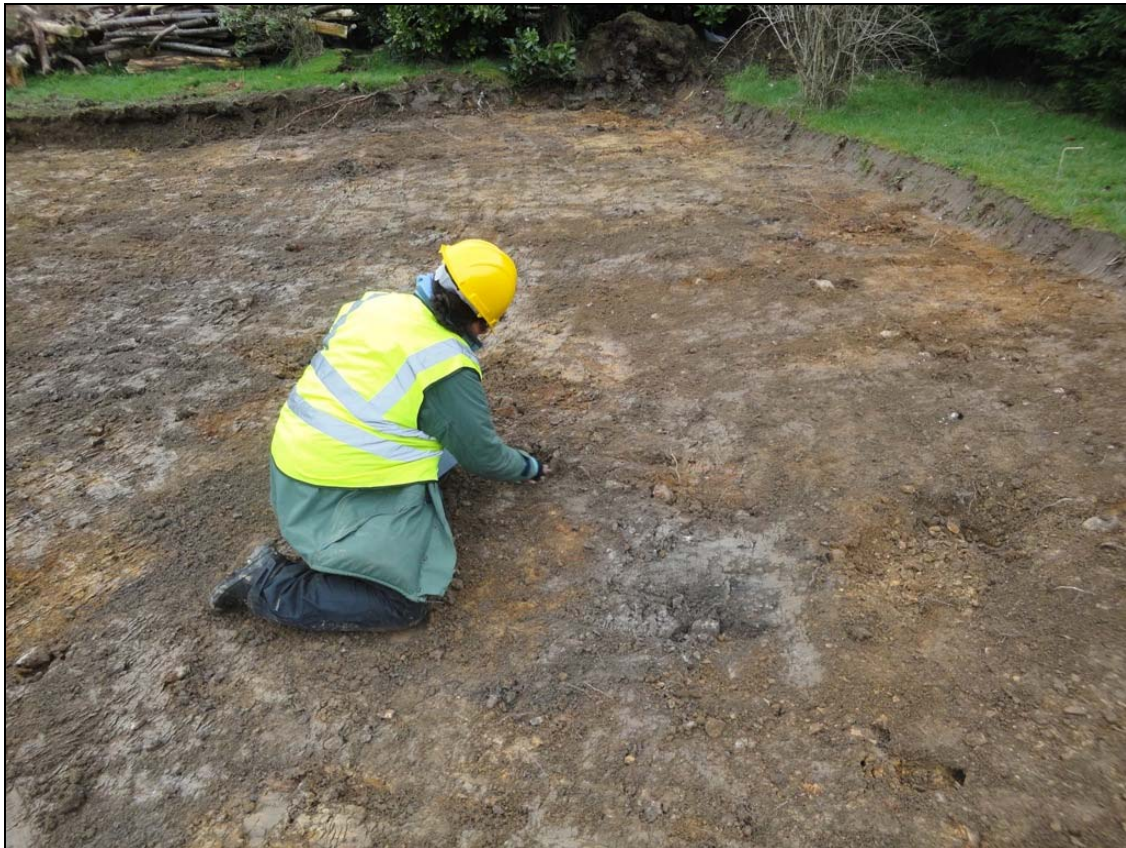
**Plate 13: WRL\_013**

exposing context 2, the natural subsoil and postholes 004, 006 and 008 had been half sectioned.		
<b>WRL_013</b>	Detail of the mixed subsoil on the northern part of the site, with some gleyed clays, thought to have formed in wet hollows when the ground was open moorland.	04/01/2012	Looking northwest
