Chimney's Link Town Centre Enhancement Scheme

Fishguard Junior School - Level 1 Building
Recording

Pembrokeshire County Council

26 October 2017

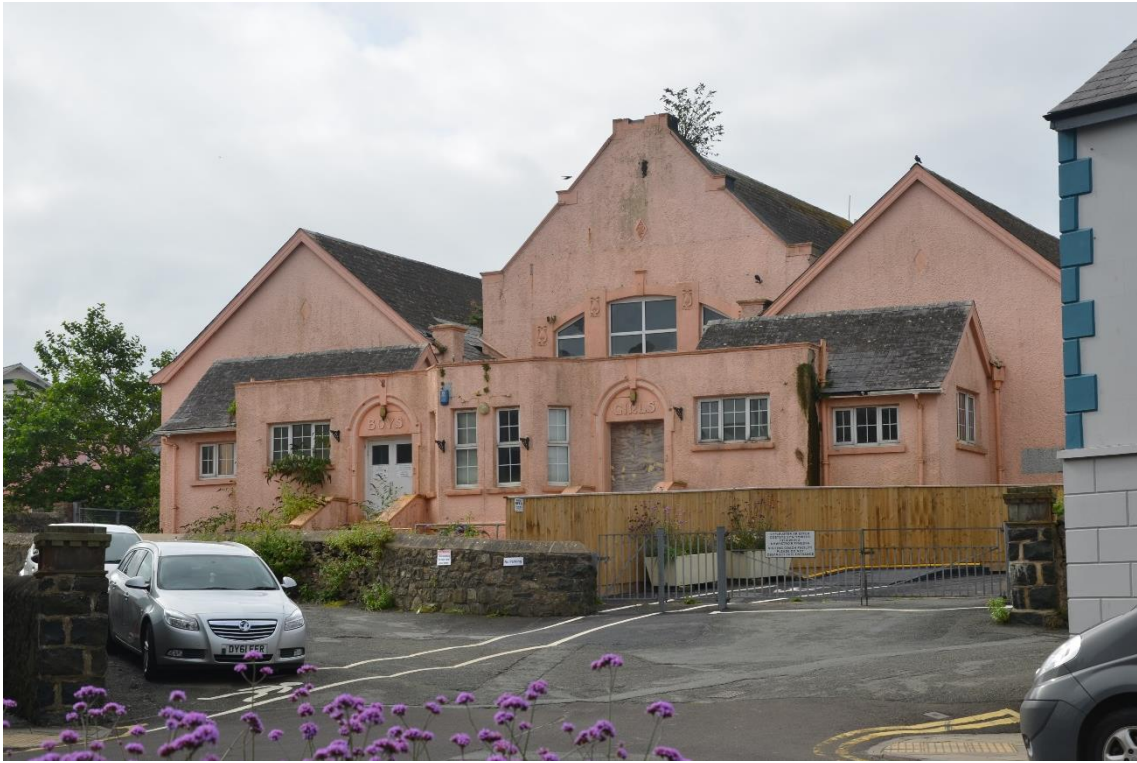
Plate 1. The former Fishguard Junior School, viewed from the north-east on West Street.

The former Fishguard Junior School comprises a single storey building, constructed of Goodwick brick coated in pebble dash render (Plate 1). Though the entire building is a single storey, the main body of the school consists of a double height storey, with the gable ends of the roof pitches set above the lower roofs of the entrance hall rooms when viewing the front elevation from West Street (as visible in Plates 1 and 2). The render on the north-eastern entrance elevation has been painted a distinctive pastel pink, with the majority of the rest of the school white-washed; some of the additional buildings to the rear have been painted in other pastel colours.

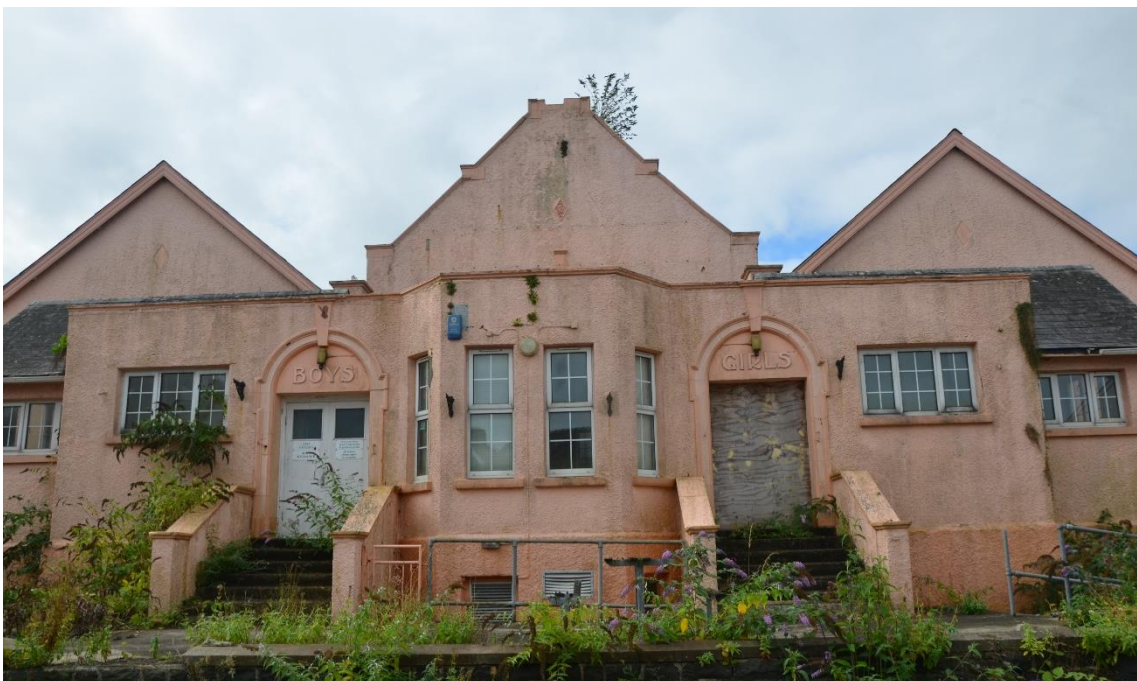
Plate 2. The former Fishguard Junior School, entrance (north-eastern) elevation

The principle façade is the north-eastern elevation, forming the main entrance of the school facing towards West Street (Plate 2). The entrance elevation is symmetrical, comprising single storey entrance hall rooms aligned perpendicular to the double height storey of the main body of the school, which forms three gable ends behind. This elevation comprises a projecting central bay, with two entrance doorways either side atop sets of steps. Each doorway is set within a decorative archway, adorned above with “BOYS” (for the south entrance) and “GIRLS” (for the north entrance), indicating the original segregation within the building (Plate 3). Behind, the parapet of the entrance partly obscures two pitched roofs aligned perpendicular to the main body of the building. The main body from this elevation comprises three gable ends, the central of which features a large segmented arched window, separated into three parts. This central gable features steps at the base and halfway up each pitch, while at the top is the truncated base of the original school bell-cote.

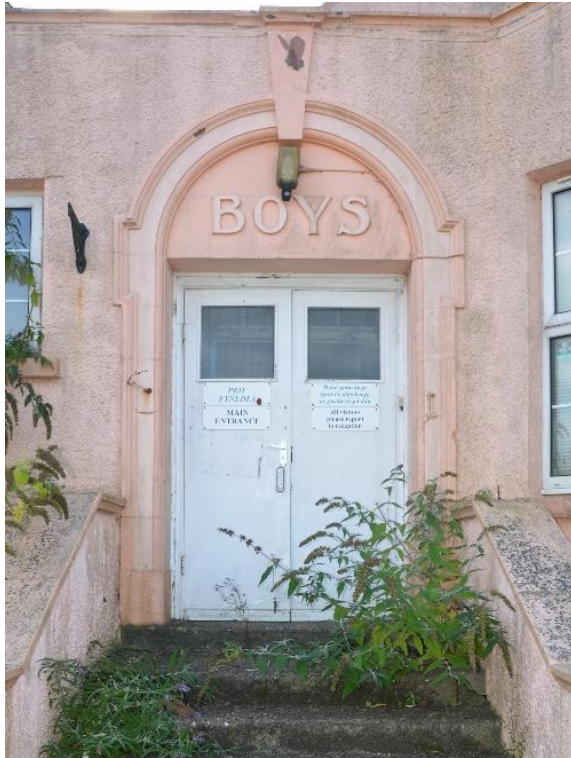
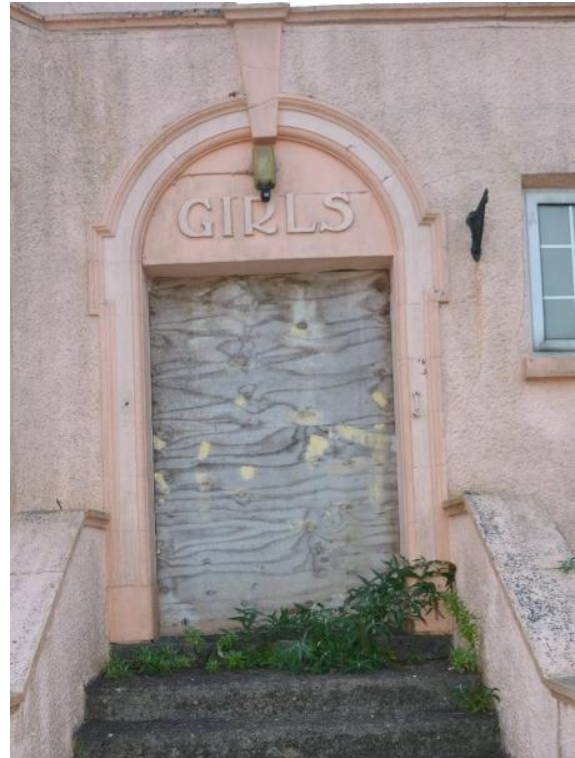
Plate 3. Entrance doorway(s) in front elevation, showing segregated entrances

The apparent segregation of the entrances would suggest that the school was originally segregated internally, with the northern half for girls and the southern half for boys, their respective classrooms leading onto the central hall servicing the entire school.

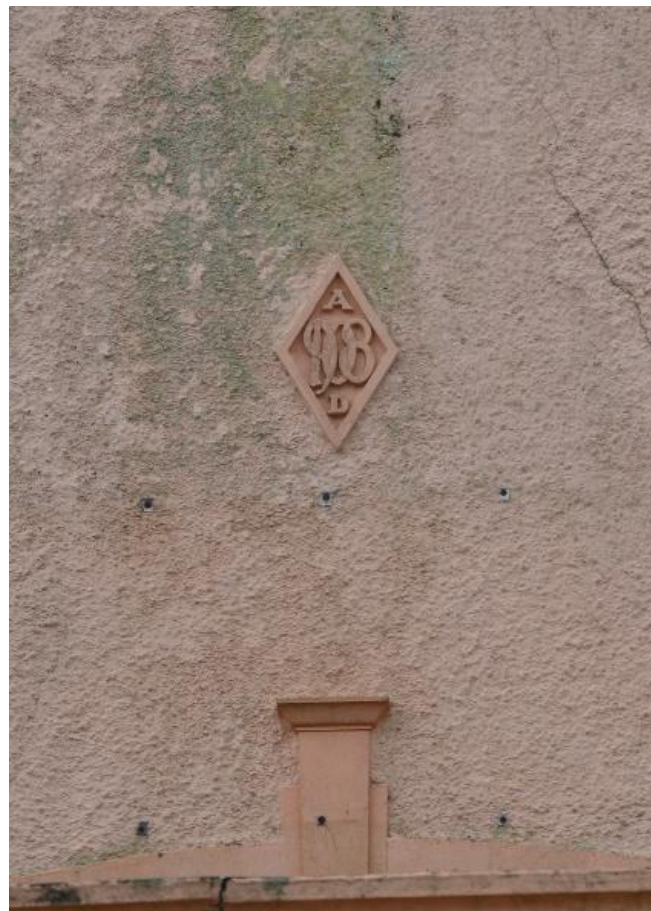
Plate 4. Entrance elevation, detail of date plate on central gable end

The entrance elevation features a number of neo-classical details, including pilasters adorning the doorways and window of the central gable end, and faux keystones above the same elements. Each gable end also features the date of construction in an embossed diamond plate (Plate 4).

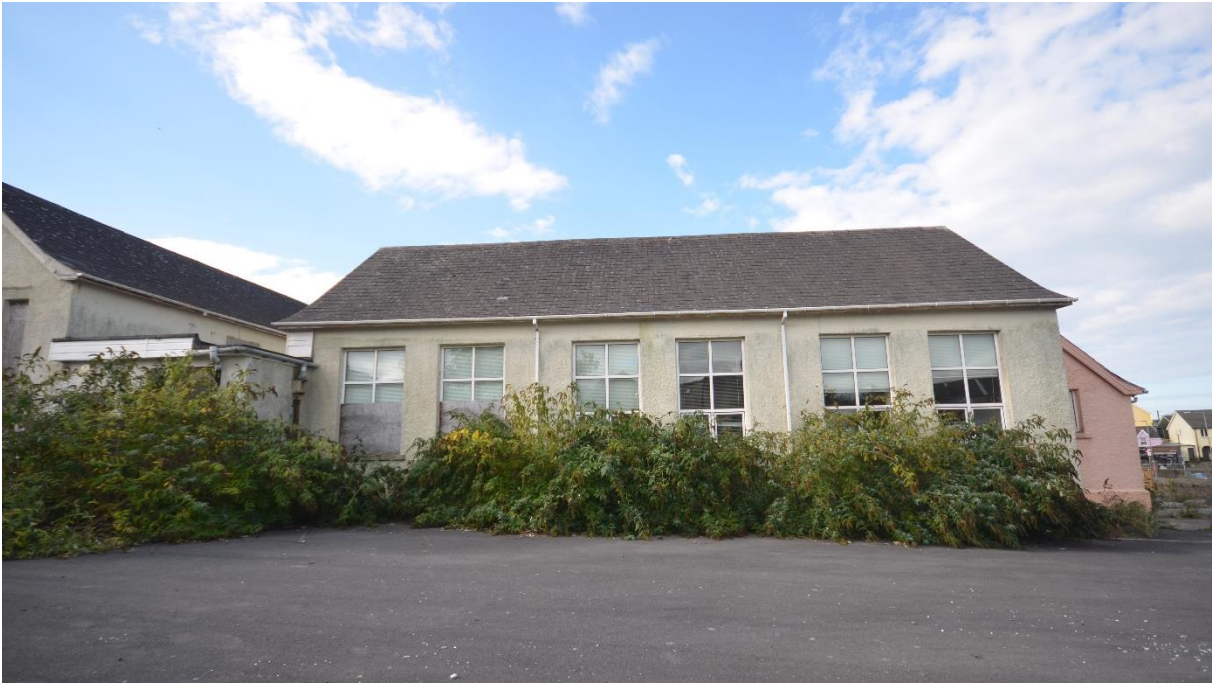
Plate 5. The former Fishguard Junior School, southern elevation

The north and south elevations of the main body of the school building both consist of six bays of unadorned eight-light windows (Plates 5 and 6). Compared to the façade of the front entrance, the side elevations are unremarkable with no decoration or detailing.

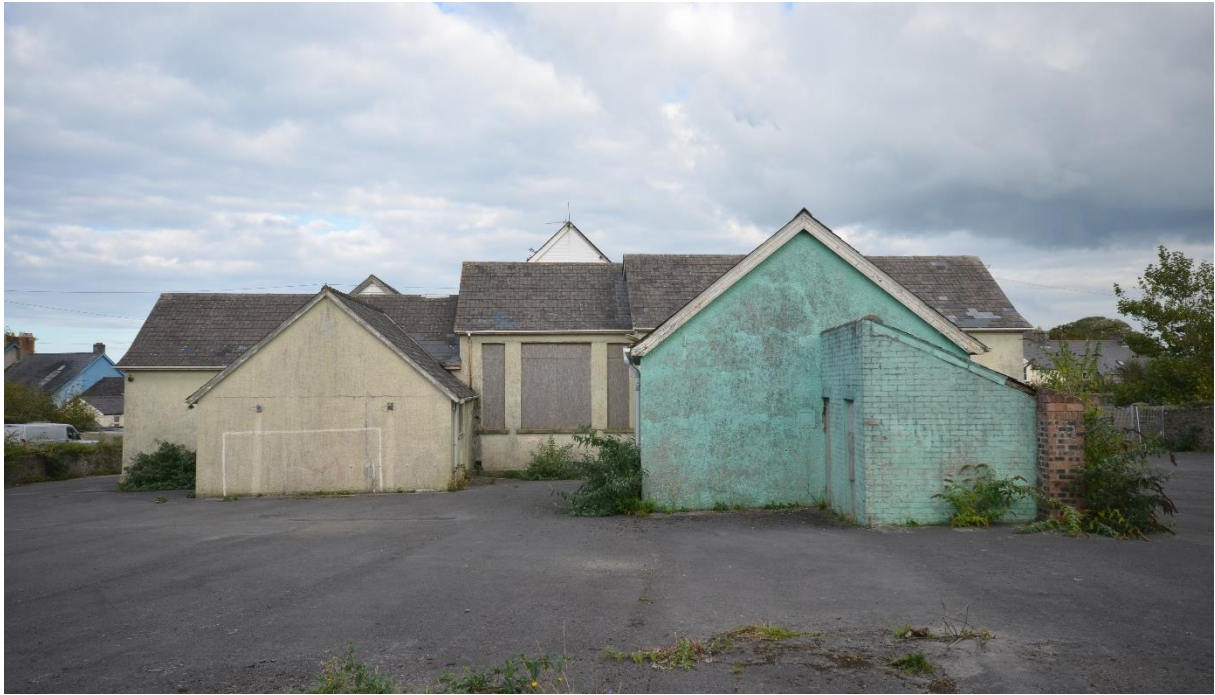
Plate 7. The former Fishguard Junior School, rear of school from the west. Note the difference in the height of the later pitched roof extension.

A number of later additions were made to the rear of the school, with a small number of post-war ancillary buildings being constructed. These appear to have included store rooms, toilets and extra classroom space, with an additional separate infants school building to the west, latterly the school canteen. A pitched roof extension to the very rear of the main body of the school has been added at some point post-1976, evidenced by the different heights in the pitched roofs (see Plate 7).

At the rear of the main body of the school is a range of pitched roof buildings (Plate 7), arranged perpendicular to the main body, with the gable ends of the three pitched roofs above, as displayed over the front entrance elevation. This range appears in particularly poor condition, with windows boarded up and damage to masonry. There appears to be a small connecting section of the building between the main body and these pitched roof elements, indicated by a small flat-roofed section of building with prominent fascias.

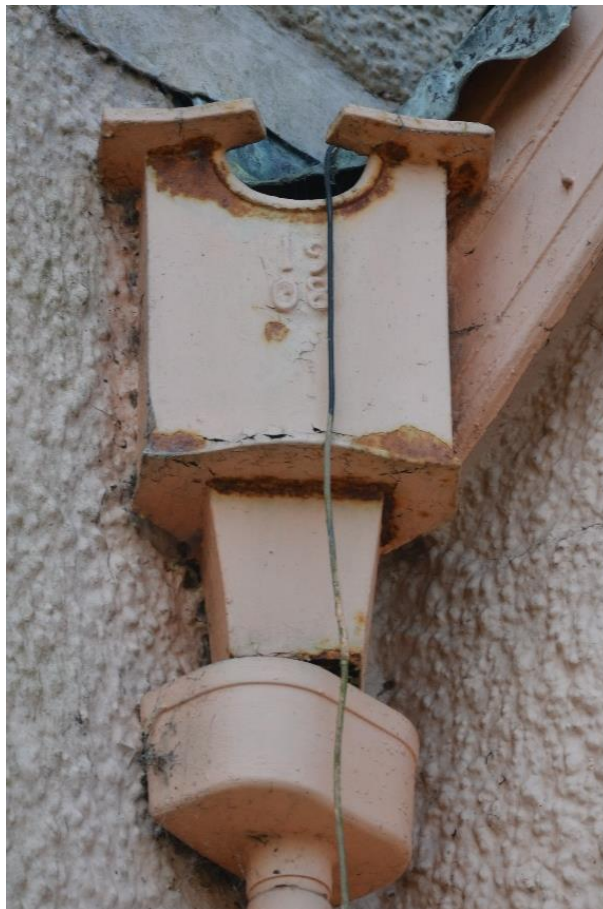
Plate 8. Detail of downpipe rainwater hopper, showing decorative date imprint

The majority of the school has pitched roofs of Welsh slate, with some isolated areas of flat roofs in between. It would appear that none of the roofs have had later additions, and the building does not incorporate any chimneys. The drain downpipes serving the pitches and valleys of the roofs appear to be original cast iron, with a number of the rainwater hoppers decorated with the date of the school's opening (Plate 8).

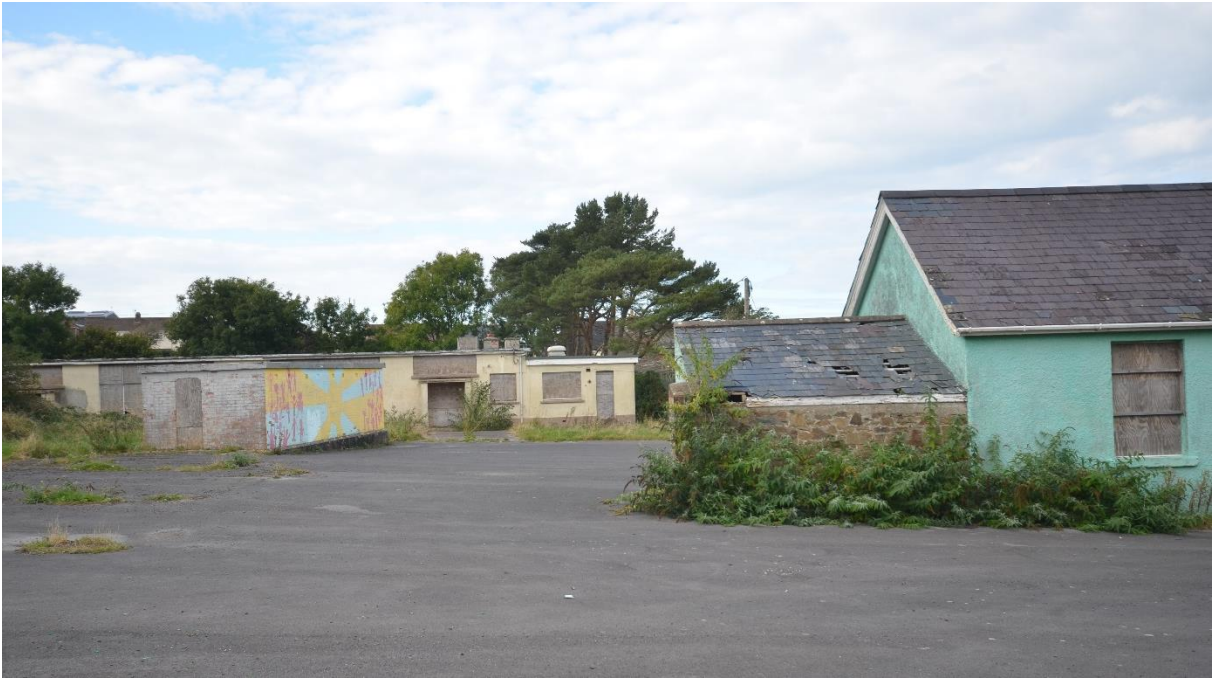
Plate 9. Later ancillary buildings to the rear of the former Fishguard Junior School, viewed from the south.

A number of ancillary buildings are located within the school boundary to the rear of the school building (Plates 7 and 9). These have been added at a later date, and appear to have consisted of store rooms, canteen, toilets and extra classroom space. They are largely constructed of painted brick or concrete breeze block, with a mixture of flat and pitched roofs, and are in similarly poor condition to those buildings at the rear of the main body of the school. To the west of the Junior School complex is the later infant school building (later the school canteen), post Second World War, which is still extant (Plate 10), and again in poor condition with windows and doors boarded up. This building is flat roofed, and appears to be constructed of concrete, with similar pebble dash render to the Junior School.

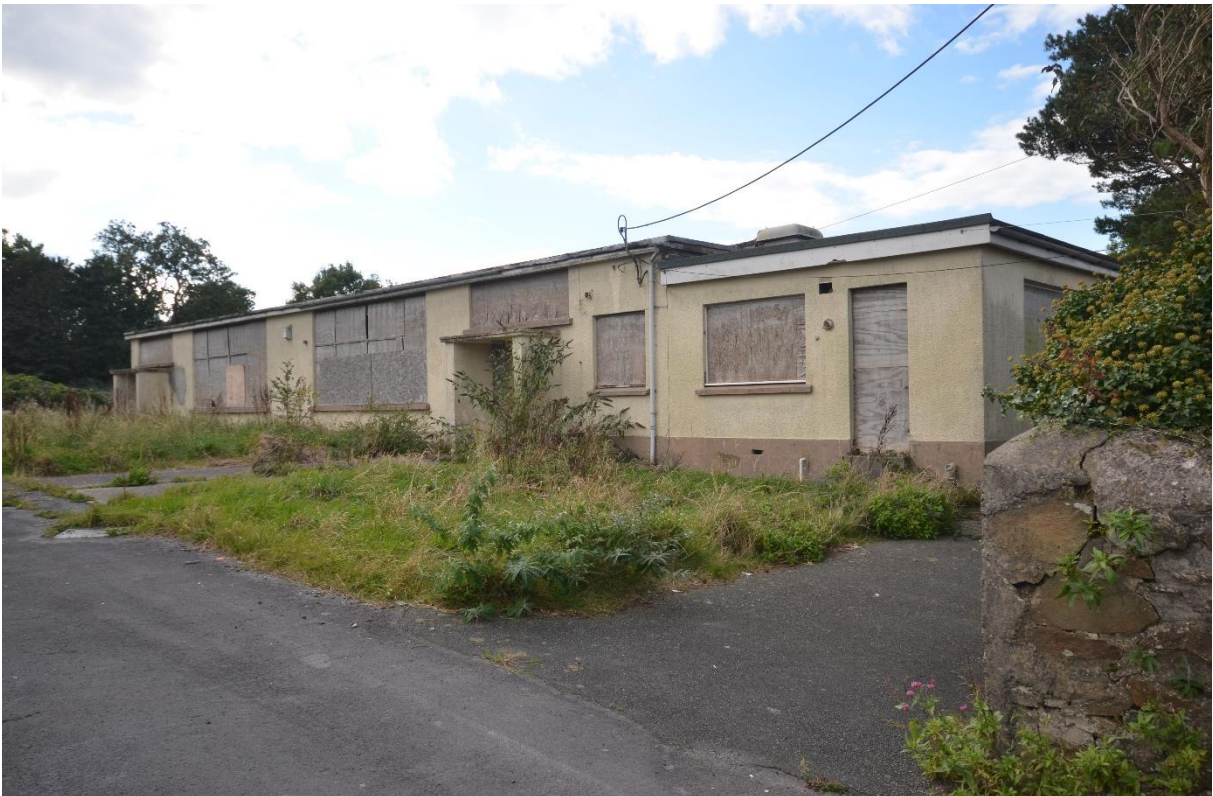
Plate 10. Later infant school building, subsequently used as the school canteen, to the west of the Junior School buildings.

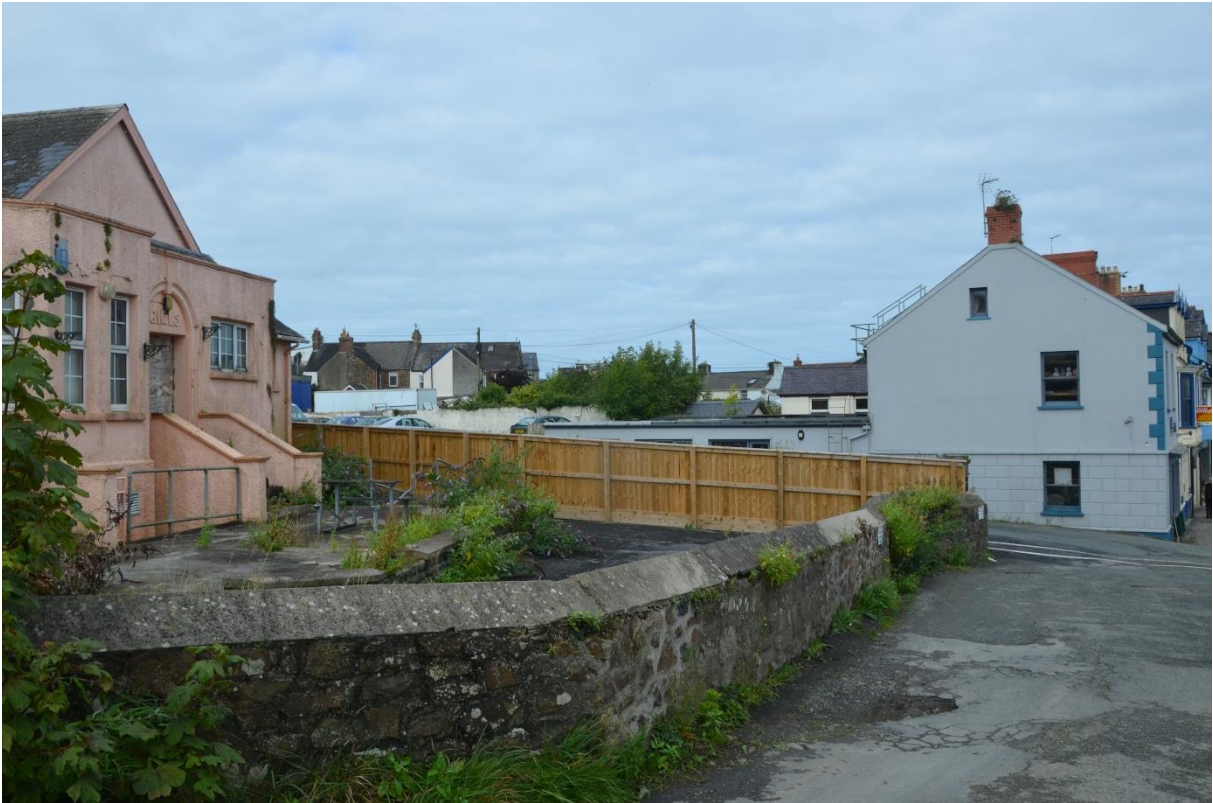
Plate 11. Stone wall on north-western boundary of the Junior School.

The entrance to the main school is fronted by a stone wall which remains extant (Plate 11), topped with concrete coping stones a number of which are missing. The original gates and one of the gateposts have also been removed. To the north side of the school's principal elevation a set of modern metal gates marks the entrance to the school site from West Street at the time of the closure of the school. The school is bounded on the north side by a modern timber fence (possibly contemporary with the aforementioned gates), and on the south side by a modern metal mesh fence (at the eastern end of the boundary) and a tall stone wall (see Plate 12) in the same style as that at the front of the school (at the western end of the boundary). This stone wall includes an opening from the asphalt playground to the rear of the school buildings into the open space of the former playing field.

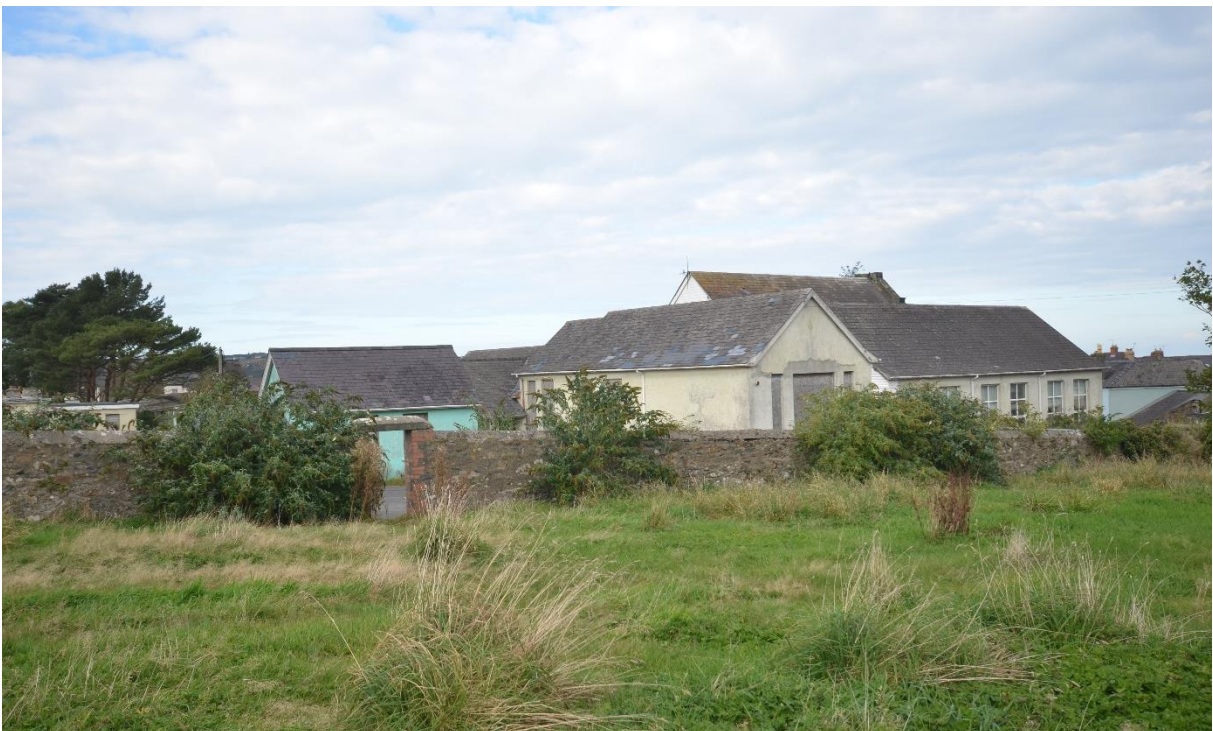
Plate 12. The former Fishguard Junior School from the south, showing southern boundary wall to playground and opening into former playing field. Note the apparent evidence of the removal of neo-classical features from around the south-facing window on the gable end.

The original windows throughout the school have been replaced with uPVC window frames. A number of features have also been removed over time, including the bell-cote atop the central gable end of the entrance elevation, and the spiked finials along the roof ridges. Towards the rear of the building, it appears that some neo-classical detailing may possibly have been removed from around the windows (for example as visible in Plate 12). The exterior of the building has undergone a number of additions in places, in the form of brackets for hanging baskets, security lights and alarm boxes.

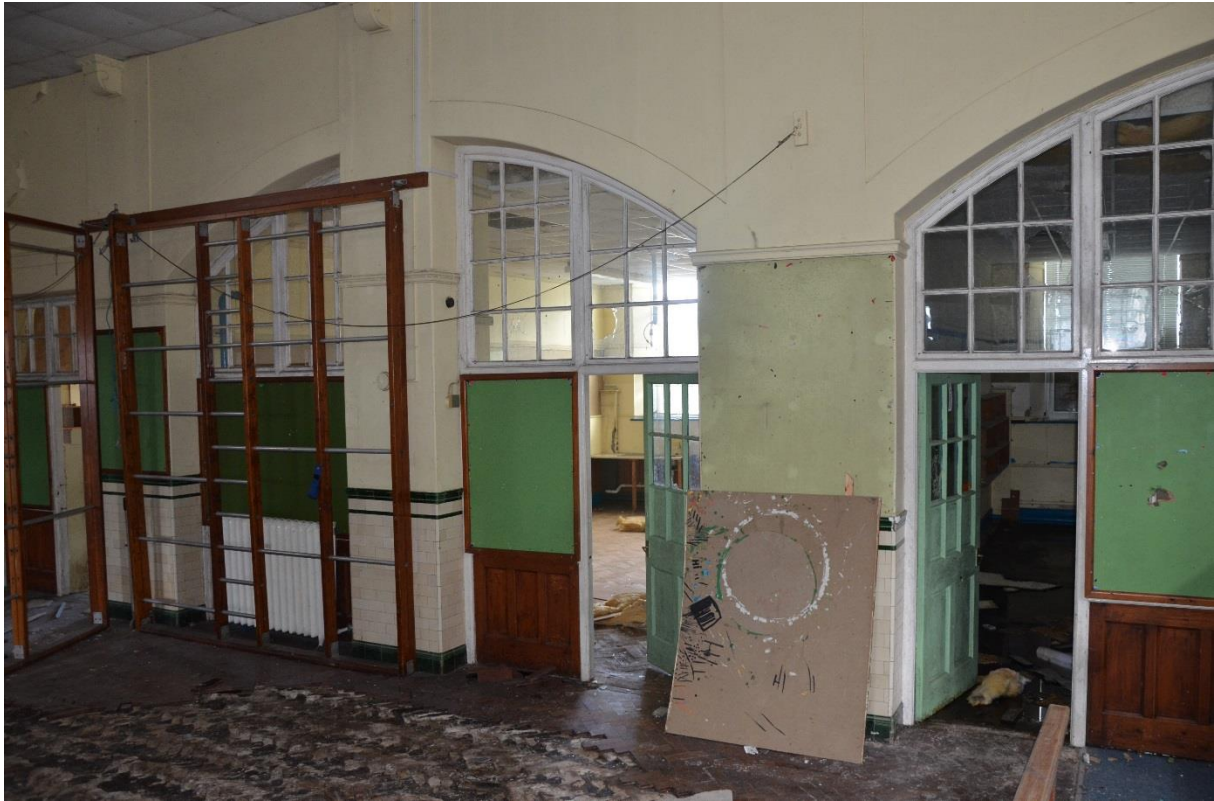
Plate 13. Central hall, showing arched windows and original timber doorframes to classrooms. Note the survival in parts of the original parquet flooring.

Though the interior has undergone a number of additions and alterations, some original features remain, while the original layout of classrooms appears to be largely retained. The arched windows from the central hall to classrooms on either side survive, as do some of the original doorframes (Plate 13). Within the hall itself, areas of glazed tiling has also been

retained (Plate 14). Some areas of the original parquet flooring appears to survive in situ (see Plates 13 and 14); this has been covered in carpet in places, and elsewhere removed or damaged by water ingress. The majority of the interior has seen the later installation of dropped ceilings; in the hall corbel features survive (Plate 15, also visible in Plate 13), the bases of the original roof frame structure which survives hidden above the later ceiling (Plate 16), while in the classrooms the later ceiling has truncated the upper parts of the windows (Plate 17). Gym equipment and frames (folding to the side of the room for storage) survive in the hall (visible in Plate 13), though later additions have been made, for example the addition of an access ramp to the front of the raised stage/dais area at the west end of the hall (Plate 18). A number of the classrooms feature original fitted timber panelled cupboards (Plate 19).

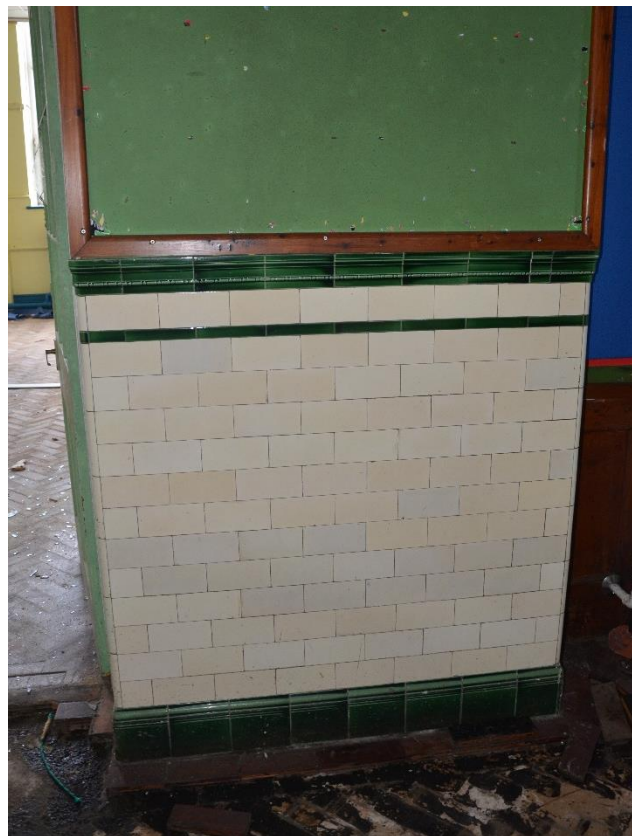
Plate 14. Central hall, surviving original glazed tiling.

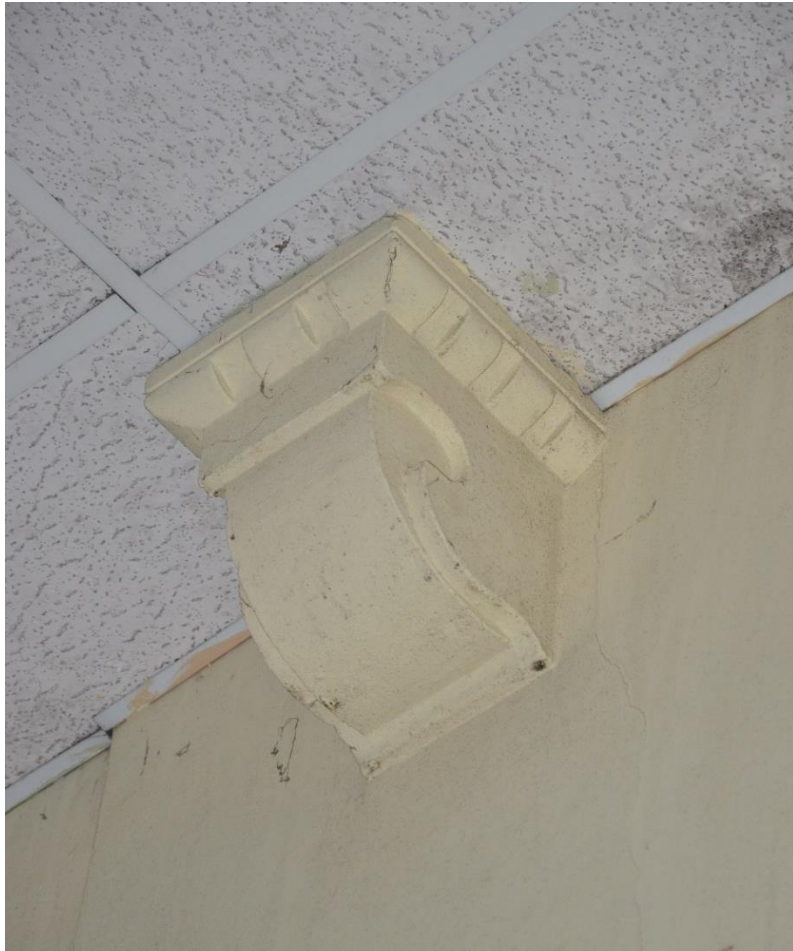
Plate 15. Central hall, surviving corbel beneath later inserted dropped ceiling.

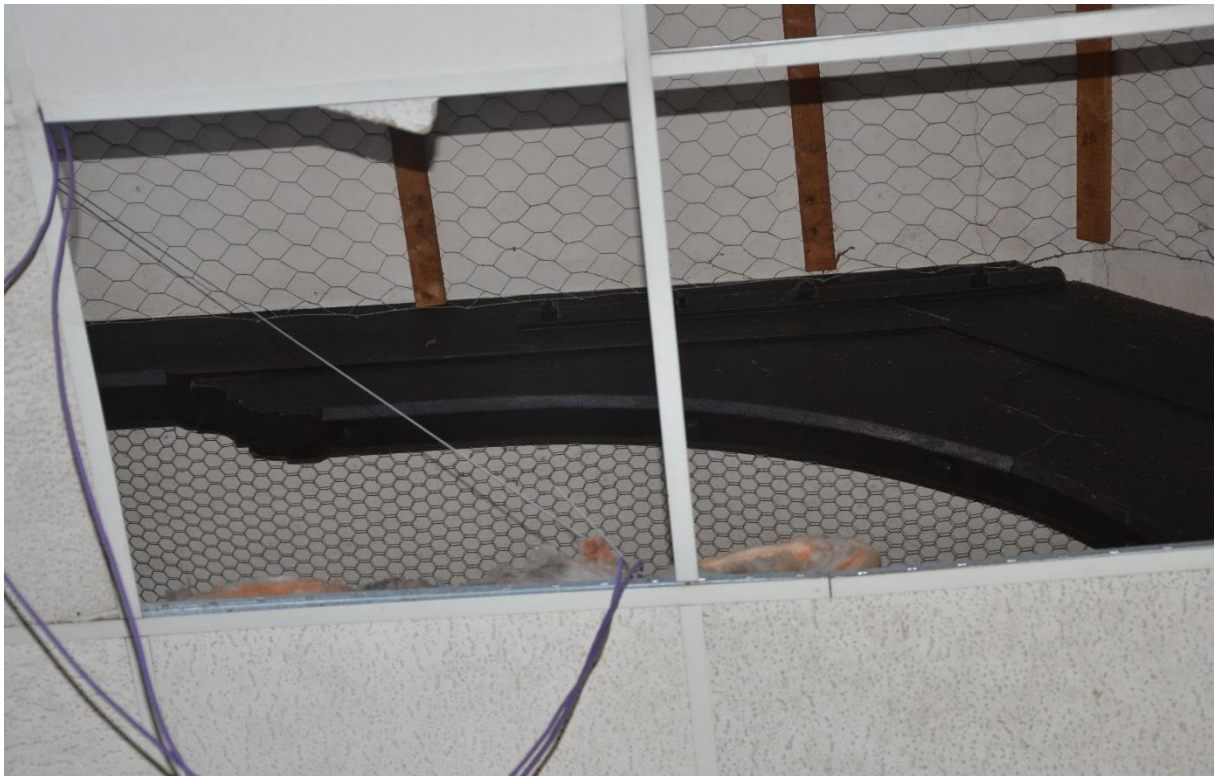
Plate 16. Central hall, original roof structure visible above later inserted dropped ceiling.

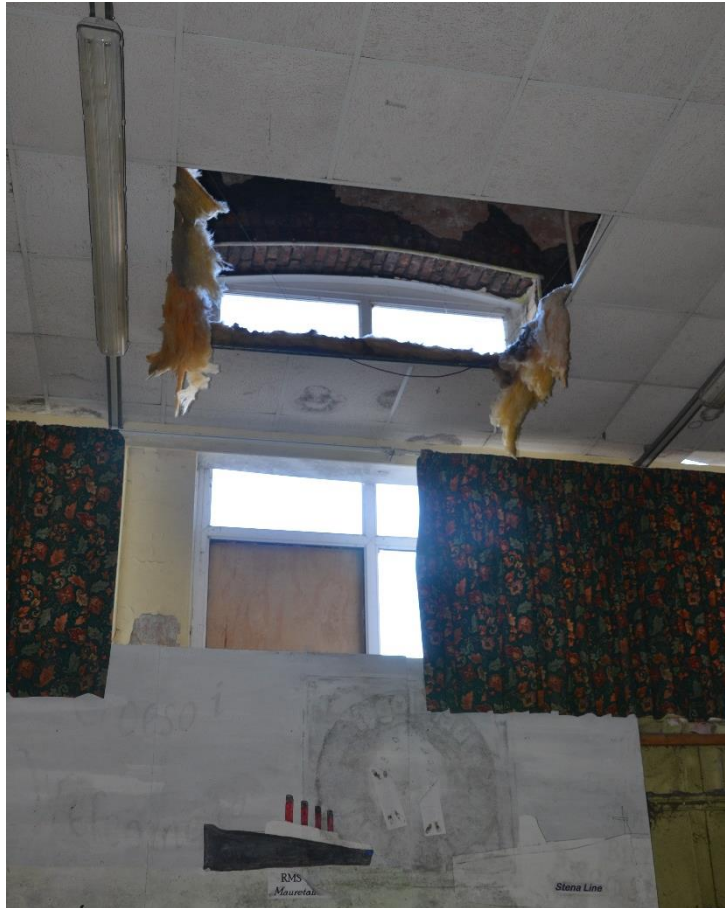
Plate 17. Classroom, showing original window truncated by later inserted dropped ceiling.

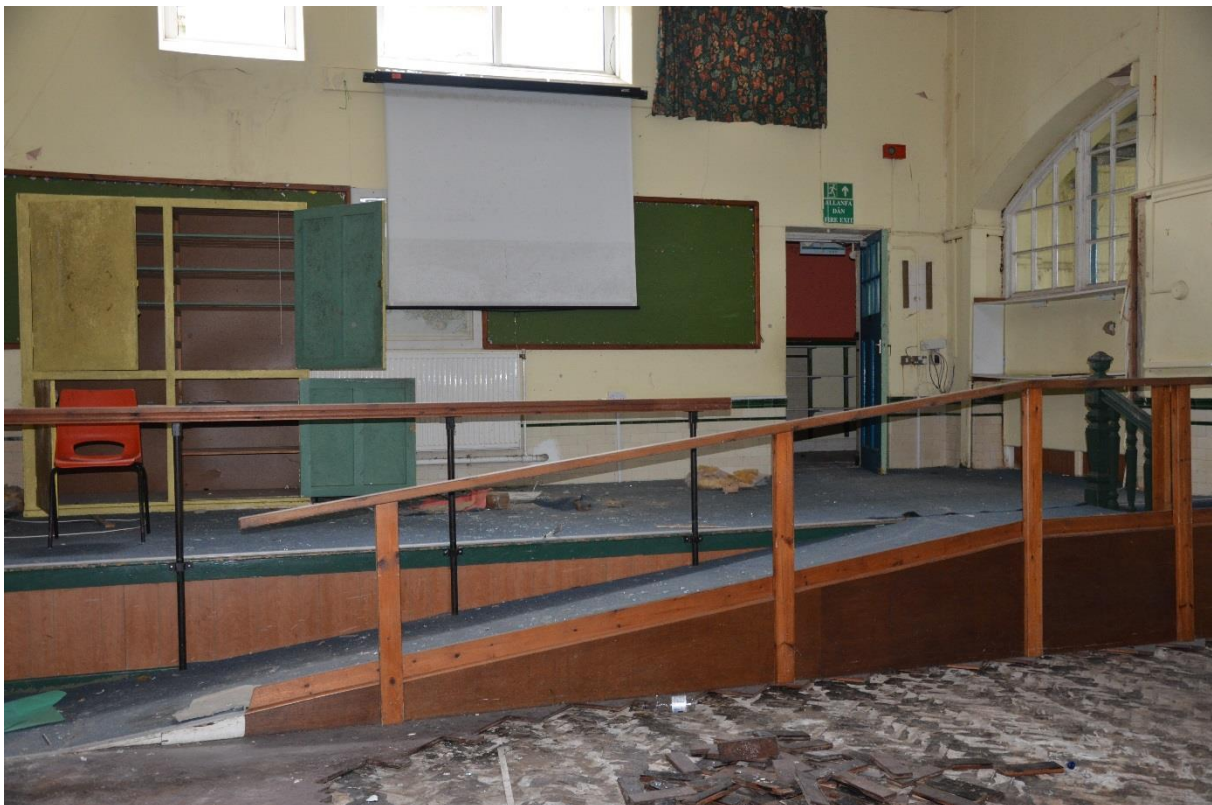
Plate 18. Central hall, west end showing addition of stage/dais and access ramp.

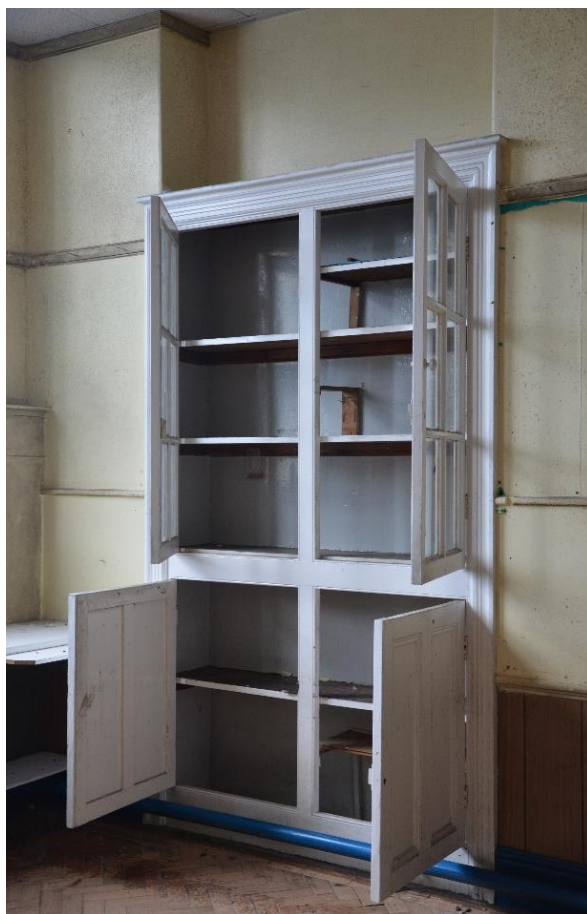
Plate 19. Original fitted timber panel cupboard in a classroom.
