Plots at Llandre site, Llanpumsaint, Carmarthenshire Watching Brief

Report by: Trysor

Trysor Project No. 2012/293

November 2014

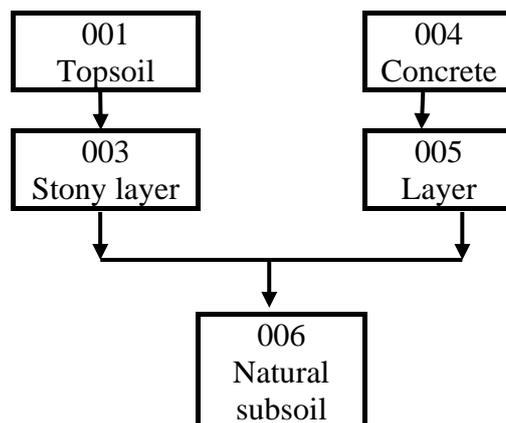
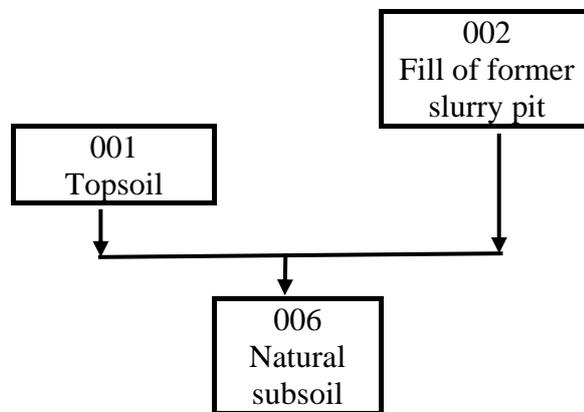
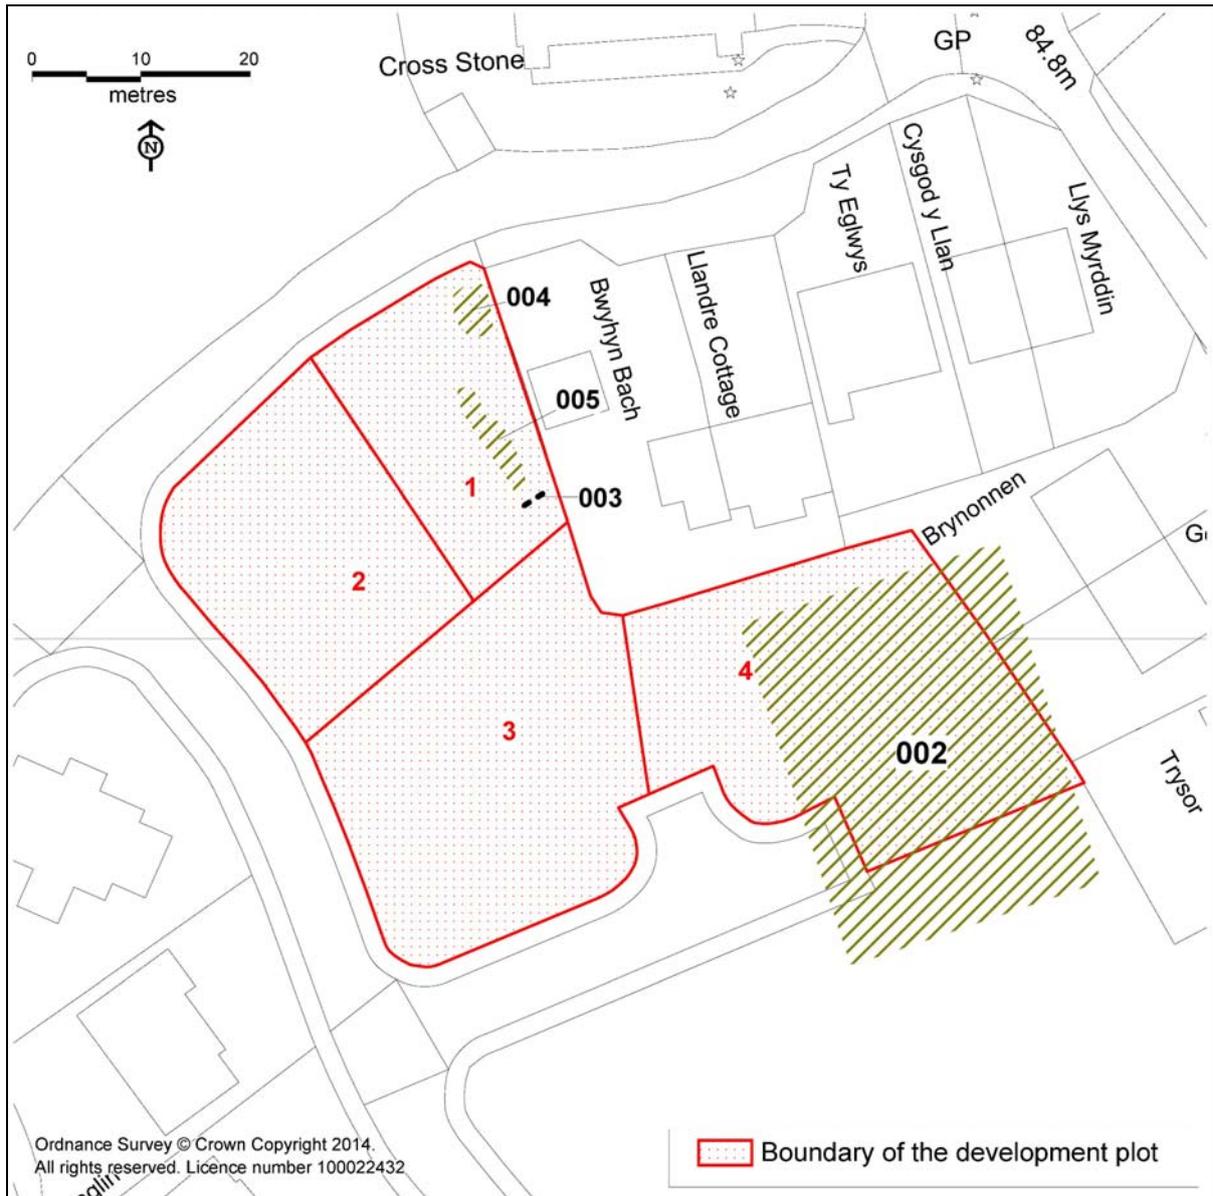
Figure 4: Location of contexts recorded. 003 and 005 are not extents of the context, but where it was noted in sections, true extent not known as material did not need to be removed.

9.2 The excavation of the foundations in plot 1 were watched in order to confirm the nature of the subsoil which was very variable from loose shale grit to clay.

9.3 Plots 2 & 3 were machined down to subsoil 006 and no archaeological contexts were observed above or cutting into the subsoil.

9.4 A large part of plot 4 was covered by 002, the fill of a former slurry pit, shown on 1978 1:2500 Ordnance Survey map.

11.3 Plot 1 had the remains of a former building in its northeast corner. 004 was a concrete slab, presumably the floor of the building. Layer 005 was topsoil/garden soil in the vicinity of this building. The landowner said that a pigsty/cowshed had formerly stood in this area. South of this the topsoil 001 overlay a thin stony layer 003 containing 20th century pottery. The exact source of this layer was not clear but could be related to the building of the wall around the garden to the east. Elsewhere topsoil 001 overlay natural subsoil 006.

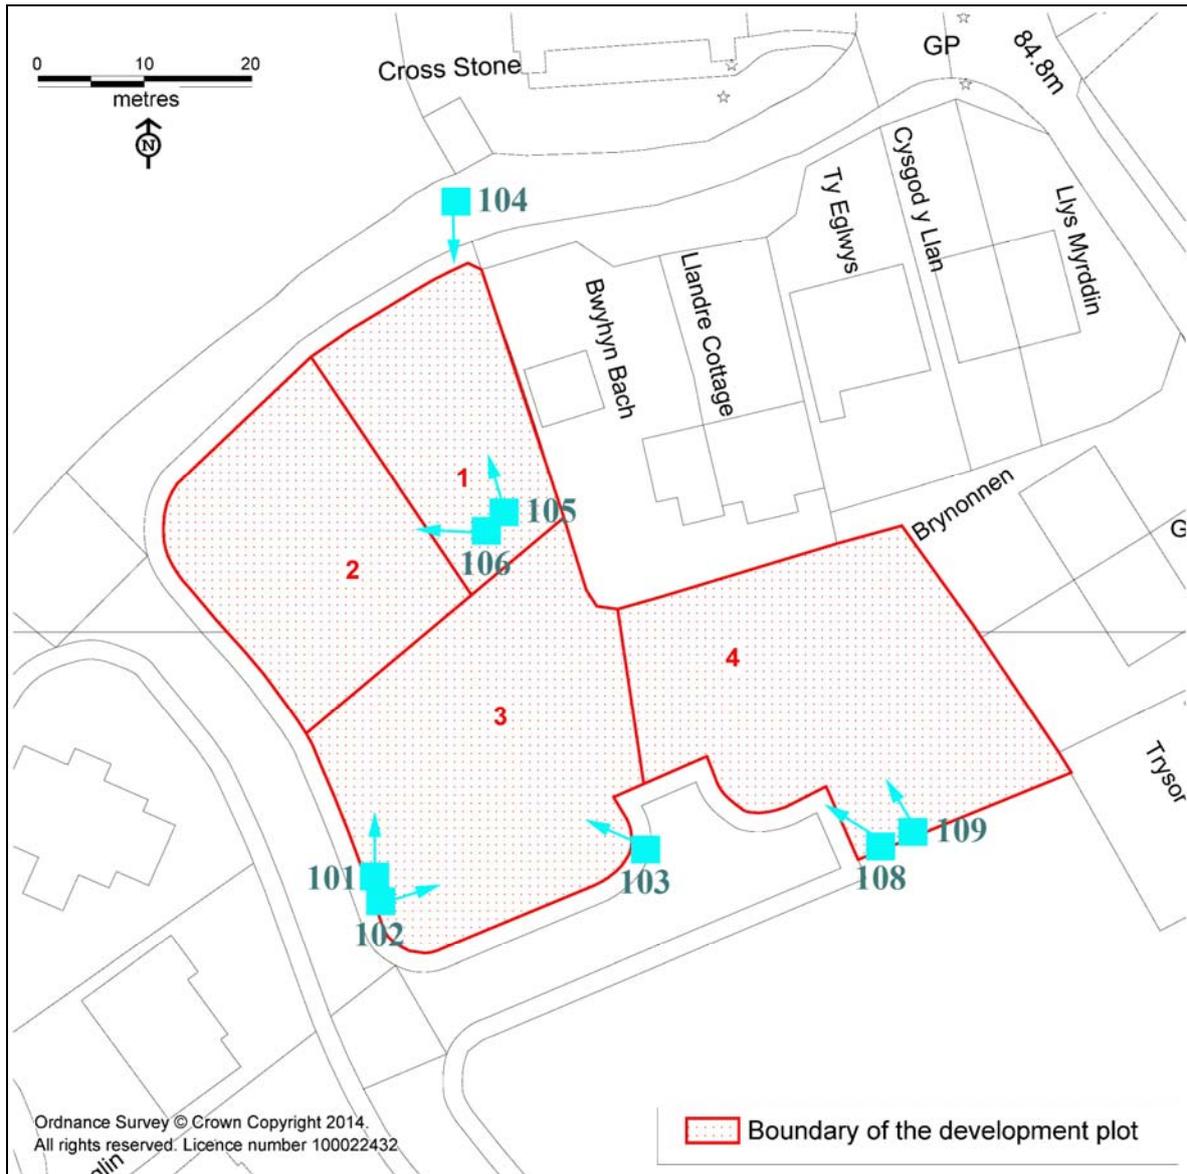
Figure 5: Location and directions of photographs

10.1 Colour digital photographs were taken of topsoil stripping and excavation of trenches using a 14M pixel camera. The following table describes the content of each photograph included in the project archive and their locations are provided in the following map, see Figure 5. The photographs are included in Appendix B at the end of the report.

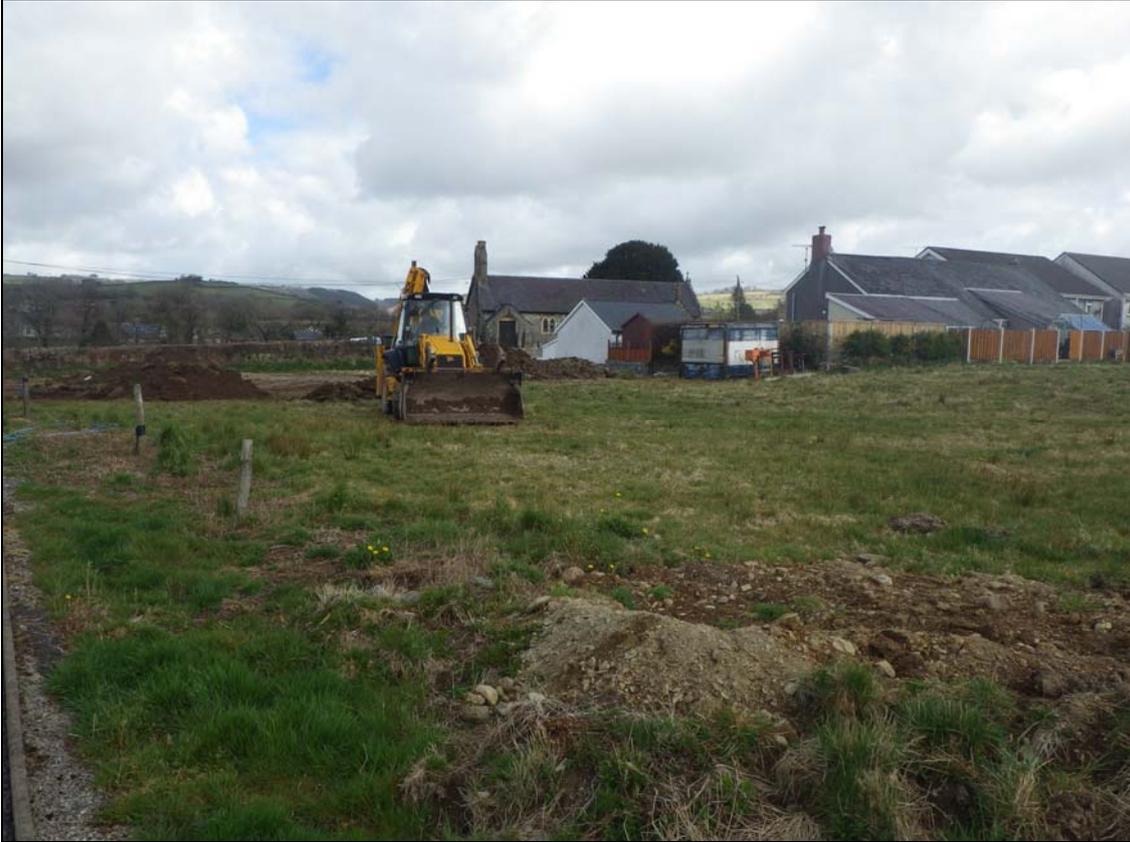
Plate 1: LLL2013_101, The development site before clearance of the topsoil started in 2013, looking north, across plots 3, 2 and 1.

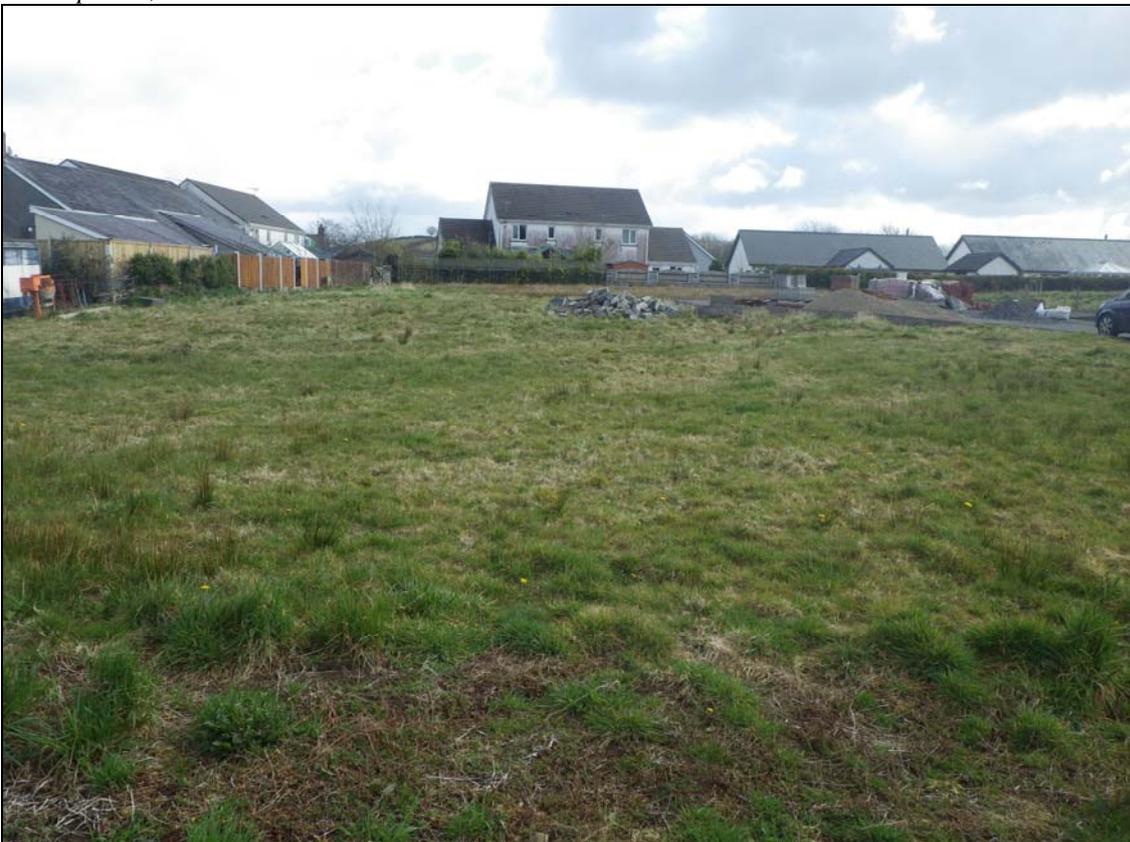
Plate 2: LLL2013_102, The development site before clearance of the topsoil started in 2013, looking east northeast, across plots 3 and 4.

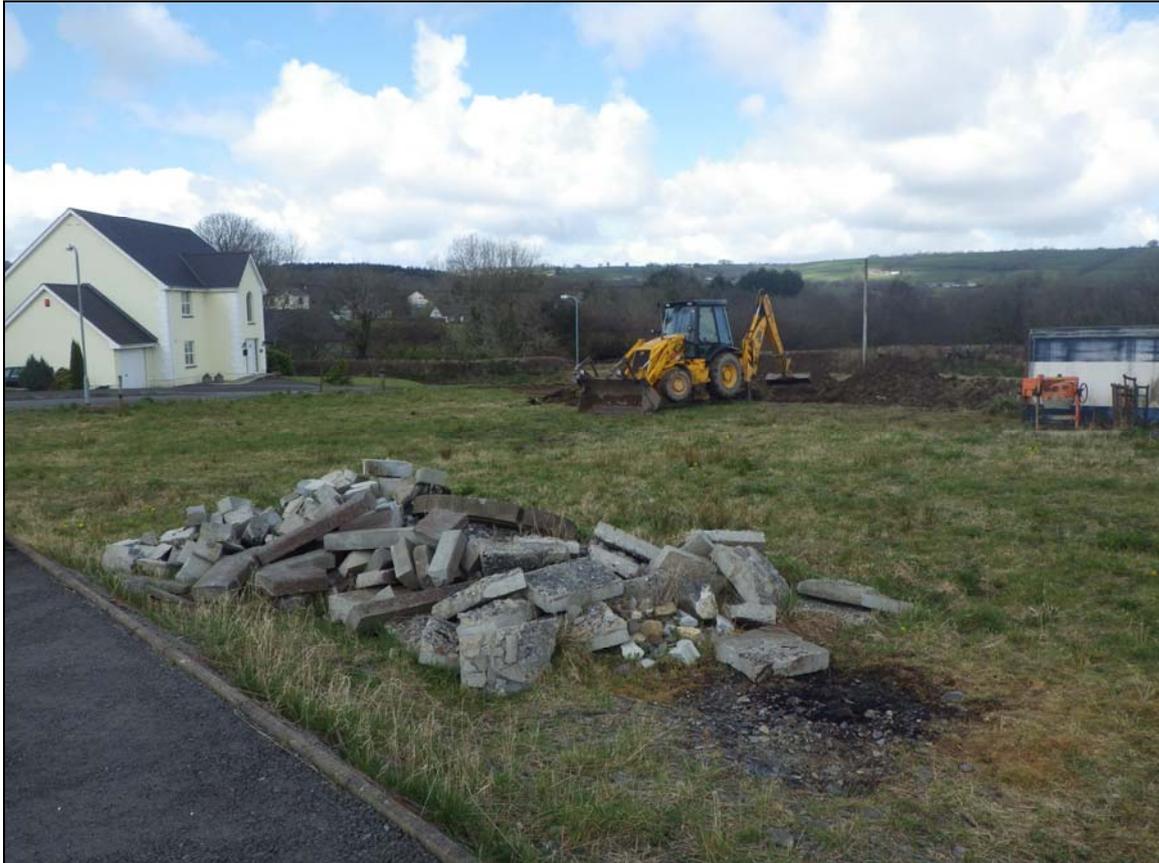
Plate 3: LLL2013_103, The development site before clearance of the topsoil started in 2013, looking northwest across plot 3.

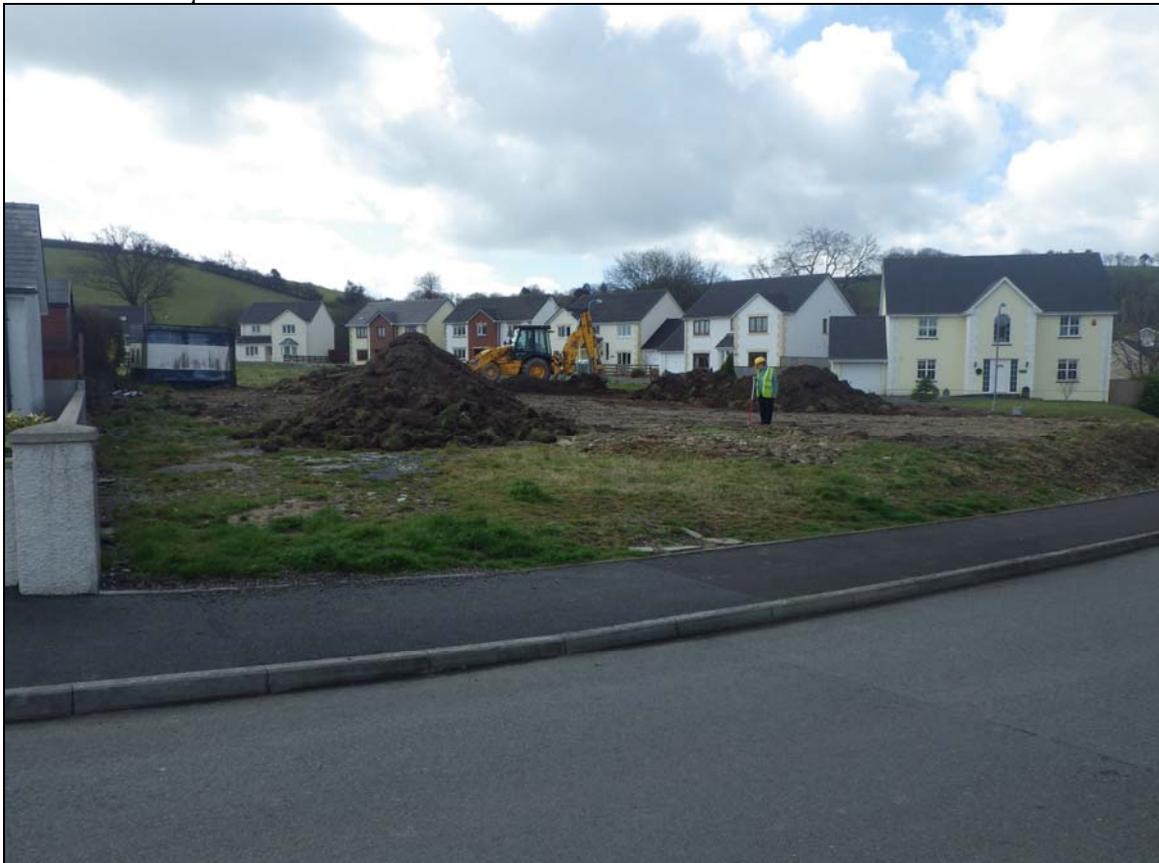
Plate 4: LLL2013_104, Starting clearance of topsoil in plots 1 and 2 down to subsoil looking south.

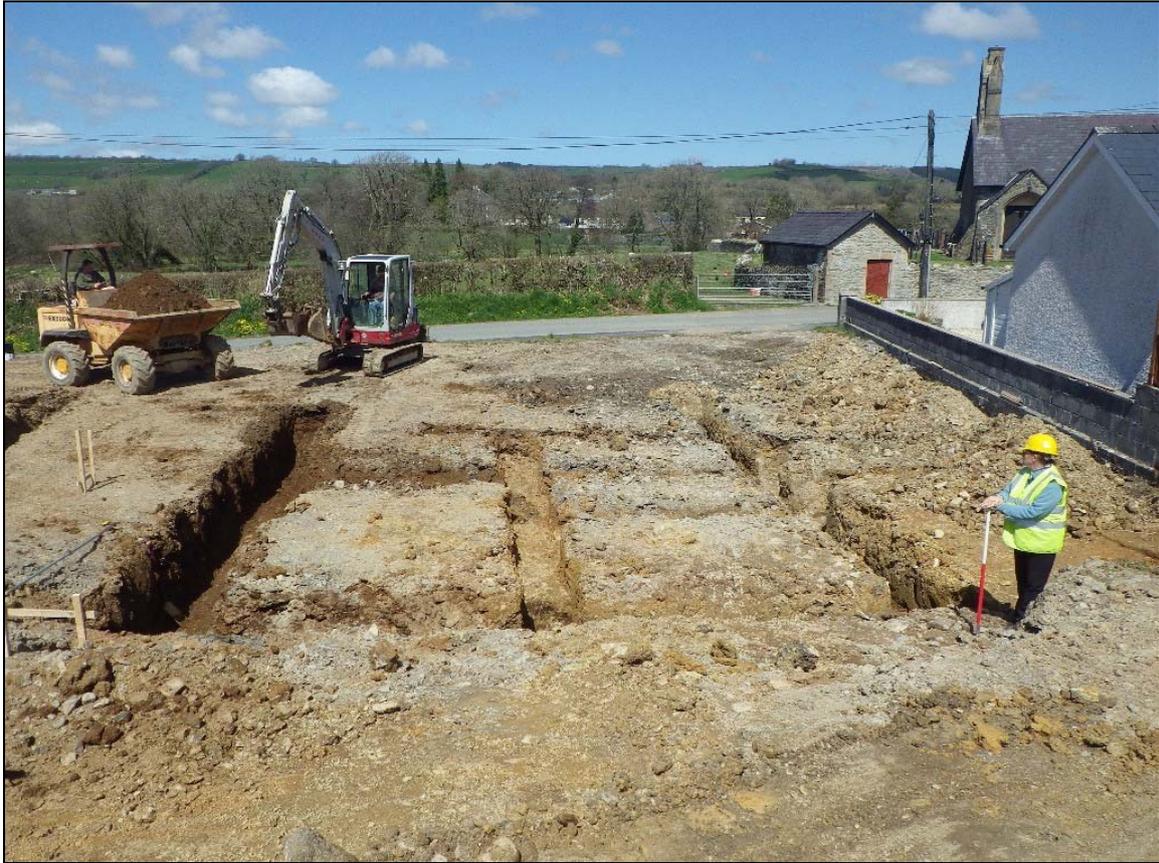
Plate 5: LLL2013_105, foundation trenches for house in plot 1, looking north northwest.

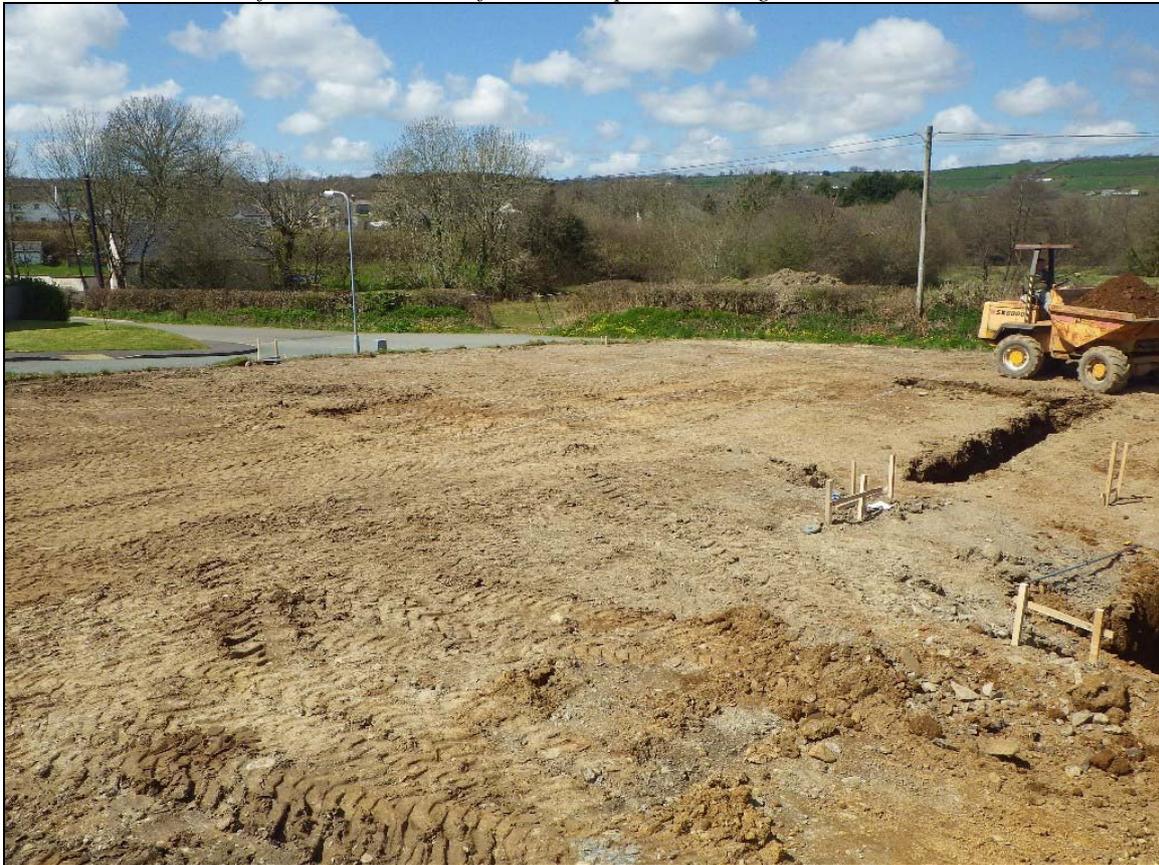
Plate 6: LLL2013_106, Topsoil removed from Plot 2, looking west.

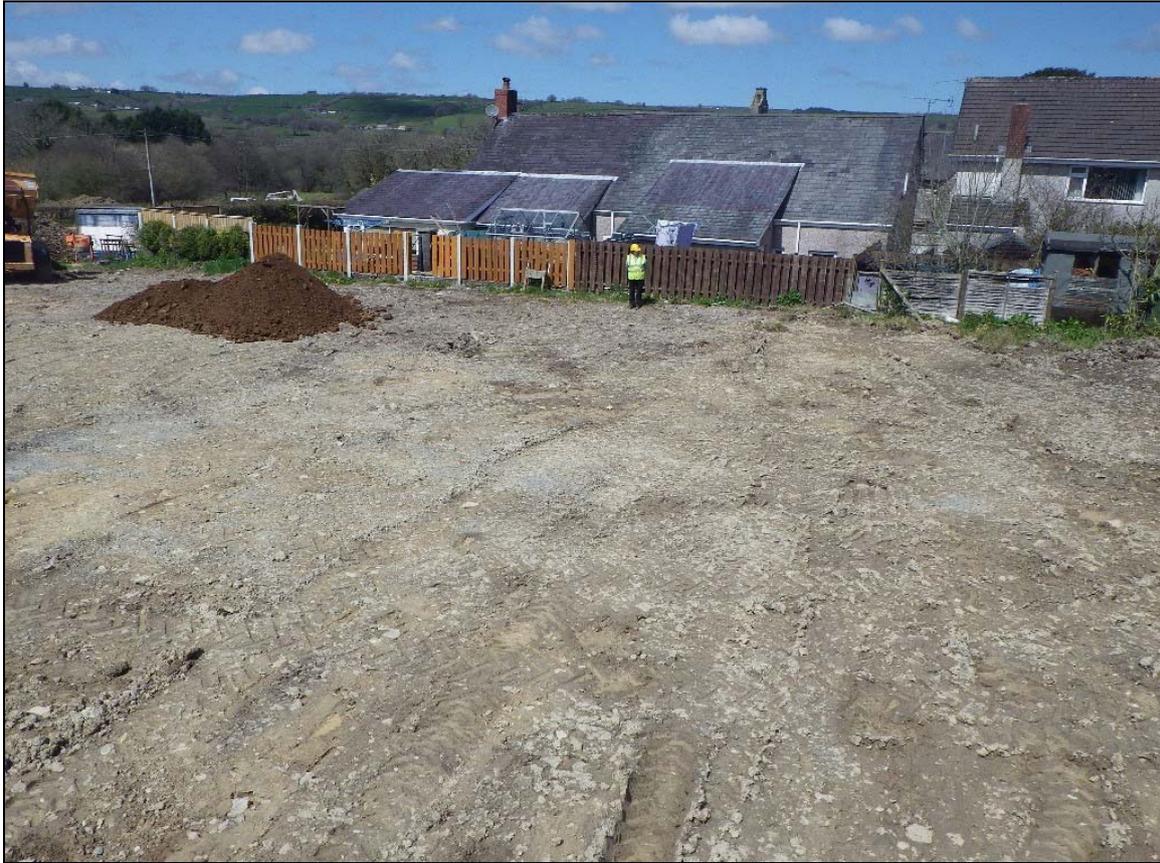
Plate 7: LLL2013_107, Plot 4 cleared, site of former slurry pit, looking north northwest

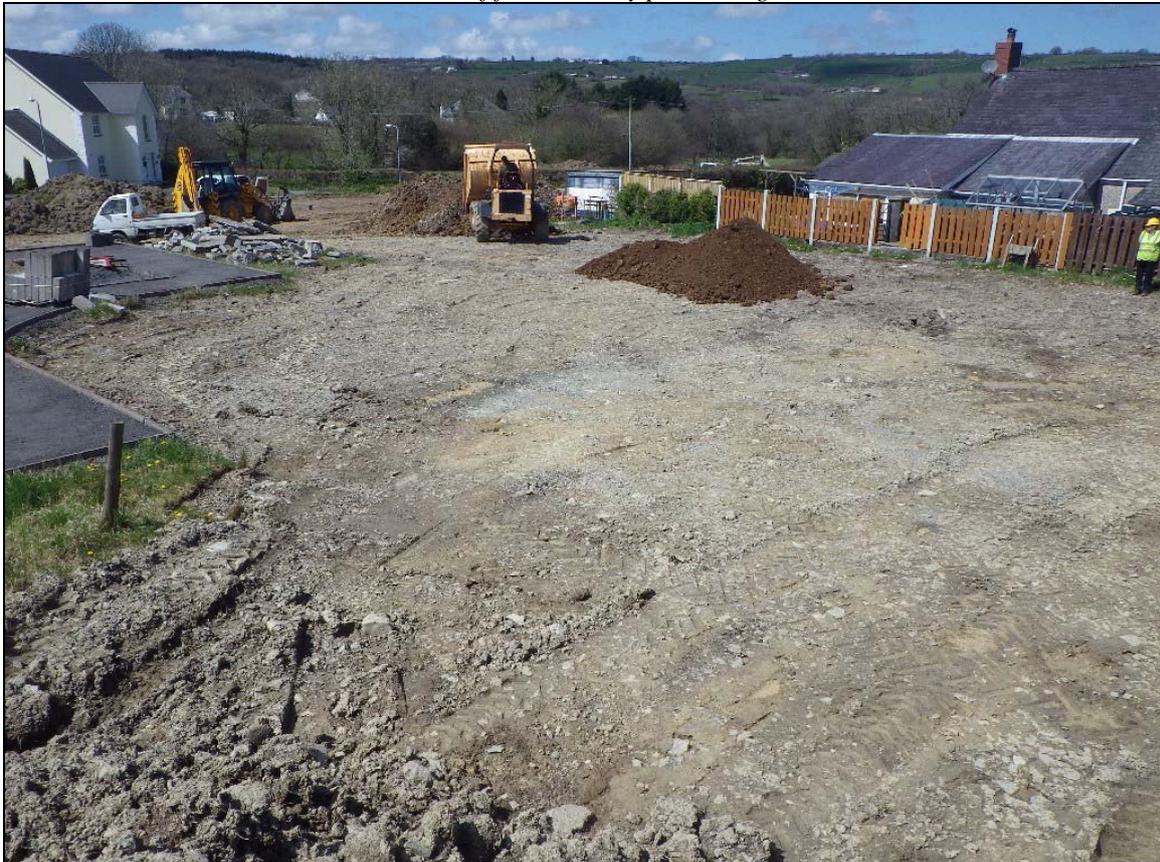
11.2 In plot 4 much of the area was covered by 002, a very mixed material, including modern plastic, which was filling a former slurry pit as shown on the 1978 1:2500 Ordnance Survey map. The rest of the plot was topsoil 001 above natural subsoil 006.

Plate 8: LLL2013_108 Looking across plot 4 to plots 2 and 3 beyond. The mixed fill 002 of the former slurry pit can be seen, looking northwest.
