Pantglas, Llanboidy Carmarthenshire Historic Environment Appraisal

Pantglas, Llanboidy, Carmarthenshire Historic Environment Appraisal

Trysor Project No. 2013/327

For: Ventus Vox

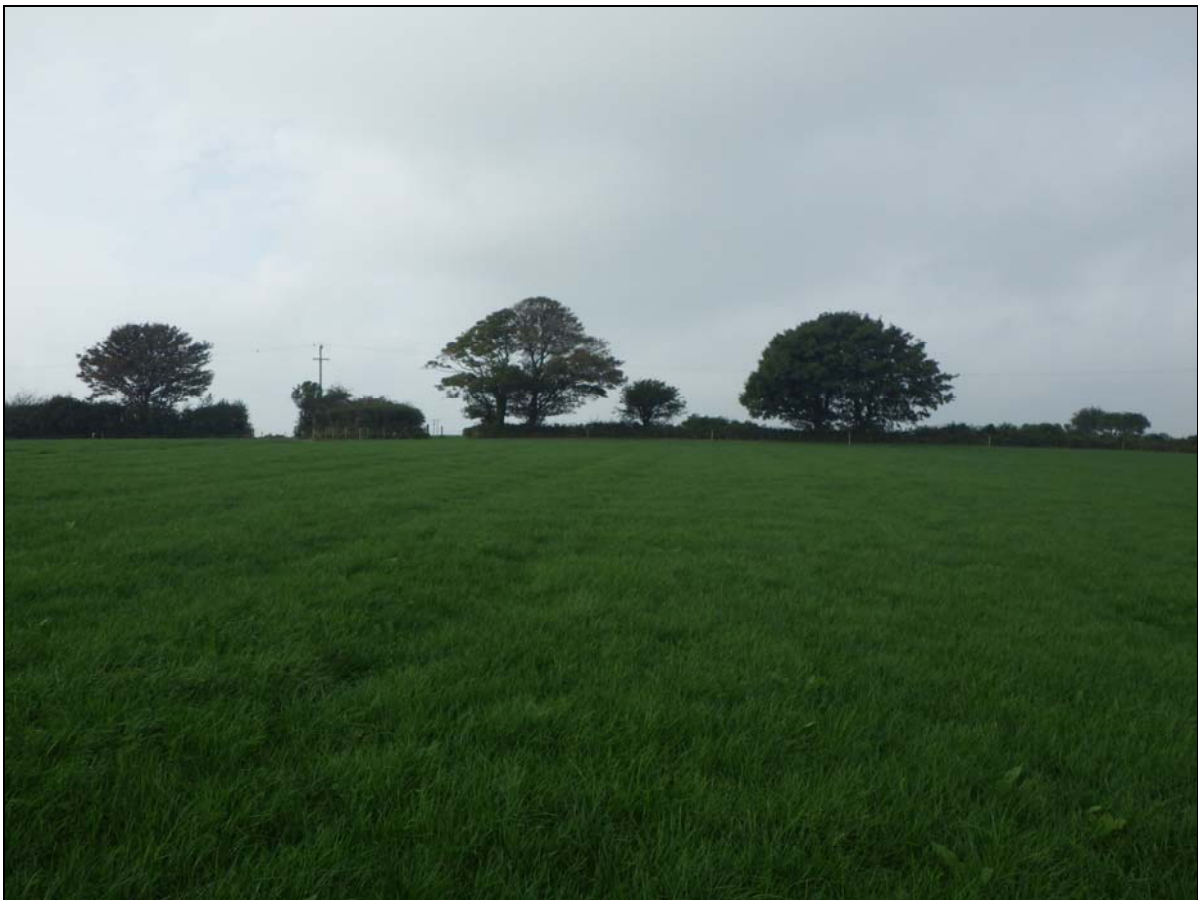
Cover photograph: From the approximate location of the proposed turbine, looking west northwest towards the western field boundary. Round barrow ID number 7 lies within the field beyond.

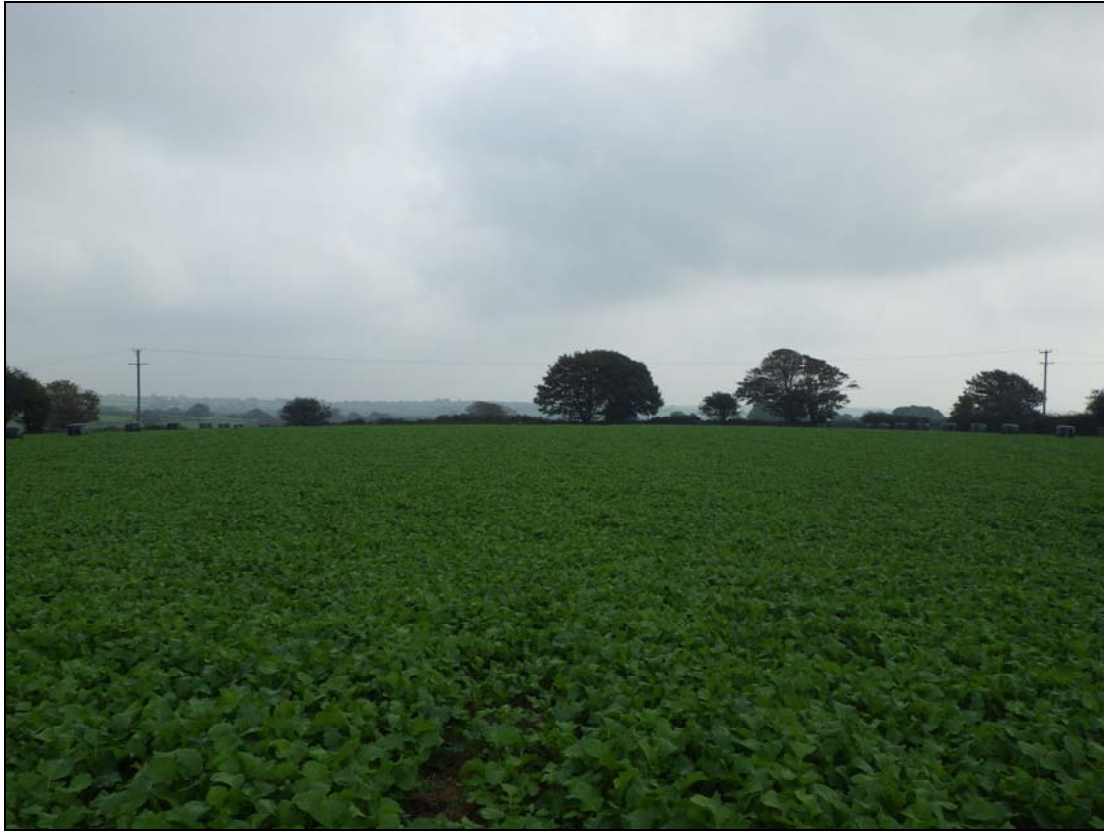
Plate 1: The view east-south east from round barrow ID number 7. The proposed turbine would stand behind the middle tree of the three large trees to the right in the photograph.

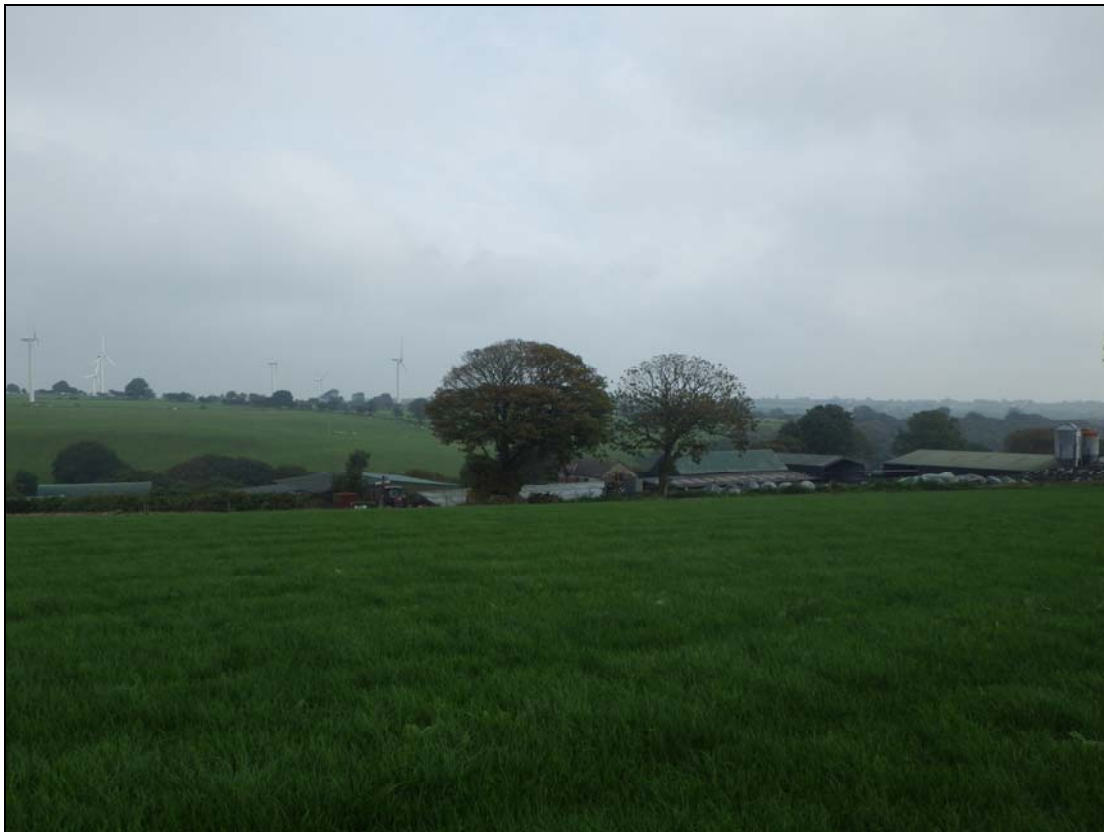
Plate 2: The view northeast from the proposed turbine site, overlooking the buildings of Pantglas Farm, with part of the Dyffryn Brodyn Wind Farm visible in the middle distance.
