Rhyddgoed, Tavernspite Carmarthenshire Historic Environment Appraisal and Walk-over

For: TGVHydro Ltd

June 2015

Trysor Project No. 2015/448

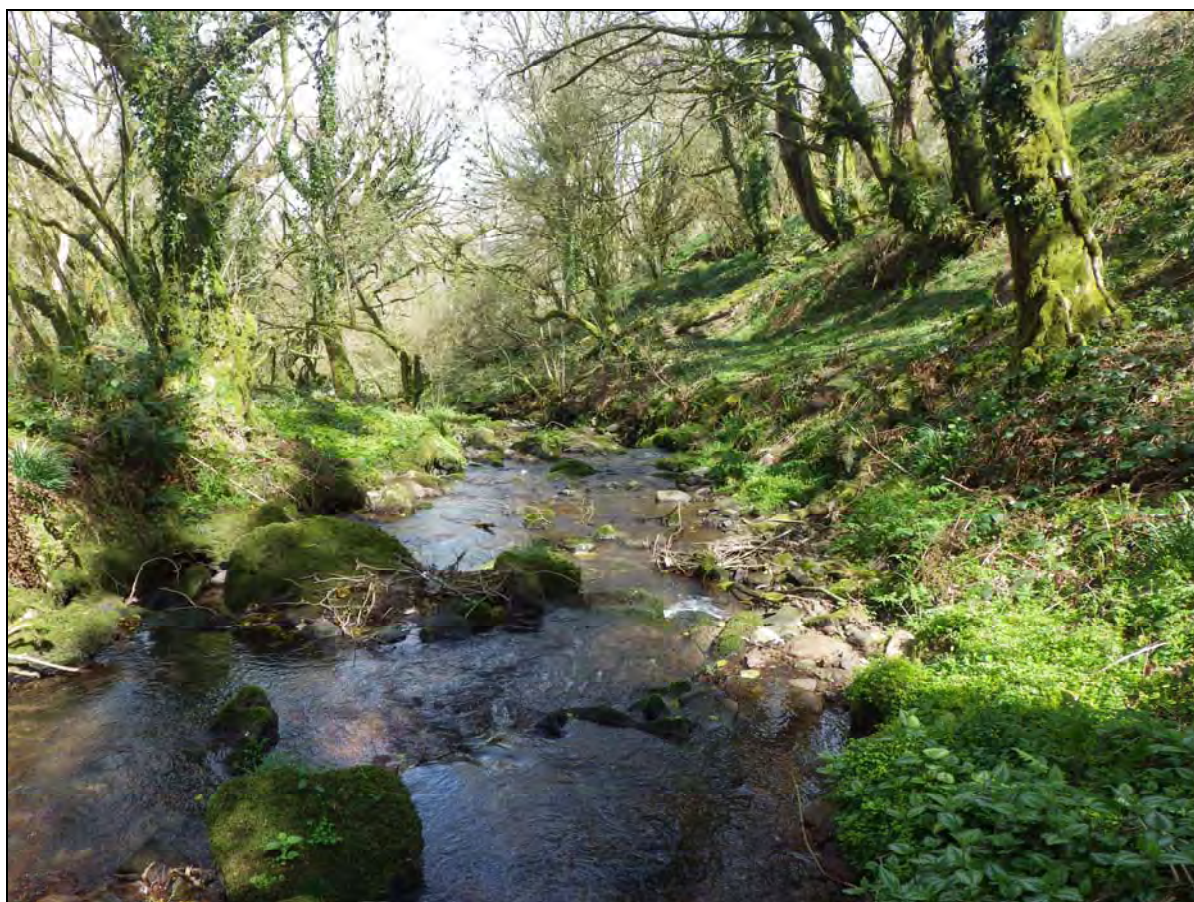
*Cover photograph: Looking north, downstream, down the Afon Cwm valley
from the intake location.*
