Rhydygwydd, Taliaris, Carmarthenshire Historic Environment Appraisal Revised

Report by: Trysor

For: Seren Energy Ltd

Trysor Project No. 2014/348

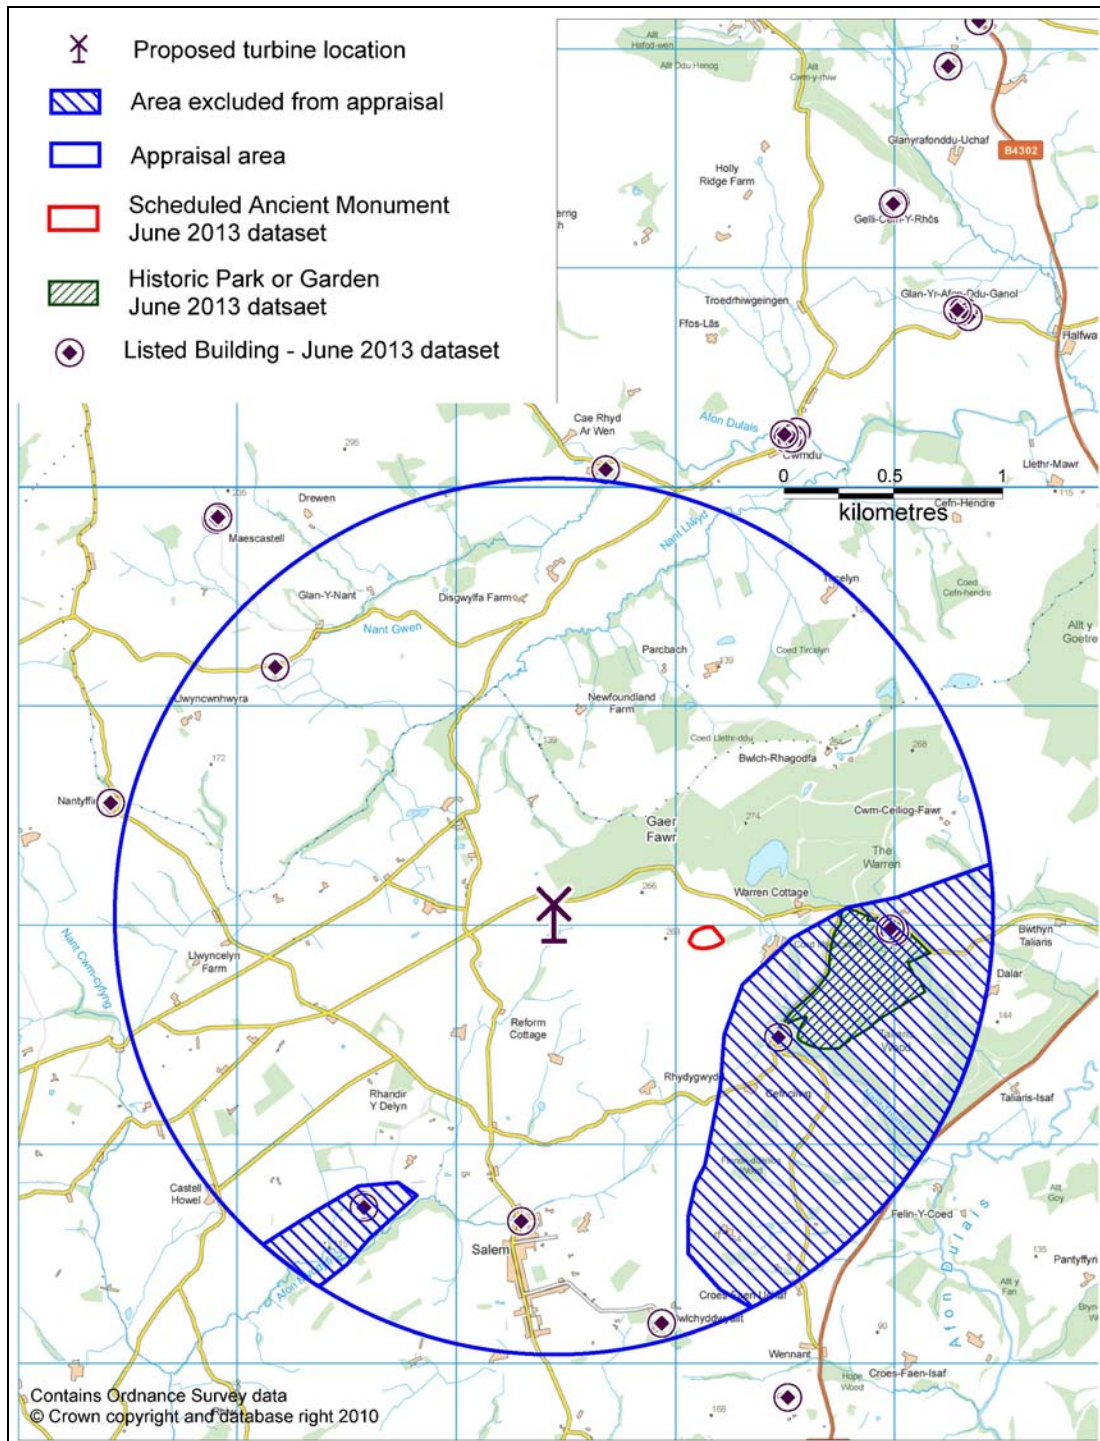
Figure 2: Showing the area excluded from the appraisal area as there would be no intervisibility with the proposed turbine.

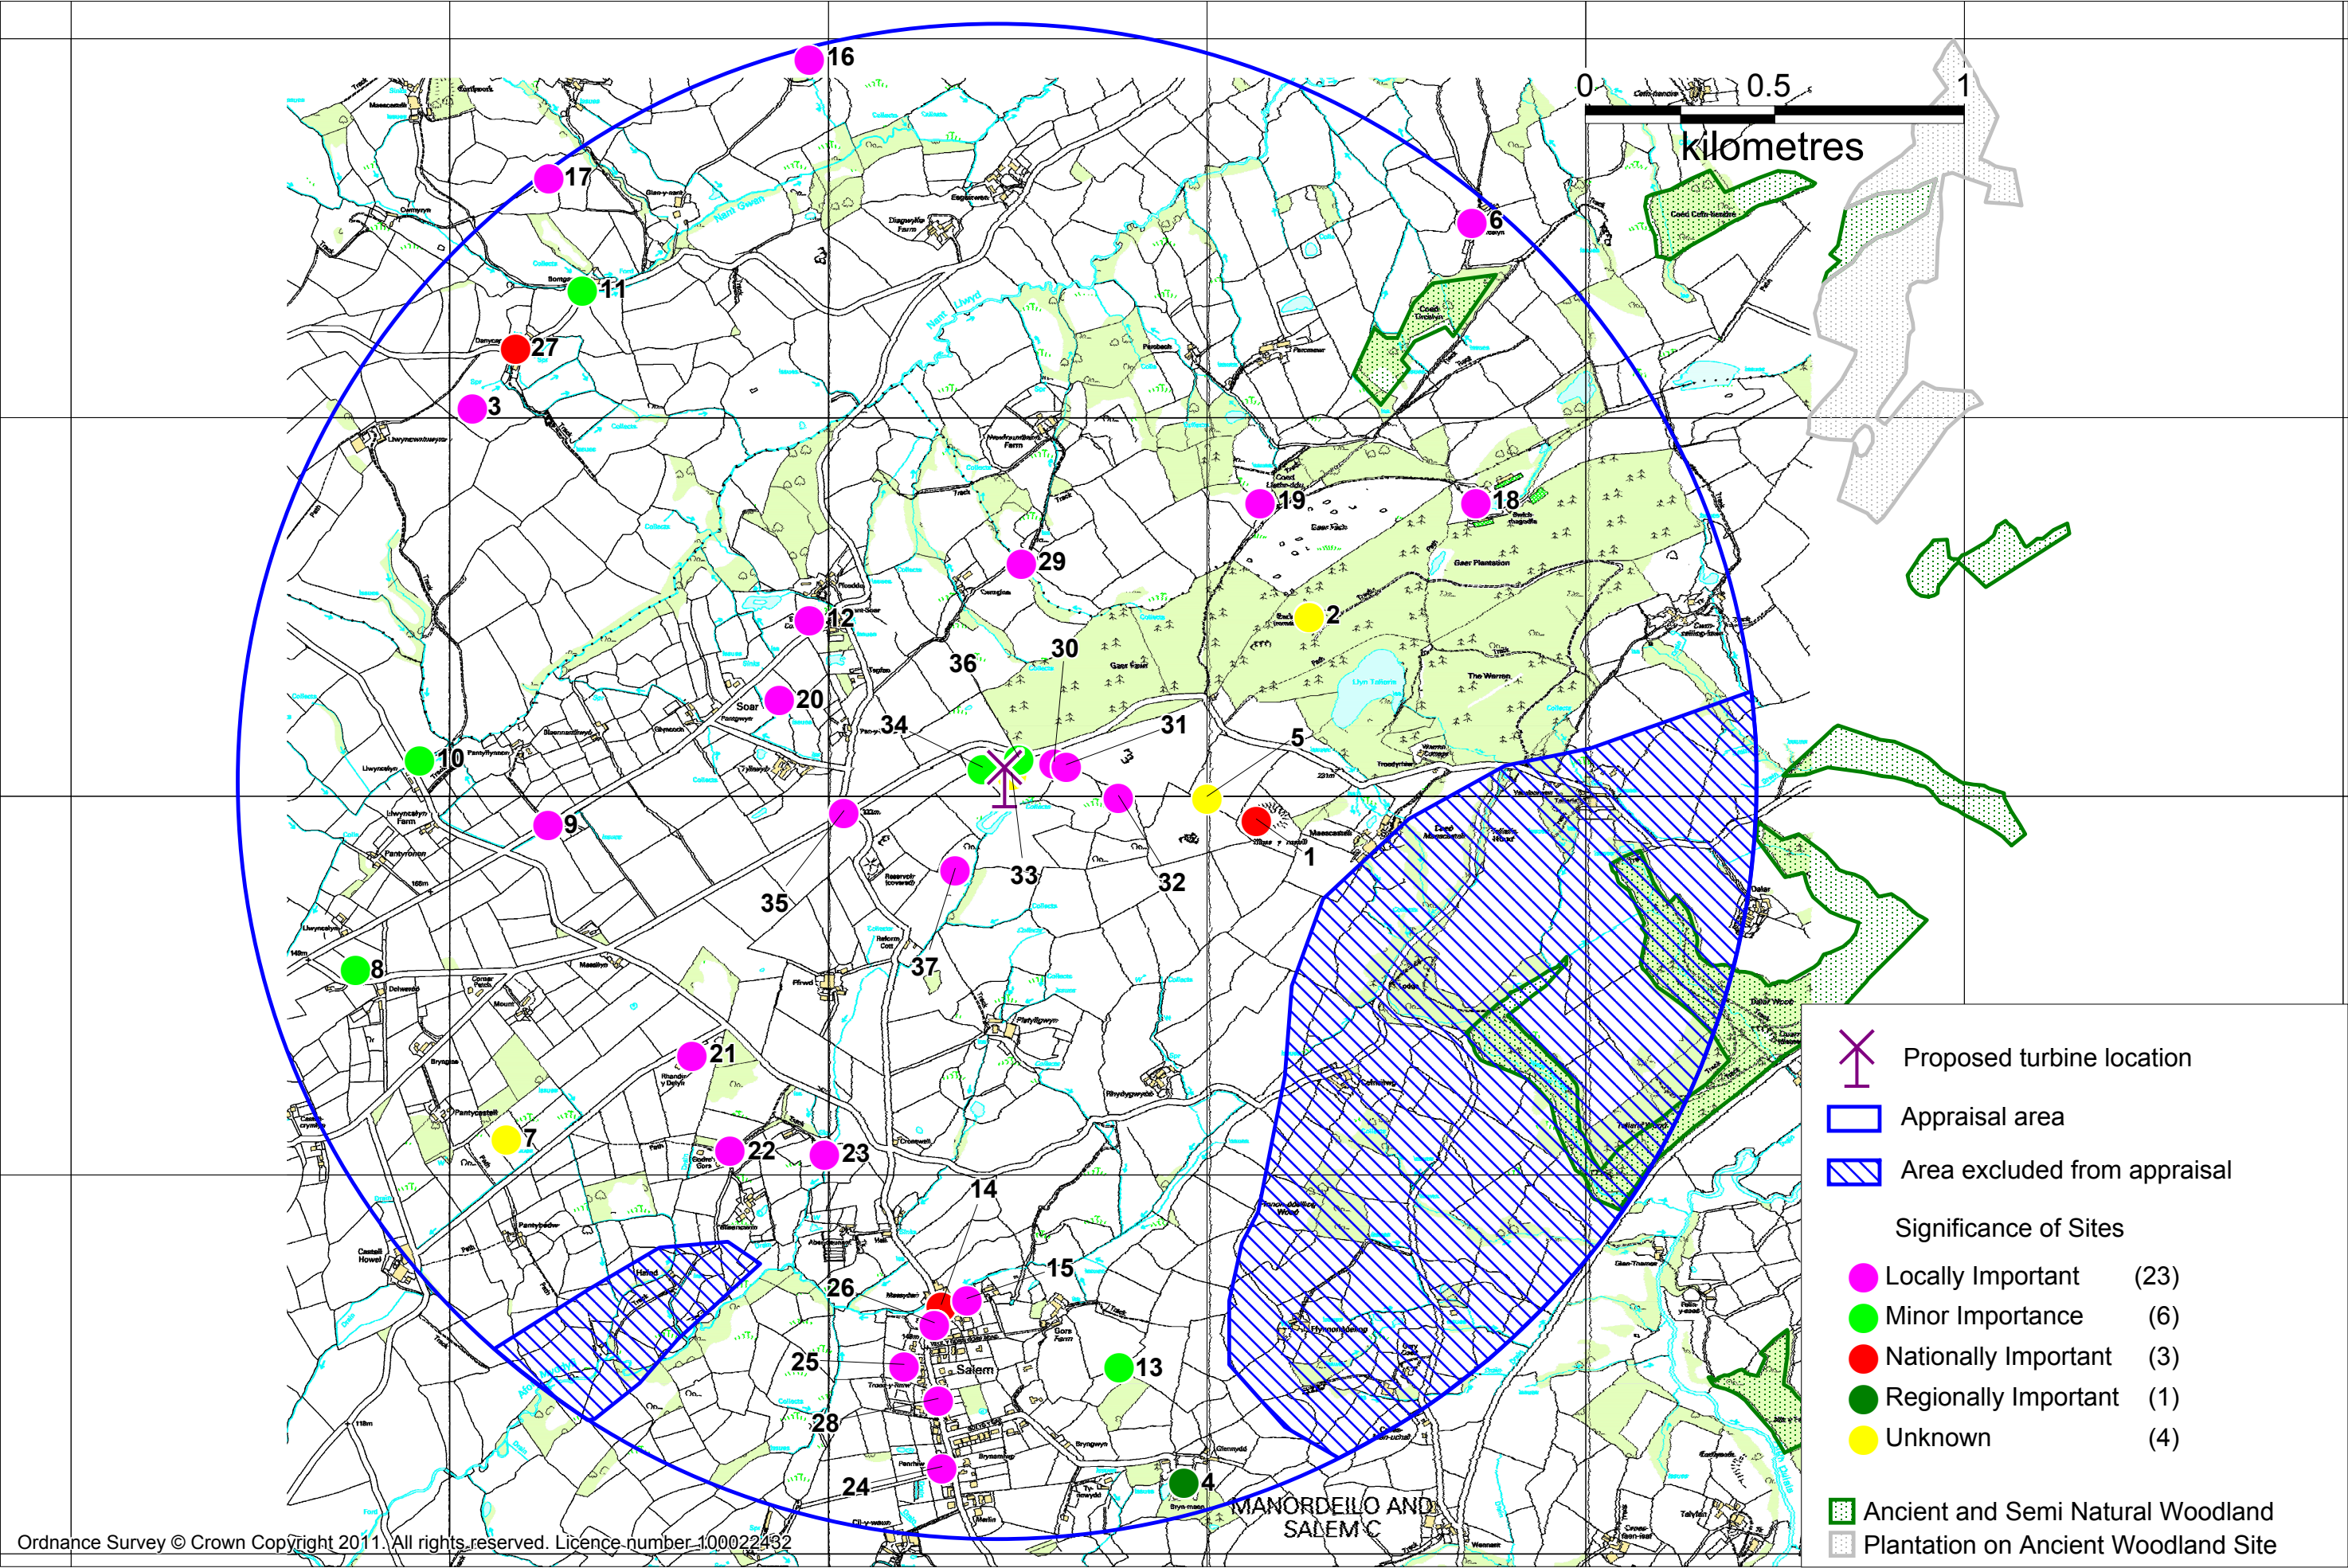
Figure 3: The 2km appraisal area showing significance of sites, labelled with Project ID number

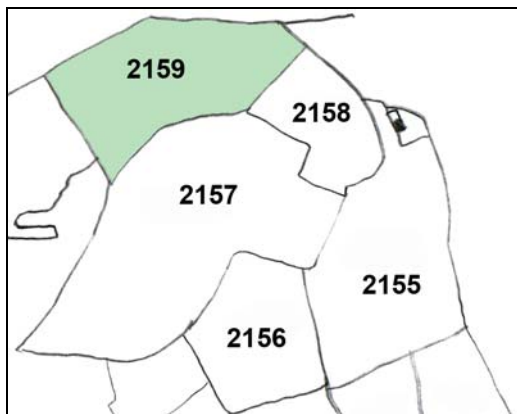
6.3 The Llandeilo Fawr parish tithe map of 1841 shows the field system here in detail. The field parcel in question formed the eastern half of a larger field named *Y Bank* by the tithe schedule. The land was at that time part of the farmstead of Cwm Ceiliog, a holding on the Taliaris estate, nearly 2km to the east-northeast of *Y Bank*.

Figure 4: Land at Y Bank (parcel 2159) as shown on the Llandeilo Fawr parish tithe map of 1841.

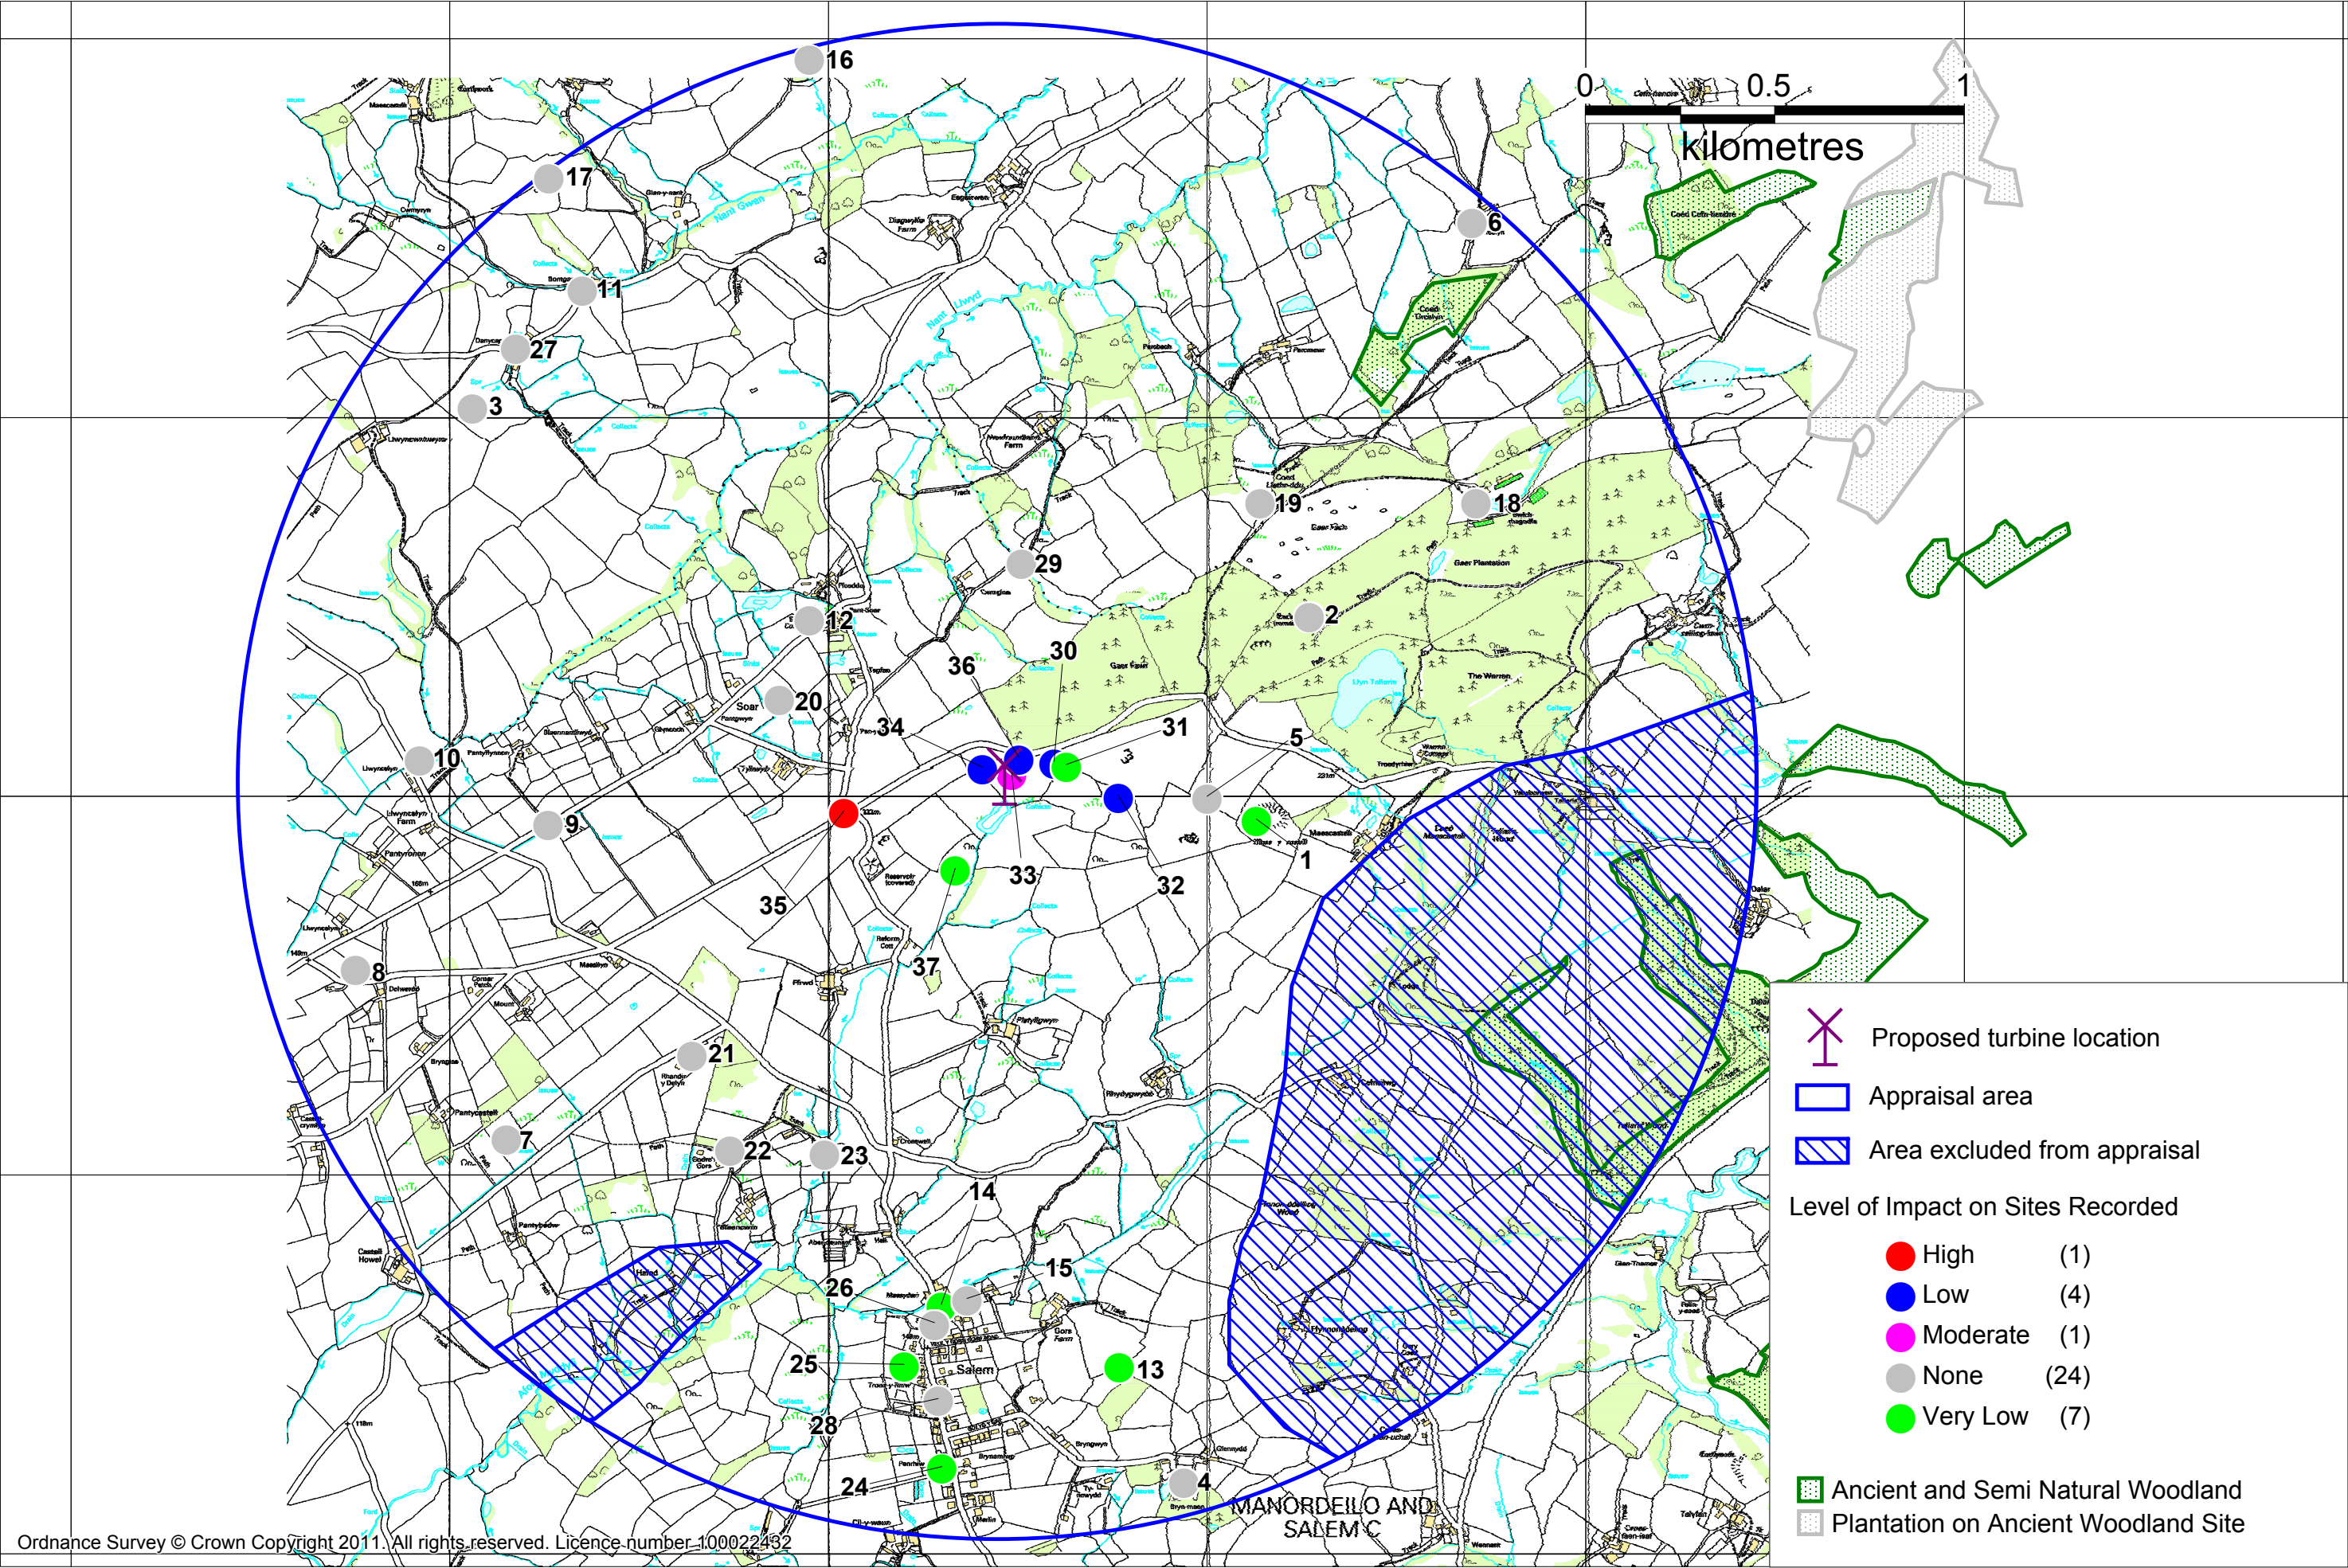
8.2 The Direct and Indirect impact on each site was assessed taking into account both physical and non-physical impacts. Each impact was assessed within the scale Very Low, Low, Moderate, High and Very High, taken into account the significance of the site and the nature of the impact. A full table is found in Appendix A but a summary is tabulated in Table 1 below and illustrated in Figure 5.

Figure 5: The 2km appraisal area showing level of impact on sites recorded, labelled with Project ID number

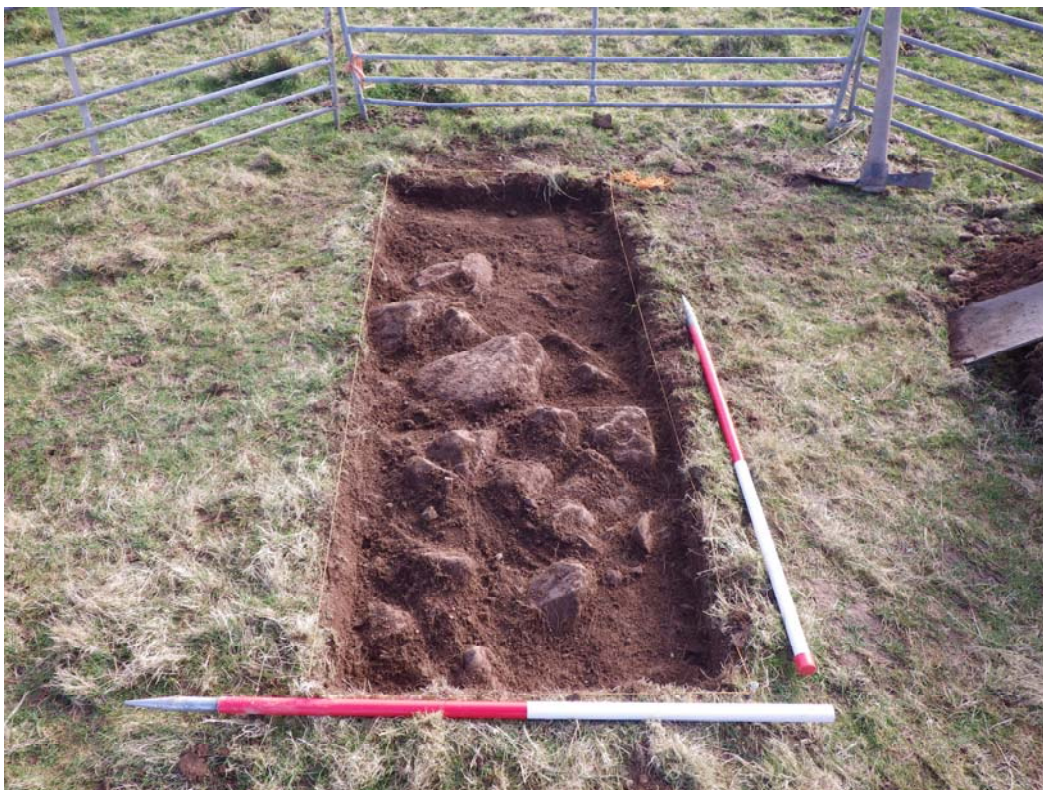
10.2 The evaluation was undertaken on March 4th, 2014. A 2 metre x 0.75 metre evaluation trench was opened. It was found that the grass cover was thin and immediately below the surface the stones of a small, man-made cairn were revealed. It is difficult to be certain of the dimensions of the cairn, most of which remained buried, but was thought likely that it would be up to 4 metres in diameter.

Plate 1: The stone cairn (ID number 33) revealed in the evaluation trench

8.5 A new access track would be created via an existing gateway, which would be widened for ease of entry into the field. The access track, as originally proposed, would have passed very close to cairn ID number 33. Mitigation has been undertaken to reposition the access track and an associated hardstanding area. A buffer zone and plans to fence of the cairn are proposed to ensure the cairn will not be damaged by vehicles or machinery during construction.

10.5 Having established the existence of the cairn, Seren Energy have subsequently amended the design of the access track and hardstanding area for the turbine in order to ensure that the feature will be avoided. It would be fenced off during the construction phase to avoid unintended damage by vehicles or machinery.
