Trefawr, Llanfyrnach Pembrokeshire Historic Environment Appraisal

For: Cymdeithas Cwm Arian

Trefawr, Llanfyrnach, Pembrokeshire Historic Environment Appraisal

Trysor Project No. 2013/306

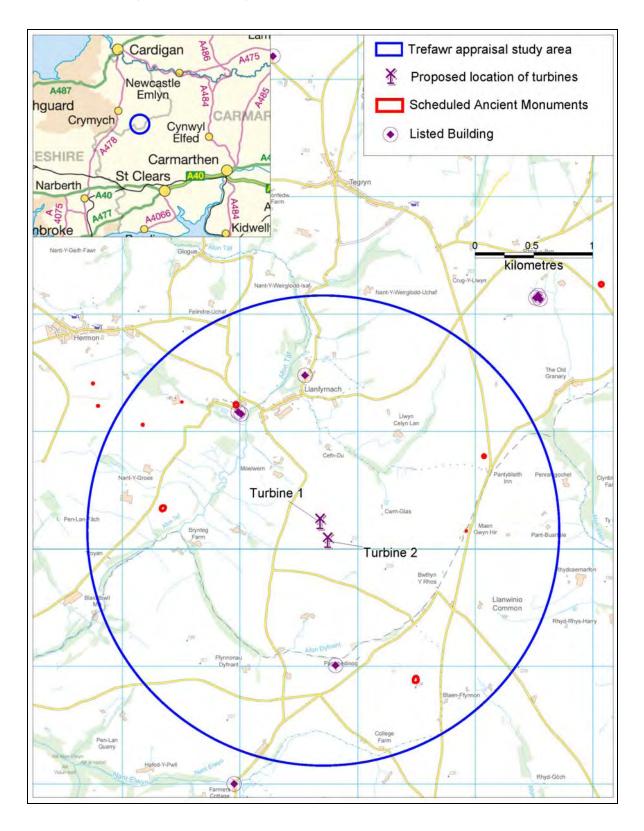
Figure 1: Location of the proposed turbine, showing the 2km radius appraisal area.

4.1 It is proposed that two wind turbines, 170 metres apart will be located in two adjacent field parcels at Trefawr Farm, Llanfyrnach, Pembrokeshire. The central point between the two proposed turbines is SN2272030140, see Figure 1. The turbines will have a 50m hub height and a 54m rotor diameter giving an overall blade tip height of 77m.

5.2 An appraisal search area of 2km radius centred on SN2272030140 was agreed with Dyfed Archaeological Trust Heritage Management section, see Figure 1, as was the specification (Trysor 2013)

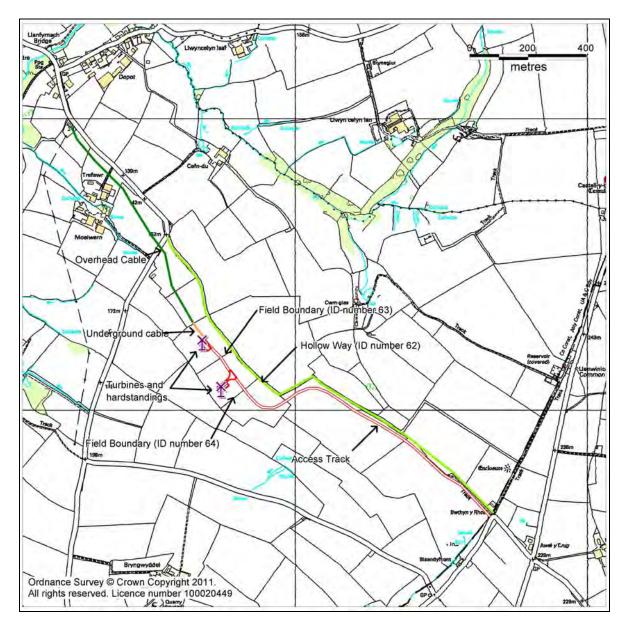
Figure 2: the location of the turbines and the access track and cables, and the recorded hollow way and field boundary

4.2 The turbines will require octagonal foundation holes approximately 12 metres by 12 metres and up to 1.5 metres deep. Each turbine will have a hardstanding for construction cranes measuring 35 metres by 15 metres. A new access trackway, about 1 km in length, will be laid from the southeast, using existing gateways and breaks in boundaries which may need to be widened. Both the trackway and hardstandings will include some removal of the topsoil. The trench for the underground cable will be 0.40 to 0.45m wide and 0.70 to 1m deep. It will run northwestwards for about 60 metres to connect to a new overhead line, see Figure 2.

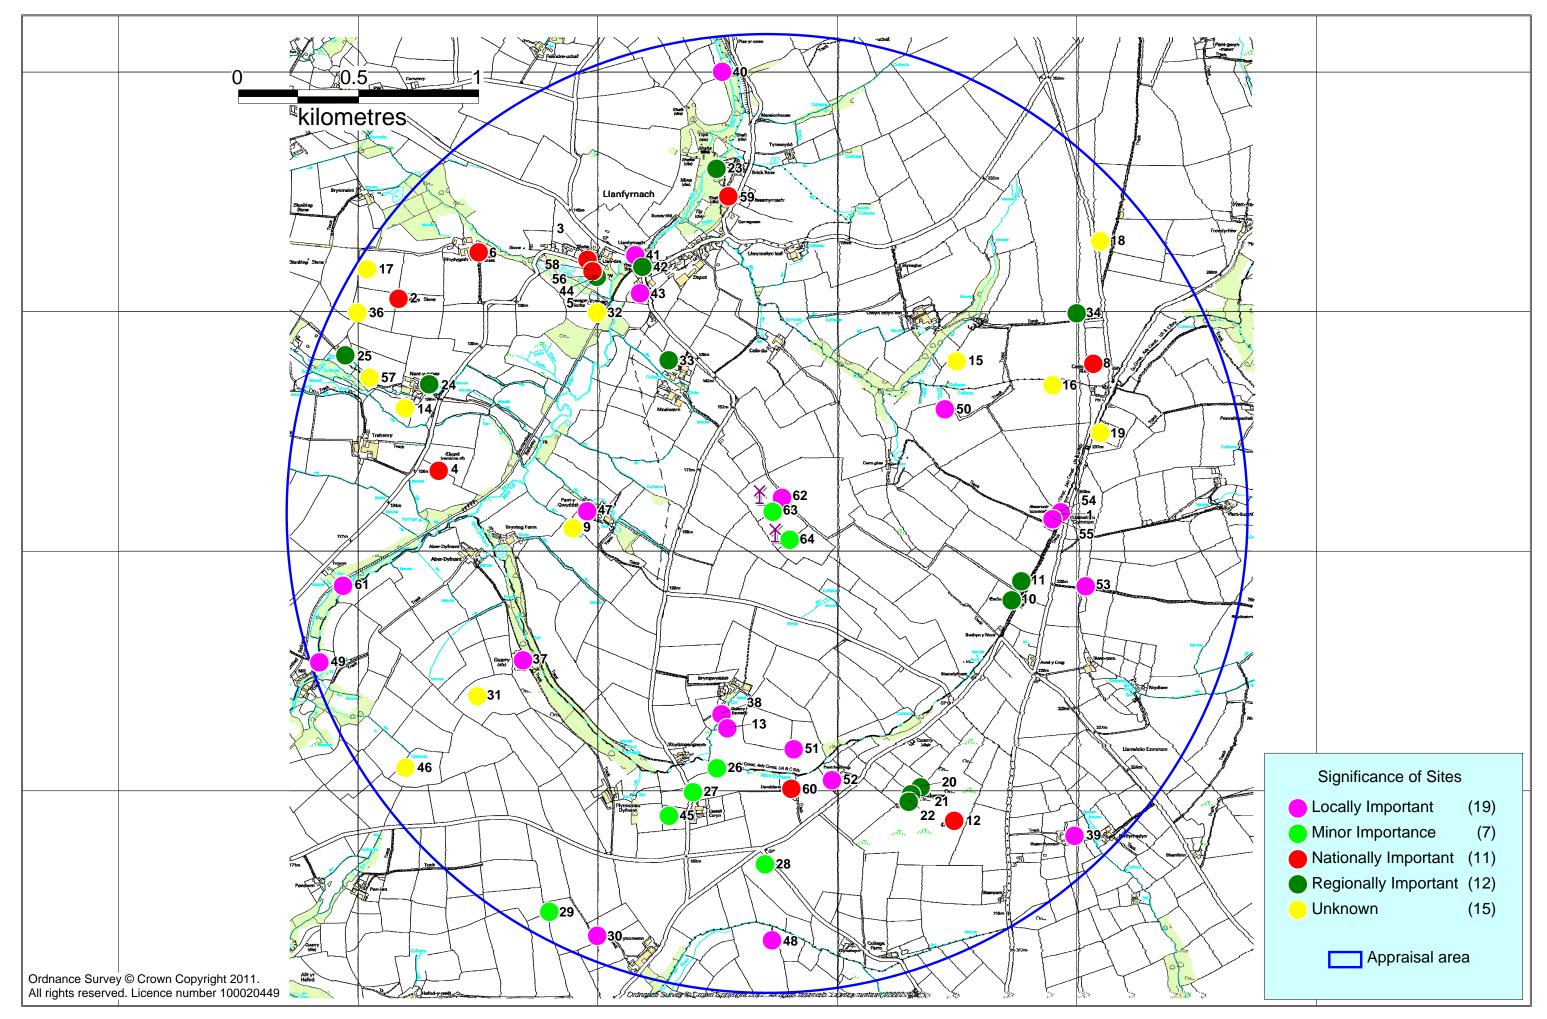
Figure 3: Sites showing significance, labelled with Project ID number

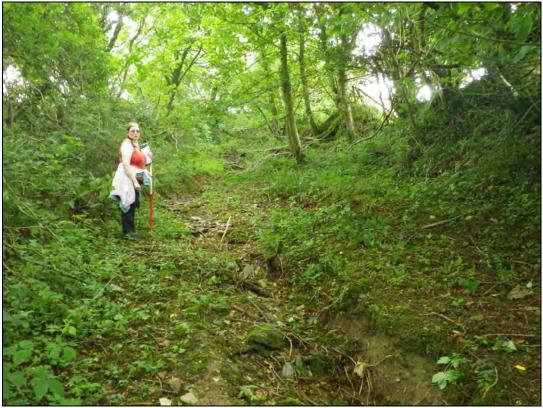
Plate 1: Within the hollow way (ID number 62) on the northeast side of the fields where the turbines would be located. The hollow way is deepest at its northwest end and becomes shallower as it goes up hill to the southeast. Water erosion has removed the soil in places to reveal bedrock.

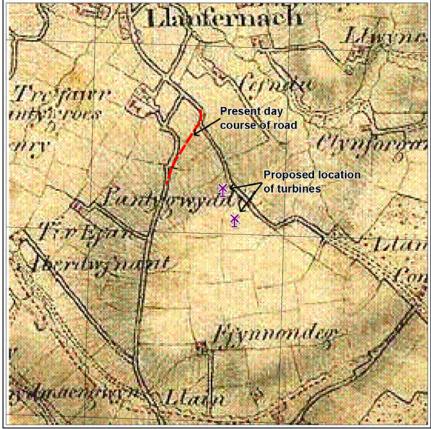
Figure 4: The 1810 Ordnance Survey Original Surveyors Drawing showing the original course of the road south from Llanfyrnach.

7.1 The Trefawr farmstead is shown on the 1810 Cardigan Ordnance Survey Original Surveyors Drawing in its present position. However the road running past the farm southwards from Llanfyrnach took a slightly different course, and the hollow way (ID number 62) was a road running southeast up onto the unenclosed land of Llanwinio Common, see figure 4.

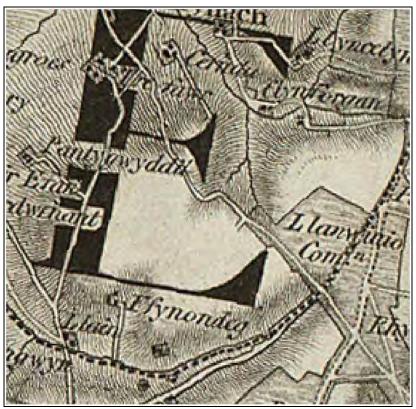
Figure 5: the 1819 edition Ordnance Survey map showing similar road pattern to that of the Original Surveyors Drawing in Figure 4.

7.3 The same road layout is shown on the 1819 Ordnance Survey map, but the field boundaries are not depicted, Figure 5.

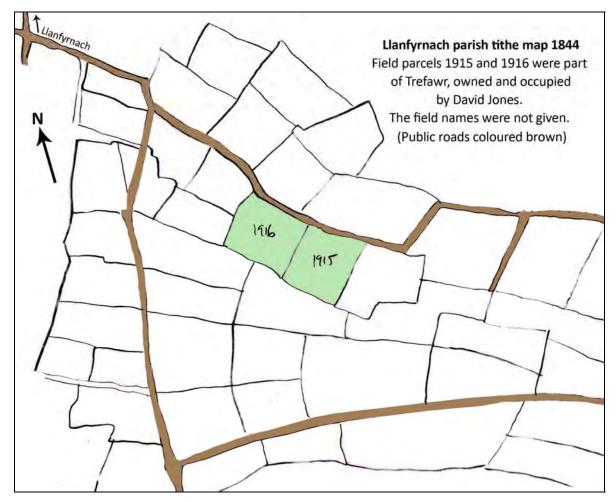
Figure 6: the tithe map of 1844 shows the realignment of the road running south from Llanfyrnach, the insertion of the road running east to west and the apparent change of field boundaries between this road and the hollow way (ID number 62)

7.4 The tithe map of 1844 shows that several changes had occurred within the previous two decades. The road running south from Llanfyrnach now followed its present day course, and the east to west road, south of the proposed turbine locations, inserted. This seems to have led to the field boundaries being rearranged to accommodate it, see Figure 6.

7.5 The tithe survey shows that Trefawr was owned and occupied by David Jones. This included the fields, numbered 1915 and 1916 on the tithe map, where the turbines would stand which are the same shapes and size as today, see Figure 6. The Llanfyrnach tithe map does not give field names.

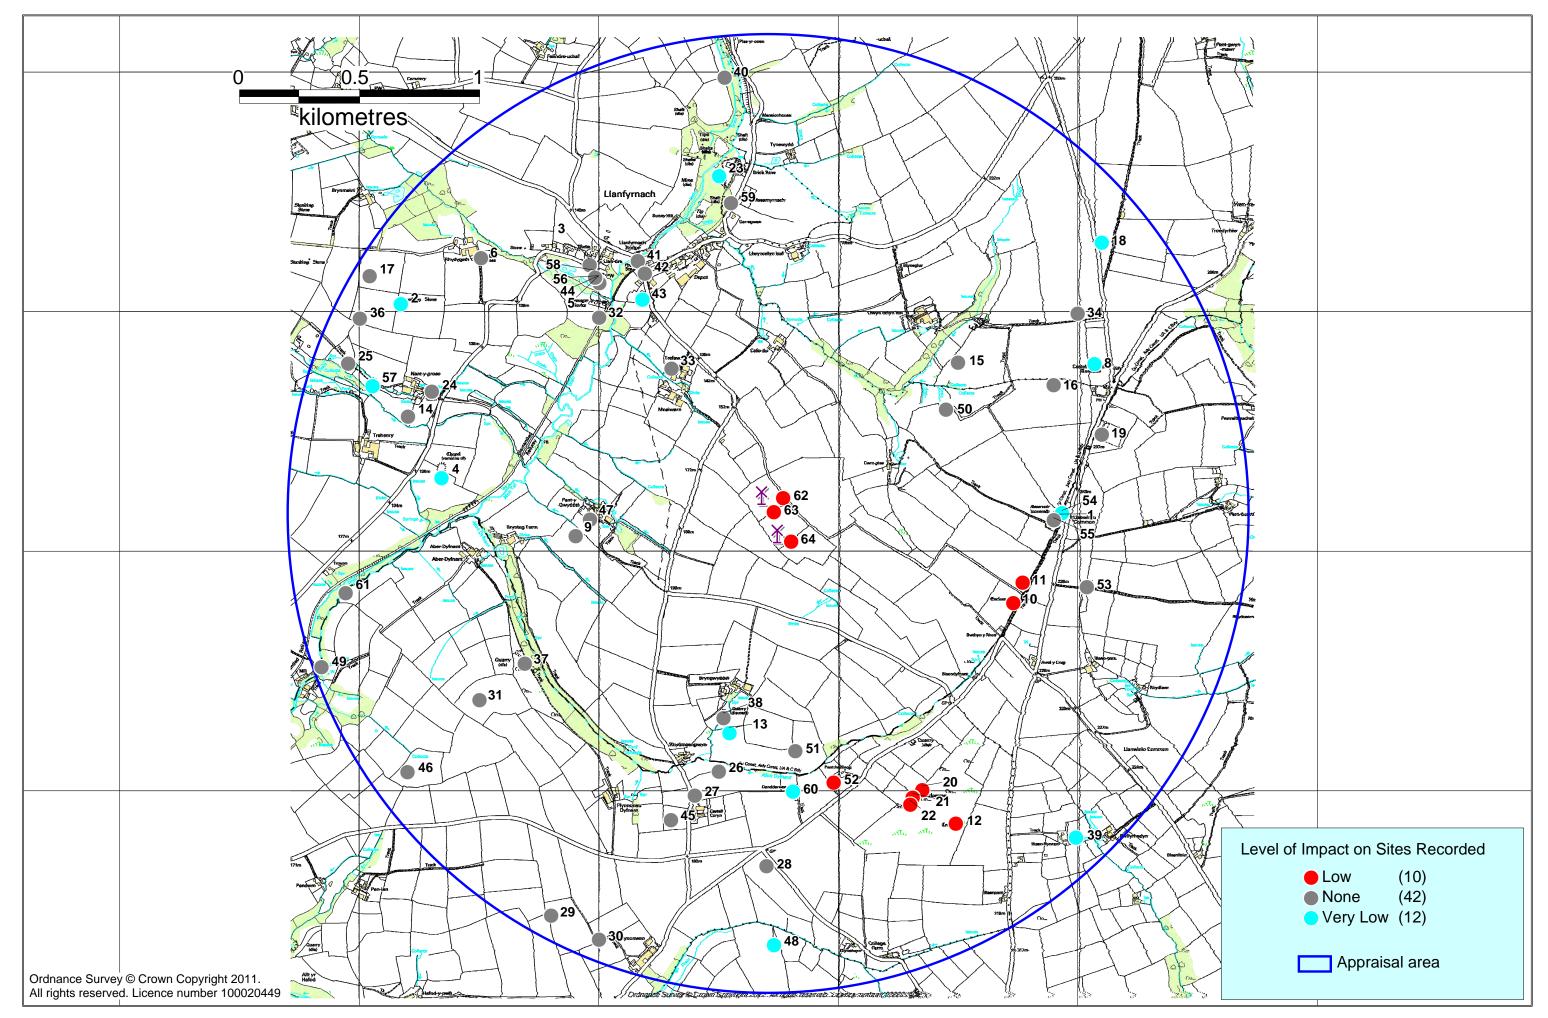
Figure 7: Sites showing impacts, labelled with Project ID number

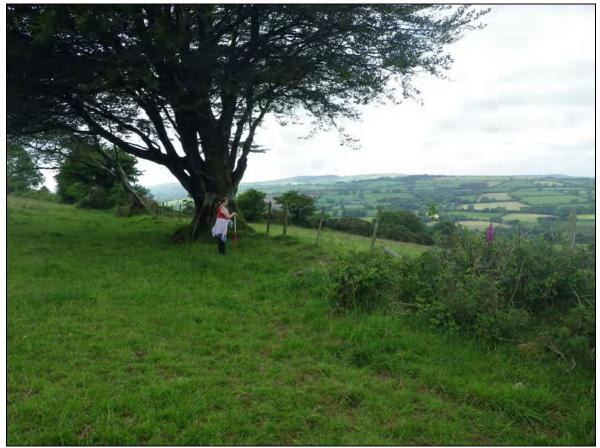
Plate 2: Field boundary (ID number 63) looking west.

9.7 The only mitigation thought necessary in relation to the cable trench is to ensure that the disturbance to the banks and hedges is minimised and any cut through any boundaries should be followed by the restoration of the banks and the replacement of any affected hedgerow.
