PRESELI ESA, HISTORIC MONITORING

BASELINE 1994

OS 1:10000 SHEET: SM/SN 13 SW	GRID REF: SM/SN 1215 3378
PRN: 11510 SITE NAME: CARNGOEDOG	
AIR PHOTO No 70/92/154 No GROUND PHOTOS:	LANDSCAPE TYPE: A
DATE SURVEYED: 1/12/94	SURVEYED BY: G.A. Hopwood
ACCESS: Common land. Park on track at G. Ref: SW 120348.

PRESELI ESA HISTORIC MONITORING RESURVEY 1997/98

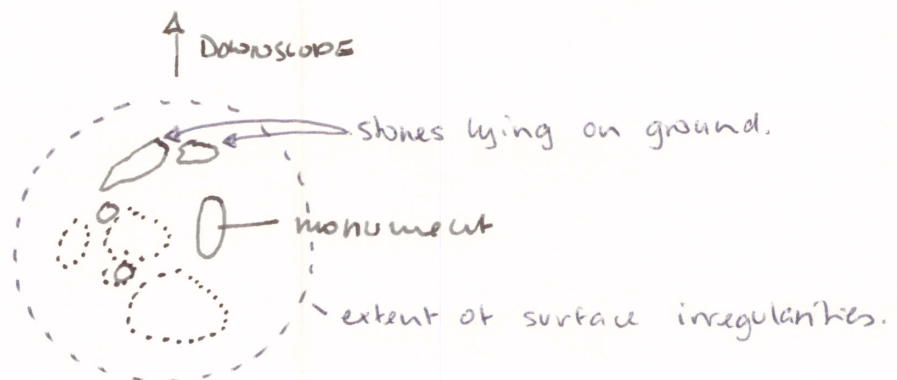
D activity.

Edges of the stone have been smoothed by animal rubbing.

Whole area around stone is irregular + has a wumpy appearance.

○ = badger hole.

⊙ = digging + pile of earth.
