PRESELI ESA, HISTORIC MONITORING

BASELINE 1994

OS 1:10000 SHEET: SM/SN 14 SE	GRID REF: SM/SN 1719 4253
PRN: 1175 SITE NAME: GAGER Y	
AIR PHOTO No 31/92/043	LANDSCAPE TYPE: E
No GROUND PHOTOS: 9	
DATE SURVEYED: 1/12/94	SURVEYED BY: G.A. HOPEWOOD
ACCESS: Mrs James, Penralltdu farm. Grid ref: 170425 Tel: Cardigan 612785.

PRESELI ESA HISTORIC MONITORING RESURVEY 1997/98

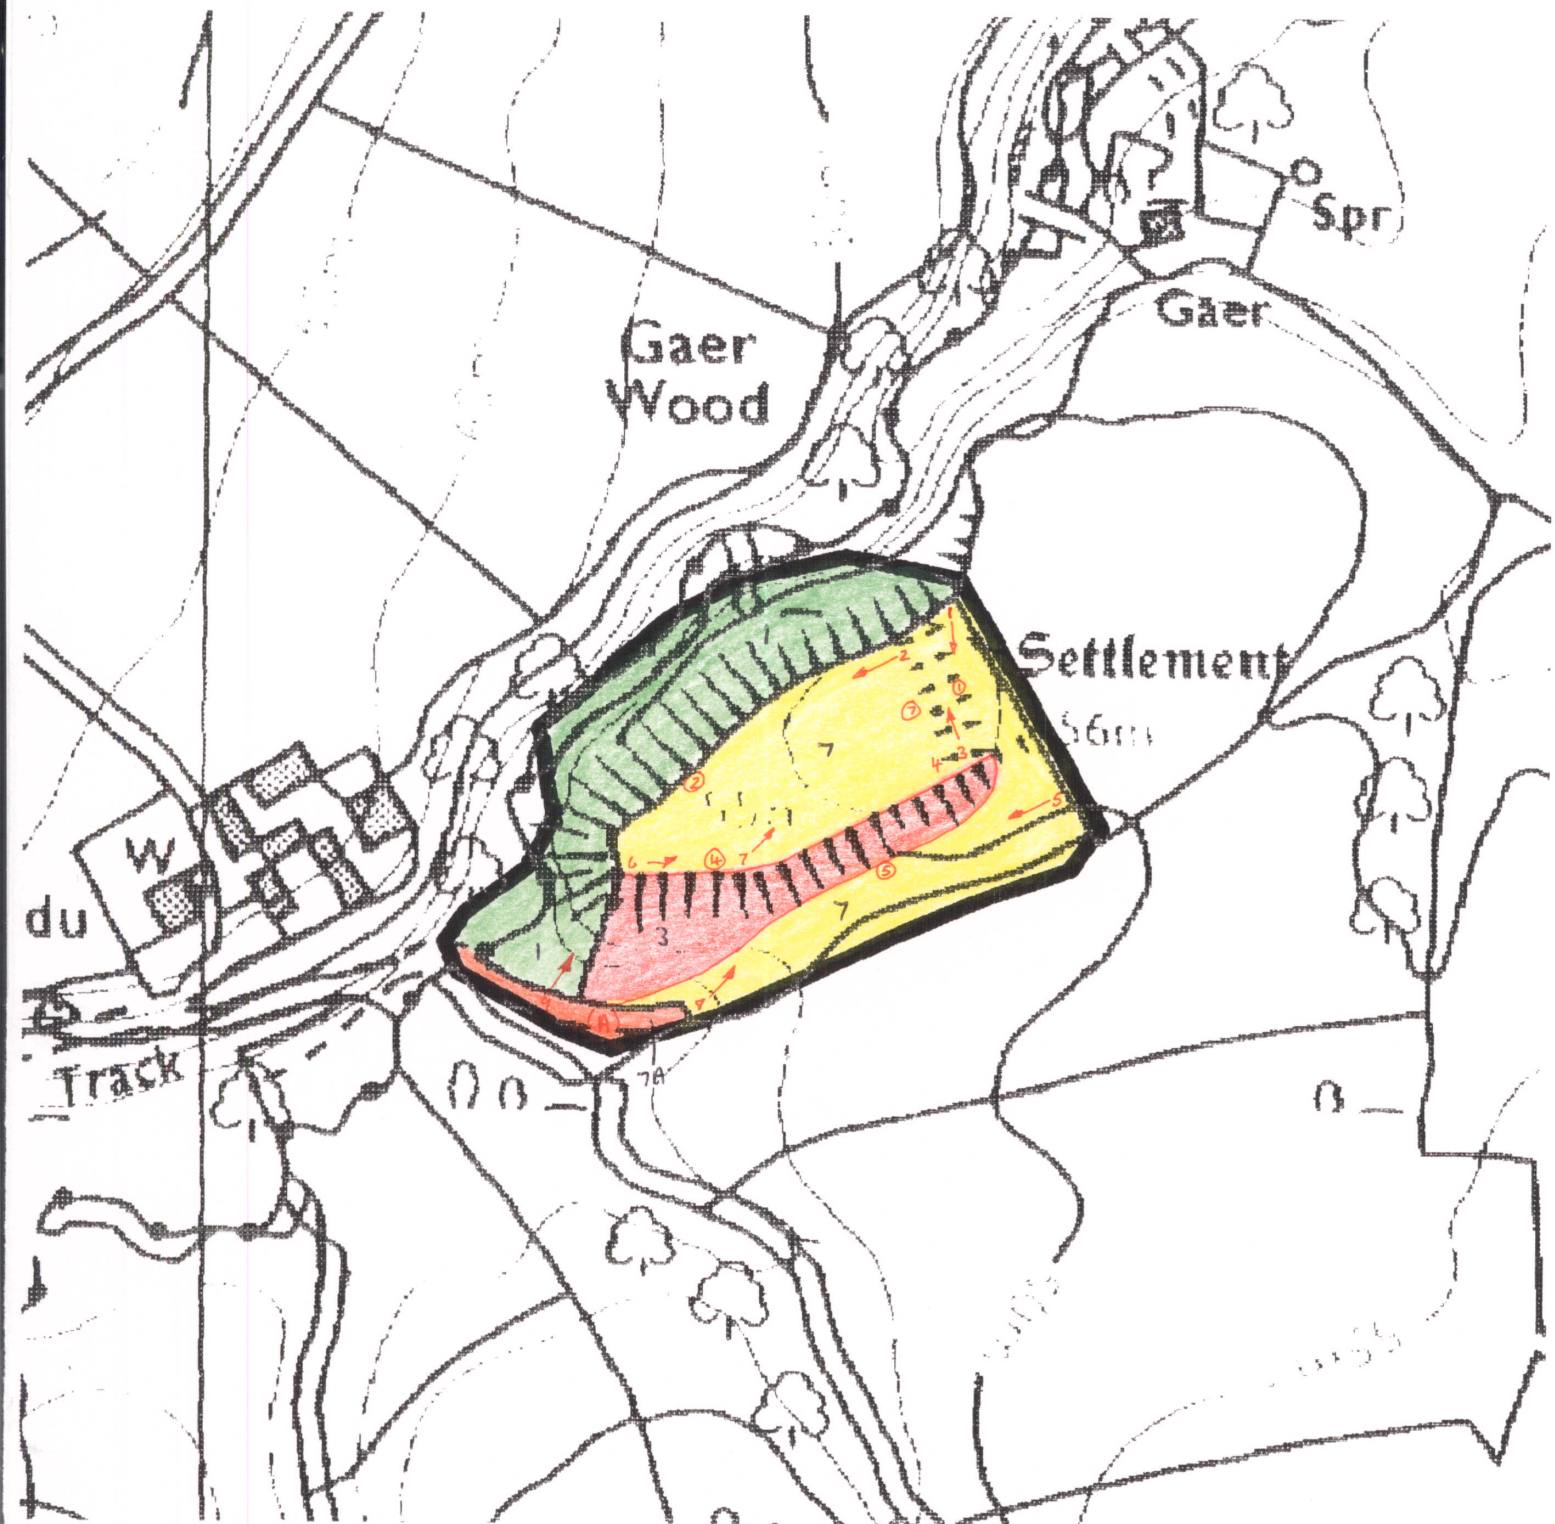
LAND COVER:
SITE: A mix of broadleaved woodland, improved grassland and gorse. Gorse growing on banks of feature.
HALO: grassland wet/marshy in places (A) on map.

Roughly rectangular area bounded on two sides by a fairly well defined bank. River valley forms one boundary - no evidence of defensive bank here. Opposite bank covered in gone and fairly well obscured. Very obvious bank at NE end ranging from 1 - 2.5 m in height. Clearly defined with smooth profile + continuous grass cover.

- 1) Sheep tracks eroding bank.
- 2) Badger digging on enclosure area.
- 3) Scrub encroachment - Gone + Hawthorn from banks onto enclosure area.
