PRESELI ESA, HISTORIC MONITORING**BASELINE 1994****A**

OS 1:10000 SHEET: SM/SN 70 NE	GRID REF: SM/SN 7977 1119
PRN: 2620 SITE NAME: CASTLE HEAD	
AIR PHOTO No 29/12/272	LANDSCAPE TYPE: C
No GROUND PHOTOS: 8	
DATE SURVEYED: 29/11/94	SURVEYED BY: GA HOPWOOD
<p>ACCESS: Park in St Dwidgets church car park + walk along Pembrokeshire Coast Path. Grid ref: 803108</p>

PRESELI ESA HISTORIC MONITORING RESURVEY 1997/98

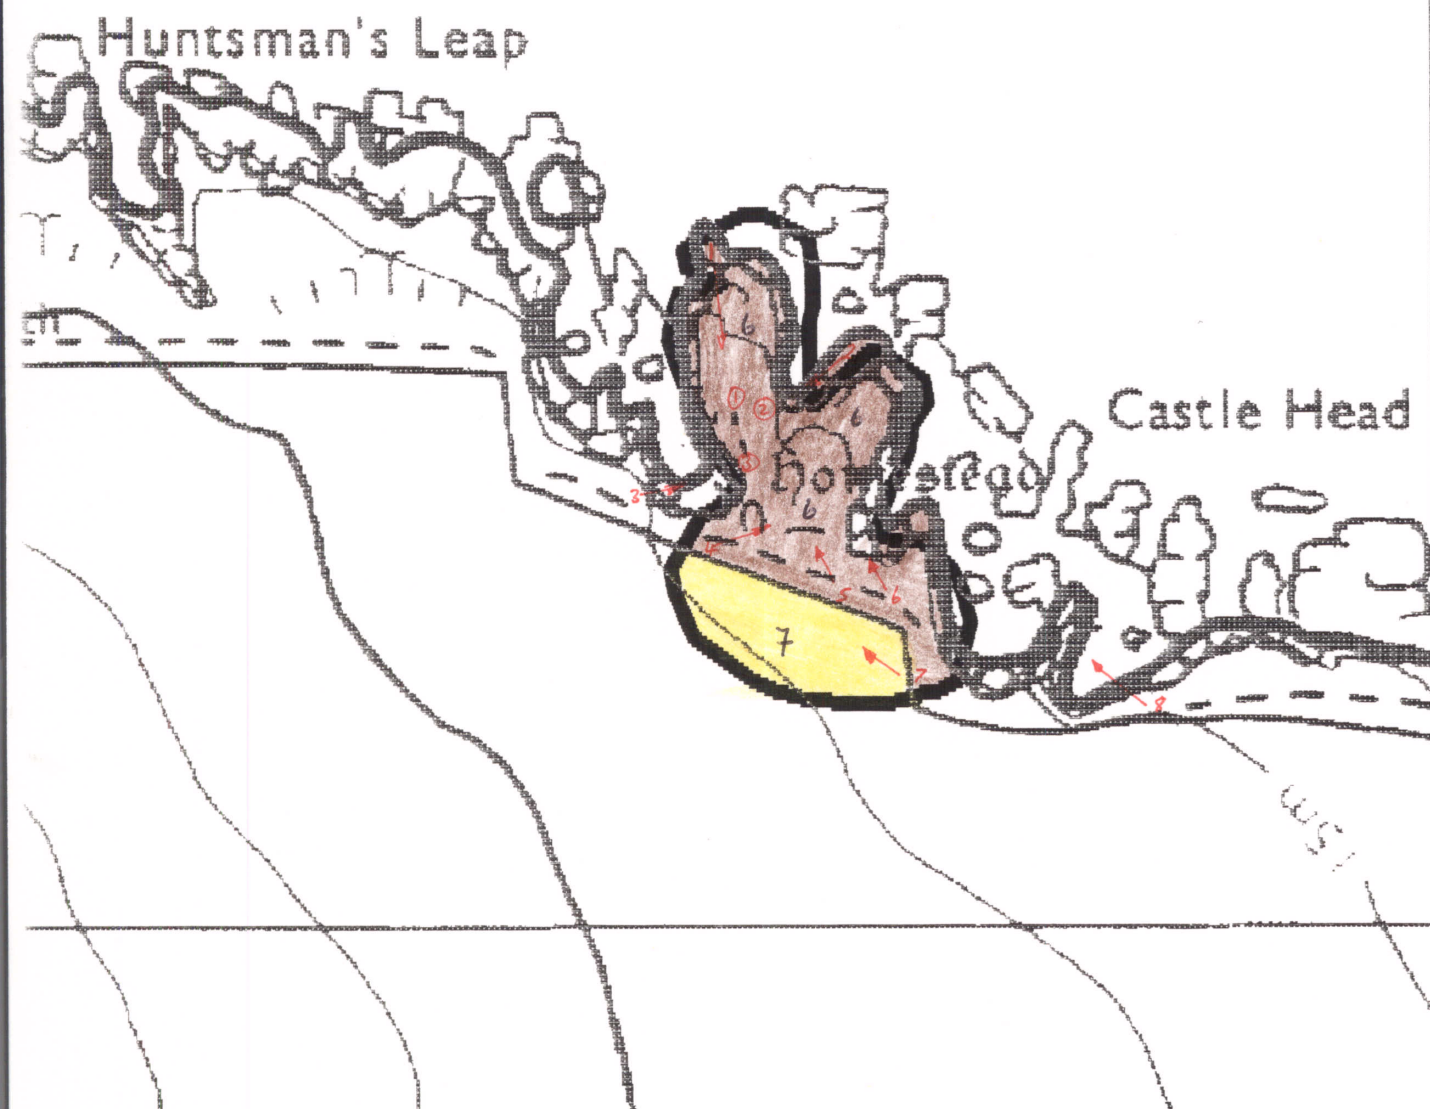
(161) - Areas of rabbit holes/activating

/// LARGE AREAS OF GORSE
see P. 26/20/1

SITE: INCREASED amount of scrub - mainly gorse
on top of fort see map for location

note, rabbit burrowing detected.
(see map for location)

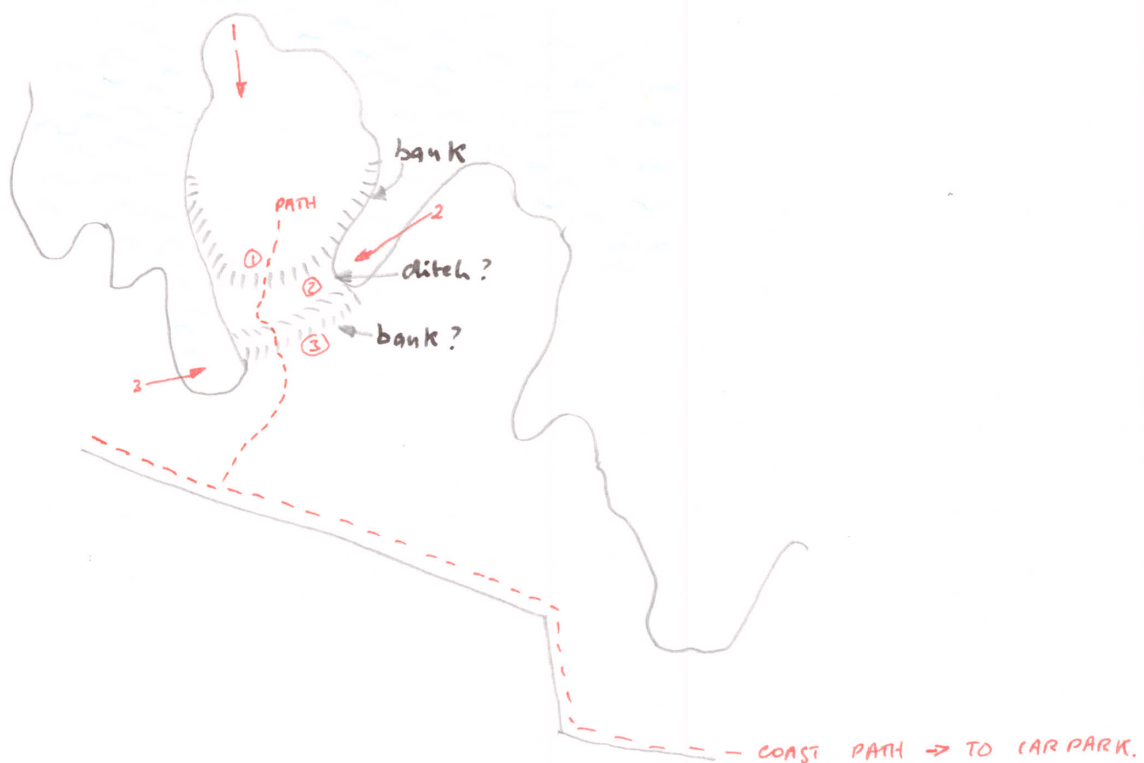
D/

Stands out as a raised bank around part of a headland. The landward side of the headland only appear to have had defences. Evidence of a defensive ditch or ditches + further banks. Land cover is distinctly different on feature - more grassy with gorse. Appears in fairly good condition, no burrowing animal damage. See diag.

E/ Photograph 2 shows what could be a partially filled in defensive ditch.

The site is in a very exposed location with the sea cliffs being eroded all around the feature.
