Historic Environment Feature Management Report:

Elusendy, ruined cottage

Customer Reference Number: A0022082

UID: 306,900

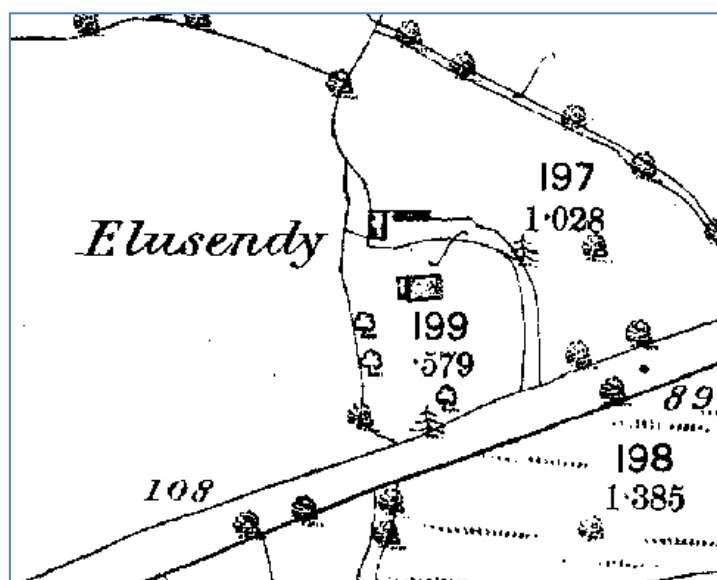
Detail from the Ordnance Survey 1st edition map (1888) © and database right Crown copyright and Landmark Information Group Ltd (All rights reserved 08/05/2012)

Site of a ruined farmhouse marked on the 1st edition OS map and named as Elusendy. It is depicted as an E-W aligned single cell building with a small out-shut on the west side. To the north are two outbuilding. The whole is enclosed within a paddock/garden area. With a curving access track. At a field visit in 1976 it was described as being the ruins of dry stone rubble house of 17th/18thC style with dressed stone windows and corners. Aerial photographs (Next perspectives, 2009) show the area is now covered with mature trees which obscure the extent and condition of any remains. However recent mapping (Mastermap 2011) shows the outline of the house building indicating that it survives in some form (H. Pritchard, 2014)

- Cut any invasive vegetation by hand in order to retain the visibility of the features.
- When removing vegetation cut by hand. Leave roots in situ and spot treat. The action of removing roots can destabilise masonry bonds.
- Spot treat to prevent re-growth.
- Remove any tree limbs overhanging the remains
