Historic Environment Feature Management Report:

Sheepfold 700m NW of Nantyrast

Customer Reference Number: A0023092

UID: 312,428

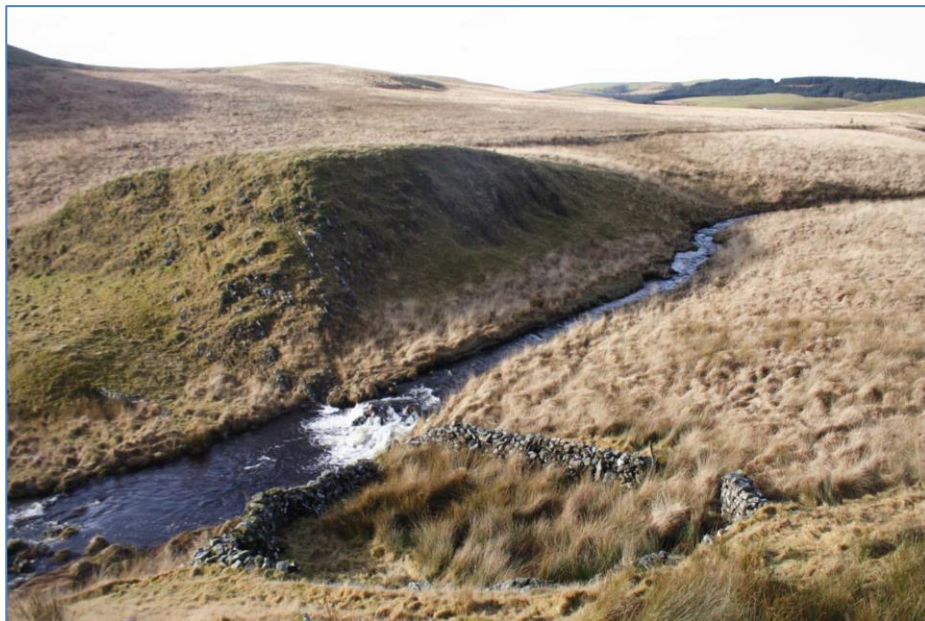
Sheepfold. The walls of the enclosure are of dry-stone wall construction, with an entrance to the north and an exit to the west, opening to the fast-flowing stream. It is used for washing sheep fleeces prior to shearing. It is not known whether the enclosure originally had permanent, wooden gates or hurdles, possibly of willow, were put in place when it was in use. It is understood that some restorative work was undertaken on the structure for the filming of the S4C drama series Dihirod Dyfed in the late 1980s. (H.Pritchard, 2014)

The sheepfold survives as dry stone walls with some post and wire fencing. Sites such as these are vulnerable to intrusive vegetation growth around wall bases damage from livestock sheltering or clambering over the remains dislodging stones from wall tops. Photographs from 2010 show the walls to be sound with the interior being overgrown with rough grass and reed.

- Remove any unwanted vegetation growing from the wall bases.
- Remove excessive vegetation from within the interior
- Reset any loose stones forming the walls.
